A46 Newark Bypass

6.3 Environmental Statement

Appendix 8.13 River Physical Habitat Technical Report

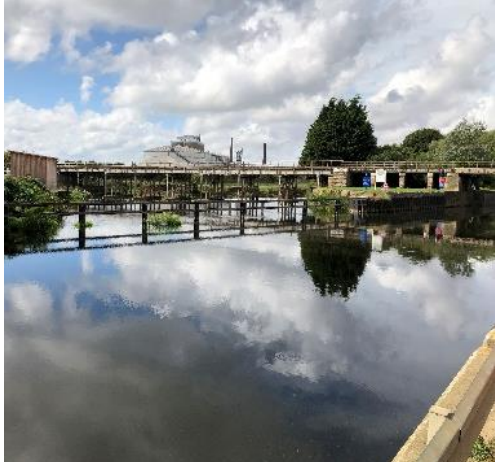
Feature number	Feature type	NGR(s)	Description of ecological significance	Photograph
12	Modification	SK 80127 55310 to SK 80101 55335	Fence across water.

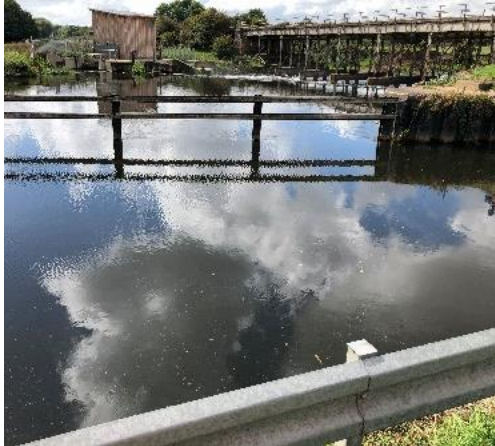
13	Feature	SK 80109 55340	Confluence of main river and lock channel creating localised flow diversity with fish observed to be concentrated in this area.

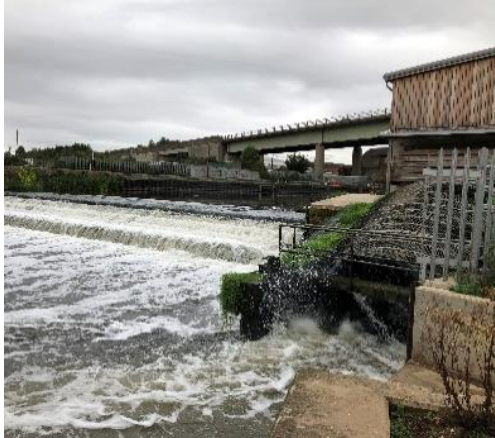
15	Modification	SK 80076 55317	Weir, likely inhibiting fish passage during most conditions; however providing localised flow diversity and oxygenation of water.

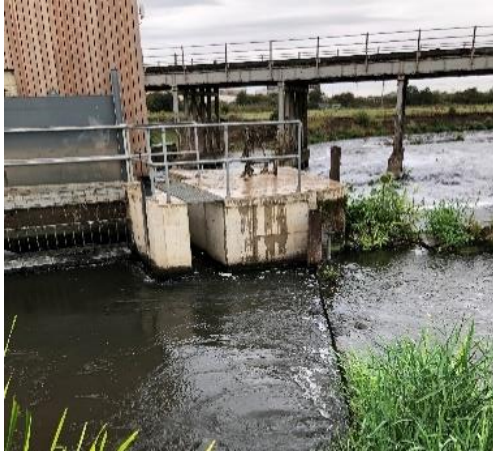
Feature number	Feature type	NGR(s)	Description of ecological significance	Photograph
16	Feature/modification	SK 80087 55292	Fish passage structure on weir.

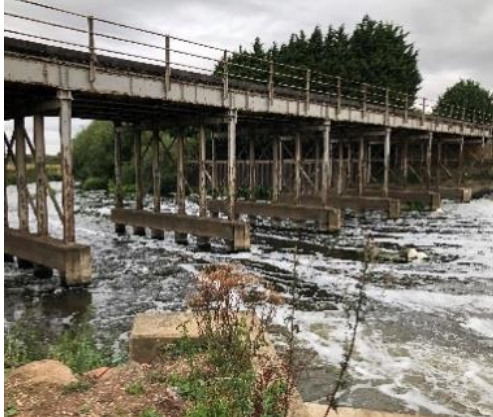
17	Feature	SK 80070 55309 to SK 80007 55490	High flow energy and diversity associated with weir. Area may support various life stages of several fish species including lithophilic spawning.	N/A
18	Modification	SK 80058 55316	Railway bridge over weir. Includes in-channel supports.
