HINCKLEY NATIONAL RAIL FREIGHT INTERCHANGE

Interim Stage 1 Road Safety Audit Response Report

Document reference: 21.1

Report Title:	Hinckley National Rail Freight Interchange – Interim Stage 1 RSA Response Report
Document Number:	HRF-BWB-HGN-RSA-RP-CH-0001
Prepared By:	BWB Consulting Ltd
Overseeing Organisation:	Leicestershire County Council
BWB Reference:	NTT2814

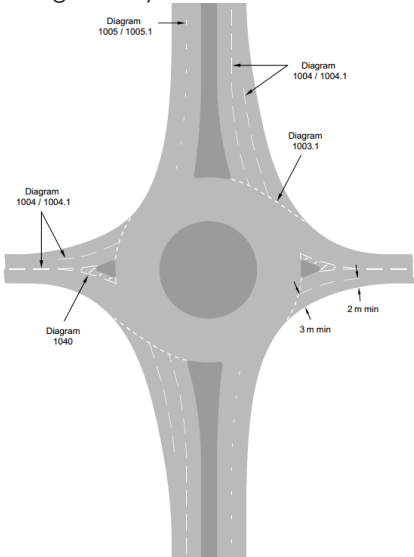
<p style="text-align: center;">Figure 6-1 Conventional roundabout</p>

RSA Ref.	RSA Problem and Recommendation	Design organisation response	Overseeing organisation response	Agreed RSA action
3.2	<p>Location: Coal Pit Lane, B4027 and A5 northbound approaches to the junction.</p> <p>Summary: Narrow lane widths risk side-swipe type collisions.</p> <p>The proposed two-lane approaches appear to show lane widths of under 3.0m. Given the high-speed approaches and high percentage of HGV movements observed and expected through the junction, there is a risk that narrow lanes may result in side-swipe type collisions.</p> <p>Recommendation:</p> <p>It is recommended that the lane widths are reviewed, and that localised widening is provided so that suitable lane widths can be provided</p>	<p>Agree with RSA Recommendation: No</p> <p>The lanes on the approaches to the roundabout flare from 1 to 2 lanes. The geometry here is in accordance with CD116 and the markings for the second lane commence as early as possible in accordance with para 6.1.3 of Traffic Signs Manual Chapter 5 which states: <i>'Where the carriageway is widened on the approach to a roundabout and extra lanes provided, drivers should be made aware of this by marking the lanes as early as possible. However, no lane should be less than 2 m wide at the start of the taper, or less than 3 m wide at the Give Way line (see Figure 6-1)'.</i></p>

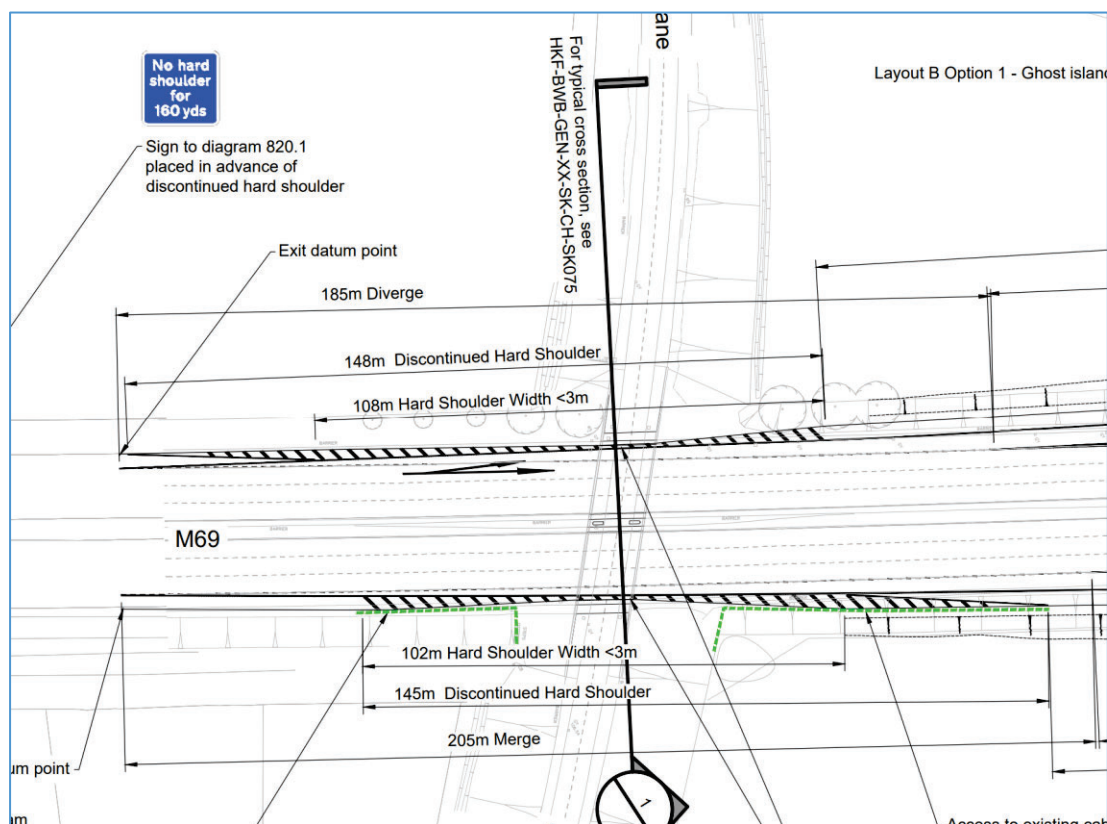
1.7 Having reviewed the implications of these departures on the safety of the network, whilst amendments to the existing vehicle restraint system will be required to accommodate the works no indication is shown on plan of this. It will be essential that working widths and containment levels past identified hazards are maintained and that adequate protection is afforded to maintenance and emergency workers operating in this area. The formal departures report will be awaited before commenting further.

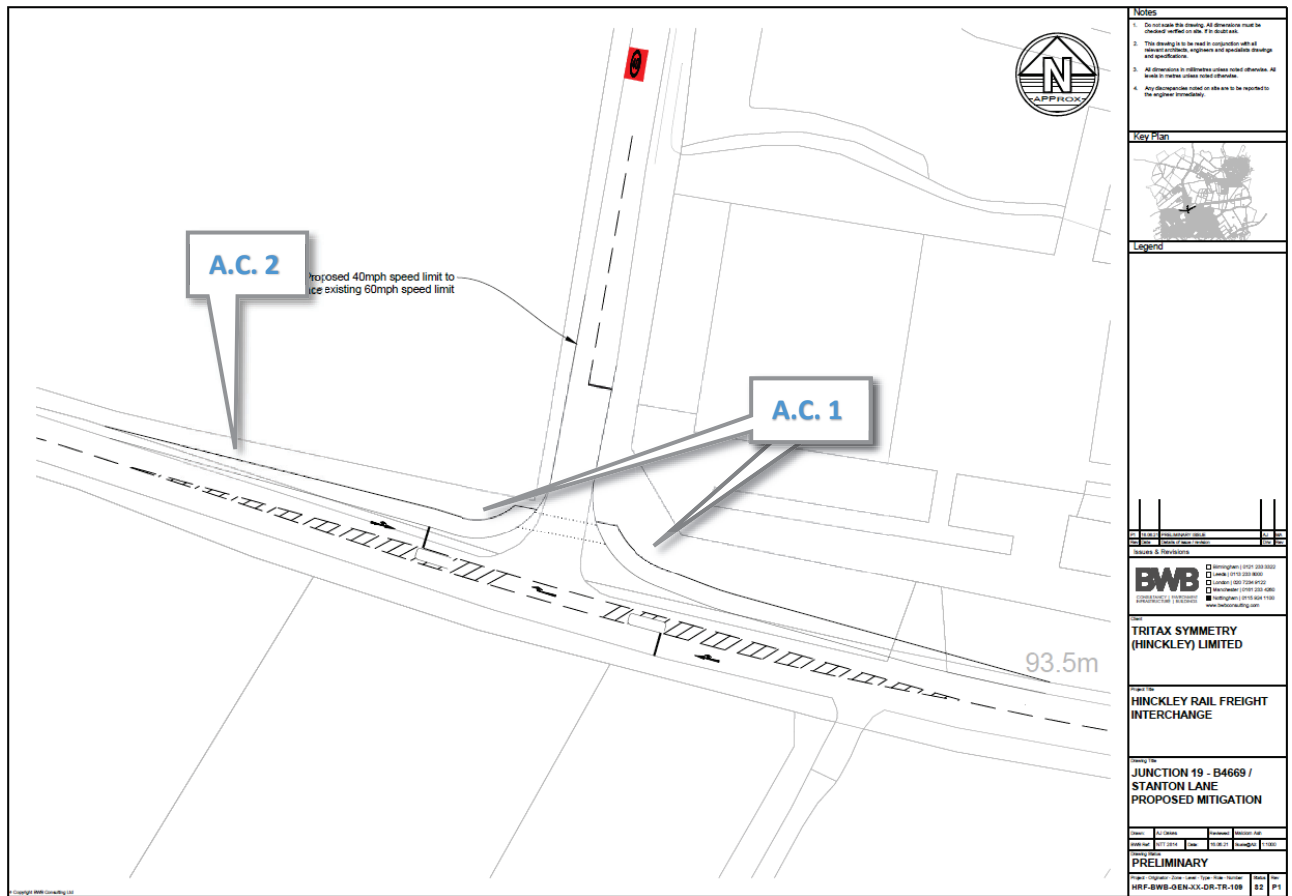
Figure 2 – Problem Location Plan

Whilst on site it was observed that a level difference was present between the base of the hedgerow to the west of the Stanton Lane junction and the existing verge and footway. As part of the proposals this approach will be widened to accommodate the central hatched area and traffic signals infrastructure. As part of the detailed design, it is recommended that the finished levels of the footway and embankment here are reviewed and amended so that there is not an immediate drop to the back of the footway that would pose a risk of injury to pedestrians.

The proposals include a significant set-back for the signals and stop line on the Stanton Lane arm of the junction. As part of the detailed design, it is recommended that suitable inter-greens and vehicle detection are provided so as to ensure that vehicles are able to clear the junction before opposing phases in the signals are ‘released’.

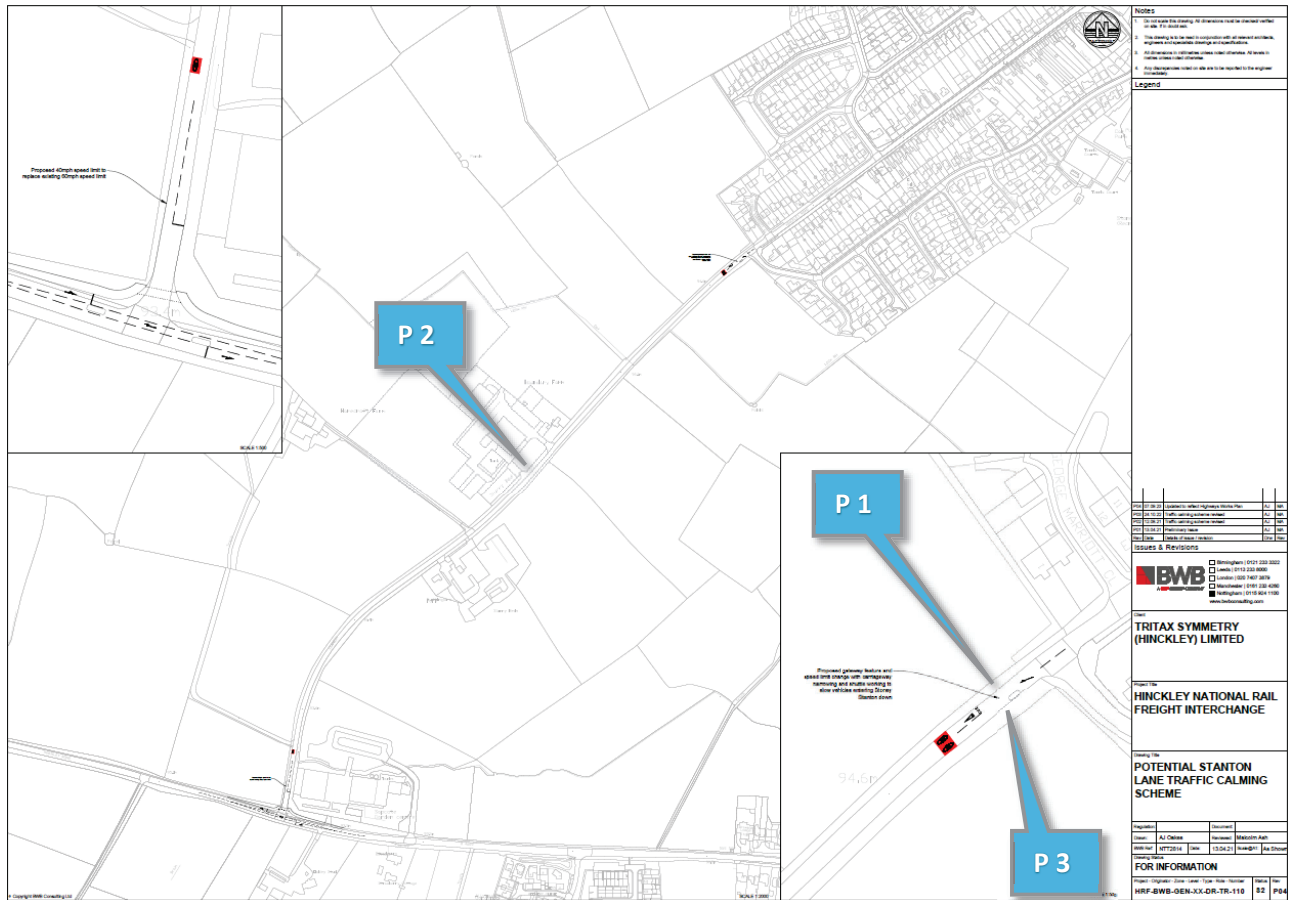
Figure 2 – Problem Location Plan

Whilst on site it was observed that there is a field access opposite the proposed feature on the northern side of Hinckley Road. It is unclear whether a farm vehicle (potentially with a trailer) would be able to turn in/out of the access without overrunning the feature, leading to it being damaged and potentially rendering it inconspicuous to other road users, risking kerb strikes and loss of control collisions.

Traffic flows on Stanton Lane were observed to be low, with little two-way traffic observed at the same time. There is a concern that drivers will seldom be required to give way to oncoming vehicles and, as such, will not be prepared to slow or stop when approaching the give way. This is exacerbated by the location of the proposed feature – within the outbound lane on Stanton Lane – meaning that vehicles required to give way will not have a feature to negotiate or be informed of such. This, along with the potential high-speed approach as detailed in Problem 2 above means that there is a risk of vehicles striking the kerbed build out, as well as failures to give way and late braking, resulting in loss of control or head-on collisions. In the experience of the Audit Team, these types of features in this scenario and as a first response to reducing speed on entry to a village can result in collisions when used in isolation.

It is recommended that a speed survey is undertaken to determine likely compliance with the lower limit. Should speeds be significantly higher than the proposed limit and compliance therefore unrealistic, given a sign only reduction is likely to result in a small reduction in measured speeds, it is recommended that additional measures to support the lower limit are provided, or that the proposed limit is amended in accordance with the results returned from the speed survey.

It is recommended that a swept path analysis is undertaken using appropriate farm vehicles to assess whether they can access/egress the field access without overrunning the feature. If not, it is recommended that the arrangement is amended to accommodate the required movements.

It is recommended that the gateway feature type is amended and / or that additional supportive measures are provided to ensure slow approach speeds at the feature. It is also recommended that should this feature type be provided, that the build-out is located within the in-bound lane, on the side that drivers will be required to give way.
