London Luton Airport Expansion

8.118 Applicant's Response to Issue Specific Hearing 4 Action 7 - Update on Road Safety Audits

Application Document Ref: TR020001/APP/8.118

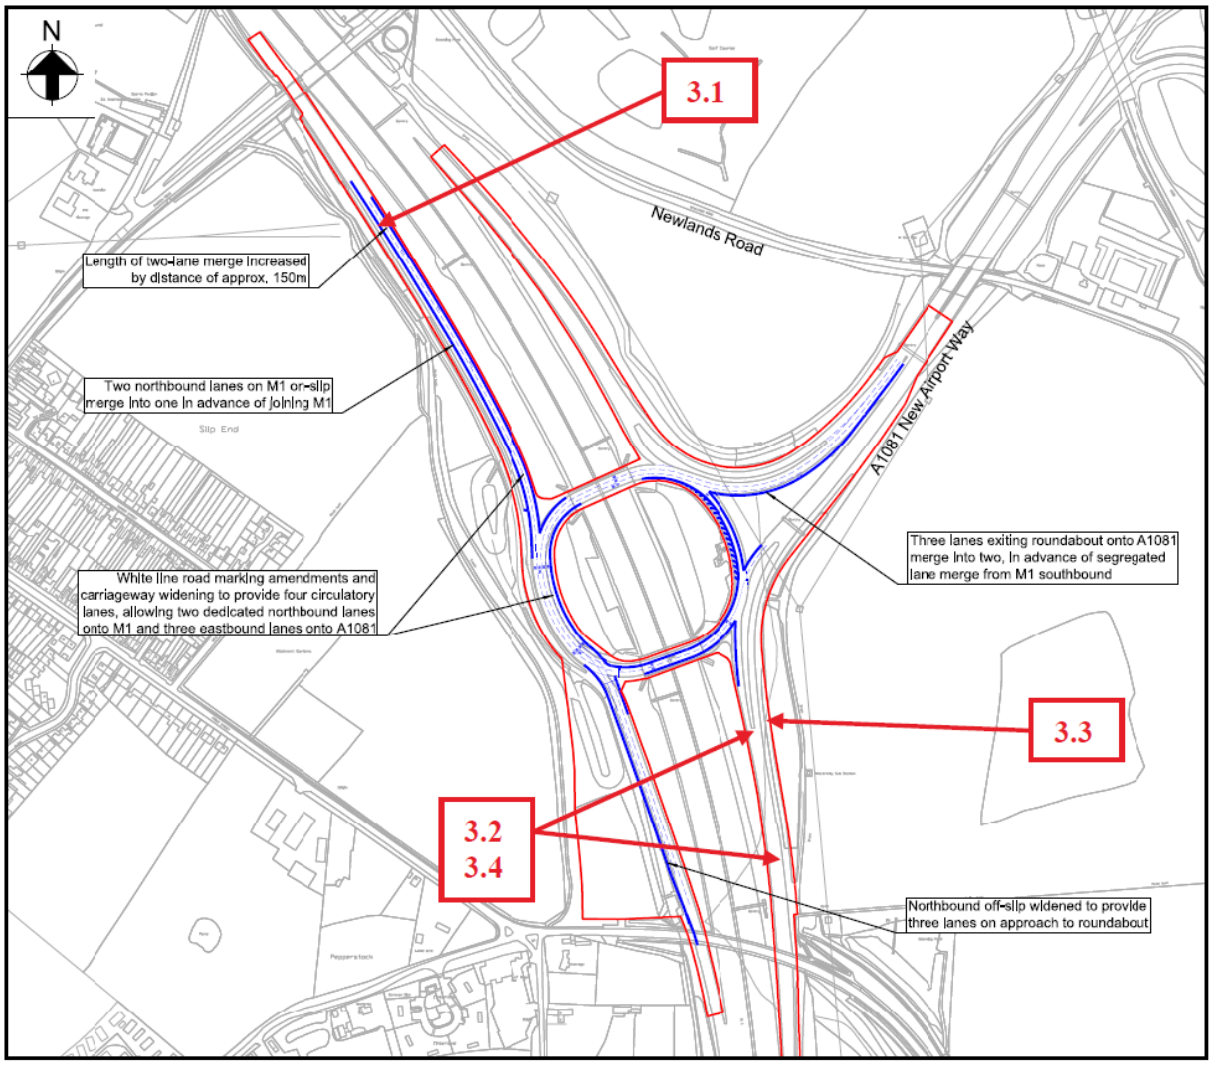
Figure 2.1: Locations of Problems Identified within the Audit

Ref.	RSA Problem	RSA Recommendation	Design Organisation Response	Overseeing Organisation Response	Agreed RSA Action
3.1	Drawing LLADCO-3C-ARP-SFA-HWM-DR-CE-0009 indicates that the length of the two-lane merge is to be extended by 150m. This may result in forward visibility of the merge point being compromised by an existing hidden dip in the northbound on-slip. This problem increases the risk of side swipe and loss of control type collisions.	Ensure that sufficient forward visibility of the merge is maintained.	Accepted. Forward visibility would be checked at the detailed design stage to ensure that appropriate visibility of the merge is maintained.	National Highways agree with the RSA. Traffic on the slip will be visible but the designer has agreed to checks.	Forward visibility would be checked at the detailed design stage to ensure that appropriate visibility of the merge is maintained.

Ref.	RSA Problem	RSA Recommendation	Design Organisation Response	Overseeing Organisation Response	Agreed RSA Action
	problem may be exacerbated due to the short merge length (See Problem 3.4) and potential difference in speed between merging road users and those in the segregated left turn lanes.

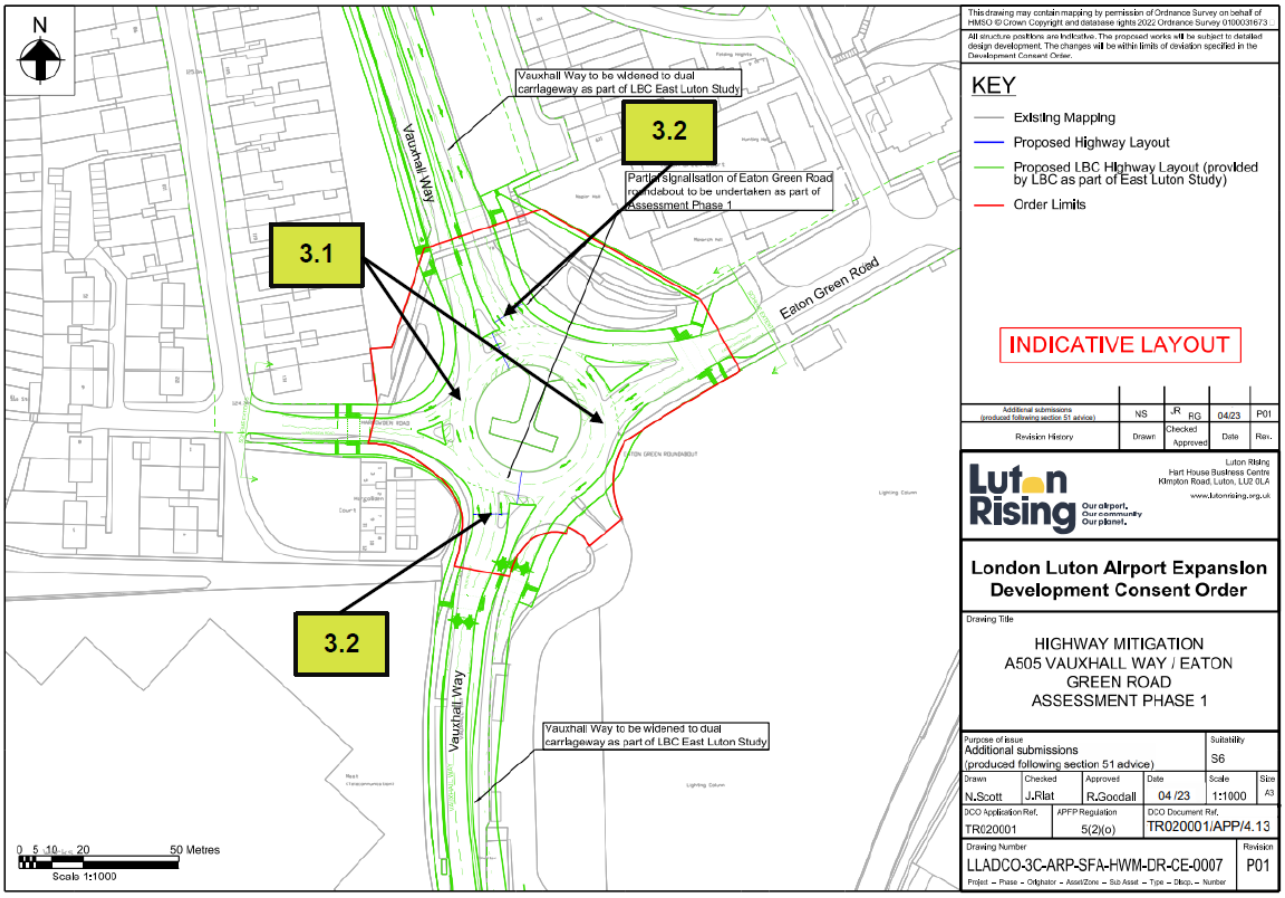
Figure 2.1: Locations of Problems Identified within the Audit

Ref.	RSA Problem	RSA Recommendation	Design Organisation Response	Overseeing Organisation Response	Agreed RSA Action
3.1	The stacking distance between successive signal stop lines is quite short, which could lead to vehicle queues extending across the Harrowden Road and Eaton Green Road entries to the roundabout. As a result, collisions could occur as road users attempt to weave through queues or change lane suddenly.	It should be ensured that the road layout and traffic signalling strategy is suitable to prevent vehicles queuing across entry arms to the roundabout.	Accepted. The operation of the signals would be optimised to ensure the efficient operation of the junction and would include consideration of queue lengths within the circulatory carriageway of the roundabout.	Design Response is accepted.	RSA recommendation to be adopted as part of the detailed design.

3.2	The widening to three lanes on the approaches to the junction could increase the likelihood of the primary signals being masked by high sided vehicles. If a red signal is not clearly visibly to road users, there could be an increased risk of overshoot collisions or accidents involving sudden and late braking, such as rear-end shunts.	High-mounted duplicate primary signals should be provided on the Vauxhall Way approaches to the junction.	Accepted. The provision of high-mounted signals would be considered at the detailed design stage.	Design Response is accepted.	RSA recommendation to be adopted as part of the detailed design.

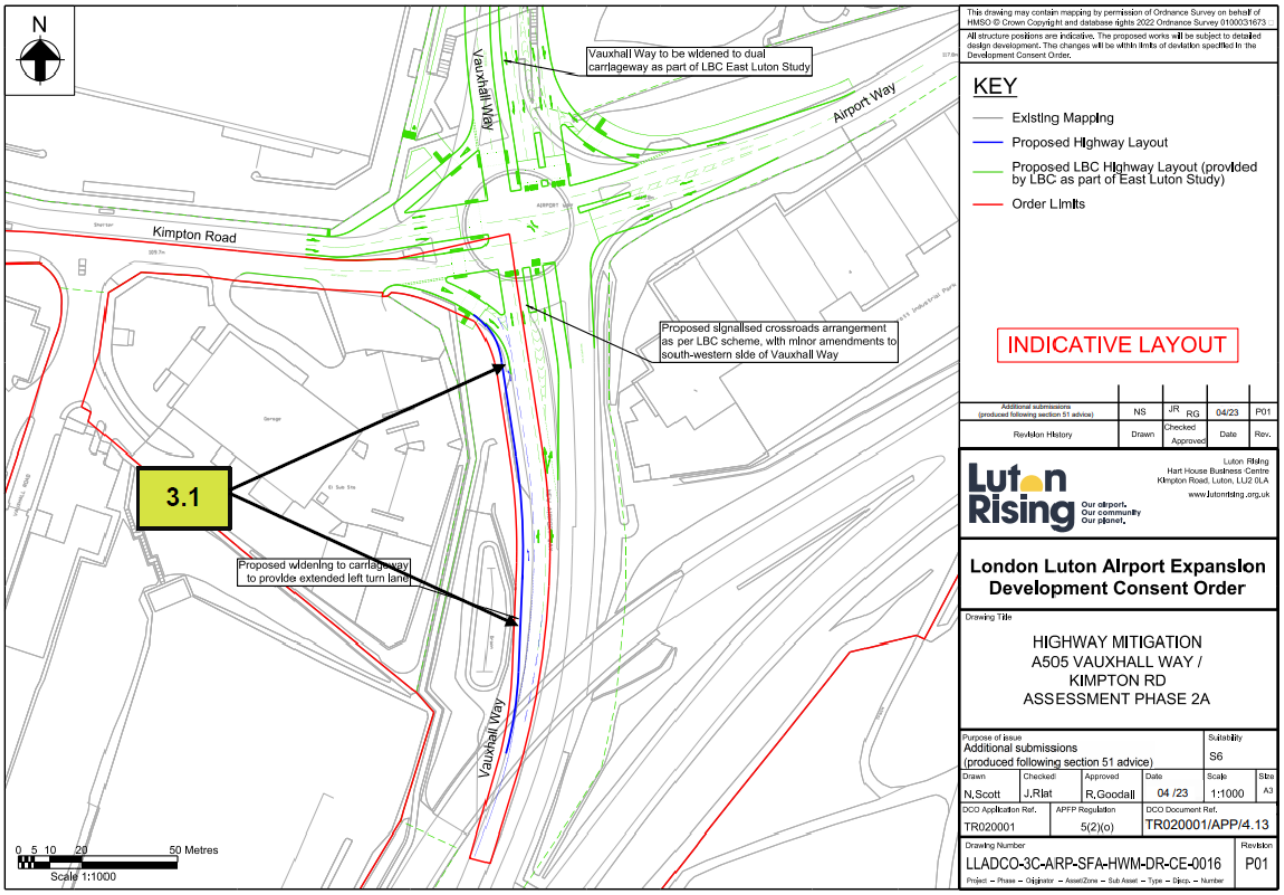
Figure 2.1: Locations of Problems Identified within the Audit

Ref.	RSA Problem	RSA Recommendation	Design Organisation Response	Overseeing Organisation Response	Agreed RSA Action
3.1	There are lamp columns and trees within the verge that will be closer to the edge of carriageway when the road is widened. A temporary vertical concrete barrier is also present, but it is not clear whether this will be retained. If not, the lamp columns and trees could present a roadside hazard to road users if they lose control and collide into the objects. Injuries could be serious if vehicles are brought to an abrupt halt or redirected violently.	A suitable vehicle restraint system should be provided, unless the lamp columns are replaced by passively safe systems and any mature trees removed that will be close to the edge of carriageway.	Accepted. This would be addressed at the detailed design stage.	Design Response is accepted.	RSA recommendation to be adopted as part of the detailed design.

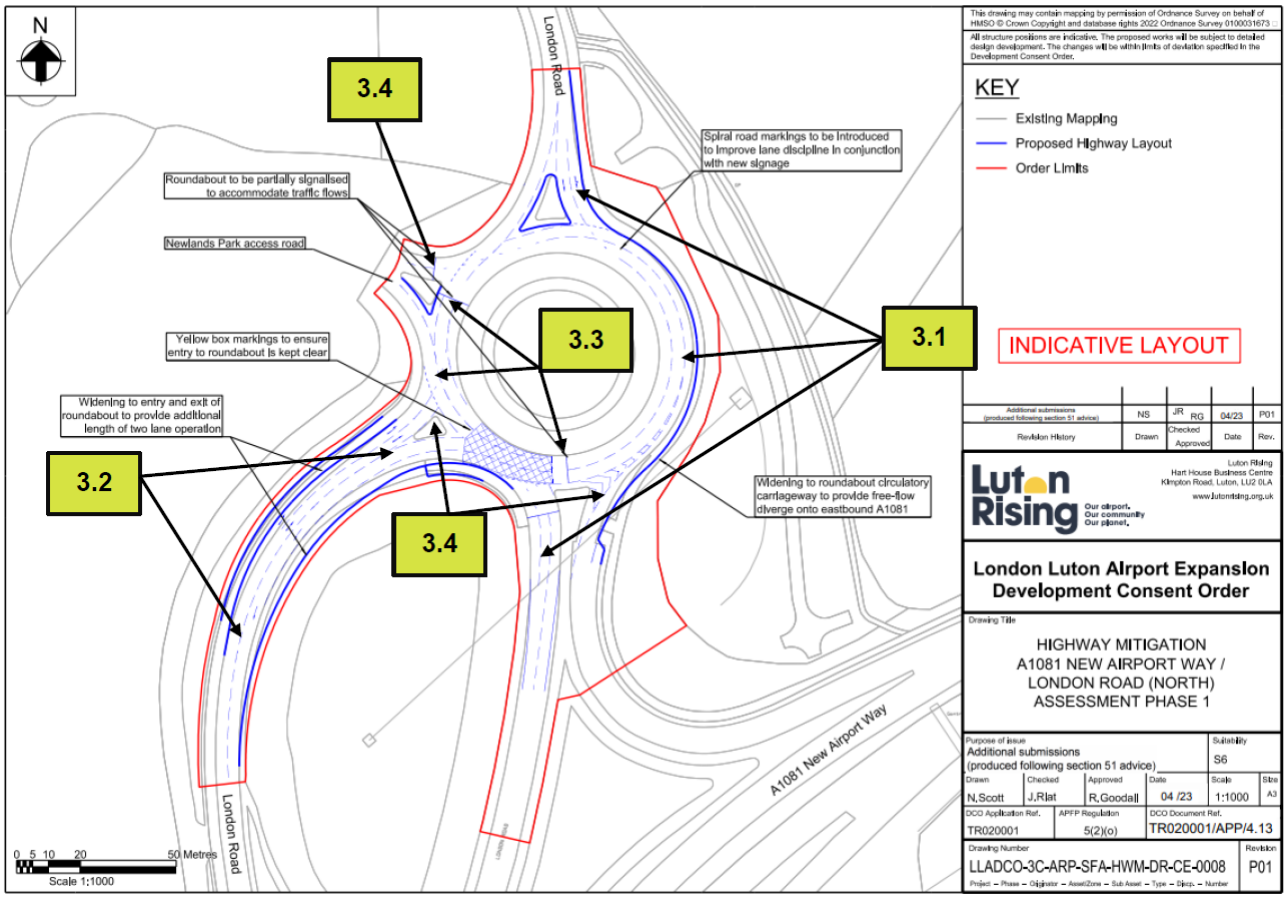
Figure 2.1: Locations of Problems Identified within the Audit

Ref.	RSA Problem	RSA Recommendation	Design Organisation Response	Overseeing Organisation Response	Agreed RSA Action
3.1	Road users may not be able to anticipate which lanes to use to reach their intended destination. For example, on the A1081 approach, road users may use the middle lane to reach London Road (north) rather than the designated offside lane. On the London Road southbound approach, road users may use the offside lane to reach the A1081 (which they can currently), instead of using the nearside lane only. If road users find that they are in the incorrect lanes, side swipe and lane change collisions could occur.	Lane destination signs and road markings should be provided at strategic locations to inform road users of the correct lanes to use.	Accepted. Lane markings and signage would be provided to clarify which destinations are reached from each approach lane. This would be addressed at the detailed design stage.	Design Response is accepted.	RSA recommendation to be adopted as part of the detailed design.

Ref.	RSA Problem	RSA Recommendation	Design Organisation Response	Overseeing Organisation Response	Agreed RSA Action
3.3	The stacking distance between successive signal stop lines is quite short, which could lead to vehicle queues extending across the London Road southern entry to the roundabout. As a result, collisions could occur as road users attempt to weave through queues or change lane suddenly.	It should be ensured that the road layout and traffic signalling strategy is suitable to prevent vehicles queuing across entry arms to the roundabout.	Accepted. The operation of the signals would be optimised to ensure the efficient operation of the junction and would include consideration of queue lengths within the circulatory carriageway of the roundabout.	Design Response is accepted.	RSA recommendation to be adopted as part of the detailed design.

3.4	The widening of the roundabout could make crossing movements more hazardous for pedestrians and cyclists, especially at times of high vehicle flows (peak times) or when speeds could be higher at off-peak times. This could be a particular issue on the London Road southern arm and on the A1081 exit arm. On the Newlands Park access entry to the roundabout, the position of the signal stop line could make it difficult to provide a crossing point. Vulnerable road users could be at increased risk of being struck by vehicles under such circumstances.	It should be ensured that the pedestrian and cycle crossing points will be safe to use (for example, controlled crossings may be beneficial at some locations).	Noted. The proposed realignment on the A1081 exit arm increases the crossing distance by approximately 1.0m and could be reduced at the detailed design stage to minimise any additional crossing distance. The pedestrian demand on the London Road (south) exit arm is likely to be very low, and the proposed signalisation of the A1081 arm should create gaps in the traffic for pedestrians to cross. In addition, the widening to the London Road exit is c1.5m and would only add c.1 second to the crossing time for pedestrians.	Design Response is noted. Recommend that non-motorised user demand is reviewed as part of the detailed design.	RSA recommendation is noted and overseeing organisation comment accepted.

Ref.	RSA Problem	RSA Recommendation	Design Organisation Response	Overseeing Organisation Response	Agreed RSA Action
			The position of the stop line at the exit from Newlands Park would be adjusted to accommodate a pedestrian crossing at the detailed design stage.

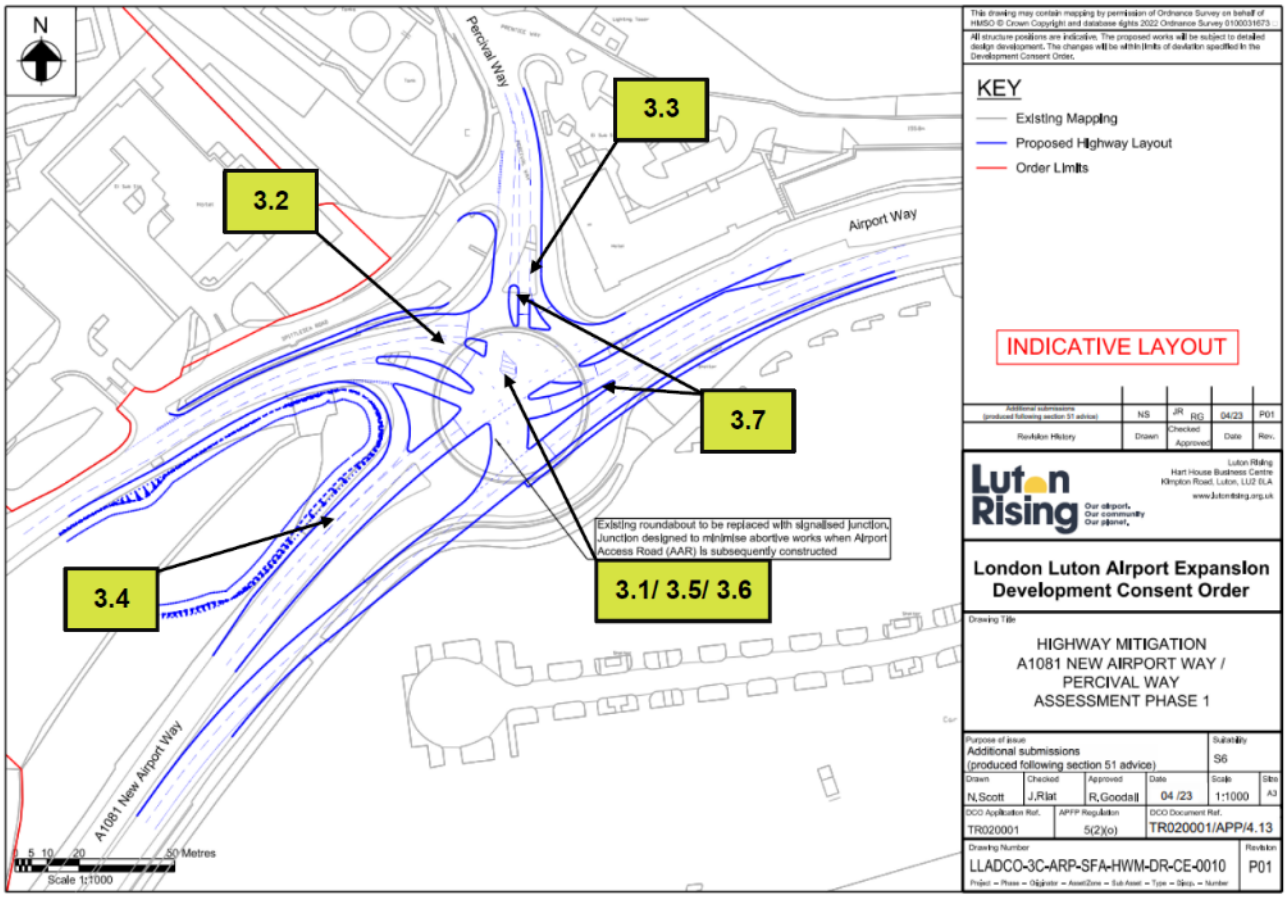
Figure 2.1: Locations of Problems Identified within the Audit

Ref.	RSA Problem	RSA Recommendation	Design Organisation Response	Overseeing Organisation Response	Agreed RSA Action
3.1	It was noted that the existing roundabout for New Airport Way and Percival Way is on a steep gradient which slopes away from the north side. With the introduction of the signalised junction there could be a level difference between each approach, which could create an adverse camber for vehicles turning at the junction. This could increase the risk of loss of control collisions and could cause larger, high sided vehicles to turn over.	The levels should be checked for each approach ensuring a level junction platform with no adverse cambers for vehicle turning movements.	Accepted. It is accepted likely that some regrading would be required on the approaches to and within the junction. This would be addressed at the detailed design stage.	Design Response is accepted.	RSA recommendation to be adopted as part of the detailed design.

Ref.	RSA Problem	RSA Recommendation	Design Organisation Response	Overseeing Organisation Response	Agreed RSA Action
3.3	The vertical alignment for Percival Way on the approach to the junction is on a steep downhill section. With the introduction of the signal control there could be more sudden braking movements such as when the lights change from green to red. This combined with being on a downhill section could increase the risk of loss of control and subsequent shunt and junction overshoot collisions.	A level dwell area of suitable length should be created for this arm of the junction.	Accepted. See response to 3.1.	Design Response is accepted.	RSA recommendation to be adopted as part of the detailed design.

3.7	It is not known at this stage if there are going to be any controlled crossing facilities at the proposed signalised junction. It is noted that for Airport Way and Percival Way there are existing shared footway/ cycleways and uncontrolled crossing facilities which link to a nearby hotel and car park area. With the new multilane signalised arrangements with greater crossing distances this could increase the risk of collisions with pedestrians and cyclists.	Pedestrian and cyclist movement should be reviewed around the junction and appropriate controlled crossing facilities should be installed where required such as Toucan crossings. These should also be compliant with the latest cycling guidance, such as LTN 1/20.	Accepted. There is flexibility within the junction design to accommodate crossing facilities on existing desire lines and this would be considered at the detailed design stage.	Design Response is accepted.	RSA recommendation to be adopted as part of the detailed design.

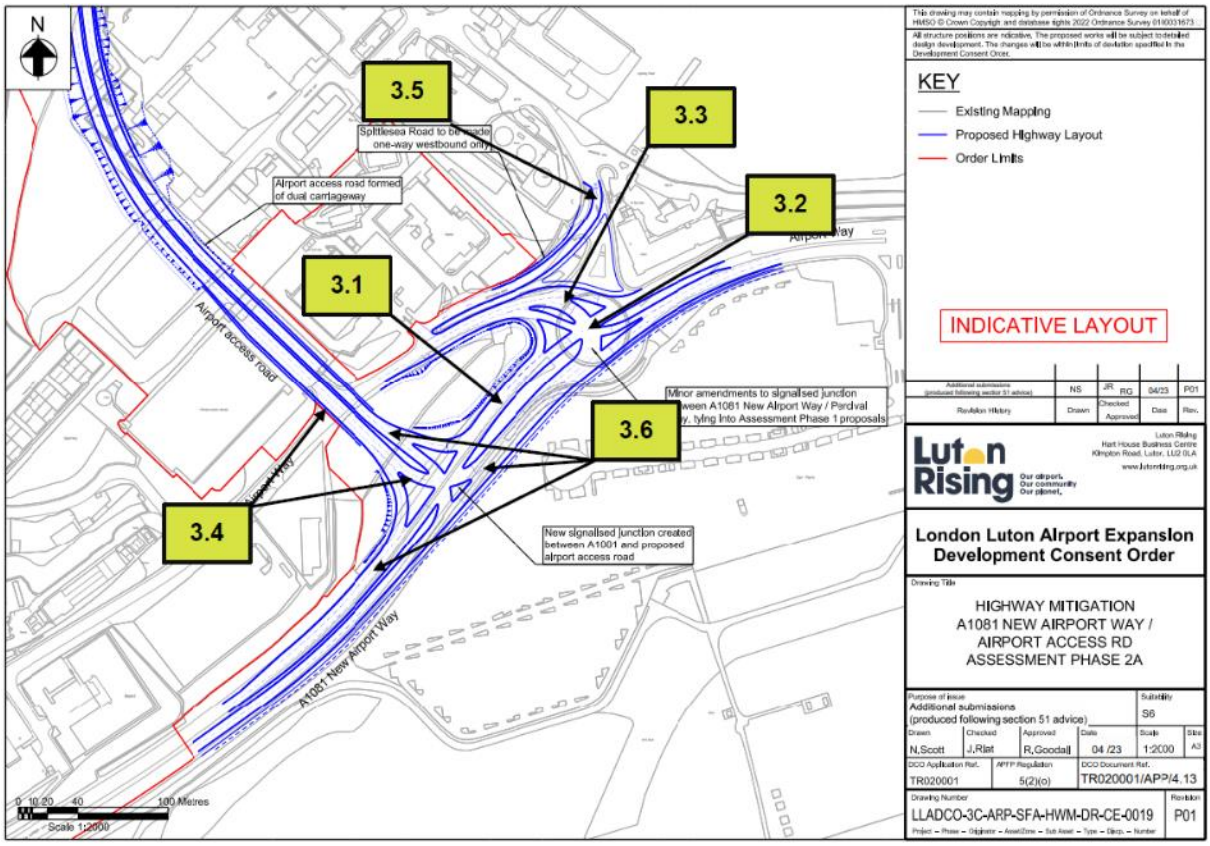
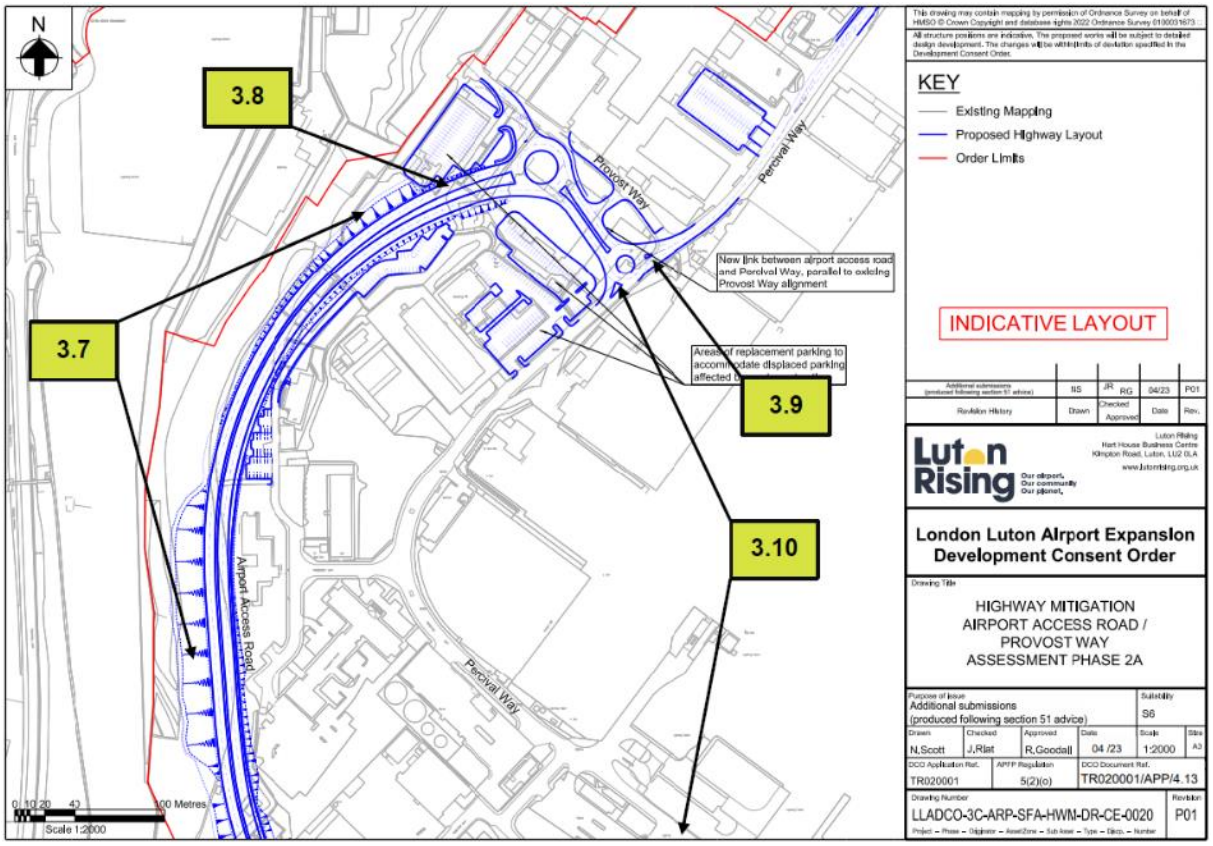
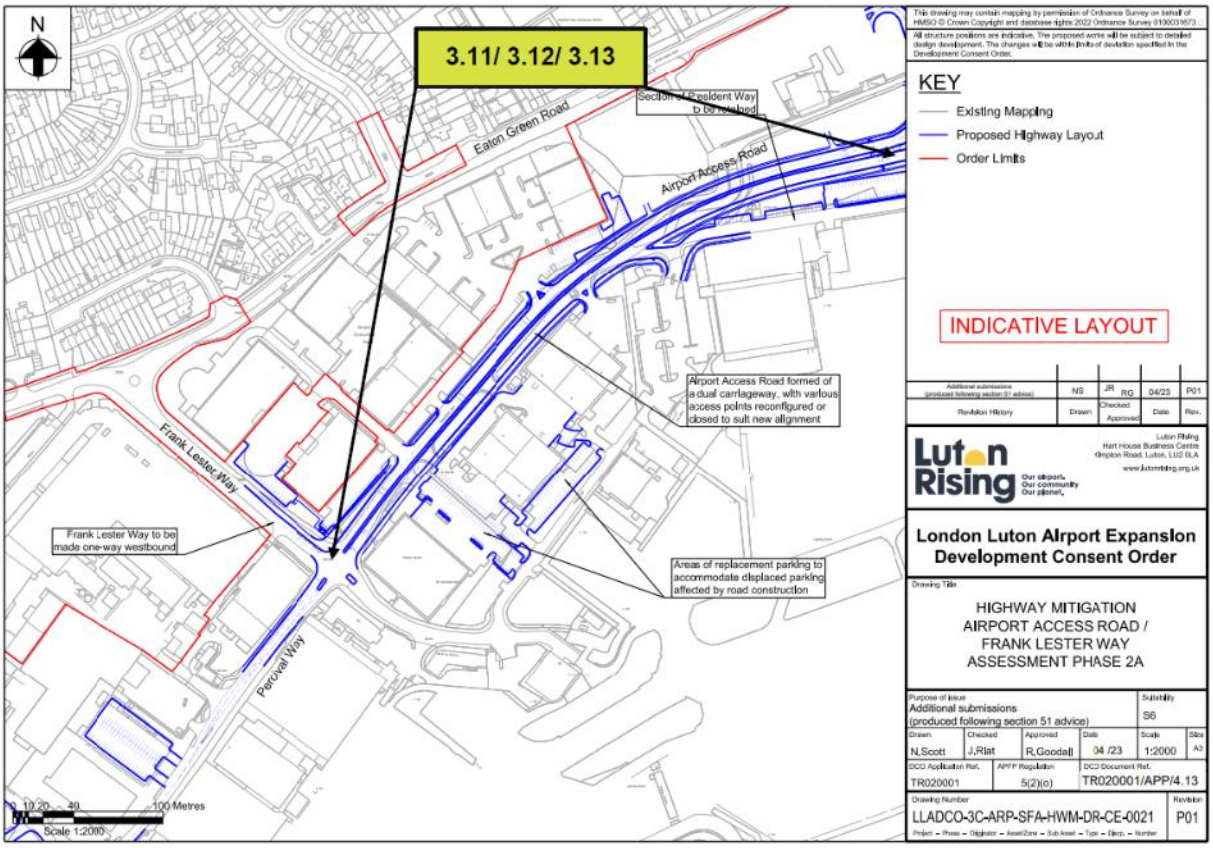
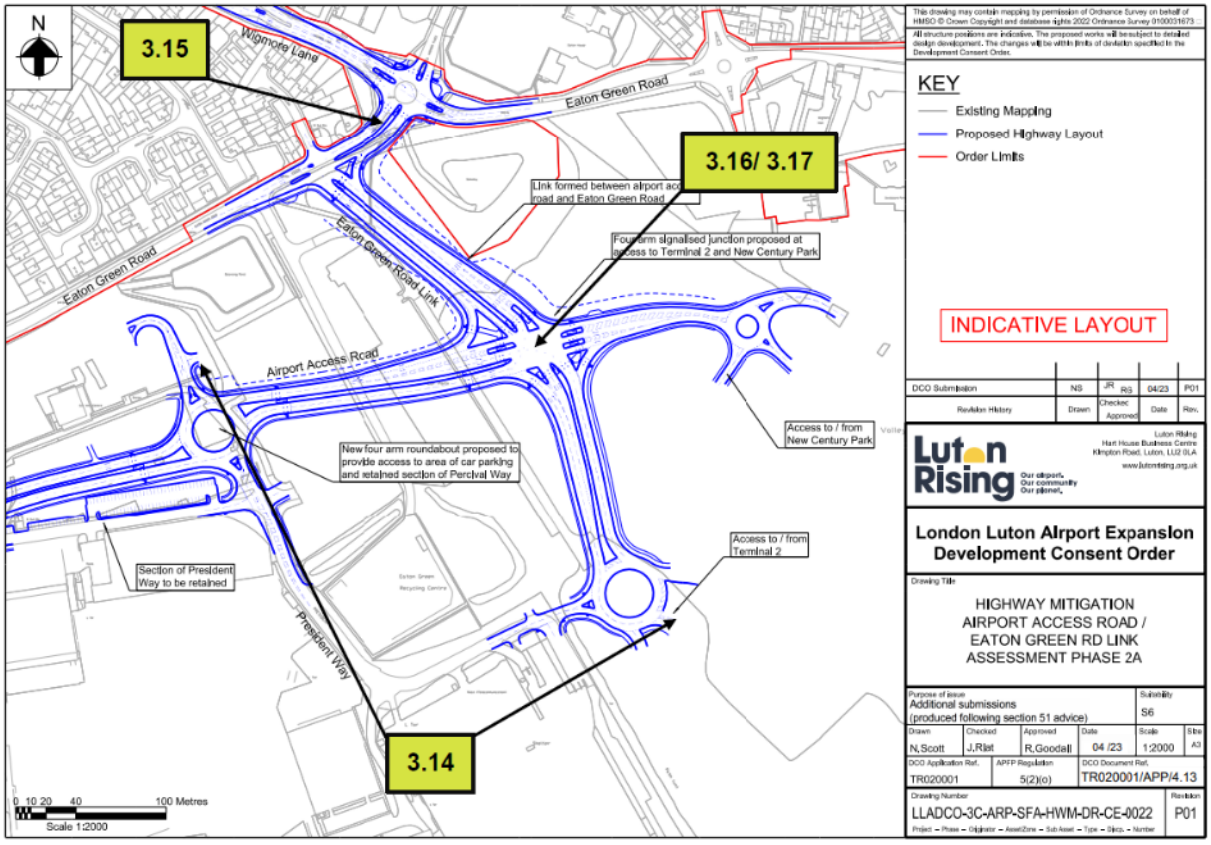
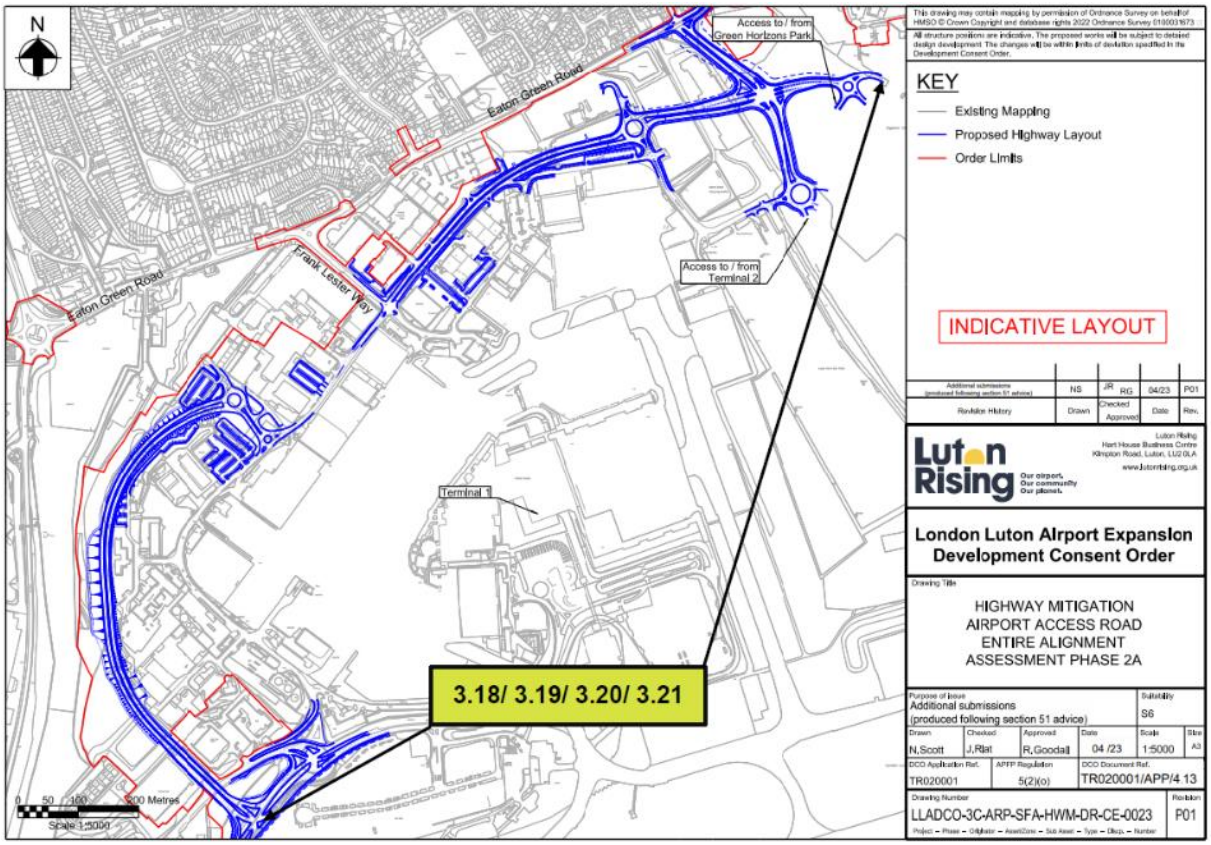
Ref.	RSA Problem	RSA Recommendation	Design Organisation Response	Overseeing Organisation Response	Agreed RSA Action
3.1	Due to the close proximity of the two proposed signalised junction for this A1081 section of the scheme, there is limited traffic stacking capacity between them. Depending on the signal phasing and timings for each junction, traffic could queue back into the other junction, such as when one is at a red light phase and the other is on a green light. Road users might not expect to have to slow down suddenly for queuing traffic as they pass through the junction, increasing the risk of shunt collisions.	At detailed design stage the stacking capacity and signal phasing of the junctions should be reviewed, ensuring they are synchronised, and that the junction throughput is adequate for the expected traffic flow levels.	Accepted. The traffic signals would be designed to operate in the most efficient manner, taking account of the stacking capacity between the junctions. This would be addressed at the detailed design stage.	The Design organisation's response is noted and accepted. Traffic signal design should be undertaken in consultation with the highway authority	RSA recommendation is noted and overseeing organisation comment accepted.

3.2	It was noted that the existing roundabout for New Airport Way and Percival Way is on a steep gradient which slopes away from the north side. With the introduction of the signalised junction there could be a level difference between each approach, which could create an adverse camber for vehicles turning at the junction. This could increase the risk of loss of control collisions and could cause larger, high sided vehicle to turn over.	The levels should be checked for each approach ensuring a level junction platform with no adverse cambers for vehicle turning movements.	Accepted. It is acknowledged that regrading of the existing levels would be required to construct the new signalised junction. This would be addressed at the detailed design stage.	The design organisation's response is noted and accepted	RSA recommendation is noted and the design organisation comment accepted.

Ref.	RSA Problem	RSA Recommendation	Design Organisation Response	Overseeing Organisation Response	Agreed RSA Action
3.3	Airport Way currently has a steep approach to the roundabout with no level dwell area. With the introduction of the signalised junction, there are likely to be more hill starts from traffic being stationary on a red light. This could result in slow get aways, especially for HGV's, where there could be the increased risk of shunt collisions from traffic following, who might not be expecting the slow speeds. This could also reduce the throughput capacity for this arm at the junction and increase queue lengths.	A level dwell area of suitable length should be created for this arm of the junction.	Accepted. See response to 3.2.	The design organisation's response is noted and accepted	RSA recommendation is noted and the design organisation comment accepted.

3.4	With the steep level differences between the proposed airport access road and the New Airport Way (A1081) Junction, it is assumed to overcome this, the access road will be elevated and there will be a bridge at its intersection with Airport Way. This could lead to high drop offs from the edge of the carriageway, which could increase the risk of fall hazards, such as in the case of any errant vehicle leaving the carriageway.	At detailed design stage a suitable vehicle restraint system should be devised for the junction and its approaches, including at the intersection with Airport Way. As per Problems 3.2 and 3.3, the camber should also be reviewed for turning vehicles and level dwell areas introduced for all approaches.	Accepted. A vehicle restraint system (VRS) would be provided where appropriate and levels regraded as necessary. This would be addressed at the detailed design stage.	The design organsation's response is noted and accepted	RSA recommendation is noted and the design organisation comment accepted.

3.5	With the merging of Percival Way into Spittlesea Road, which will form a righthand bend into a one-way road, the alignment on this approach is on a downhill section,	The levels should be reviewed ensuring the righthand bend is a banked turn.	Accepted. Levels would be designed to the appropriate standard at the detailed design stage.	The design organisation's response is noted and accepted	RSA recommendation is noted and the design organisation comment accepted.

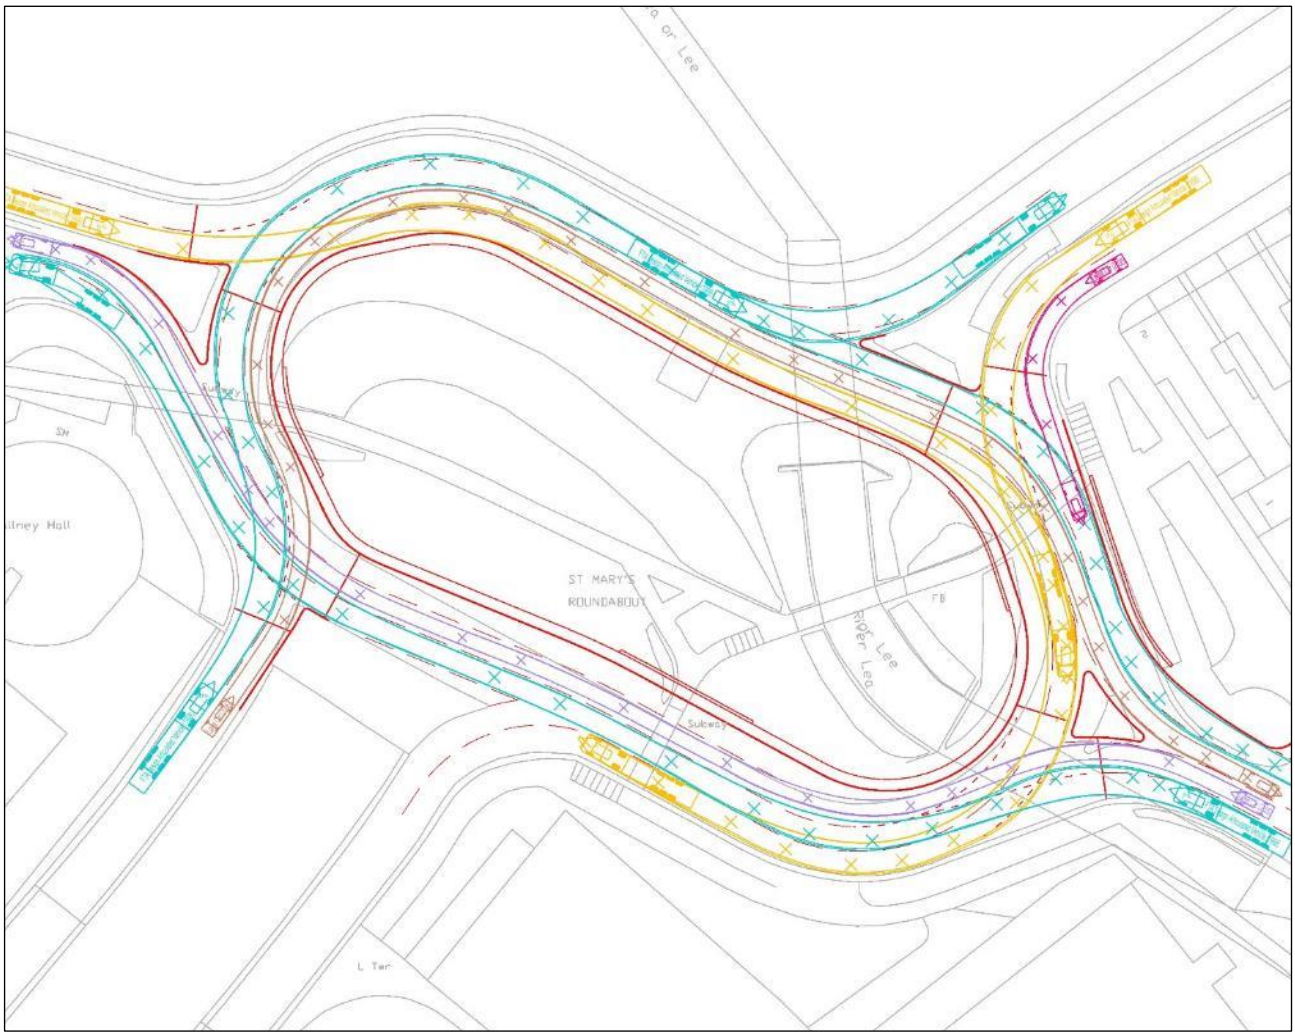
Figure 3.1: Swept Paths - Windmill Road / St. Mary's Road / Crawley Green Road

3.2.2 Whilst these swept paths show that there would be some overrunning of lanes for HGV manoeuvres, it is noted that a significant majority of the design retains the current lane widths and entry widths/radii, with the main change being the addition of an additional circulatory lane on the inside of the roundabout. As such, many of the areas where overrunning occurs are existing, and widening or realignment has been proposed where possible to mitigate these issues.

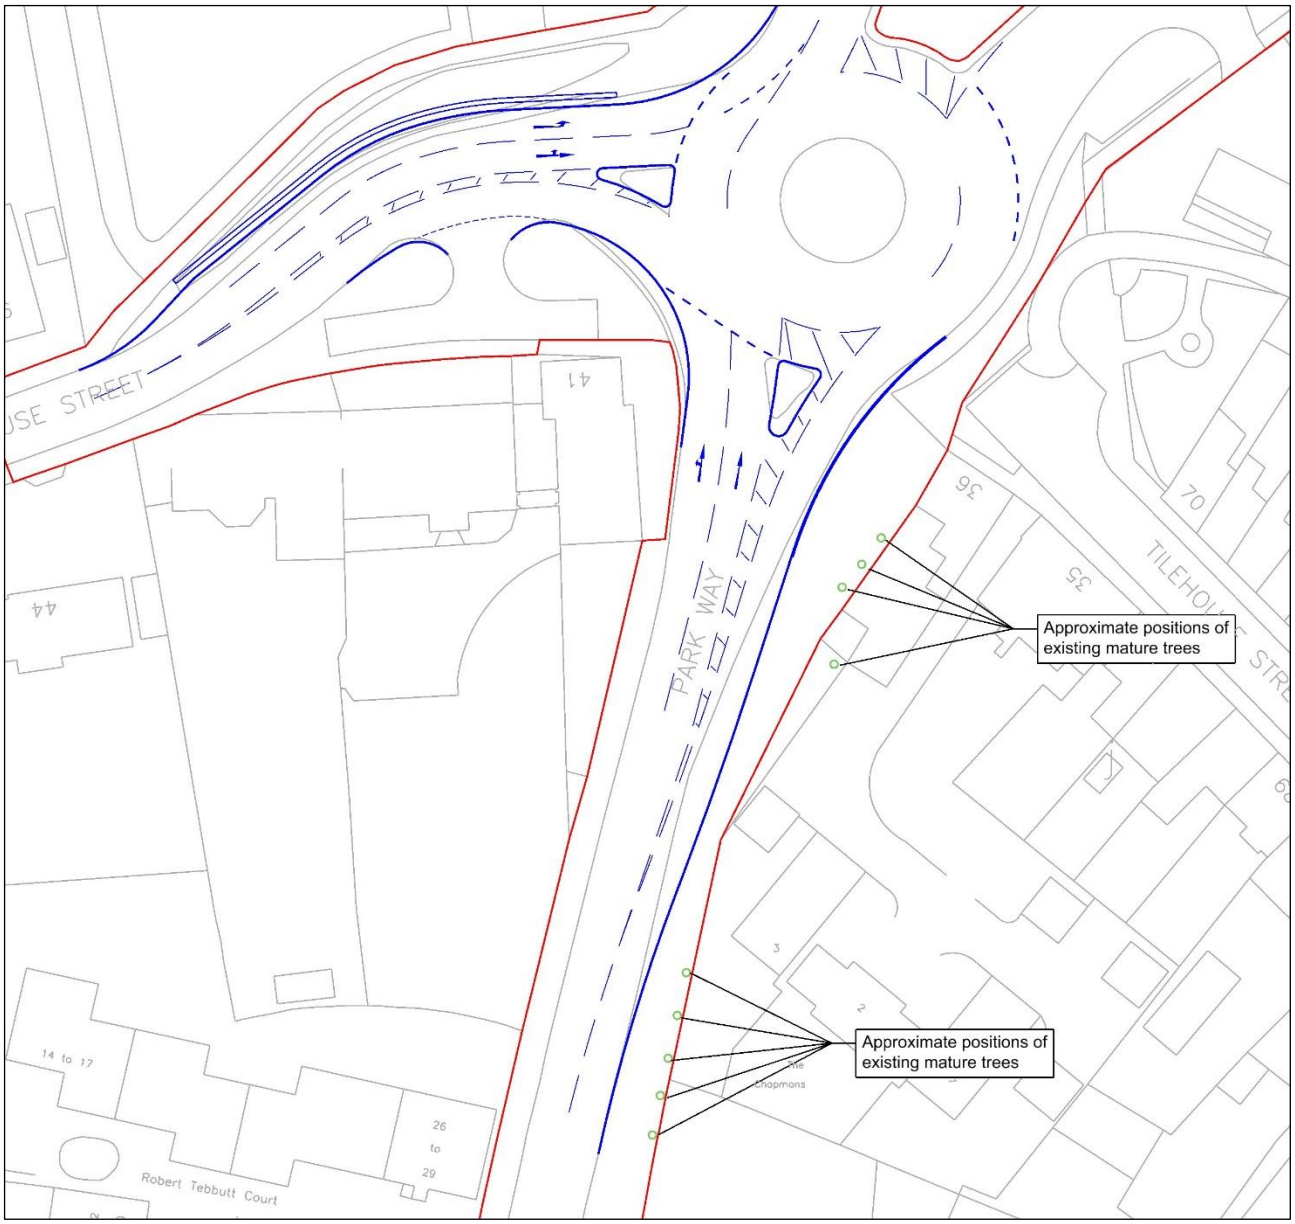
Figure 3.1: Existing Tree Locations – A602 Park Way

3.2.1 Figure 3.1, below, shows the existing tree locations along the eastern side of A602 Park Way, together with the proposed Order Limit.

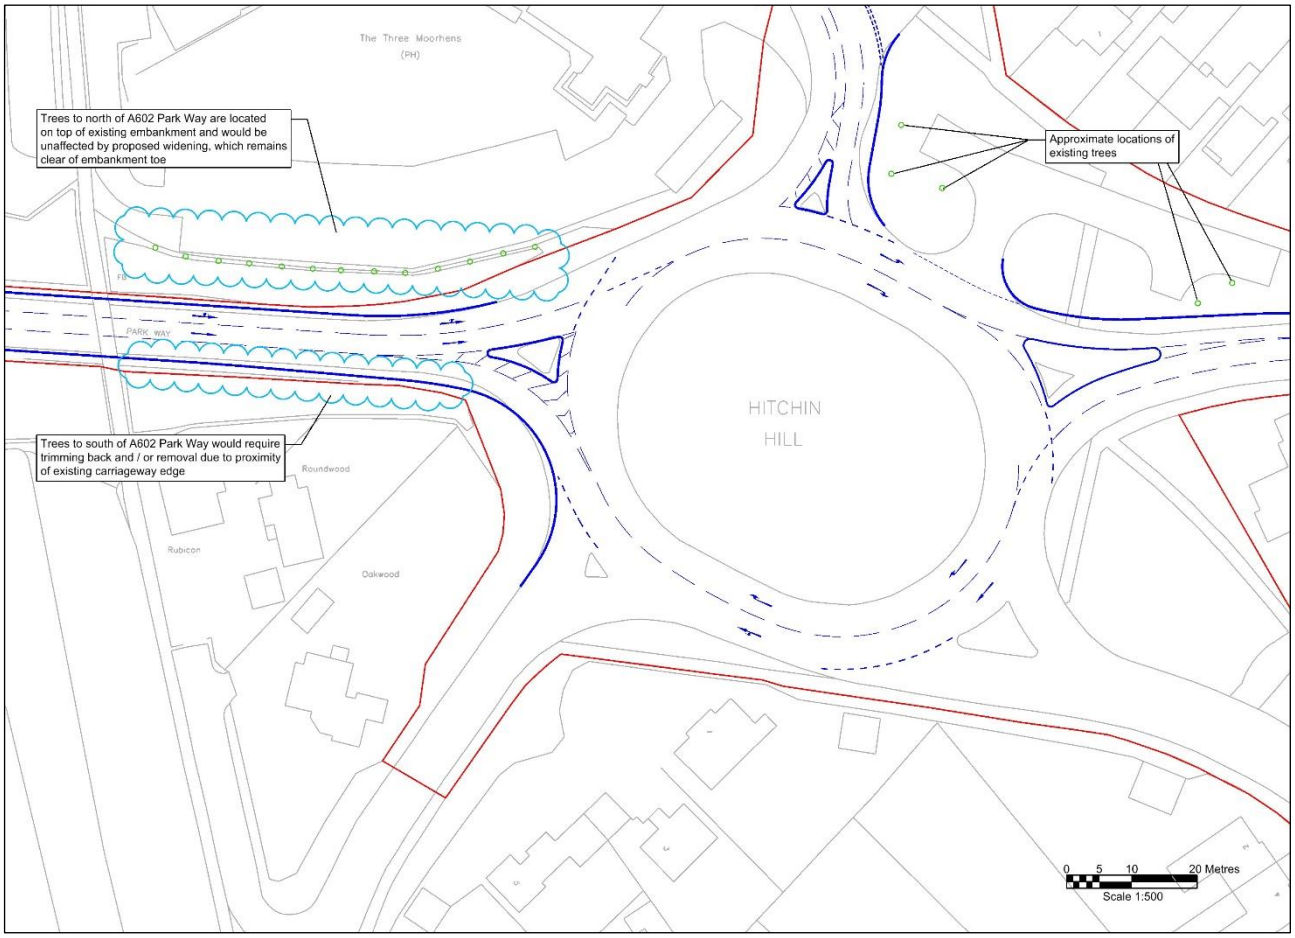
Figure 3.1: Existing Tree Locations

3.2.1 Figure 3.1, below, shows the approximate locations of existing trees in the vicinity of the A602 Park Way / Hitchin Hill arms of the junction, together with a potential minor amendment to the Hitchin Hill arm of the junction to minimise potential impact on trees to the east.

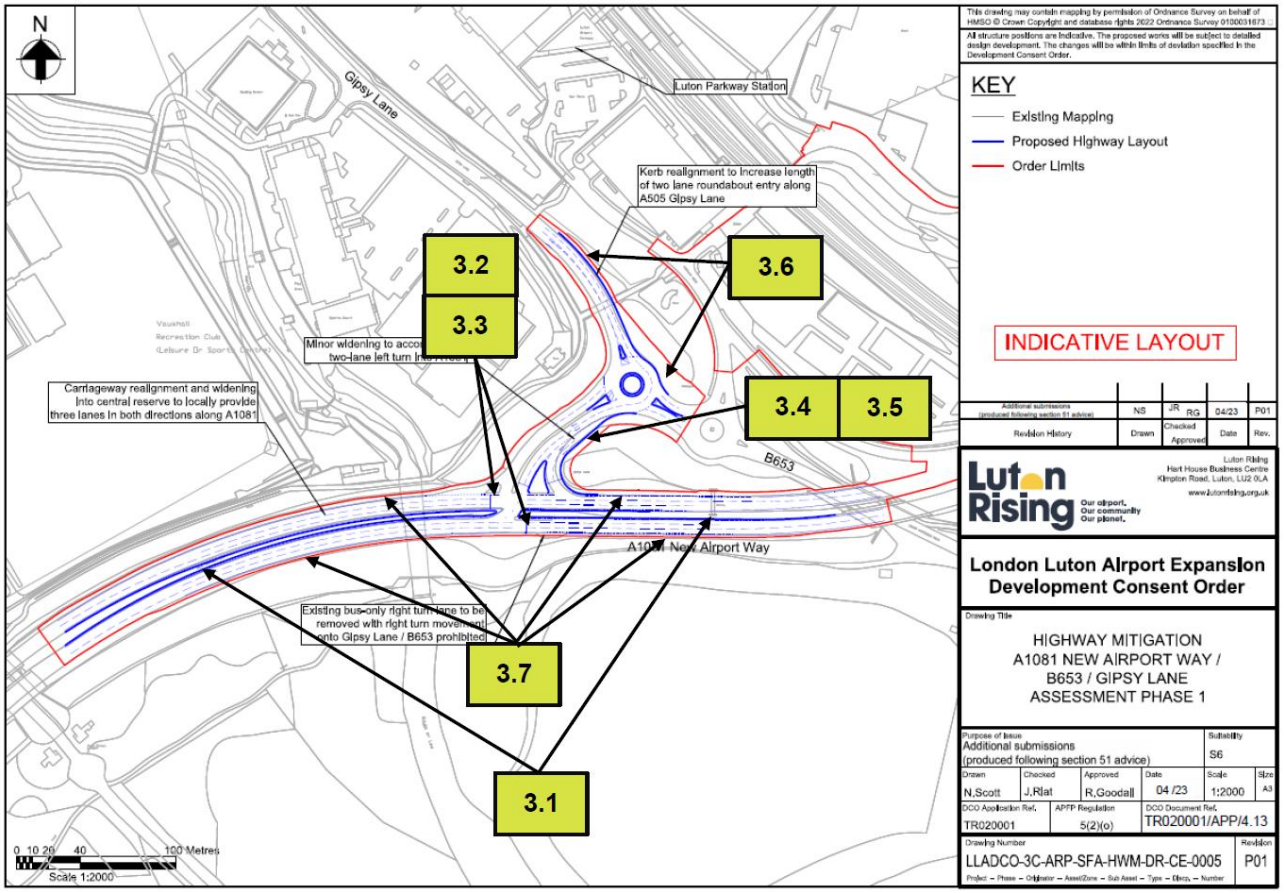
Figure 2.1: Locations of Problems Identified within the Audit

Ref.	RSA Problem	RSA Recommendation	Design Organisation Response	Overseeing Organisation Response	Agreed RSA Action
3.1	There are existing heavy-duty items of street furniture within the central reservation, such as lamp columns, a gantry support and signposts. When the reservation is narrowed to accommodate the widening works, there may be insufficient width to provide protection for the items. In addition, the items may be within the working width of the vehicle restraint system (VRS). Road users could suffer serious injury if vehicles collide into the street furniture and are brought to an abrupt halt or redirected violently.	It should be ensured that the items of street furniture can be adequately protected by vehicle restraint systems, without encroaching into the working width of the VRS.	Accepted. The detailed design of the realignment would ensure that sufficient clearance is provided to items of street furniture including lighting columns, signage and the gantry support. Space would also be provided for the VRS and its associated working width and for the existing A1081 cycle lane with a width of 1.5m to meet LTN 1/20 guidance. Indicative cross sections are shown on Figure 3.4. The side agreement allows for works to be undertaken within highway land, should this be required at the detailed design stage	Accepted. With regards to Safety Audit 3.1, the revised cross section shows a reduced level of clearance between the RRS and the gantry footing, at 0.6m. The Safety Audit recommendation is that 'It should be ensured that the items of street furniture can be adequately protected by vehicle restraint systems, without encroaching into the working width of the VRS.' Whilst the designer's response accepts the recommendation, and states that this would be addressed at detailed design stage, CBC concern is as previously stated, i.e.: that there may not be sufficient available width within the DCO limits to achieve this, with no information provided as to the working widths which would need to be provided for, and with the submitted cross sections already working on the basis of minimum lane widths, clearances, and	Position agreed. To be addressed at the detailed design stage.

3.4	There is dense vegetation in the verge and a cutting slope on the approach to the traffic signals. These features will be closer to the edge of carriageway when the road is widened, creating a roadside hazard to road users if they lose control and leave the carriageway. The vegetation and slope could also restrict the stopping sight distance (SSD) to the signal heads, increasing the risk of overshoot and failure to stop type collisions.	The verge should be cleared of dense vegetation and the slope regraded over a sufficient distance to ensure the features do not present a roadside hazard to road users, and to ensure suitable SSD can be provided to the traffic signals.	Accepted. For the existing layout, an SSD of 38m would be achievable to the offside signalhead of the left turn lane. The proposed design would provide an SSD of approximately 50m to the same signal head - see Figure 3.3. This provides a substantial improvement compared to existing. Note: CD123 para 7.3.1 states that where multiple lanes are provided on the approach, a signal-controlled junction may have offside primary signals.	With regards to Safety Audit Problem 3.4, as per the previous CBC comments, the order limits include land which is not public highway, however the most recent updates to Book of Reference and the submission of the new Streets, Rights of Way and Access Plan would appear to resolve this issue, allowing for the clearance of vegetation, the regrading of the slope, and the replacement of signage. Whilst it is noted that Forward Stopping Sight Distance improves relative to the	Position agreed. Stopping Sight Distance to be considered further at the detailed design stage with the potential for a greater extent of verge and embankment clearance considered.

3.7	There are existing cycle facilities along the A1081 New Airport Way in both directions. It is not clear how the proposed layout will accommodate cyclists. If the cycle routes become discontinuous, cyclists could be vulnerable to being struck by vehicles, if they have to travel within or close to the live traffic lanes of the dual carriageway.	It should be ensured that adequate and safe cycle facilities are provided as part of the proposals.	Accepted. The existing A1081 cycle lane would be retained with a width of 1.5m to meet LTN1/20 guidance. Indicative cross sections are shown on Figure 3.4. The side agreement allows for works to be undertaken within highway land should this be required at the detailed design stage. The traffic signal maintenance bay would be retained.	With regards to Safety Audit Problem 3.7, having taken on-site measurements of the existing layout, it appears that the existing cycle lane on the A1081 northern side (which was the only element safely accessible to obtain measurements) has a width of between 1.4 and 1.5m. As such the revised proposals would result in the further narrowing of what are already narrow cycle lanes, with a proposed width of 1.2m. CBC would also note that the recommended absolute minimum width of a cycle lane in LTN 1:20 table 5.2 is 1.5m). When considered in combination with the proposed 3.0m running lanes immediately adjacent to the cycle lanes, this would bring	Position agreed. To be addressed at the detailed design stage.
