London Luton Airport Expansion

8.118 Applicant's Response to Issue Specific Hearing 4 Action 7 - Update on Road Safety Audits

Application Document Ref: TR020001/APP/8.118

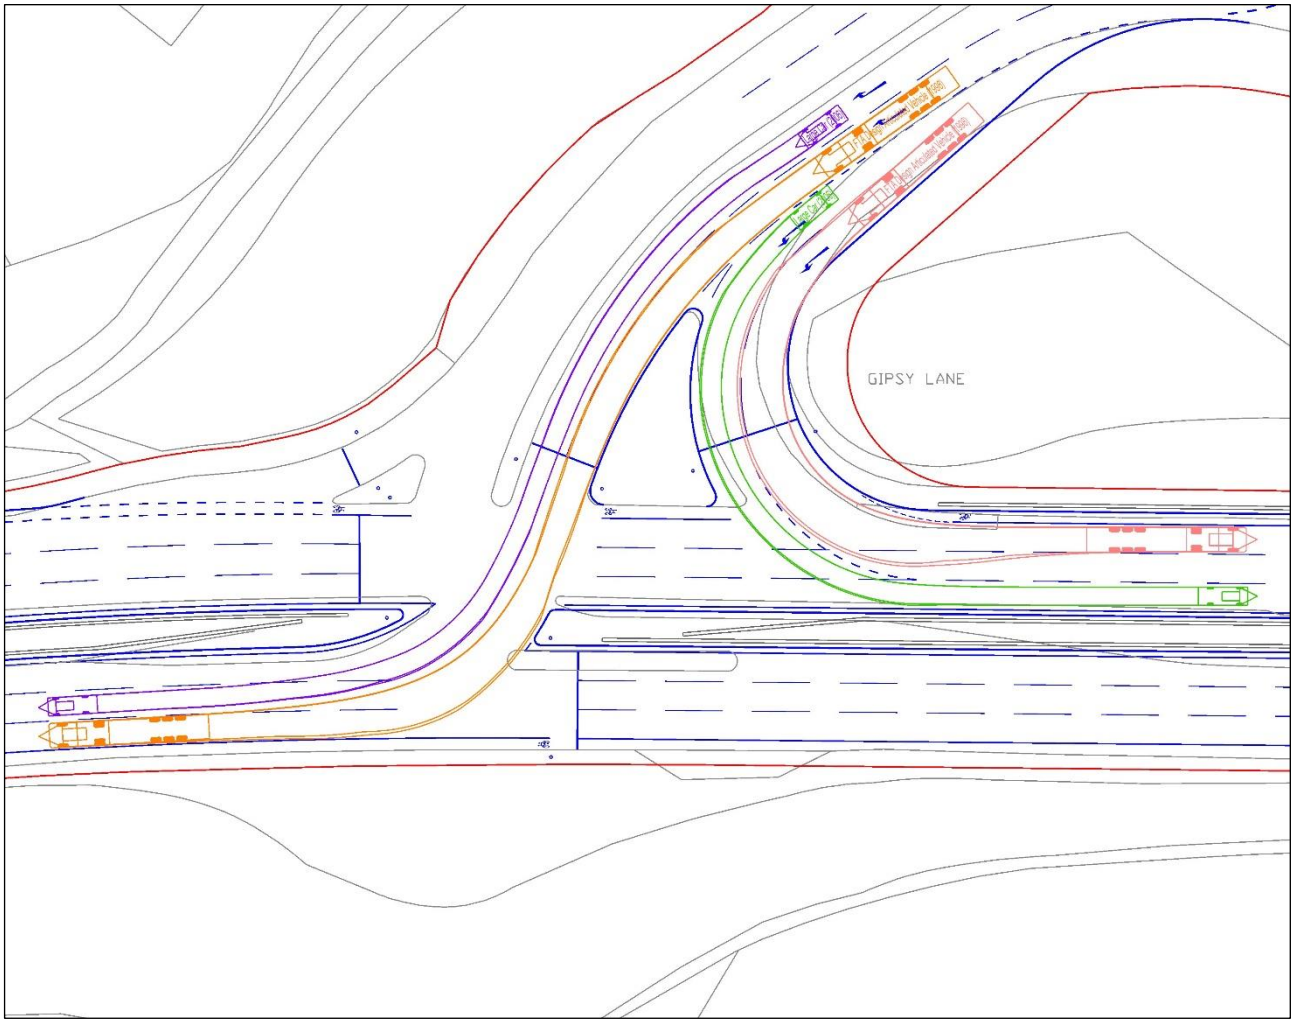
Figure 3.2: Swept Paths – A1081 New Airport Way / B653 Gipsy Lane Link

3.2.2 Figure 3.2 above shows the swept path analysis for 16.5m articulated HGVs and large cars at the signalised junction between A1081 New Airport Way and the Gipsy Lane link road. The left turn onto the A1081 has not been designed to accommodate two parallel HGVs, as this would result in an abnormally wide stop line.

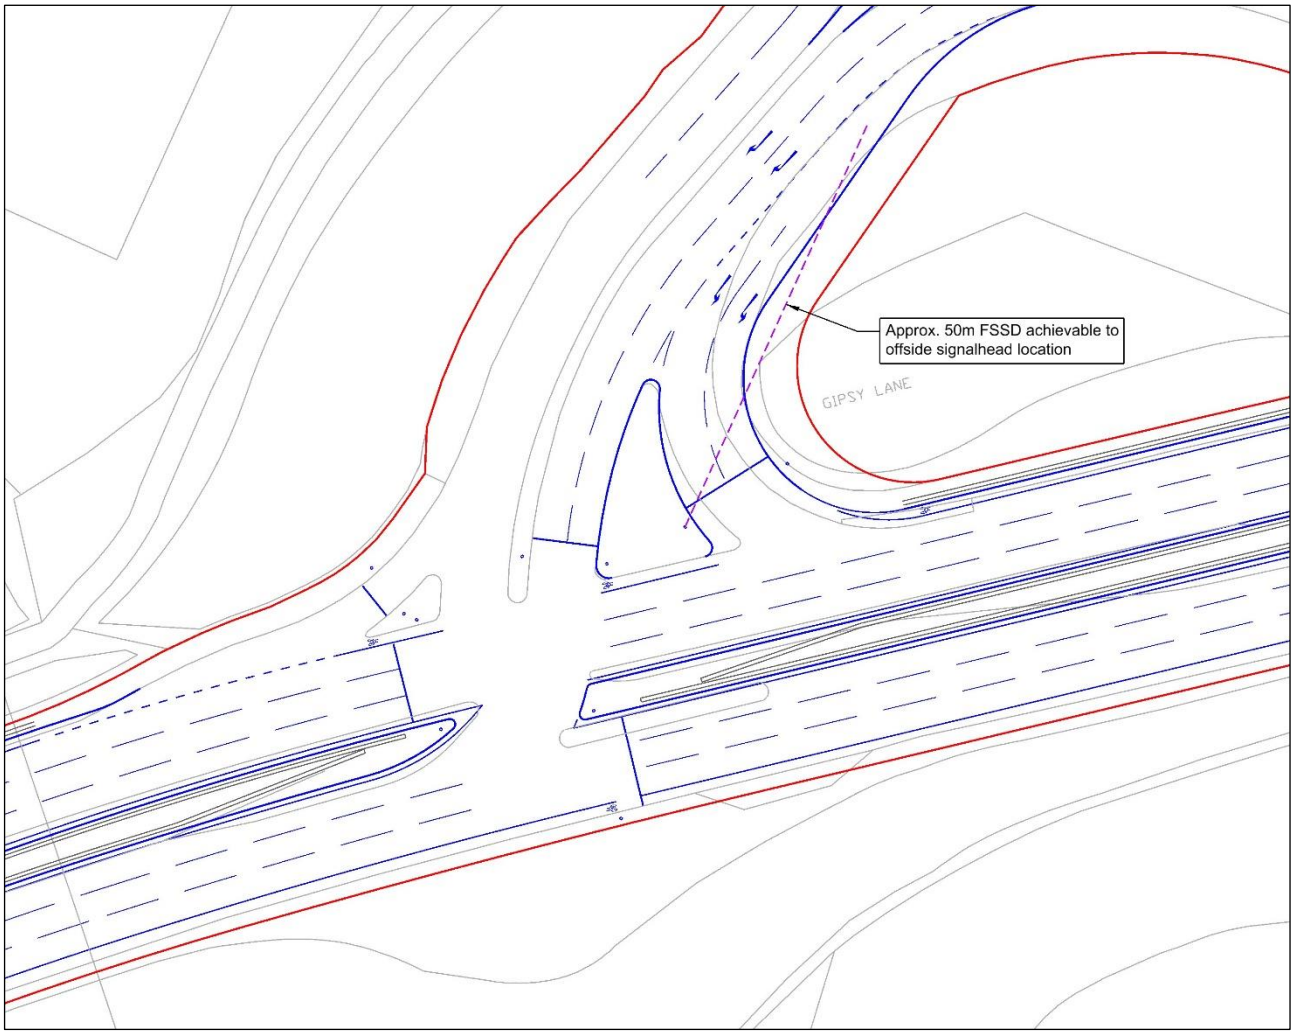
Figure 3.3: A1081 New Airport Way / B653 Gipsy Lane Link SSD

3.3.1 Figure 3.3 above shows the proposed SSD to the offside signalhead. A SSD of at least 50m SSD to a primary signalhead for the left turn is achievable (covering the entirety of the left turn lanes) without removing significant amounts of trees, which is an improvement over the current SSD of approximately 38m.

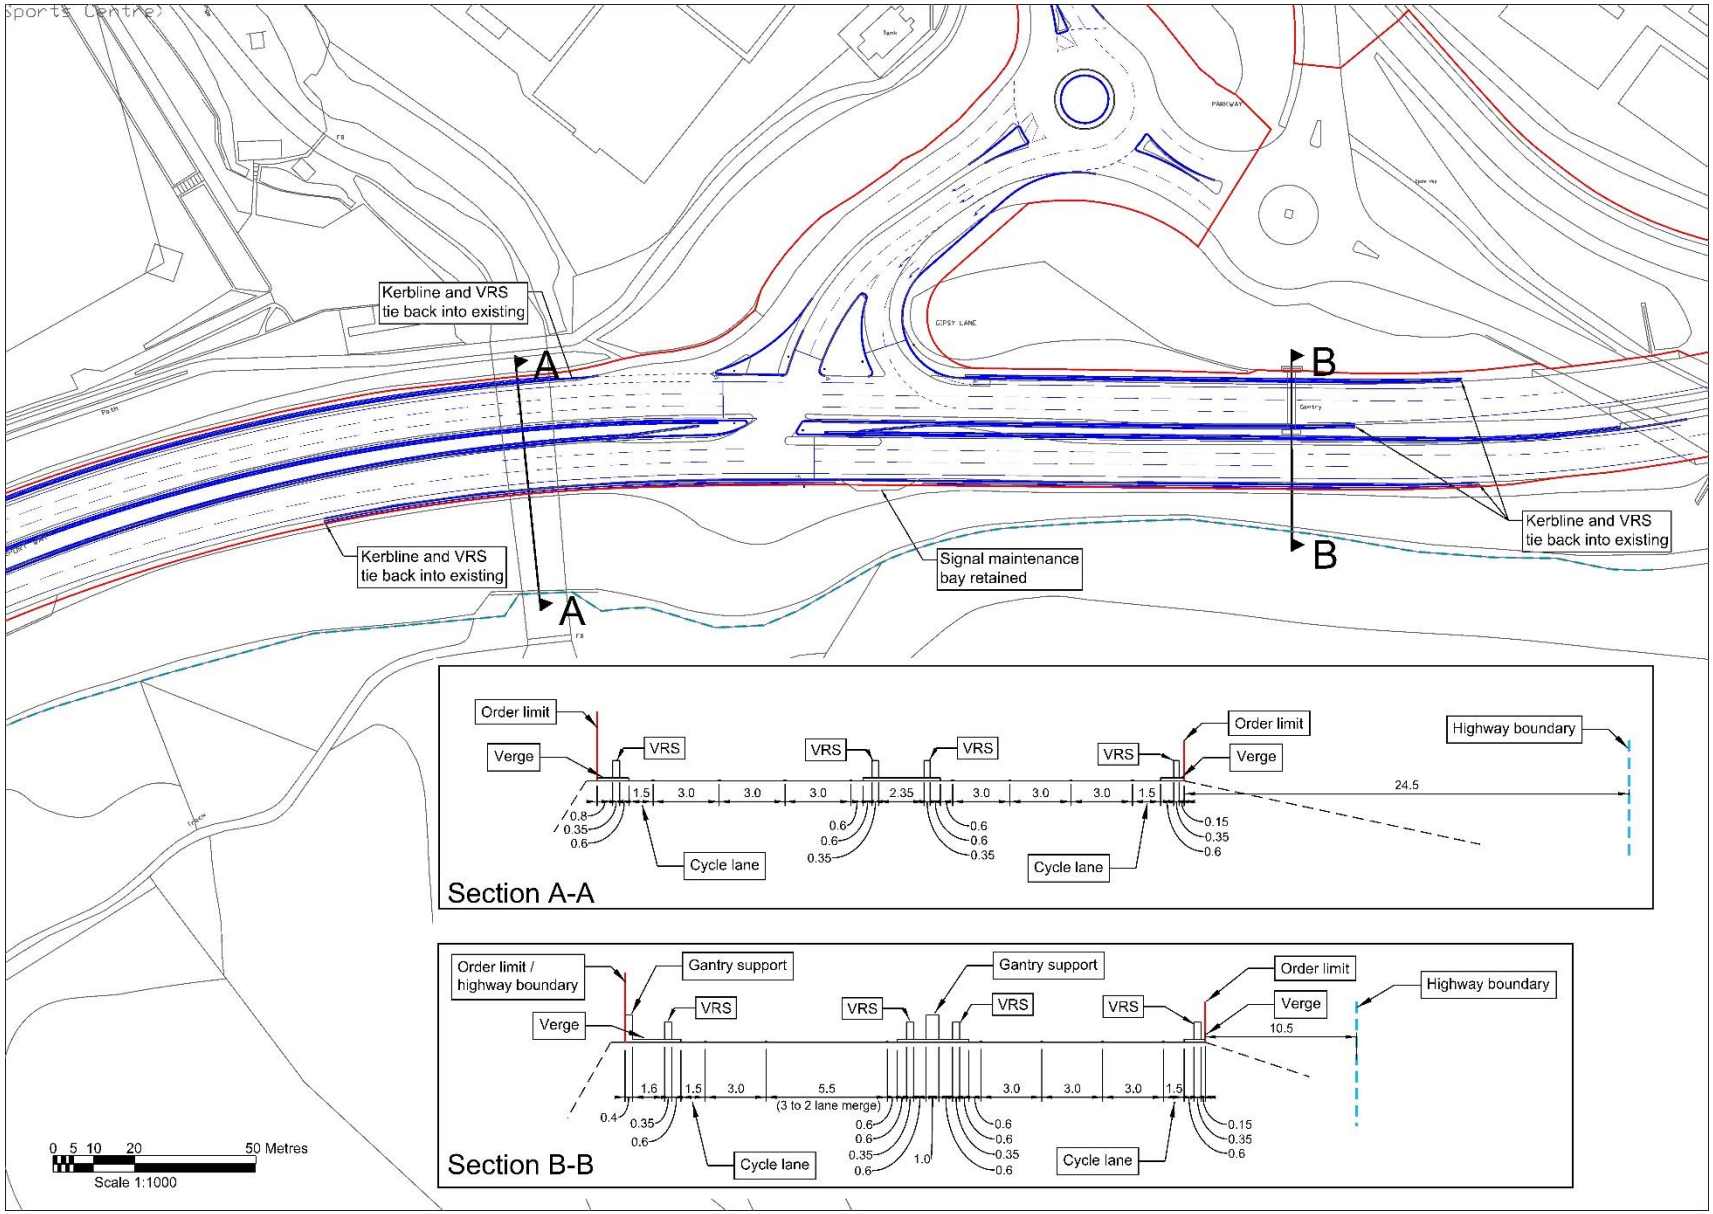
Figure 3.4: Indicative A1081 Cross Sections

3.4.1 Figure 3.4, below, shows indicative cross sections at two locations along the proposed A1081 New Airport Way alignment, to the east and west of the junction. The western cross section (Section A-A) is located at the narrowest point of the central reserve and the eastern cross section (Section B-B) is located at theexisting gantry.

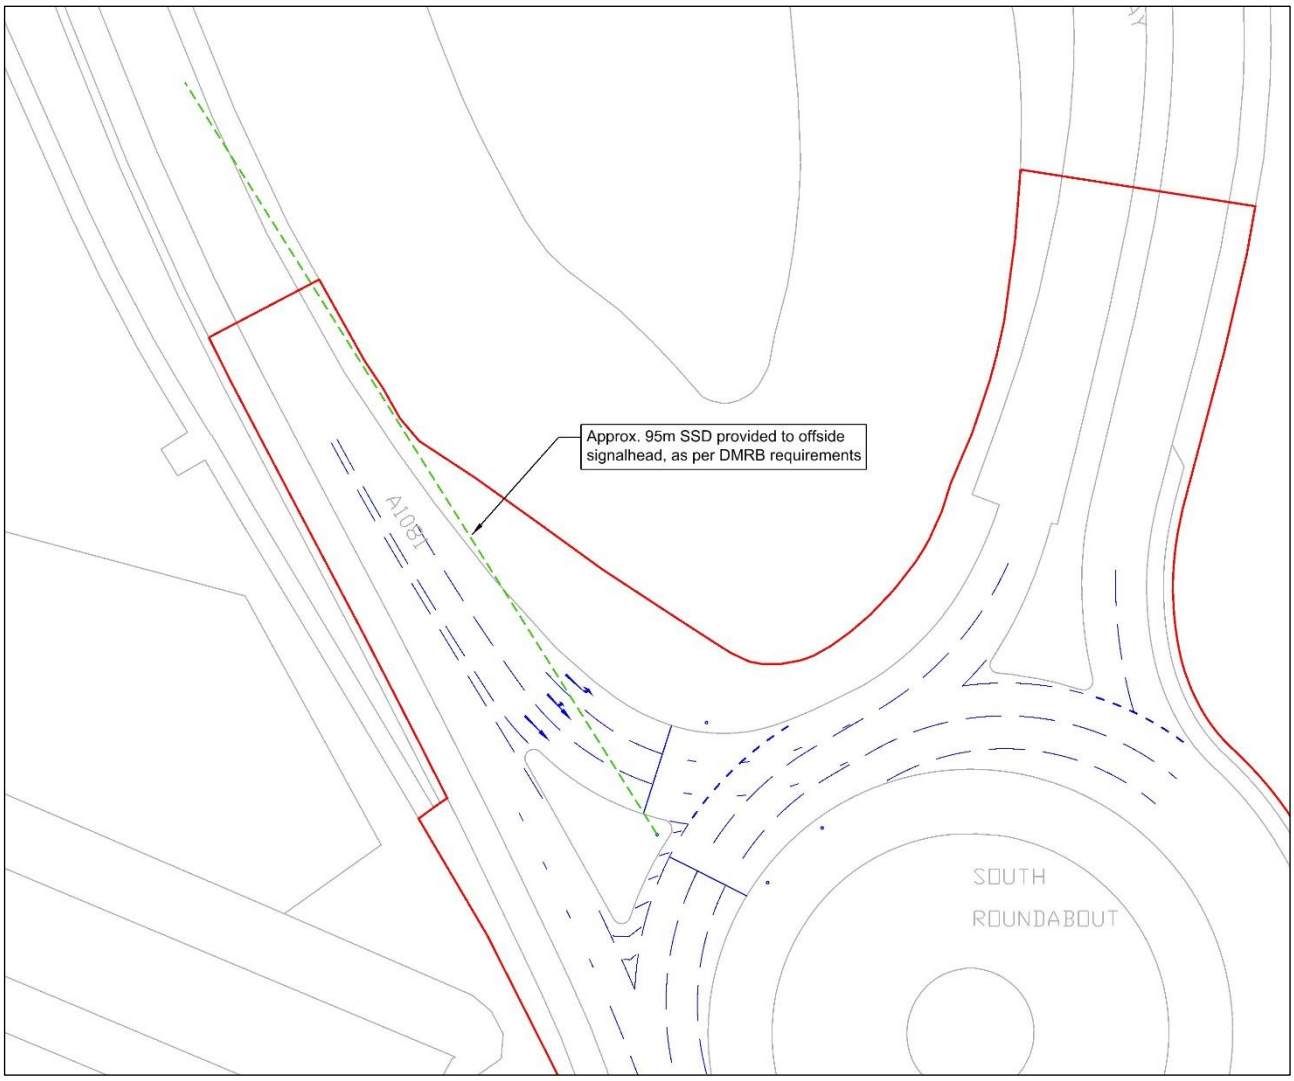
Figure 3.1: Forward Stopping Sight Distance to Signalhead

3.2.1 Figure 3.1, above, shows that the Desirable Minimum FSSD to the offside signalhead can be achieved in line with DMRB guidance for a 30mph speed limit (90m). Paragraph 4.7 of CD116 states:

"On an external approach to a signal-controlled roundabout, each traffic lane shall have clear visibility of at least one primary traffic signal associated with its particular movement, from a distance equivalent to the desirable minimum SSD of the approach road."
