Necton Parish Council

Vanguard: response to PINS questions ref 17.16

REPORT ON THE RECOVERY OF AN RDAF F-16 TRAINER ET 205 FROM MONA FARM, NECTON, SWAFFHAM, NORFOLK.

A REPORT ON AN ENVIRONMENTAL ASSESSMENT OF THE CRASH
SITE OF A ROYAL DANISH AIR FORCE F16 FIGHTING FALCON DUAL
SEAT TRAINER NEAR NECTON, SWAFFHAM, WEST NORFOLK

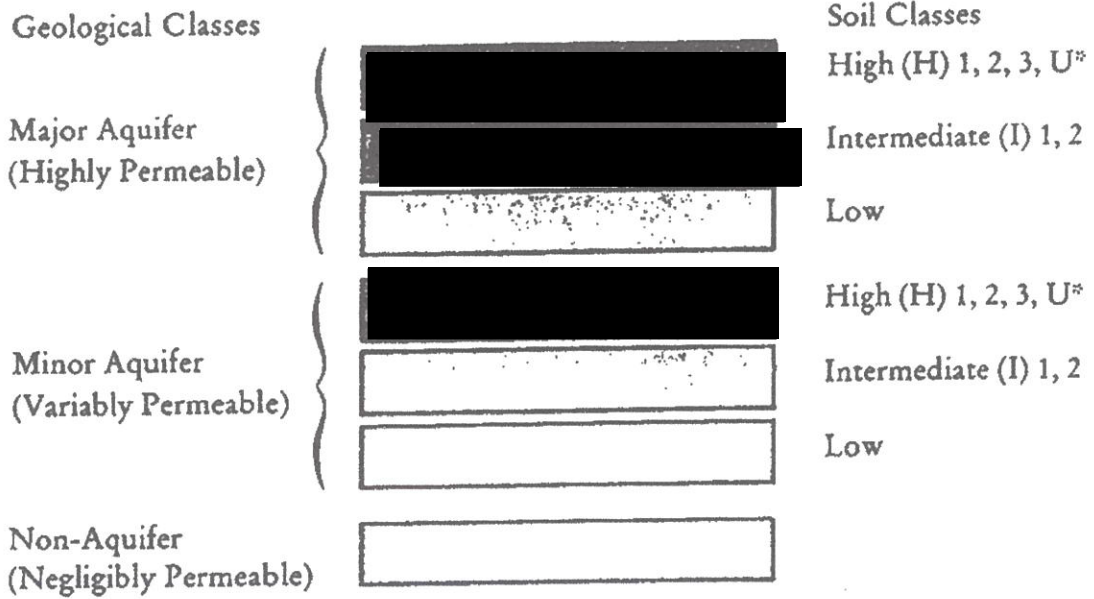
VULNERABILITY CLASSES

Low permeability, non-water bearing drift deposits occurring at the surface and overlying Major and Minor Aquifers are head (clayey), shell marl, Nar Valley clay, Terrington Beds, Barroway Drove Beds, glacial silts and clays and till (excluding Cromer Till).
