Ship/platform collision incident database (2001)

Prepared by **Serco Assurance**
for the Health and Safety Executive 2003

RESEARCH REPORT 053

J K Robson
Serco Assurance
Culham
Abingdon
Oxfordshire
OX14 3ED
United Kingdom

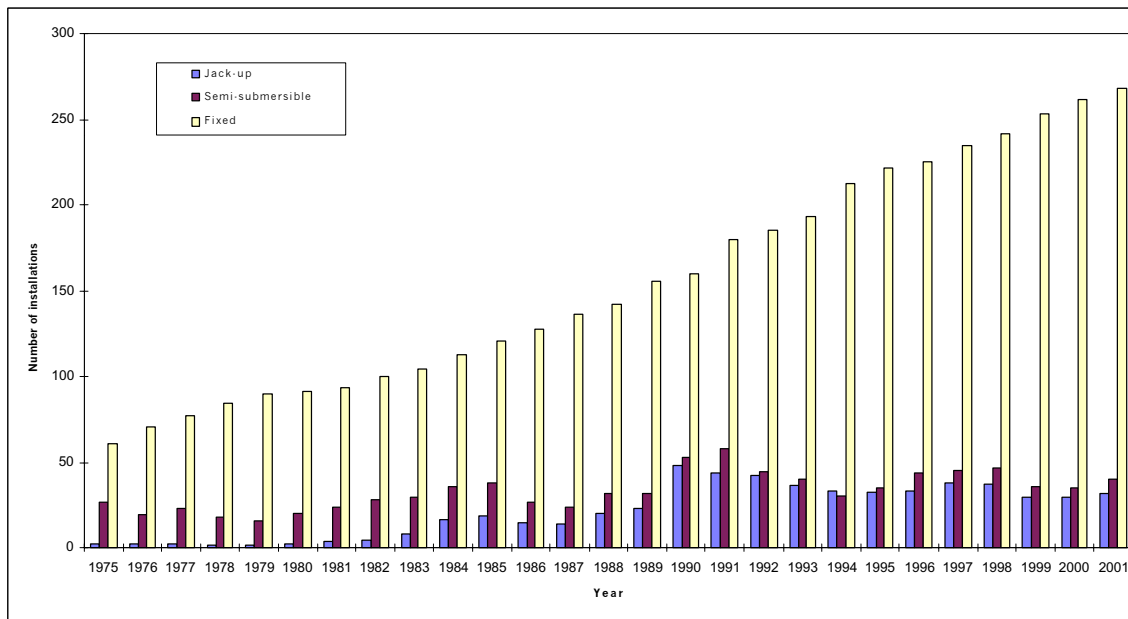
Figure 1: Fixed installations and mobile rig utilisation

A summary of operating experience for fixed installations/complex and mobile units over the period of study is contained in Table 1 (overleaf) and represented graphically in Figure 1.

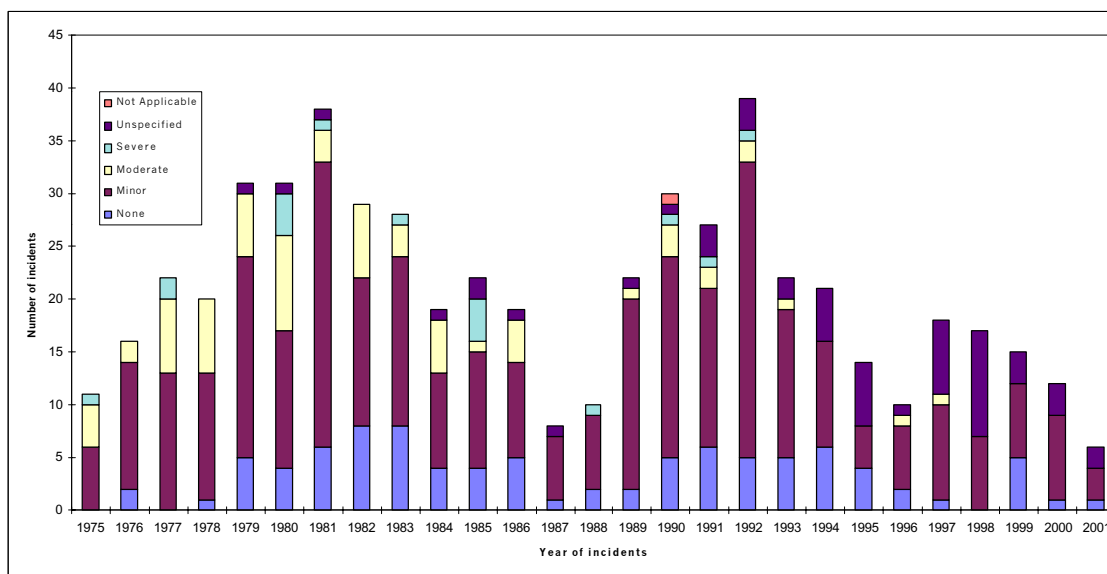
Figure 2: Damage resulting from incidents to all installations per year

Table 2 and Figure 2 summarise the number and damage category of all recorded incidents to fixed installations and mobile units, by year, since 1975. Seventeen incidents were classed as severe, 69 incidents as moderate and the remainder classed under minor or no damage, including 55 incidents where the damage was not specified but is believed to be minor or none.

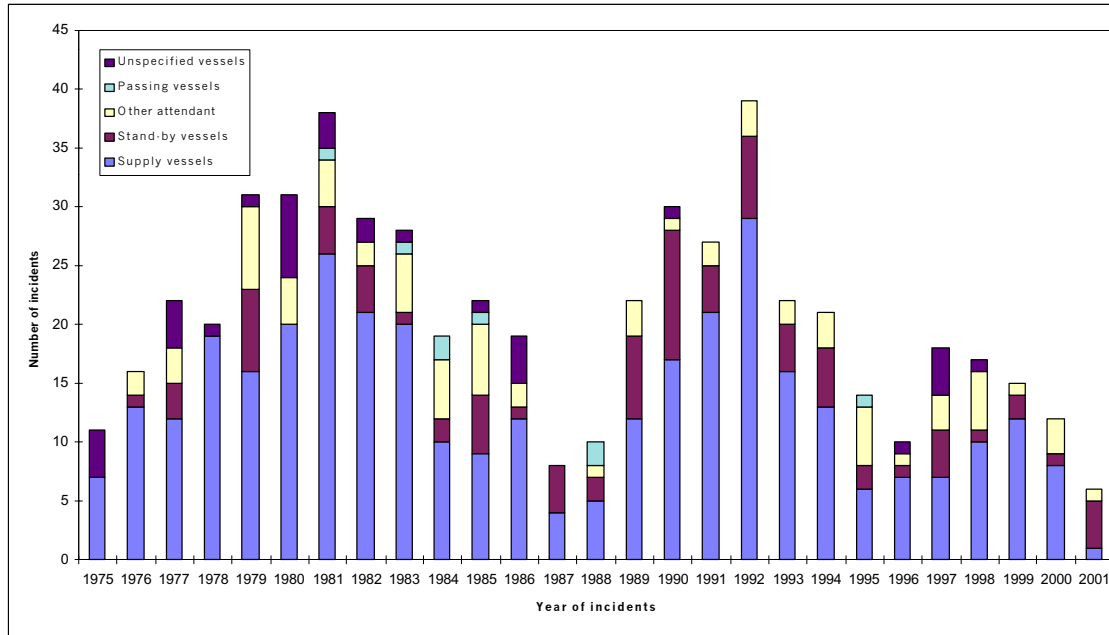
Figure 3: Incidents per year by all vessel types

A summary and chart of impact vessel types is produced as Table 3 and Figure 3. This indicates that the vast majority of incidents, as would be expected, have occurred with attendant vessels. Of the attendant vessels, 353 incidents were with “Supply Vessels”, 87 were “Stand-By Vessels” with the remaining being either “Unspecified”, with 35 incidents or “Other Attendant Vessels”, 74 incidents. The latter category comprising the following vessel types:

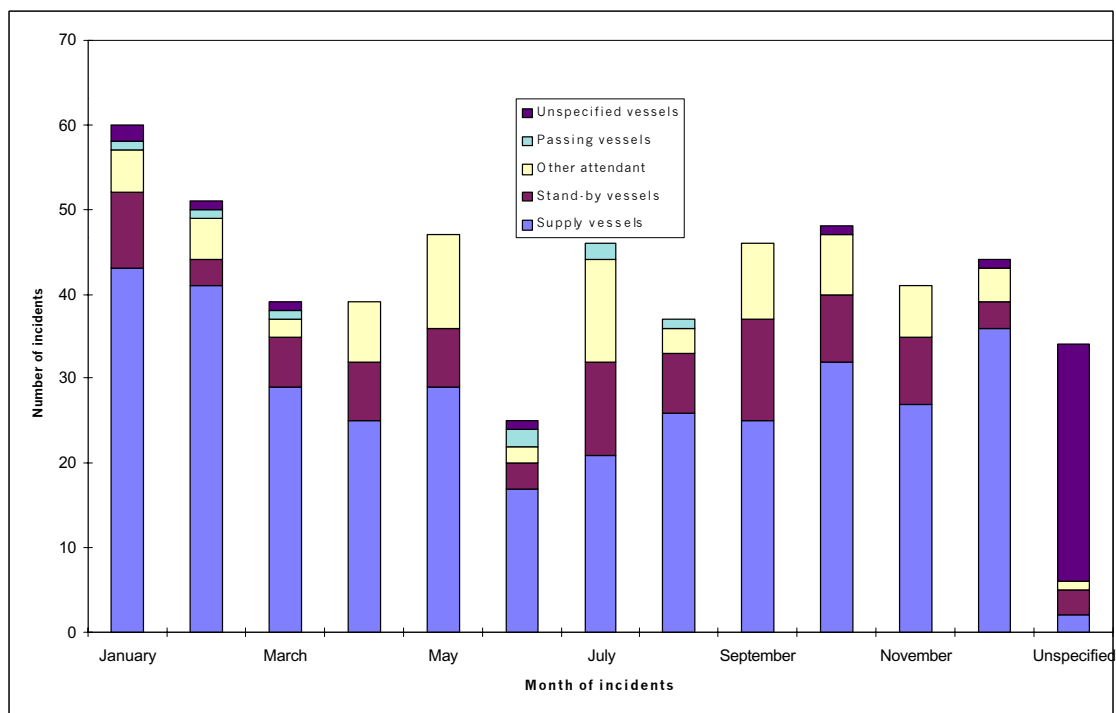
Figure 4: Incidents per month by vessel type

Table 4 and Figure 4 summarise the trend for incidents occurring with respect to month for all different vessel types. Despite several slight anomalies, possibly caused by the small number of data for some vessel categories, broadly speaking more incidents have occurred during the period October to February. For supply vessels engaged in cargo transfer this is perhaps understandable when weather conditions are more likely to be adverse with high winds and storms. Conversely, in the months normally associated with better weather (July to September) the incidence of stand-by vessel collision has increased, possibly caused by more installation overside work being carried out and the need for close support. The months between May and October also see an increase in the number of incidents involving diver support vessels when annual inspections and repairs to installations tend to take place.

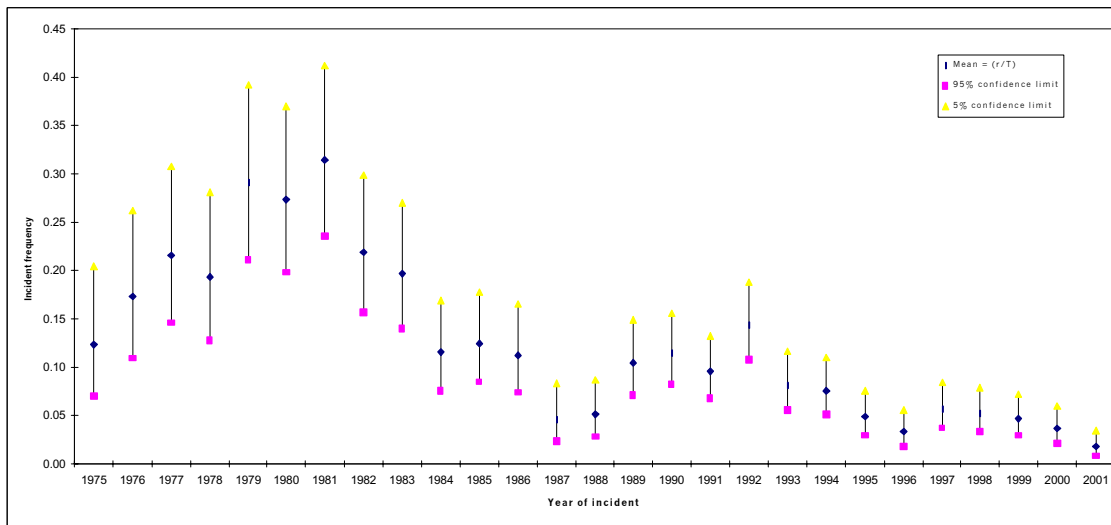
Figure 5: Frequency of all reported incidents to all installations per year

As in other studies (Refs. 19 and 20) it has been assumed that the incident likelihood follows a Poisson distribution. With this assumption 5% and 95% confidence limits for fixed installations and mobile rigs have been calculated and are shown in Figures 5, 6, 9, 10, 13, 14, 17 and 18. The interval between the limits reflects the number of incidents and causes the line connecting the upper and lower confidence limit to be longer where there are fewer incidents. 5% and 95% confidence limits have been calculated using accepted methodology (note Refs. 19 and 20) including those occasions where no collision incidents have been reported.

Tables 5 and 6 respectively, show the mean frequency and confidence limits of all reported incidents and those categorised as resulting in moderate or severe damage occurring to all installations by year. Table 7 summarises the mean frequency in the year in question and also cumulatively to any year end from 1975. Figures 5, 6 and 7 graphically represent the variation in the results summarised in these tables.

There is a large spread in the annual incident frequency but generally the number of reported incidents tends to increase to a peak in 1981 before declining quite rapidly to a minimum in 1987. A second, lesser, peak occurred in 1992 before declining again. The rise in the mean incident frequency in 1992 can almost entirely be accounted for by the rise in the number of reported incidents involving semi-submersibles, and to a lesser extent jack-ups. This is broadly in line with the increase in mobile rig utilisation during this period with its attendant collision risks, for example when anchor handling.

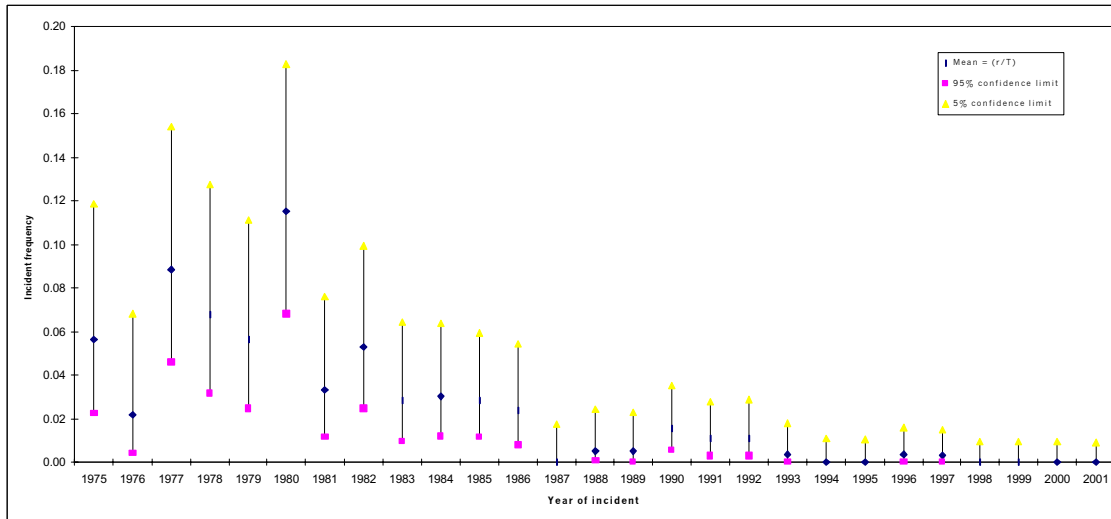
Figure 6: Frequency of moderate or severe damage to all installations per year

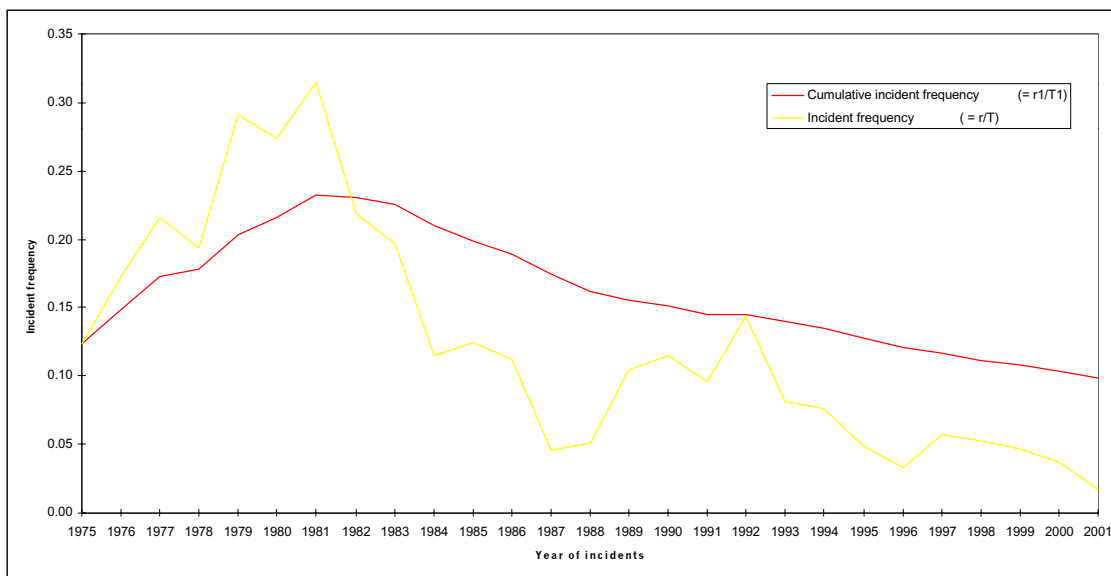
Figure 7: Mean and cumulative frequency of all reported incidents to all installations

Though the average, all incident frequency, has fluctuated considerably over the period of study the probability is on average 0.099 per year. Using the total operating experience this equates to 1 incident every 10.14 installation years or approximately 33 per annum for the current year level of installation activity. The analysis for reported incidents resulting in damage categorised as moderate or severe indicates the probability is on average 0.015 per year (1 incident every 65.64 years or approximately 5 every year for the current level of installation activity). These statistics are clearly at odds with the actual number of recorded incidents in recent years and highlight the general improvements made in support vessel operating practices.

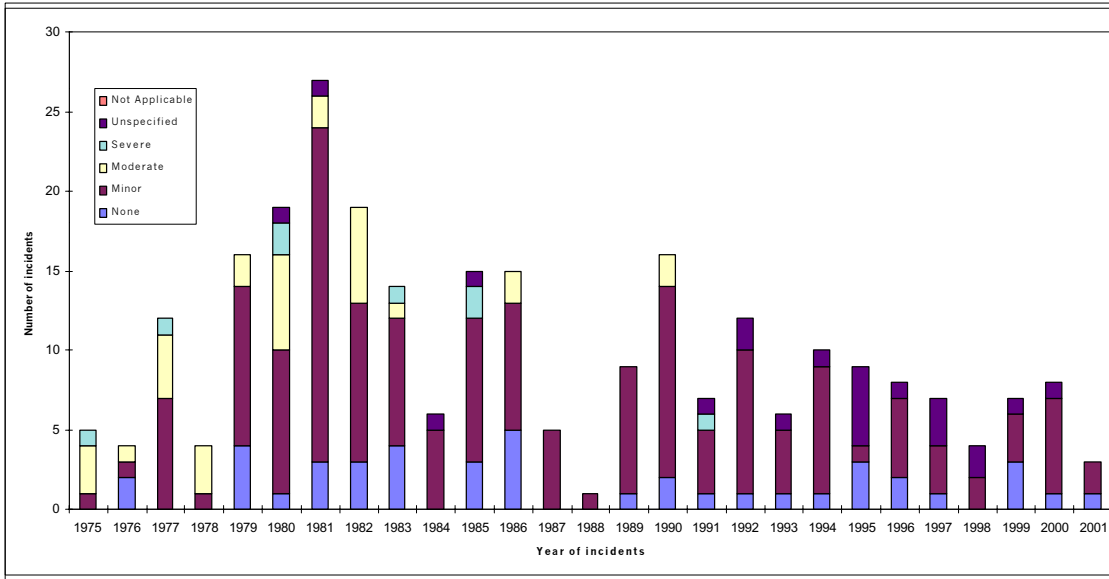
Figure 8: Damage resulting from incidents to fixed installations per year

Table 8 and Figure 8 summarise the number and damage category of all incidents occurring to fixed installations. Eight incidents were classed as severe, 32 incidents as moderate and the remainder classed under minor or no damage, including 22 incidents where the damage was not specified but is believed to be minor or none.

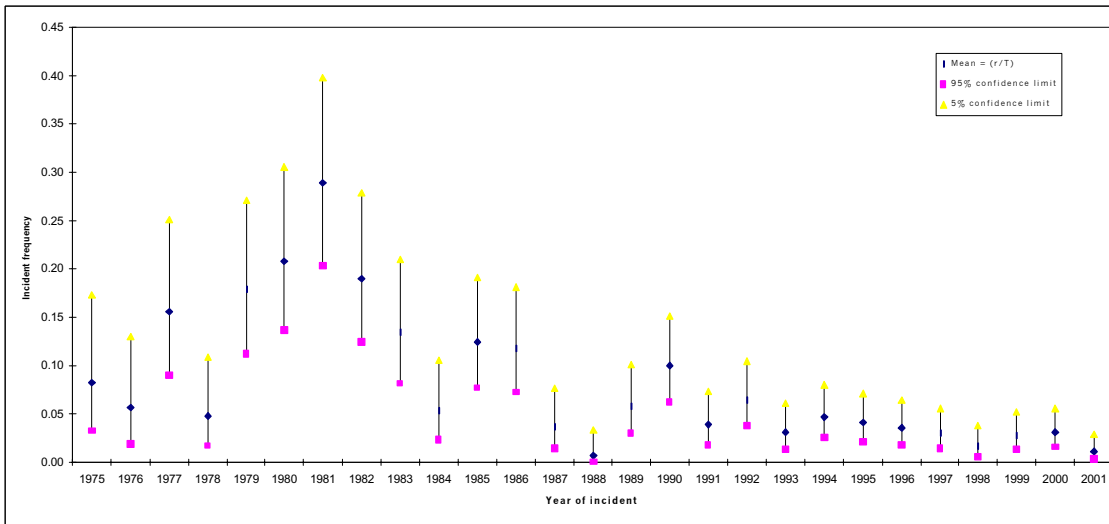
Figure 9: Frequency of all reported incidents to fixed installations per year

Tables 9 and 10 show respectively, the mean frequency and confidence limits of all reported incidents and those categorised as resulting in moderate or severe damage occurring to fixed installations by year. Table 11 summarises the mean frequency in the year in question and also cumulatively to any year end from 1975. Figures 9, 10 and 11 graphically represent the variation in the results summarised in these tables.

Apart from 1978, in the early years of the study the mean incident frequency rose dramatically until 1981. Subsequent to this the incident frequency rose and fell over a relatively narrow range caused by an erratic number of incidents occurring each year and, prior to 1994, a reasonably consistent increase in the number of installations operating.

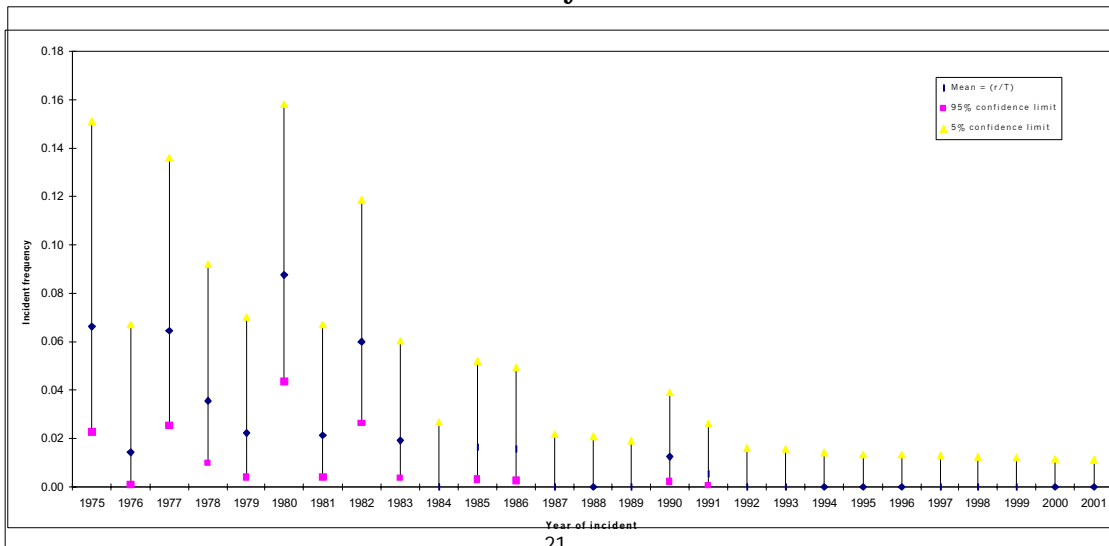
Figure 10: Frequency of moderate or severe damage to fixed installation per year

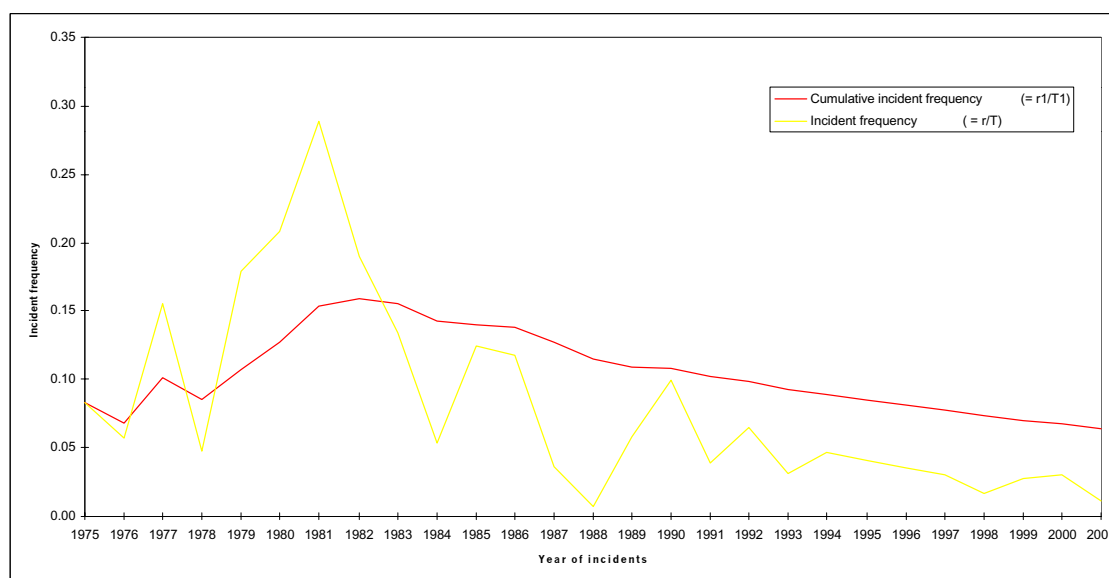
Figure 11: Mean and cumulative frequency of all reported incidents to fixed installations

Over the whole period of study the probability of an incident occurring is on average 0.064 per year (1 incident every 15.68 years or approximately 17 every year for the current level of installation activity). The analysis for reported incidents resulting in damage categorised as moderate or severe indicates the probability is on average 0.009 per year (1 incident every 105.09 years or approximately 2.5 every year for the current level of installation activity). Recent experience indicates that these figures are an exaggeration of the actual number and are probably skewed by the larger incident frequencies in the early years of study adversely affecting the figure for the current level of activity.

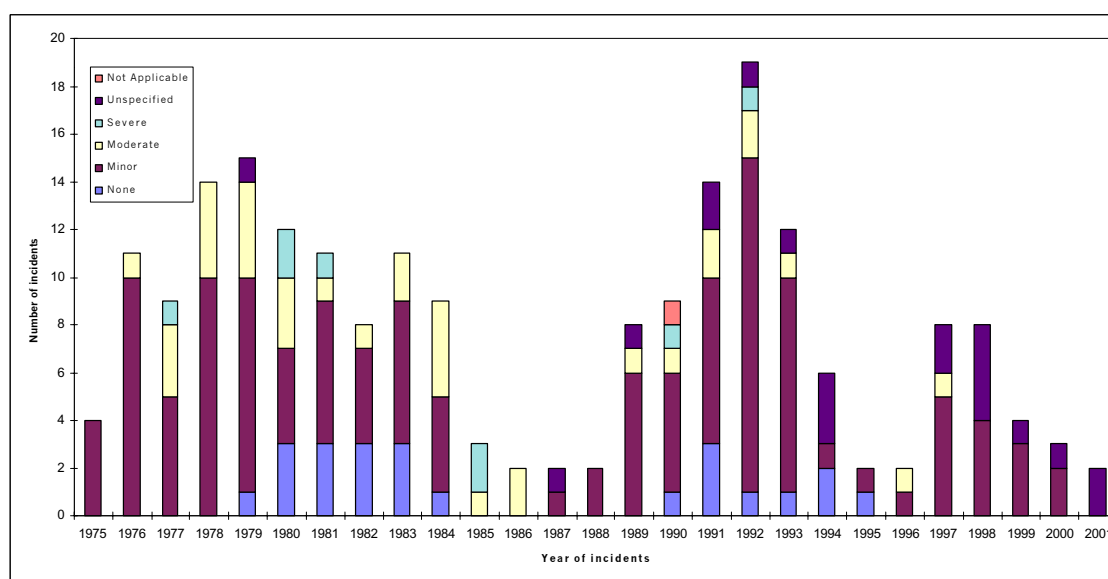
Figure 12: Damage resulting from incidents to floating installations by year

Table 12 and Figure 12 summarise the number and damage category of all incidents occurring to floating installations. Eight incidents were classed as severe, 35 incidents as moderate and the remainder resulting in minor or no damage, including 20 incidents where the damage was not specified but is believed to be minor or none.

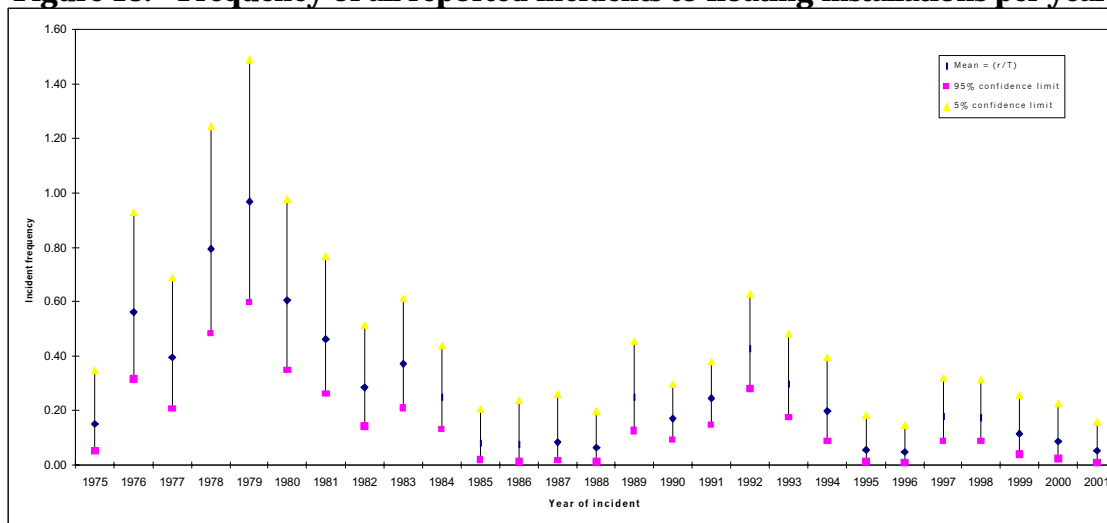
Figure 13: Frequency of all reported incidents to floating installations per year

The mean frequency and confidence limits of all reported incidents and those categorised as resulting in moderate or severe damage occurring to semi-submersibles by year are summarised in Tables 13 and 14 respectively. Table 15 summarises the mean frequency in the year in question and also cumulatively to any year end from 1975. Figures 13, 14 and 15 graphically represent the variation in these results.

Overall there is a large spread in the annual incident frequency. The number of reported incidents increased to a peak in 1979 before declining to a minimum in the years 1986 to 1988. An increase in the annual incident frequency then occurred up to a second, lesser, peak in 1992, this generally being in line with the increase in semi-submersible utilisation. A minimum frequency occurred in 1995 and 1996, however, in more recent years the frequency has again increased before gradually decreasing again.

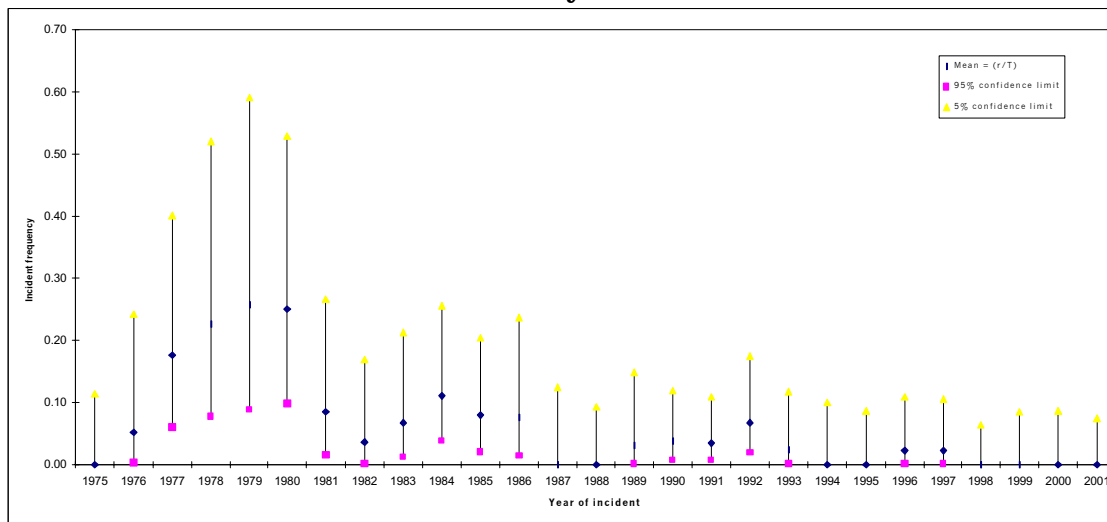
Figure 14: Frequency of moderate or severe damage to floating installations per year

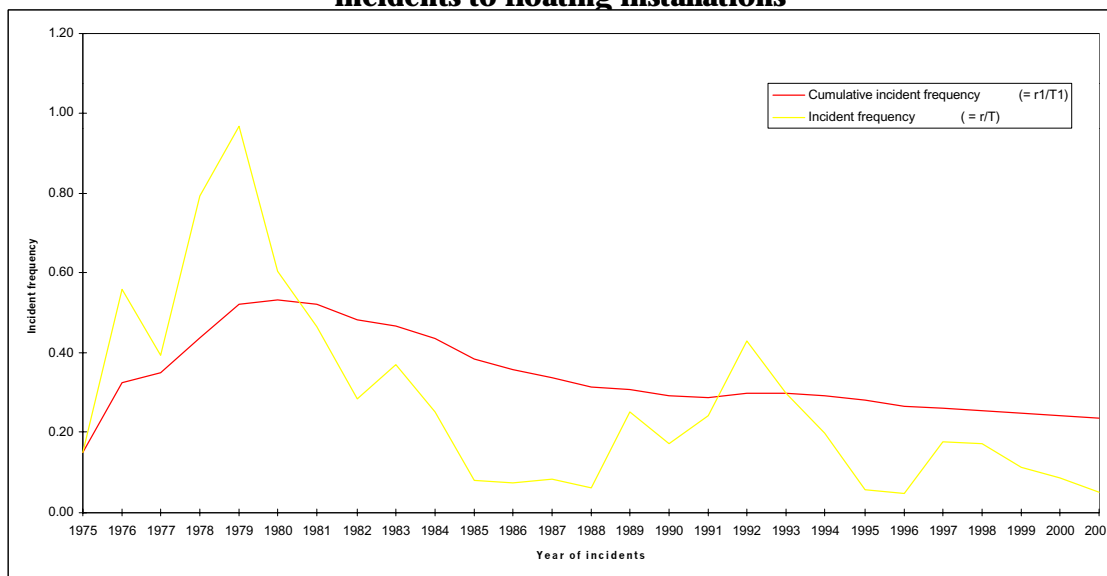
Figure 15: Mean and cumulative frequency of all reported incidents to floating installations

Over the whole period of study the probability of an incident occurring is on average 0.238 per year (1 incident every 4.20 years or approximately 9 every year for the current level of installation activity). The analysis for reported incidents resulting in damage categorised as moderate or severe indicates the probability is on average 0.049 per year (1 incident every 20.53 years or approximately 2 every year for the current level of installation activity). Recent experience indicates that these figures are an exaggeration of the actual number.

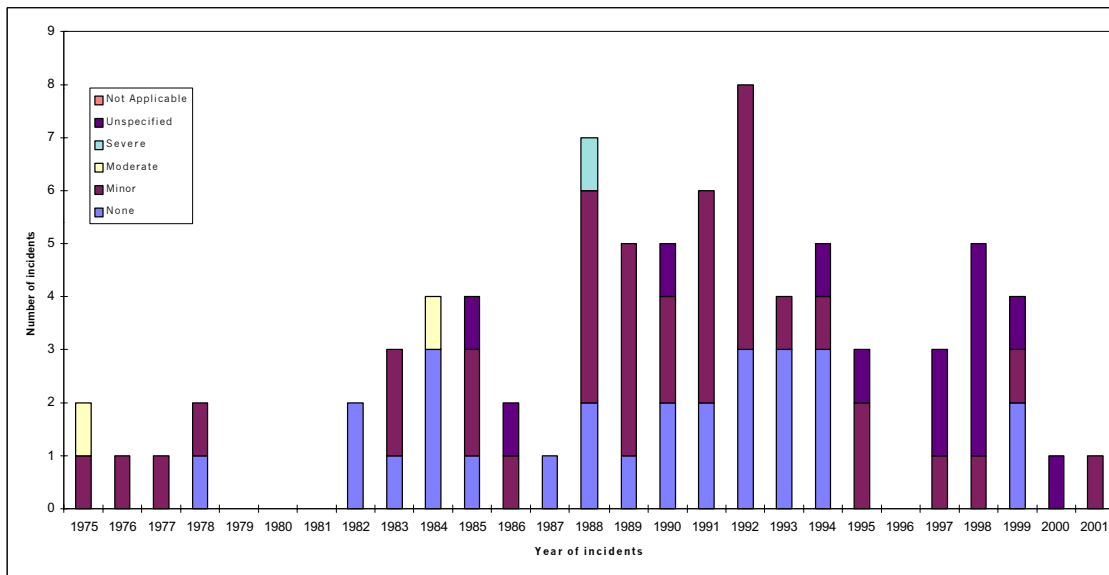
Figure 16: Damage resulting from incidents to jack-up installations by year

A total of 79 incidents were recorded to installations of this type. Table and Figure 16 summarise the number and damage category of all incidents occurring to jack-ups. One incident (Glomar Labrador 1/Irving Forest - 23/06/88) was classed as severe, 2 incidents as moderate and the remainder resulting in minor or no damage, including 13 incidents where the damage was not specified but is believed to be minor or none.

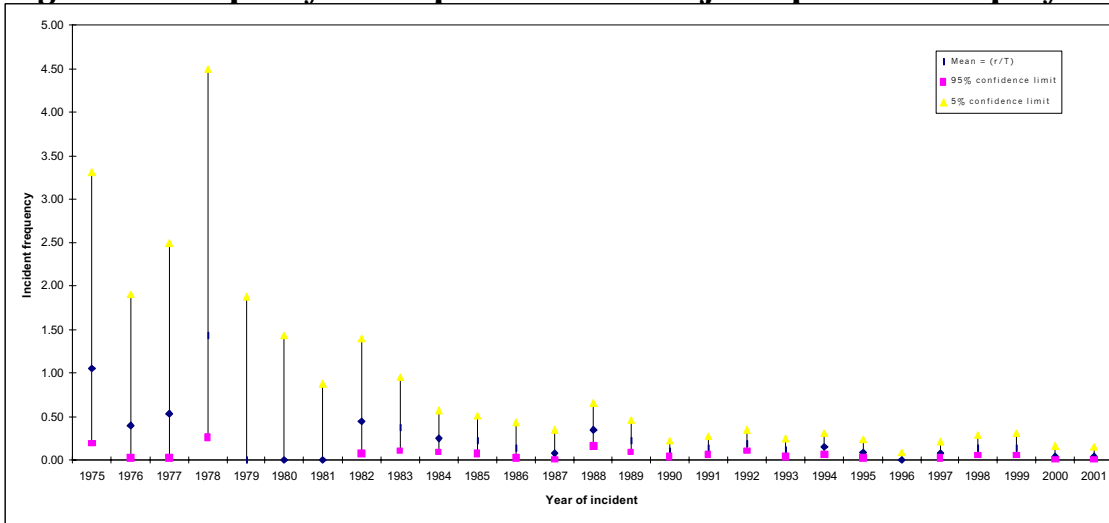
Figure 17: Frequency of all reported incidents to jack-up installations per year

The mean frequency and confidence limits of all reported incidents and those categorised as resulting in moderate or severe by year are summarised in Tables 17 and 18 respectively. Table 19 summarises the mean frequency in the year in question and also cumulatively to any year end from 1975. Figures 17, 18 and 19 graphically represent the variation in these results.

The relatively small jack-up population, especially in the early years of the study, has to a degree devalued the data. Post 1983 jack-up utilisation increased four fold from two years previously and thereafter mean incident frequency remained within a reasonably narrow band in relation to the constraints imposed by a small population.

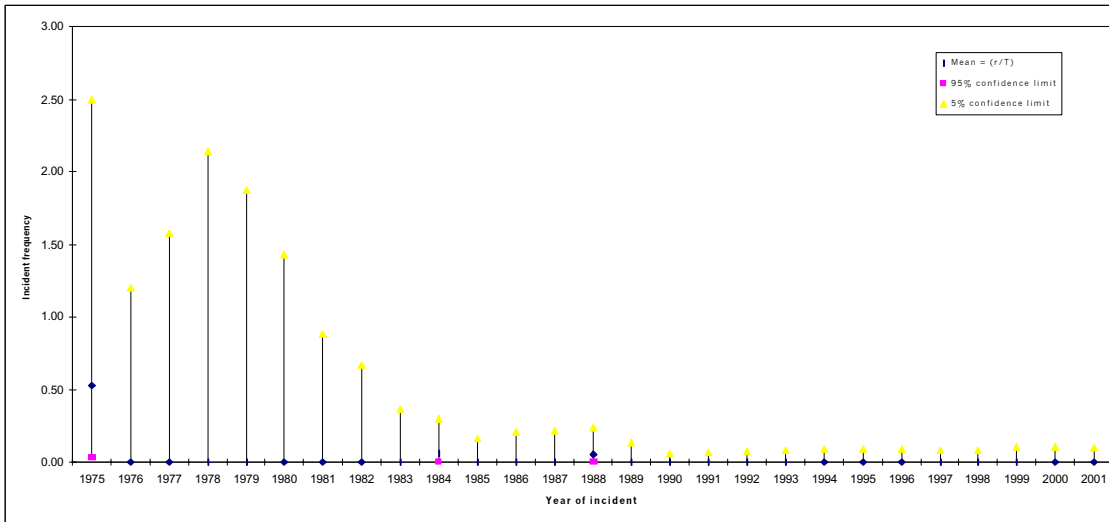
Figure 18: Frequency of moderate or severe damage to jack-up installations per year

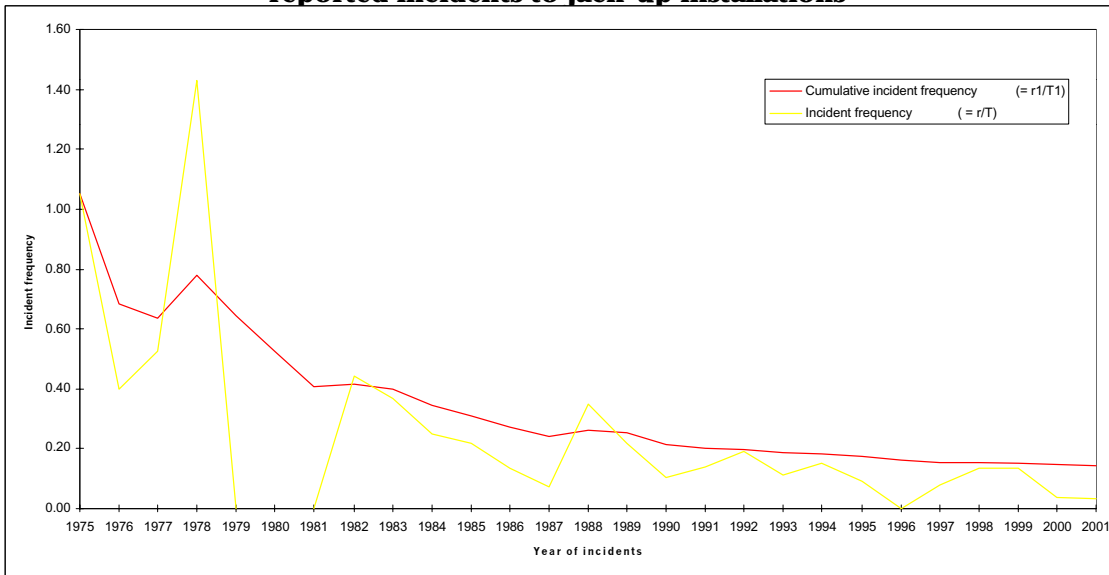
Figure 19: Mean and cumulative frequency of all reported incidents to jack-up installations

Over the whole period of study the probability of an incident occurring is on average 0.141 per year (1 incident every 7.08 years or approximately 4.5 every year for the current level of installation activity). The analysis for reported incidents resulting in damage categorised as moderate or severe indicates the probability is on average 0.005 per year (1 incident every 186.4 years or approximately 1 every 6 years for the current level of installation activity). Recent experience indicates that these figures are an exaggeration of the actual number and is probably skewed by the larger incident frequencies in the early years of study adversely affecting the figure for the current level of activity.

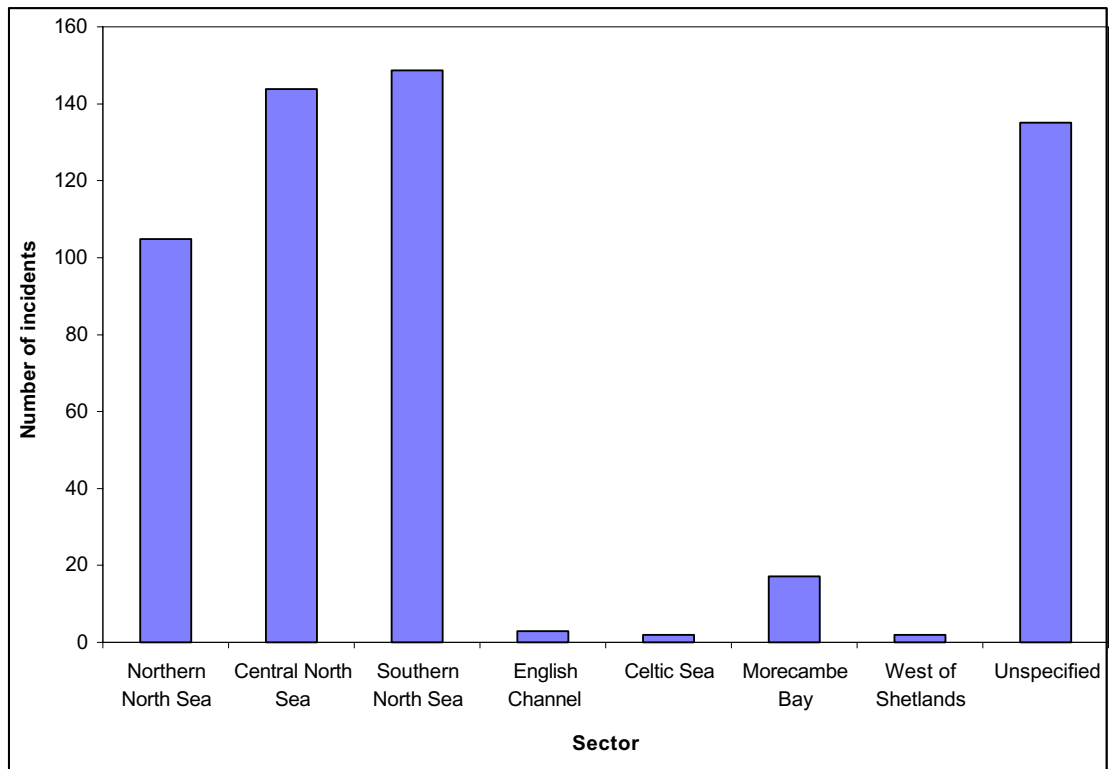
Figure 20: Geographical distribution of incidents

A simple comparison of the number of incidents occurring in each sector of the UKCS has been produced in Table 24 and graphically in Figure 20. These highlight those areas that have historically suffered most incidents, however, it should be viewed against the very different levels of activity between sectors. Unless the number of incidents is compared with the total number of installations operating in that sector a relative frequency is impossible to determine. Unfortunately, sector activity throughout the period of study is difficult to achieve with any degree of accuracy as mobile units move location frequently even when engaged under the same contract.

Of particular interest is the geographical distribution of “passing vessel” incidents as these tend to be more location specific than those of “attendant vessels”. The 8 passing vessels incidents all occurred in the Southern North Sea.

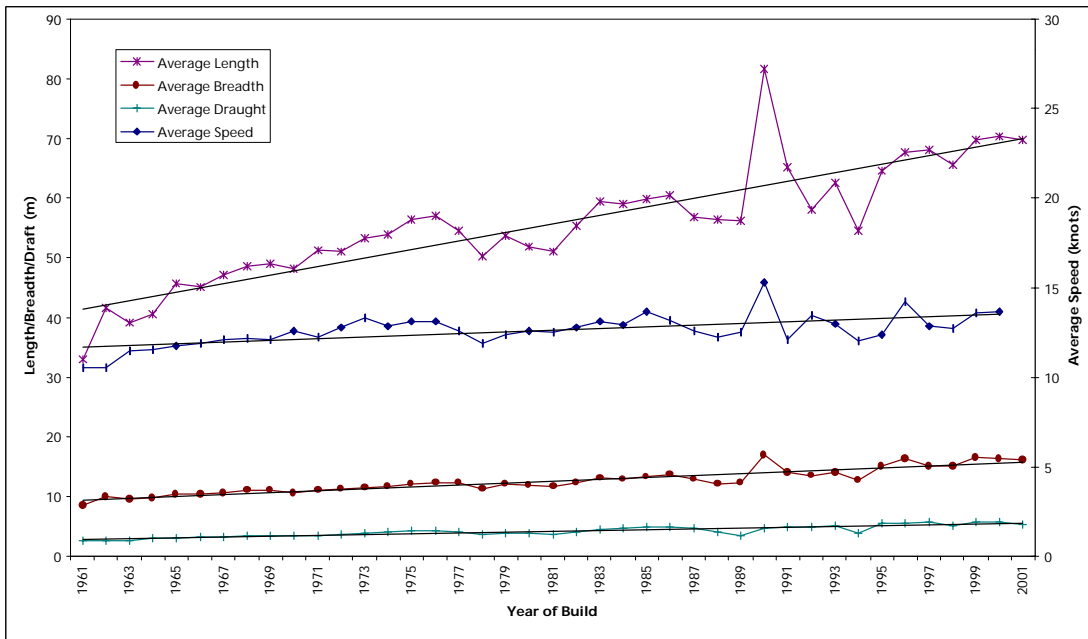
Figure 21: All offshore supply vessels average dimensions over time

A graphical representation of the year on year average of the main vessel dimensions and speed is presented in Figure 21 for all vessels listed as 'offshore supply' and in Figure 22 for those that have been active on the UKCS. Similarly, Figures 23 and 24 present a representation of the year on year average of tonnages.

As will be noted, there has been an increase to varying degrees in all the assessed parameters over time. This is the case for both all the current offshore supply vessels and those active on the UKCS.

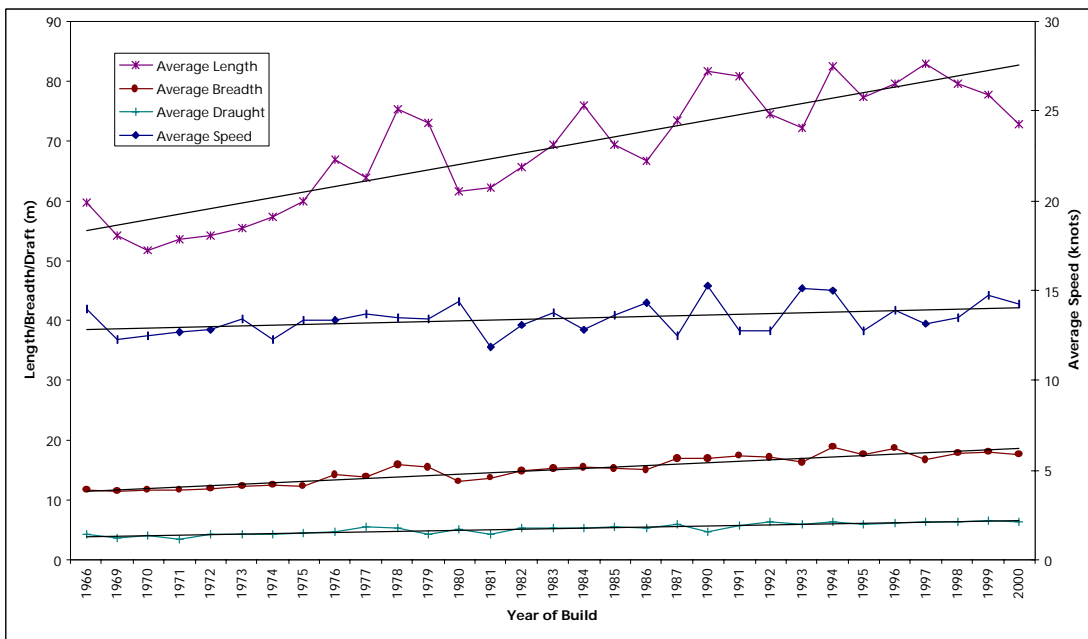
Figure 22: UKCS offshore supply vessels average dimensions over time

NB: The apparent omission of data for 1967 – 1968 and 1988 – 1989 occurred because there were no vessels built in these years operating on the UKCS and reporting cargo through MARSTATS. The inclusion of 'zero' data for these years would have unjustly skewed the average figures and trend lines.

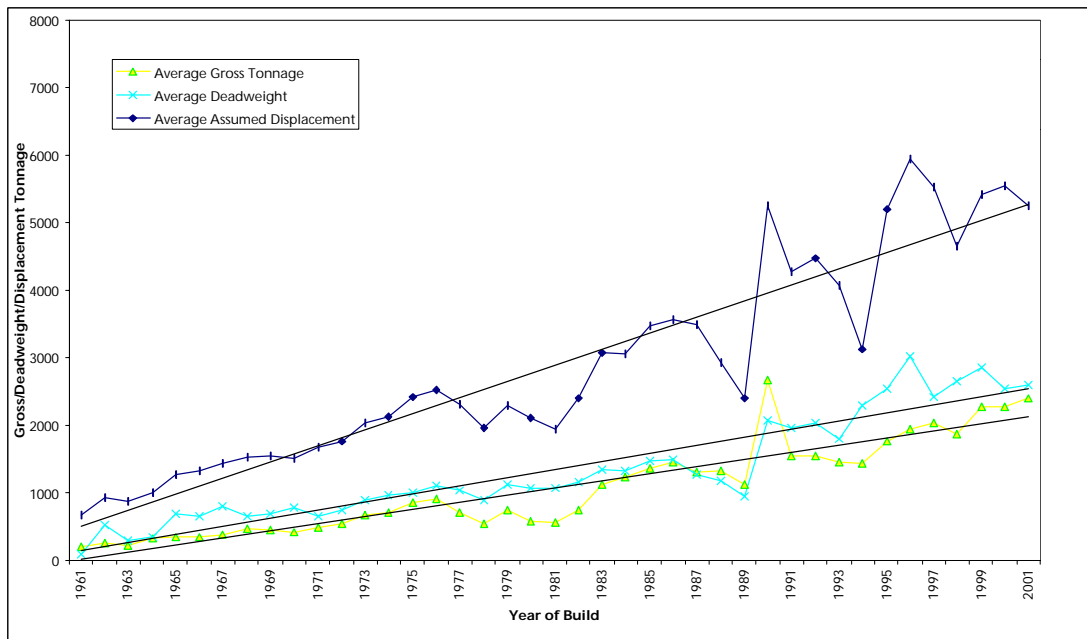
Figure 23: All offshore supply vessels average tonnages over time

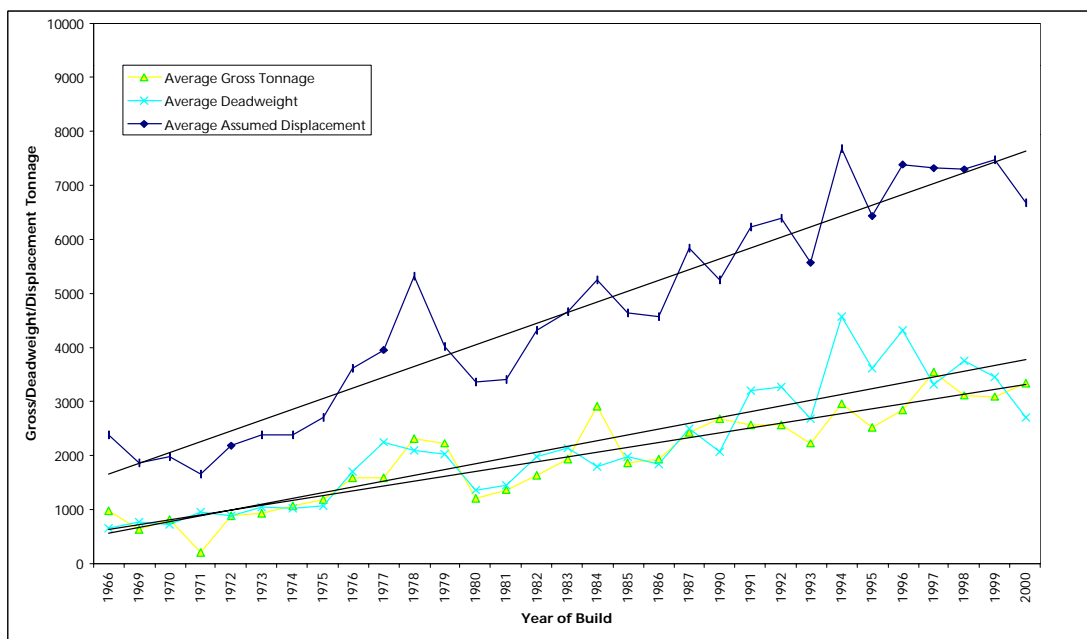
Figure 24: UKCS offshore supply vessels average tonnages over time

NB: The apparent omission of data for 1967 – 1968 and 1988 – 1989 occurred because there were no vessels built in these years operating on the UKCS and reporting cargo through MARSTATS. The inclusion of 'zero' data for these years would have unjustly skewed the average figures and trend lines.

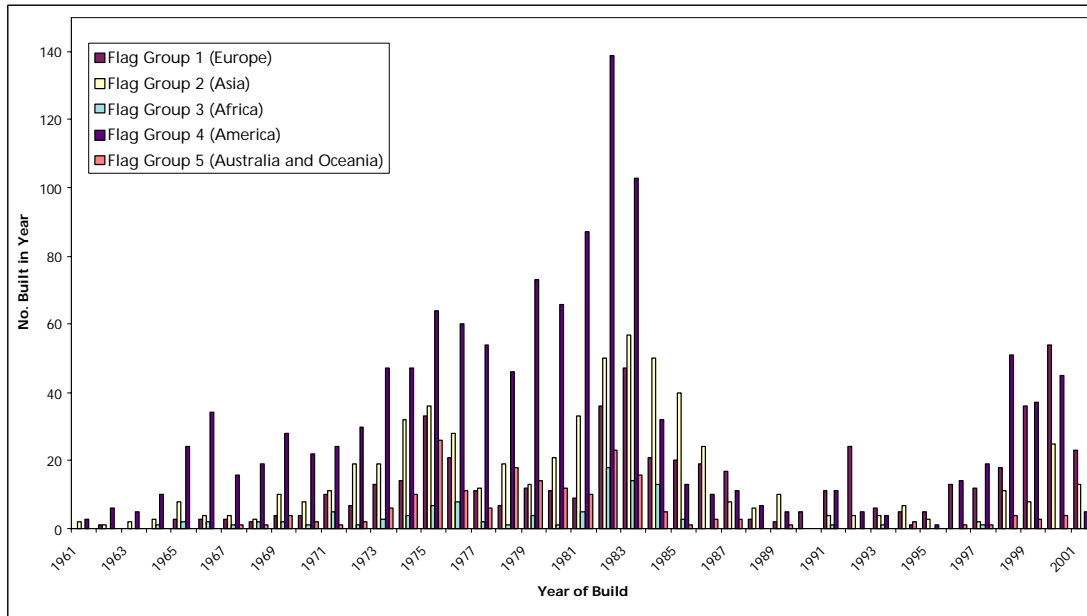
Figure 25: All offshore supply vessel flags over time

Other information held in the fleet list refers to a vessel's current flag. Using data correct as of 30 June 2001 the entire fleet of 'offshore supply' and those active on the UKCS have been assessed in terms of their flag. For ease of representation all flags have been divided into groups based on the continents, i.e., Europe, Asia, Africa, America and Australia/Oceania and grouped according to the vessels year of build.

It will be noted that the majority of vessels operating on the UKCS appear to be of more recent build than the world fleet average and the majority are registered in European countries. It is perhaps to be expected that vessels operating in European waters would be registered in European countries and no inference should be drawn from this.

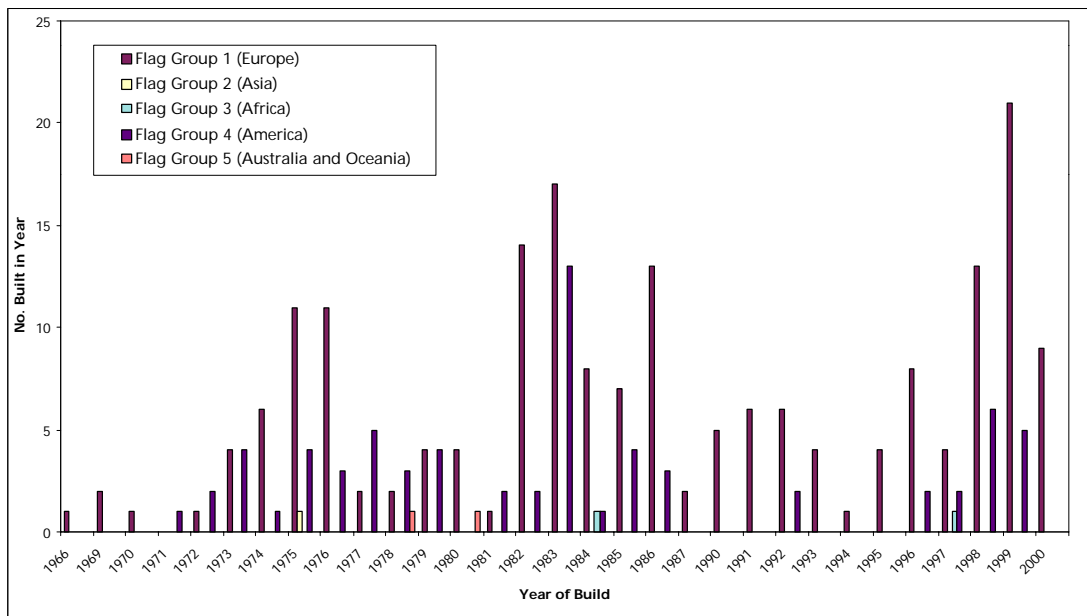
Figure 26: UKCS offshore supply vessel flags over time

NB: The apparent omission of data for 1967 – 1968 and 1988 – 1989 occurred because there were no vessels built in these years operating on the UKCS and reporting cargo through MARSTATS. The inclusion of 'zero' data for these years would have unjustly skewed the average figures and trend lines.

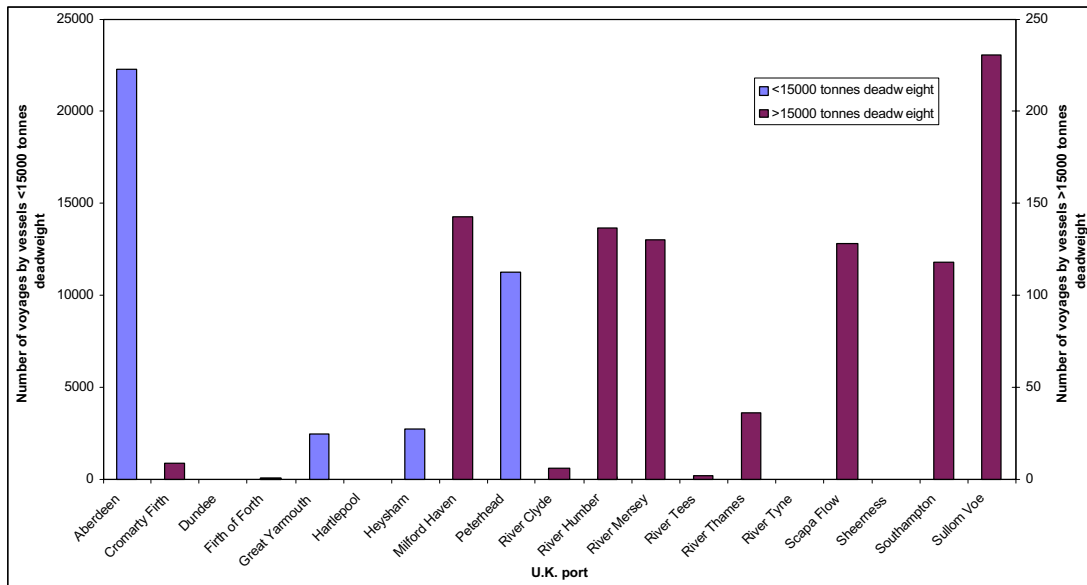
Figure 27: Vessels carrying commercial cargo between U.K. ports and UKCS

Figure 27, overleaf, is a graphical representation of the total number of voyages where cargo was carried between U.K. ports and the UKCS in the period between 1 January 2000 and 30 June 2001. It demonstrates that Aberdeen is the busiest port in terms of number of voyages followed by Peterhead. However, when the graph is compared with the table in Appendix B it shows that the bulk of the voyages are carried out by relatively small vessels compared to other ports that are used as discharge ports for shuttle tankers, such as the Sullom Voe, Milford Haven, River Humber, River Mersey and Scapa Flow.

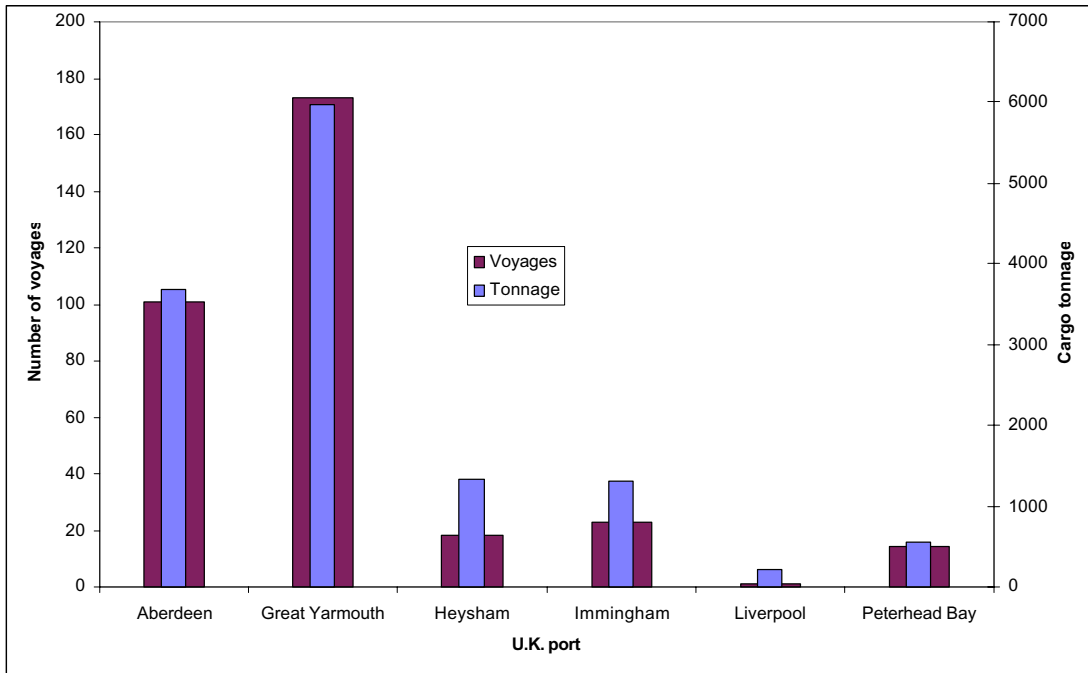
Figure 28: ERRV carrying commercial cargo between U.K. ports and UKCS

A graphical representation of the comparison of ports used for ERRV vessels when carrying commercial cargo is presented in Figure 28. This demonstrates that in terms of both the number of voyages and cargo tonnage Great Yarmouth is the most usual port of loading/discharge for ERRV while Aberdeen is the second most usual.
