Ship/platform collision incident database (2001)

Prepared by **Serco Assurance**
for the Health and Safety Executive 2003

RESEARCH REPORT 053

J K Robson
Serco Assurance
Culham
Abingdon
Oxfordshire
OX14 3ED
United Kingdom

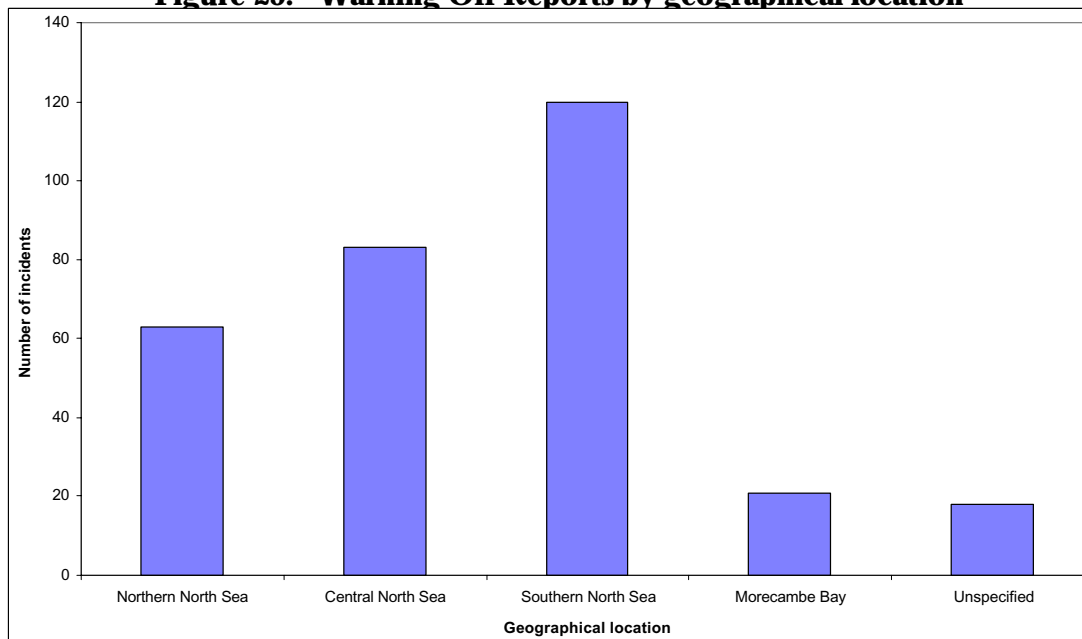
Figure 29: Warning Off Reports by geographical location

- Northern North Sea 63 records
- Central North Sea 83 records
- Southern North Sea 120 records
- Morecambe Bay 21 records
- Unspecified 18 records

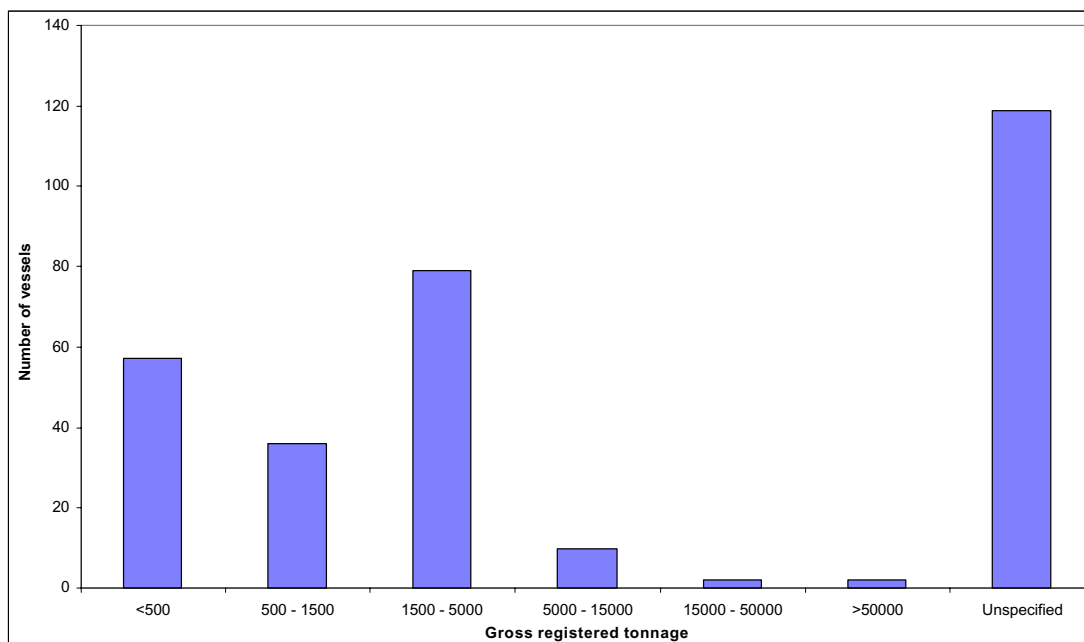
Figure 30: Gross registered tonnage of threatening vessel

- Gross tonnage less than 500 g.r.t. 57 records
- Gross tonnage between 500 – 1500 g.r.t. 36 records
- Gross tonnage between 1500 – 5000 g.r.t. 79 records
- Gross tonnage between 5000 – 15000 g.r.t. 10 records
- Gross tonnage between 15000 – 50000 g.r.t. 2 records
- Gross tonnage greater than 50000 g.r.t. 2 records
- Unspecified gross tonnage 119 records

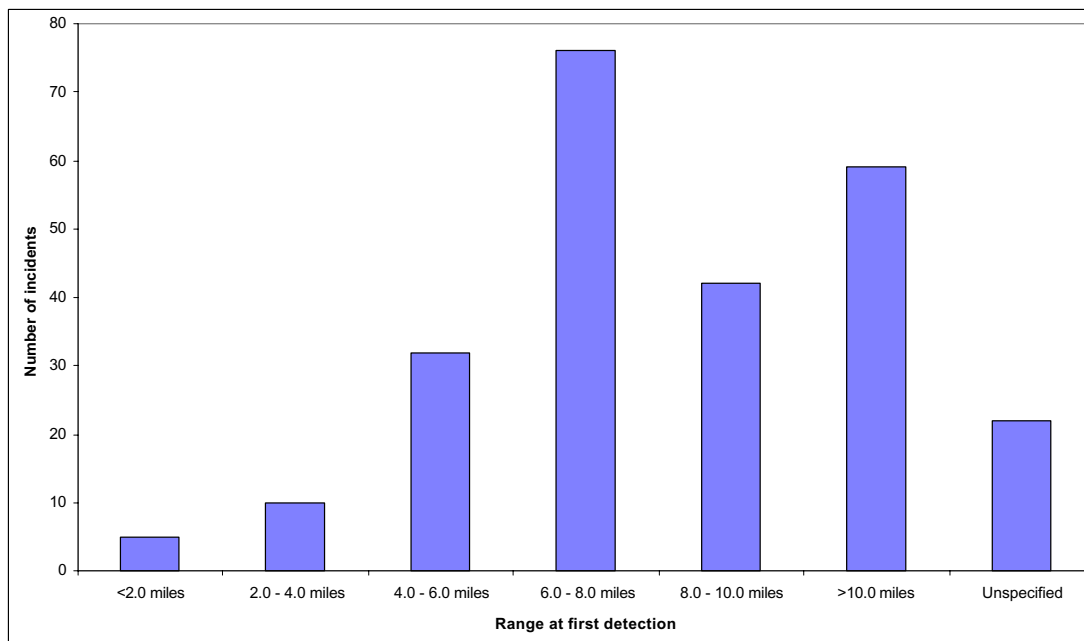
Figure 31: Radar range at first detection

- First detection at less than 2.0 miles 5 records
- First detection between 2.0 to 4.0 miles 10 records
- First detection between 4.0 to 6.0 miles 32 records
- First detection between 6.0 to 8.0 miles 76 records
- First detection between 8.0 to 10.0 miles 42 records
- First detection at greater than 10.0 miles 59 records
- Unspecified range of first detection 22 records

efficiency of ERRV radar under different environmental conditions as the data provides the range of first detection of an approaching vessel.

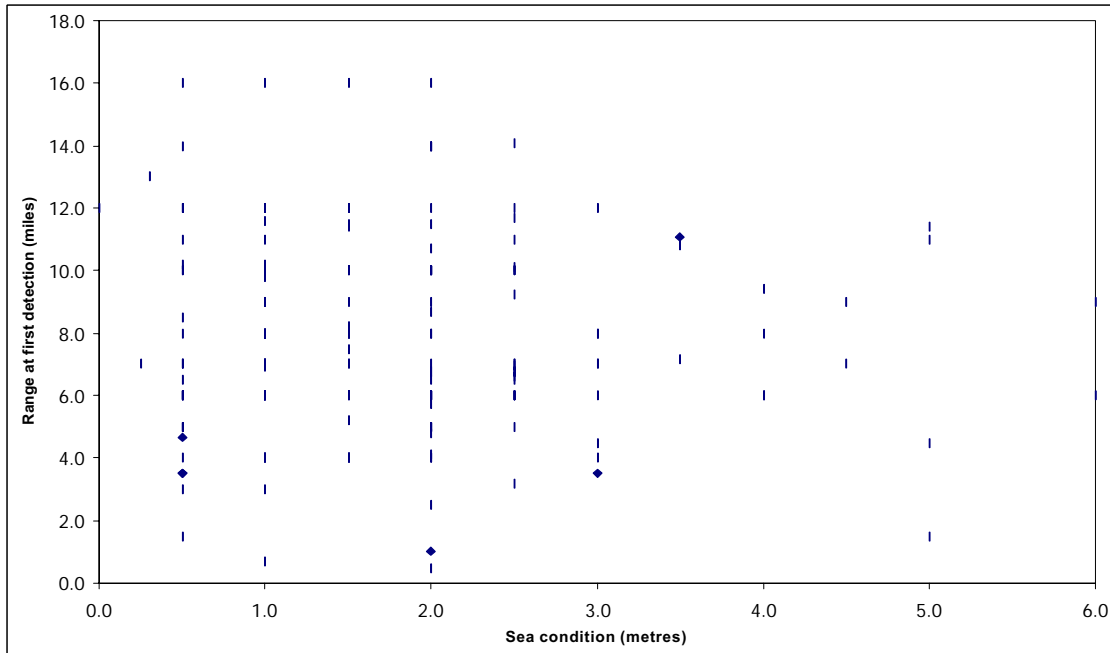
Figure 32: Radar range at first detection in prevailing sea condition

Data in Figure 32 appears as it does because of the normal seagoing practice of reporting the sea condition to the nearest 0.5 metre of wave height. Indeed, it is considered extremely difficult to be even more precise when attempting to determine the wave height from a vessel's deck or bridge when the vessel is rolling/pitching in a seaway.

Bearing the foregoing in mind, there appears not to be a clearly discernible trend from an analysis of this data. Radar detection range was in most cases good regardless of the prevailing sea condition although if further analysis was undertaken, particularly with respect to the size, type, construction material and aspect of the target vessel, better information may be available. For example, the detection of large, angular, steel vessels, such as car carriers or container vessels will inevitably be better at longer ranges and in worse weather conditions than the detection of smaller fibreglass or wooden fishing vessels at shorter ranges and in less severe weather.

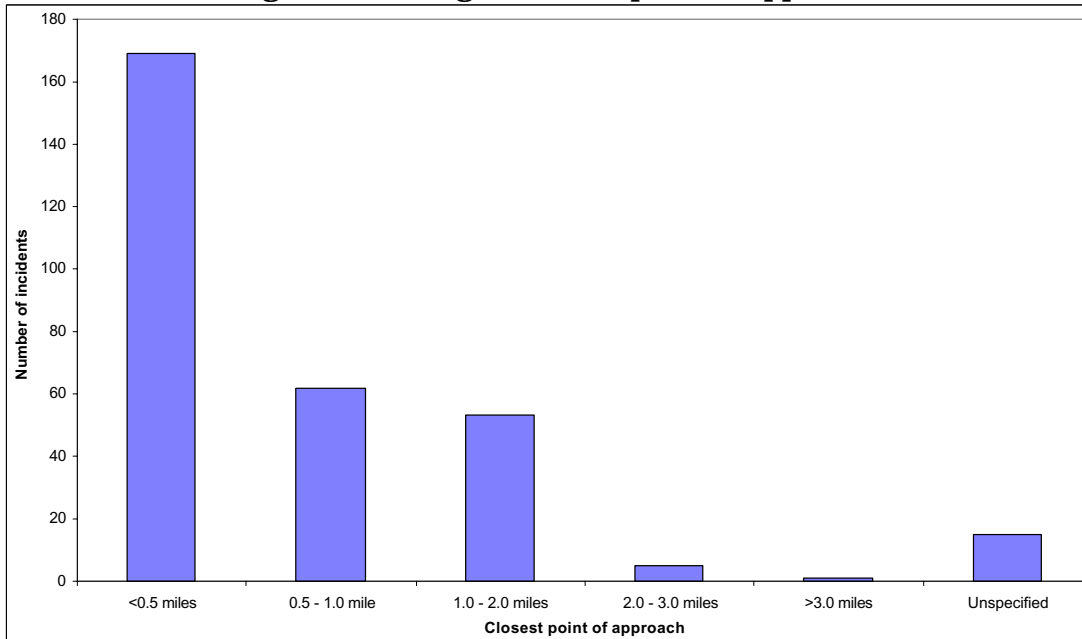
Figure 33: Range at closest point of approach

- CPA less than 0.5 mile 169 records
- CPA between 0.5 - 1.0 mile 62 records
- CPA between 1.0 - 2.0 miles 53 records
- CPA between 2.0 - 3.0 miles 5 records
- CPA greater 3.0 miles 1 record
- Unspecified CPA 15 records

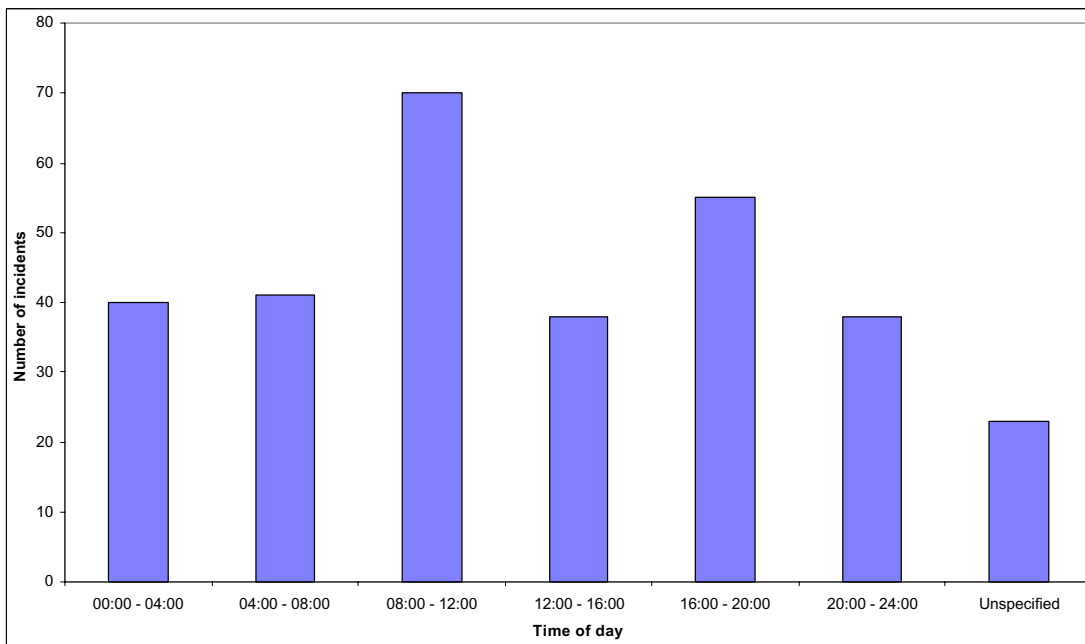
Figure 34: Time of day of incidents

- Total incidents between 00:00 - 04:00 40 records
- Total incidents between 04:00 - 08:00 41 records
- Total incidents between 08:00 - 12:00 70 records
- Total incidents between 12:00 - 16:00 38 records
- Total incidents between 16:00 - 20:00 55 records
- Total incidents between 20:00 - 24:00 38 records
- Unspecified time of incident 23 records
