XLINKS' MOROCCO-UK POWER PROJECT

Volume 2, Appendix 1.11: River Condition Assessment

Report Title: XLinks North Devon – River Condition Assessments

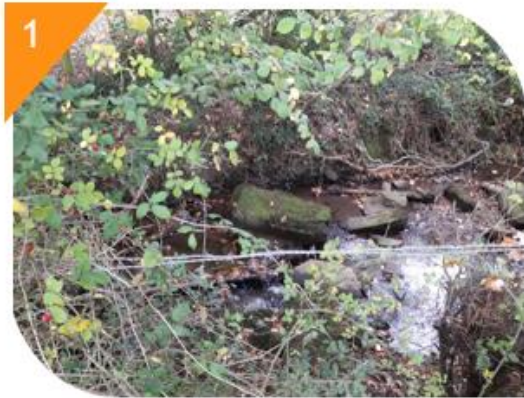
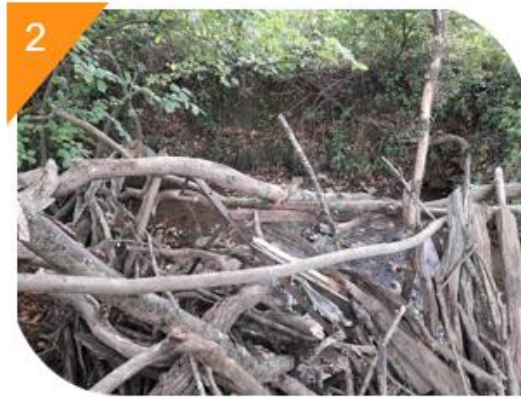
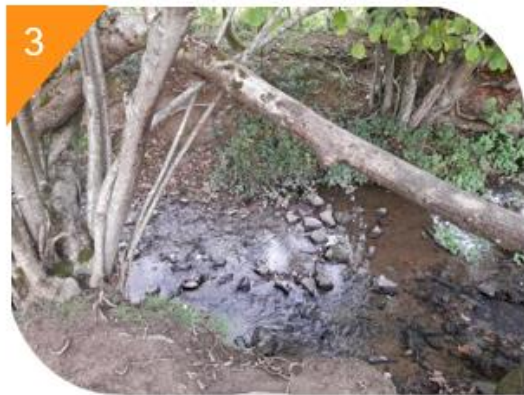
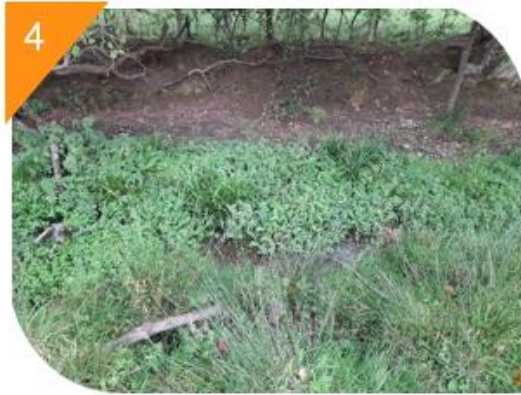
- 1 Site 1, Subreach 1, Module 1
- 2 Site 1, Subreach 1, Module 2
- 3 Site 1, Subreach 1, Module 3
- 4 Site 1, Subreach 1, Module 4

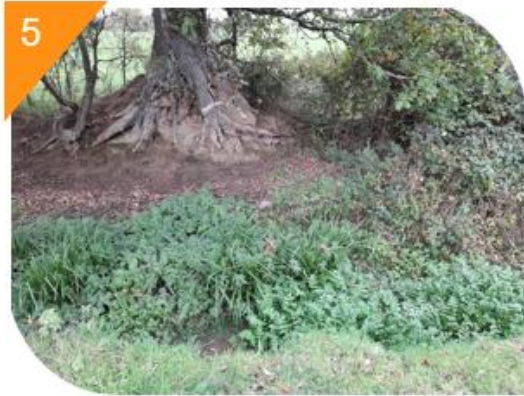
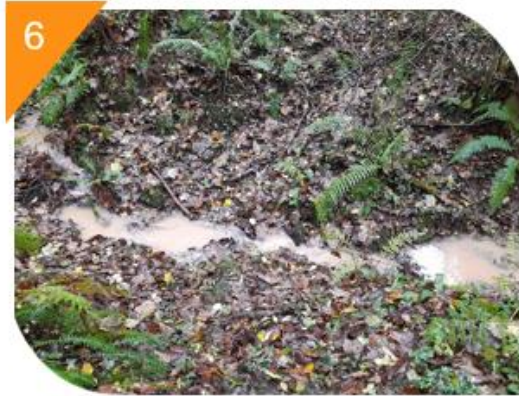
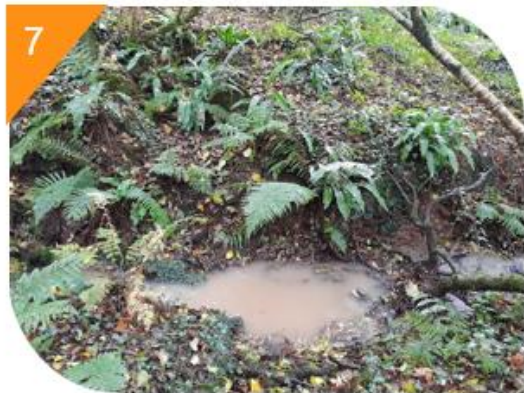
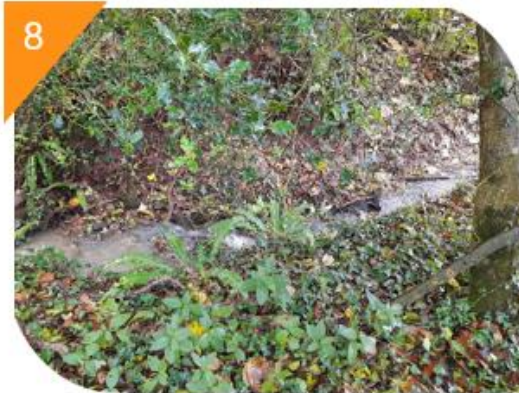
- 5 Site 1, Subreach 1, Module 5
- 6 Site 3, Subreach 1, Module 1
- 7 Site 3, Subreach 1, Module 2
- 8 Site 3, Subreach 1, Module 3

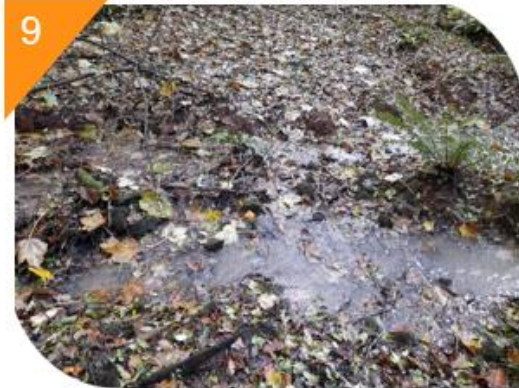
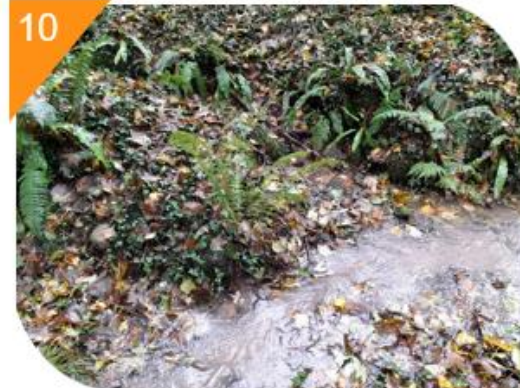
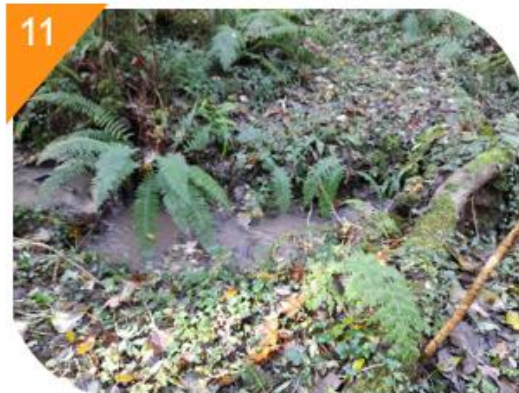
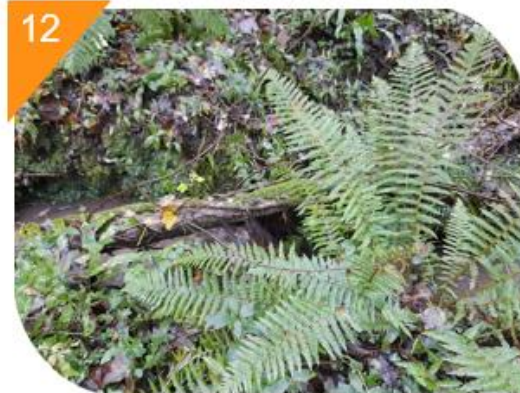
- 9 Site 3, Subreach 1, Module 4
- 10 Site 3, Subreach 1, Module 5
- 11 Site 3, Subreach 2, Module 1
- 12 Site 3, Subreach 2, Module 2

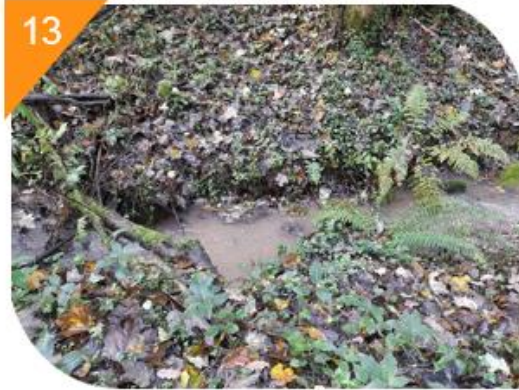
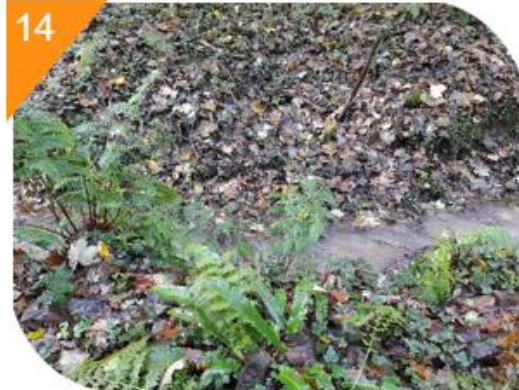
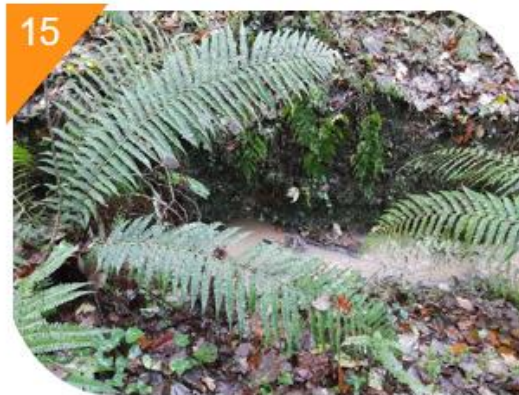
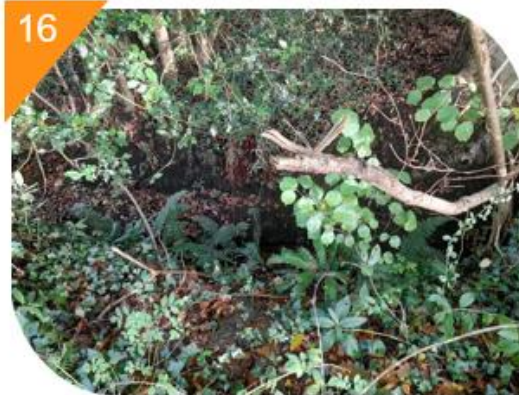
- 13 Site 3, Subreach 2, Module 3
- 14 Site 3, Subreach 2, Module 4
- 15 Site 3, Subreach 2, Module 5
- 16 Site 4, Subreach 1, Module 1

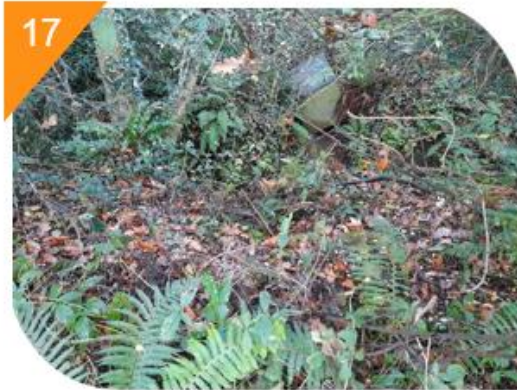
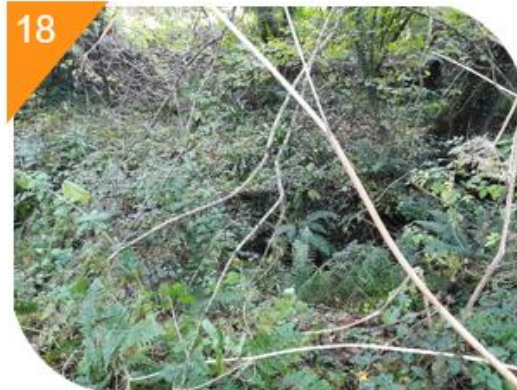
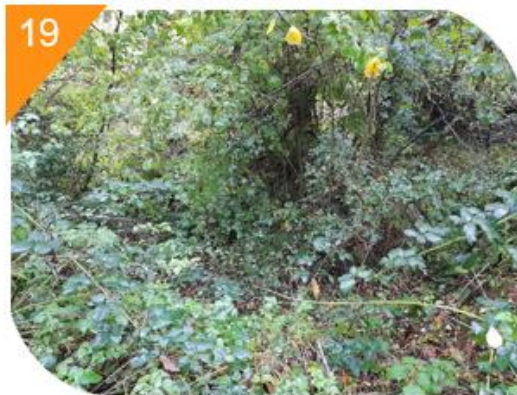
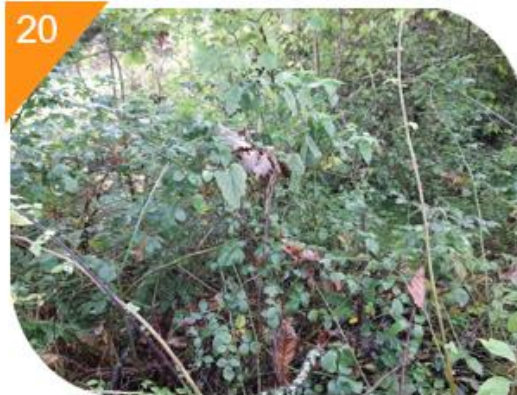
- 17 Site 4, Subreach 1, Module 2
- 18 Site 4, Subreach 1, Module 3
- 19 Site 4, Subreach 1, Module 4
- 20 Site 4, Subreach 1, Module 5

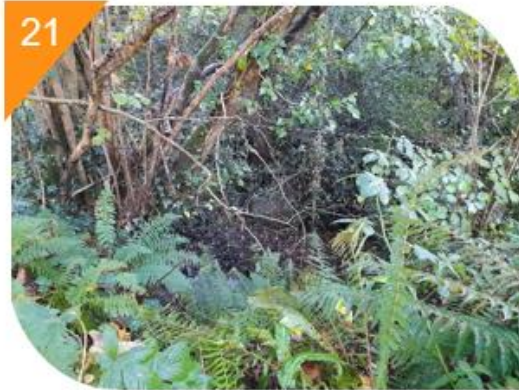
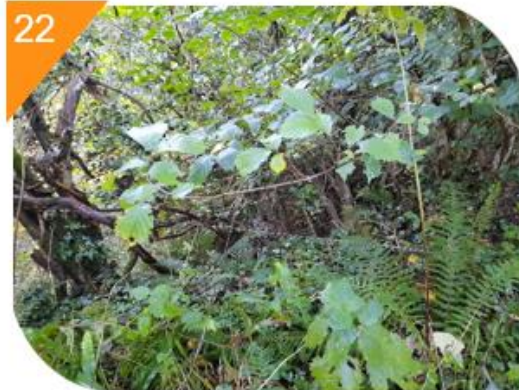
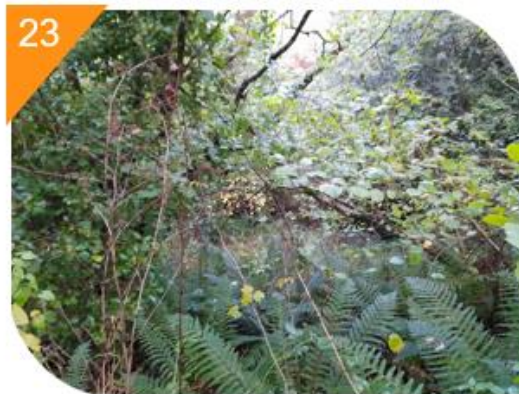
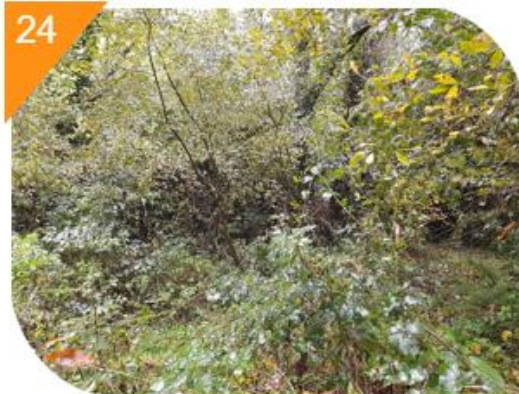
- 21 Site 4, Subreach 2, Module 1
- 22 Site 4, Subreach 2, Module 2
- 23 Site 4, Subreach 2, Module 3
- 24 Site 4, Subreach 2, Module 4

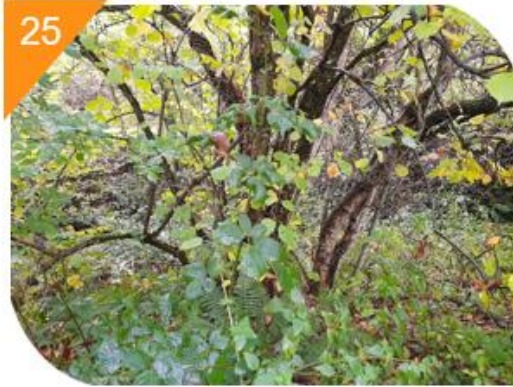
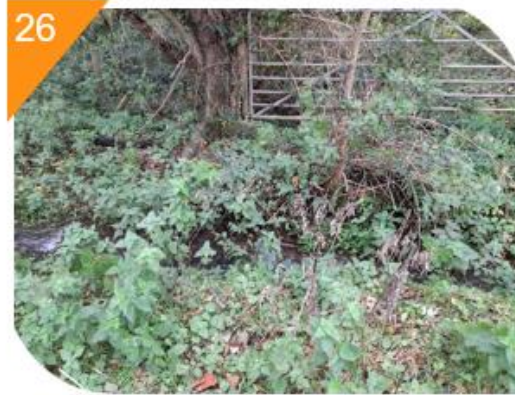
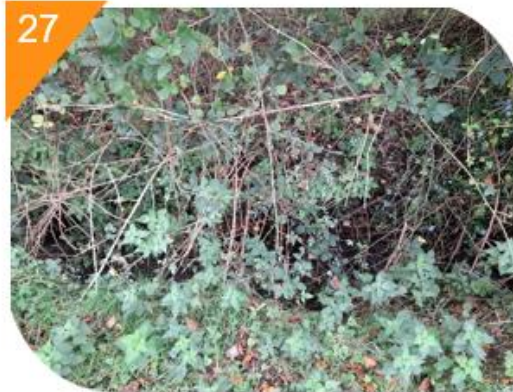
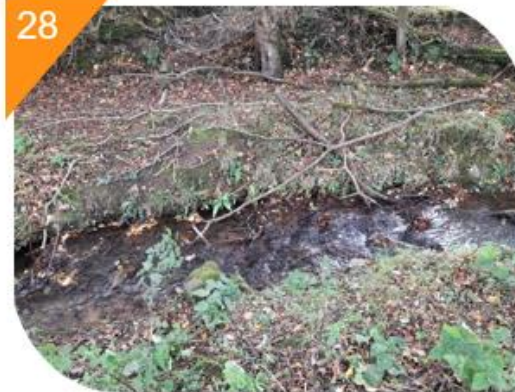
- 25 Site 4, Subreach 2, Module 5
- 26 Site 5, Subreach 1, Module 1
- 27 Site 5, Subreach 1, Module 2
- 28 Site 5, Subreach 1, Module 3

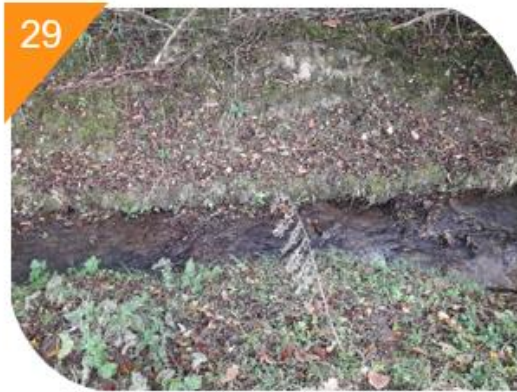
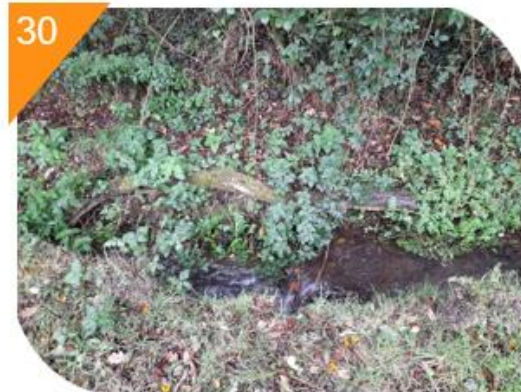
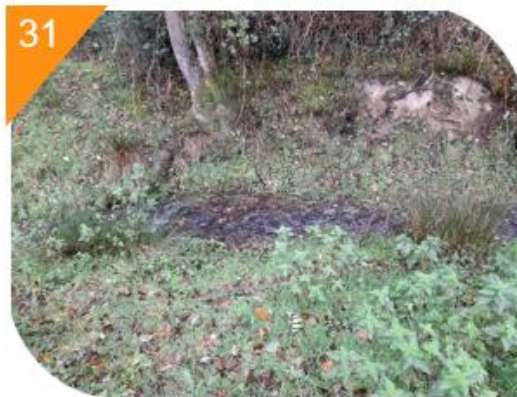
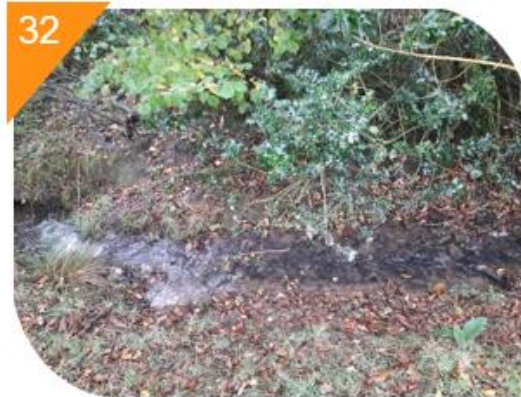
- 29 Site 5, Subreach 1, Module 4
- 30 Site 5, Subreach 1, Module 5
- 31 Site 5, Subreach 2, Module 1
- 32 Site 5, Subreach 2, Module 2

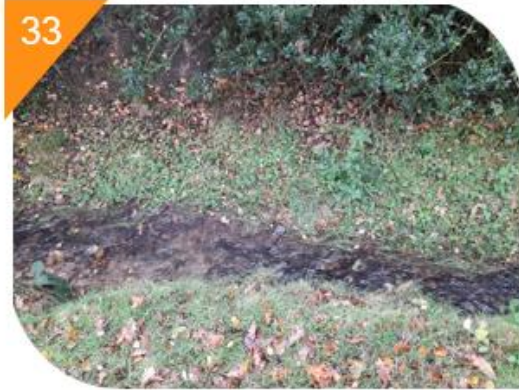
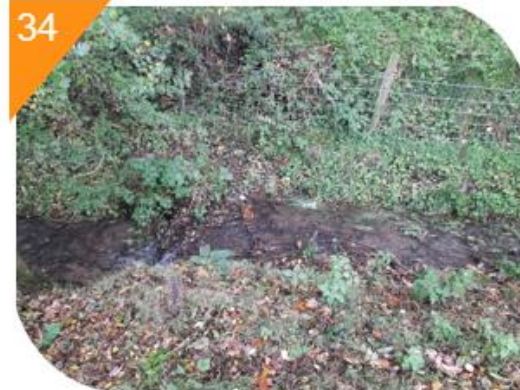
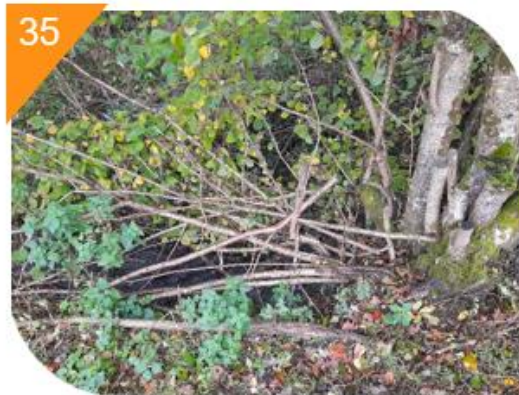
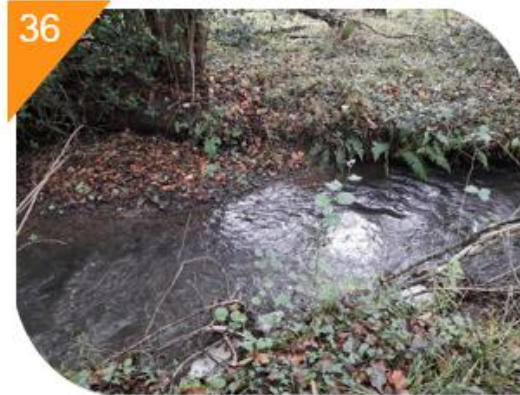
- 33 Site 5, Subreach 2, Module 3
- 34 Site 5, Subreach 2, Module 4
- 35 Site 5, Subreach 2, Module 5
- 36 Site 6, Subreach 1, Module 1

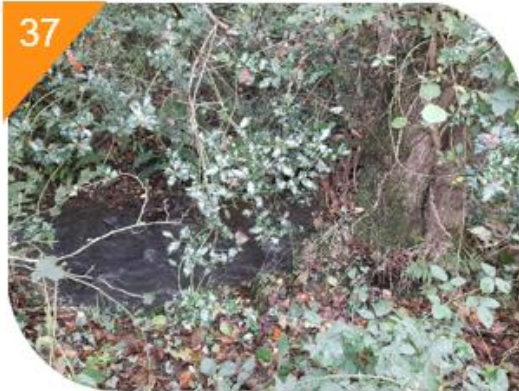
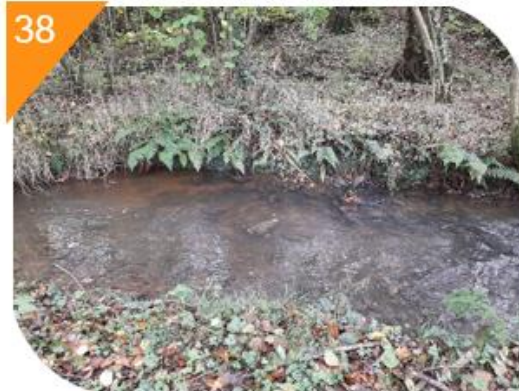
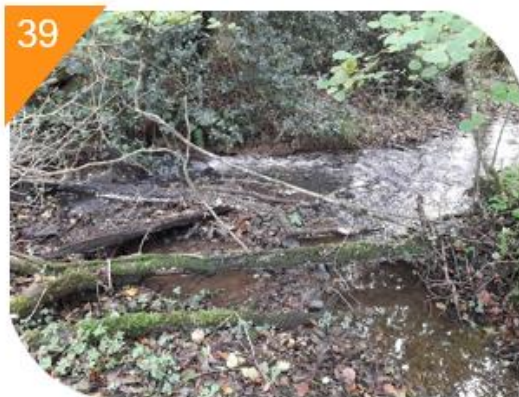
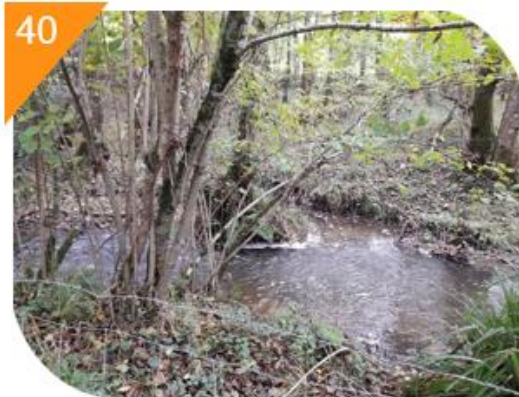
- 37 Site 6, Subreach 1, Module 2
- 38 Site 6, Subreach 1, Module 3
- 39 Site 6, Subreach 1, Module 4
- 40 Site 6, Subreach 1, Module 5

3.1.1 MoRPh5 surveys were carried out at five Sites (or 'Reaches'), each consisting of two sub-reaches, except for Site 1, which consisted of one sub-reach. The locations of each Site/Reach surveyed are displayed in **Figure 2**. Sub-reach locations for each Site are displayed in **Figures 3.1 – 3.5**. Site habitat photographs are provided in **Appendix 2**.

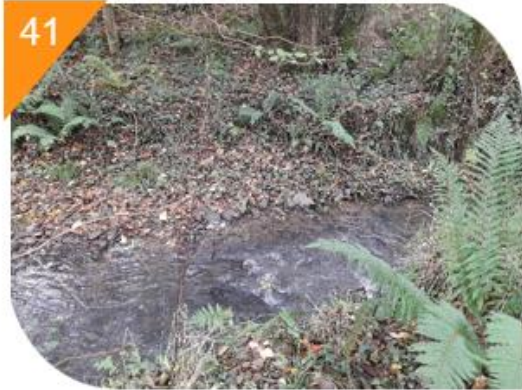
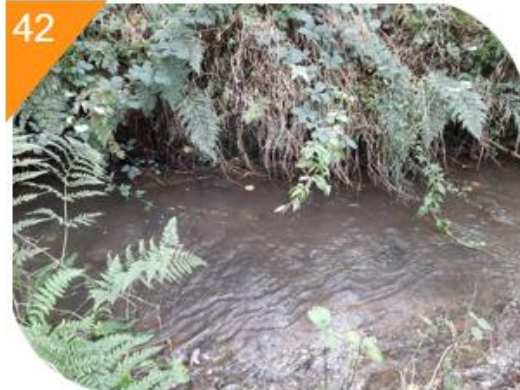
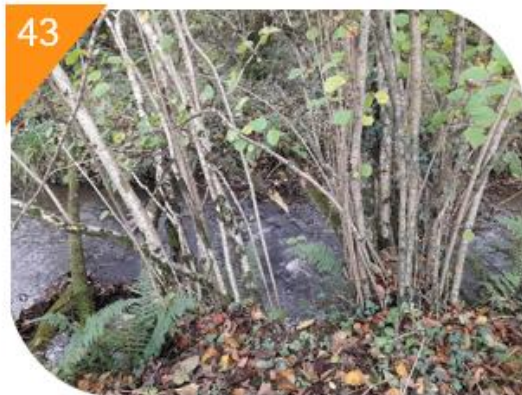
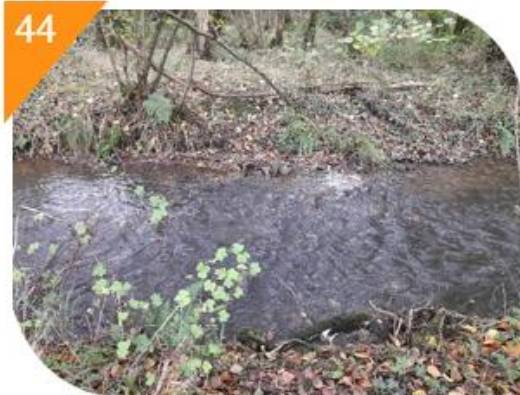
- 41 Site 6, Subreach 2, Module 1
- 42 Site 6, Subreach 2, Module 2
- 43 Site 6, Subreach 2, Module 3
- 44 Site 6, Subreach 2, Module 4

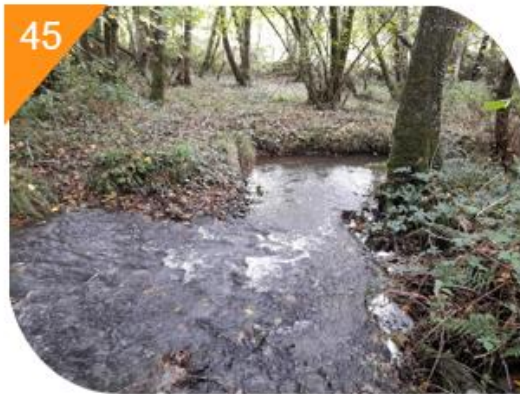
45

Site 6, Subreach 2, Module 5

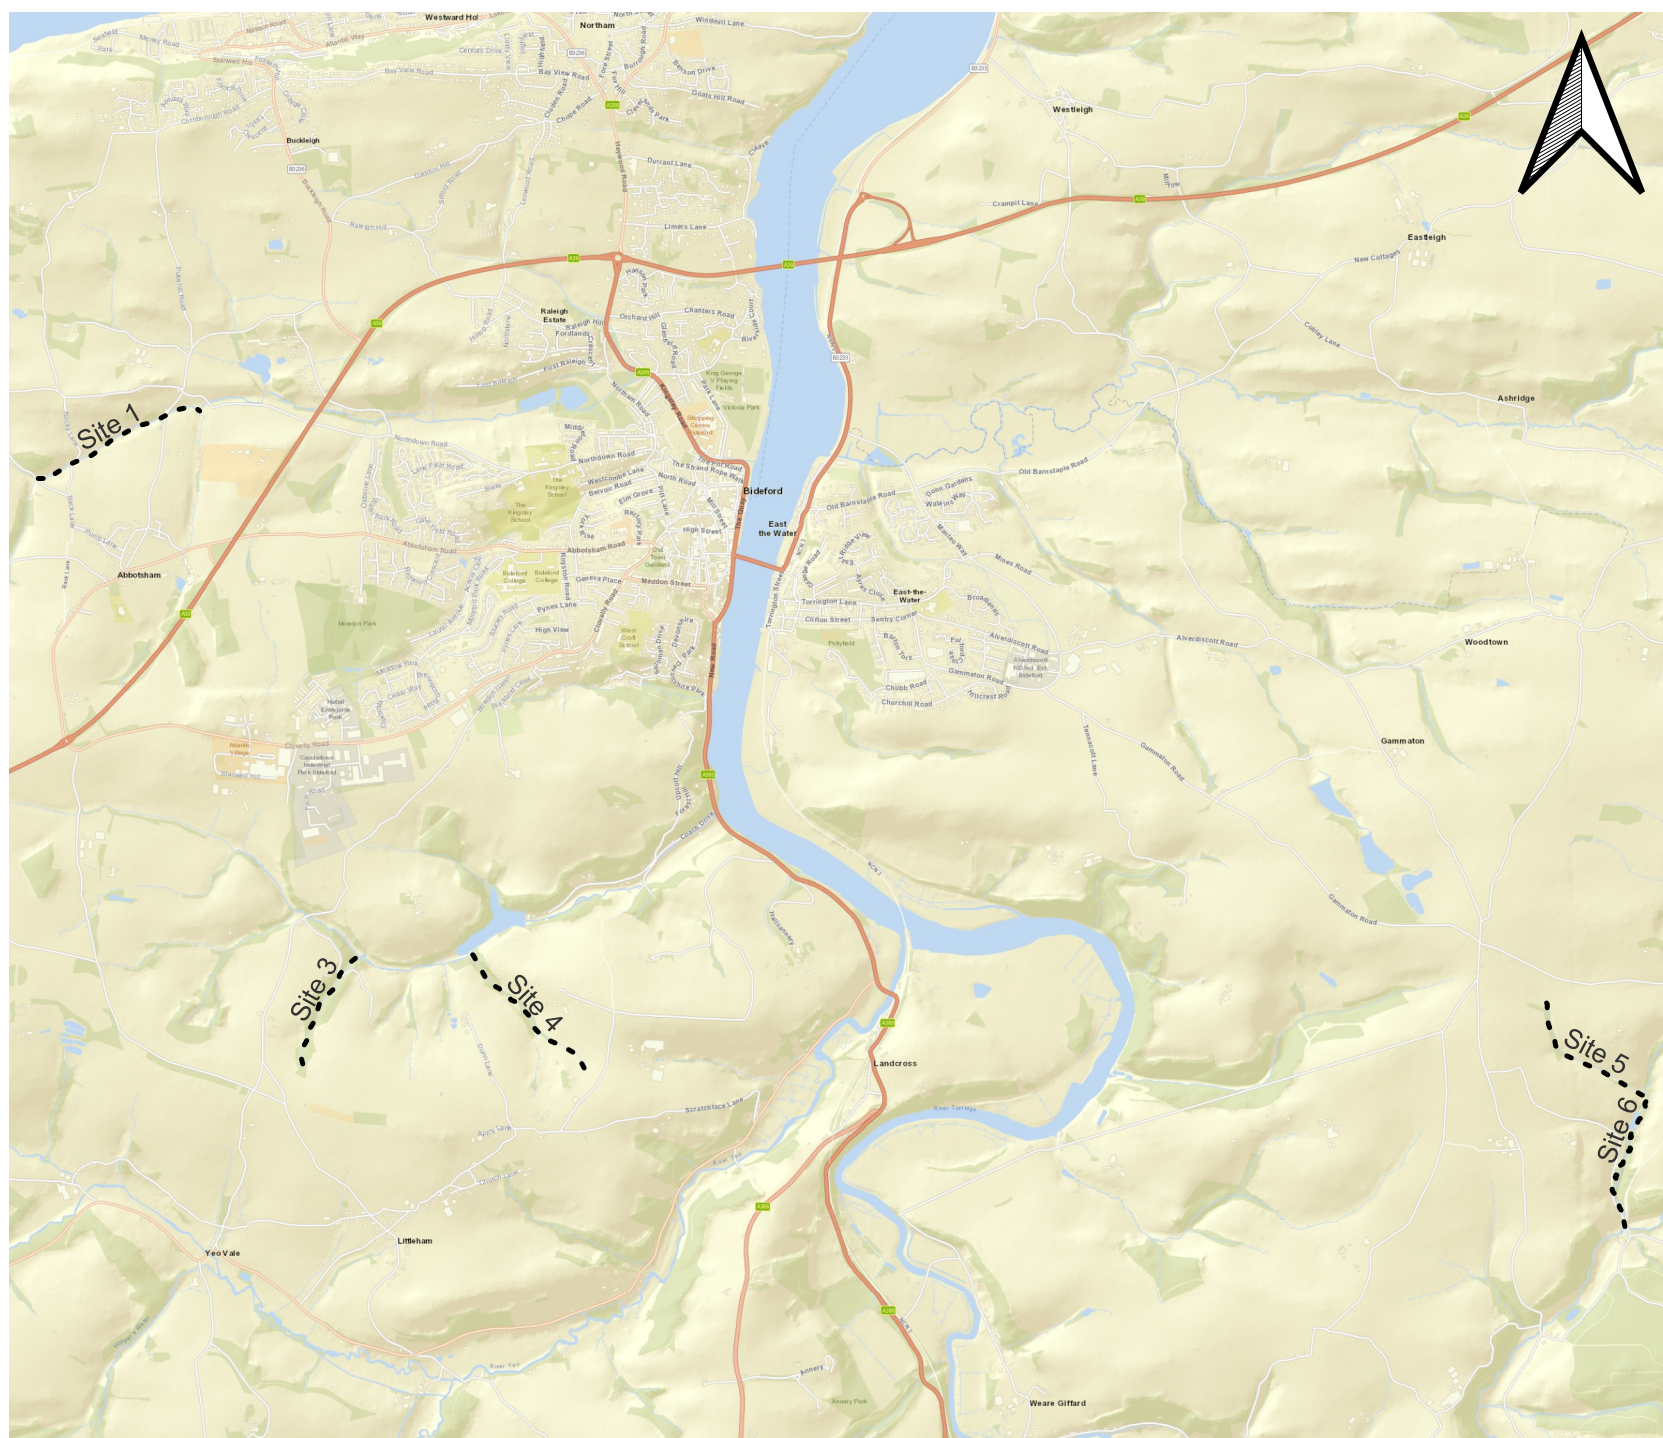
Figure 2
Reach Locations

Figure 2: Reach Location Map

- - - River Condition Assessment Reaches

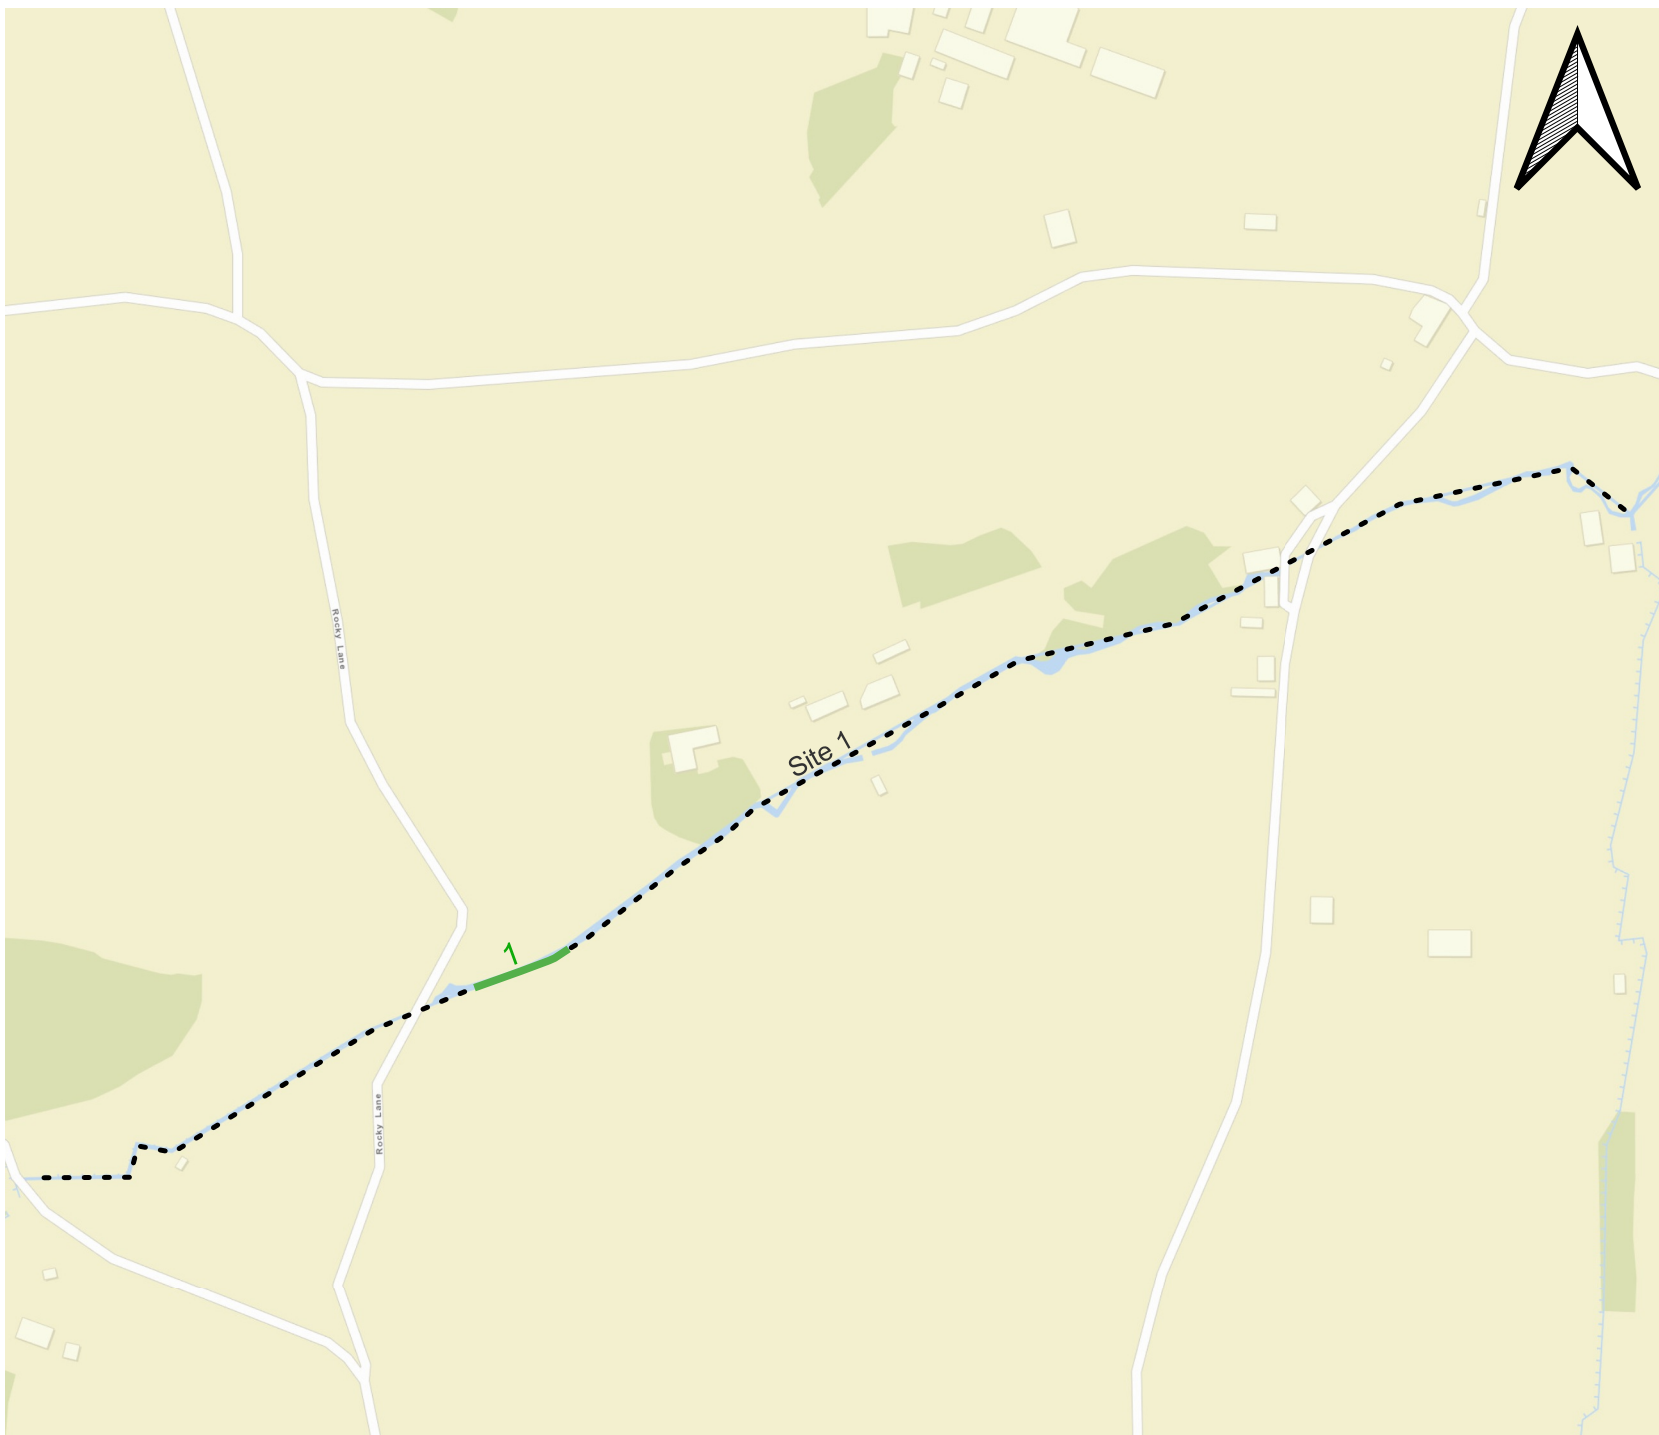
Figure 3.1
Site 1 Subreach Location

River Condition Assessment Reaches

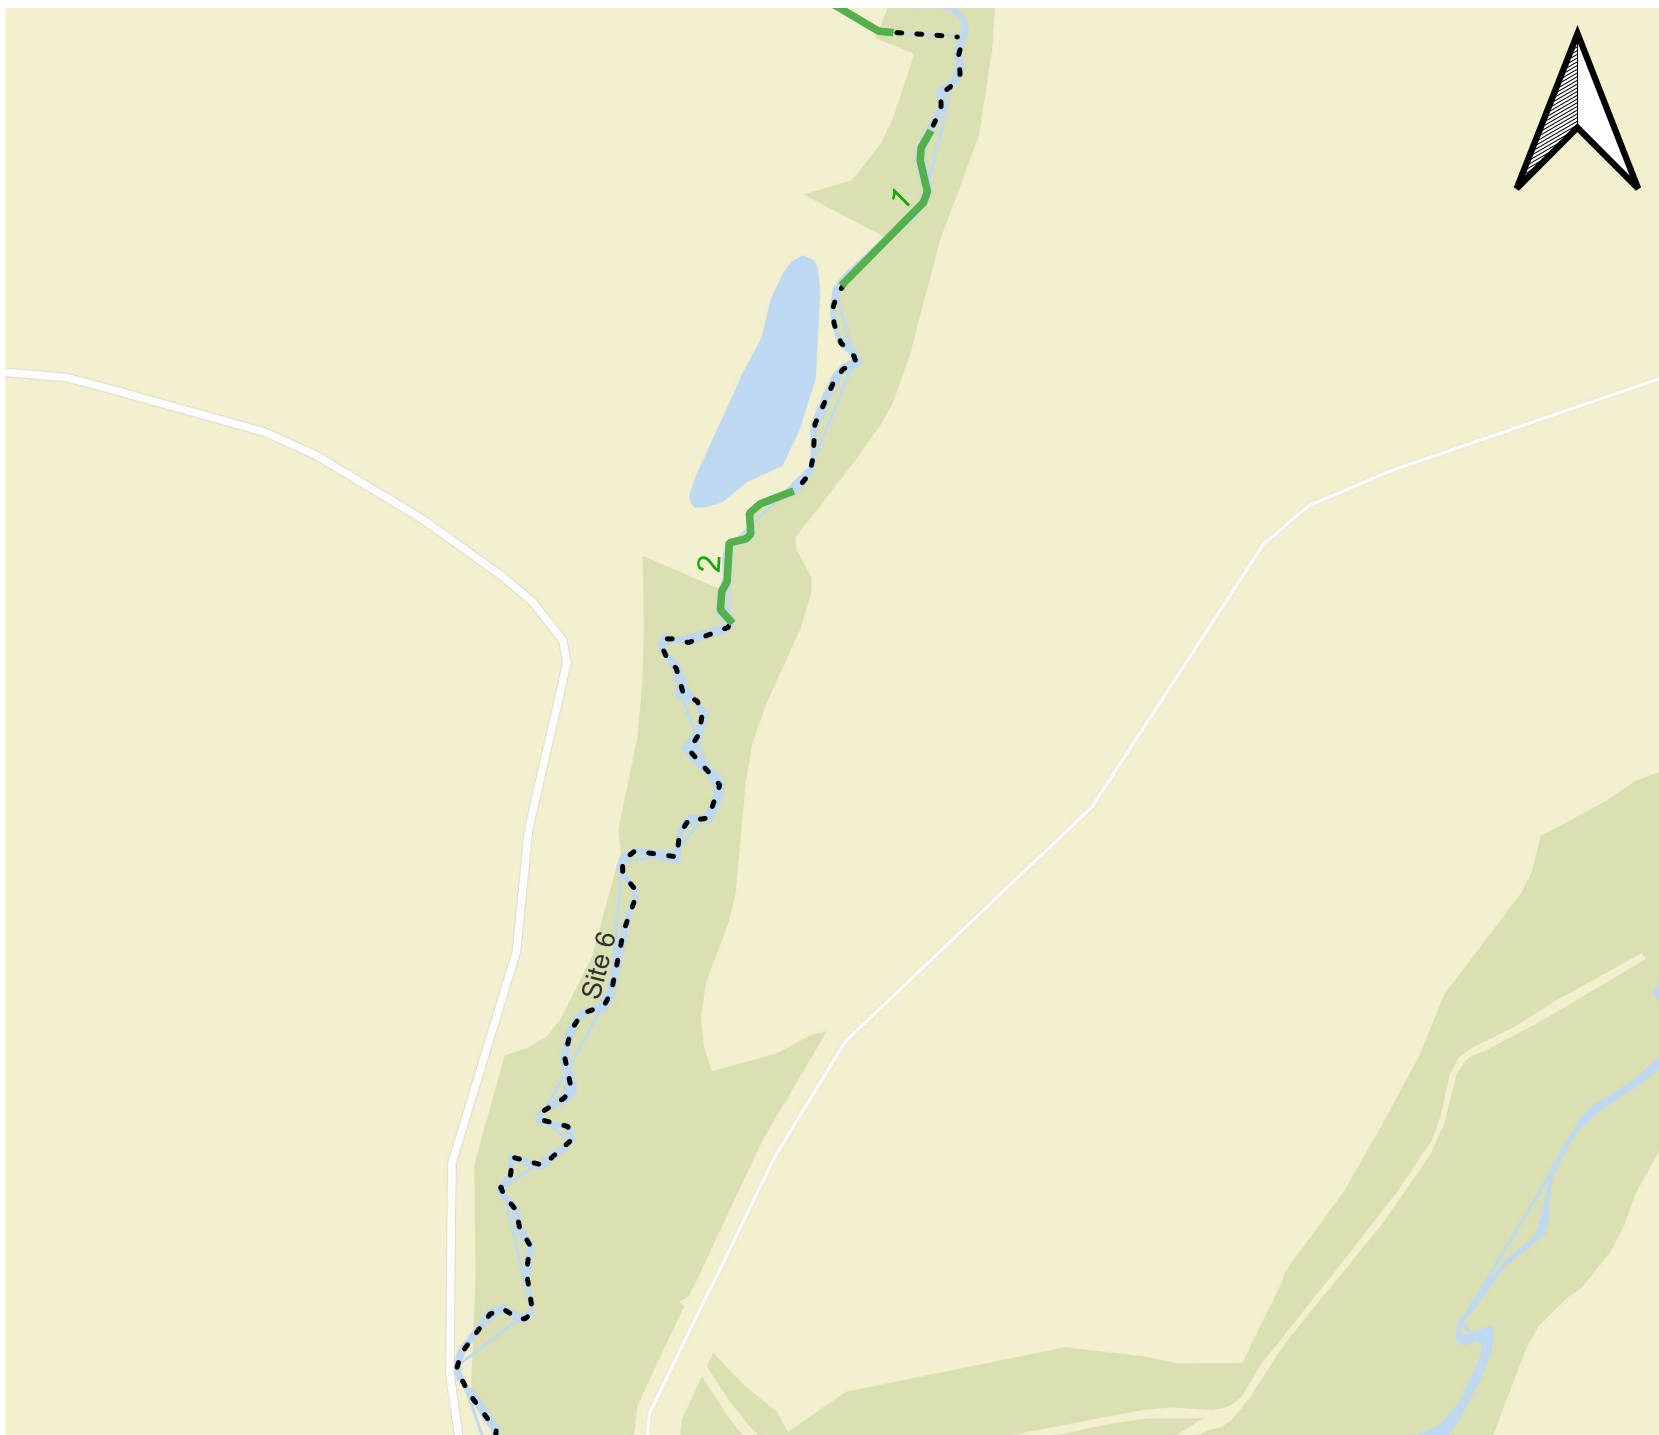
Figure 3.5
Site 6 Subreach Location

River Condition Assessment Reaches
