Project EN070005: Southampton to London Pipeline Project
Interested Party: Nick Jarman, reference: 20022545

Deadline 5 Submission on Behalf of the Neighbours and Users of Queen Elizabeth Park

We have produced annotated versions of sheets 1-5 of the Queen Elizabeth Park Arboricultural Survey drawings, showing all trees listed in the ATI. These can be found in Appendix B. Extracts from these drawings are also used to illustrate specific points in the sections which follow.

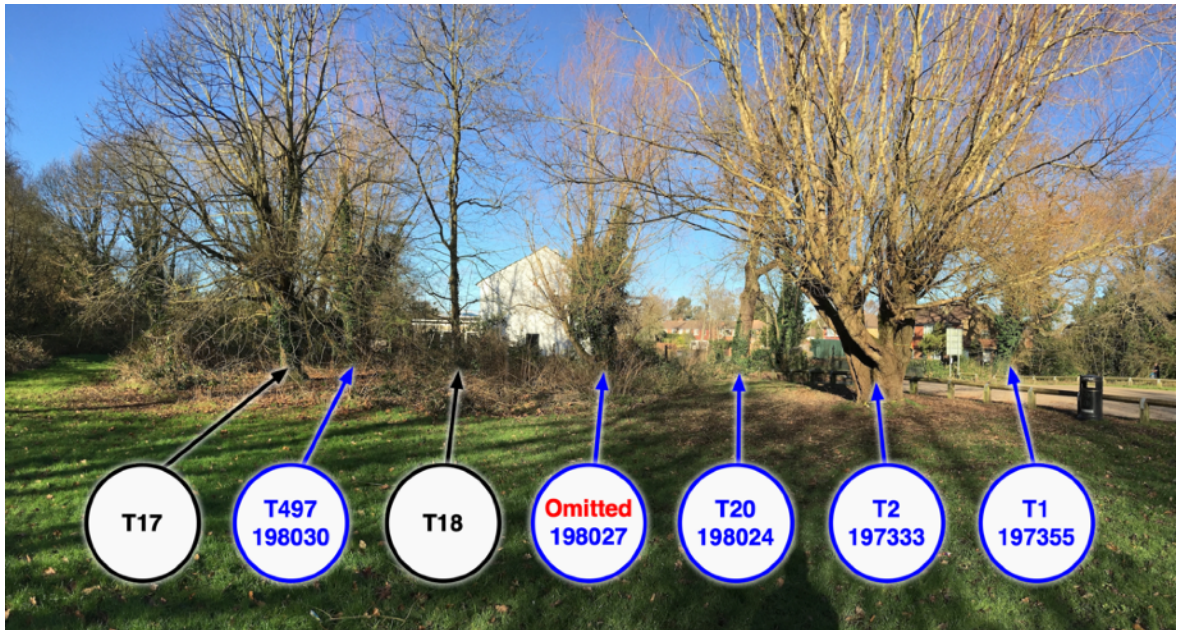
The image below shows the Notable Tree in the proposed Cabrol Road construction compound. It is listed in the Woodland Trust's ATI as number 198027.

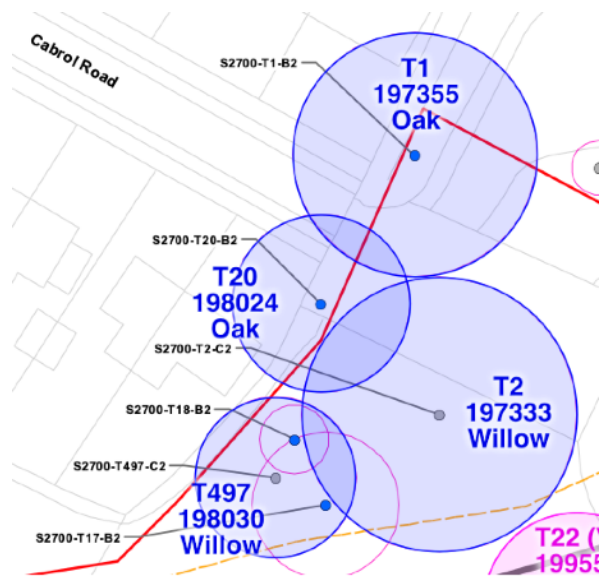
The relevant area of Esso's tree survey map is shown below:

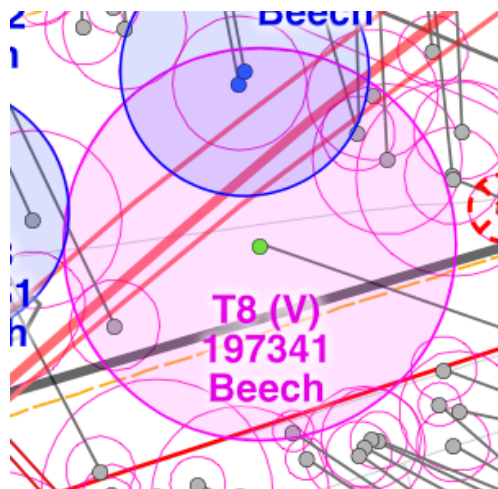
(Extract from sheet 4)

The Fairy Tree (T42/S2700-T8-A3 - Veteran)

The trench (black line running through the RPA) is only 4.7 metres away from the trunk and severs 29% of the root area.

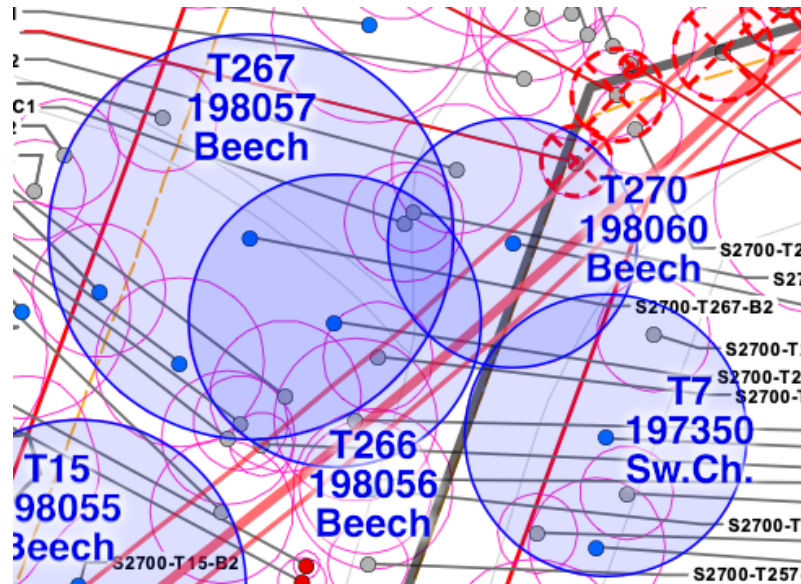
(Extract from sheet 4)

Beech S2700-T270 (Notable)

This tree is critically endangered by the trench, which passes so close to the trunk that it seems impossible that the tree can be retained. We calculate that the trench passes 0.8 metres from the centre of the trunk and severs 44% of its root area. We are deeply concerned that this tree will be removed to facilitate trenching. Whilst we understand that Esso do not currently plan to remove this tree, the DCO gives them the power to do this if needed. We would be interested to hear Esso's comments on this.

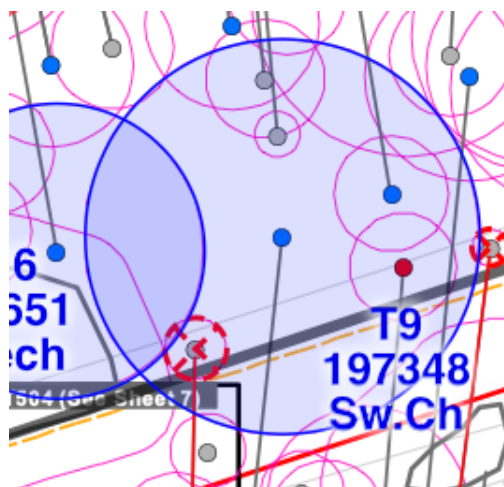
(Extract from sheet 4)

Sweet chestnut S2700-T9

This tree has 20% of its root area severed, with the trench 6 metres away from the centre of its trunk.

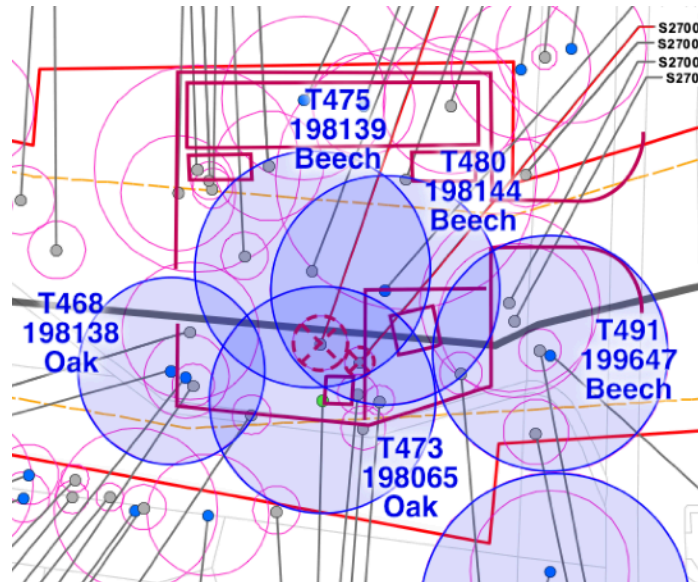
(Extract from sheet 5)

Oaks S2700-T468 and S2700-T473 and beeches S2700-T475 and S2700-T480

These trees are all affected by the trench, having between 16% and 27% of their root areas severed. These are all Notable Trees. The added complication for this group of trees is that they are in the auger boring compound and will be exposed to other threats described in subsequent sections.

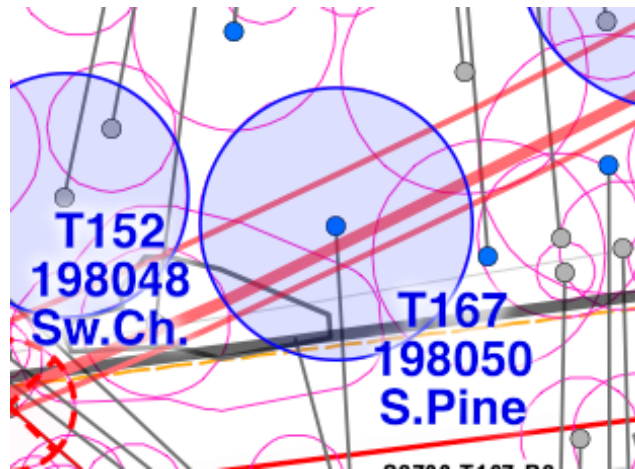
(Extract from sheet 2)

Scots Pine S2700-T167 (Notable)

This tree has 7% of its root area severed and will be further stressed by stringing activities (see section 2.4):

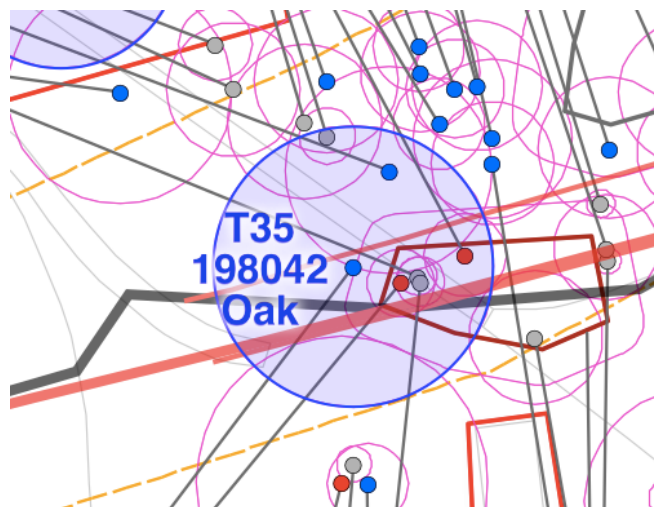
(Extract from sheet 1)

Oak S2700-T35 (Notable)

This tree is in grave danger because of the proximity of the trench to its trunk. 34% of its root are will be severed as the trench passes 2.5 metres from the centre of its trunk.

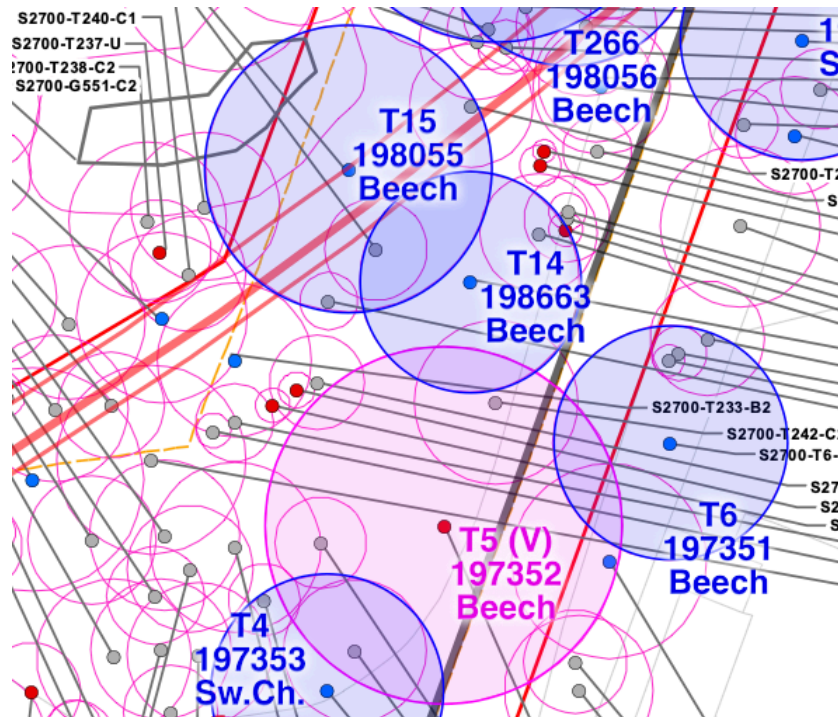
(Extract from sheet 3)

Blocker 1

Beeches S2700-T15, S2700-T14 (both Notable) and Veteran beech S2700-T5 span the Order Limits. Beech S2700-T6 also forms part of this group.

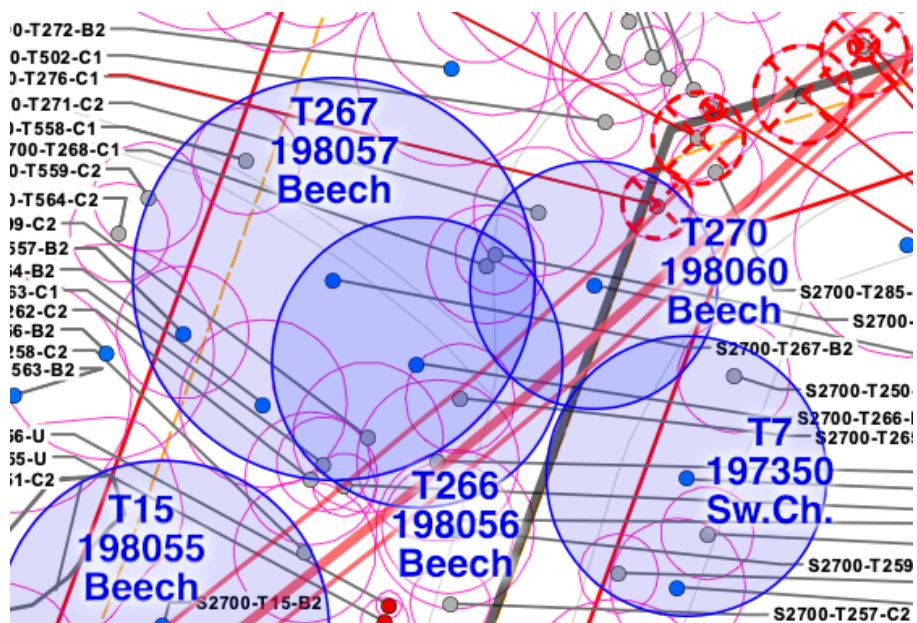
(Extract from sheet 4)

Blocker 2

Beeches S2700-T267 and S2700-T270 (both Notable) span the Order Limits, with beech S2700-T266 (Notable) and sweet chestnut S2700-T7 (Notable) contributing additional cover.

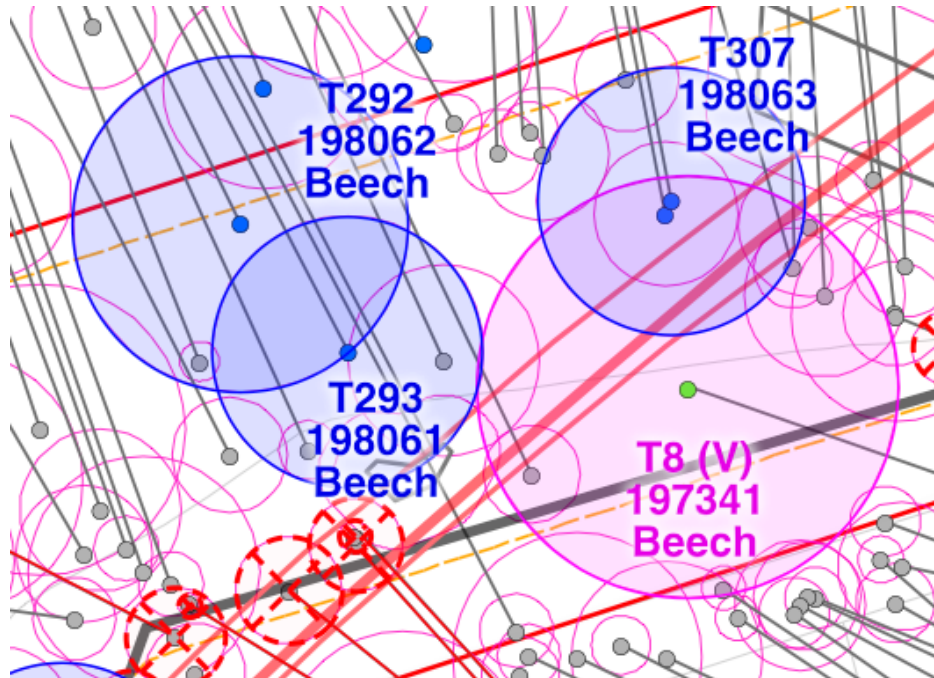
(Extract from sheet 4)

Blocker 3

The Fairy Tree (T42/S2700-T8, Veteran) is in a group which also spans the Order Limits, with the help of beeches S2700-T293 and S2700-T292 (both Notable). Also in this group of trees is beech S2700-T307, which although it does not reach the edge of the Order Limits, does cover the Limits of Deviation.

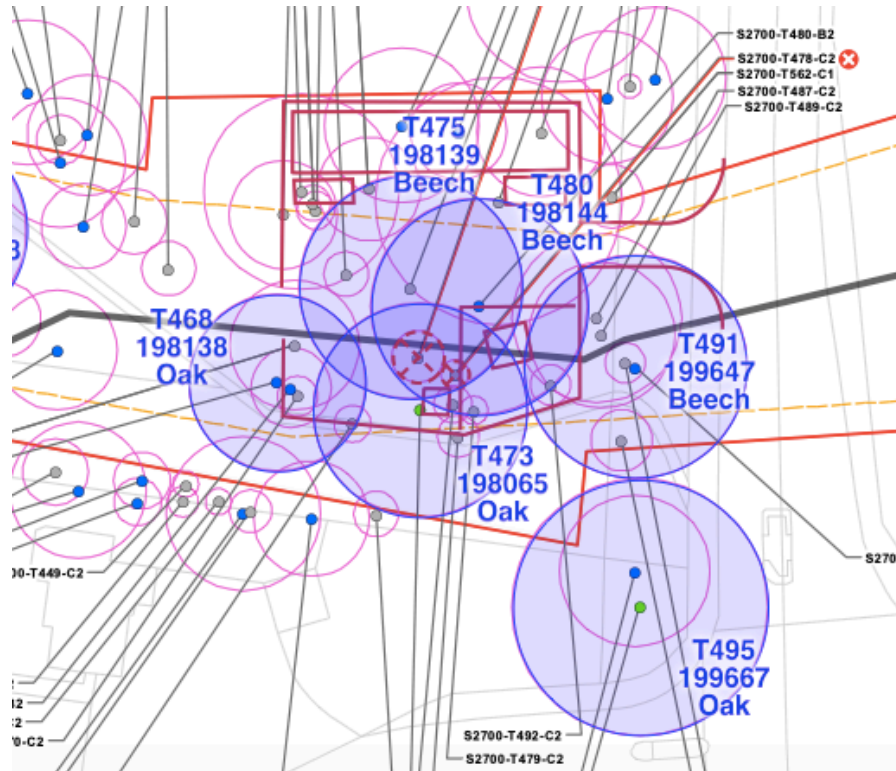
Wherever the pit is located within the compound, excavating it will cause the loss of many of the trees due to the destruction of their root areas. There may be no intention to remove the trees before work starts, but the amount of roots damaged by the work will be significant.

This is one of the densest areas of Notable Trees in the park, containing S2700-T475, S2700-T480, S2700-T468, S2700-T473 and S2700-T491 as shown above.

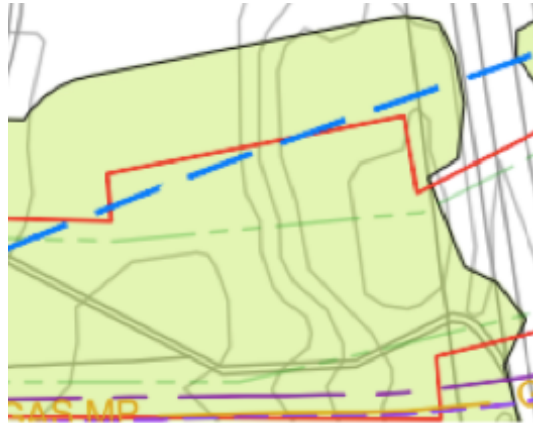
There are numerous ground level changes within the proposed auger boring compound. Walking through the compound area, starting at the A325, the first obstacle is a ditch, after which the ground rises before dipping again into a large trough. There is then a steep rise before the surface levels out, near the western edge of the compound. Overall elevation change is somewhere between 3 and 4 metres.

There is one map extract which helps to illustrate this, taken from page 9 of Esso's Responses to ExA's Further Written Questions - Queen Elizabeth Country Park, which shows the contours in the area. Unfortunately this map is small and lacks any contour labels so the elevations they represent are unknown (though we estimate they are 1 metre lines).

It is hard to imagine this being a safe working area without significant grading and levelling of the surface before any work can start.

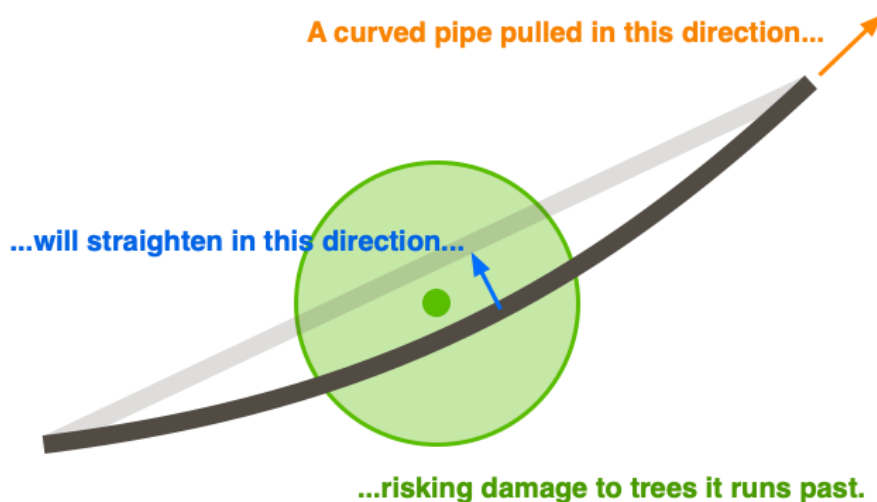
The proposed pipe string is a shallow 'S' shape. During construction of the string, it will be pulled into the park. When the string and bore are complete, the string will be pulled back into the bore.

During both pulling operations, forces exerted on the pipe string will cause the string to straighten. Any trees on the inner edge of a straightening curve are at risk of damage.

Control and containment of these straightening forces is critical where the proposed string runs close to any tree. We understand that guides and blocks will be used to counteract these forces but we are still particularly concerned about specific Notable and Veteran Trees.

Beech S2700-T188 (Notable), beech S2700-T15 (Notable), beech S2700-T270 (Notable) and beech T42/S2700-T8 (Veteran) are all at significant risk of damage as the pipe attempts to straighten during pulling.

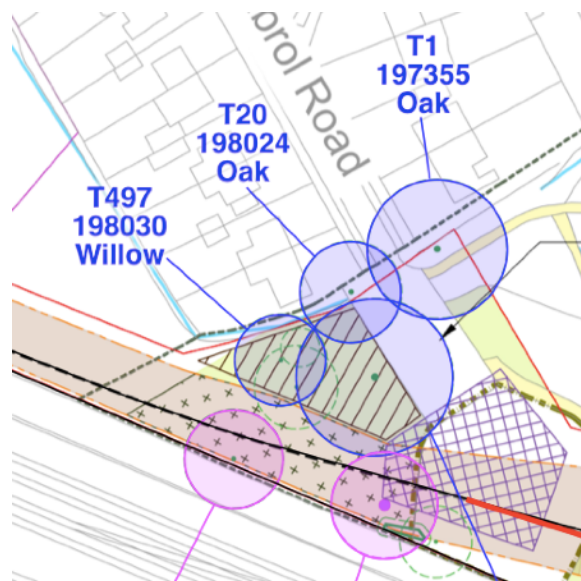
The area of the proposed Cabrol Road construction compound is contained within the root protection areas of three notable trees: oak S2700-T20 (Notable), willow S2700-T2 (Notable) and willow S2700-T497 (Notable).

The root protection areas of these Notable trees cover nearly all of the proposed compound area (95%). The following activities should not be undertaken within the compound due to the root protection areas of the Notable trees:

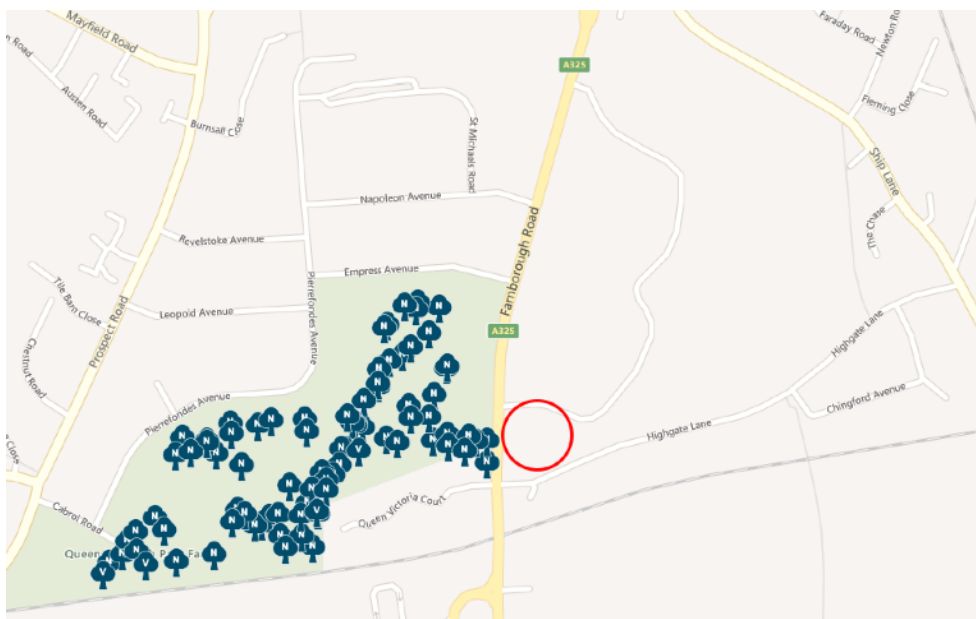
The Woodland Trust's Ancient Tree Inventory does not record any trees in the grounds of Farnborough Hill. The circle on the map below indicates where the claimed trees are.

(Woodland Trust's ATI map, Queen Elizabeth Park on the left of the A325, Farnborough Hill on the right. No Notable or Veteran Trees are recorded in Farnborough Hill)

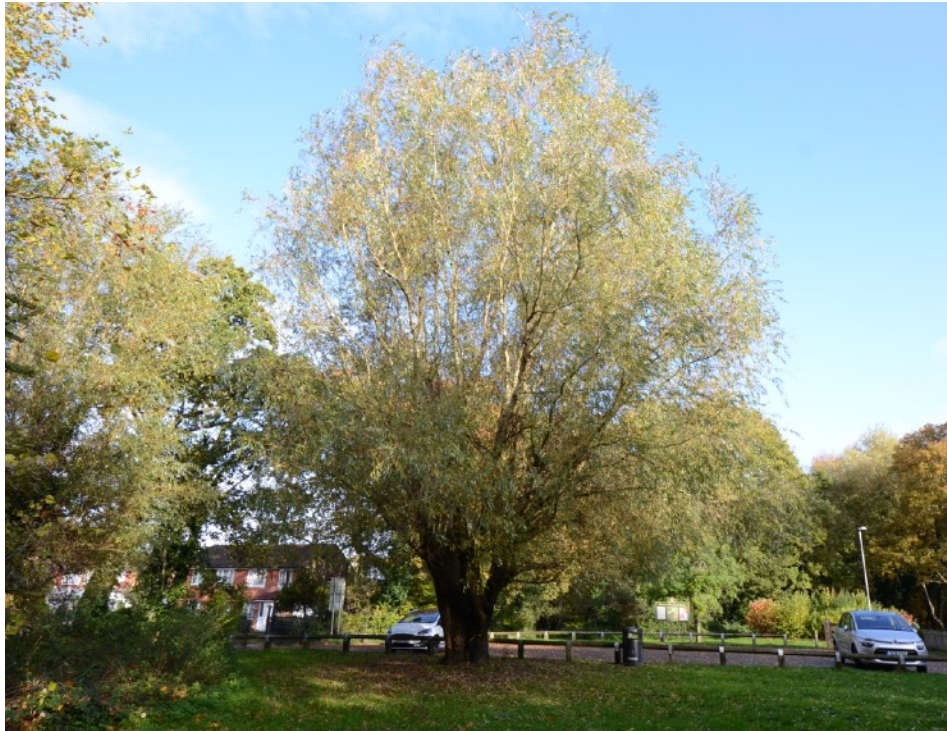
Branch lopping would destroy the character of many trees in the park, but in particular the willow T2700-T2 (Notable), which covers most of the area of the proposed construction compound, would lose its pleasing distinctive and symmetrical shape.

Willow T2700-T2 should not be lopped.

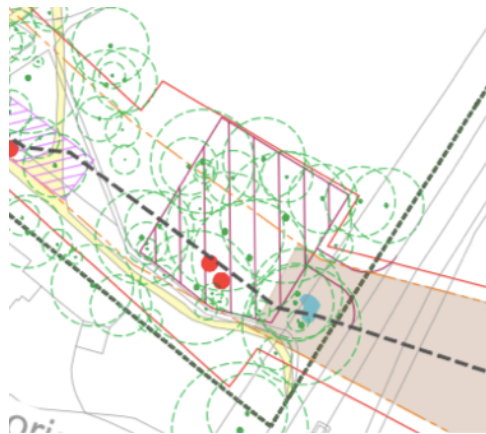
As stated in the previous section, the water body is outside the proposed compound. This is shown in Appendix B of the QEP SSP:

We would like to clarify that there is no wildlife pond on the eastern side of the park. There is a dip in the ground which collects water during heavy rain, but it is not a wildlife pond.
