Report Reference: EMS-530230_713173

Geo Insight

Address: Castle Street Buildings, Waterhouse Lane, Hull, HU1 2DA,

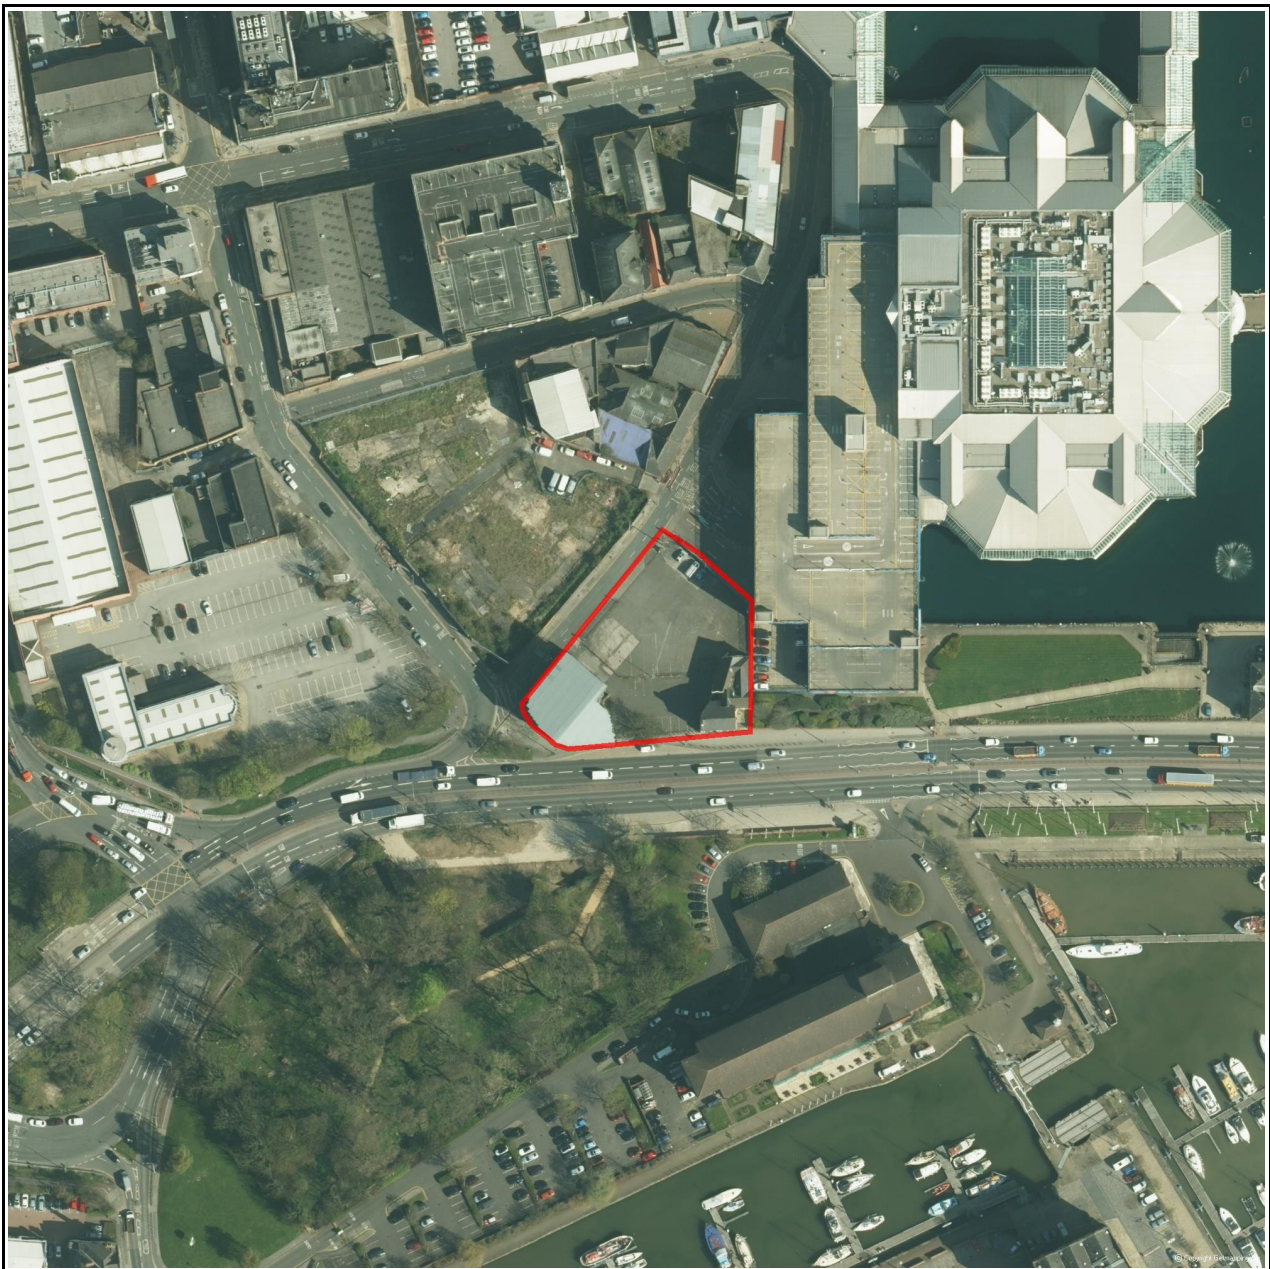
Aerial Photograph Capture date: 20-Apr-2016
Grid Reference: 509512,428484
Site Size: 0.2805ha
