# M25 junction 10/A3 Wisley interchange TR010030

## 6.5 Environmental Statement: Appendix 7.3 Veteran trees and Arboricultural Impact Assessment

### 6.5 ENVIRONMENTAL STATEMENT

#### APPENDIX 7.3 VETERAN TREES AND ARBORICULTURAL IMPACT ASSESSMENT

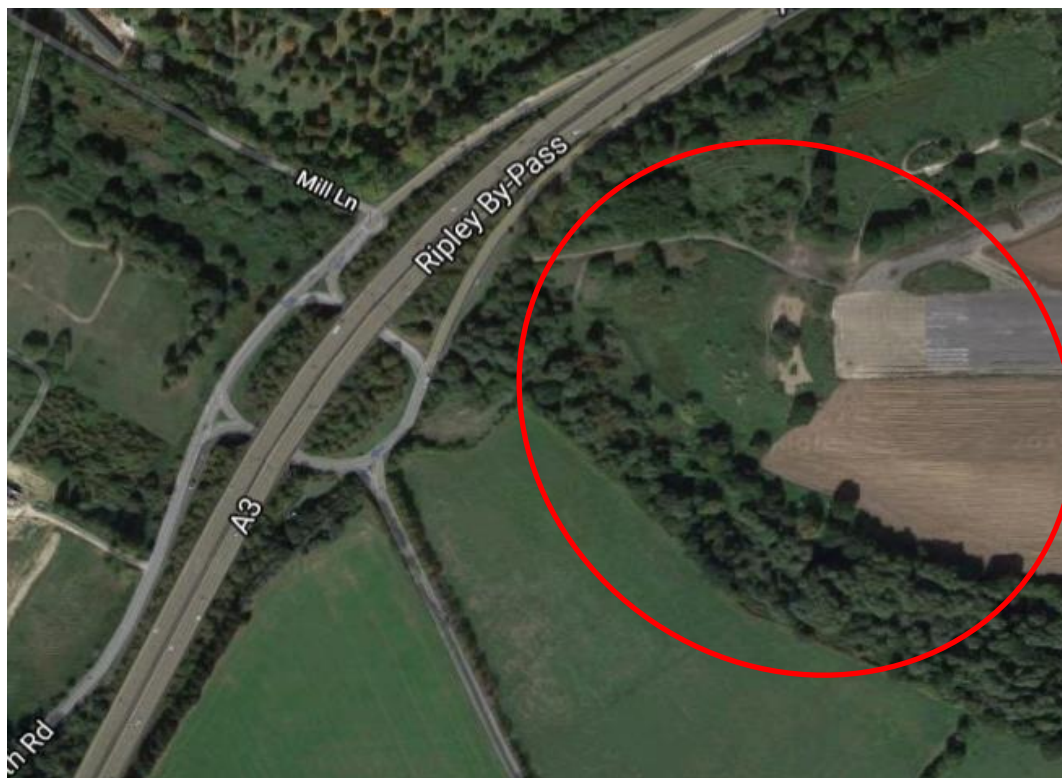
**Insert 7.1 land to east of A3, adjacent to former Wisley airfields**

7.5.1.2 The areas of land that were not accessible will be assessed prior to the commencement of construction and surveyed in accordance with BS5837:2012 guidelines. The main areas that were not accessed during the tree survey are illustrated on the inserts below within the red outlines:

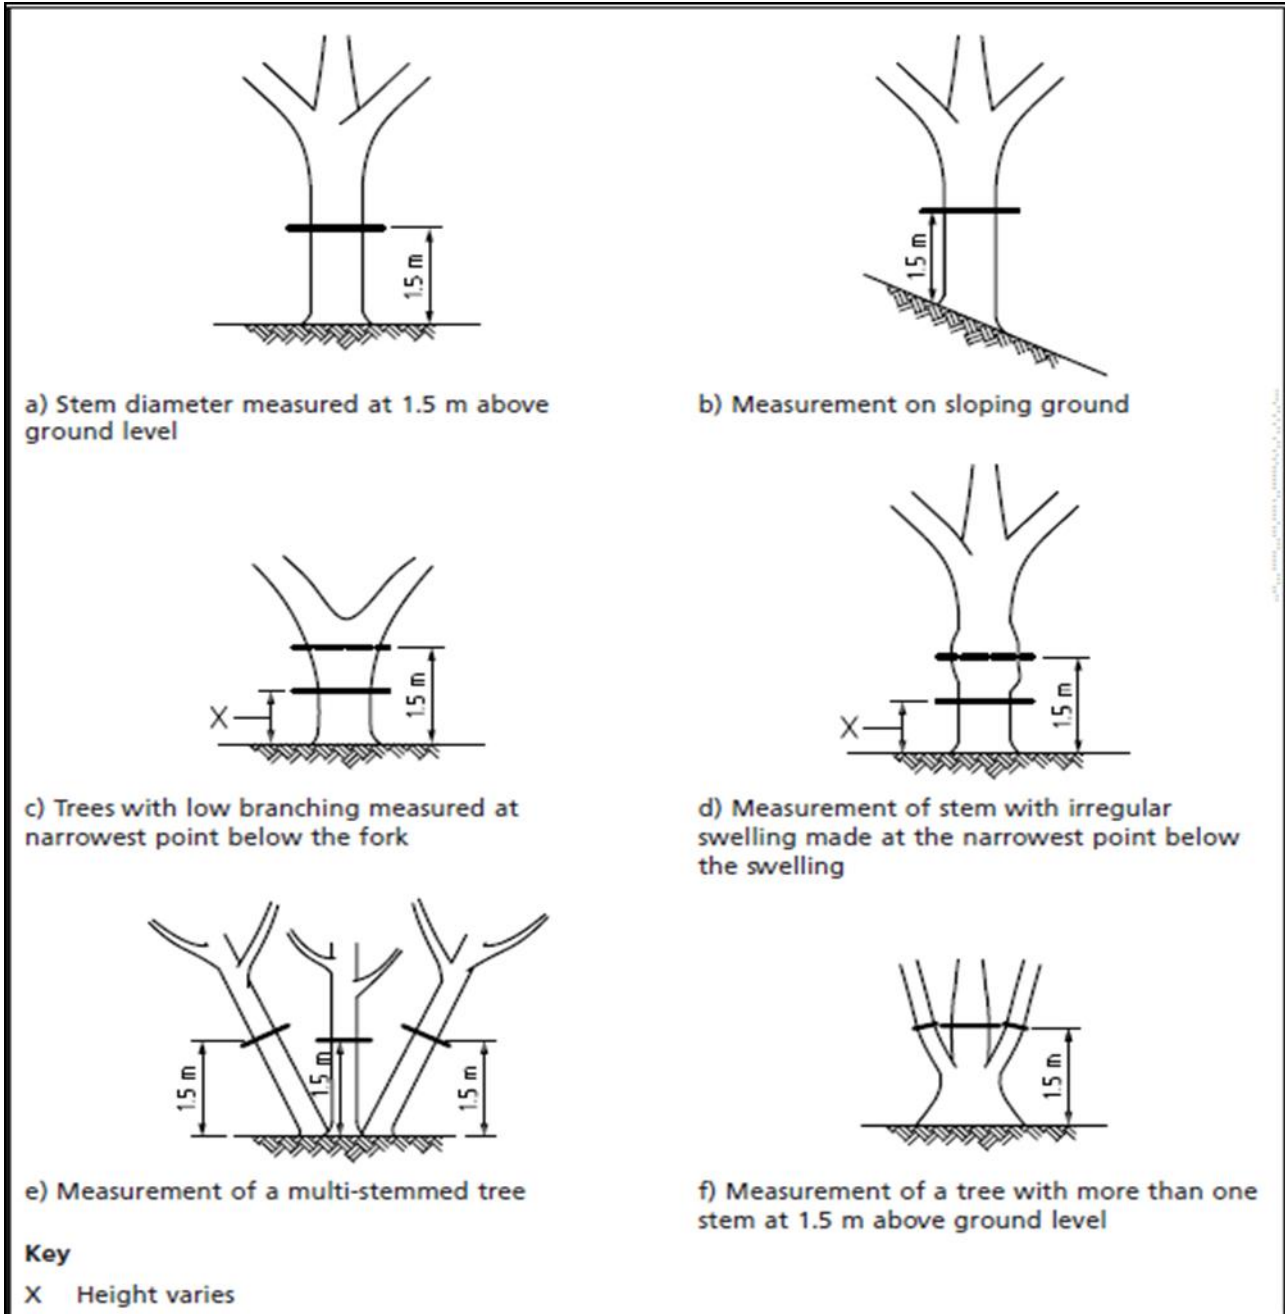
#### Insert 7.4: BS5837:2012 measurement of tree stems dependant on tree form methods

### A2.1 Measurement of tree stems dependant on tree form
