Lower Thames Crossing
6.3 Environmental Statement
Appendices
Appendix 12.9 - Effects of Vibra-
tion from Road Traffic (Highways
England Ref. 1-457 Noise Support
2017-2021)

Planning Inspectorate Scheme Ref: TR010032
Application Document Ref: TR010032/APP/6.3

Executive Summary

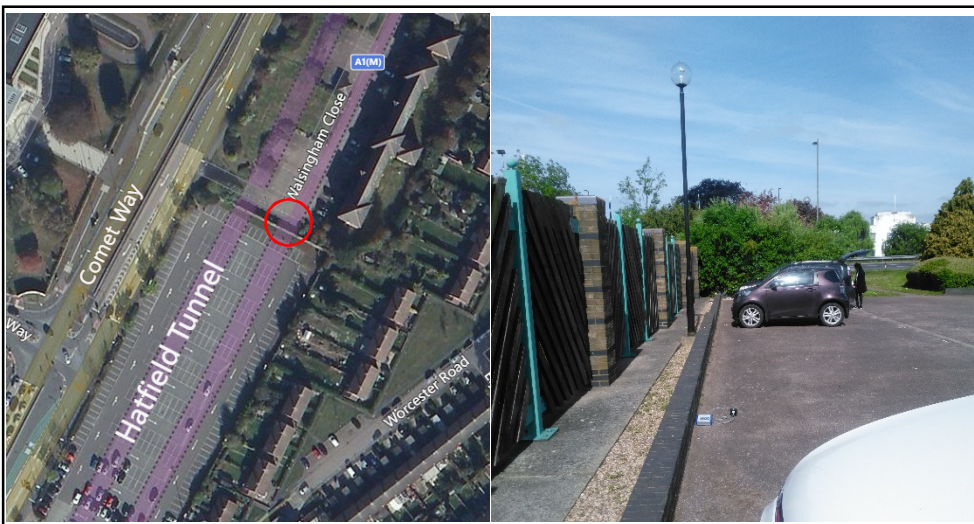
Figure 1 – Hatfield Tunnel Vibration Survey Location

This location is an example of a cut and cover tunnel over the busy A1(M). Figure 1 indicates the location of the survey, which was at the end of Walsingham Close (UTM 51°45'55" N 0°14'10" W).

The vibration transducer was placed directly on the hard surface car park, at a location above the south-bound carriageway of the A1(M) Hatfield Tunnel. The location was approximately 40 m from the nearby A1001 Comet Road. As this location is a cul-de-sac there was no regular pass-by of local vehicles.

A note was made of any nearby activities that could result in a vibration event. At 10:09:25 a large tractor passed by on the A1001 Comet Way, resulting in a tri-axial vibration peak of 0.197 mm/s PPV. A van also passed within 10 m of the equipment undertaking a u-turn in the Walsingham Close car park at 10:26, although no particular vibration peak was noted for this event.

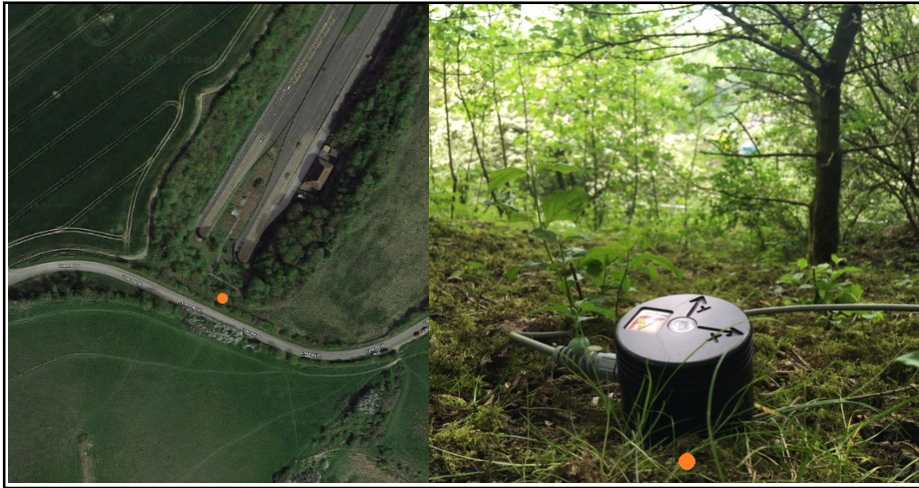
Figure 2 – A20 On top of bored tunnel - Vibration Survey Locations

This location is a bored tunnel, with the A20 passing through, Figure 2 indicates the survey location. The measurement at this location was of a 30-minute duration. The accelerometer was located at the north-east tunnel portal on top of the tunnel up on the bank at approx. 18 m from the tunnel portal (UTM 51°06'08.6" N 1°10'13" W).

The vibration transducer was mounted to the Profound ground spike and pushed into the ground. The ground at the location was firm and considered to provide a solid transmission path to the tunnel structure.

During the duration of the survey there was an observed constant road traffic flow on the A20 with consistent flow of Heavy Goods Vehicles (HGV) entering the tunnel. During the measurement there were no noted vibration events.

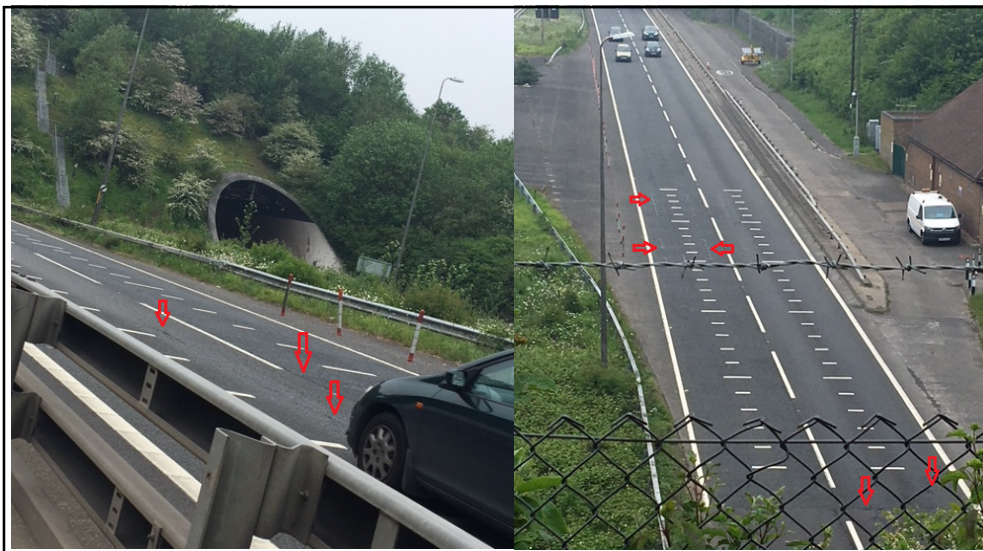
Figure 3 – A20 Road surface near vibration survey locations

The road surface at the section just before the tunnel portal and inside the tunnel on A20 was thought to be HRA. The road surface was not new or totally smooth, and some small areas of roughness and discontinuities were noted. Figure 3 shows a section of the A20 road on the approach to the tunnel portal, with arrows pointing to the areas of surface roughness.

The road surface at that section of A20 is the same as the shown in the site photos in Figure 3 where the pavement is not entirely smooth. The traffic on A20 was constant during the measurement, with a steady component of HGVs and free flowing.

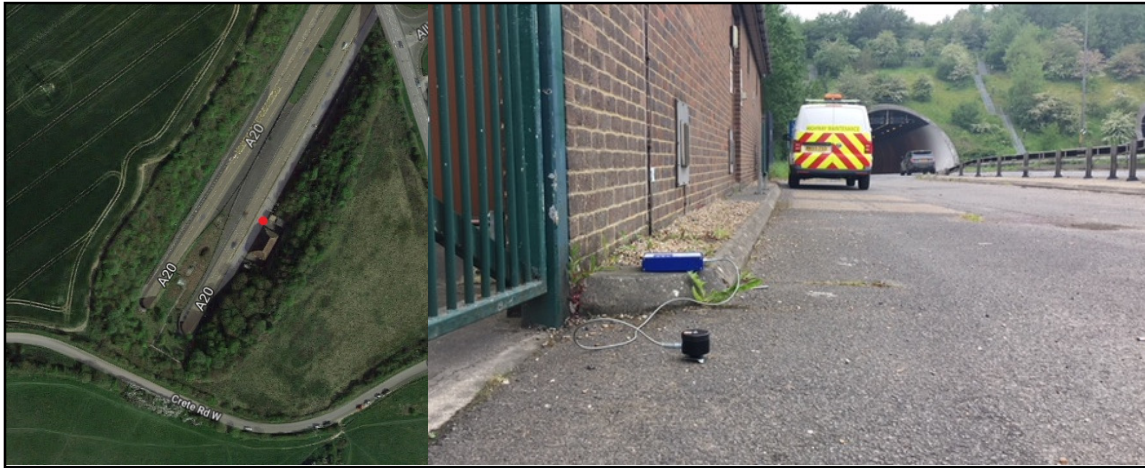
Figure 4 – A20 Service building adjacent to carriageway - Vibration Survey Location

The survey location is at the base of the nearby service building, approx. 10m from the A20 south bound carriageway (UTM 51°5'60" N 1°10'13" W). The vibration transducer was placed at approximately 20 cm from the building foundations and directly on the hard surface of the limited access lane to the service building. No vehicles used the access lane during the survey. Figure 4 shows the survey location.
