A1 in Northumberland: Morpeth to Ellingham

Scheme Number: TR010041

6.8 Environmental Statement – Appendix 11.6 Coal Mining Risk Assessment

Part B

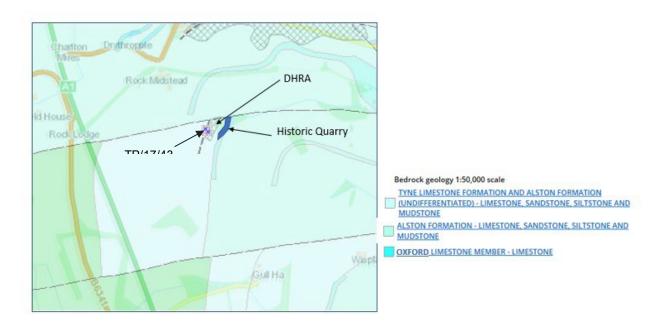
Figure 3-1 - Bedrock and Development High Risk Area (DHRA) map at Rock South Farm (British Geological Survey Onshore GeoIndex)

As seen in Figure 3-1, the coal outcrops are consistent with the inferred coal seam identified by the BGS. However, based on the GI undertaken in the area, no evidence was identified to indicate particularly shallow coal seams, or outcrops at the location.

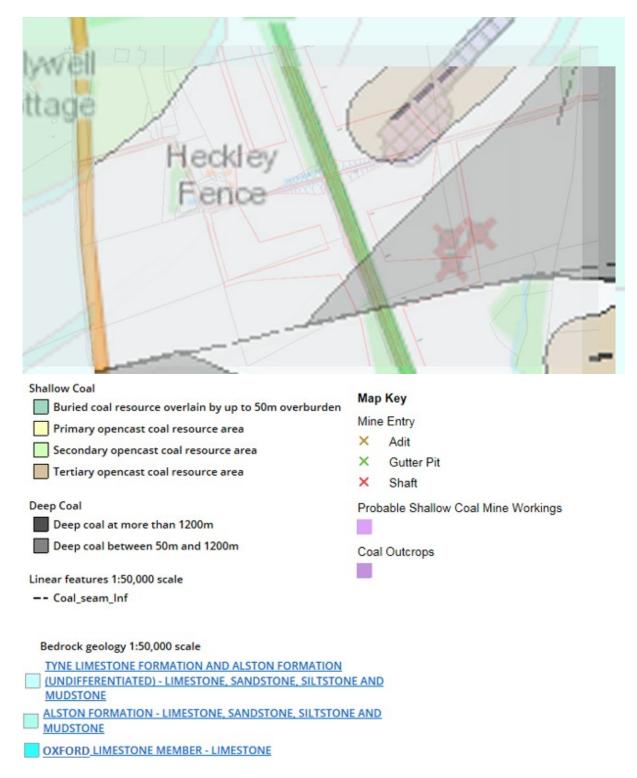
Figure 3-2 shows identified coal mining hazards and geology within the red-line boundary in the area of Heckley Fence.

Figure 3-2 - Geology and coal mining hazards within the red-line boundary at Heckley Fence (BGS Onshore Geolndex, Coal Authority Intervative Map Viewer)

As seen in Figure 3-2, an inferred coal seam, identified in the BGS map, approximately 200m from the existing A1, indicates a dip to the south-east with an unknown dip angle. An abandoned pit shaft was also identified in the BGS Sheet Map 6, at the southern extent of the coal sea, in the area identified as having probable shallow coal mine workings and tertiary opencast coal resource. (Please refer to Appendix B.)

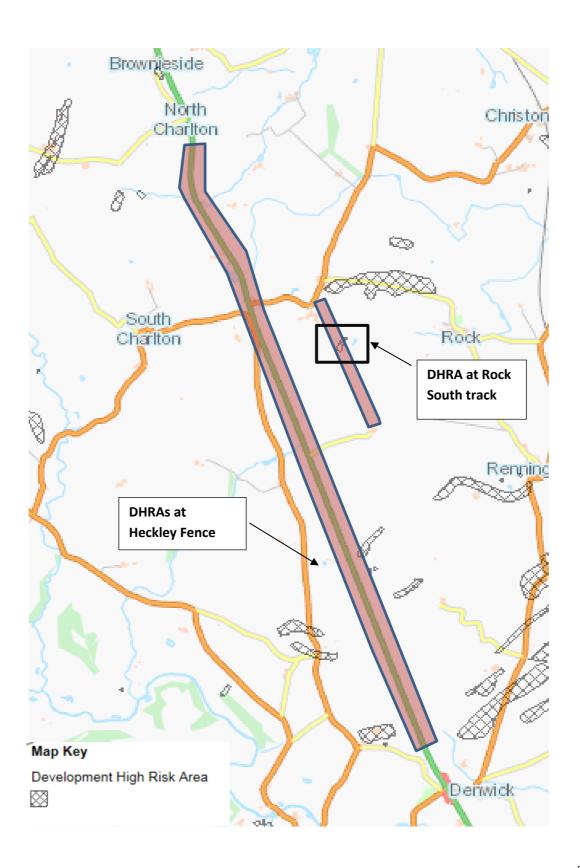
Location of Development High Risk Areas

(Coal Authority Interactive Viewer, 2019.

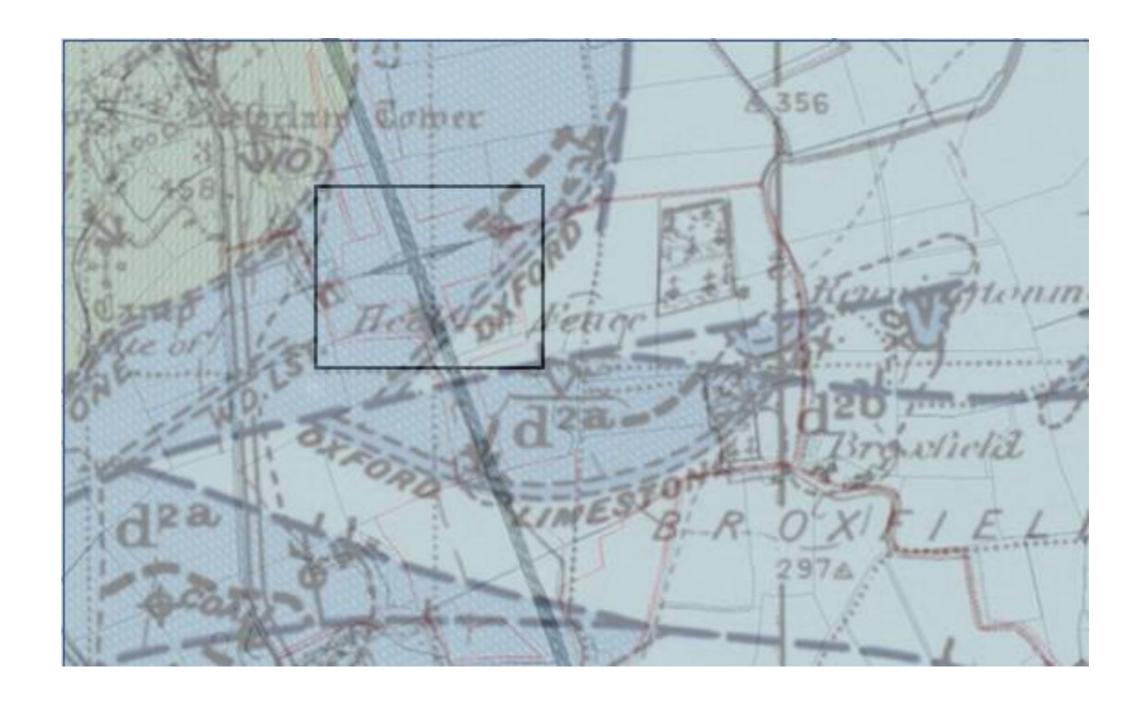
Heckley Fence

Red-Line Boundary and Alignment, May 2019
