### A1 in Northumberland: Morpeth to Ellingham

**GS.1 Appendices to PSSR WQ GS.1.6**

# A1 in Northumberland Morpeth to Felton

**Preliminary Sources Study Report**

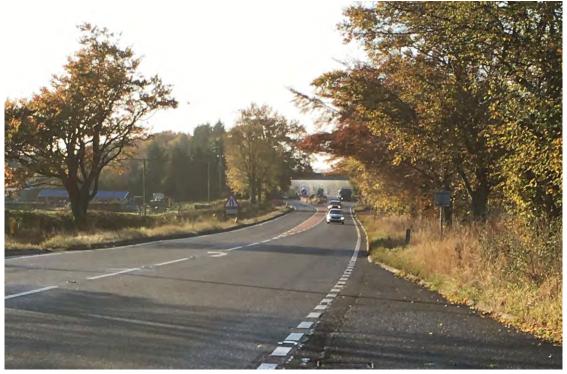
Land adjacent to the carriageway is arable farmland for most of the route. Where residential, educational and commercial properties occur, they are commonly at junctions with side roads. The carriageway follows the undulating topography and the alignment is at grade with the adjacent land (Plate 3-1) as far as can be discerned on account of thick vegetation including mature trees.

Plate 3.1 Stop 1 (approx. Ch. 1500m) looking south from a lay-by on the west of the road.

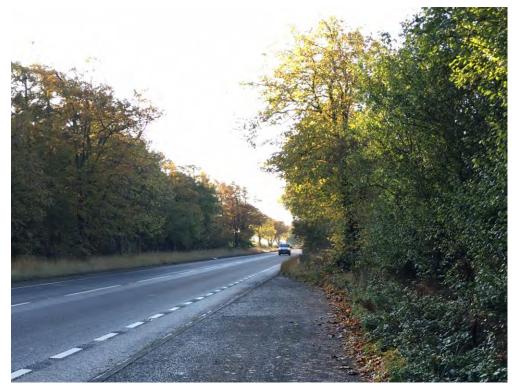
Hedgerows and crops with occasional trees line the road. All options pass through woodland near Floodgate Burn (Stop 3, Plate 3.2), Long dike Burn and the River Coquet (Stop 11, Plate 3.3).

Plate 3.2 Stop 3 (approx. Ch. 3600m) looking south the lay-by on the west on the carriageway.

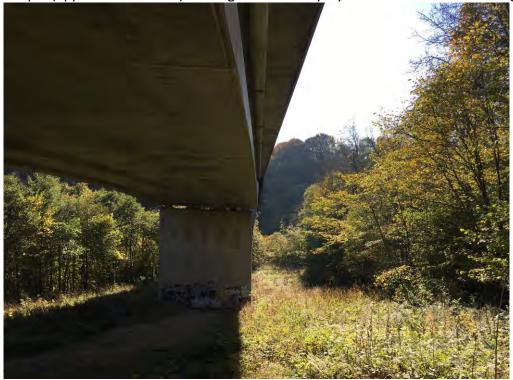
**Plate 3.3** Stop 11 (approx. Ch. 12800m) View from the footpath north bank, River Coquet looking south underneath the bridge.

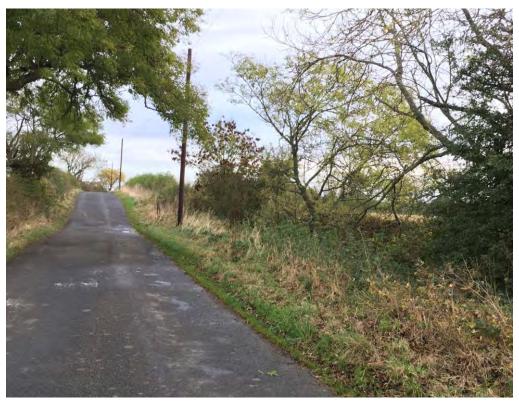
Stop 5 is located on Fenrother Lane at the location of the proposed offline option, approximately 0.5km west of the A1. The topography is undulating and falls to the south (Plate 3.4). The proposed junction between the offline option and Fenrother Lane will require earthworks to accommodate the overbridge.

**Plate 3.4** Stop 5 (approx. Ch. 5000m) looking east on Fenrother Lane. Topography is undulating and falls to the south.

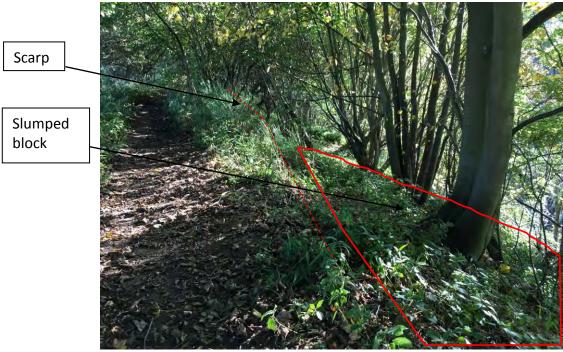
Slopes are densely vegetated which limits the inspection area to the slopes close to the footpath. Several slips were observed parallel to the footpath at the top of the valley in the superficial glacial deposits. Scarp features and slumped blocks are observed on the southern edge of the footpath (Plate 3.5).

**Plate 3.5** Stop 11 (approx. Ch. 12800m) View from the footpath on the north side of the River Coquet looking south east.

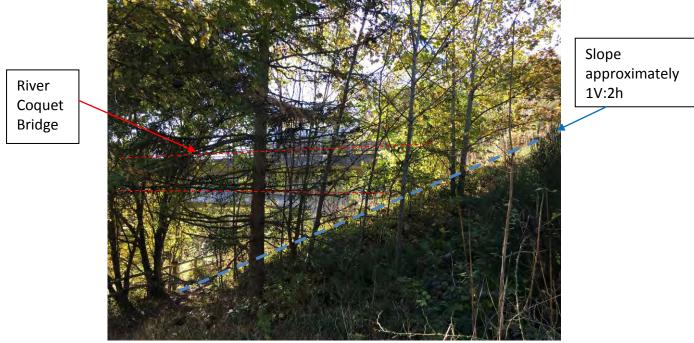
The gradient of the northern slope is approximately 1V:2H about 100m east of the River Coquet Bridge, as shown in Plate 3.6.

**Plate 3.6** Stop 11 (approx. Ch. 12800m) View from the footpath on the north side of the River Coquet looking west to the River Coquet bridge.

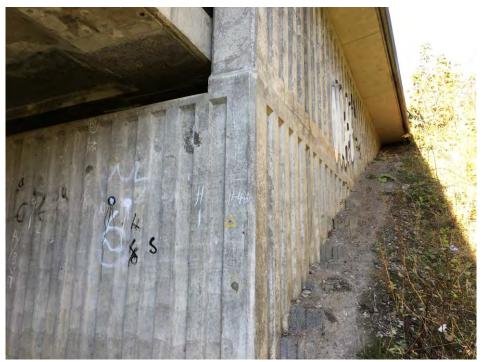
Slopes have been re-graded and dense vegetation has been removed to accommodate the existing bridge piers and abutments (Plate 3.7). No signs of instability were observed on the slopes next to the bridge.

**Plate 3.7** Stop 11 (approx. Ch. 12800m) View of the east side of River Coquet Bridge abutment on the north slope.

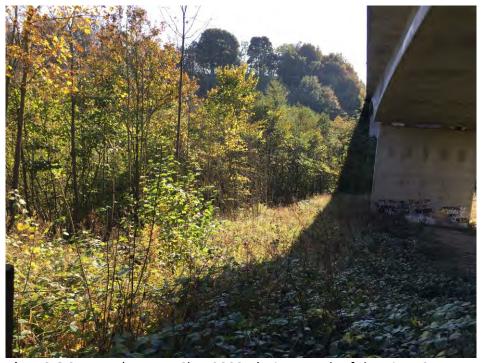
**Plate 3.8** Stop 11 (approx. Ch. 12800m) View south of the River Coquet Bridge piers from the footpath on the North Slope.

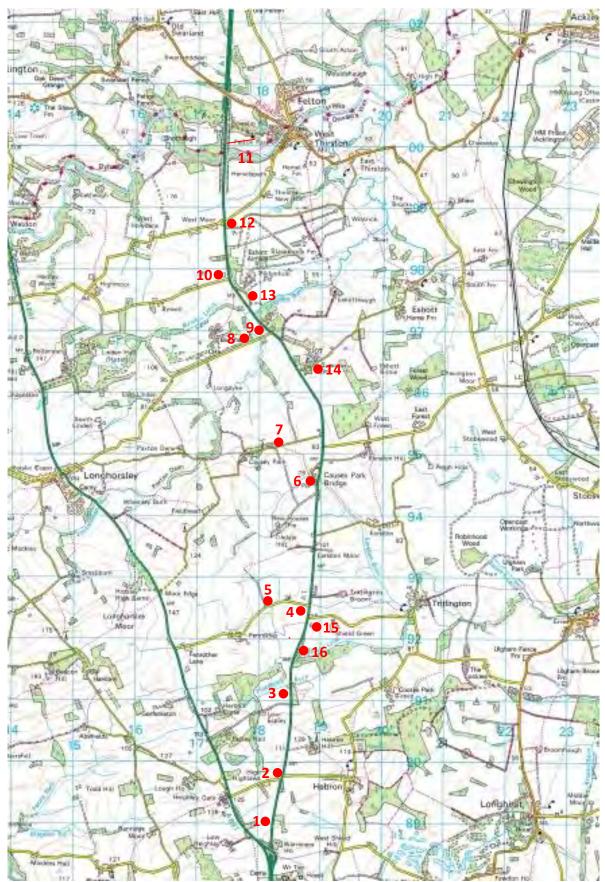
For health and safety reasons the site was accessed by car to drive between 16No. stopping points located on the northbound and southbound sides of the A1 and on side roads between Morpeth and Felton. Stopping points positions are shown in Figure 3-1. A summary is present here with a more detailed observation in Appendix H.

Figure 3-1 Site walkover stopping locations. Ordnance Survey ©.

The site walkover was completed on a bright day in October 2016. The wind was low and the visibility was clear. All Chainages referenced refer to the Orange Route which represents the online option in the Preliminary Sources Study Report. All locations refer to Figure 3.1 in the PSSR.

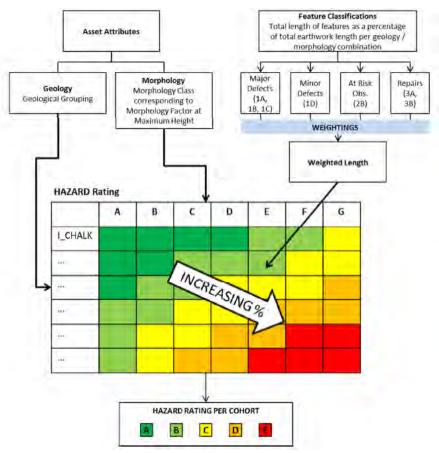
The risk rating methodology is described within Plate 4-1.

Plate 4-1 - Risk classification for earthworks within Highways England

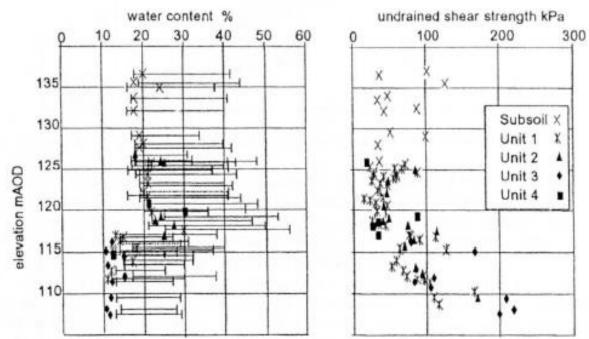
Taken from an extract from Plate 5-1:

Plate 5-1 - Typical classification profile at Acklington Coal (Reference 23)

This is largely confirmatory of the values obtained from the site specific data. It does identify the undrained shear strength of the glacial till as high which has been recorded in the site specific data at shallow depth.

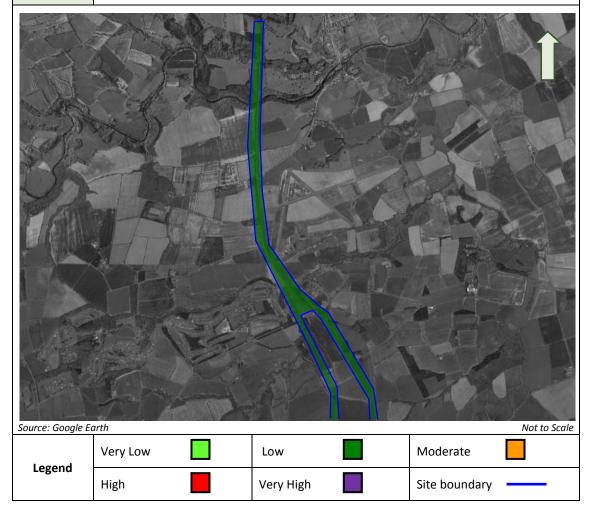
**Figure** UXO hazard zone plan of the Site (northern part of the Site)

It is considered that the Site has a low UXO hazard level, as shown in the Figures below, reproduced as Figures 6 and 7 in the main report.

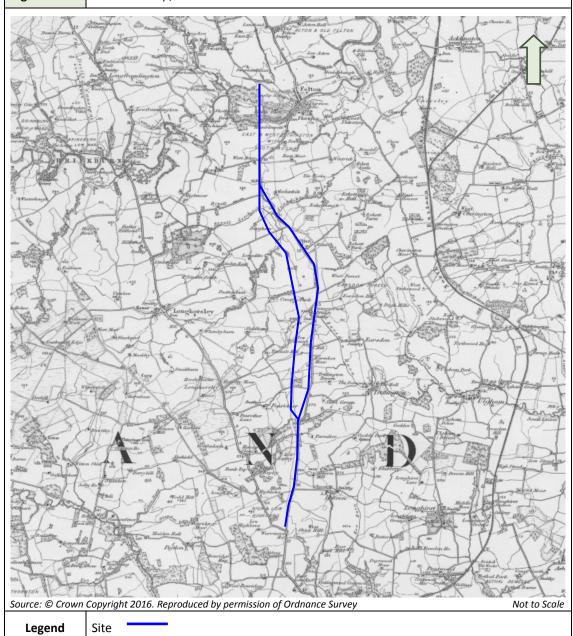
Figure 2 Historical map, 1897

The historical map of 1897 (Figure 2) shows that in the late 19<sup>th</sup> century the Site comprised part of the Great North Road and areas of adjacent farmland in a largely rural area.

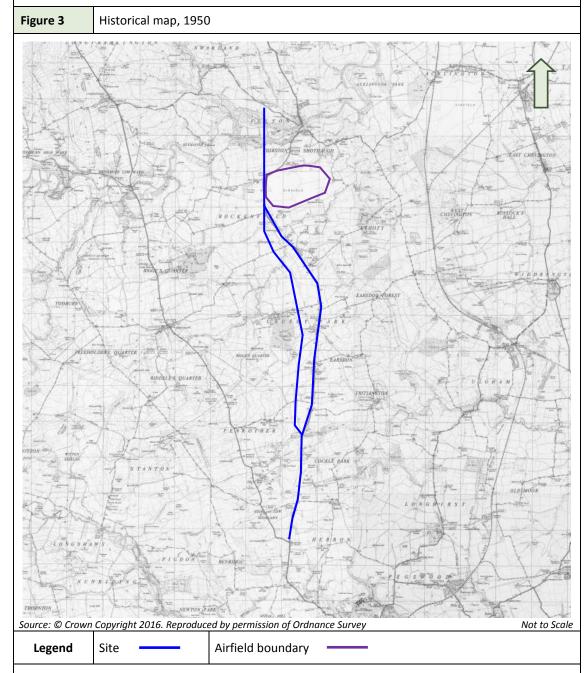
No significant development had occurred on the Site during the first half of the 20<sup>th</sup> century, which remained comprised of a roadway and adjacent farmland. This is shown on the historical map of 1950 (Figure 3).

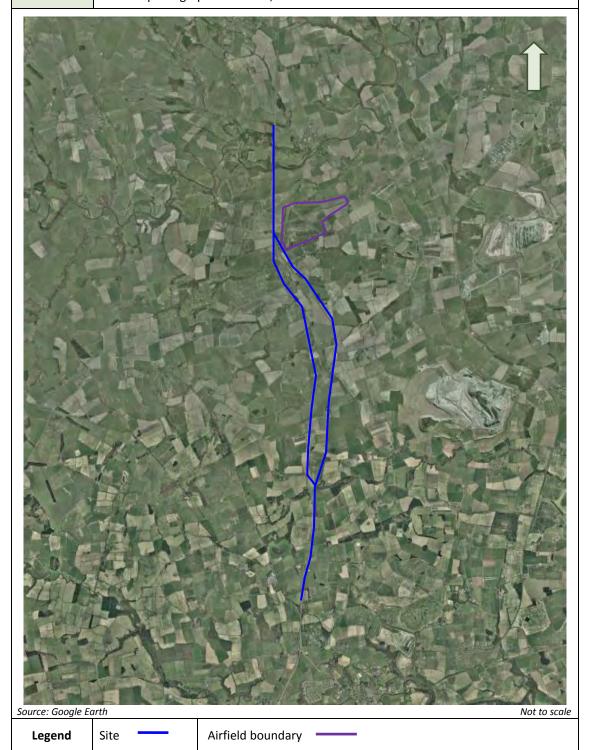
Plate 2 Satellite photograph of the Site, 2002

In the 1990s Eshott Airfield was reopened for use as a civilian aerodrome, as is shown in Plate 2, a satellite photograph of the Site dating from 2002.

No significant development has occurred on the Site since 2002 (see Plate 1).

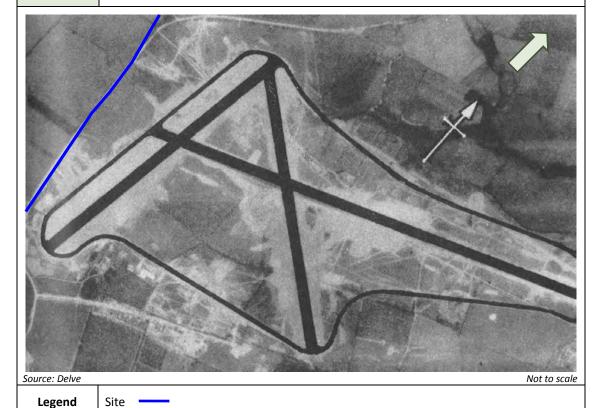
Plate 9 Aerial photograph of RAF Eshott, WWII

Plate 9 is a WWII-era aerial photograph of the airfield.

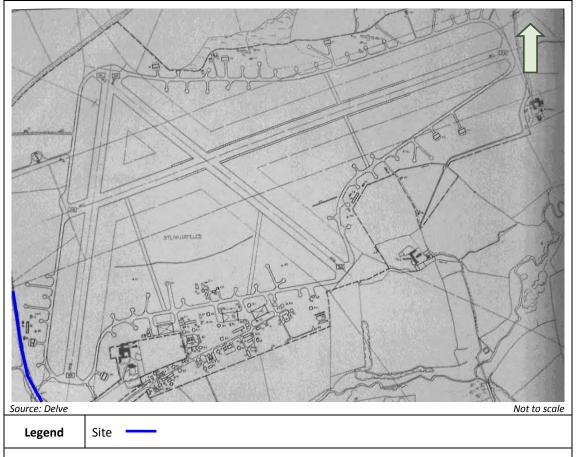
Figure 5 Extract of WWII site plan of RAF Eshott

Figure 5 is an extract of the airfield site plan. It shows that the Site ran in close proximity to aircraft dispersals, and was located approximately 0.3km from the Technical Area, which included 1No. T1 hangar and 8No. Blister hangars.

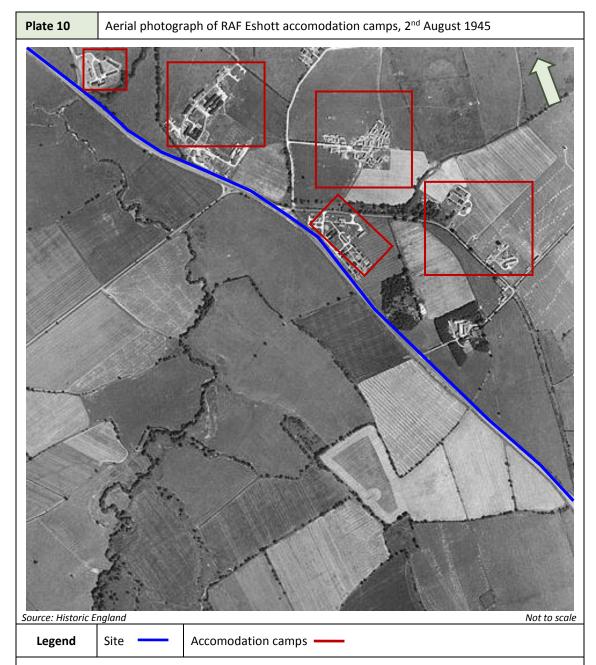
Domestic facilities associated with the airfield were constructed adjacent to the Site, as shown in Plate 10.

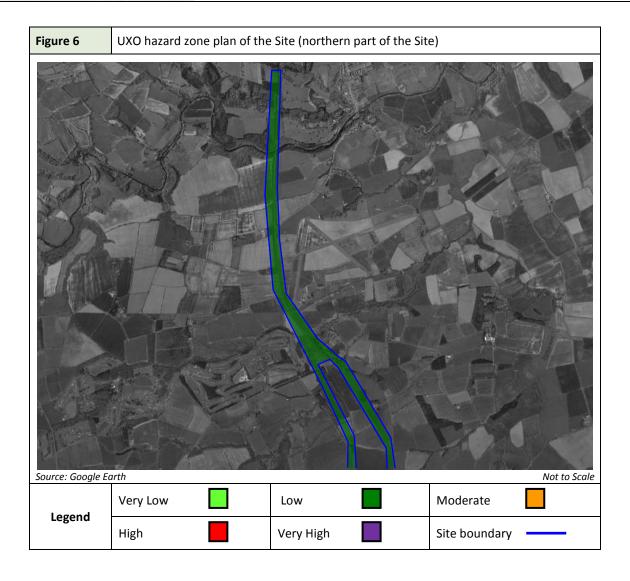
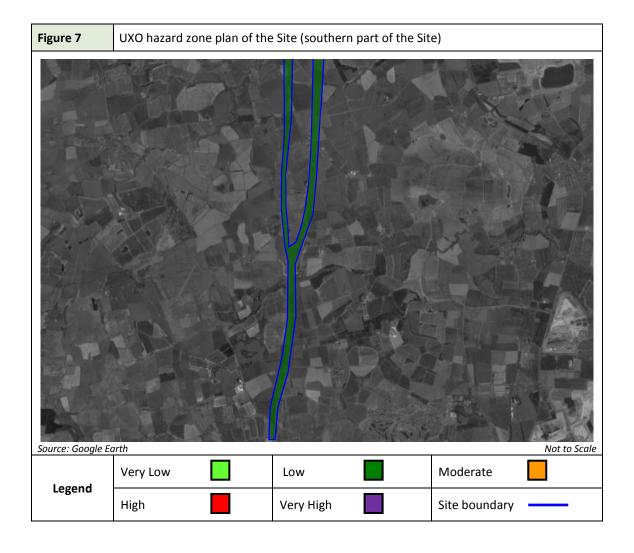
It is considered that the Site has a low UXO hazard level, as shown in Figures 6 and 7.

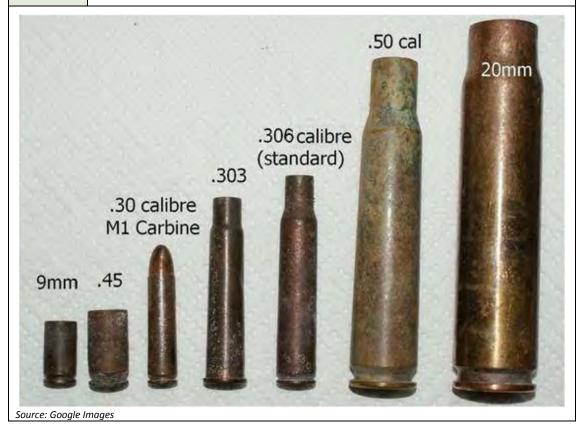
# Plate Photograph of typical WWII small arms ammunition

Generally small arms ordnance has a relatively low risk as UXO, although the larger calibre categories may have the same detonation risk as larger high explosive ordnance. SAA is often associated with discarded ammunition boxes around firing practice ranges. The Plate below illustrates some common SAA.

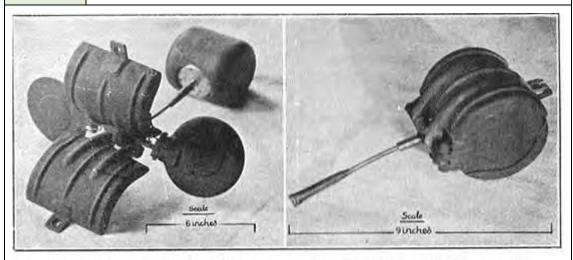
# Photographs of typical AP ('Butterfly') bombs

BOMB WITH CASING OPEN

BOMB WITH CASING CLOSED

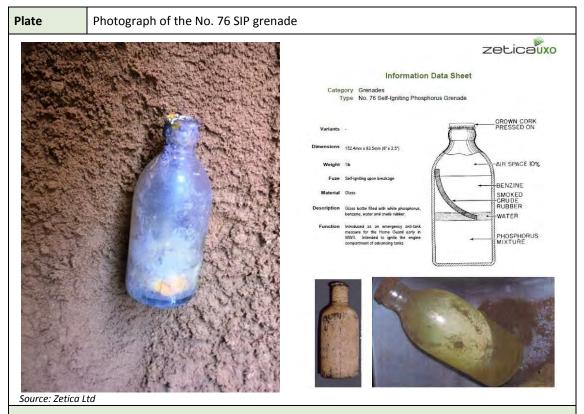
The Plate below is a photograph of a No. 76 SIP grenade (LHS) with an explanatory leaflet produced by ZeticaUXO for site staff (RHS).

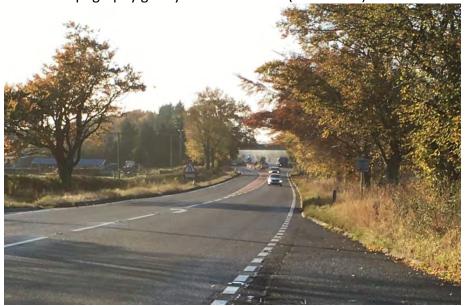
Stop 1 is a lay-by on the northbound carriageway at the southern end of the Morpeth to Felton dualling route. Photo A- 1 and Photo A- 2 show the road is at-grade with the surrounding agricultural land. The topography gently falls to the east (Photo A- 2).

Photo A- 1 Stop 1 looking south down the A1 from a lay-by on the west of the road.

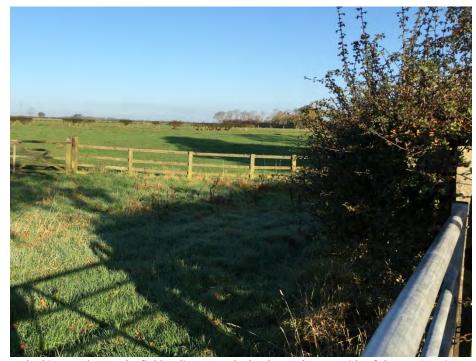
Photo A- 2 Stop 1 looking north over the fields adjacent to the lay-by on the west side of the A1. Gate is accessed from the lay-by.

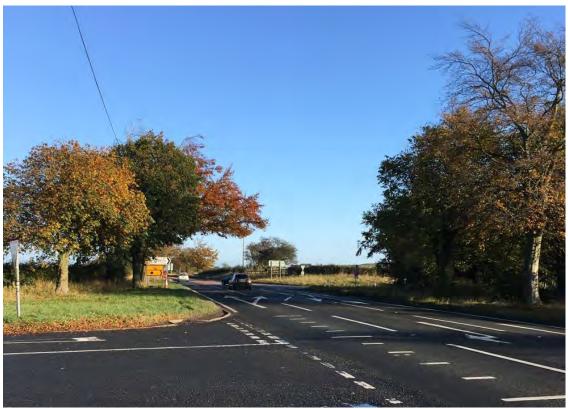
Stop 2 was at the junction of the northbound A1 and High Highlaws. The roads are at grade with the surrounding fields that are generally level (Photo A- 3 and Photo A- 4).

Photo A- 3 Stop 2 Looking north up the A1 at the junction with High Highlaws lane.

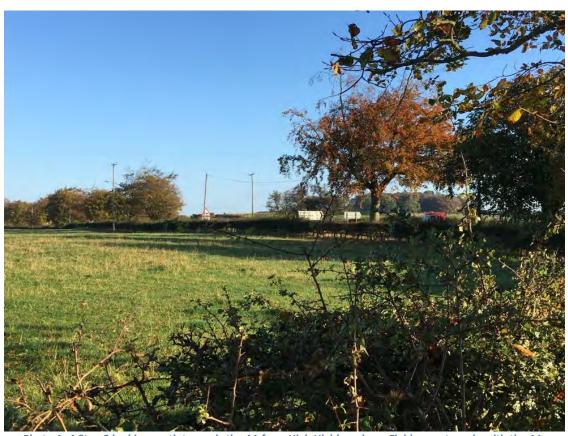
Photo A- 4 Stop 2 looking north towards the A1 from High Highlaws lane. Fields are at-grade with the A1.

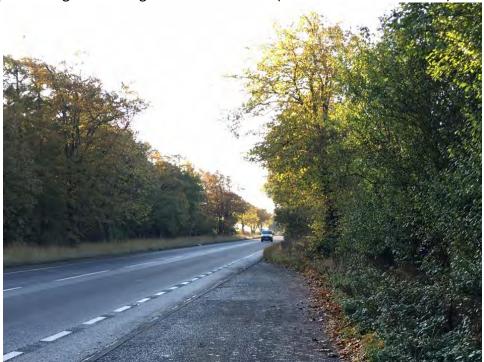
Photo A- 5 Stop 3 looking south on the A1 from the lay-by on the west on the carriageway.

Stop 3
The lay-by on the northbound side of the A1 near Floodgate Burn was the location of Stop 3.
The route passes at-grade through a small woodland (Photo A- 5 and Photo A- 6).

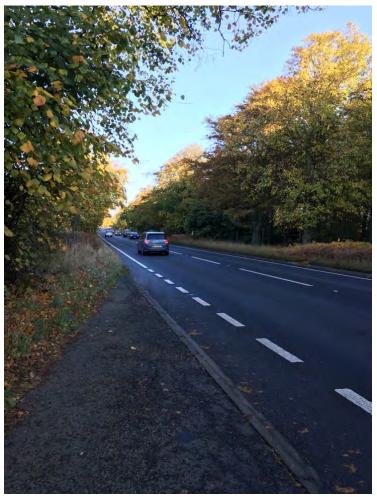
Photo A- 6 Stop 3 Looking north on the A1 from the lay-by on the west side of the carriageway.

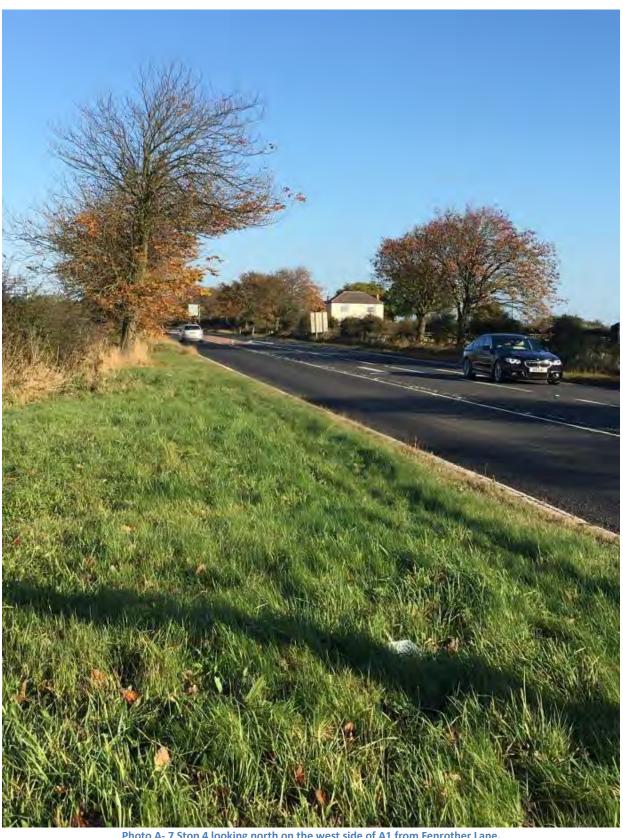
Photo A- 7 Stop 4 looking north on the west side of A1 from Fenrother Lane.

Stop 4 Stop 4 was at the junction of the northbound A1 and Fenrother Lane. The route is at-grade and vegetation is limited to hedgerows surrounding the adjacent agricultural land (Photo A-7, Photo A- 8 and Photo A- 9).

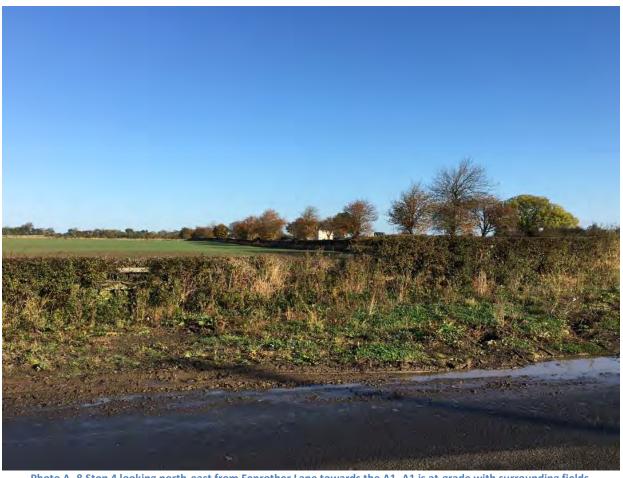
Photo A- 8 Stop 4 looking north-east from Fenrother Lane towards the A1. A1 is at-grade with surrounding fields.

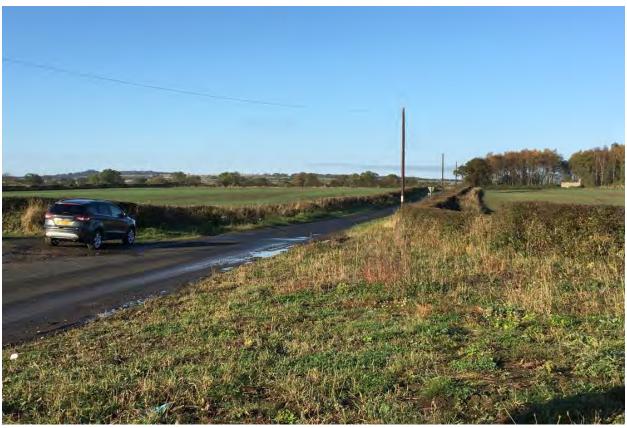
Photo A- 9 Stop 4 looking west along Fenrother Lane. Gently undulating agricultural land.

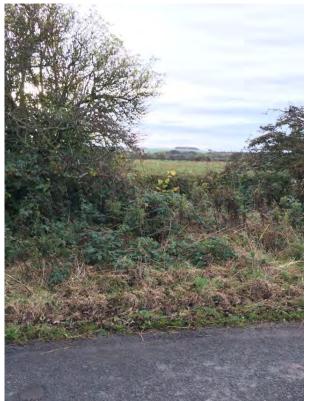
Photo A- 10 Stop 5 on Fenrother Lane looking south towards proposed location of offline route.

Stop 5 was located on Fenrother Lane at the proposed location of the offline option, approximately 0.5km west of the A1. Photo A- 10 shows that fields south of the lane are approximately at-grade with the existing lane. The topography is undulating and falls to the south (Photo A- 11).

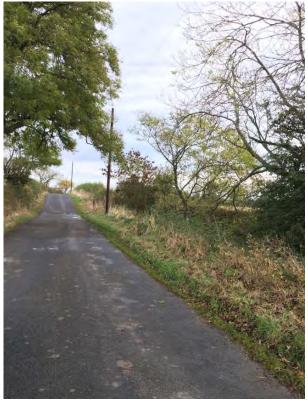
Photo A- 11 Stop 5 looking east towards undulating topography on Fenrother Lane that falls to the south.

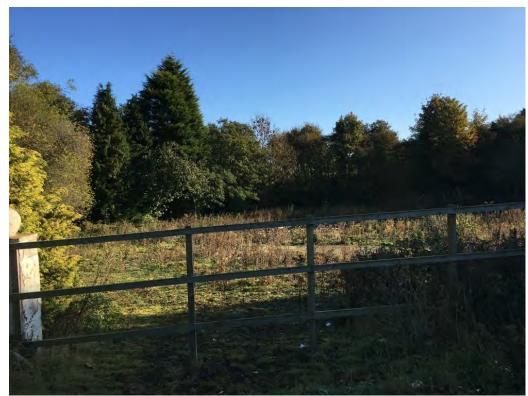
Photo A- 12 Stop 6 looking east from the Oak Inn over disused land.

Stop 6 on the lane at Causey Park Bridge was situated west of the A1 alignment. Photo A- 12 shows disused land between the Causey Park Bridge and the A1. The A1 is on an embankment (estimated <2m) behind the tree line. West of the lane is open agricultural land. Causey Park is highlighted in Photo A- 13 and the topography falls to the south-east.

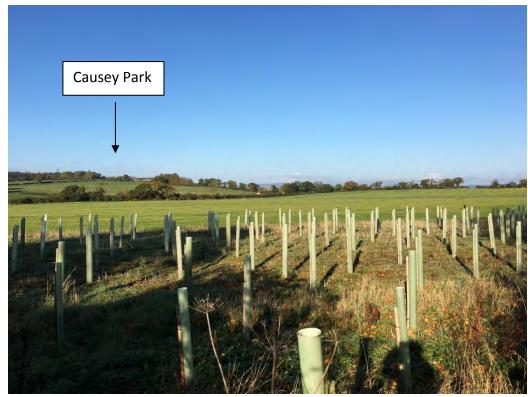
Photo A- 13 Stop 6 Looking west from the lane towards the proposed offline option location. Ground level increases to the north-west.

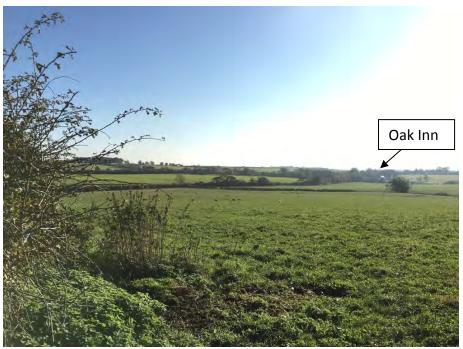
Photo A- 14 Stop 7 at Causey Park. Looking south east towards the proposed offline option.

# Stop 7 Stop 7 was at Causey Park. Photo A- 14 is a view towards the south-east over the land through which the offline option is proposed. Land falls to the south east and is gently undulating,

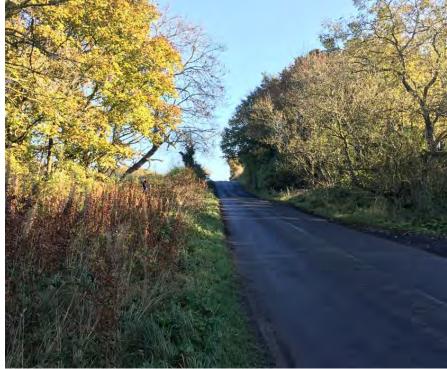
Photo A- 15 Stop 8 looking east (uphill) from the stream on East Road.

Stop 8 was located on East Road. Burgham Underbridge is proposed for the offline option to take East Road underneath the re-aligned A1. Photo A- 15 looks eastwards towards the proposed offline alignment. Material will need to be excavated to create the underbridge. Thick deposits of glacial till (>25m in BGS Borehole NZ19NE82) are expected above the bedrock unit of the Stainmore Formation.

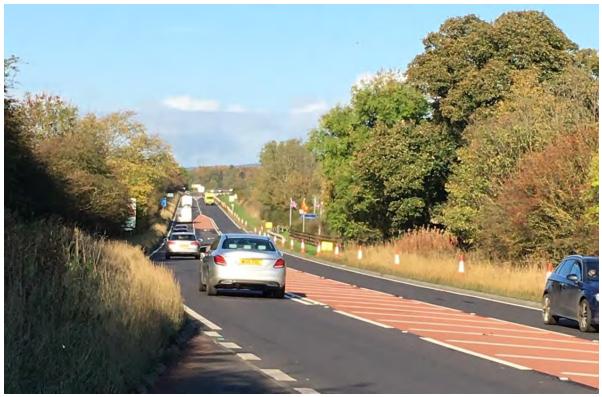
Photo A- 16 Stop 9 in looking north from A1 lay-by.

$\underline{\text{Stop 9}}$  Stop 9 was located at the lay-by at Felmore Park (approximate chainage 9700m). Photo A- 16 shows the road is at-grade and falling to the north (Photo A- 16).

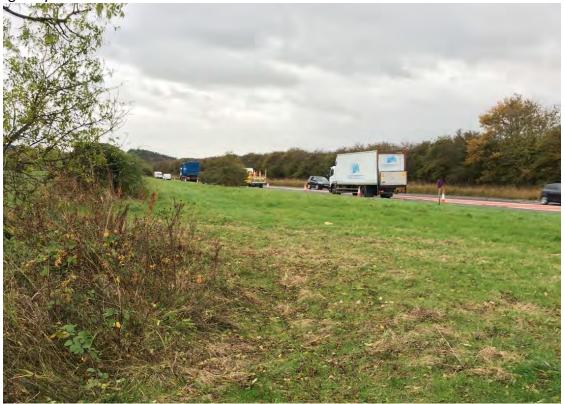
Photo A- 25 Stop 13 view south over the A1 from the bank of the lay by to the east of the A1.

Stop 13 was located at the lay-by on the east of the A1 at chainage 10250m shows the route is at grade with adjacent land. Photo A- 25 and Photo A- 26 show a wide grass verge at the side of the highway.

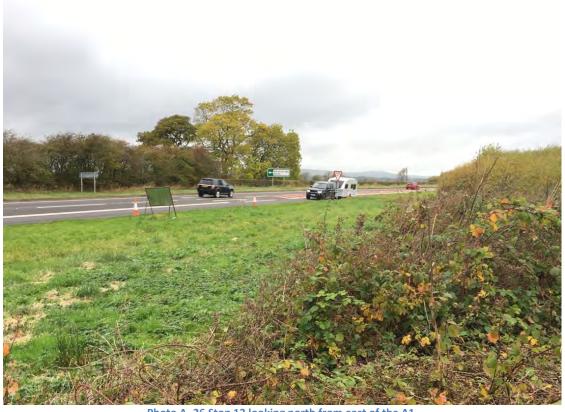
Photo A- 26 Stop 13 looking north from east of the A1.

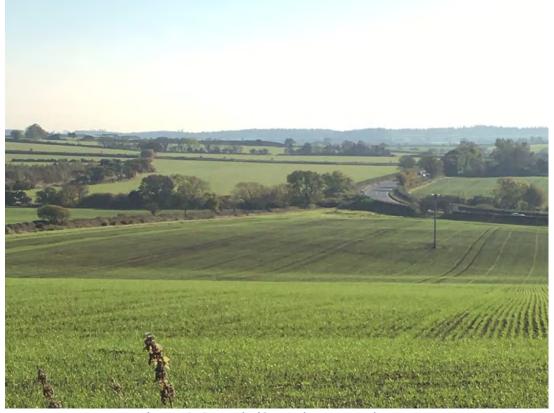
Photo A- 27 Stop 14 looking south-west towards to A1.

Stop 14 was in Helm is east of the A1. Photo A- 27 identifies the area where the online options propose maintaining a local access from Helm to the A1.
