## **A1 in Northumberland: Morpeth to Ellingham**

**Scheme Number: TR010059**

### **7.28.1 Applicant's Responses to Deadline 7 Submissions - Appendix A - River Coquet Fluvial Geomorphology Assessment – Valley Side– Channel Connectivity**

**Appendix A - River Coquet Fluvial Geomorphology  
Assessment – Valley Side-Channel Connectivity**

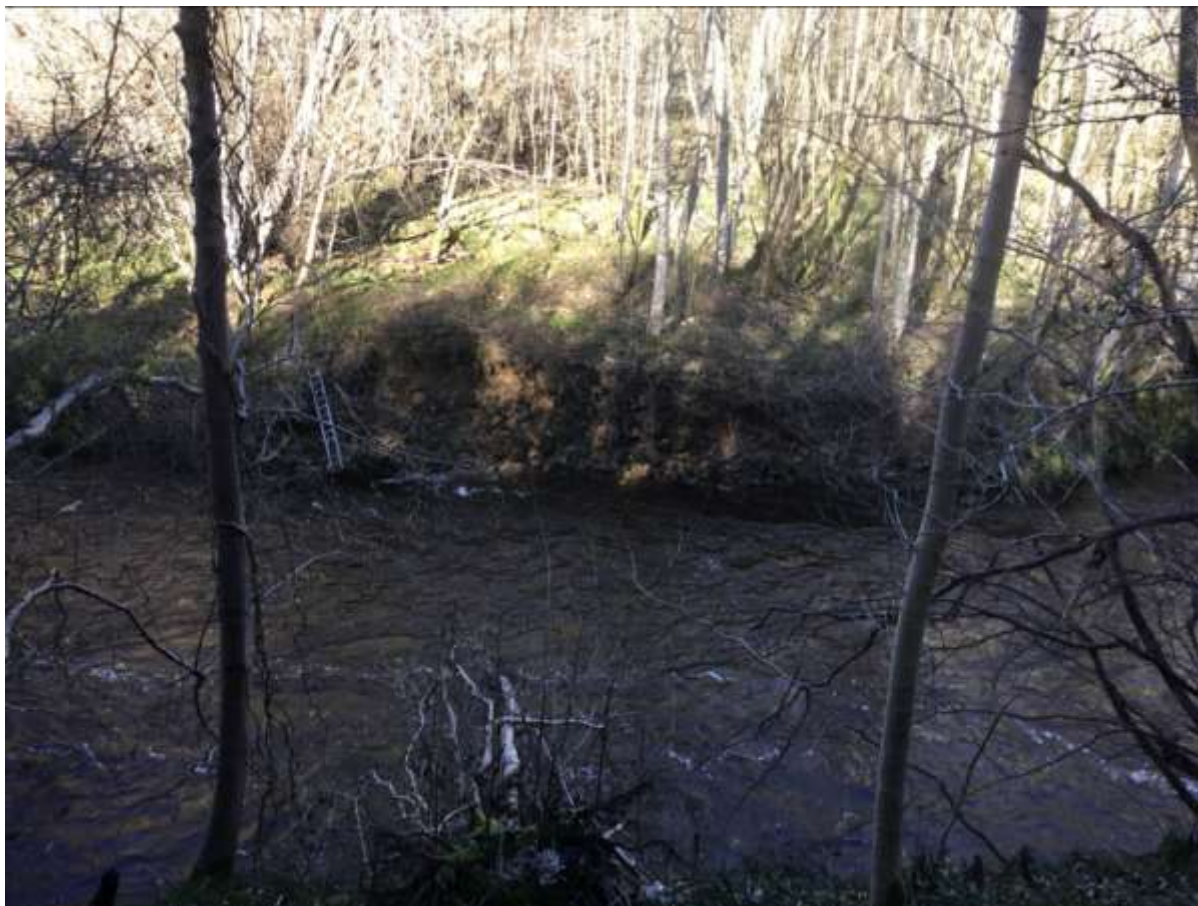
**Figure 2 - Eroding Toe of Landslide approx. 500m Upstream of Existing Bridge**

- 1.1.10. Larger valley side failures may or may not directly interact with the River Coquet. The locations of large valley side failures whose toes have reached and are being eroded by the River Coquet are indicated in Appendix A to 6.47 River Coquet Fluvial Geomorphology Assessment [REP7-003]. These are located on the left (north) bank 500m upstream and 300m downstream of the existing bridge and are unaffected by the Scheme. These failures will have historically supplied material to fluvial system and continue to do so through the erosion of their toes. The change to planform caused by these failures through constriction of the channel is likely to be temporary and localised as fluvial action removes finer failed sediment; however, some large boulders may continue to have an influence on local flow conditions over longer periods. A photograph of such a feature is shown in Figure 2.

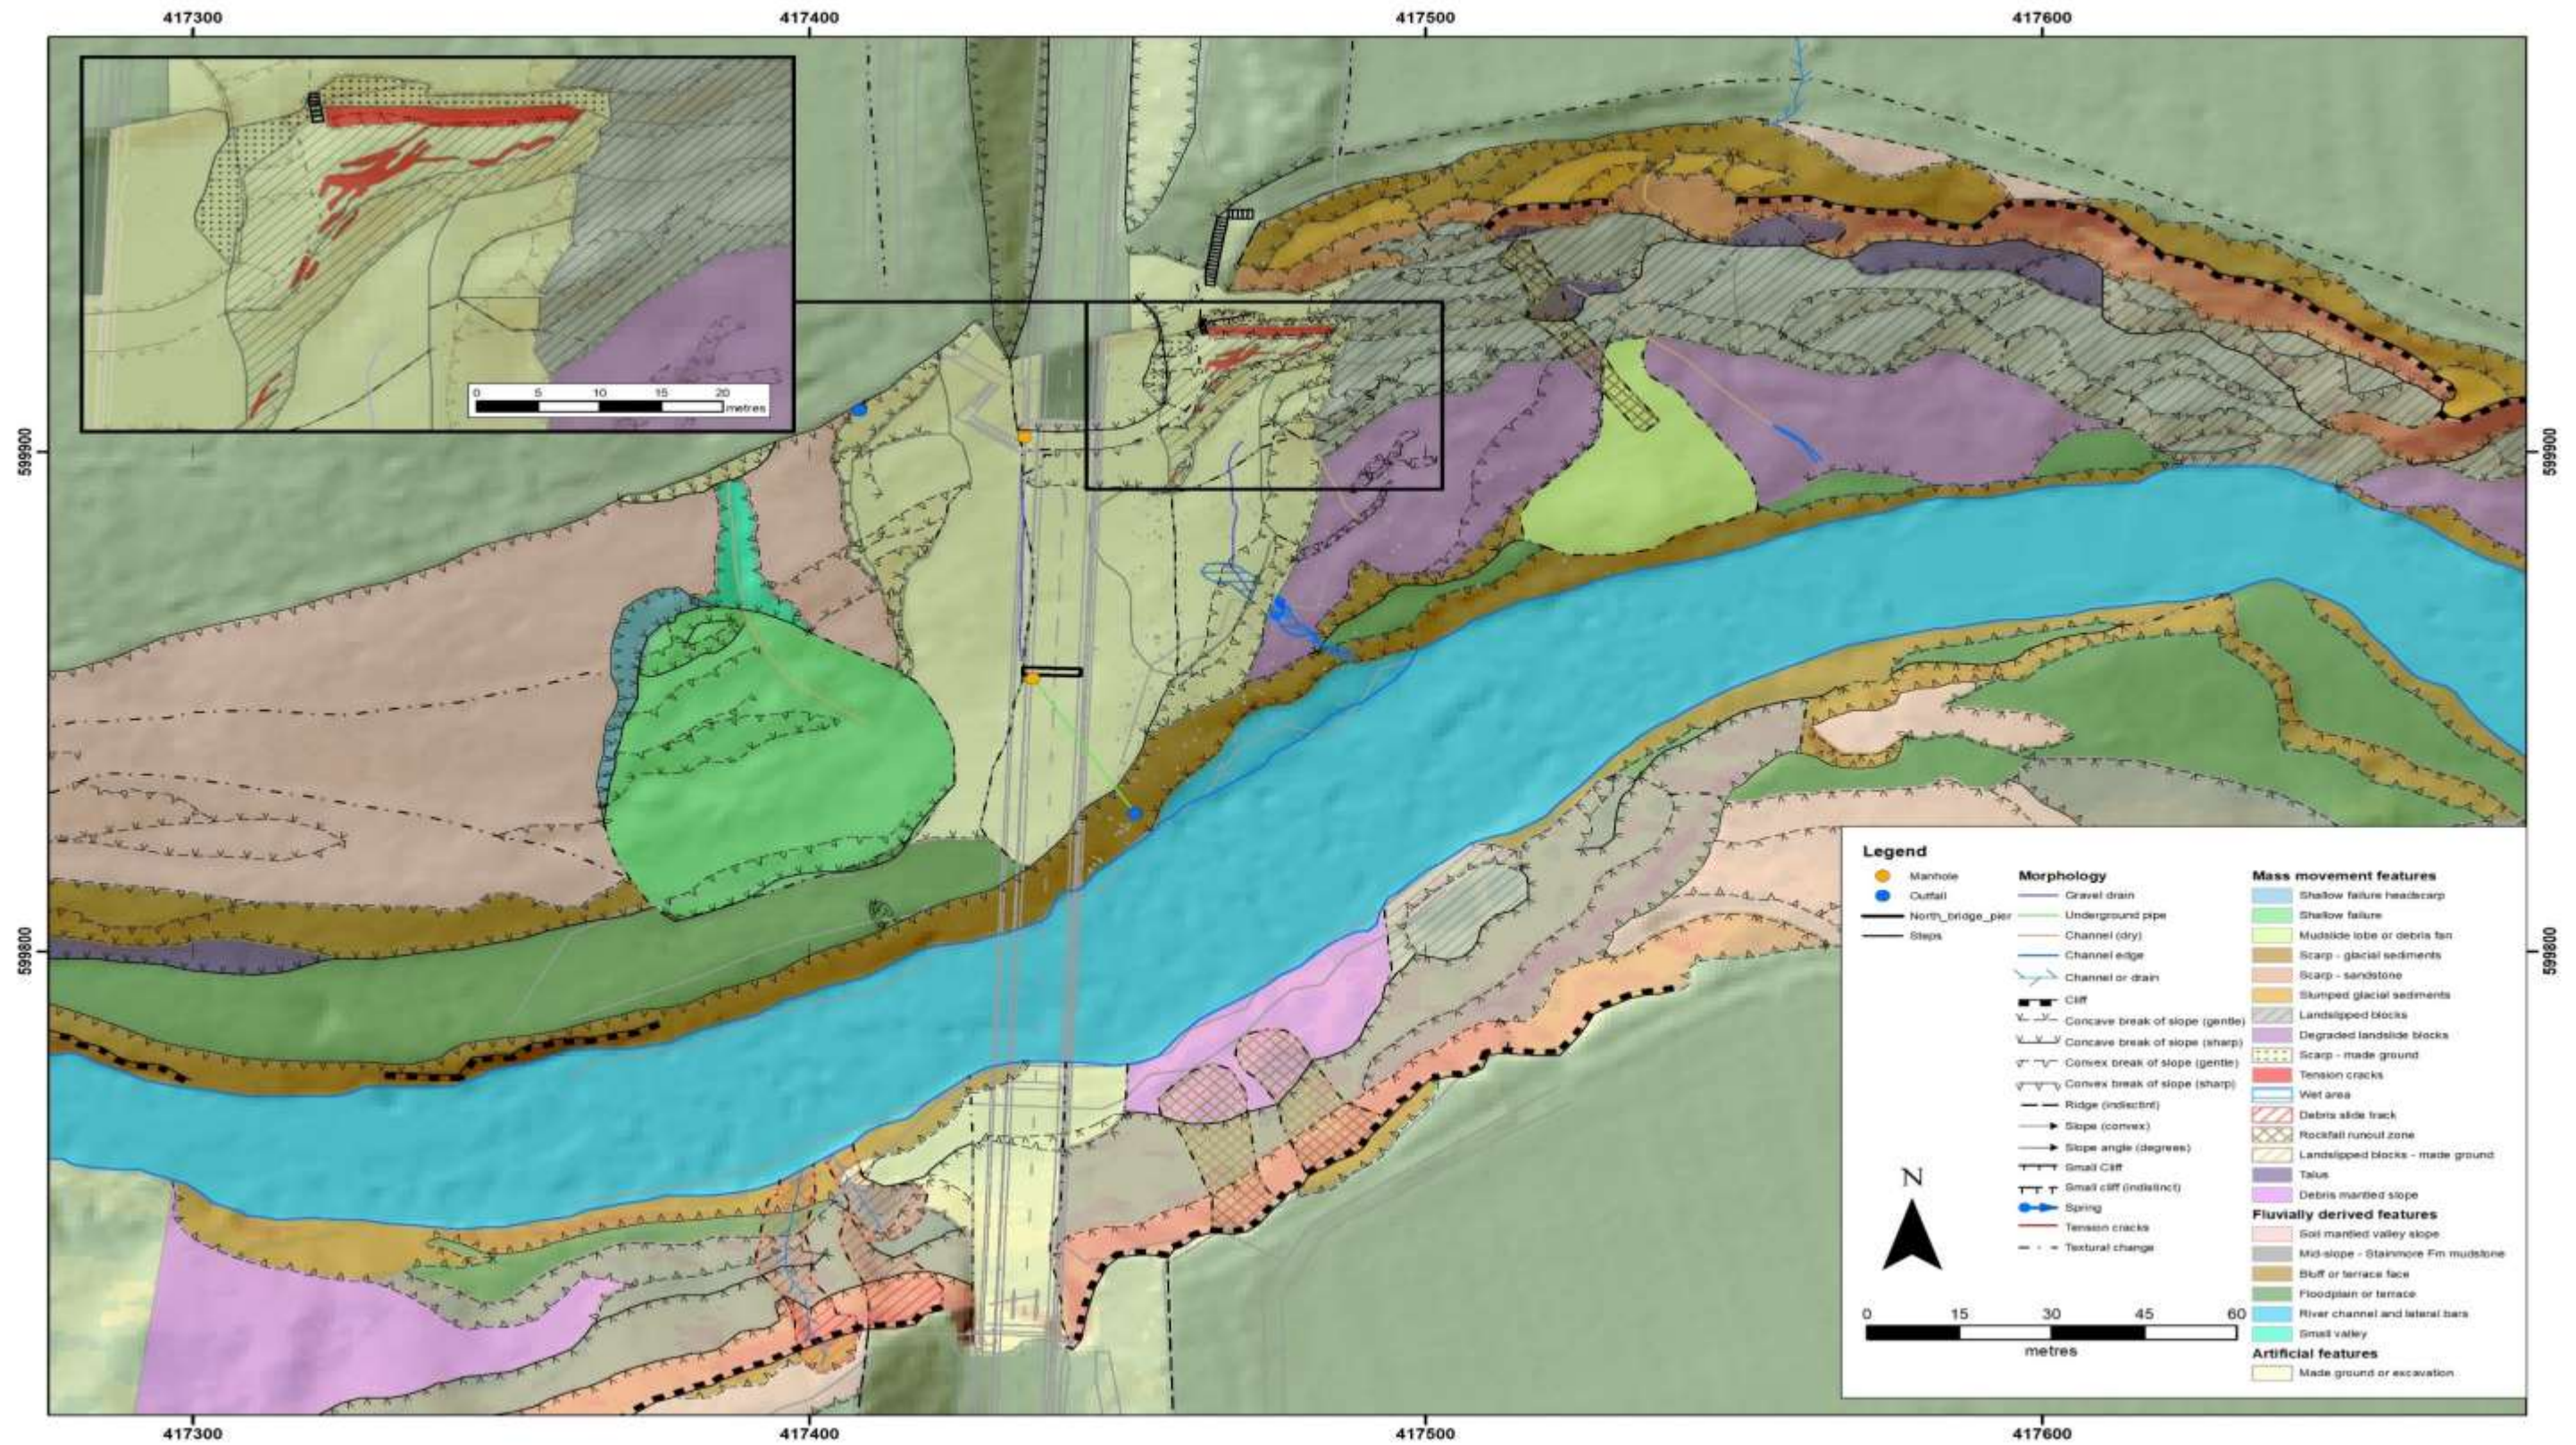
Figure 3 - Geomorphological Map of the Area around the Proposed Site

- 1.1.12. The area to the east of the existing bridge on the north bank, where the new bridge is proposed, is interpreted to be situated at the western extent of a historical (post-glacial) landslide complex developed in bedded competent over less competent strata. The landslide mechanism comprises the detachment of blocks of competent sandstone from the top of the slope, followed by downslope movement and degradation. It is also interpreted as an area which was formerly a focus of instability, but away from which the focus of erosion, which has migrated downstream. This has left comparatively low slope angles on the lower slopes and degraded instability features. A geomorphological map of this area is shown in Figure 3.
