# M5 Junction 10 Improvements Scheme

## Bat Roost Technical Appendix Addendum TR010063 - APP 9.45

#### Bat Roost Technical Appendix Addendum

<b>Rule Number:</b>	Regulation 5(2)(a)
<b>Planning Inspectorate Scheme Reference</b>	TR010063
<b>Application Document Reference</b>	TR010063/APP/9.45
<b>Author:</b>	M5 Junction 10 Improvements Scheme Project Team

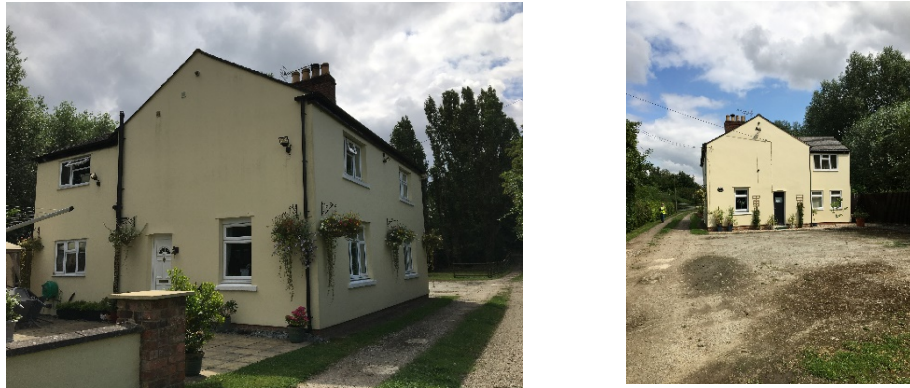
07/07/2021	21:12 to 23:22 (sunset = 21:27)	BU_963	EM Touch and Walkabout	Air temp: 18 (°C), no rain, cloud cover 6, wind speed 1
Comments: Biocensus: BM GW, AB and PP				
Roost survey results: (species and numbers, roost location, access points (include number of them) and dimensions where appropriate): No bats observed emerging by any surveyor. One surveyor observed a single bat (BM) on a brief pass.				
Photos/ diagrams:

Roost Characterisation: Soprano pipistrelle – day roost

<p>N</p>	<p>Demolished</p>	<p>External PBRA undertaken on 01/08/2019, and internal survey on 28/09/2023.</p> <p>BU_963 is located along Stanboro Lane. It is a two storey residential property with a cross gabled roof with simple flat concrete roof tiles. There are gaps behind timber fascia boards which extend under the eaves of the building, slight gaps under the ridge tiles and some missing mortar under the roof tiles. Internally, there are three roof spaces accessible for bats.</p> <p>The structure was assessed to provide high suitability for crevice and void dwelling bat species. The structure is not suitable for horseshoe bats. No classic hibernation opportunities are present.</p> <p>This building is in an area of high habitat suitability along Stanboro Lane due to the presence of suitable commuting and foraging habitats, and interconnected linear features including wet ditches, tree lines,</p>	<p>BU_963 does not support features that resemble BU_378 or BU_638 (where the presence of small numbers of hibernating bats has been confirmed) and the likelihood of hibernating bats being present in BU_963 is considered to be very low.</p>	<p>No additional roosts (in addition to the known roost) are predicted.</p>

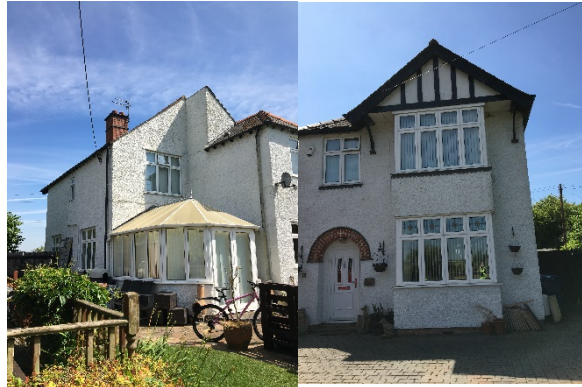
25/09/2023	18:46 to 21:01 (sunset = 19:01)	BU_987	Batlogger x4 Canon camera and infrared lights x4	Air temp: 17 to 14 (°C), no rain, cloud cover 3/5, wind speed 0/1
Comments: Atkins: WP, ME, Limitations: Both surveyors at front of the house due to safety concerns.				
Roost survey results: (species and numbers, roost location, access points (include number of them) and dimensions where appropriate: No emergences seen. Nyctaloid, pipistrelle, and myotis bats heard throughout survey. Two bats seen continuously foraging in the back garden at 19:10, seen from the front of the house.				
Photos/ diagrams:

Roost Characterisation: Soprano pipistrelle – maternity roost

S	Demolished	<p>External PBRA undertaken on 24/07/2019 and internal inspection undertaken on 28/09/2023.</p> <p>BU_987 is a two-storey multi pitch recently occupied residential property located along Withybridge Gardens. It has several extensions. The main house has a gabled roof, and an extension to the south has a hipped roof. A further two hipped roof extensions are attached to eastern elevation. On the southern hipped extension and one of the eastern hipped extensions the roof tiles appear to be asbestos. There</p>	<p>The features on this structure, in particular the gable ends and multi-pitched roof, are similar to BU_638 which is known to support solitary/small numbers of hibernating common pipistrelle bats. As a precaution, and given the absence of classic hibernation opportunities, solitary/small numbers of hibernating crevice dwelling bats are assumed to be present.</p>	<p>In addition to the known roost, solitary or small numbers of crevice dwelling hibernating bats are predicted.</p>

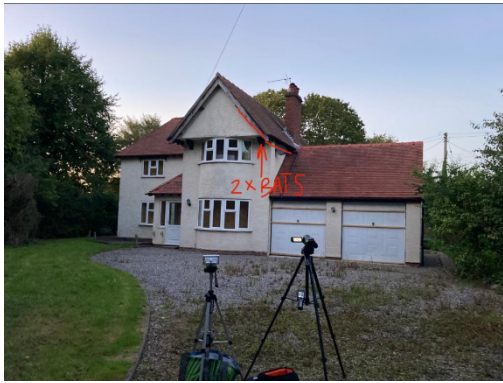
20/09/2023	18:57 to 19:12 (sunset = 19:12)	BU_1027	Batlogger M2 x 4 Canon camera and infrared light x4	Air temp: 15 to 14 (°C), rain 2 to 0, cloud cover 8 to 4, wind speed 1
Comments: Atkins: RM, AP, Limitations: Moderate rain at survey start, cameras were turned on at 19:00, no bats seen or heard during this time. Intermittent rain throughout survey Roost survey results: (species and numbers, roost location, access points (include number of them) and dimensions where appropriate: One pipistrelle was seen and heard emerging from under the eaves, the south eastern aspect of the gable end, and flew south to west at 19:33.				
Photos/ diagrams:

Roost Characterisation: Common pipistrelle – day and transitional roost, Soprano pipistrelle – day roost, <i>Myotis</i> species – day roost

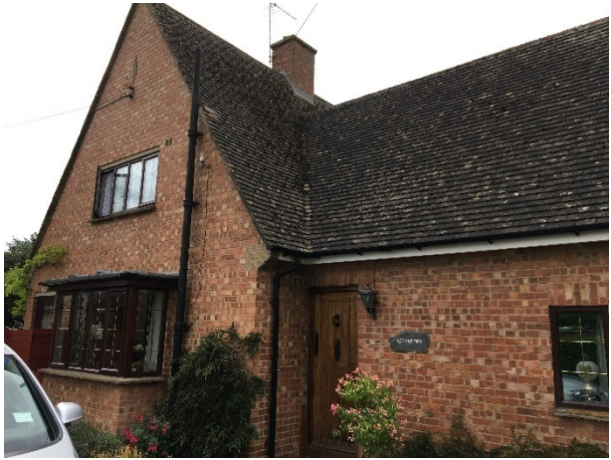
Comments: Atkins: RM, BC Limitations: Infra red light failed on two cameras after 23:16.				
Roost survey results: No emergence was recorded. Soprano pipistrelles were heard foraging and commuting throughout survey.				
Photos/ diagrams:

Roost characterisation: Soprano pipistrelle – day roost

<p>S</p>	<p>Demolished</p>	<p>External PBRA undertaken on 31/07/2019 and internal inspection on 28/09/2023.</p> <p>BU_1042 is a recently occupied residential property located along Withybridge Gardens. It is a two storey residential building constructed from red brick with a cross-gabled roof. There are flat, plain clay tiles and concrete / clay ridge tiles. Some roof tiles have recently been replaced.</p> <p>There is a ventilation slit and brick on the eastern aspect. A house sparrow entered in the ridge from gable end apex of the house. There is a red brick chimney with lead flashing at the base, a closed soffit box, a bay window on the eastern aspect with a closed laminate soffit box. The structure appears to have dry ridge system. There are gaps where dormers meet the main roof in the valley, a hole in the apex on the western gable end and access to the soffit box on the southern aspect of the house.</p> <p>Internal: Two individual roof voids in each of the gable ends. One was fully boarded across its base with breeze block gable end and bitumen roof felt lining. The other was not lined with direct visibility to the tiles, with</p>	<p>The features on this structure, in particular the clay roof tiles, gable ends and multi-pitched roof, are similar to BU_638 which is known to support solitary/small numbers of hibernating common pipistrelle bats. As a precaution, and given the absence of classic hibernation opportunities, solitary/small numbers of hibernating crevice dwelling bats are assumed to be present.</p>	<p>In addition to the known roost, it is predicted that solitary or small numbers of crevice dwelling hibernating bats are also present.</p>

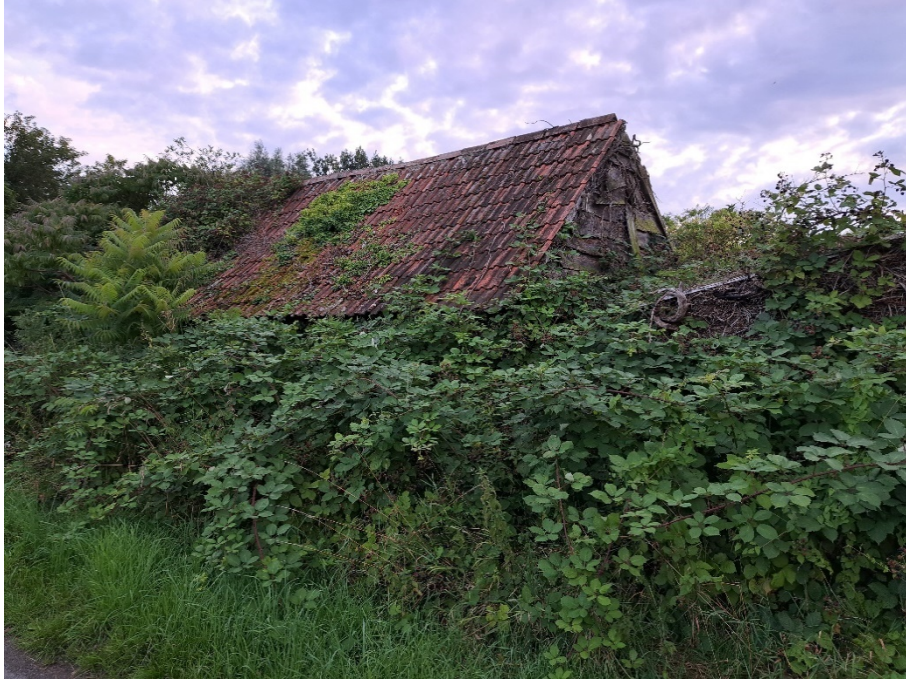
Roost survey results: (species and numbers, roost location, access points (include number of them) and dimensions where appropriate: No emergences seen. Pipistrelles heard throughout survey. Myotis bats heard from 20:19 onwards.				
Photos/ diagrams:

Roost Characterisation: Common pipistrelle – day roost

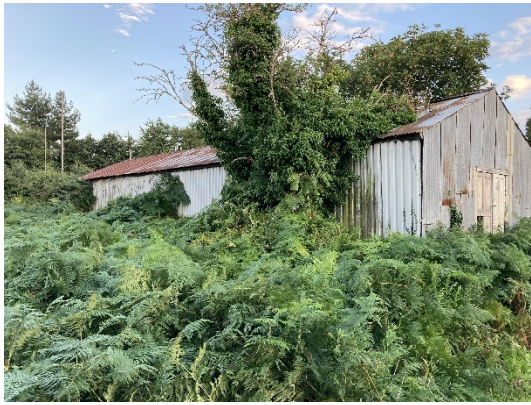
10/08/2023	20:27 to 22:42 (sunset at 20:42)	BU_48	Batlogger M2 and Canon Infra red x 2 (XA40 and XA55)	Air temp: 23 to 20, no rain, cloud cover 4 to 7 and wind speed 1 to 2-3.
Comments: RM and EH				
Limitations: heavy ivy coverage on the northern aspect and building to southern aspect. Cameras on the gable ends, but surveyors watched the northern aspect without a survey aid.				
Roost survey results: (species and numbers, roost location, access points (include number of them) and dimensions where appropriate: A single bat was observed emerging from the damaged door on the western aspect at 21:21 confirmed to be common pipistrelle.				
Survey 2 – Not complete				
Survey 3 – Not complete				
Photos/ diagrams:

Roost Characterisation: Common pipistrelle – day roost

<p>E</p>	<p>Temporary Disturbance</p>	<p>External PBRA undertaken on 10/08/2023. BU_48 is a large metal agricultural barn located north of the A4019 at the eastern extent of the Scheme. It comprises metal walls with a metal sheet roof with a metal ridge. There is a partially damaged door on the western aspect. Part of the southern aspect is bordered by an adjacent building (BU_25). There are gaps under the metal roof sheeting that could allow direct access to the barn and a gap in the door on the western aspect of the building that would allow horseshoe access.</p> <p>The structure was assessed to provide low suitability for crevice dwelling, void dwelling and horseshoe bat species. The structure is not suitable for hibernating bats being</p>	<p>Despite the surveys not being complete, the structure does not provide suitable features for larger numbers of bats, and there is therefore a high level of confidence in the common pipistrelle day roost characterisation. The presence of a lesser horseshoe bat roost and a void dwelling bat roost supporting solitary/small numbers of bats is considered to be low given that these species have been found to roost predominantly within brick built structures. However, BU_48 is relatively similar to BU_747 (see Section 2.4) which was found to support a lesser horseshoe bat day roost. It is also similar to BU_761 and BU_857 which were identified as a night roost/feeding roost/transitional roost. Therefore, as a precaution BU_48 is also assumed to be a roost for lesser horseshoe bats and void</p>	<p>In addition to the known roost, lesser horseshoe and void dwelling bat roosts supporting solitary/small numbers of bats is also predicted.</p>

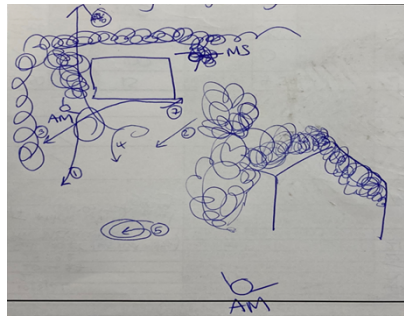
19/09/2023	19:14 to 21:14 (sunset = 19:14)	BU_668	Batlogger M2 x2 and Canon camera and infra-red lighting x2	Air temp: 17 (°C), light showers throughout, cloud cover 8, wind speed gusts of up to 6
Comments: Atkins: BC and EG Limitations: Survey did not begin until sunset, but this was not considered to be a significant limitation. Weather was sub-optimal throughout however emergence of bats was recorded. Roost survey results: (species and numbers, roost location, access points (include number of them) and dimensions where appropriate: three lesser horseshoe bats were seen to emergence from the gap above the door on the northern elevation (at 19:38, 19:44 and 19:55). Lesser horseshoe bats were recorded foraging throughout the survey.				
Survey 3 – no access. Not considered required for roost characterisation				
Photos/ diagrams:

Emergence flight path:		Emergence location (MS):

- 2.5.5. Another outhouse type structure (BU\_668, outside of the EPSML Zol within the southern quadrant) was found to support a lesser horseshoe day and mating roost to the south of the A4019, along Moat Lane. The structure comprises an ivy clad single storey brick built outhouse with a tiled roof and an open door on the northern aspect. Lesser horseshoe bat droppings were found within the structure beneath stored farm equipment, and lesser horseshoe bats were recorded emerging through the open doorway.

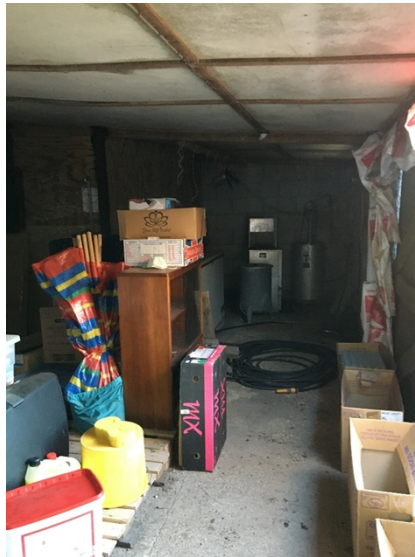
*Photo 2-1 BU\_378 showing the 'cool room' comprised of wood (shown in the left of photograph) located within the outbuilding where evidence of hibernating brown long-eared bats was confirmed.*

- 2.5.30. BU\_378 is a lean-to structure constructed from breeze block with corrugated asbestos sheets for a roof. The south elevation is open leading into one section of the building used as a garage and for storage. The remainder of the building is compartmentalised, including a 'cool room' comprised of timber within the wider structure. Brown long-eared bat droppings were identified in the 'cool room' and in the garage/storage area, and feeding remains were identified in the 'cool room' during January 2022. A brown long-eared bat was recorded once on the static bat detector in February 2022, which was placed in the 'cool room.' The 'cool room' within this structure is a key feature for hibernation.

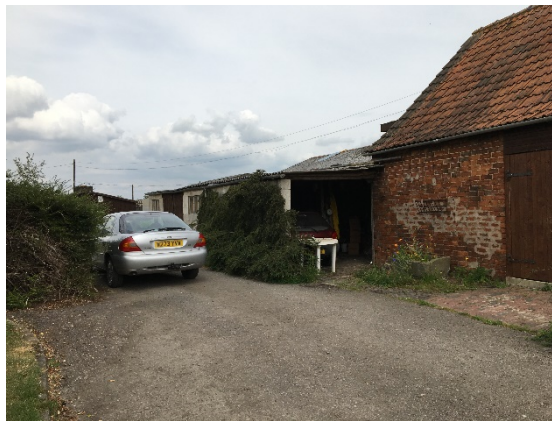
*Photo 2-2 BU\_378 external showing lean to with access points in the brick work to the cool room.*

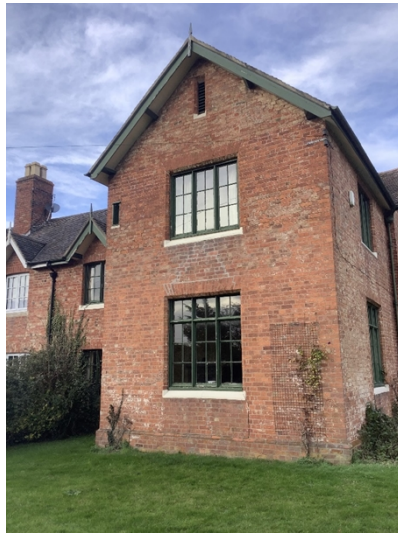
*Photo 2-3 BU\_638 confirmed common pipistrelle hibernation roost within the roof void.*

- 2.5.31. BU\_638 is a large two-storey house with several roof aspects in a poor state of repair. It has a cross-gabled roof with a rear mono pitched two-storey extension, clay roof and ridge tiles and red brick chimneys. There is lead flashing present on the extension, bargeboards with a soffit box present and windows with timber frames. The southern gable end has a potential access point in the form of a vent at the apex of the elevation. A static bat detector was deployed by the landowner into the roof space and common pipistrelle was recorded in February and March 2021. The presence of/potential presence of these features, in particular the clay roof and ridge tiles, the presence of the vent on the southern gable end and steep roof pitch, have therefore been considered as favourable for hibernating bats and have been used to help inform predicted hibernation bat roosts.

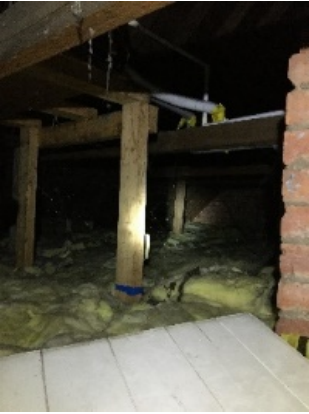
Known or Predicted Roost, Impact and Structure (if known)	Roost Type	Roost Location and Dimensions (if known)	Roost Photos	Roost Details	Compensation provided
Loss of BU_611	Lesser horseshoe day roost. No bats seen, droppings collected.	House loft void where droppings were identified Size: 5 m long x 3 m wide x 2 m high Outdoor toilet Size: 2 m long x 1 m wide x 2 m / 3 m high

Red brick construction and the tiled roof was lined with wooden sarking.  An access point for bats could not be confirmed, however not all of the loft space was accessible for inspection during the survey (due to thick loft insulation concealing access routes through the void). There was a missing half brick between this roof void and the adjacent roof void (BU_610), and a chimney was present that could be used by this species to access the void. During the emergence surveys no bats were recorded to enter or exit the property to confirm access points.	Compensatory structure with at least two voids – comprising a void within the ground floor for bats and an additional purpose-built loft void suitable for lesser horseshoes / void dwelling and light sampling species.

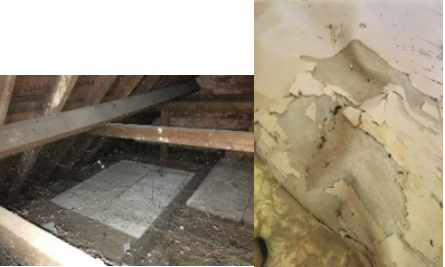
Loss of BU_694	Lesser horseshoe day roost. No bats seen, droppings collected.	House (entire, but droppings were concentrated in the roof void and first floor bedroom) Size: 5 m long x 3 m wide x 2 m high

Red brick construction and the tiled roof was lined with wooden sarking.  The residential property was derelict and therefore bats had access to the whole property through a missing loft hatch. Evidence of droppings was recorded throughout, however accumulations of droppings were concentrated below the ridge beam in the loft and below one of the light fittings in a first floor bedroom. During emergence surveys no bats entered or exited from the property to confirm access points.  As with BU_611, the whole of the loft void could not be accessed, however there was potential access between the adjacent roof void, and a chimney was

- 2.5.19. A brown-long eared bat day roost was identified within BU\_694, a vacant and derelict former residential property located north of the A4019 towards the eastern extent of the Scheme in the eastern quadrant. The roost was identified within the property itself with droppings collected within the kitchen. The access point to the roost was not identified. BU\_694 had recently been broken into and used for rough sleeping prior to the internal inspection being undertaken, and it is considered likely that the damage to the building during this time facilitated brown long-eared bat access.

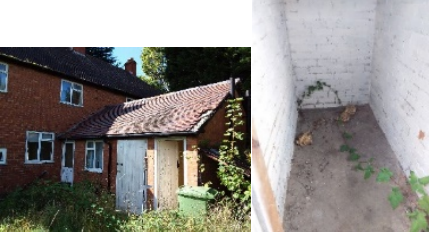
Known or Predicted Roost, Impact and Structure (if known)	Roost Type	Roost Location and Dimensions (if known)	Roost Photos	Roost Details	Compensation provided
				present that could be used by this species to access the void.	
Loss of BU_507	Lesser horseshoe day / feeding roost. No bats seen, droppings collected.	Outdoor toilet Size: 2 m long x 1 m wide x 2 m / 3 m high

All three of these roosts were in outdoor toilets of very similar construction at the rear of derelict properties. They were constructed from brick (that had been whitewashed). The roof tiles had no interior lining. Bats are assumed to access these roosts via the doors that were left open (as no other access points were identified).	Four lean-to / compartments on the exterior of, or within, the compensatory bat structure with four bat boxes within the lean-to/compartment s to provide roosts for void dwelling bats with a light sampling area. In combination these provide eight compensatory features, as each individual lean-to/compartment

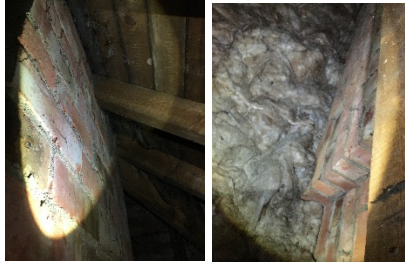
Known or Predicted Roost, Impact and Structure (if known)	Roost Type	Roost Location and Dimensions (if known)	Roost Photos	Roost Details	Compensation provided
Loss of BU_610	Noctule day roost	Under lead flashing around the base of the chimney

A noctule emerged from underneath the lead flashing at the base of the chimney in June 2021.	
Loss of BU_819	Common pipistrelle day roost	Under guttering

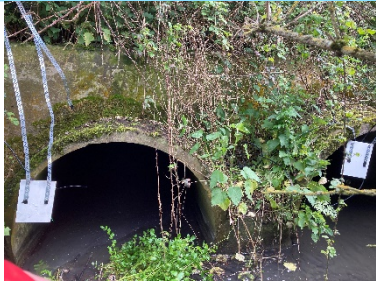
N/A	
Temporary disturbance of BU_1098 (Barn Farm culvert)	Predicted solitary or small numbers of crevice dwelling hibernating bats	Unknown

N/A	Cool tower within the compensatory structure for solitary or small numbers of hibernating bats

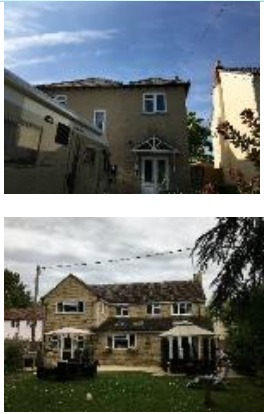
<p>BU_965 is a two storey recently occupied residential building with a hipped roof laid with slate tiles and a cross gabled extension to the south. Potential roosting features include possible holes under the eaves and potential access into the roof space, although the exact location that the bat emerged from was not identified. The roof space is 2.5 m tall to the apex, 2.5 m wide and 6 m long.</p>	<p>Compensatory structure with at least two voids – comprising a void within the ground floor for bats and an additional purpose-built loft void suitable for lesser horseshoes / void dwelling and light sampling species.</p>
Loss of BU_966/B U_983/BU_1041	Predicted void dwelling bat roost supporting solitary/small numbers of bats	Unknown

N/A	<p>Compensatory structure with at least two voids – comprising a void within the ground floor for bats and an additional purpose-built loft void suitable for lesser horseshoes / void dwelling and light sampling species.</p>

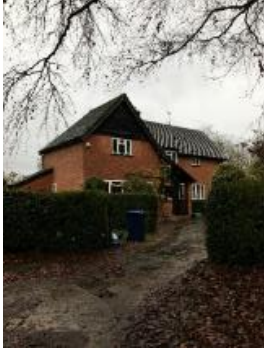
<p>One common pipistrelle bat emerged from behind the fascia board, another from an unknown crevice on the southern elevation (possibly from near the corner of the door) and one further bat emerged from the window frame, in September 2021.</p> <p>Again in September 2021, a common pipistrelle emerged from the south east corner of the building.</p>	<p><b>One</b> compensatory crevice dwelling bat roost structure with at least <b>14</b> roosting features.</p>
Loss of BU_981 (three roosts)	Common pipistrelle day roost, soprano pipistrelle day roost and pipistrelle species day roost	Various crevices.

<p>Four bats emerged from underneath hanging tiles on the eastern facing gable.</p> <p>One bat emerged from the top right of the south facing gable end.</p> <p>One bat emerged from the eaves.</p> <p>One bat emerged from underneath the roof tiles.</p> <p>One bat emerged from underneath wooden cladding on the gable wall.</p>

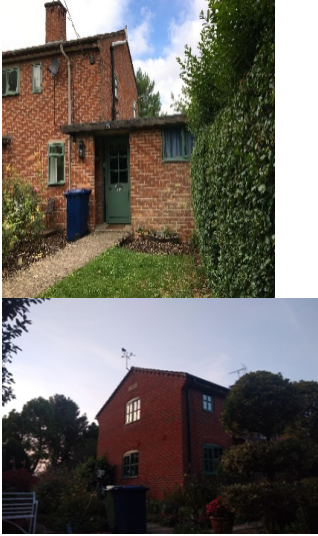
One soprano pipistrelle bat was recorded circling the gable end to the south before roosting within a crack in the concrete on the southern gable end in August 2019	
Temporary disturbance of BU_1034	Common pipistrelle day and mating roost and soprano pipistrelle mating roost.	Under barge board, behind soffit box and potentially under roof tiles.

Two common pipistrelle bats emerged from under the barge board and from behind the soffit box in August 2019.  In September 2021, common and soprano pipistrelle bats were observed swarming near to the southern wall and roof tiles, but did not appear to emerge or re-enter the structure.

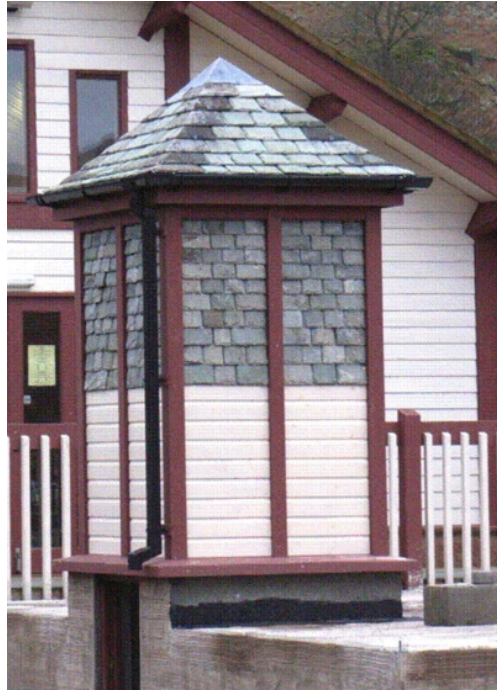
Figure 1 - Example Crevice Dwelling Bat Structure<sup>17</sup>

5.3.2. The design parameters for the crevice dwelling bat roost structure within the northern quadrant are outlined in Table 5-6 below. This is based on a similar design to the bat tower at Ravenglass Railway in Cumbria<sup>16</sup>.

Features	Reason for Requirement
General construction	Permanent structure at least 1.5 m by 1.5 m and at least 3 m tall (to the apex)	To ensure permanent roosting features.
	At least 14 access points approximately 20 mm high by 50 mm wide each leading to a crevice at between 20 mm and 50 mm deep and/or tiles, lead flashing, soffit box, cladding and fascia. All access points will be a minimum of 2 m from ground level.	To provide at least 14 crevice roosting features.
	The roost will be protected from one in five year floods	General requirements to support roosting bats in perpetuity
	Internal crevices will be made from rough saw materials that allow bats to grip within the roost	To ensure sufficient roosting features within the structure for crevice dwelling bats
	The structure will include a pitched roof, that is tiled	To mimic roof roosting features

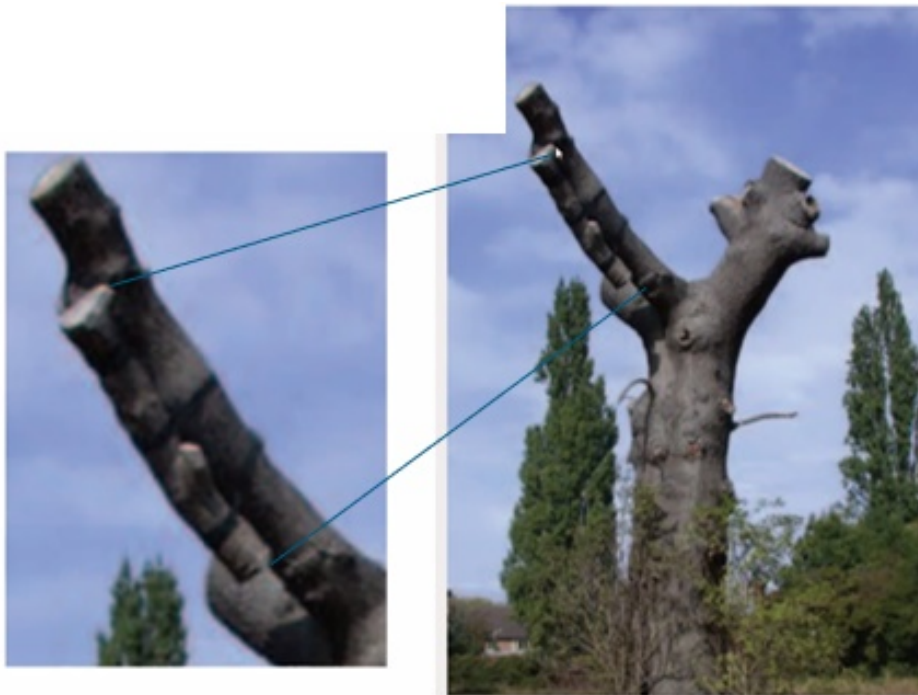
Figure 2 - Example of a Tree Roosting Feature

- 5.5.1. Table 5-8 details the compensatory tree roosting features, and which bat roosts they compensate for, across the Scheme.
- 5.5.2. These features will be created from sectionally felled trees that would be lost as a result of the Scheme, where they have high potential/confirmed roost features. The tree limb with bat roost features will be strapped onto a retained tree to preserve the roosting features in the locality. An example is shown in Figure 2 below. Alternatively, features could be created on retained trees.

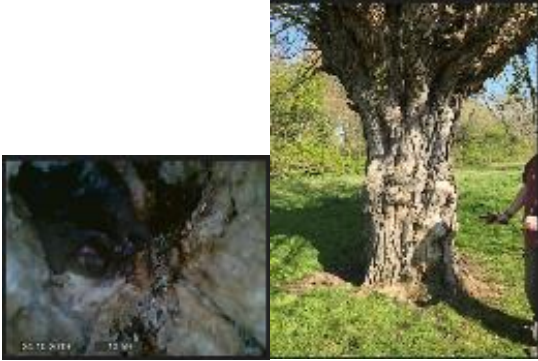
Known or Predicted Roost, Impact and Structure (if known)	Roost Type	Roost Photos	Roost location and dimensions	Compensatory Requirements
<p>Loss of Tree 496</p>	<p>Barbastelle transitional roost</p>

<p>Mature willow tree with a small knot hole on the south east aspect, 1m high. The knot hole was very shallow, no deeper than 10 cm.</p>	<p>One tree roosting feature in the northern quadrant.</p>
<p>Temporary disturbance of Tree 86</p>	<p>Natterer's day roost</p>

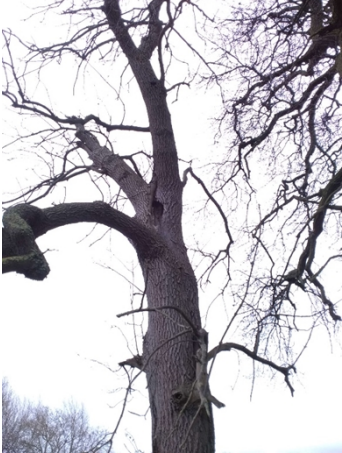
<p>Dead ash tree. Roost location and dimensions unknown.</p>	<p>Three tree roosting feature in the southern quadrant.</p>

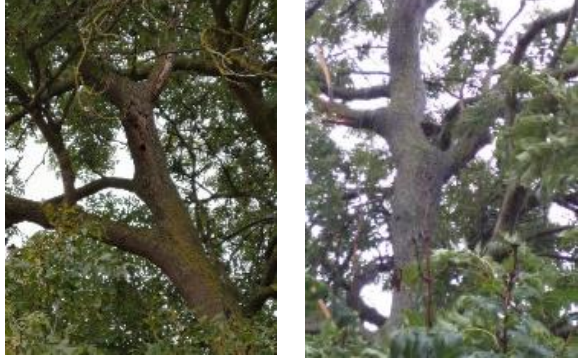
<p>Tree 576, a mature ash tree had a woodpecker hole 8m high extending inwards approximately 20 cm which was found to have a single noctule bat present in August 2020.</p> <p>Tree 578, an over mature ash tree had a woodpecker 10 m high extending upwards 8 cm and back and down approximately 40 cm which was found to have a single noctule present in August 2020 and three noctule bats present in September 2020.</p>	Two tree roosting features in the western quadrant.
