A46 Newark Bypass

Appendix 9.1 A46 Newark Northern Bypass Preliminary Sources Study Report Part 1

APPENDIX 9.1 A46 NEWARK NORTHERN BYPASS PRELIMINARY SOURCES STUDY REPORT

A46 Newark Northern Bypass Preliminary Sources Study Report HAGDMS No: 32224 09/02/21

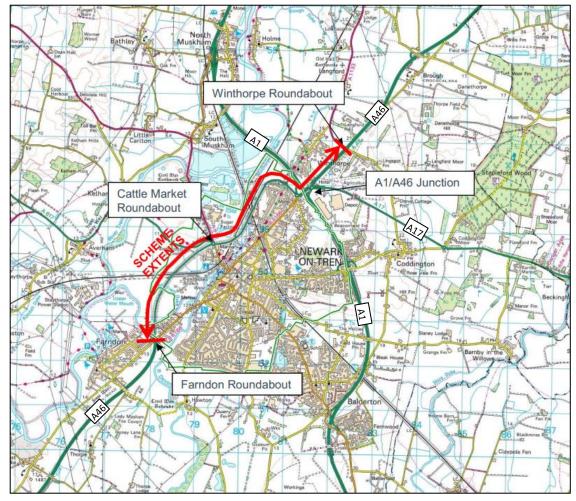
Figure 1-1: Scheme Extents

The site is located along a section of the existing A46, northwest of Newark on Trent, with the extents of the scheme being shown in Figure 1-1. The section of the existing A46 carriageway under consideration is approximately 6.5km in length., with the proposed scope entailing the widening of the A46 between Farndon Roundabout and Winthorpe Roundabout. The scope also includes widening of associated infrastructure where the route crosses the railway line (Nottingham-Lincoln line) and the River Trent, twice.

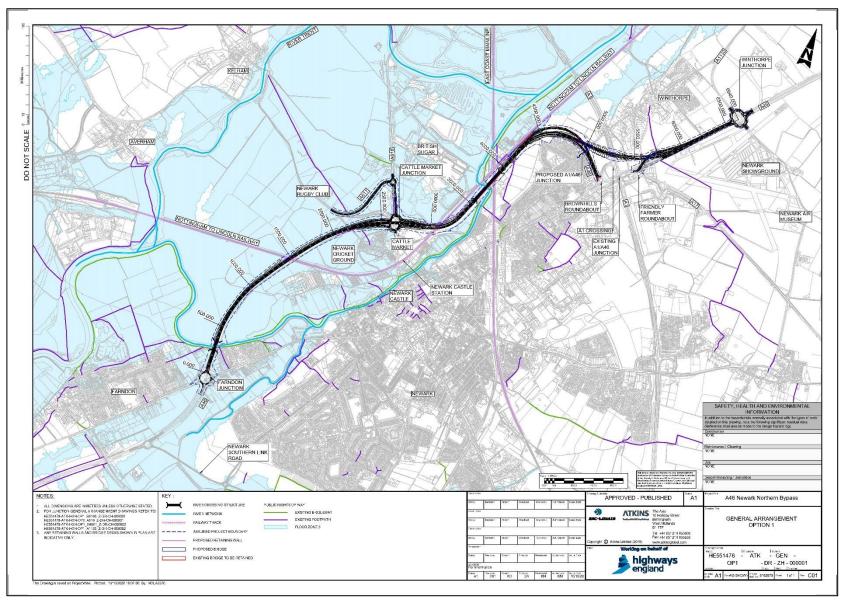
Figure 1-2: Option 1 Layout Plan

The scheme comprises two principal solutions, Option 1 and Option 2, as presented in Figure 1-2 and Figure 1-3. Table 1-1 summarises the key

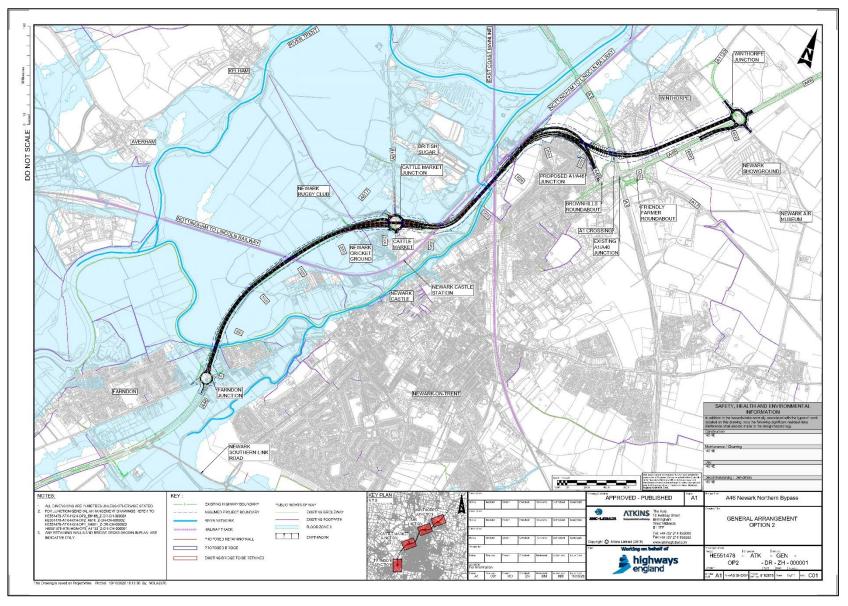
Figure 1-3: Option 2 Layout Plan

Farndon Junction would be signalised in Option 2 to improve flows on the roundabout during peak hours. The general layout of the junction would not be changed.

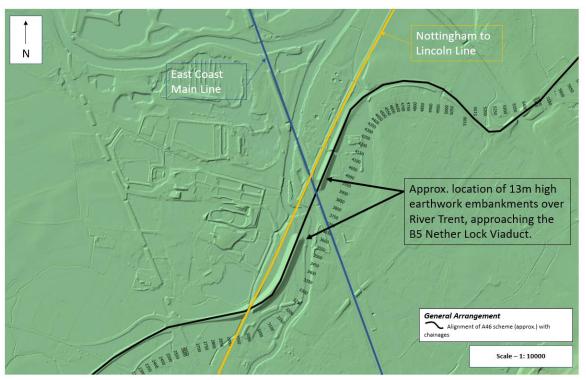
The current earthworks predominantly consist of embankments (up to 13m high, slopes 1:2.5 [12]), with some areas at grade in proximity to roundabouts and north of approximate project chainage 4500, as highlighted in the LiDAR map [17] in Figure 3-1.

Figure 3-1: LiDAR (Open source) highlighting the location of the 13m high earthwork embankments, approaching the B5 Nether Lock Viaduct.

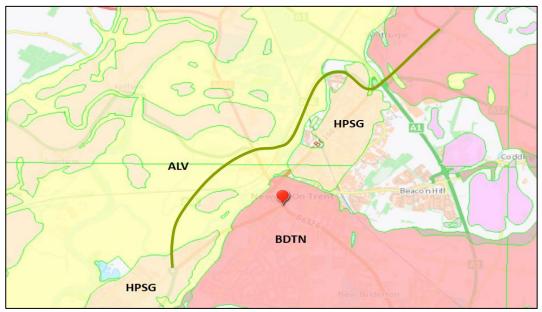
The following Superficial Deposits are indicated by BGS Onshore GeoIndex [4] and presented in Figure 3-2. The general descriptions of the materials have been taken from the BGS Lexicon [5].

Figure 3-2. Superficial Deposits (Source: BGS GeoIndex, October 2020)

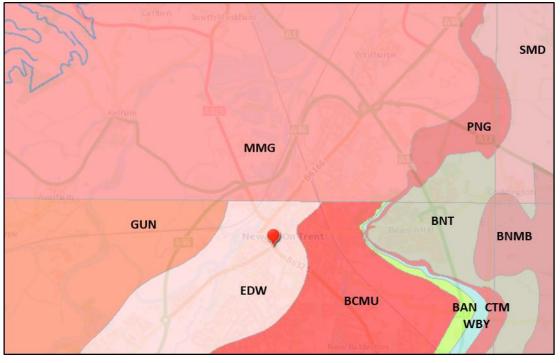
The following Solid Geology is presented in Figure 3-3. The general descriptions of the materials have been taken from the BGS Lexicon [5].

Edwalton Member Mudstone (EDW), Gunthorpe Member Mudstone (GUN), and Branscombe Mudstone (BCMU) indicated in Figure 3-3, are part of Mercia Mudstone Group (MMG).

Figure 3-3: Solid Geology. Letters refer to BGS geology codes. (Source: BGS Geolndex, October 2020)

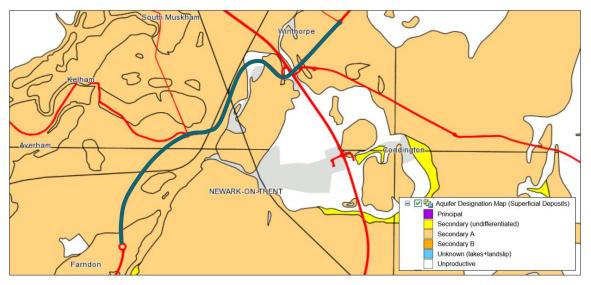
The HAGDMS website [12] indicates that the Superficial Deposits are designated as Secondary A Aquifers, as indicated in Figure 3-4. The Environment Agency [6] provides designation for Secondary A Aquifer: 'Permeable layers capable of supporting water supplies at a local rather than strategic scale, and in some cases forming an important source of base flow to rivers. These are generally aquifers formerly classified as minor aquifers'.

Figure 3-4: Aquifers – Superficial Deposits (Source: HAGDMS, November 2020)

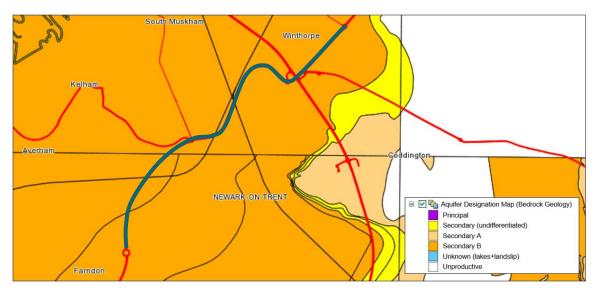
Bedrock formations are designated as Secondary B Aquifers, as indicated in Figure 3-5. The Environment Agency [6] provides designation for Secondary B Aquifer: 'Predominantly lower permeability layers which may store and yield limited amounts of groundwater due to localised features such as fissures, thin permeable horizons and weathering. These are generally the water-bearing parts of the former non-aquifers'.

Figure 3-5: Aquifer Designation Map – Bedrock Geology (Source: HAGDMS, November 2020)

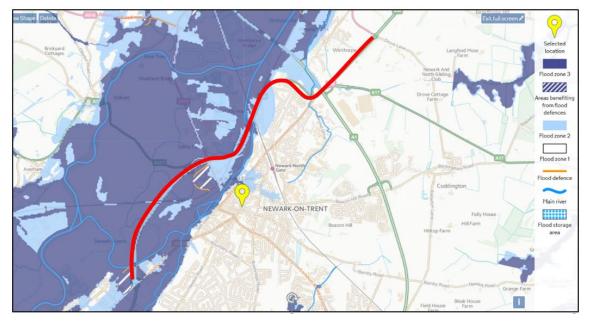
The Flood Map for Planning [7] indicates the area in the vicinity of the River Trent and its tributaries is designated as 'Flood Zone 3' which has a high probability of flooding (>1 in 100 or greater annual probability). The A46 Newark Northern Bypass scheme passes through this zone between Farndon Roundabout and A1/A46 Junction, as indicated in Figure 3-6.

Figure 3-6: Fluvial Flooding Risk Map (Source: The Flood Map for Planning [7], October 2020)

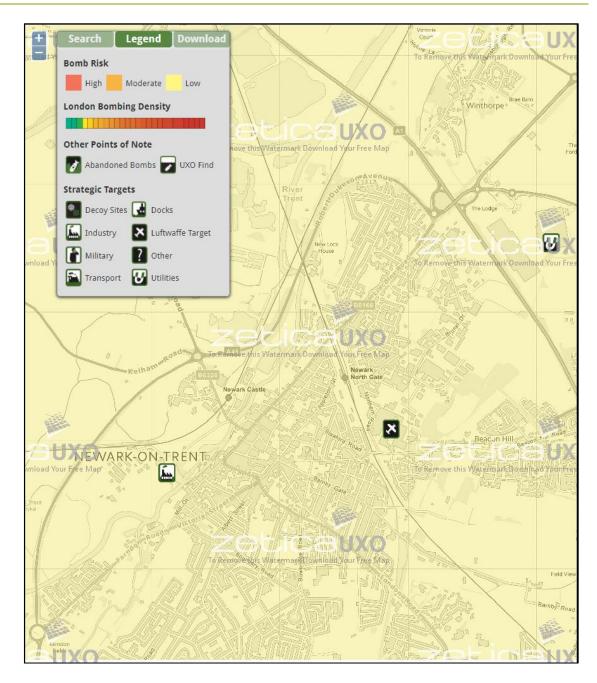
Zetica has produced freely available risk maps [11] indicating the potential risk of air dropped World War Two unexploded ordnance (UXO) to be present on the site. The mapping classifies the ground directly underlying the site as 'Low Risk' with less than 15 surveyed bomb strikes per 1000 acres, as shown in Figure 3-7 below.

Figure 3-7: Unexploded Ordnance Risk Map (Source: Zetica [11])

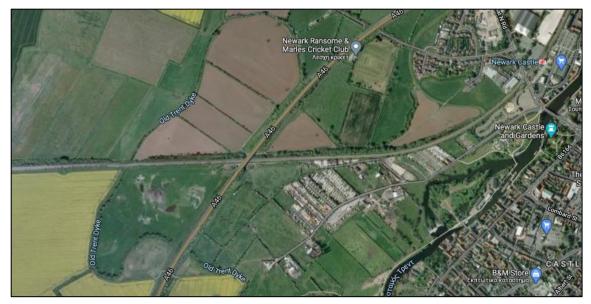
A46 crosses via overbridges the national railway in two sections (Nottingham – Lincoln rail line and East Coast railway) as shown in Figure 3-12 and Figure 3-13 below.

Figure 3-12: A46 crossing Nottingham - Lincoln rail line

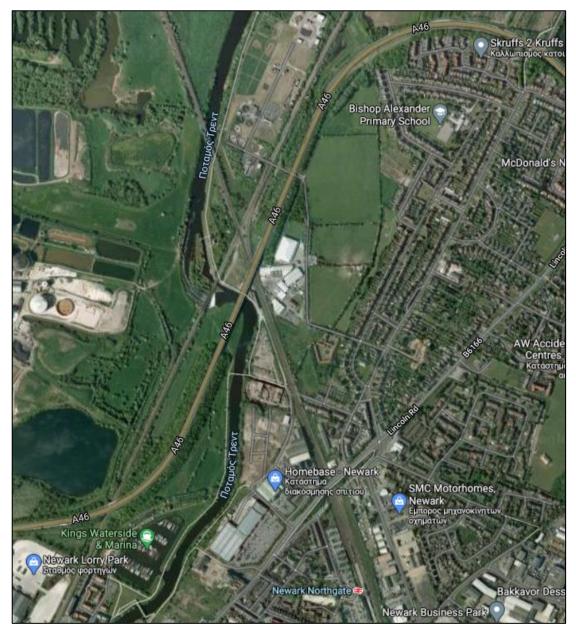
Figure 3-13: A46 crossing East Coast Railway and viaduct over River Trent As shown in Figure 3-13, there is also a viaduct crossing River Trent.

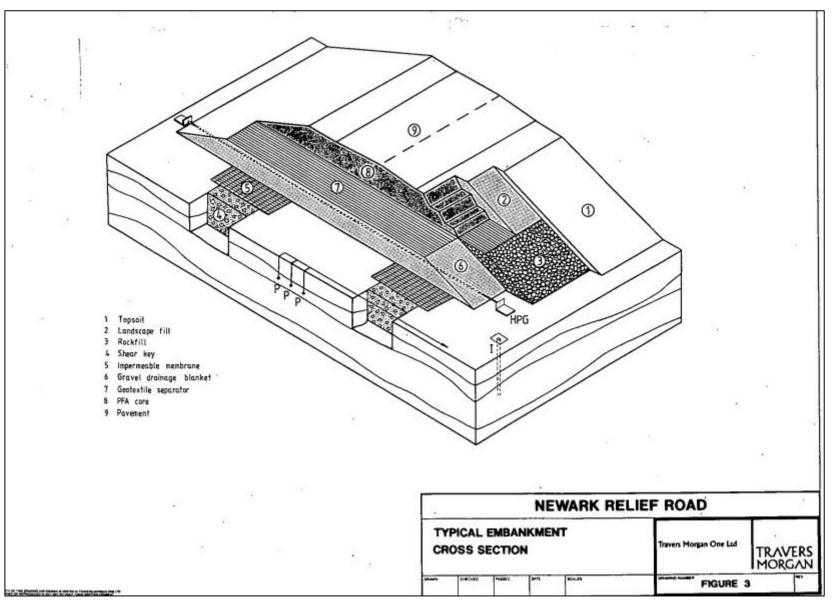
The Geotechnical Feedback Report for A46 Newark Relief Road [16] presents design sections of Earthworks. These are collated in Appendix C and a typical embankment cross section is provided in Figure 3-14 below.

Figure 3-14: Typical Embankment Cross section [16]

Figure 3-14 in Section 3.14, Existing Earthworks, demonstrated the presence of PFA at the core of the existing embankment in some sections. PFA has been widely used as fill material in the construction of earthwork, and therefore the behaviour of working with PFA is well understood. However, there is a likelihood that the PFA is either not cemented or there are only few cemented layers within the body of PFA. Exposing layers of PFA that has not been fully cemented can result in localised material loss.

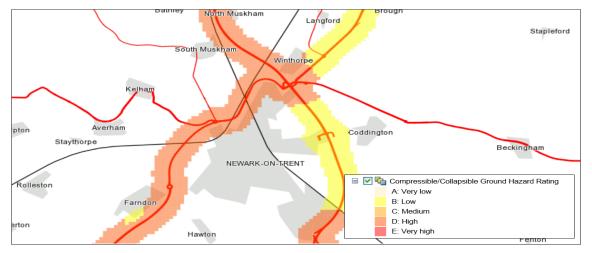
Figure 3-15 Compressible/Collapsible Ground Rating (Source: HAGDMS [12], November 2020)

Feature	Summary
Compressible/Collapsible Deposits	The scheme falls under Class D: "High" hazard rating with a significant potential for compressible problems (Figure 3-15). The area in the vicinity of Winthorpe Roundabout is classified as Class B: "Low" hazard rating. The 1983 Geotechnical Report describes a deep channel of very
	soft clay at Nether Lock, which is considered to be " <i>unique within the context of the A46</i> ". The channel is described as 150m wide and at least 6m deep [13].
Natural Landslides	The natural landslides hazard falls under Class B: "Low" to Class C: "Medium" for the majority of the scheme. The area between Cattle Market Roundabout and the railway crossing falls under Class D "High" category (Figure 3-16).
Landfill Sites	The area between the existing Cattle Market Roundabout and the railway crossing on the north-east falls under Class A: "Low" hazard rating. No data present for the rest of the scheme (Figure 3-17).

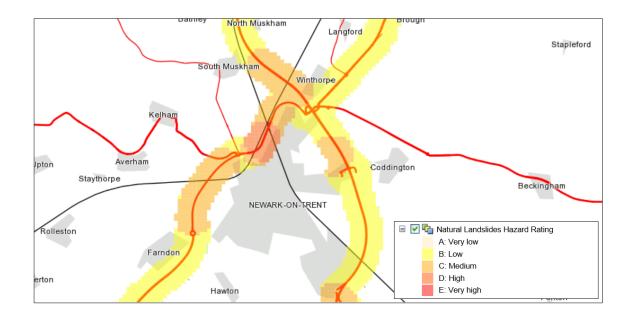
Figure 3-16 Natural Landslides Hazard Rating (Source: HAGDMS [12], November 2020)

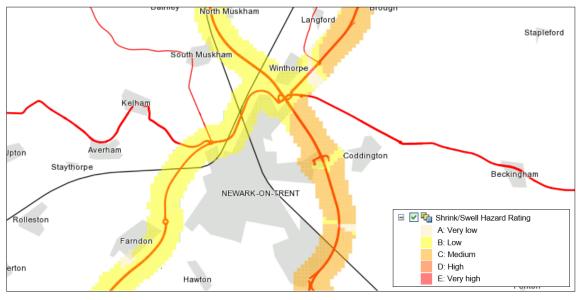
Figure 3-18: Shrink/Swell Hazard Rating (Source: HAGDMS [12], November 2020)

Swelling and Shrinkage	The area falls under Class B: "Low" hazard rating (Figure 3-18).
Slope Hazard Rating	The majority of the area between the existing Farndon Junction and A1/A46 Junction falls under "Low" hazard rating. The slope hazard rating at the railway crossing is "Very High". No rating assigned to the area between A1/A46 Junction and Winthorpe Roundabout as it is at grade (Figure 3-19).
Dissolution Features Hazard	The dissolution features hazard rating falls under Class A: "Very Low" (Figure 3-20).
Coal Mining Hazard	The scheme falls under hazard Class A: "Outside coalfield area" category (Figure 3-21).
Non-Coal Mining Hazard	The majority of the area has no hazard rating assigned. The area in the vicinity of the railway crossing falls under Class E: "Very High" category (Figure 3-22).
Historic Borrow Pits	The 1985 Geotechnical Report [13] identifies that the A46 Newark Relief Road crosses historic borrow pits used for construction of the Great North Road. There are potentially infilled borrow pits associated with construction of the existing A46.

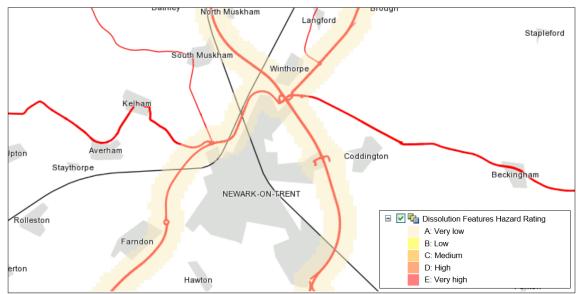
Figure 3-20: Dissolution Features Hazard Rating (Source: HAGDMS [12], November 2020)

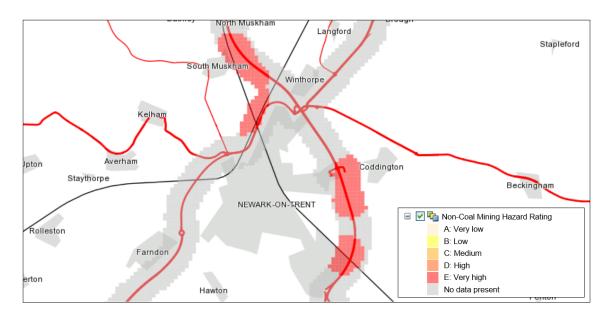
Figure 3-22: Non-Coal Mining Hazard Rating (Source: HAGDMS [12], November)

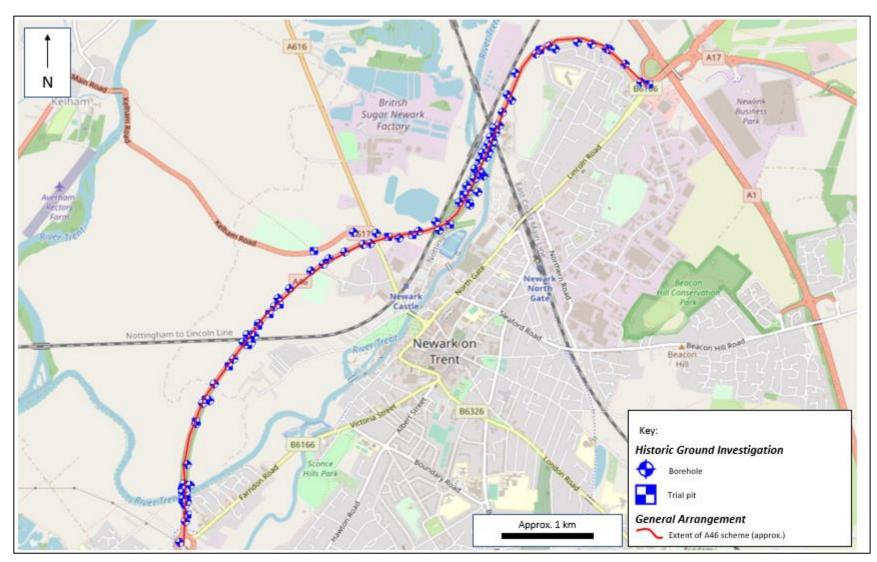
Plan and long sections generated using OpenGround are presented in Figure 4-1 to Figure 4-3 below.

Figure 4-1. Plan of historic boreholes (digitised in OpenGround)

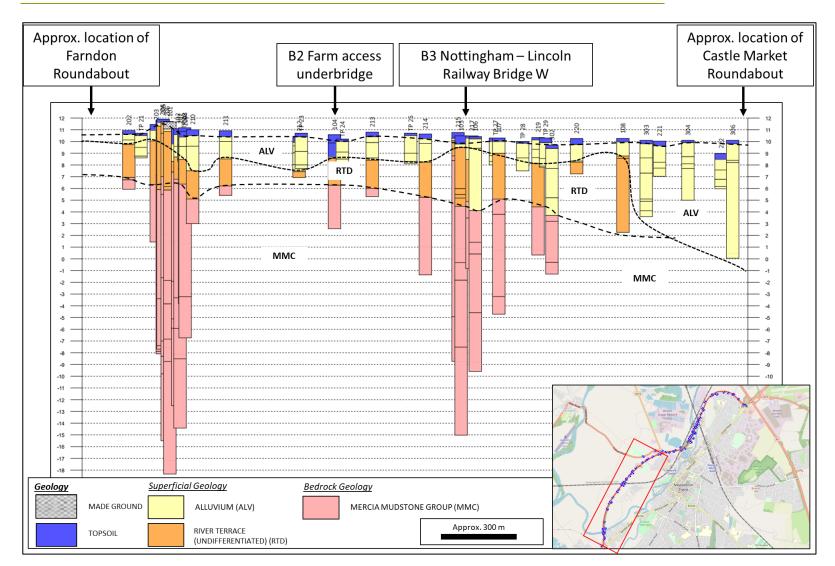
Figure 4-2. Geological Section 1 of 2 (digitised in OpenGround)

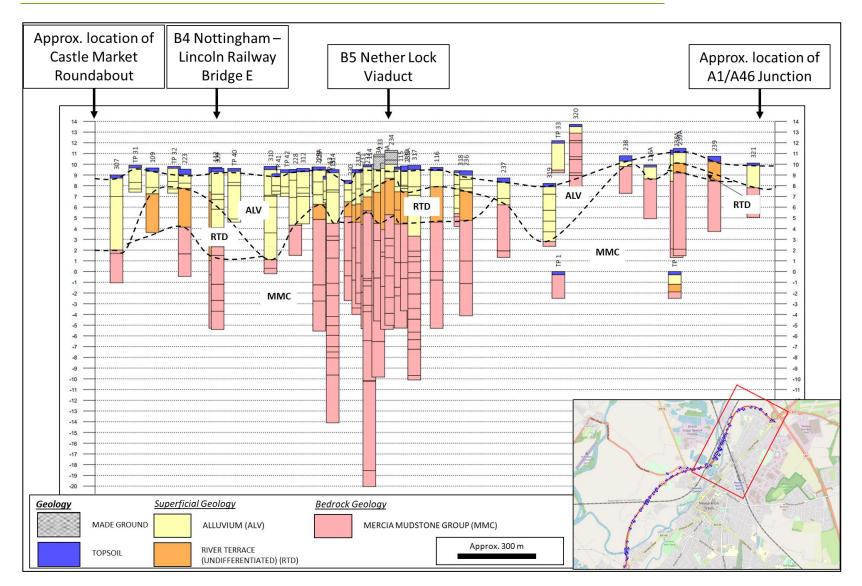
Figure 4-3. Geological Sections 2 of 2 (digitised in OpenGround)

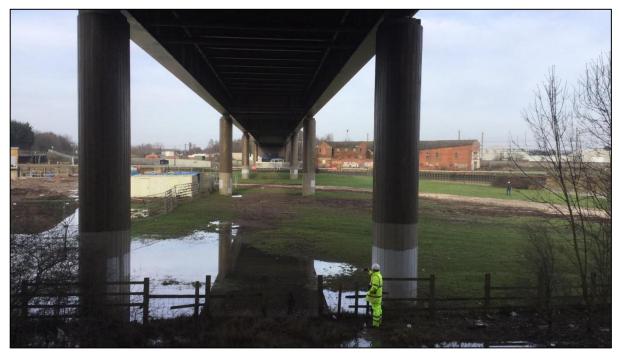
Figure 5-1 – Photograph taken during Atkins Site Walkover beneath A46 viaduct over River Trent / East Coast Main Line

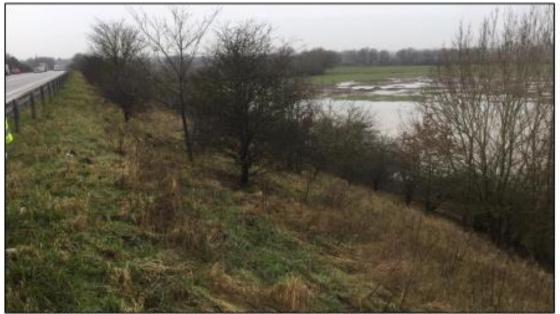
Figure 8 – General earthwork overview, looking south, between River Trent viaduct and Nottingham to Lincoln railway viaduct. Note flooded fields.

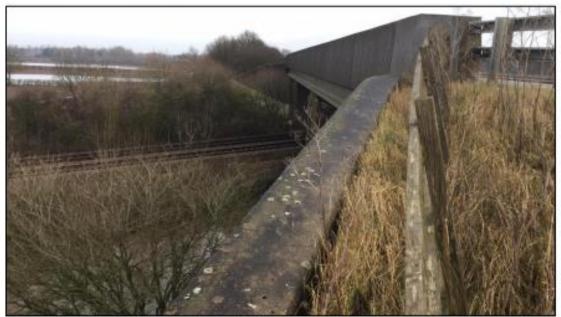
Figure 9 - A46 bridge over Nottingham to Lincoln railway line, Bridge NOB1/53A looking north.

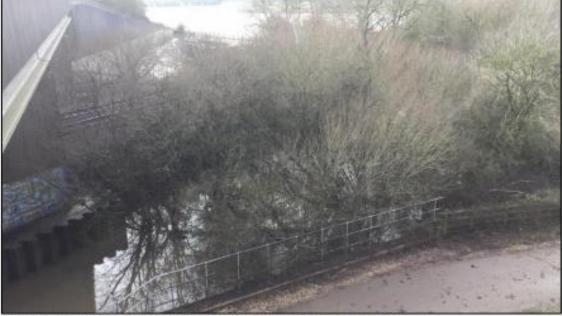
Figure 10 – Looking south, bridge NOB1/53A over Nottingham to Lincoln railway.

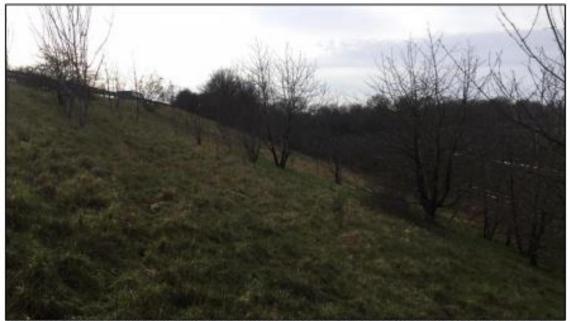
Figure 11 – Typical view of earthworks between Cattle Market roundabout and Nottingham to Lincoln railway, looking south.

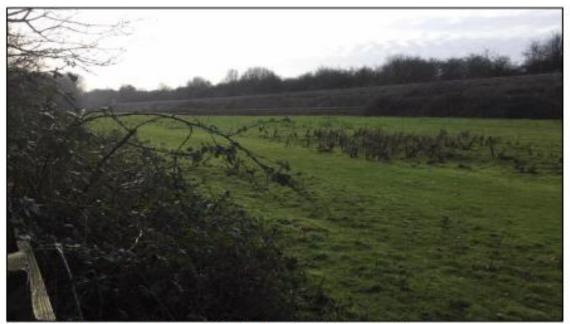
Figure 17 - Field between Nottingham to Lincoln railway line and A46 earthwork looking west.

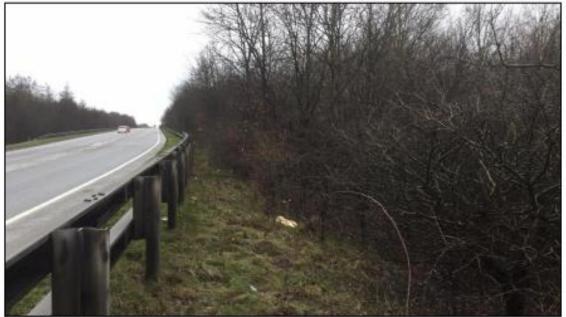
Figure 25 - A46 carriageway looking south towards viaduct over River Trent.

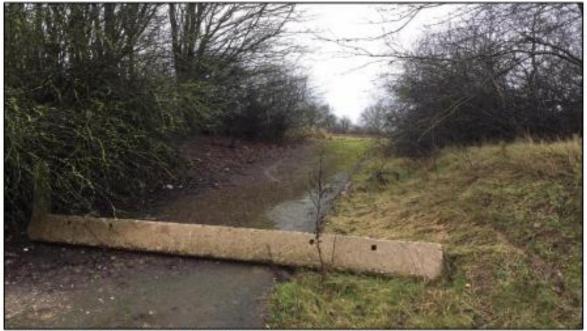
Figure 27 - Potential access from A46 to fields north of road near Bridge House.

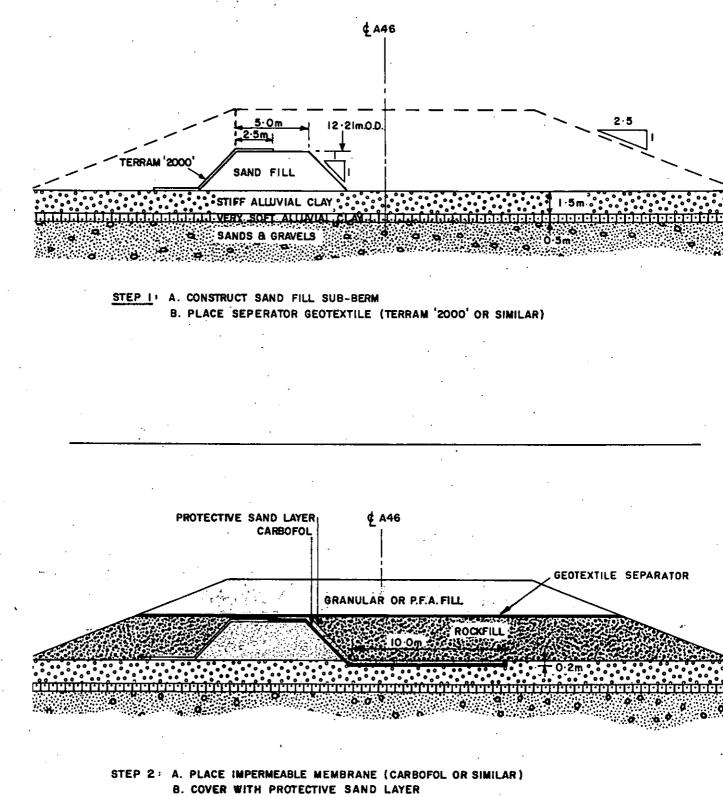
Fig. 16

C. COMPLETE MAIN EMBANKMENT

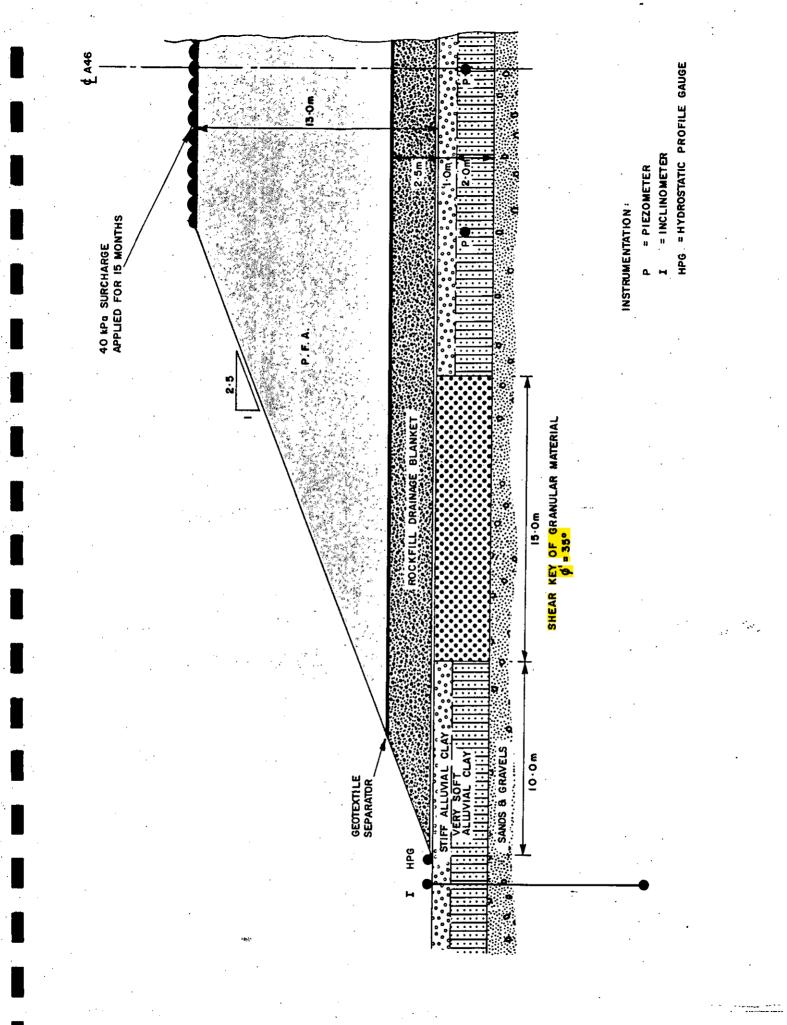
Fig. 18

Recommended method for improving stability, settlements and lateral movements at Nether Lock.

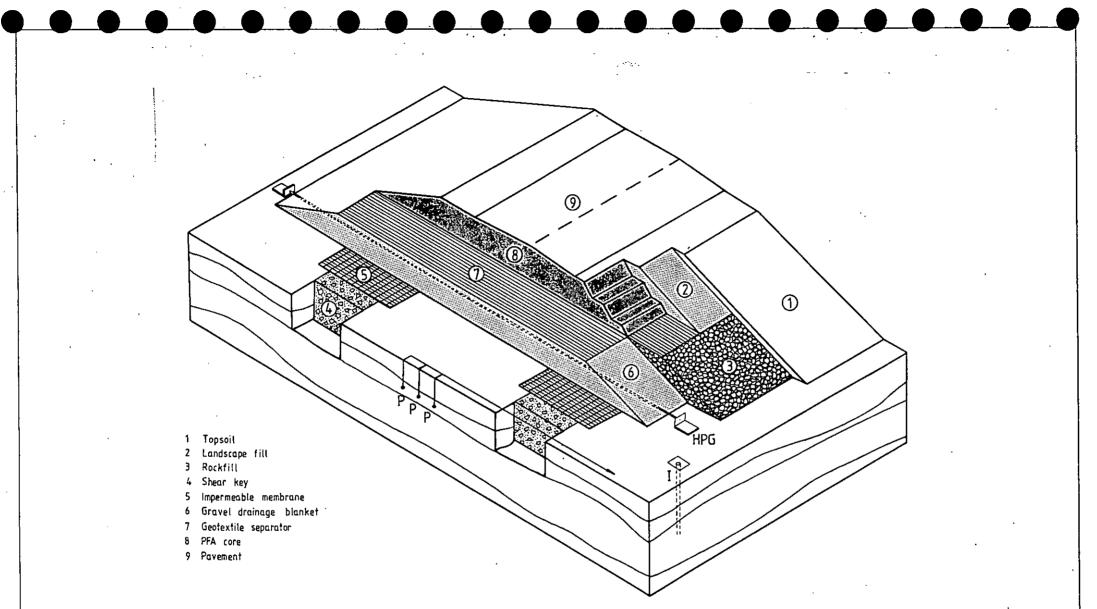
NE	WARK R	ELIEF ROAD	
		EMBAN		NT	Travers Morgan One Ltd	TRAVERS MORGAN
Derman.	CHECKED	PASSED	DATE	SCALES	FIGURE	3
