# MetroWest+

## Portishead Branch Line (MetroWest Phase 1)

**6.25, Environmental Statement, Volume 4, Appendix 11.3 and 11.4 Landscape and Visual Impacts Assessment  
The Infrastructure Planning (Applications: Prescribed Forms and Procedure) Regulations 2009, regulation 5(2)(a)  
Planning Act 2008**

**6.25, Environmental Statement, Volume 4, Appendix 11.3 Visual Impact Assessment**

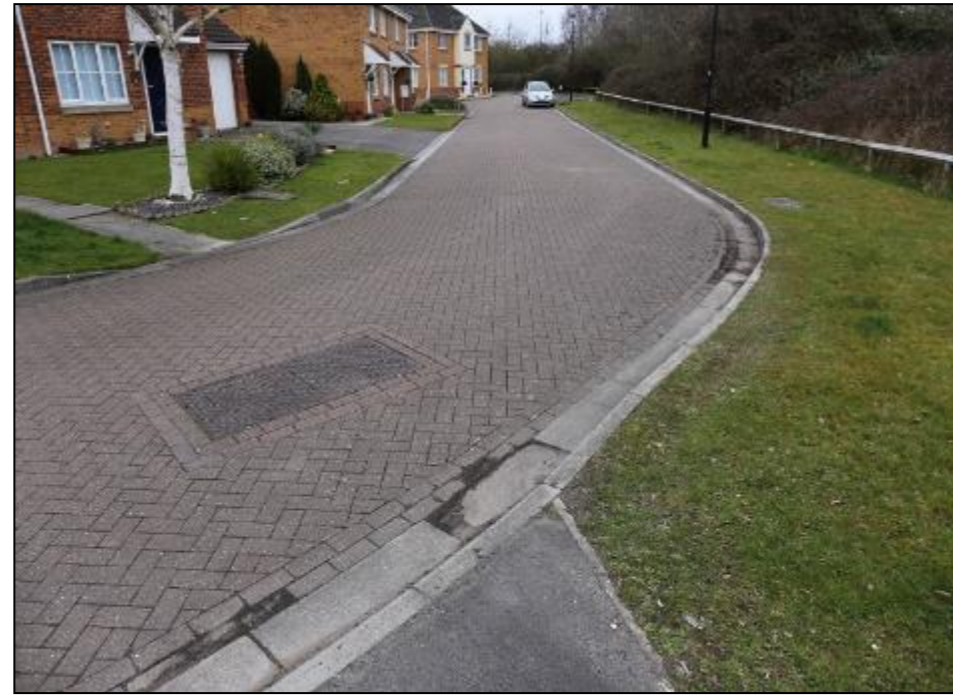
**View 1: Peartree Field - corner of the service cover**

2.1.3 The location of photograph locations is shown on the adjacent photos. The camera positions within the 3D model relate to these locations.

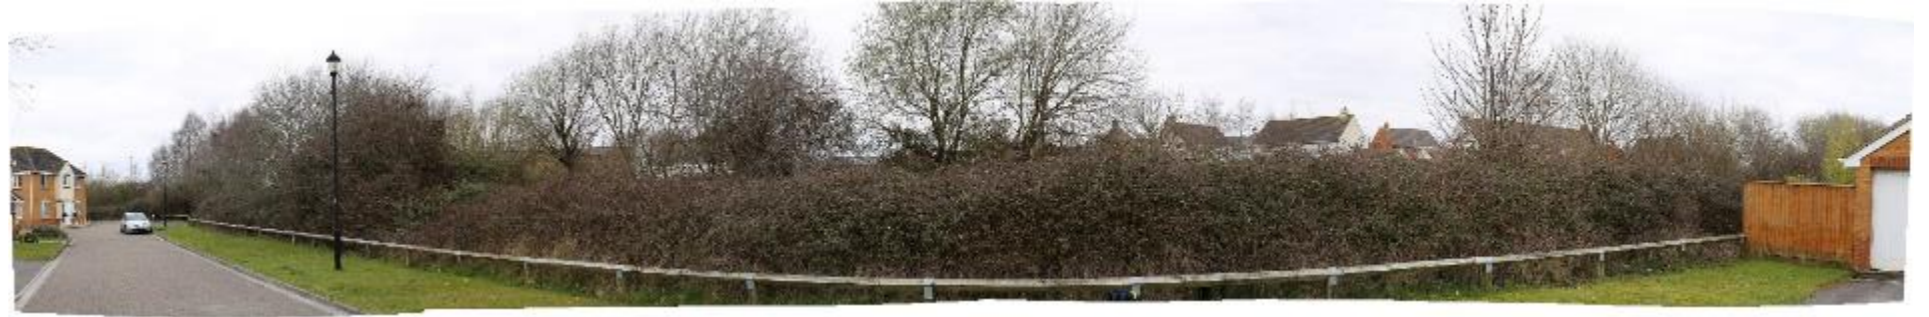
Photo 1

- 2.1.4 The 6 photographs shown on this page and the next are the existing views used as a base for the photomontages.
- 2.1.5 All photos were taken using full frame DSLR camera - Canon EOS 6D with Canon EF 24-70mm lens, set at 50mm. They are panoramas consisting of 5-7 individual photos. Adobe Photoshop CC was used to stitch the photos together using Photomerge.

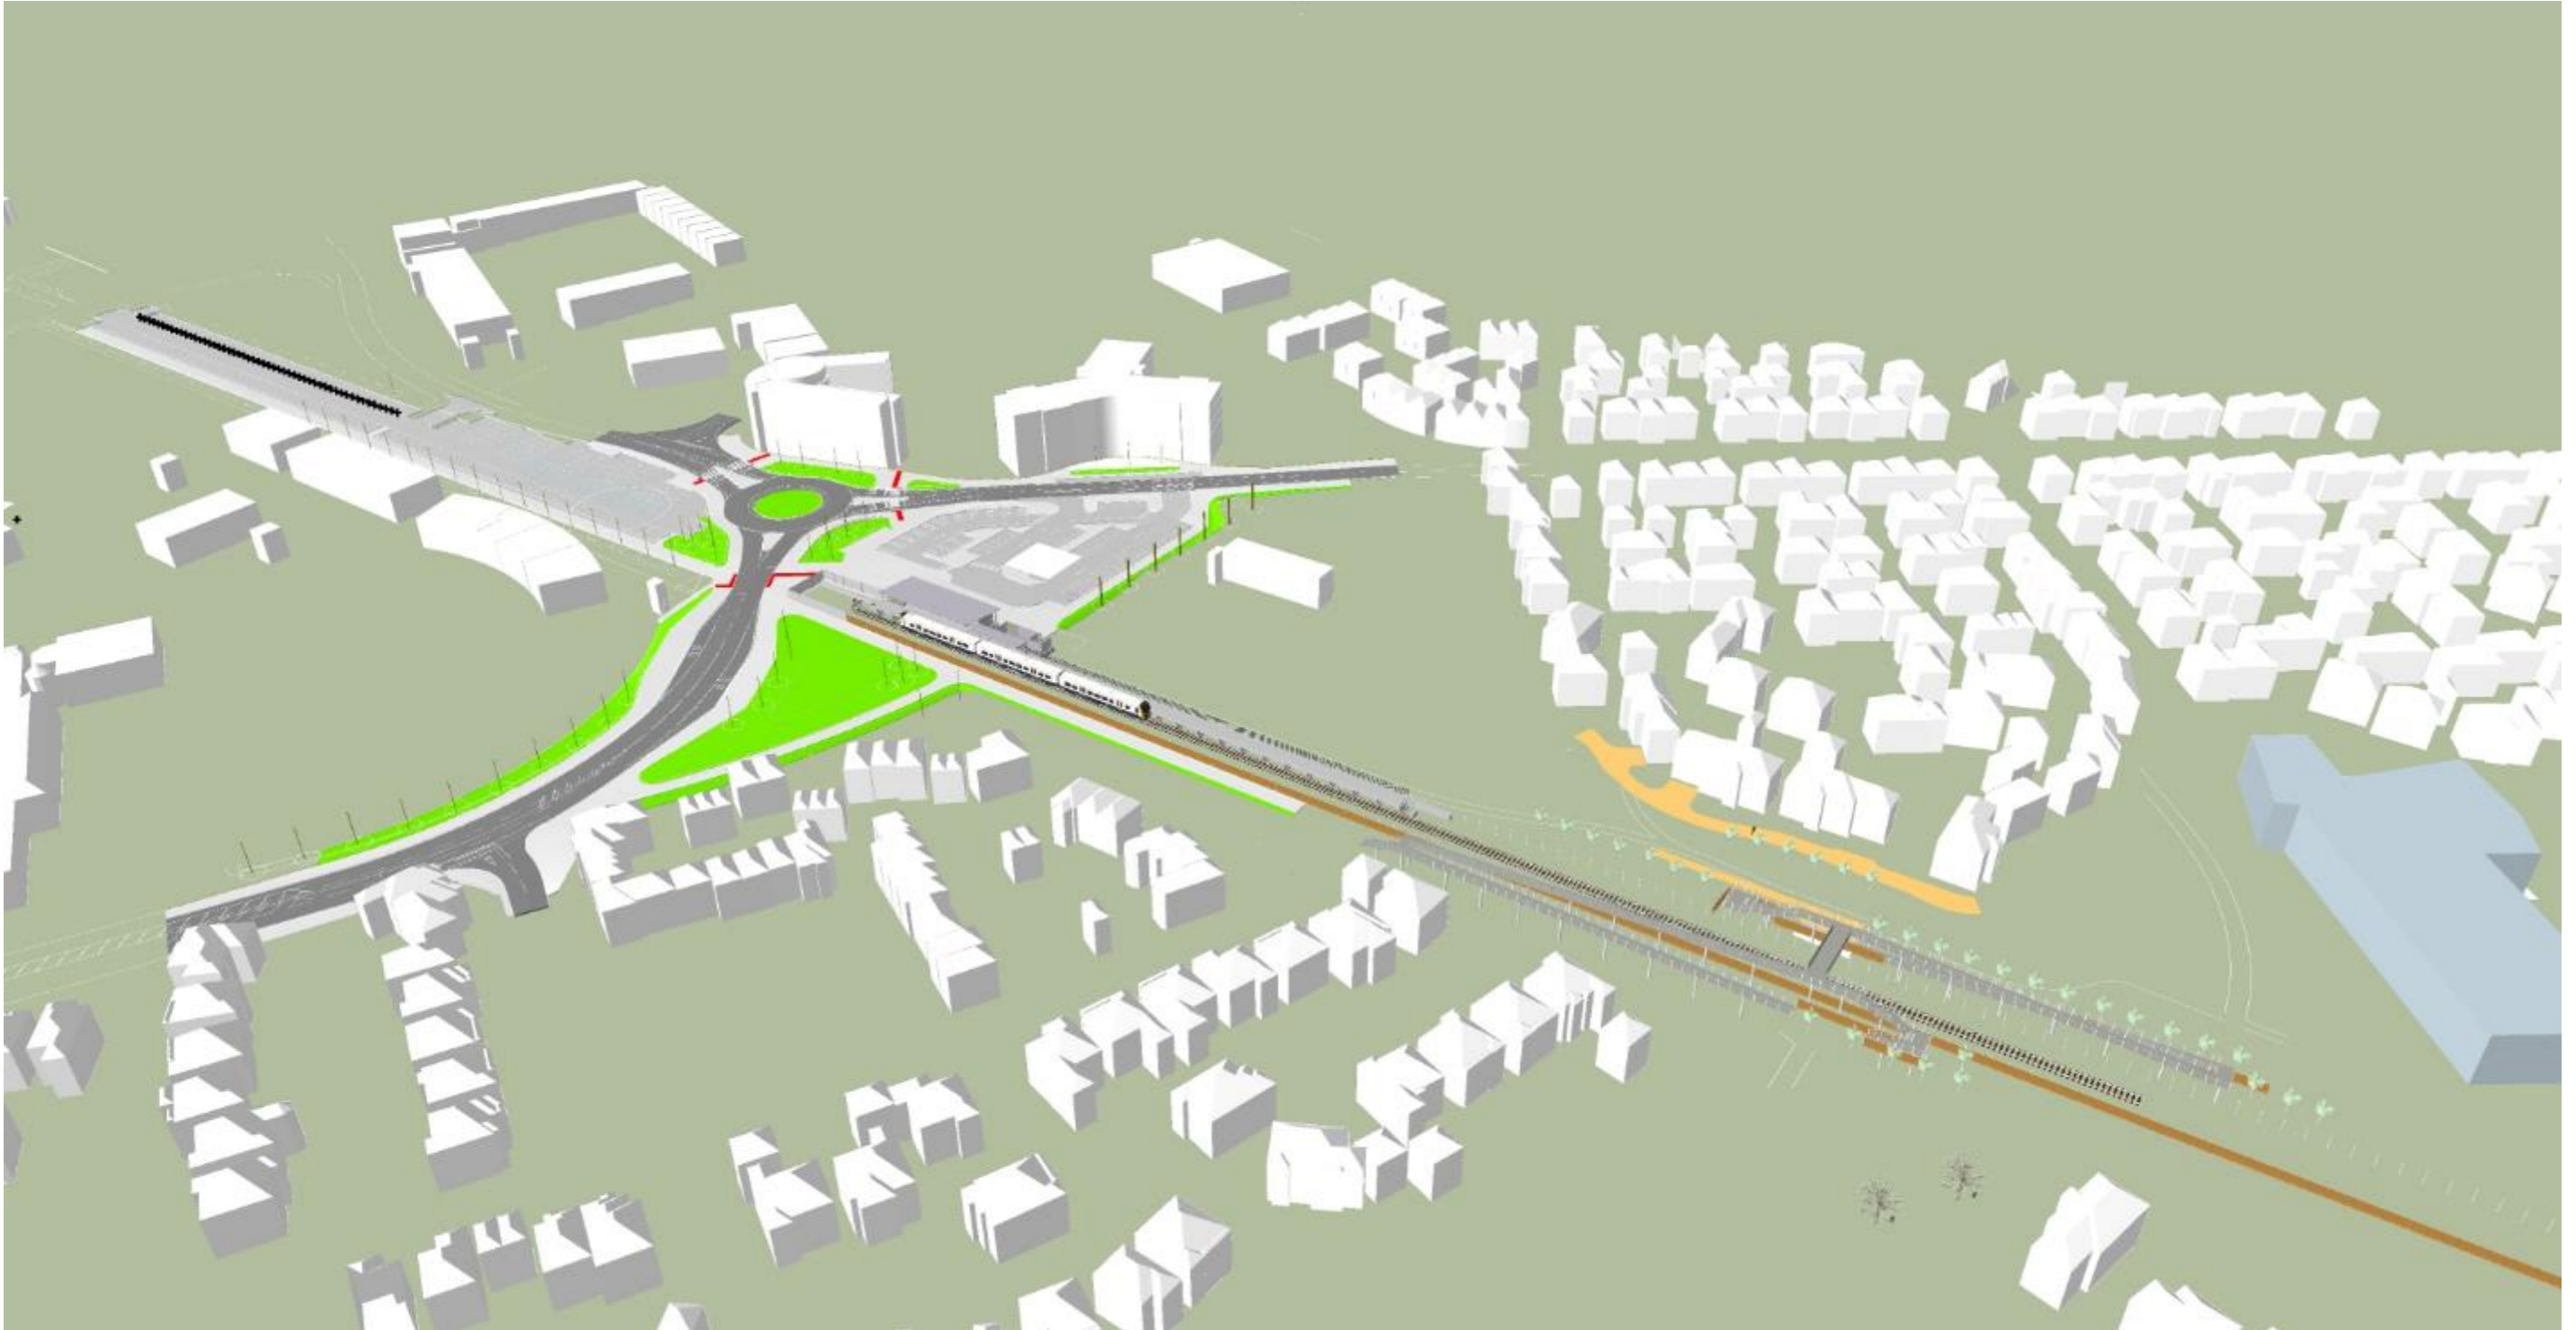
2.2.2 The image below shows the 3D model creation in progress. In this stage, the station model, surrounding buildings, bus stops, and street furniture have been added. The proposed trees have been marked as a vertical line as a reference point for the rendering stage. Surrounding buildings have been added for reference, taken from GIS data which gives correct X and Y coordinates, however the Z coordinate (building height) is an interpretation and therefore should not be considered as exact.

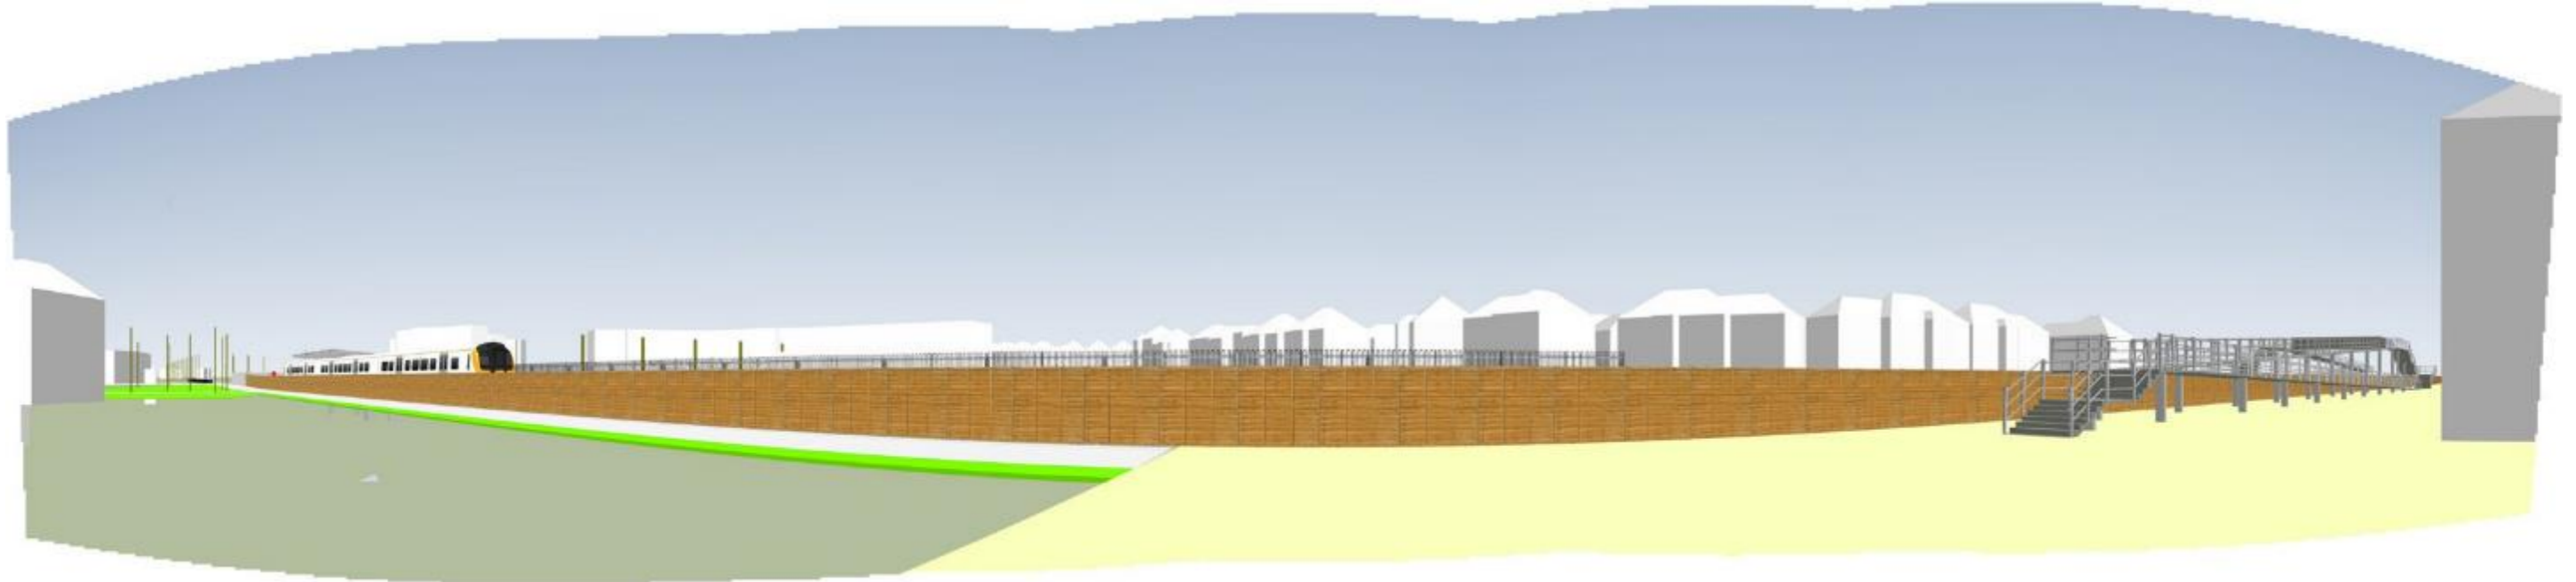
2.3.1 The final stage of creating the 3D model involved setting up camera locations within the model so that the model image output matches with the existing photograph.

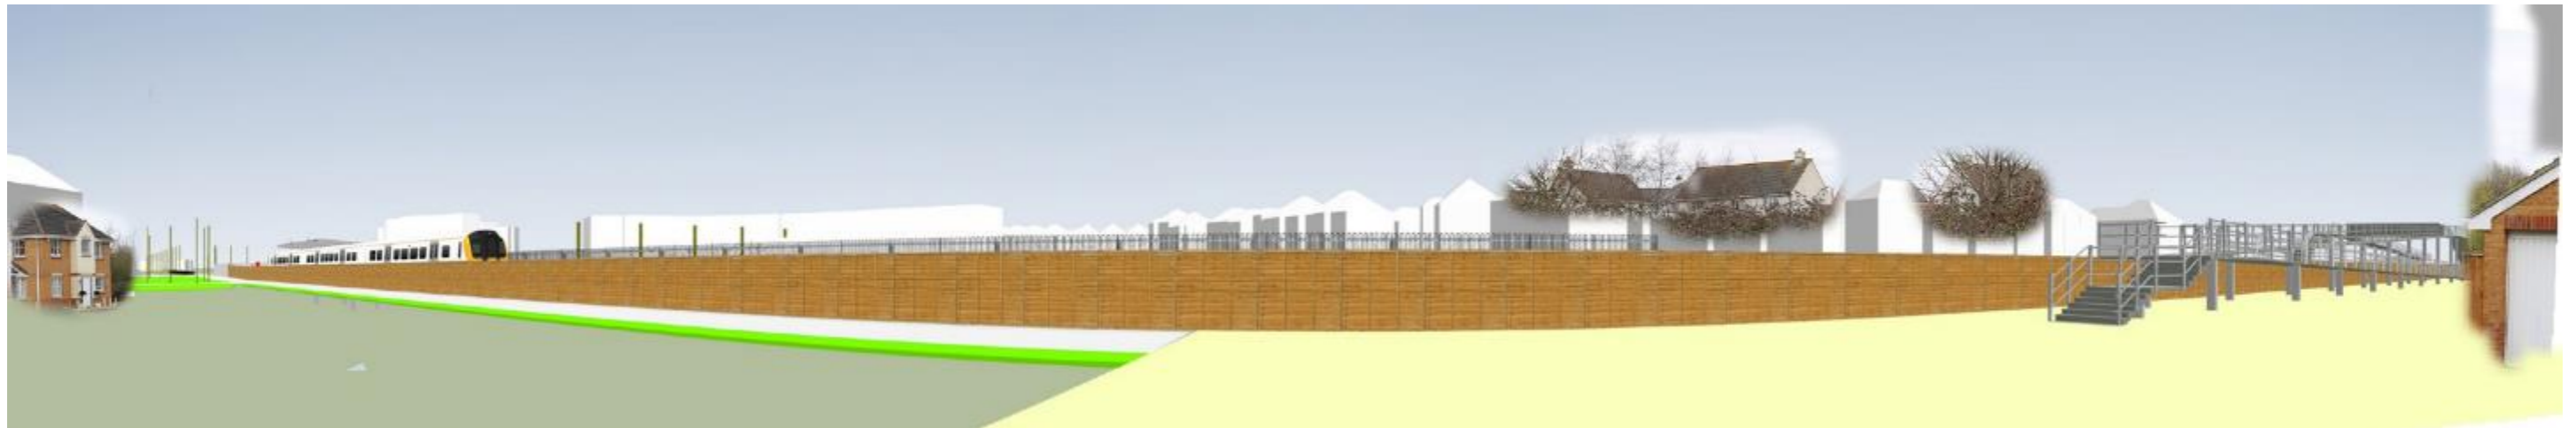
2.3.2 The existing photograph and image from the final stage of the model rendering were matched in Photoshop to prove that the rendered image from the 3D model is the correct size and location in relation to the photograph. As noted above, some of the vertical matching is not accurate due to the estimating of building heights within the 3D digital model.

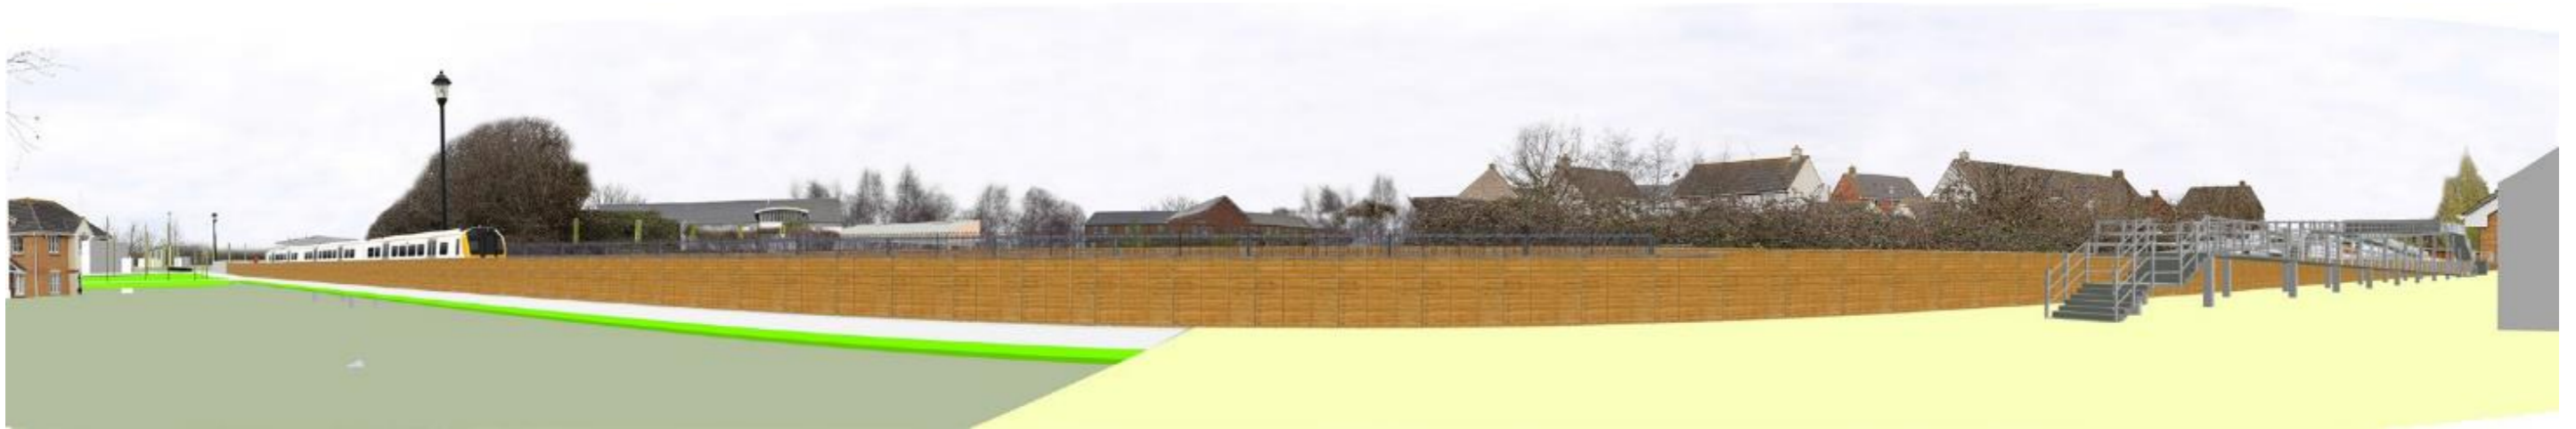
2.3.3 Photomontage stage in progress exposing background information in the photograph whilst retaining model components.

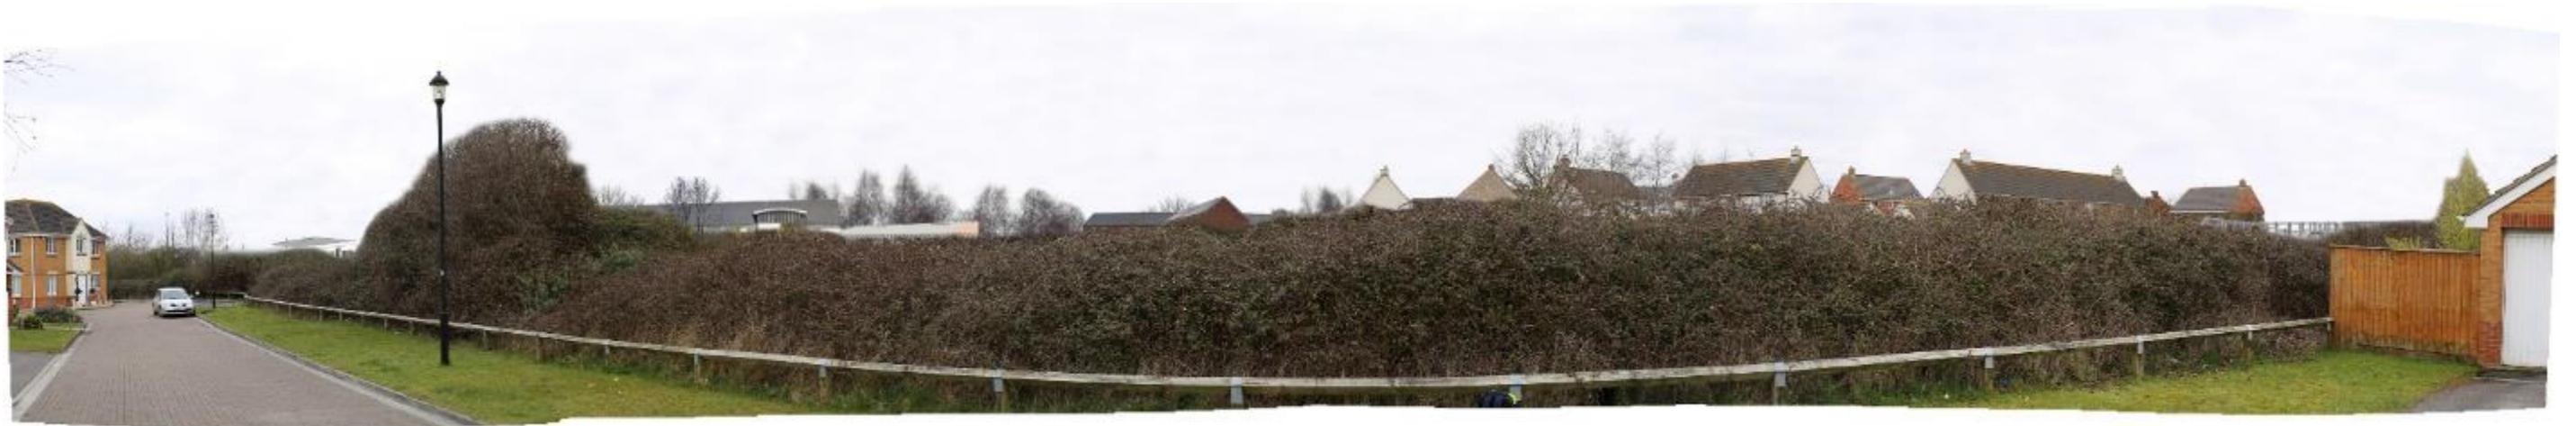
2.3.4 Photomontage 1 with foreground vegetation retained and estimated vegetation losses shown revealing more of the buildings behind.

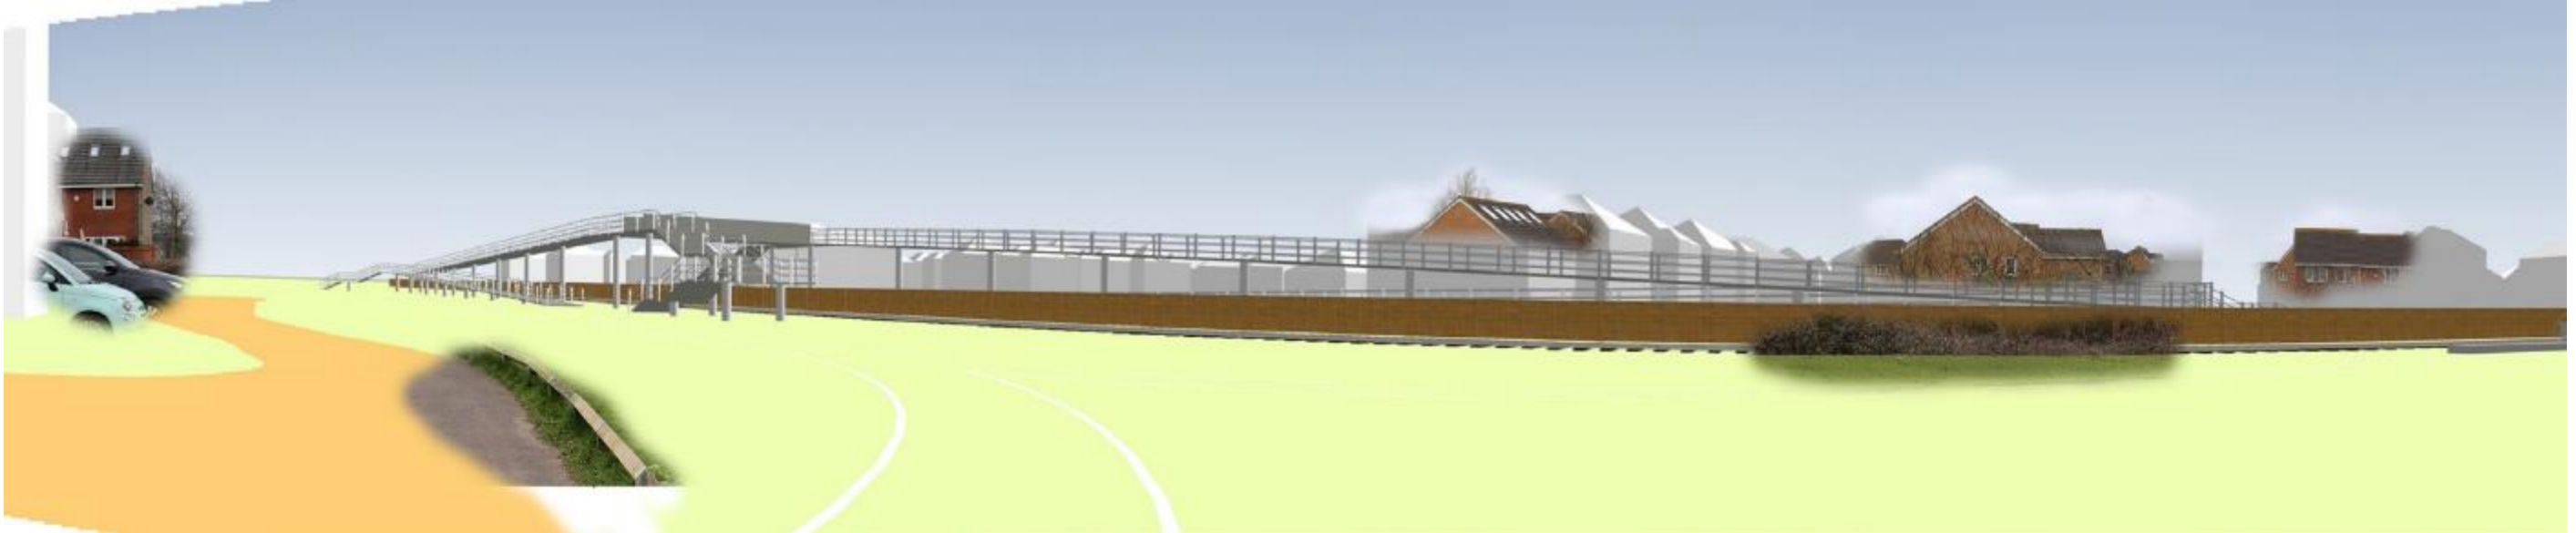
2.4.2 The image below shows the SketchUp rendered image being matched on top of the existing photograph in Photoshop with some of the render image being removed to expose existing buildings and kerbs underneath to match features.

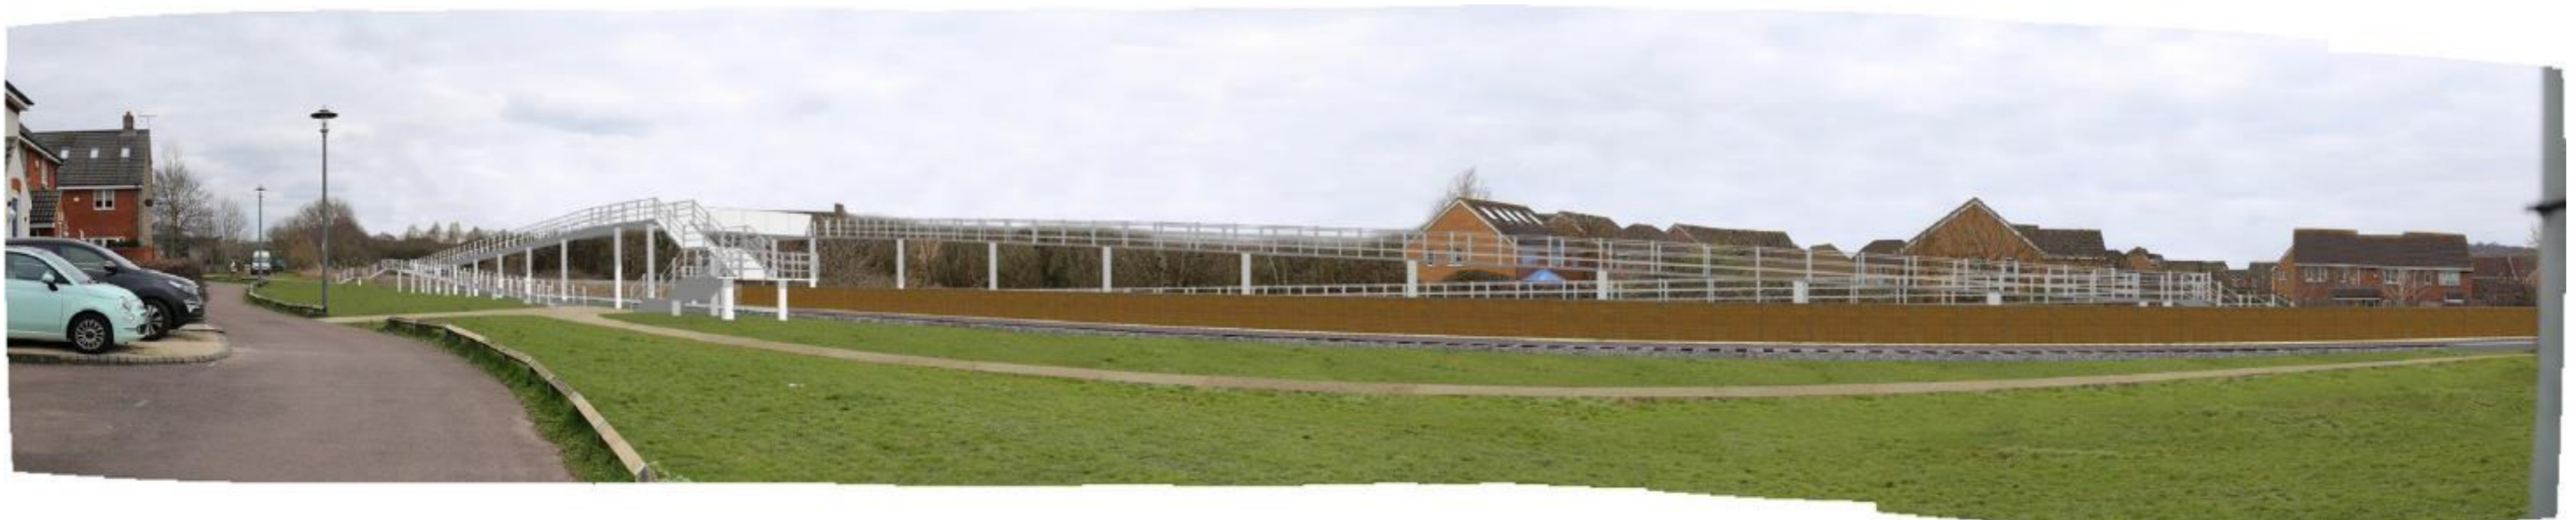
2.4.3 Photomontage in progress stage.

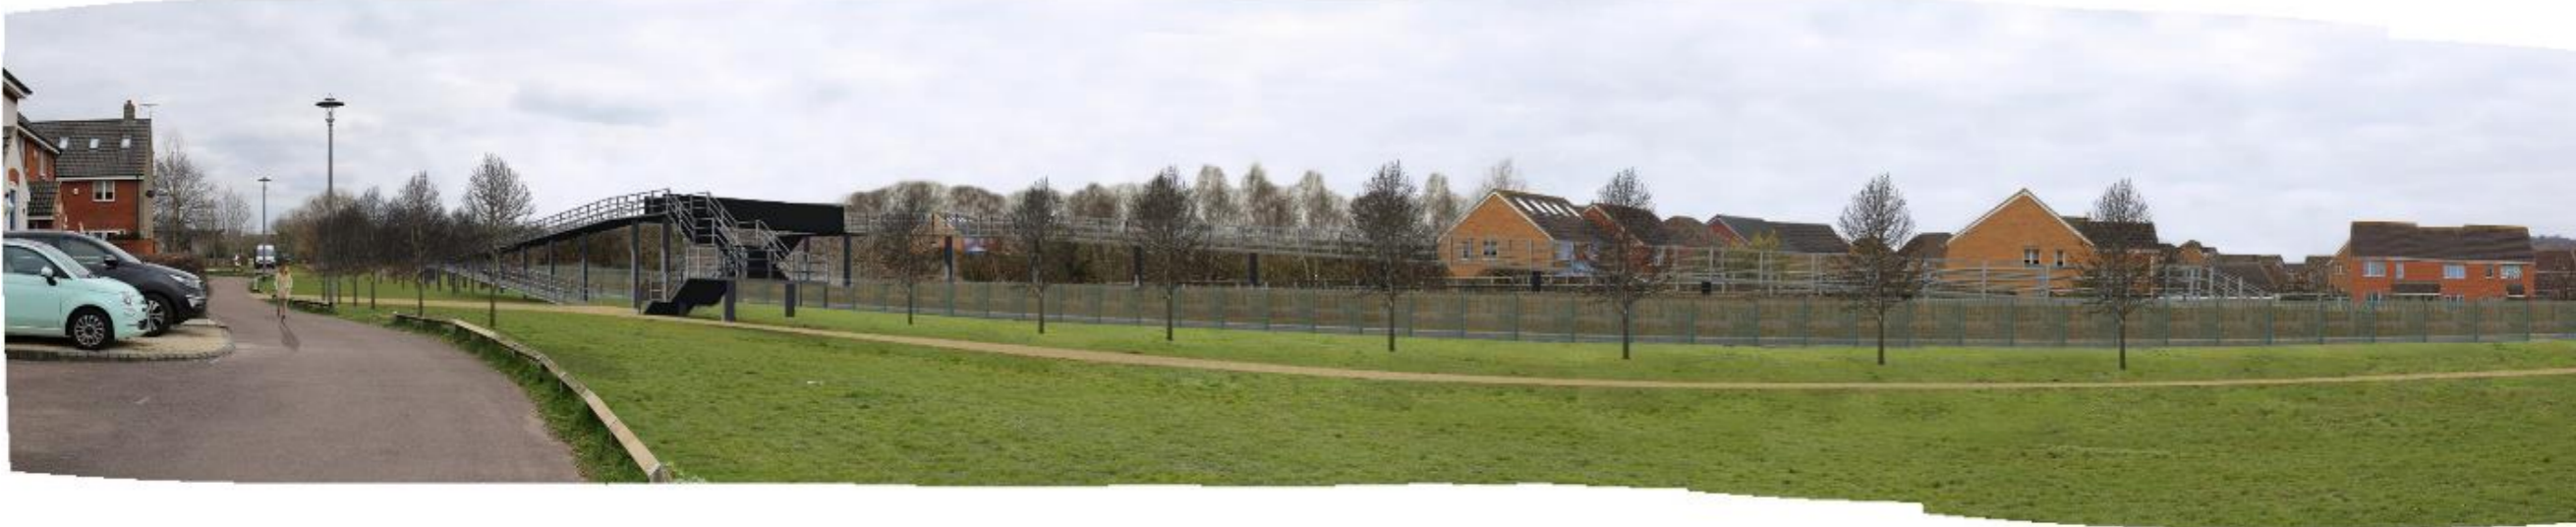
2.4.4 Final photomontage stage.

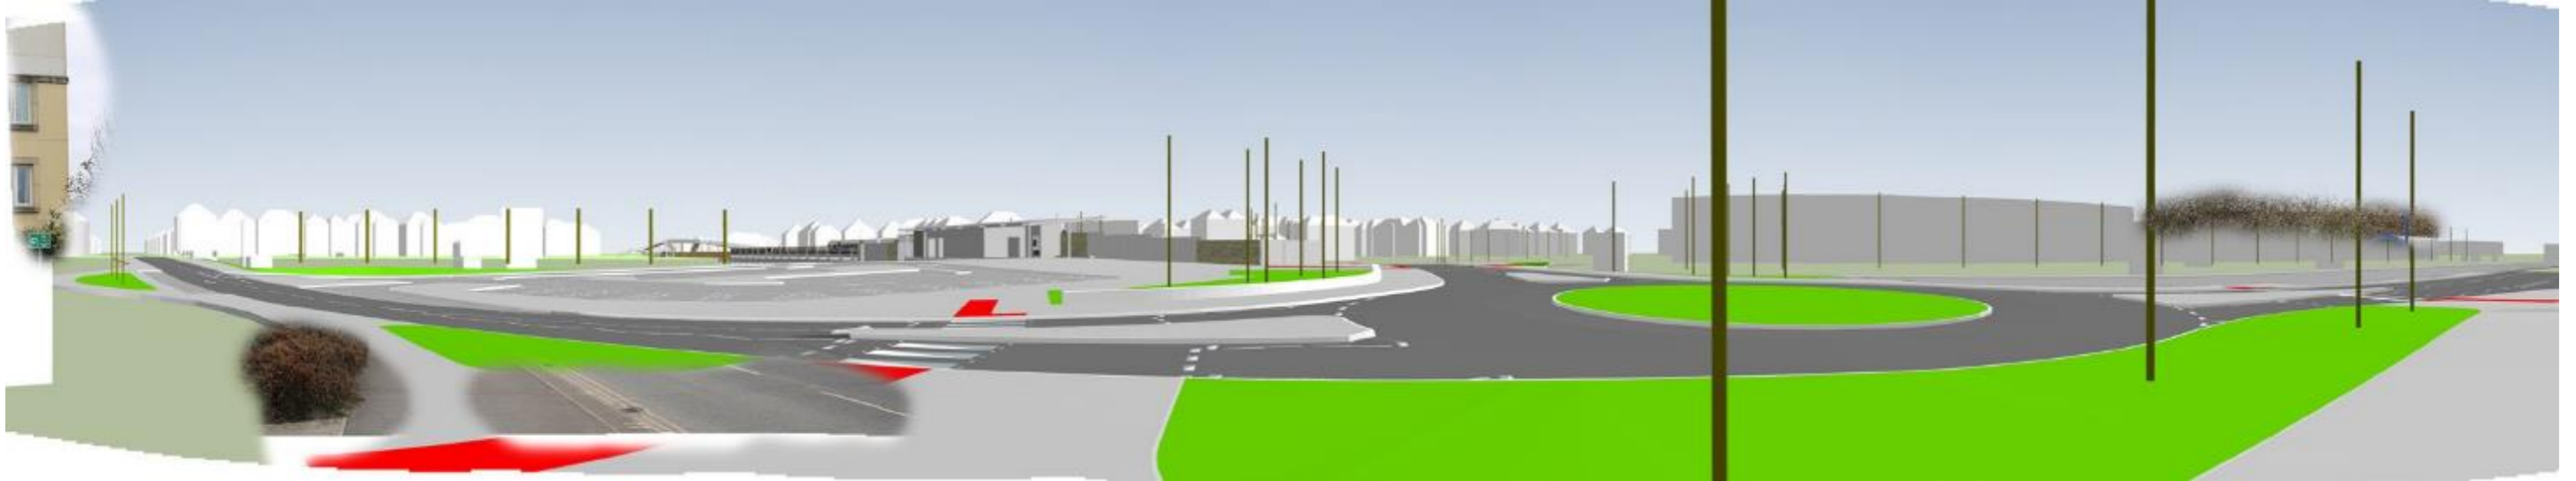
2.5.2 The image below shows the SketchUp rendered image being matched on top of the existing photograph in Photoshop with some of the model being removed to expose existing buildings and vegetation to match features.

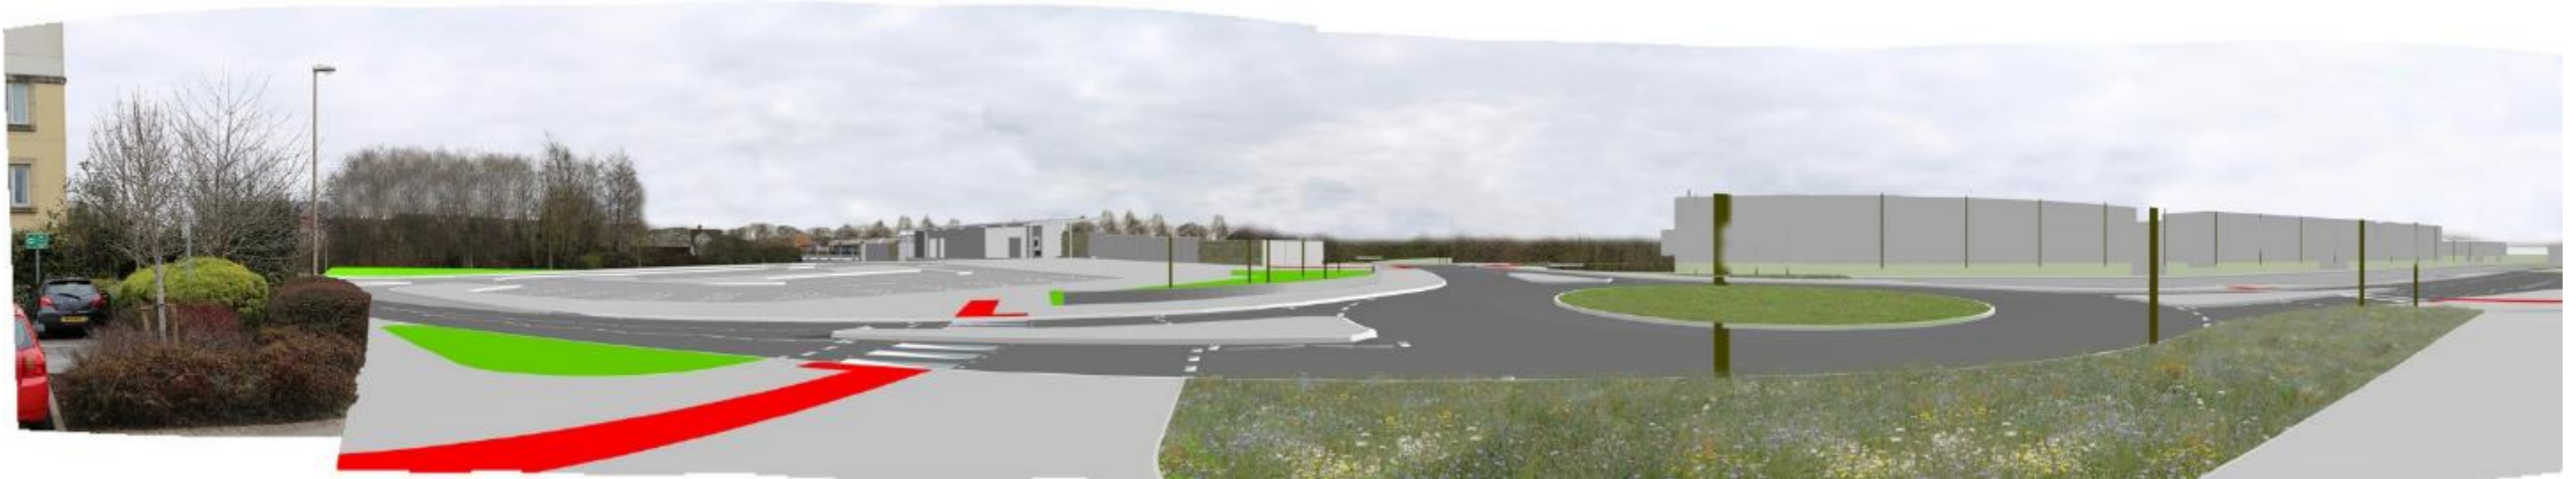
2.5.3 Photomontage stage in progress.

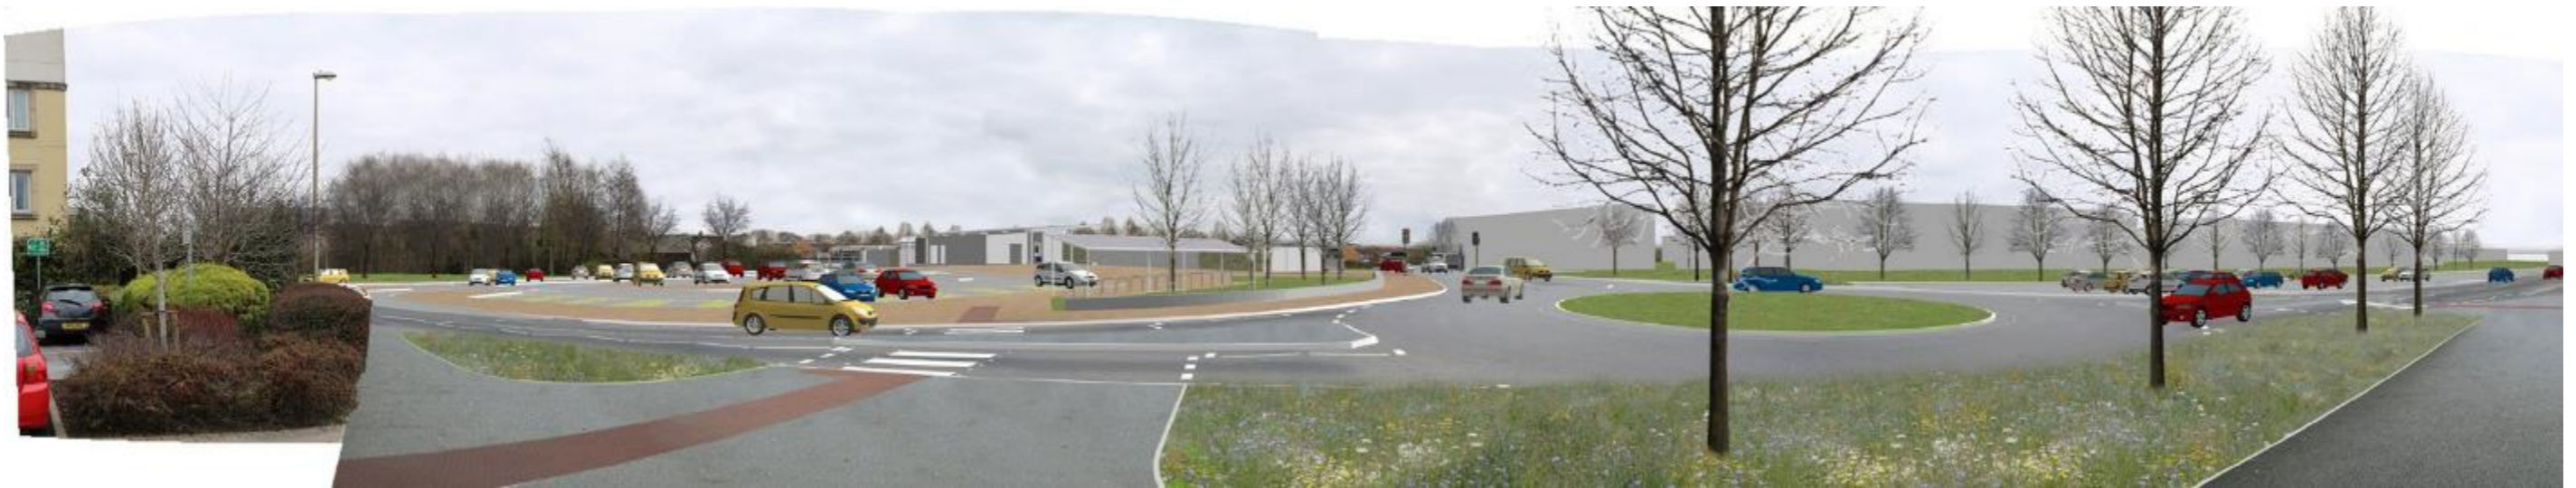
2.5.5 Photomontage stage in progress.

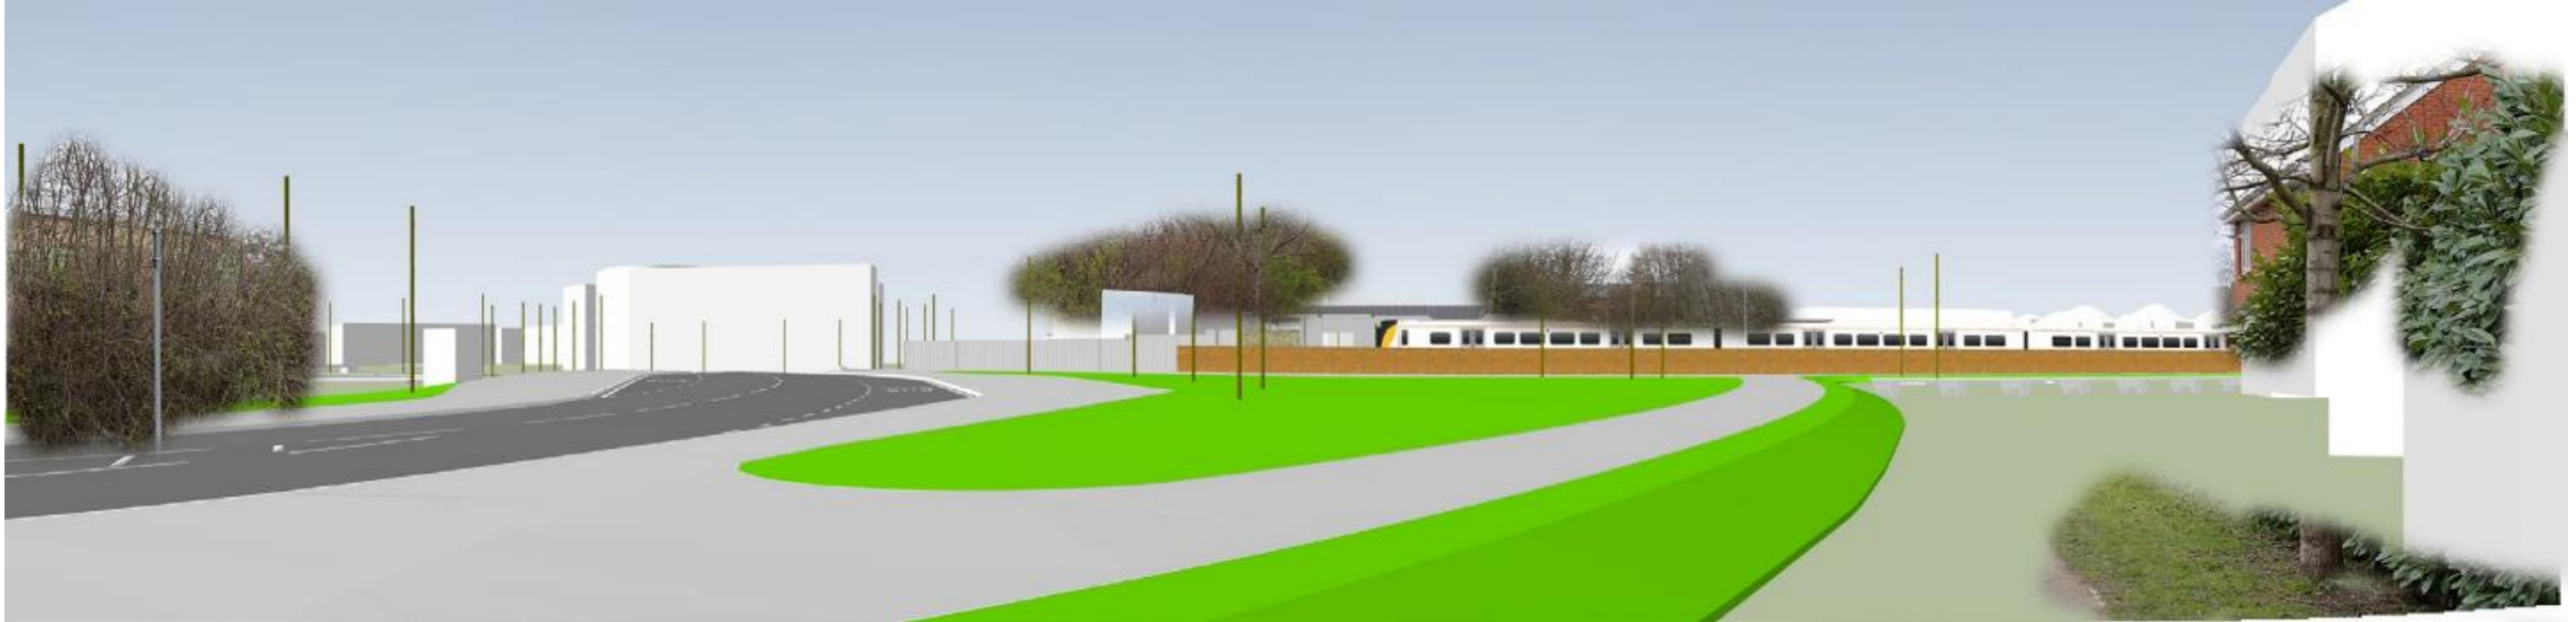
2.6.2 The image below shows the SketchUp rendered image being matched on top of the existing photograph in Photoshop with some of the model being removed to expose existing buildings to match features.

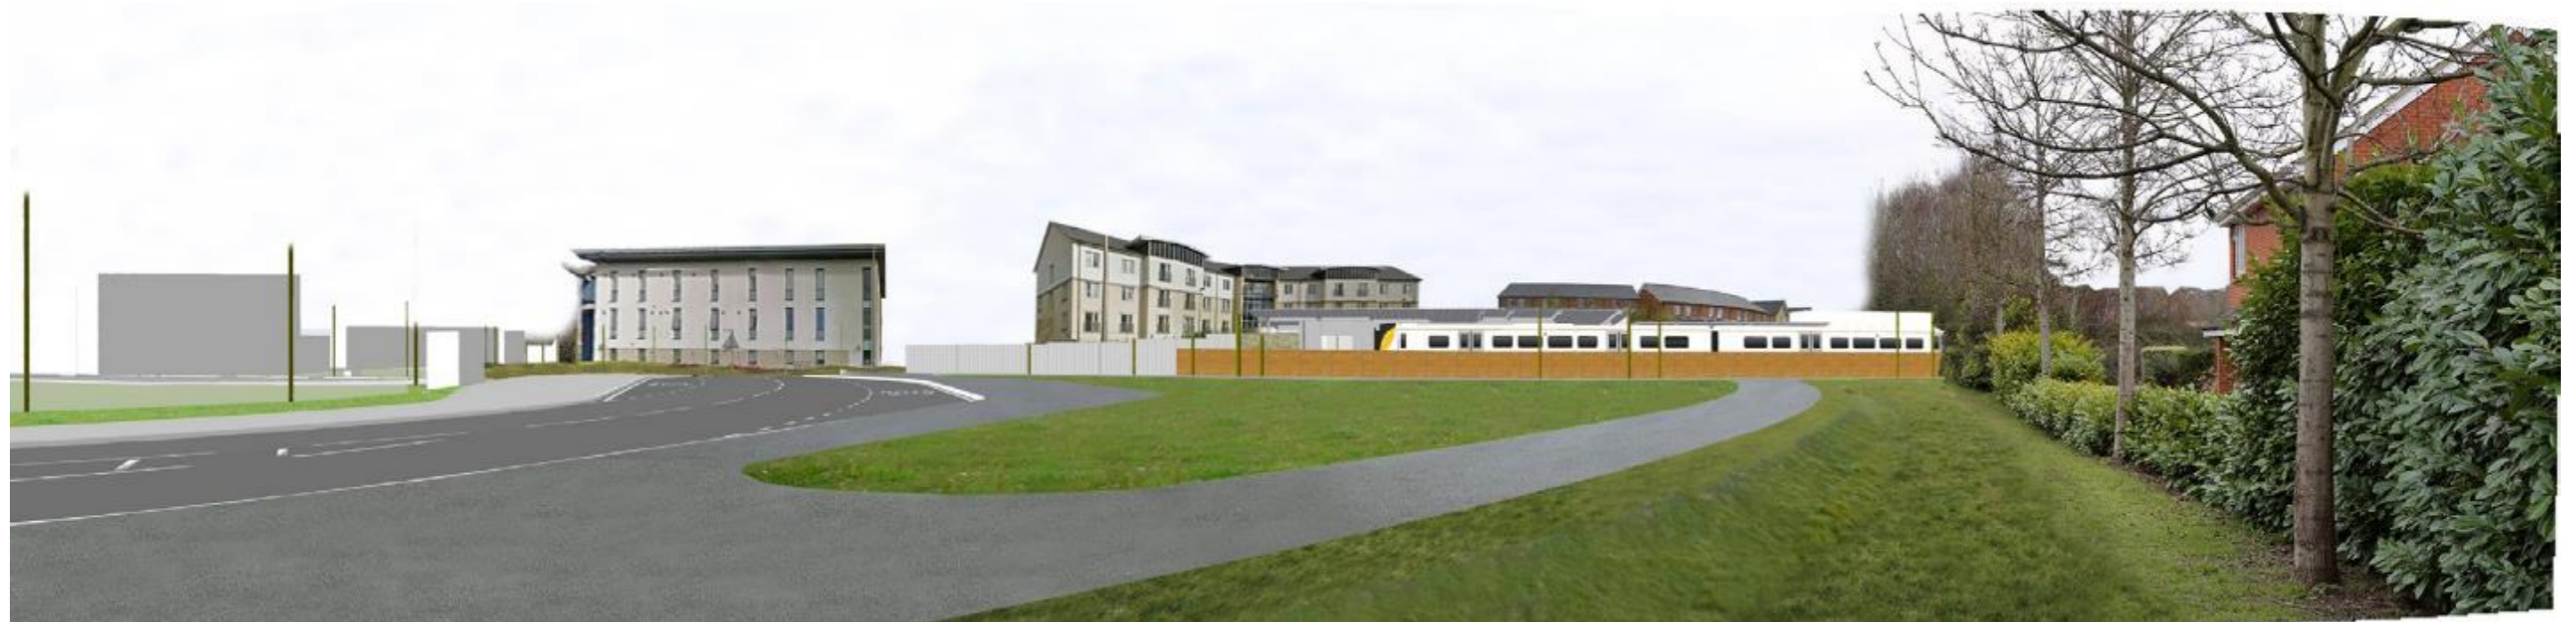
2.6.3 Photomontage stage in progress.

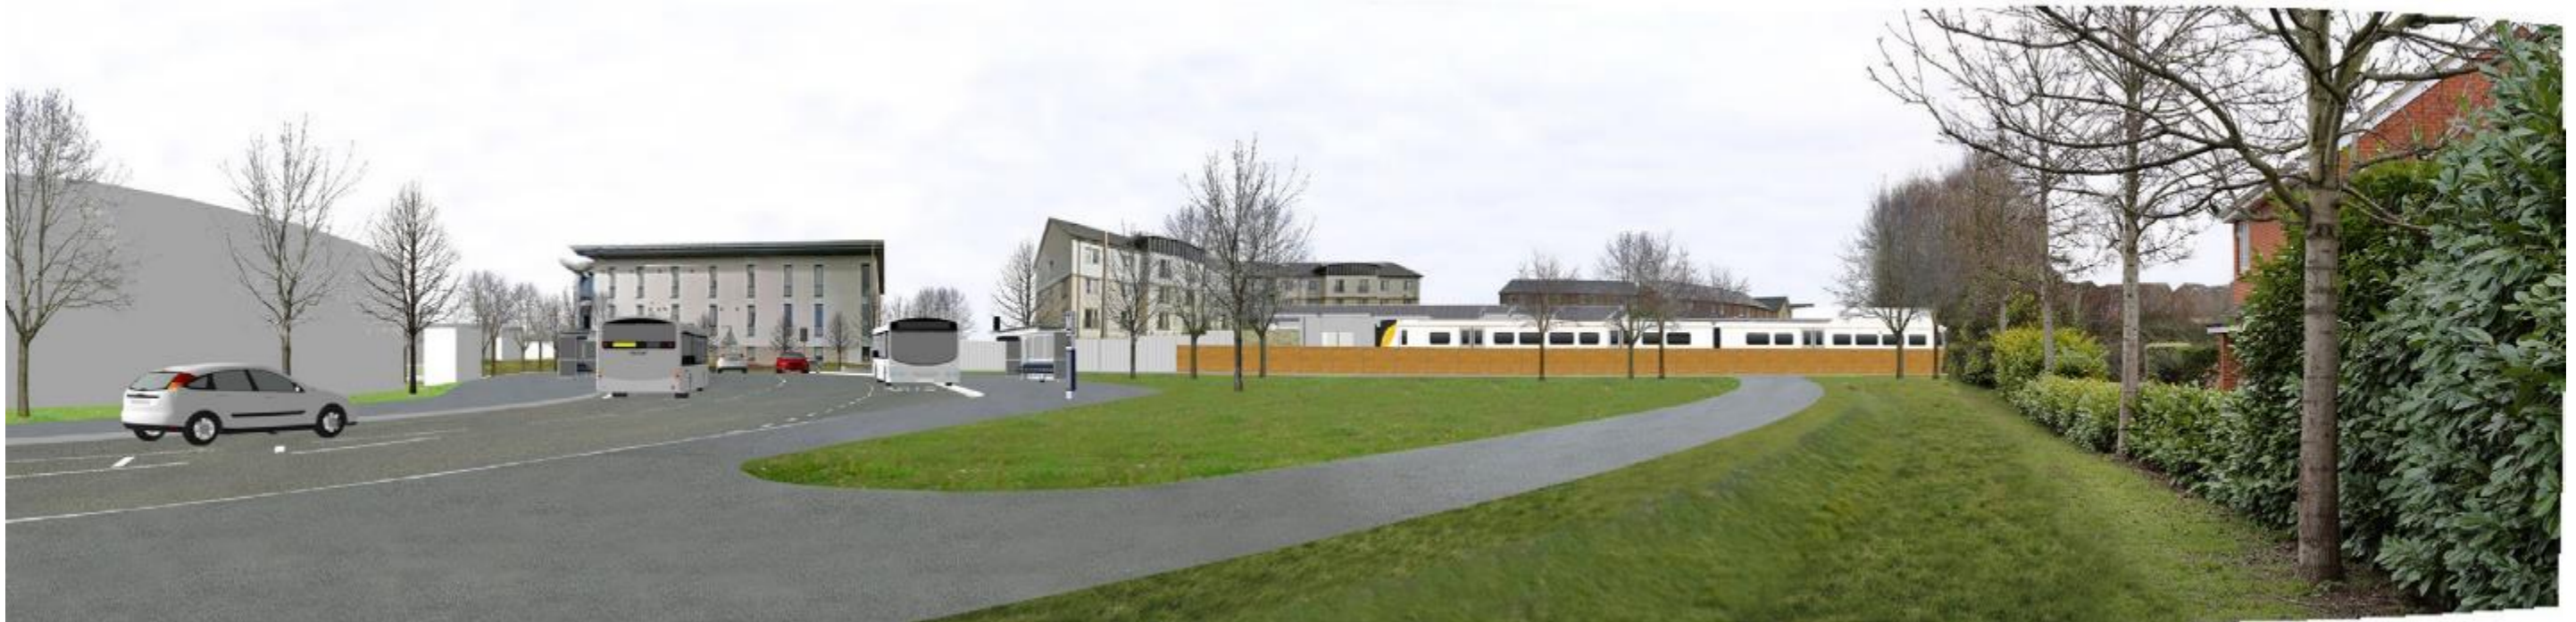
2.6.5 Photomontage stage in progress.
