# MetroWest+

## Portishead Branch Line (MetroWest Phase 1)

**6.25, Environmental Statement, Volume 4, Appendix 11.3 and 11.4 Landscape and Visual Impacts Assessment  
The Infrastructure Planning (Applications: Prescribed Forms and Procedure) Regulations 2009, regulation 5(2)(a)  
Planning Act 2008**

**6.25, Environmental Statement, Volume 4, Appendix 11.3 Visual Impact Assessment**

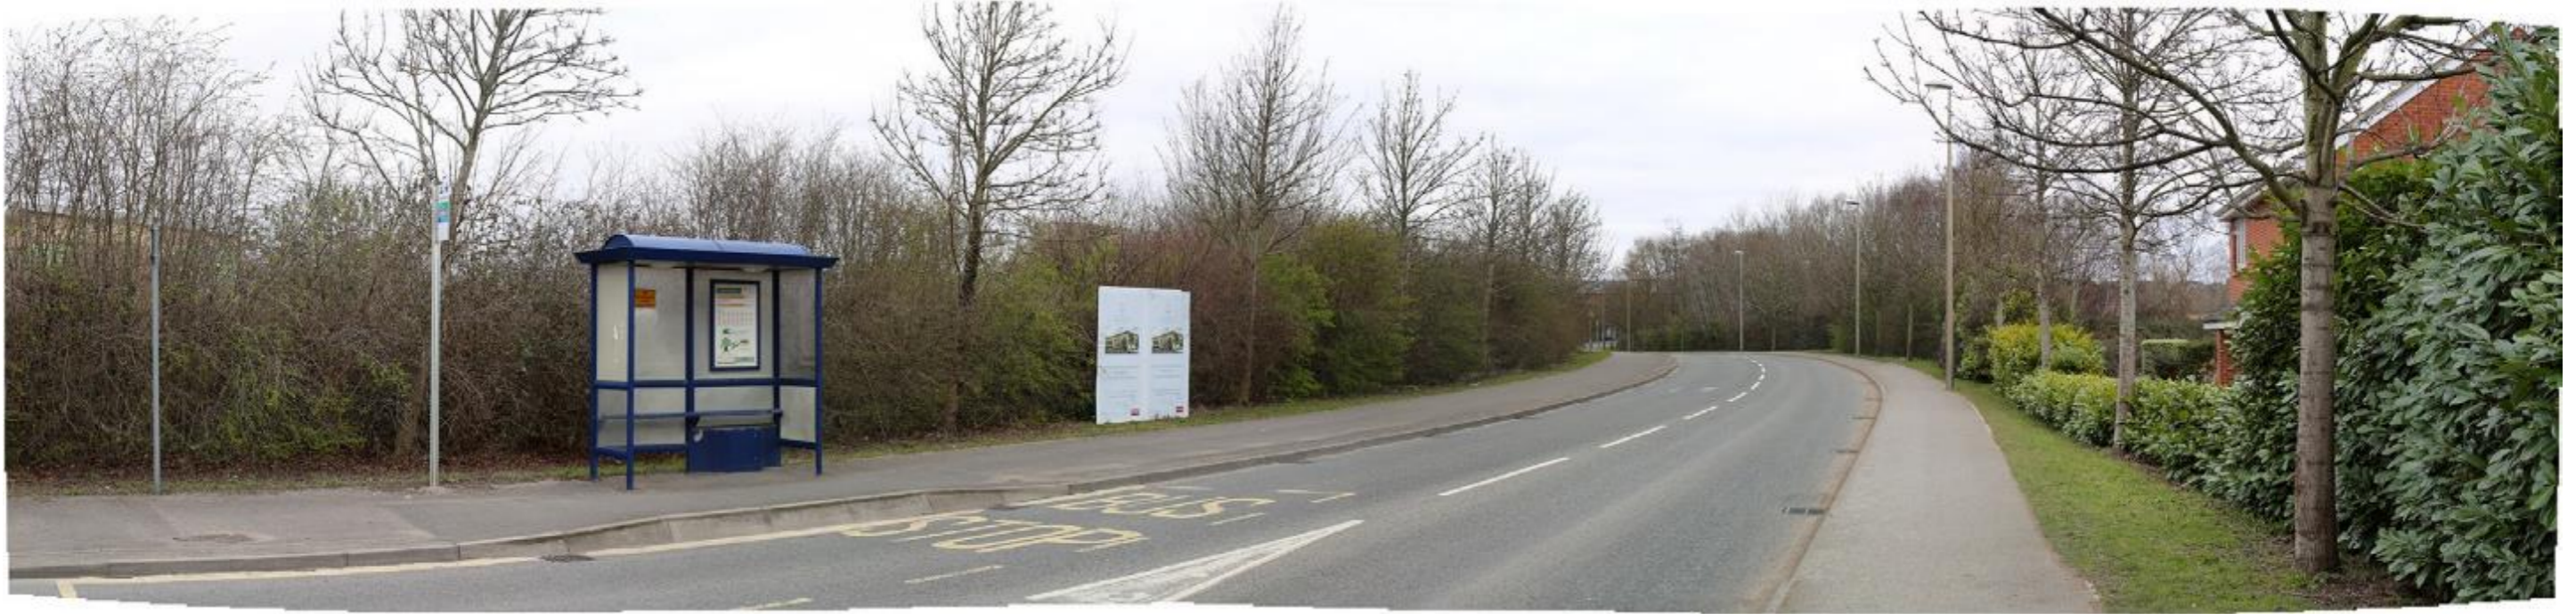
2.6.6 Existing photograph 4

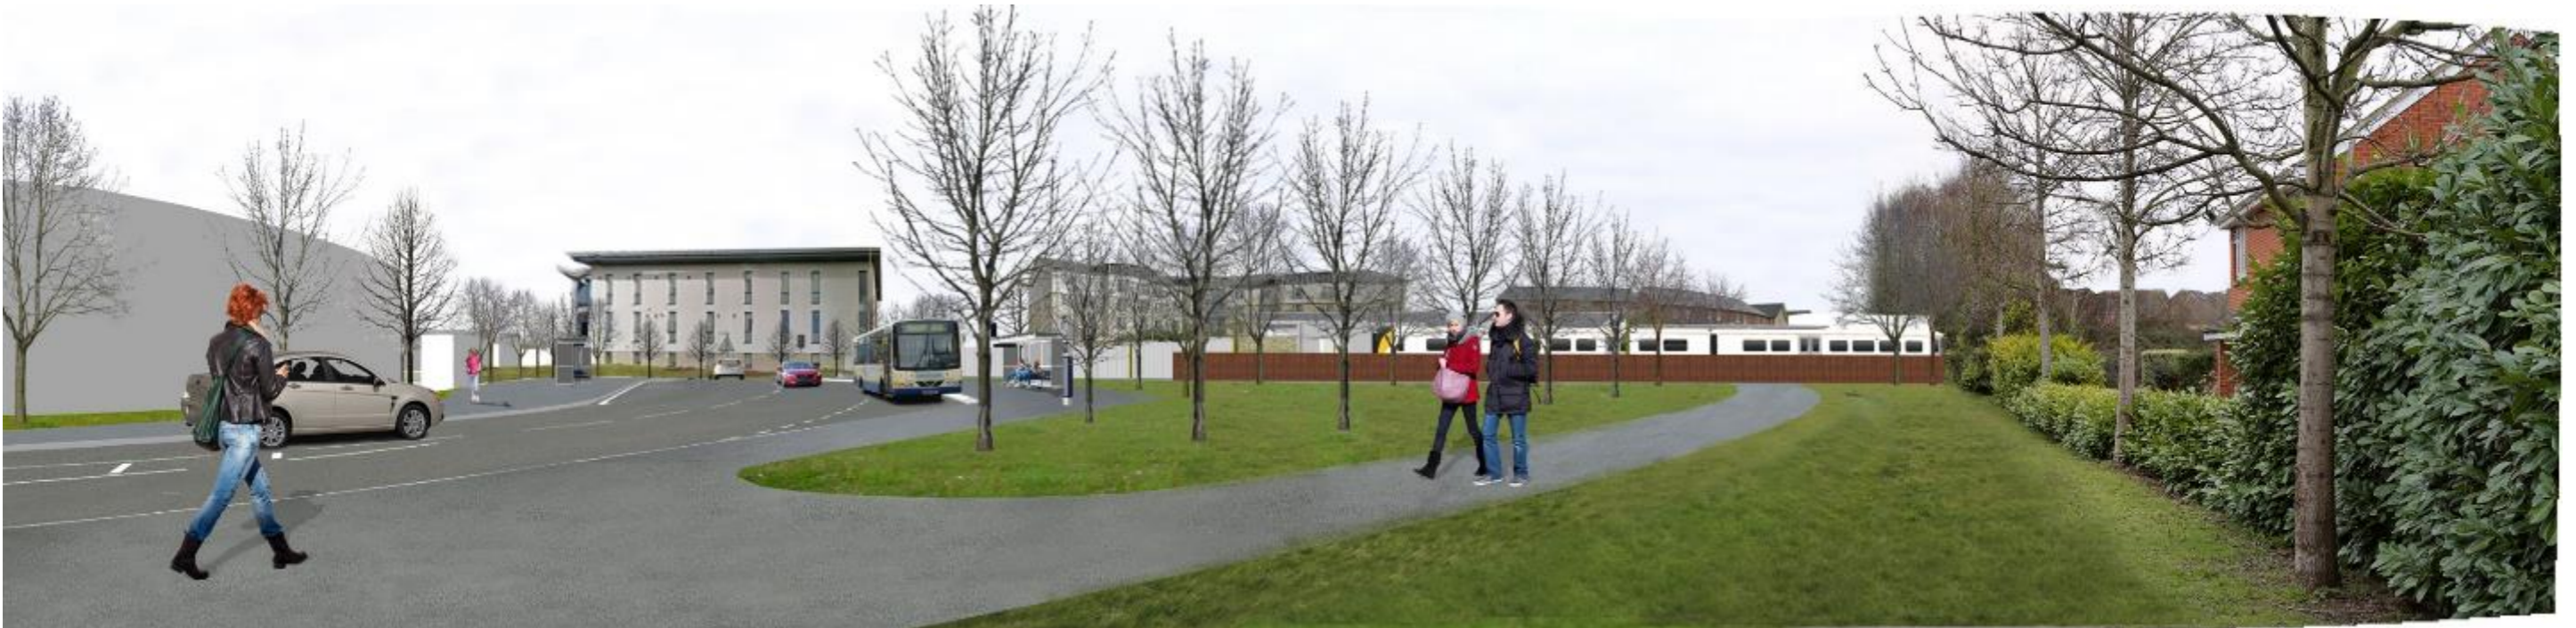
2.6.7 Photomontage 4

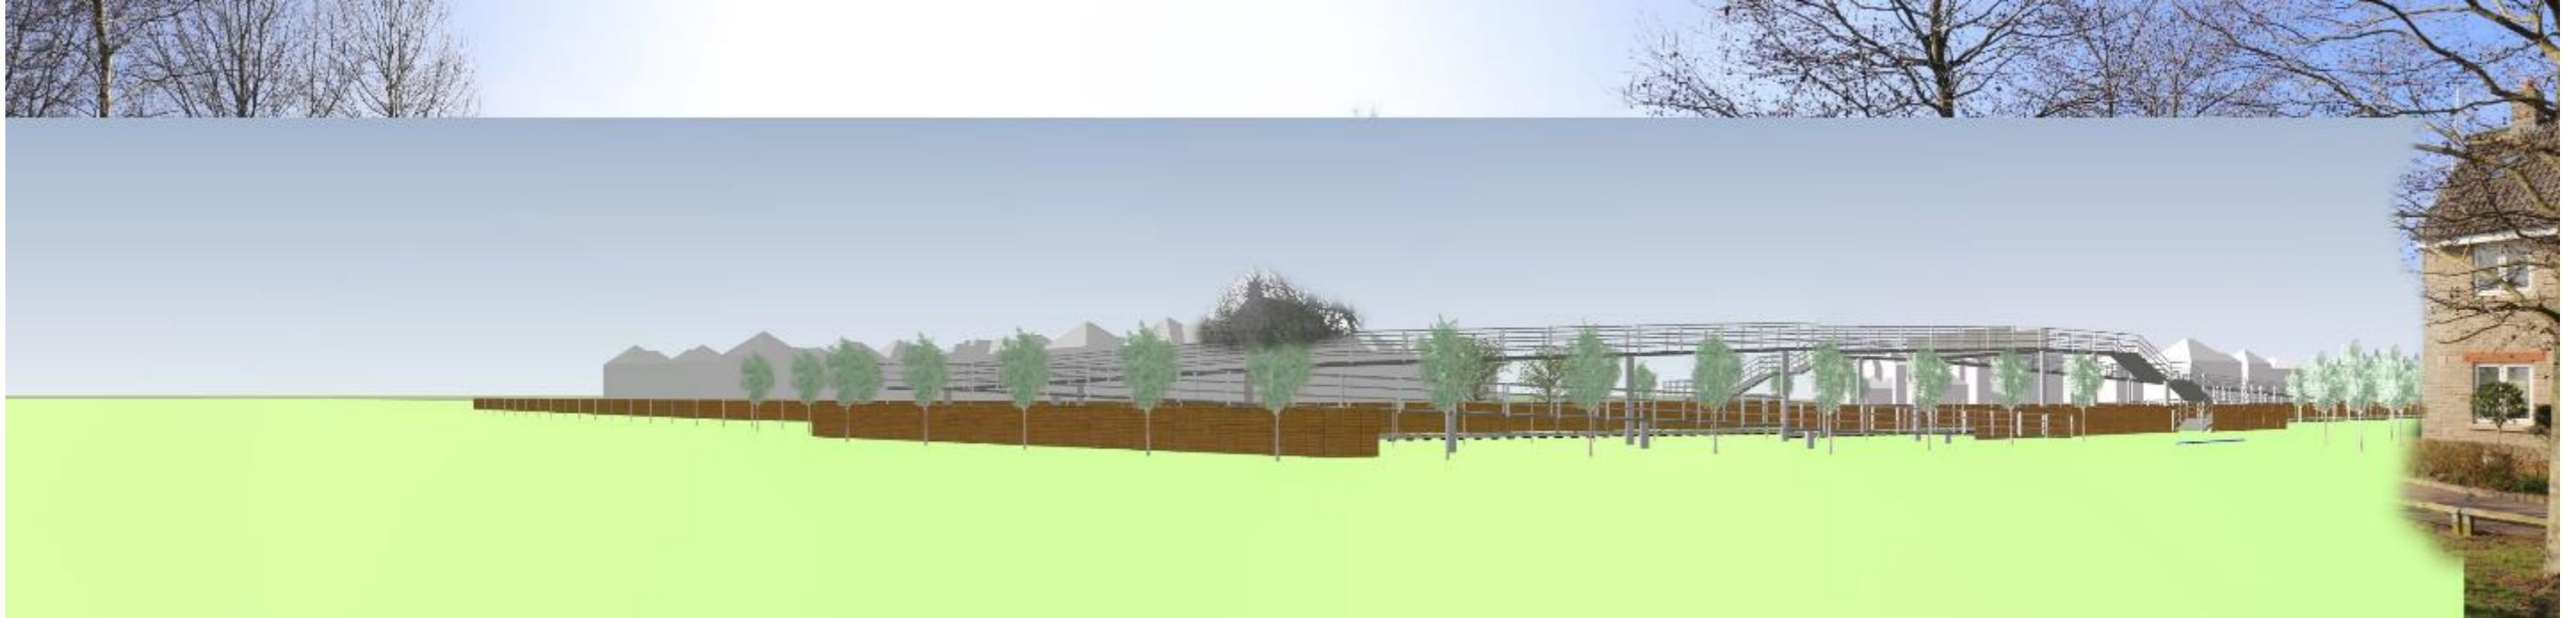
2.7.2 The image below shows the SketchUp rendered image being matched on top of the existing photograph in Photoshop with some of the model being removed to expose existing buildings to match features.

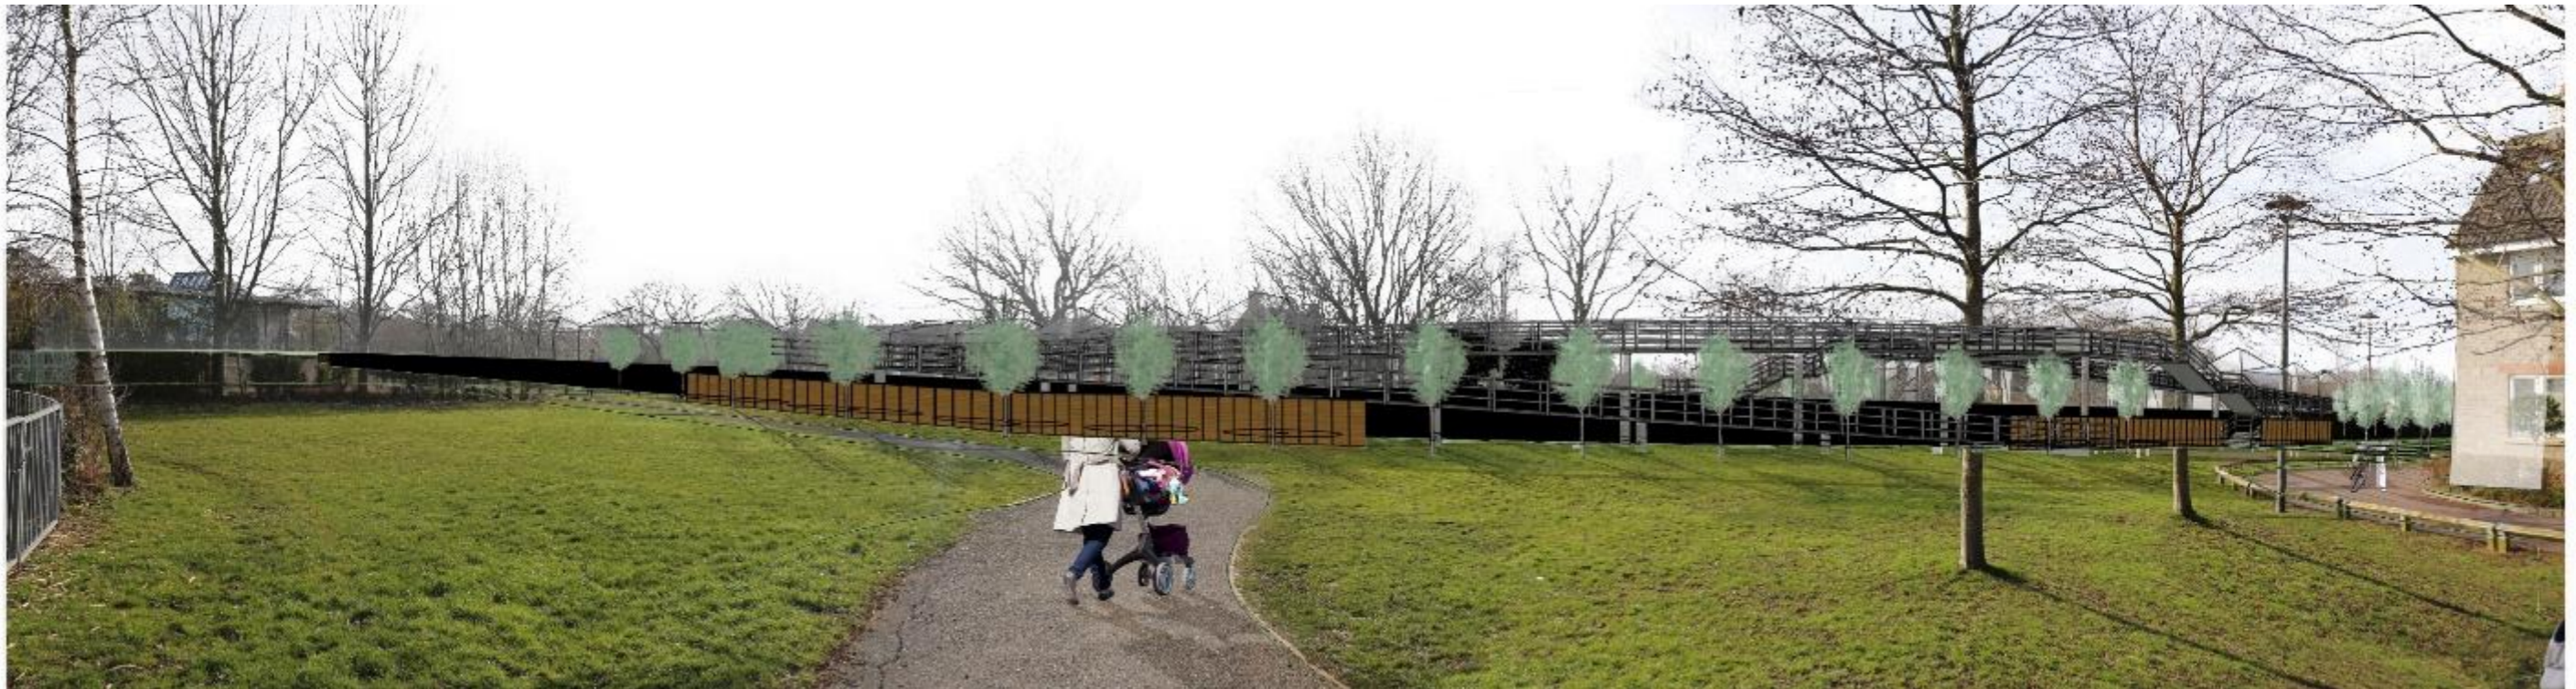
2.7.4 Photomontage stages in progress, whole SketchUp model cut out to use as guide for rendering and ascertain initial visibility.

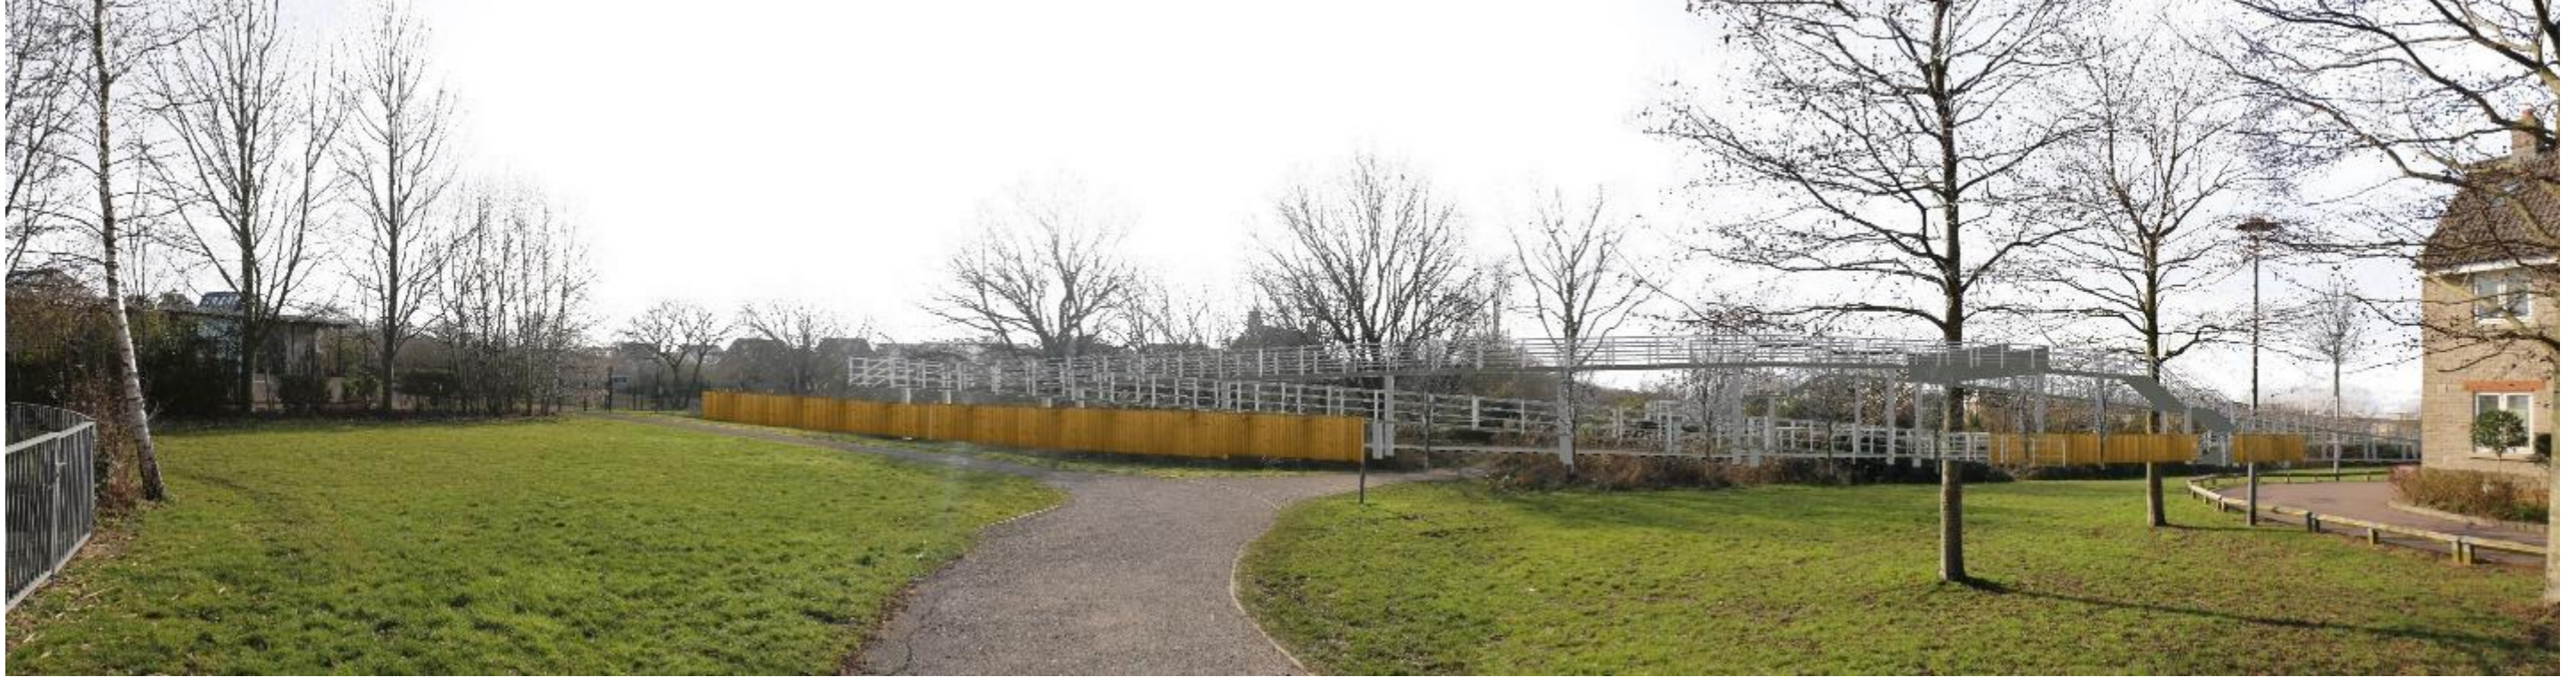
2.7.5 Photomontage stages in progress, Sketchup Model replaced with real images e.g. proposed trees, and the initial cut out, which was edited to be made sharper within the scene. The previous overlay was then used to guide the placement of features within the scene.

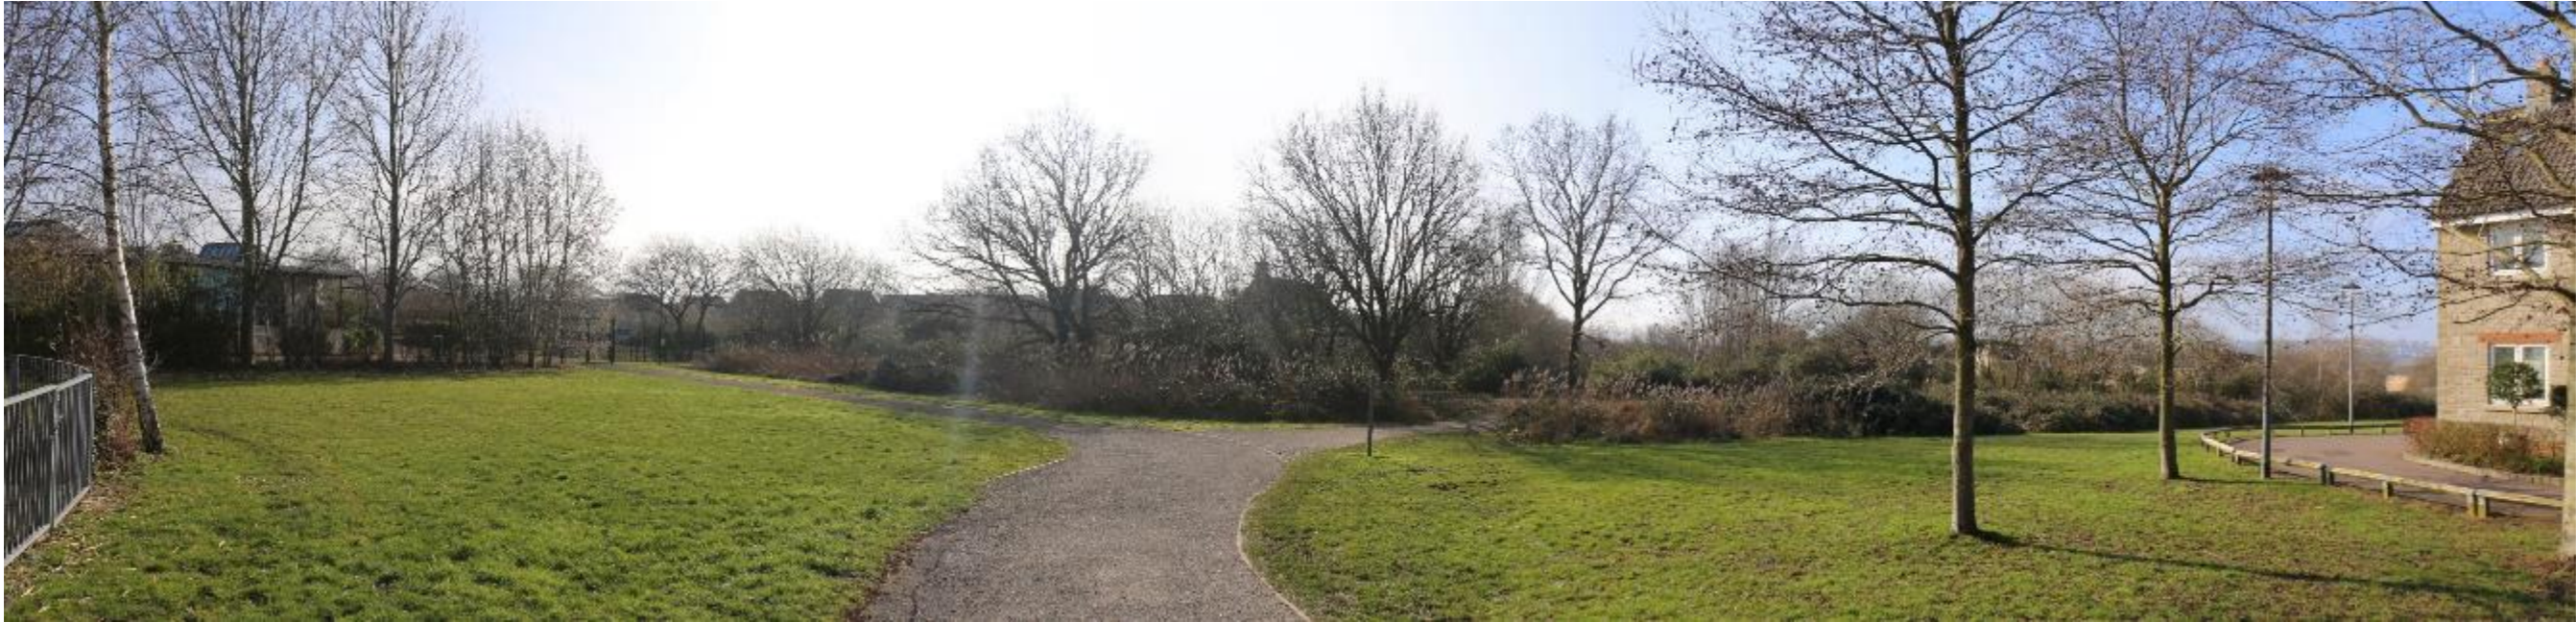
2.7.6 Existing photograph 5

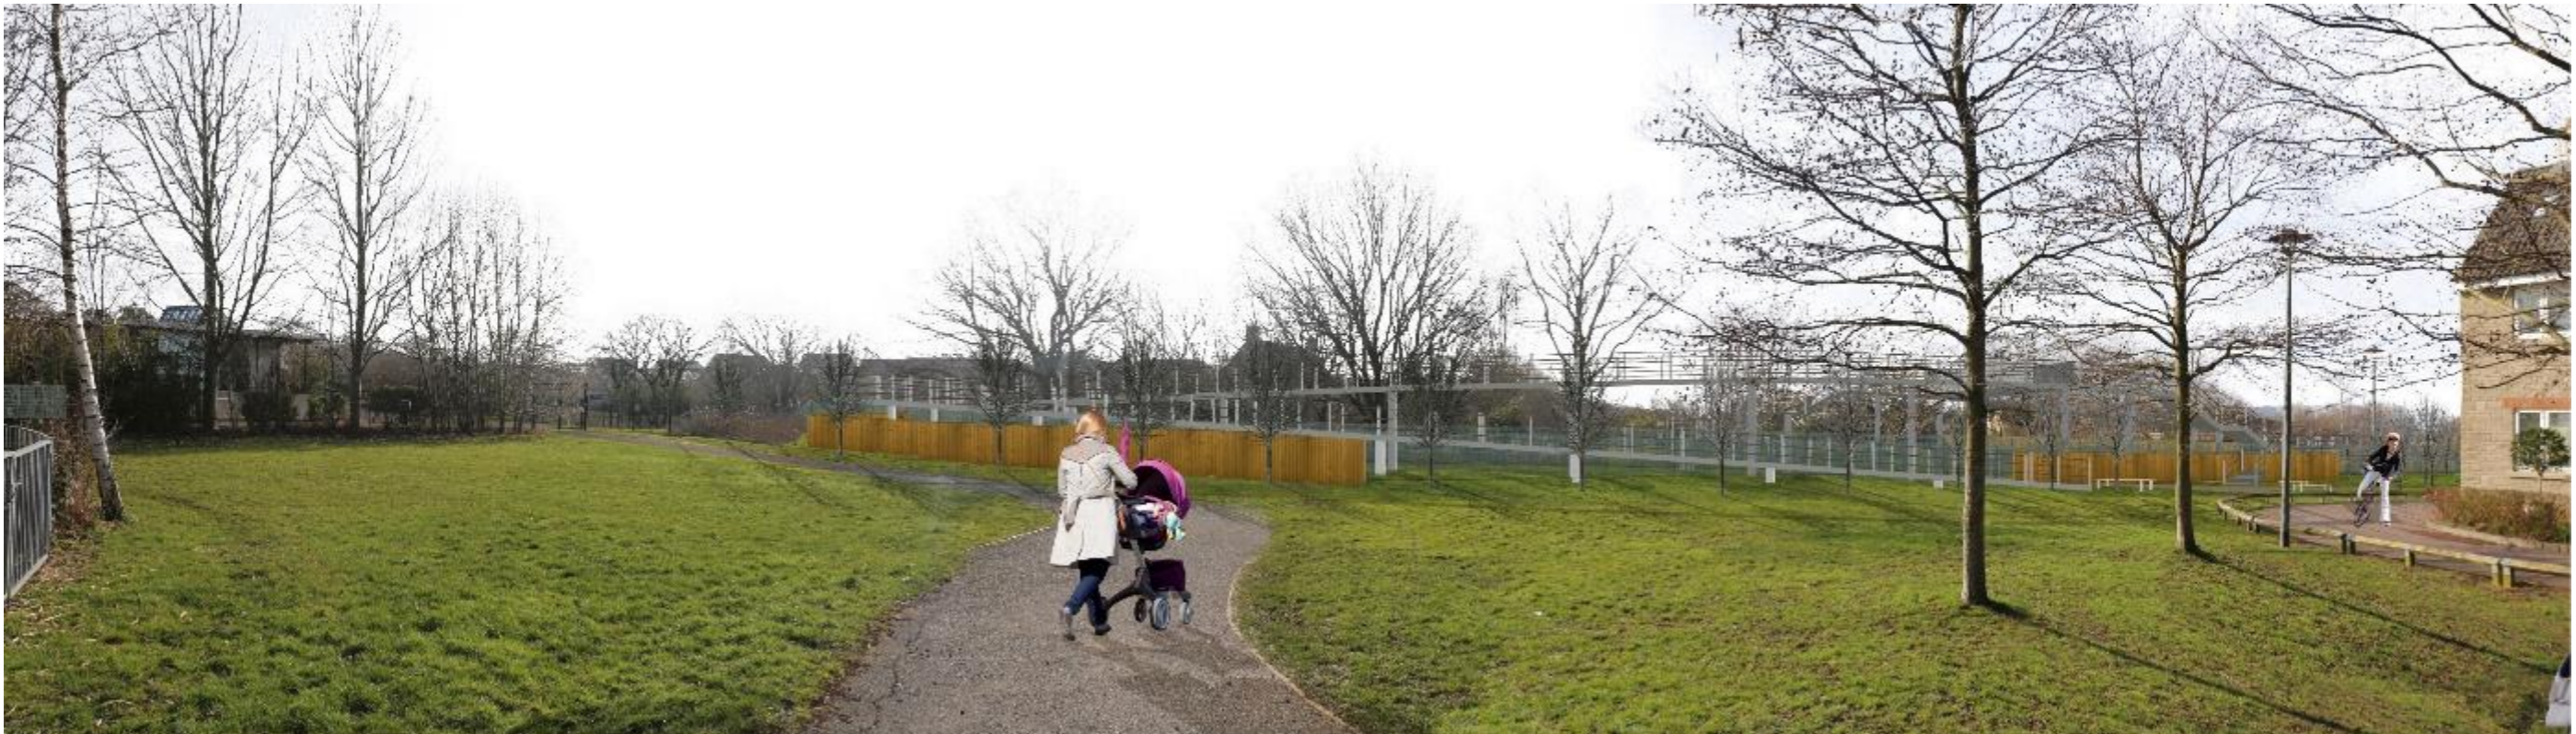
2.7.7 Photomontage 5

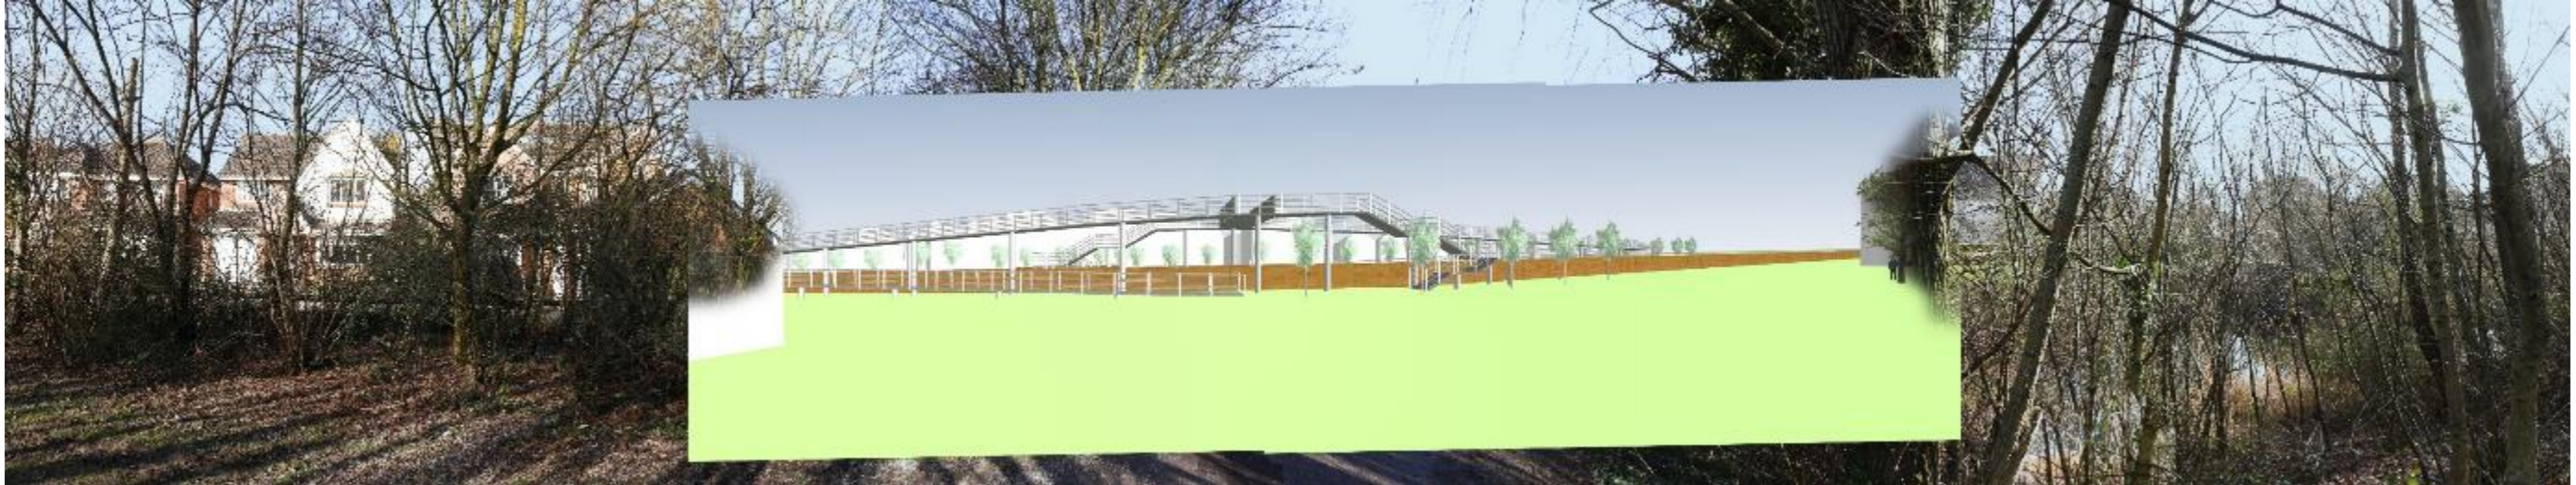
2.8.2 The image below shows the SketchUp rendered image being matched on top of the existing photograph in Photoshop with some of the model being removed to expose existing buildings to match features.

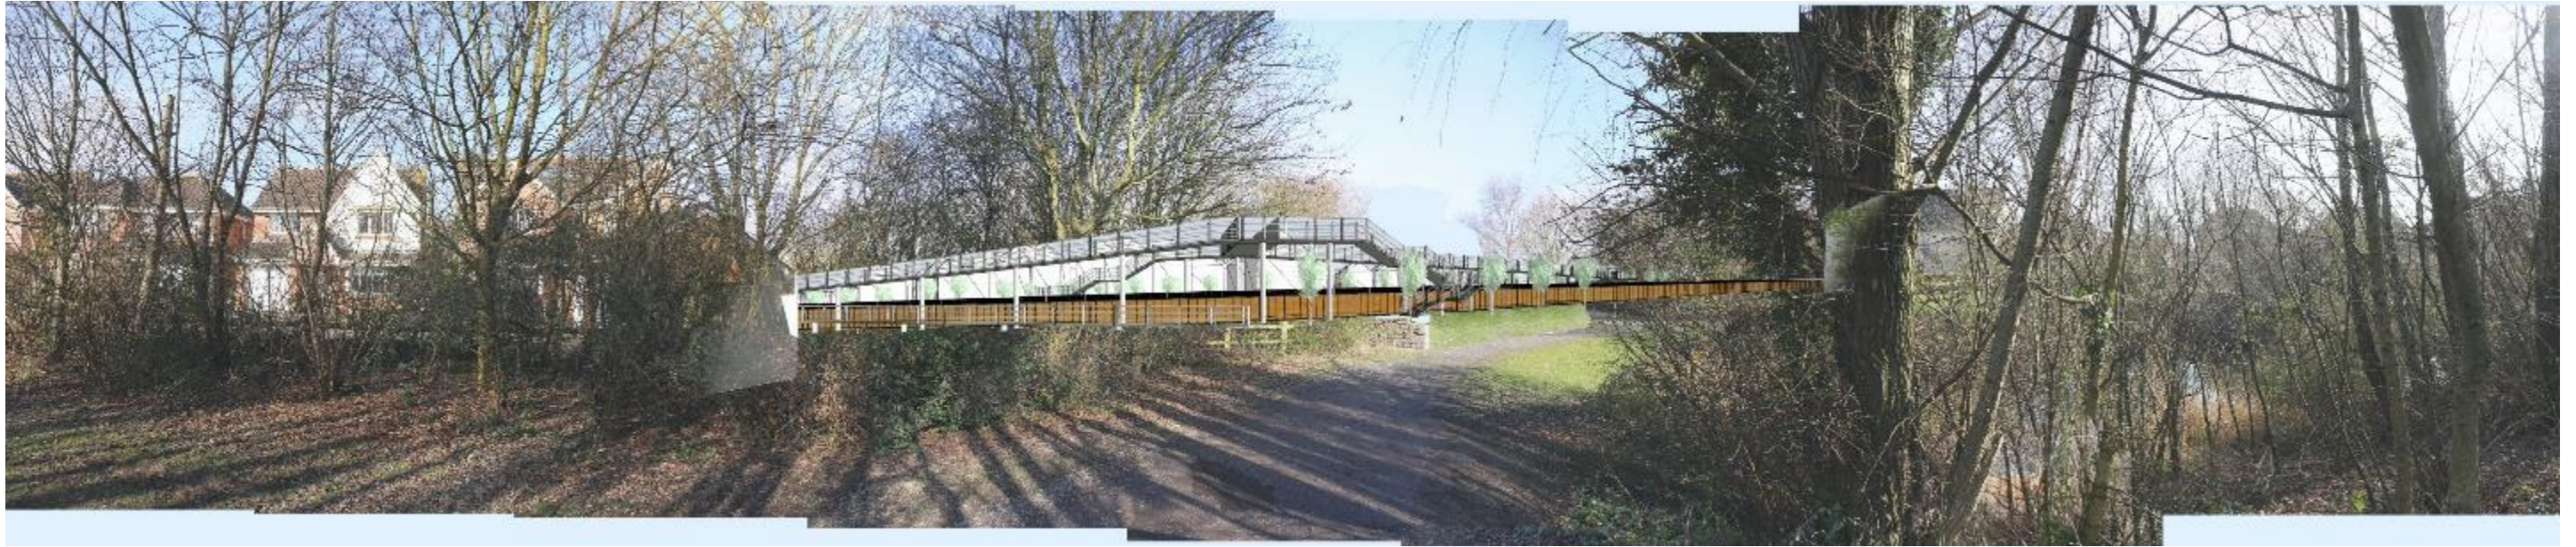
2.8.4 Photomontage stages in progress, whole SketchUp model cut out to use as guide for rendering and ascertain initial visibility.

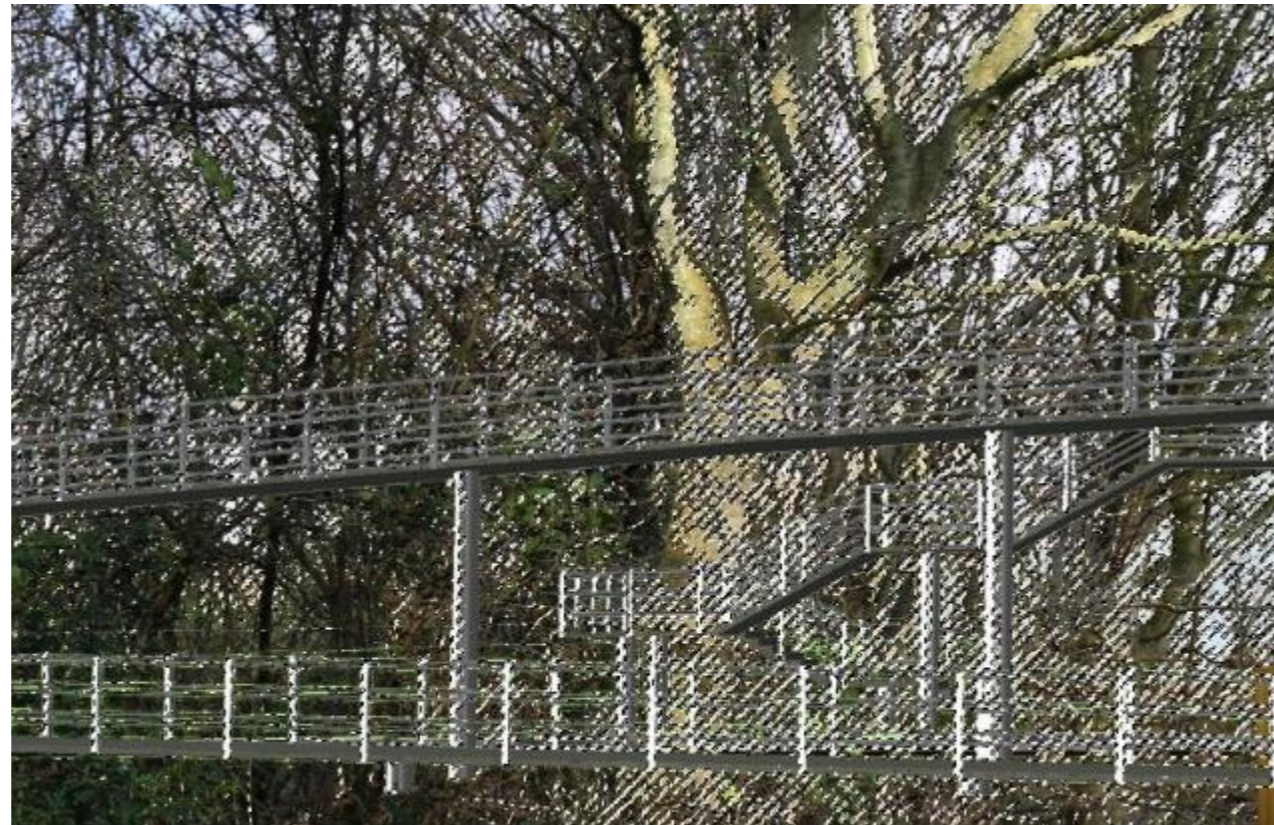
2.8.5 Photomontage stages in progress, existing vegetation (where being removed) removed from stitched photograph. The ramp is just visible in this winter view.

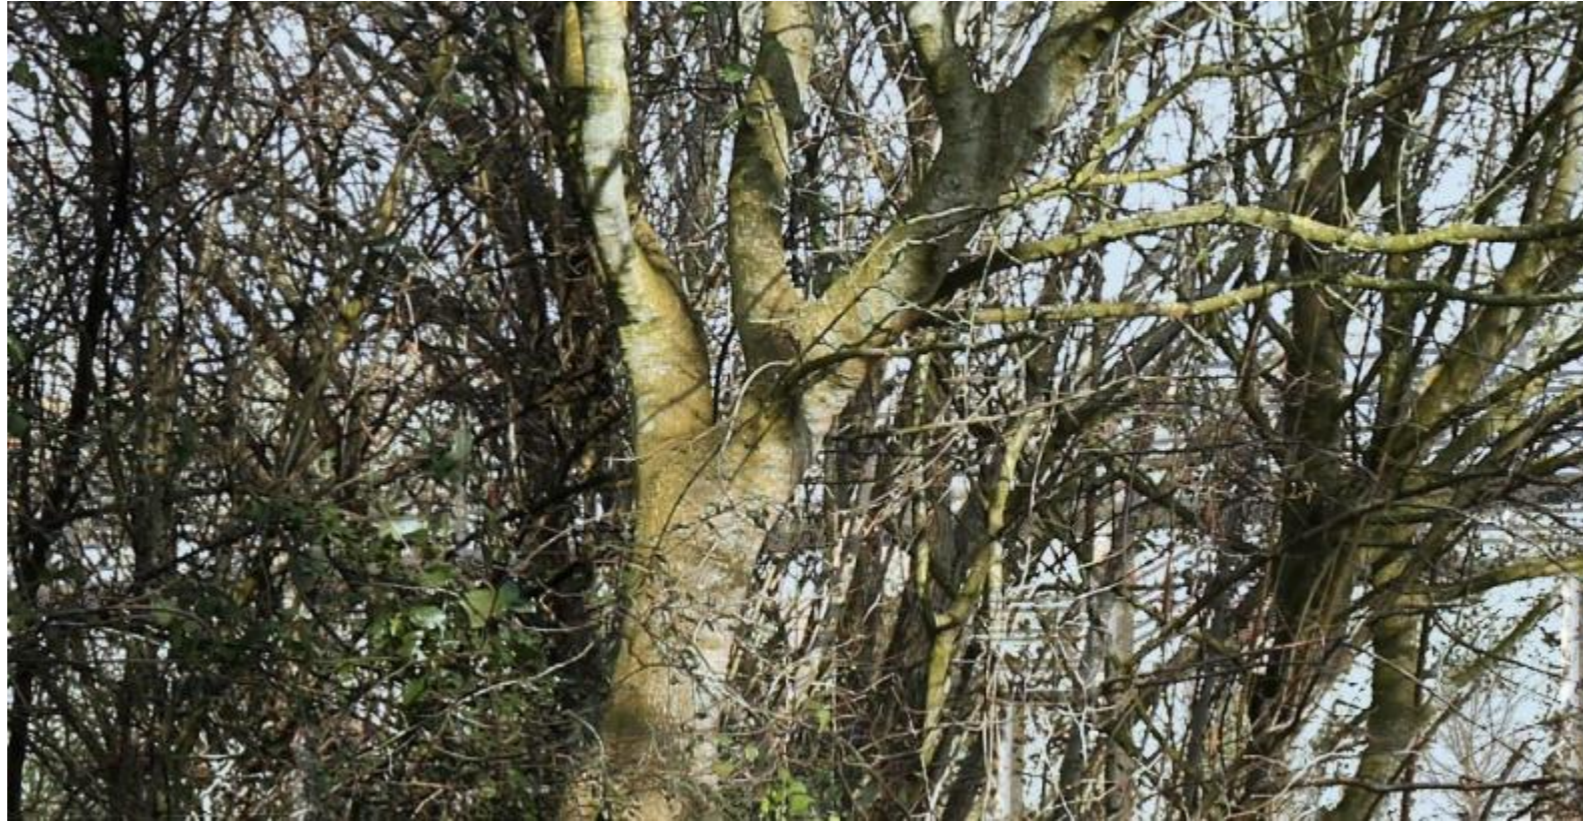
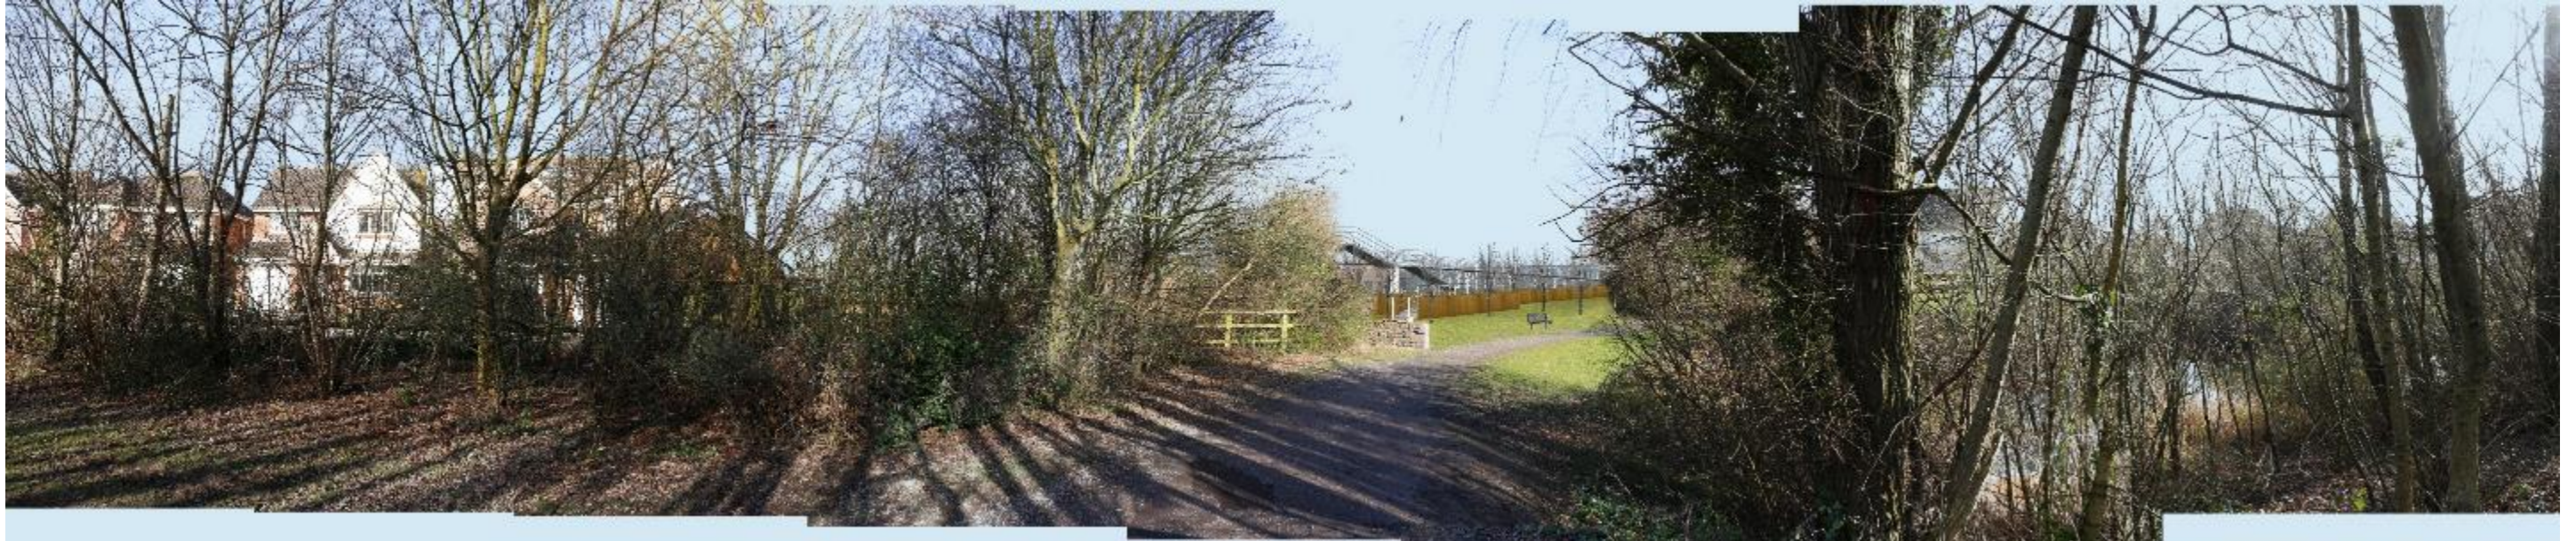
2.8.6 Photomontage stages in progress, existing vegetation features added and initial SketchUp overlay replaced.

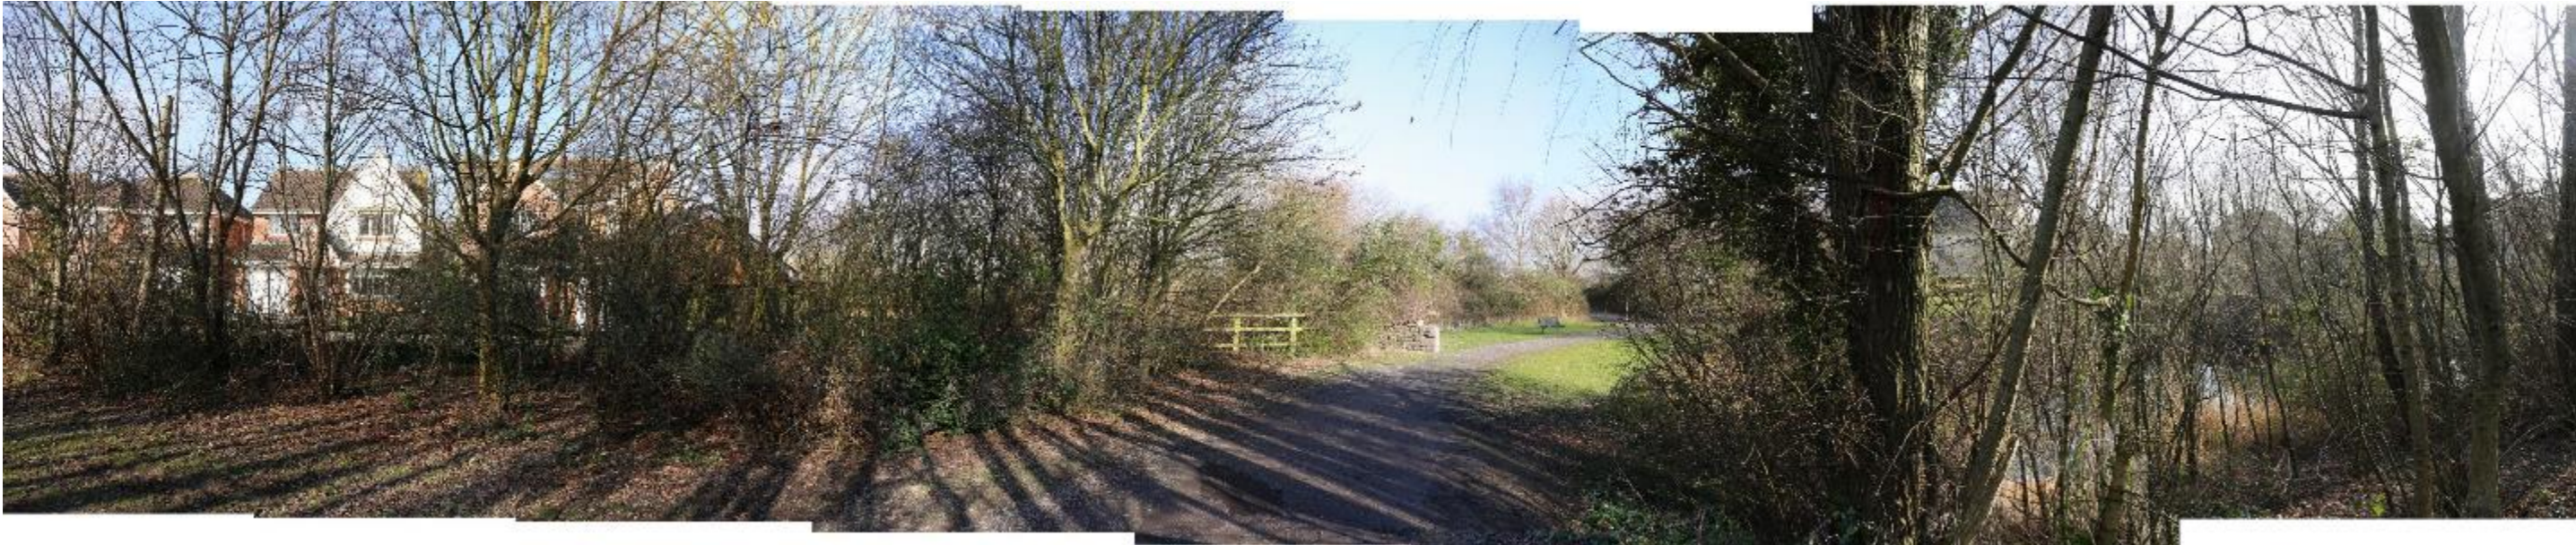
2.8.7 Existing photograph 6

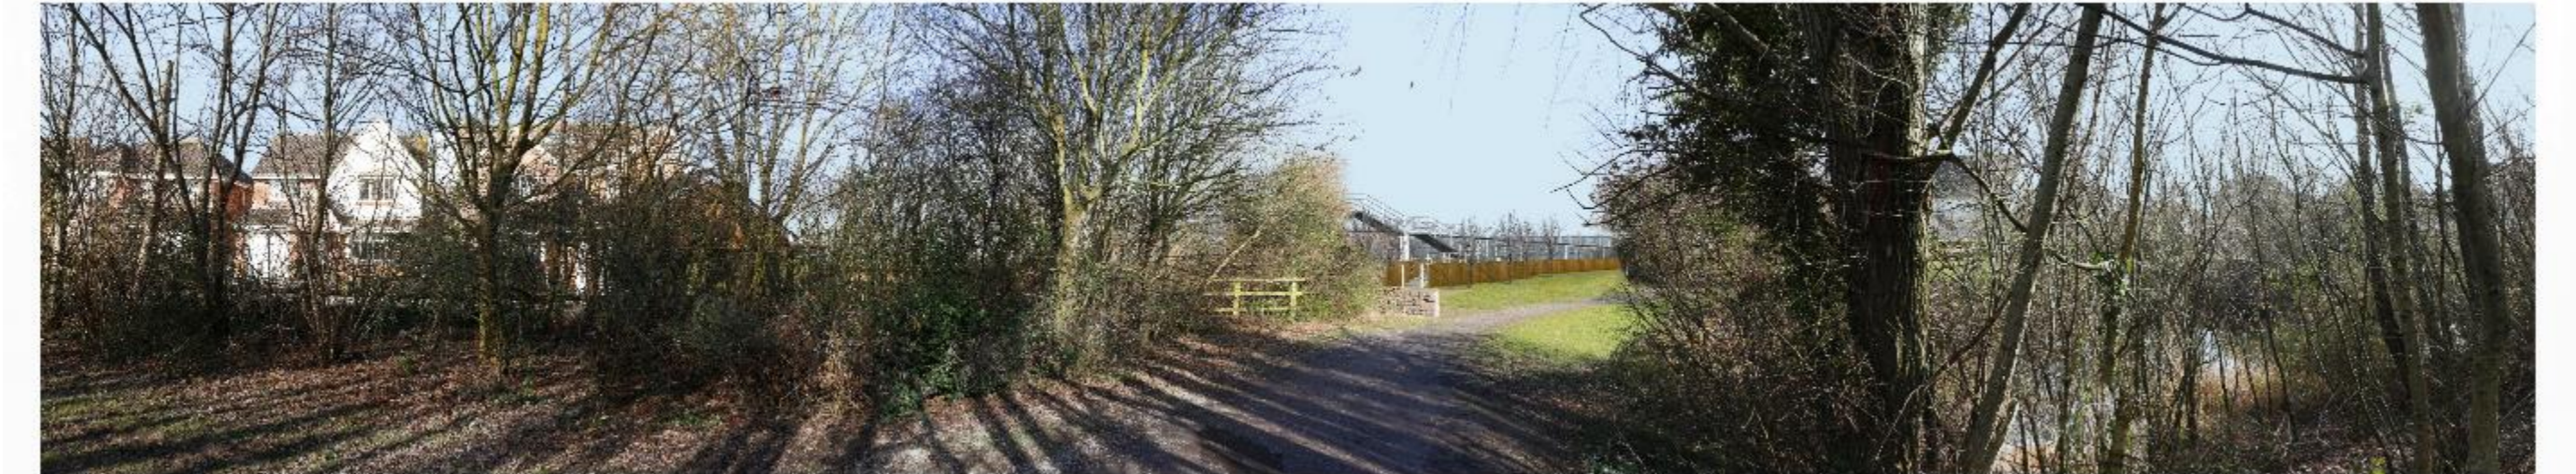
2.8.8 Photomontage 6

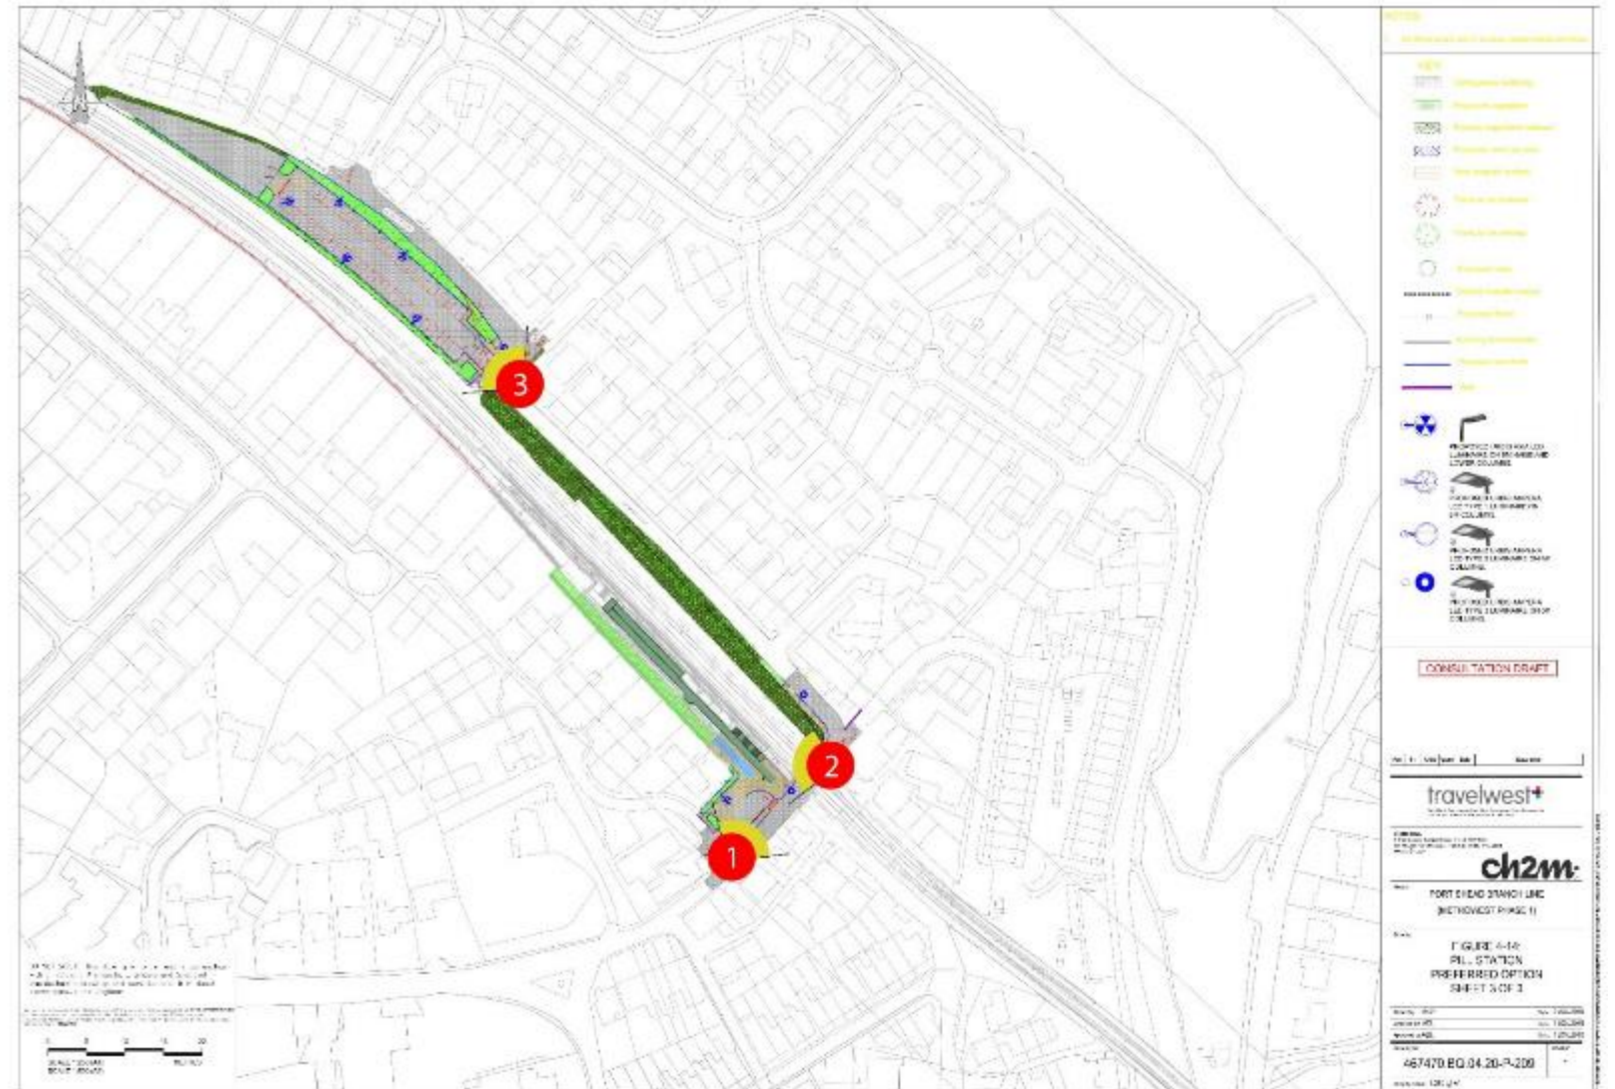
- 3.1.3 A total of 3 locations were identified around Pill Station and car park. The adjacent plan shows the locations of the selected photomontages, (1) is Photomontage 7, (2) is Photomontage 8, and (3) is Photomontage 9. Note the plan opposite should be used for referencing the photomontage locations only.
