# MetroWest+

## Portishead Branch Line (MetroWest Phase 1)

**6.25, Environmental Statement, Volume 4, Appendix 11.3 and 11.4 Landscape and Visual Impacts Assessment  
The Infrastructure Planning (Applications: Prescribed Forms and Procedure) Regulations 2009, regulation 5(2)(a)  
Planning Act 2008**

**6.25, Environmental Statement, Volume 4, Appendix 11.3 Visual Impact Assessment**

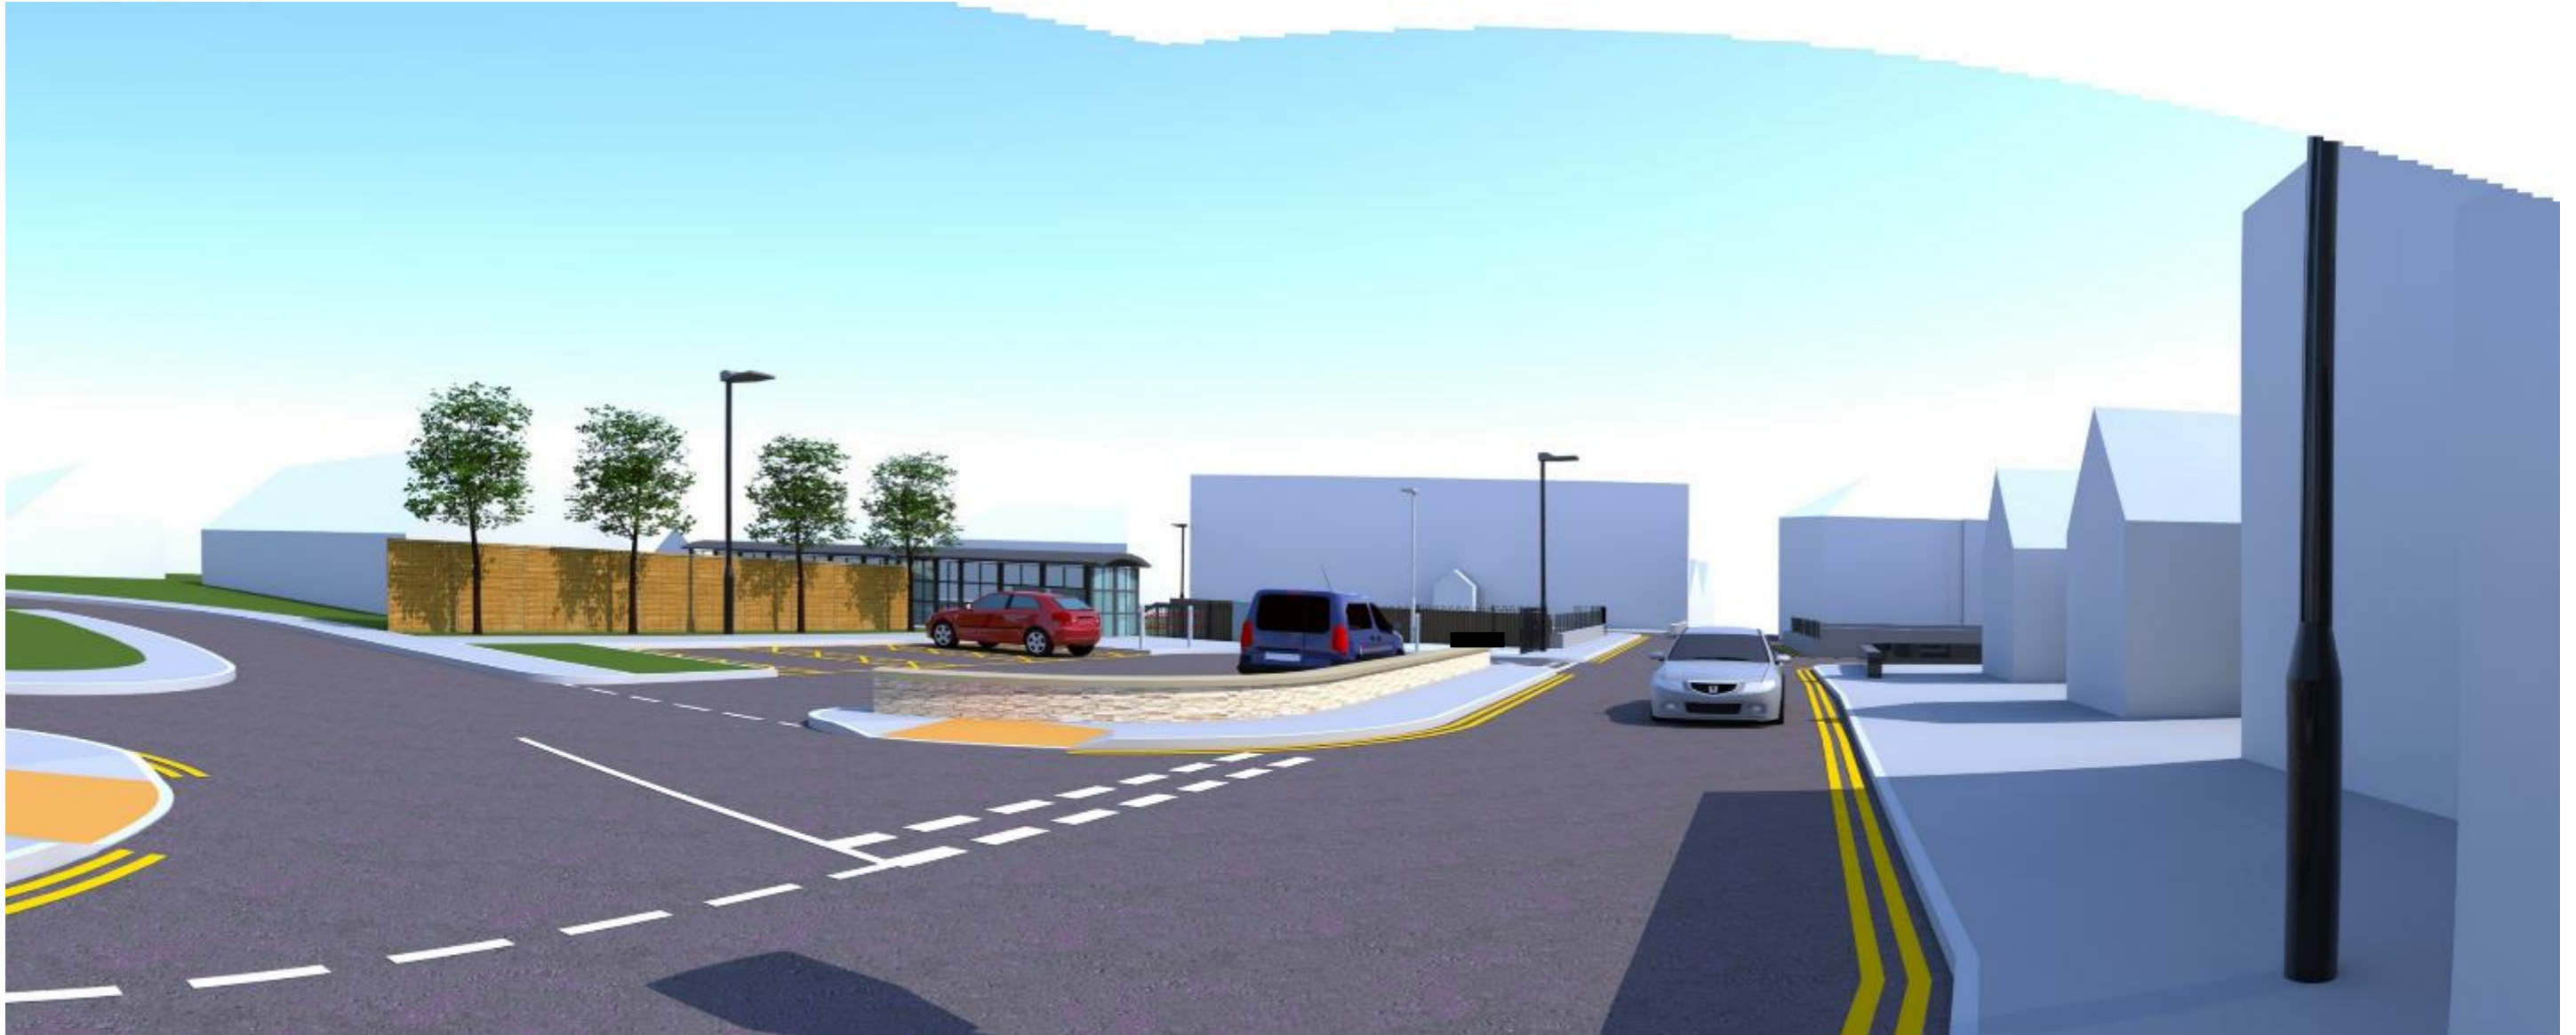
3.2.2 The image below shows the SketchUp rendered image being matched on top of the existing photograph in Photoshop.

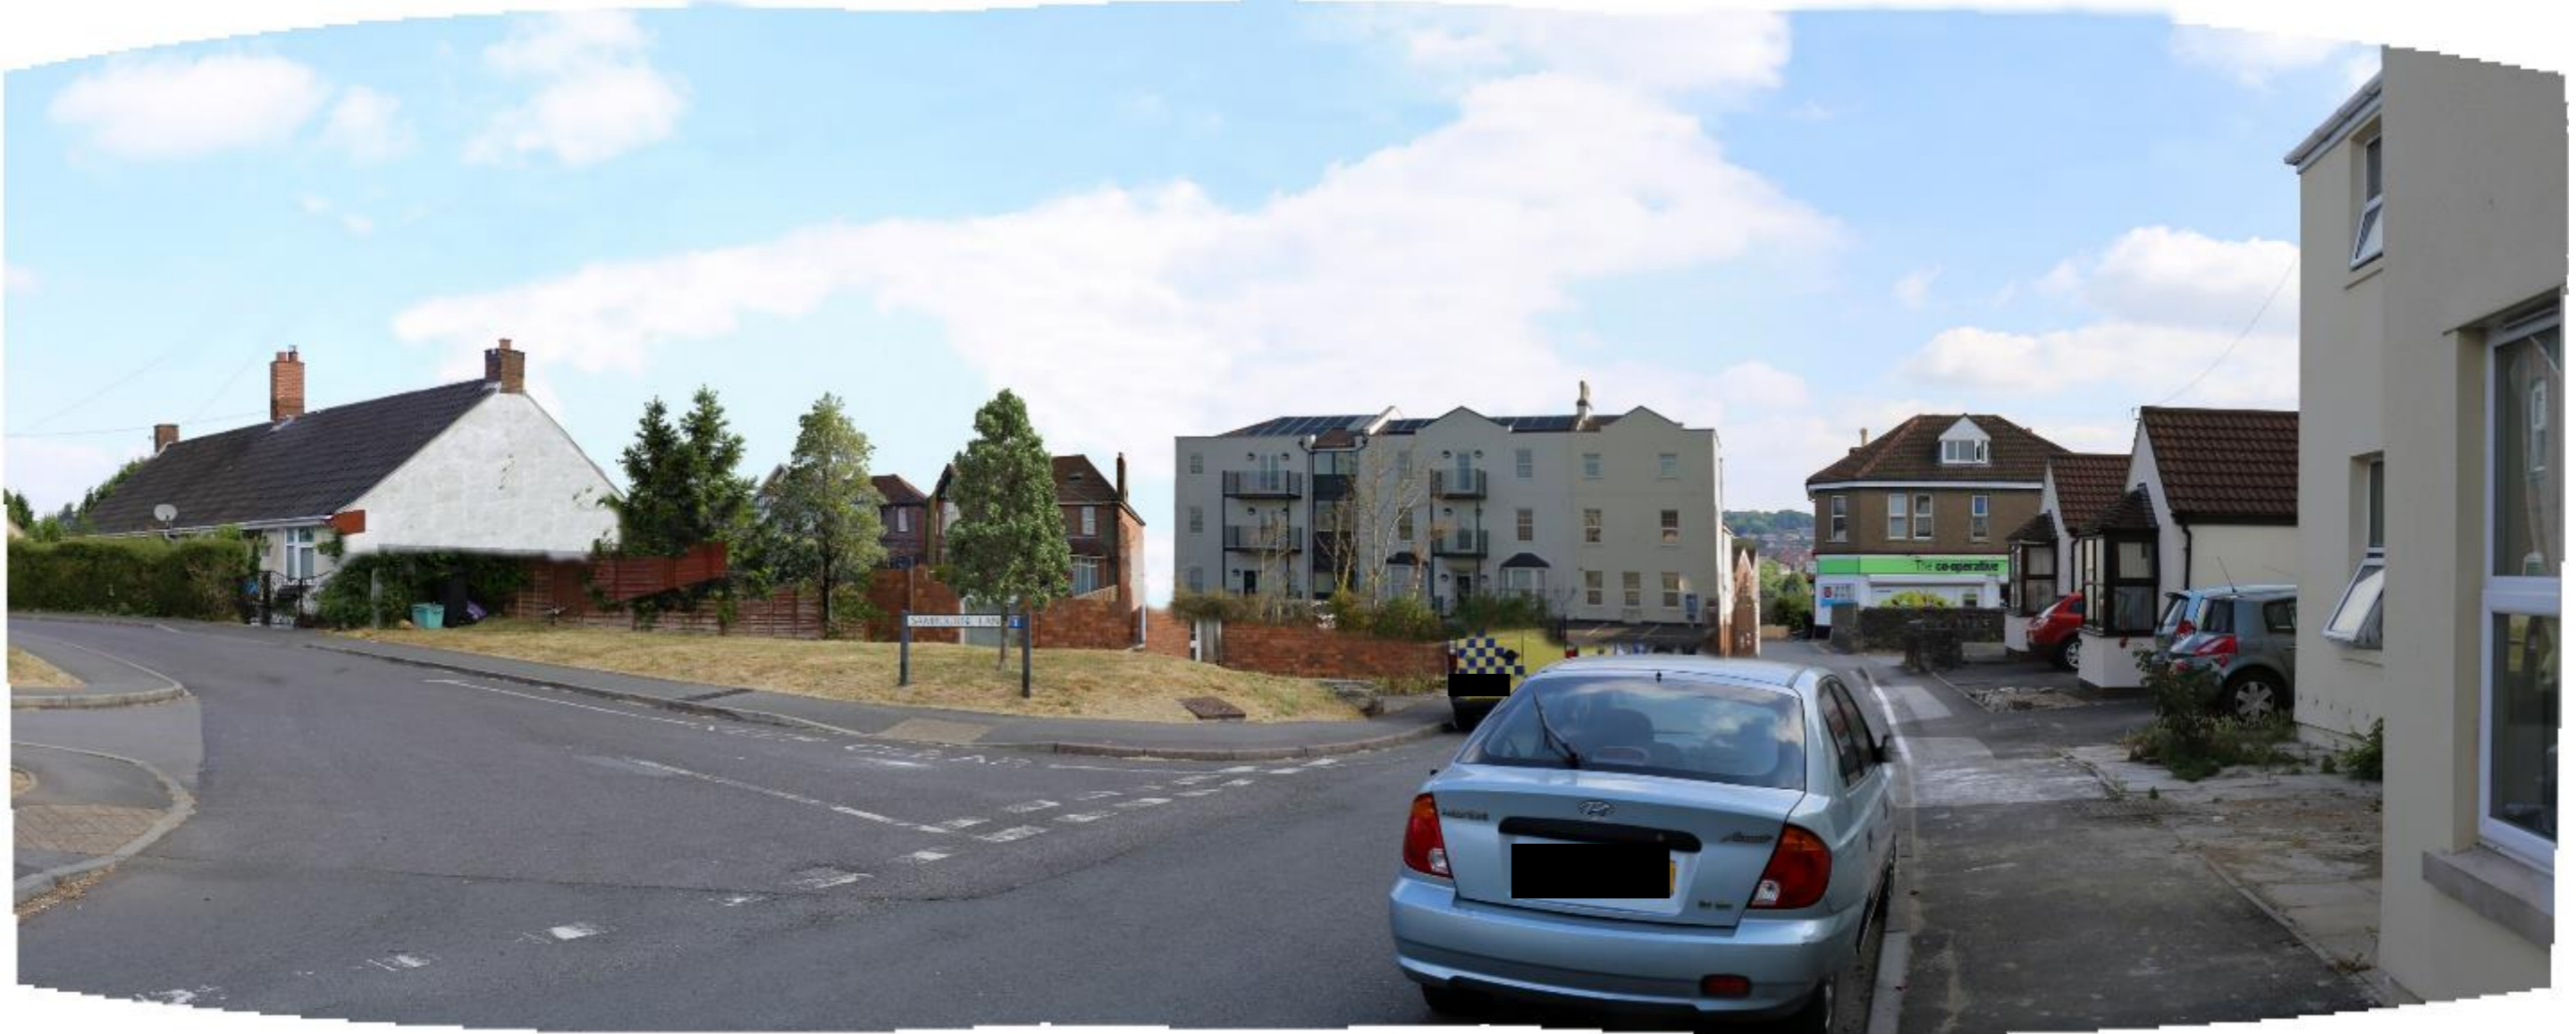
3.2.3 Photomontage stage in progress with some of the model being removed to expose existing buildings to match features.

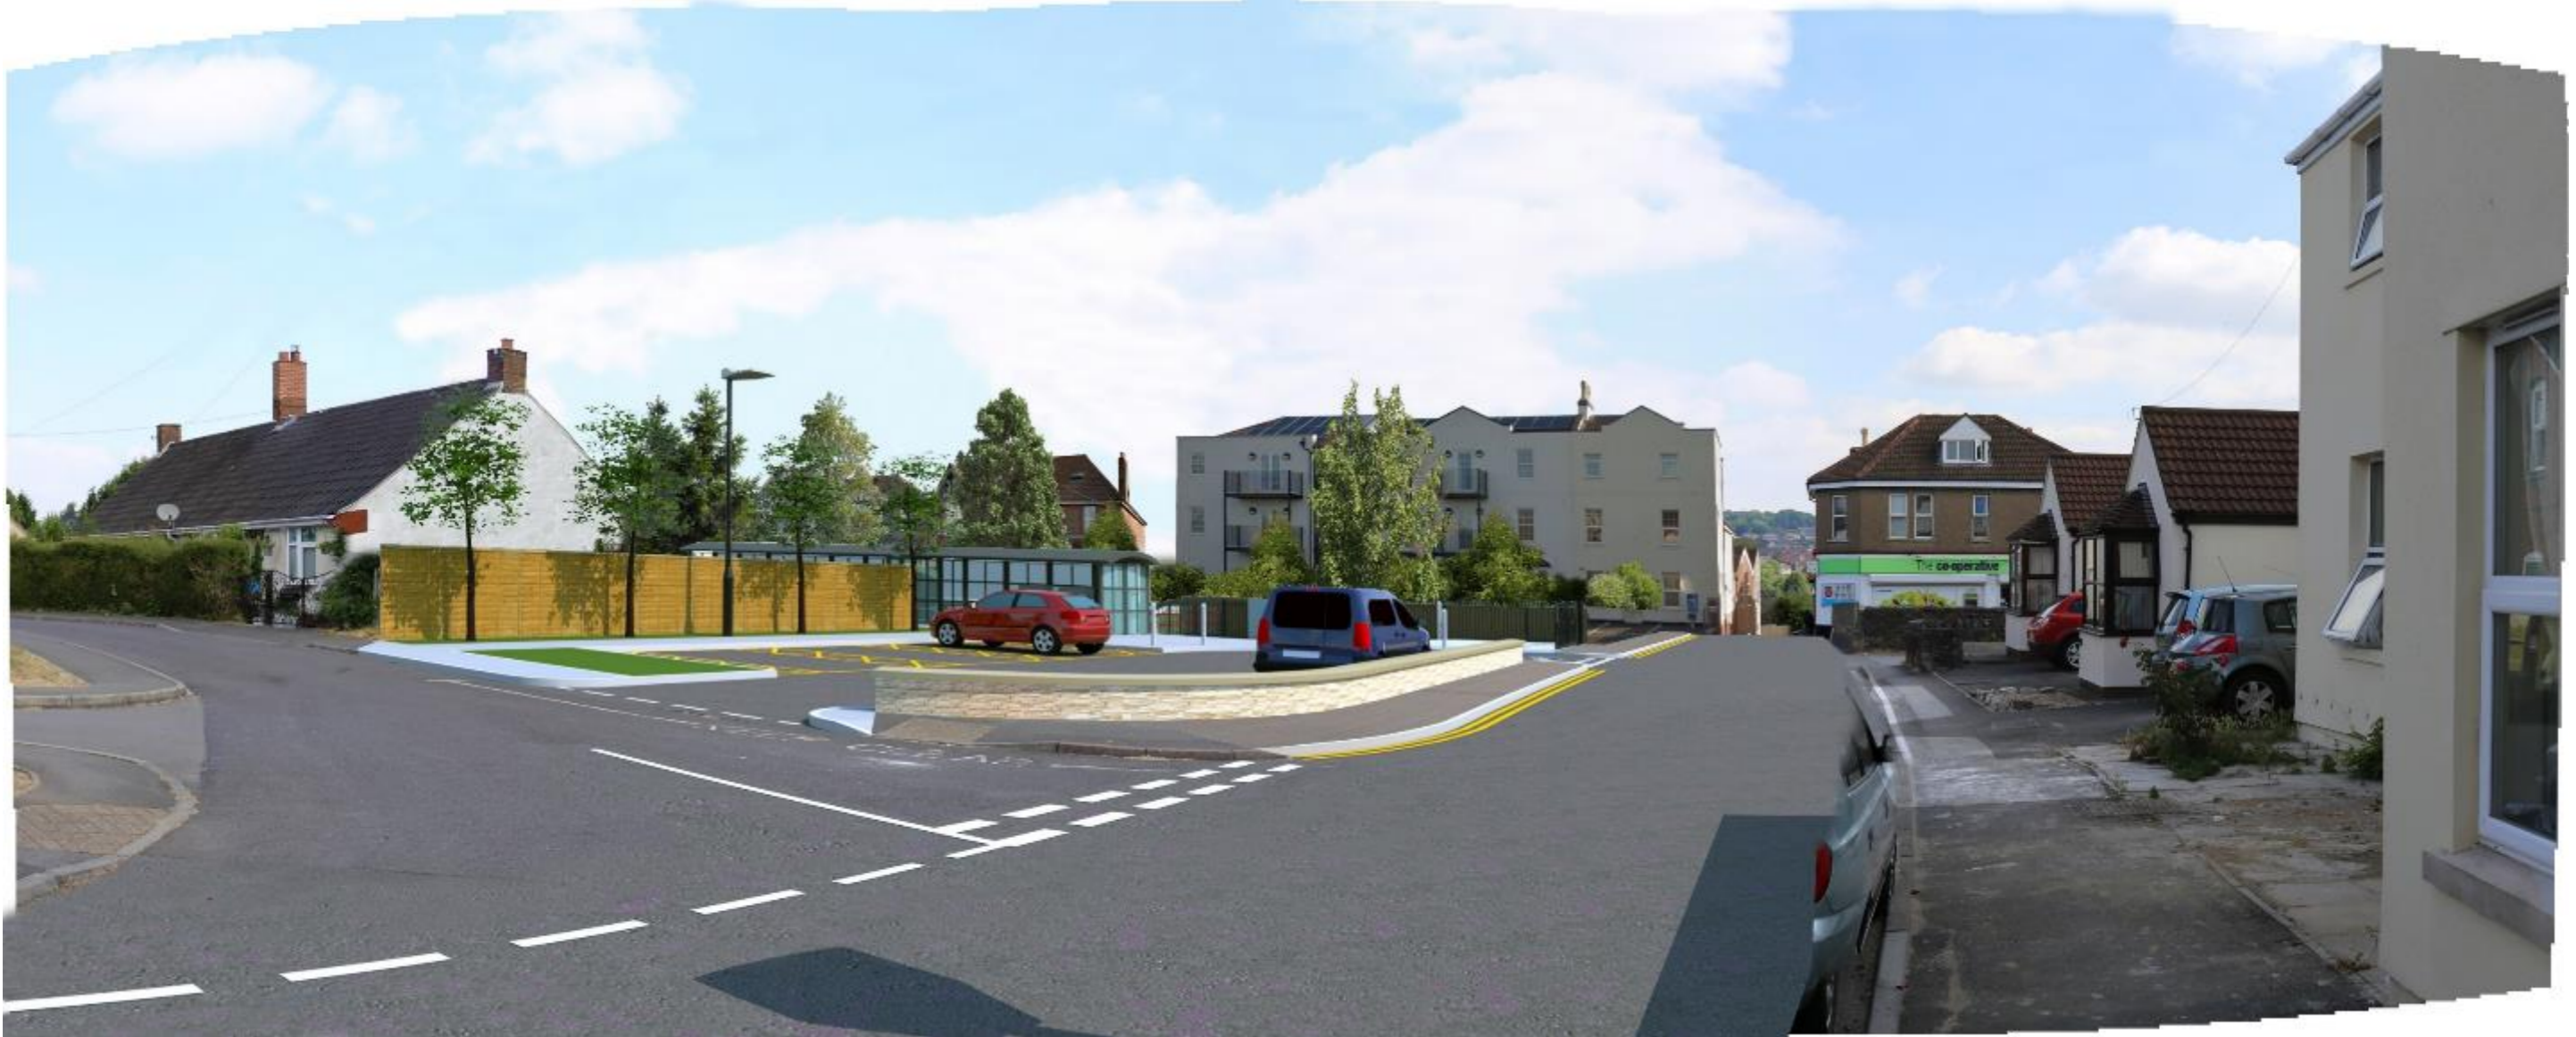
3.2.5 Photomontage stage in progress. Localised adjustments are made to the 'flat' 3D digital model, e.g. kerb lines, to match the existing adjacent ground levels.

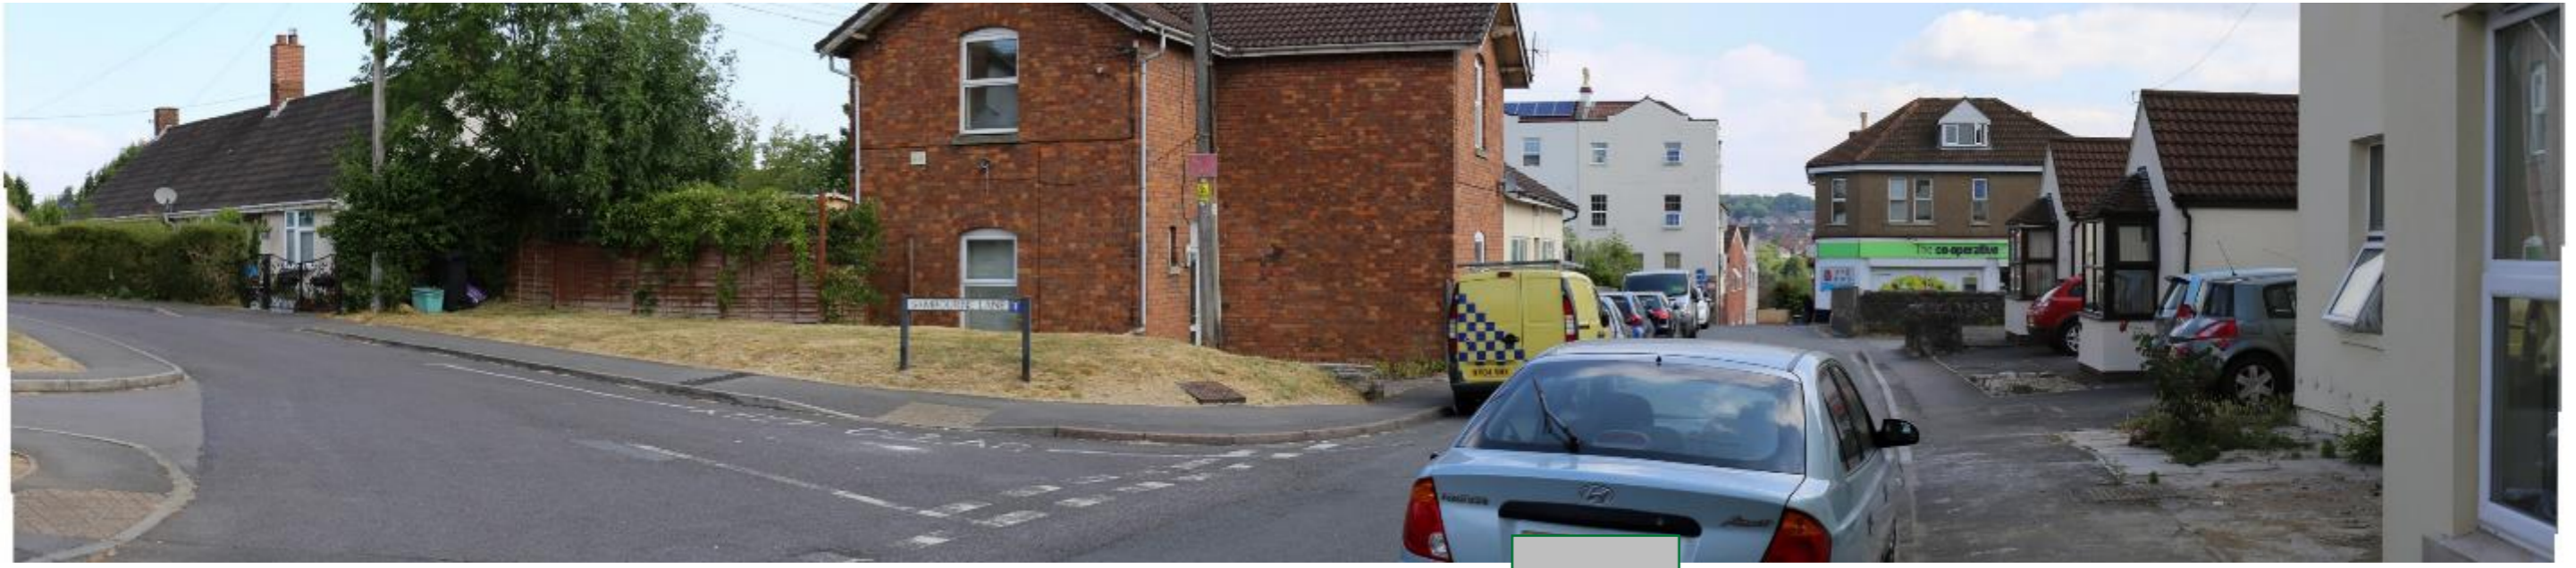
3.2.6 Existing photograph.

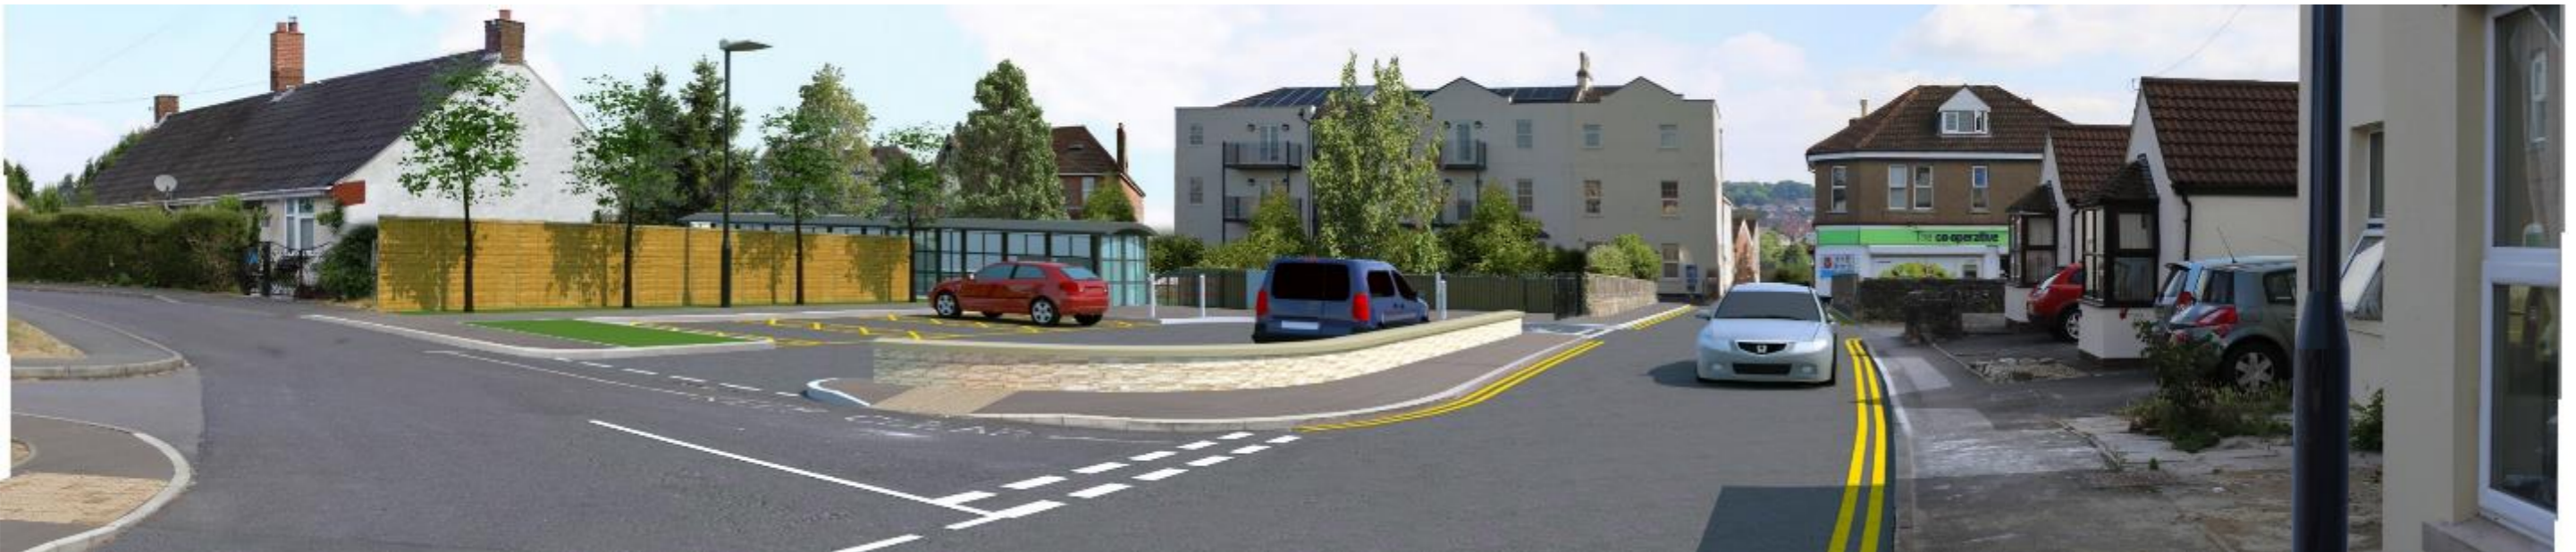
3.2.7 Photomontage 7

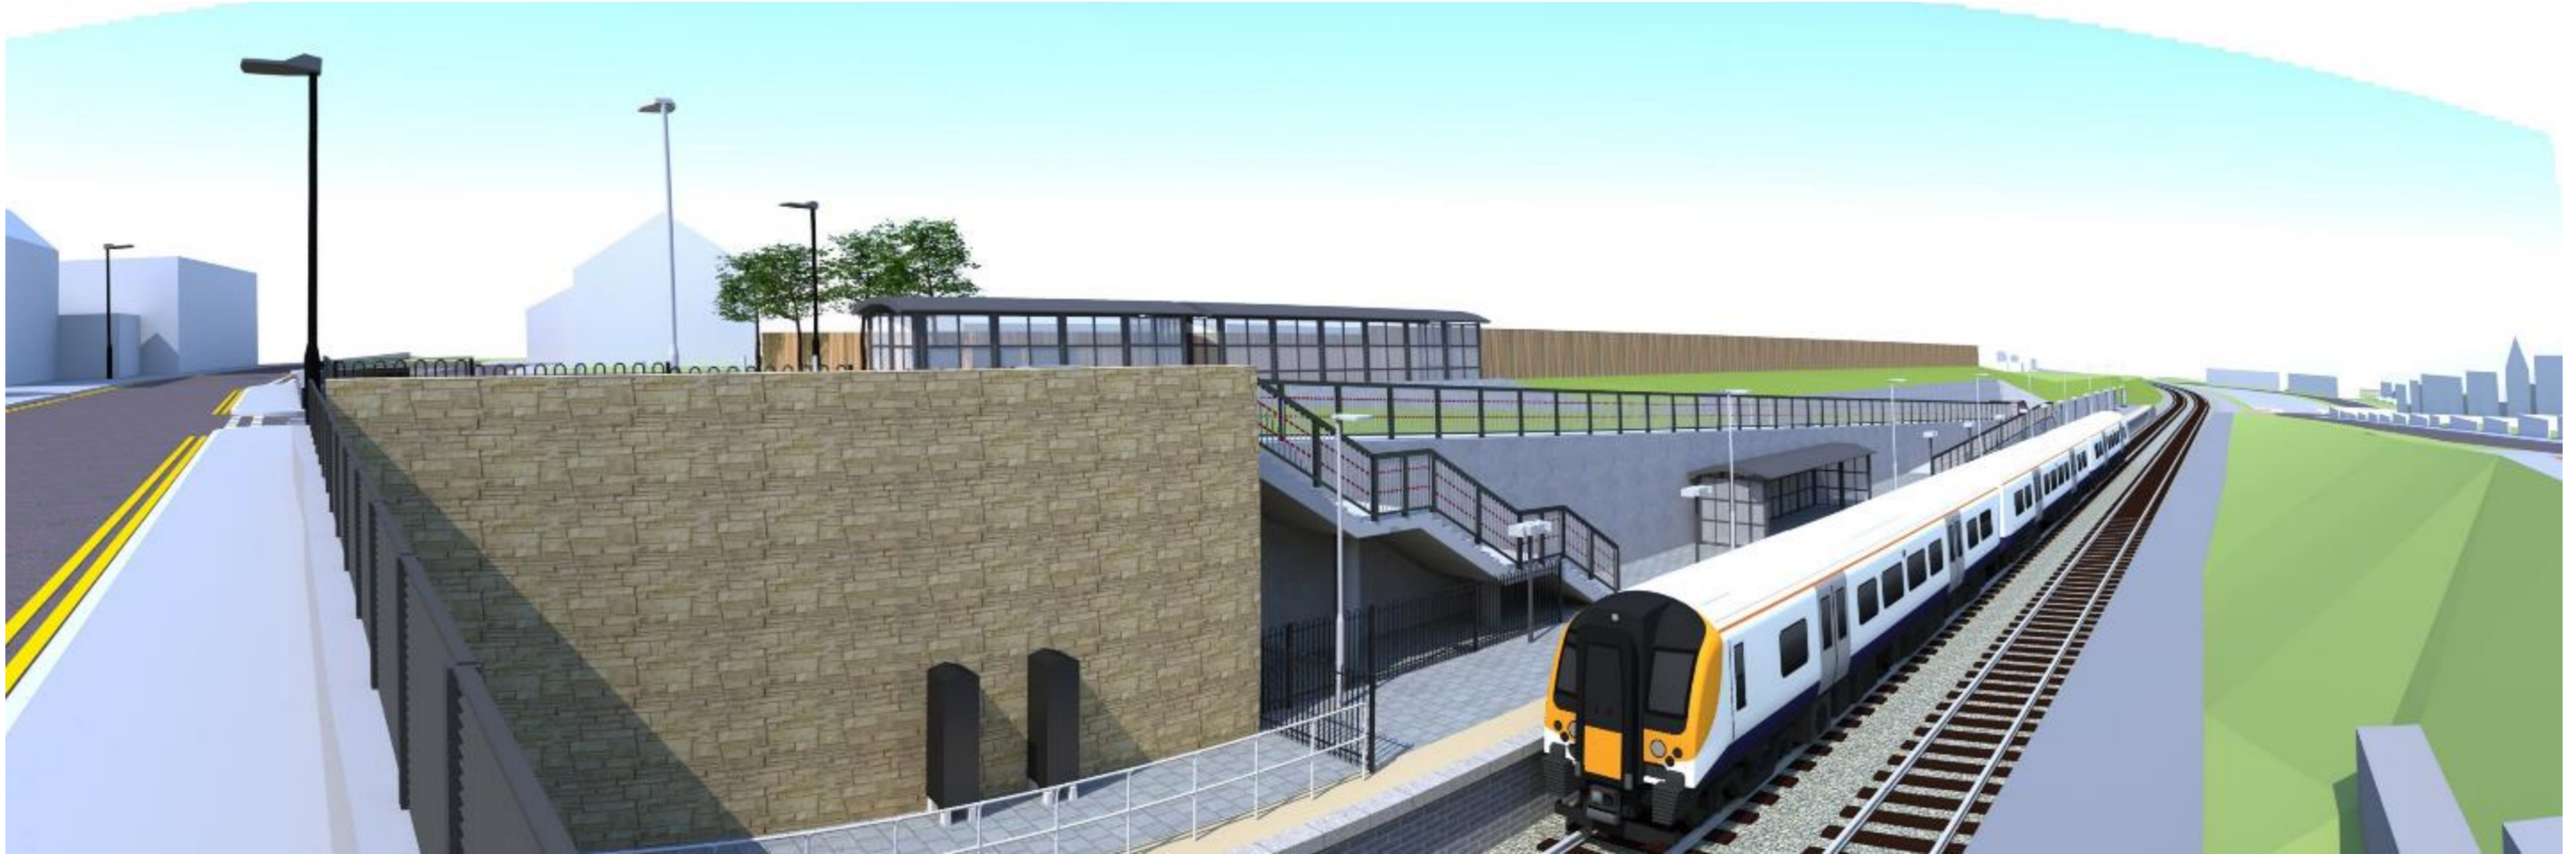
3.3.2 The image below shows the SketchUp rendered image being matched on top of the existing photograph in Photoshop.

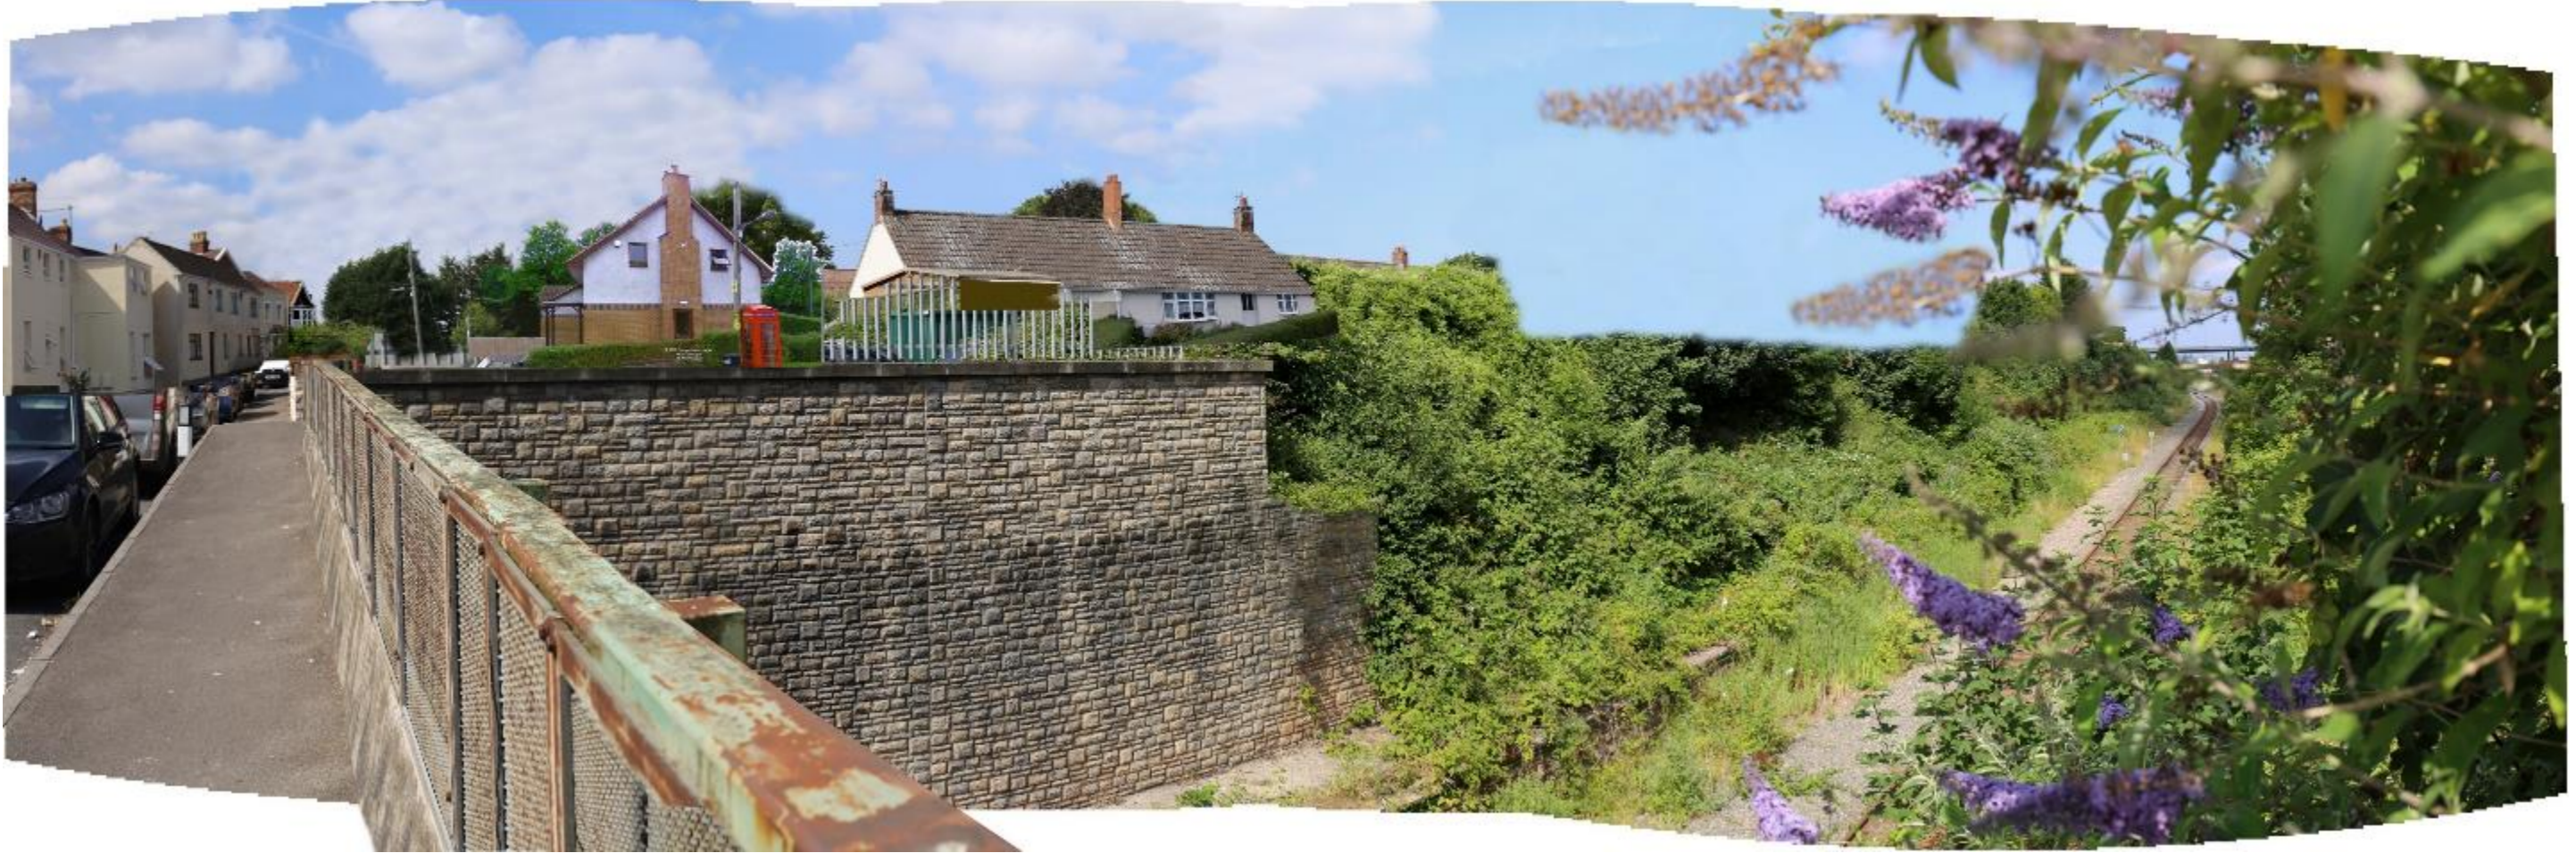
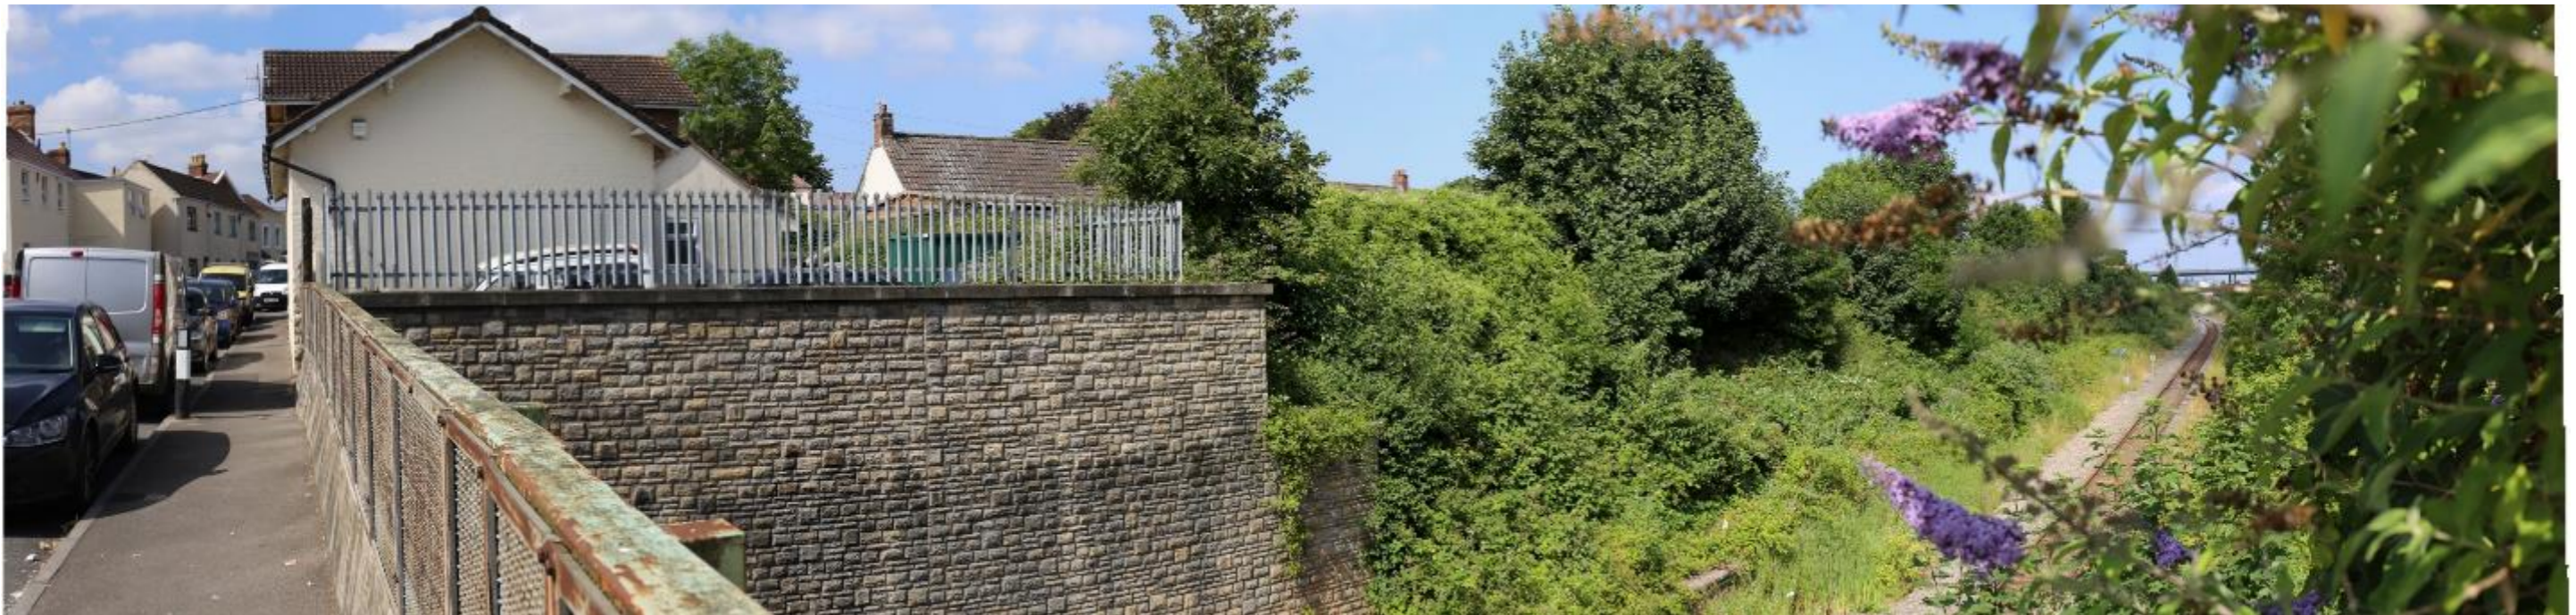
3.3.3 Some of the model render image being removed to expose existing buildings to match features between model and existing photograph.

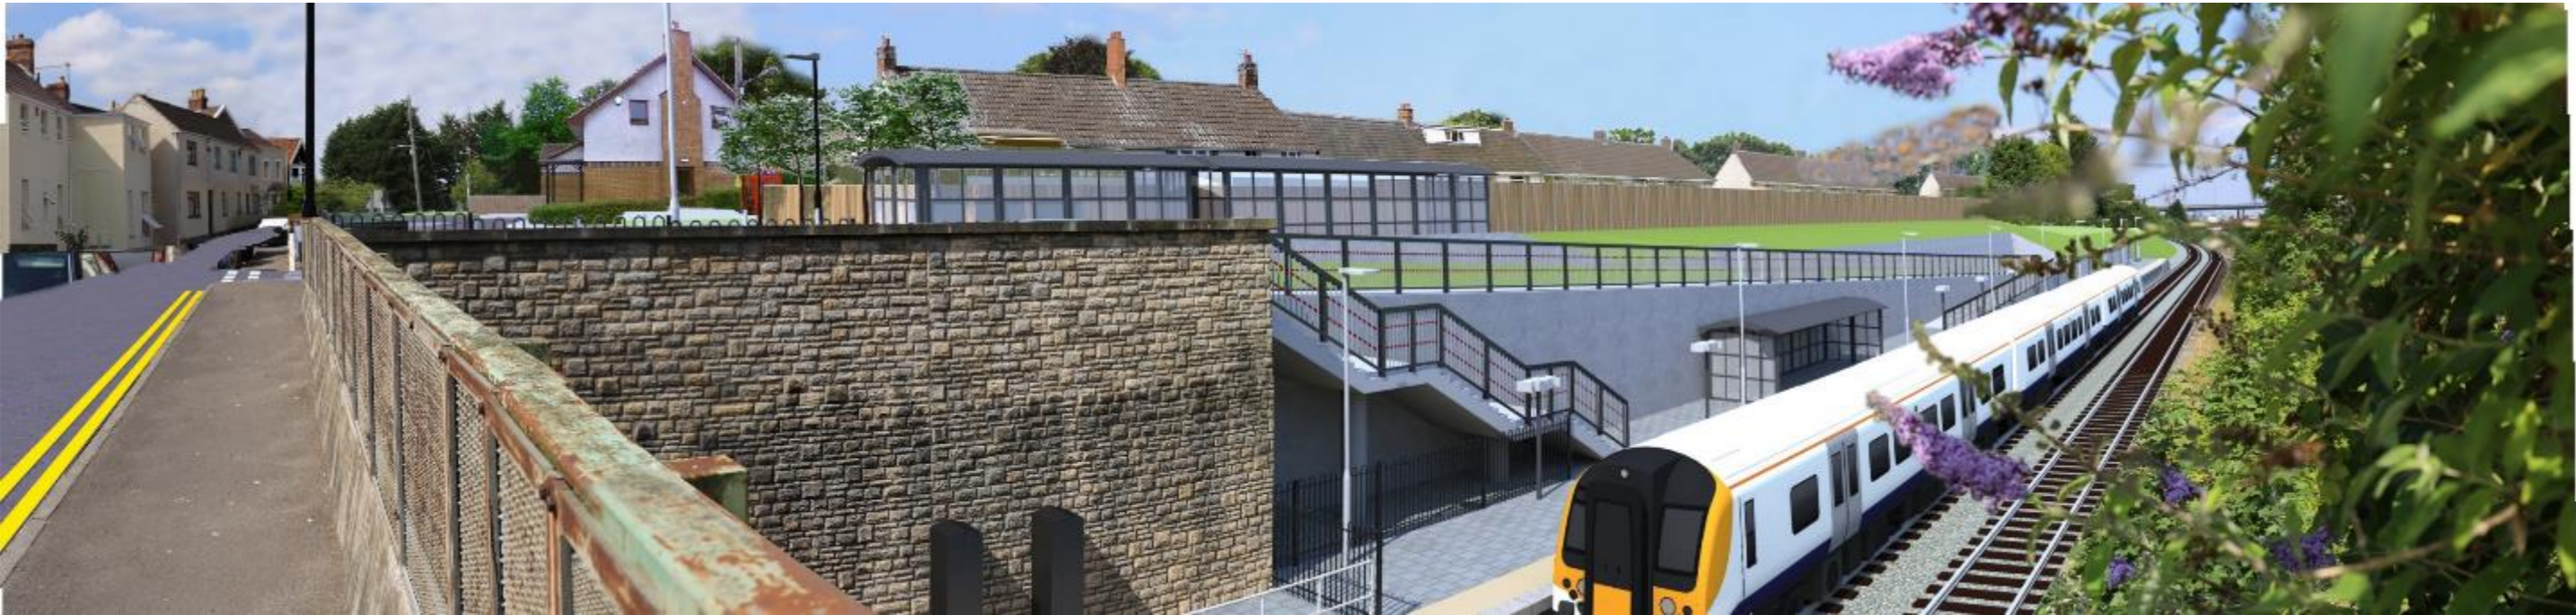
3.3.4 Photomontage 8

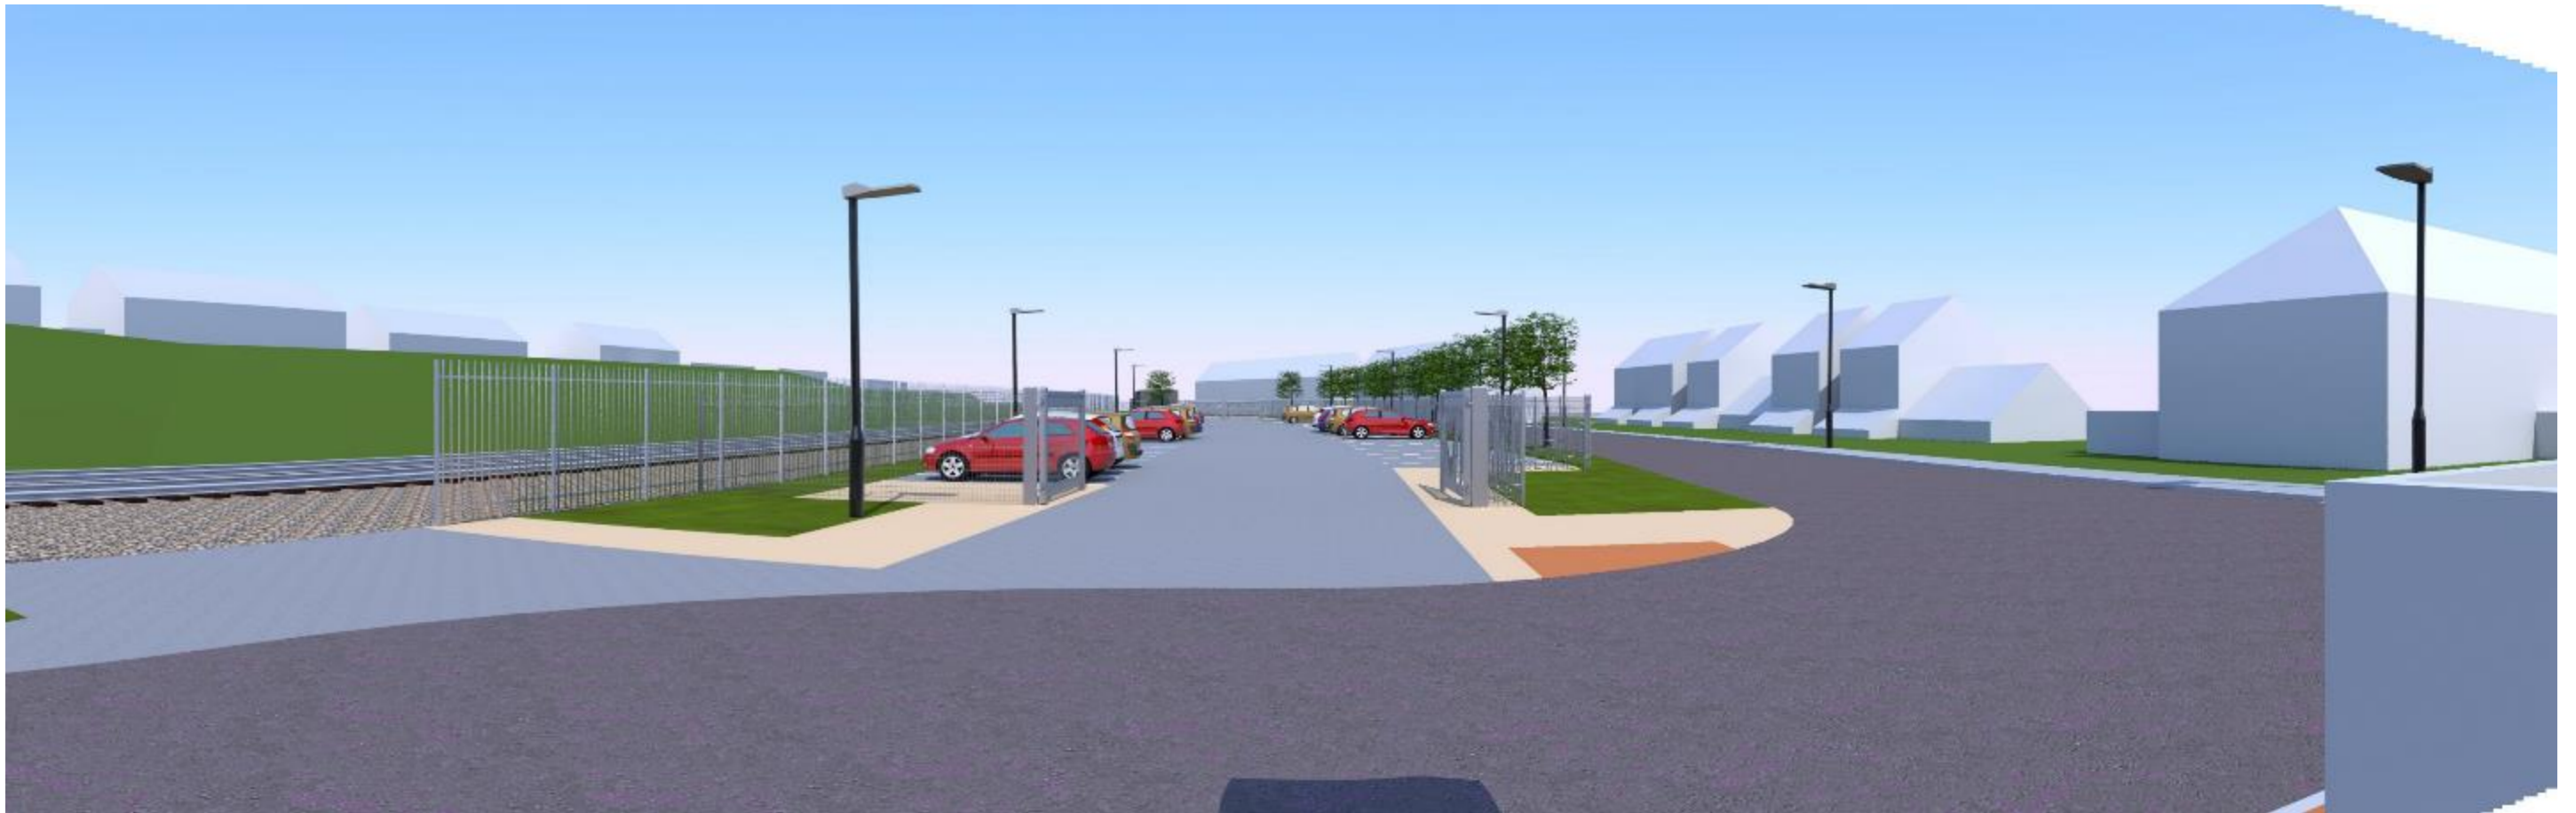
3.4.2 The image below shows the SketchUp rendered image being matched on top of the existing photograph.

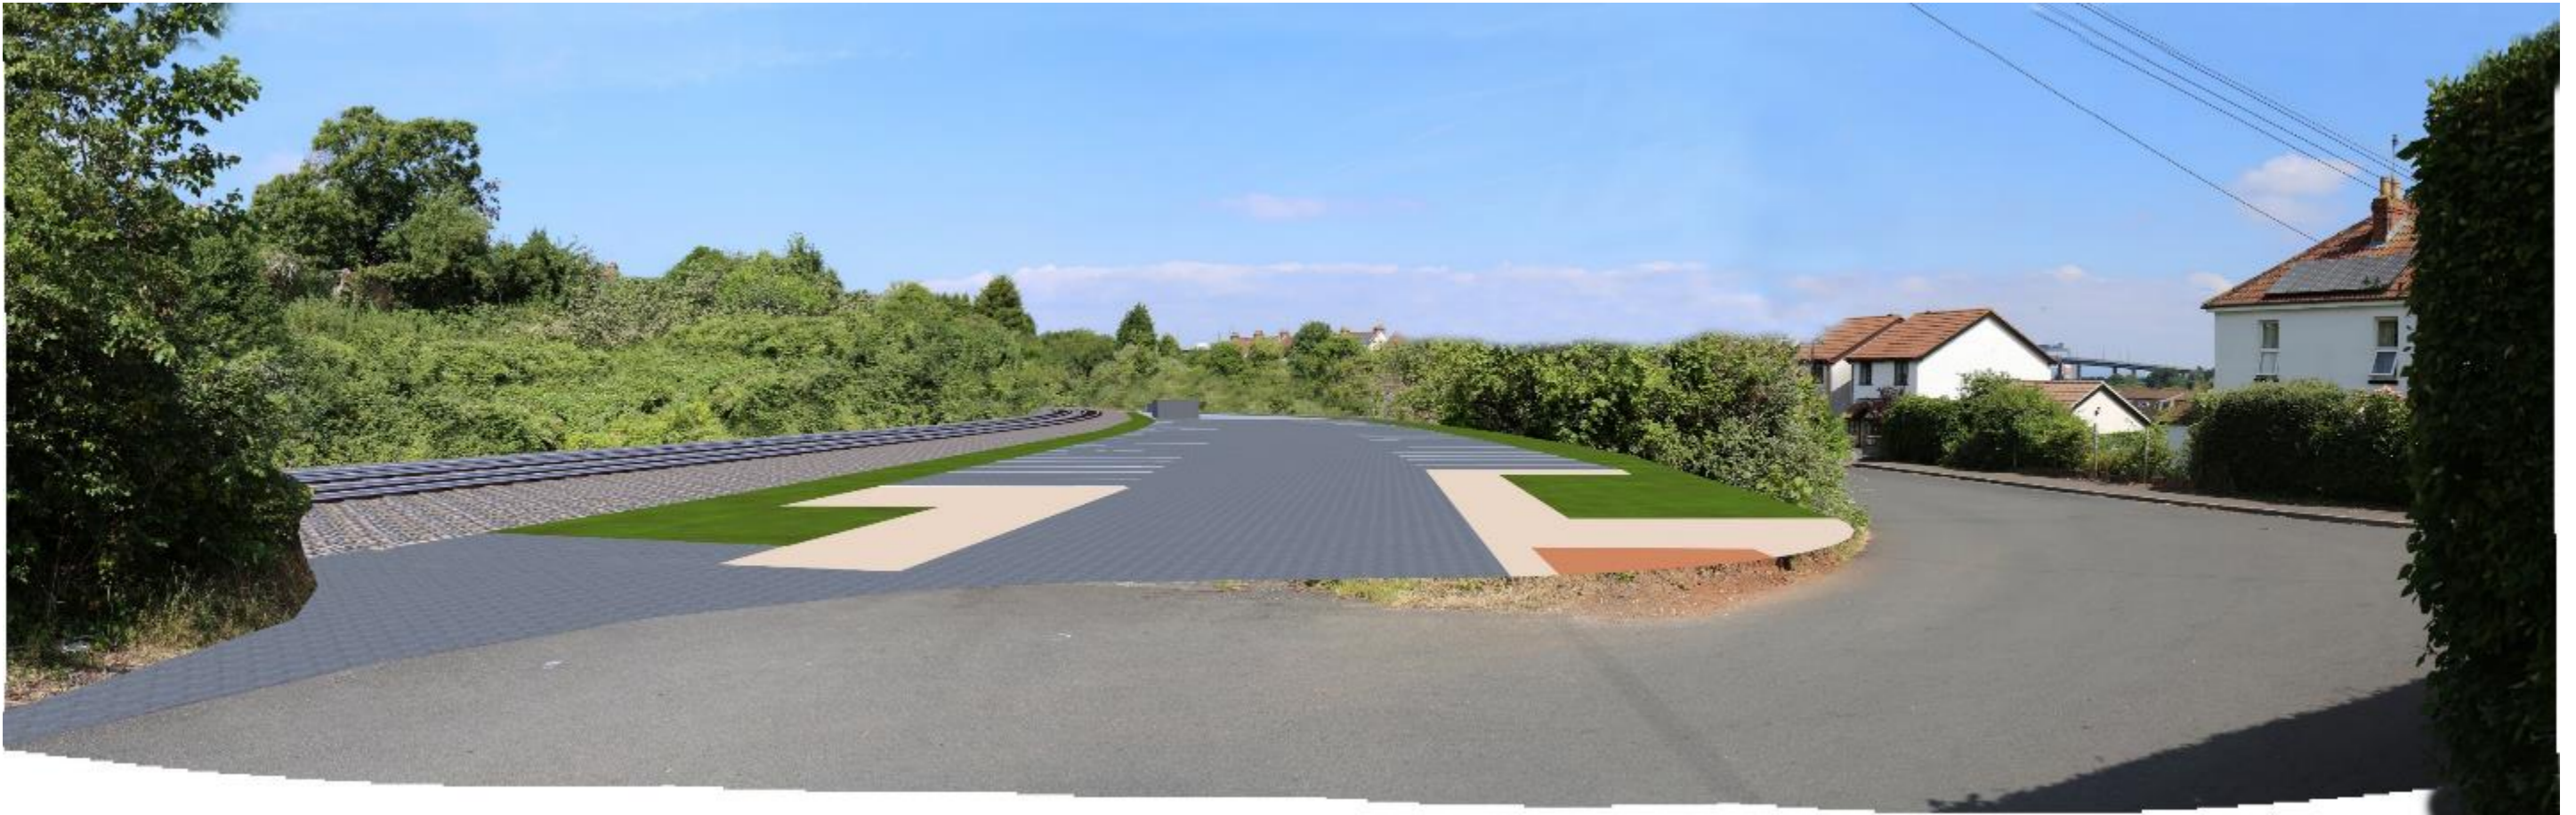
3.4.4 Photomontage stage in progress with the 'flat' 3D digital model surface level adjusted to fit existing levels.
