# MetroWest+

## Portishead Branch Line (MetroWest Phase 1)

**6.25, Environmental Statement, Volume 4, Appendix 11.3 and 11.4 Landscape and Visual Impacts Assessment  
The Infrastructure Planning (Applications: Prescribed Forms and Procedure) Regulations 2009, regulation 5(2)(a)  
Planning Act 2008**

**6.25, Environmental Statement, Volume 4, Appendix 11.3 Visual Impact Assessment**

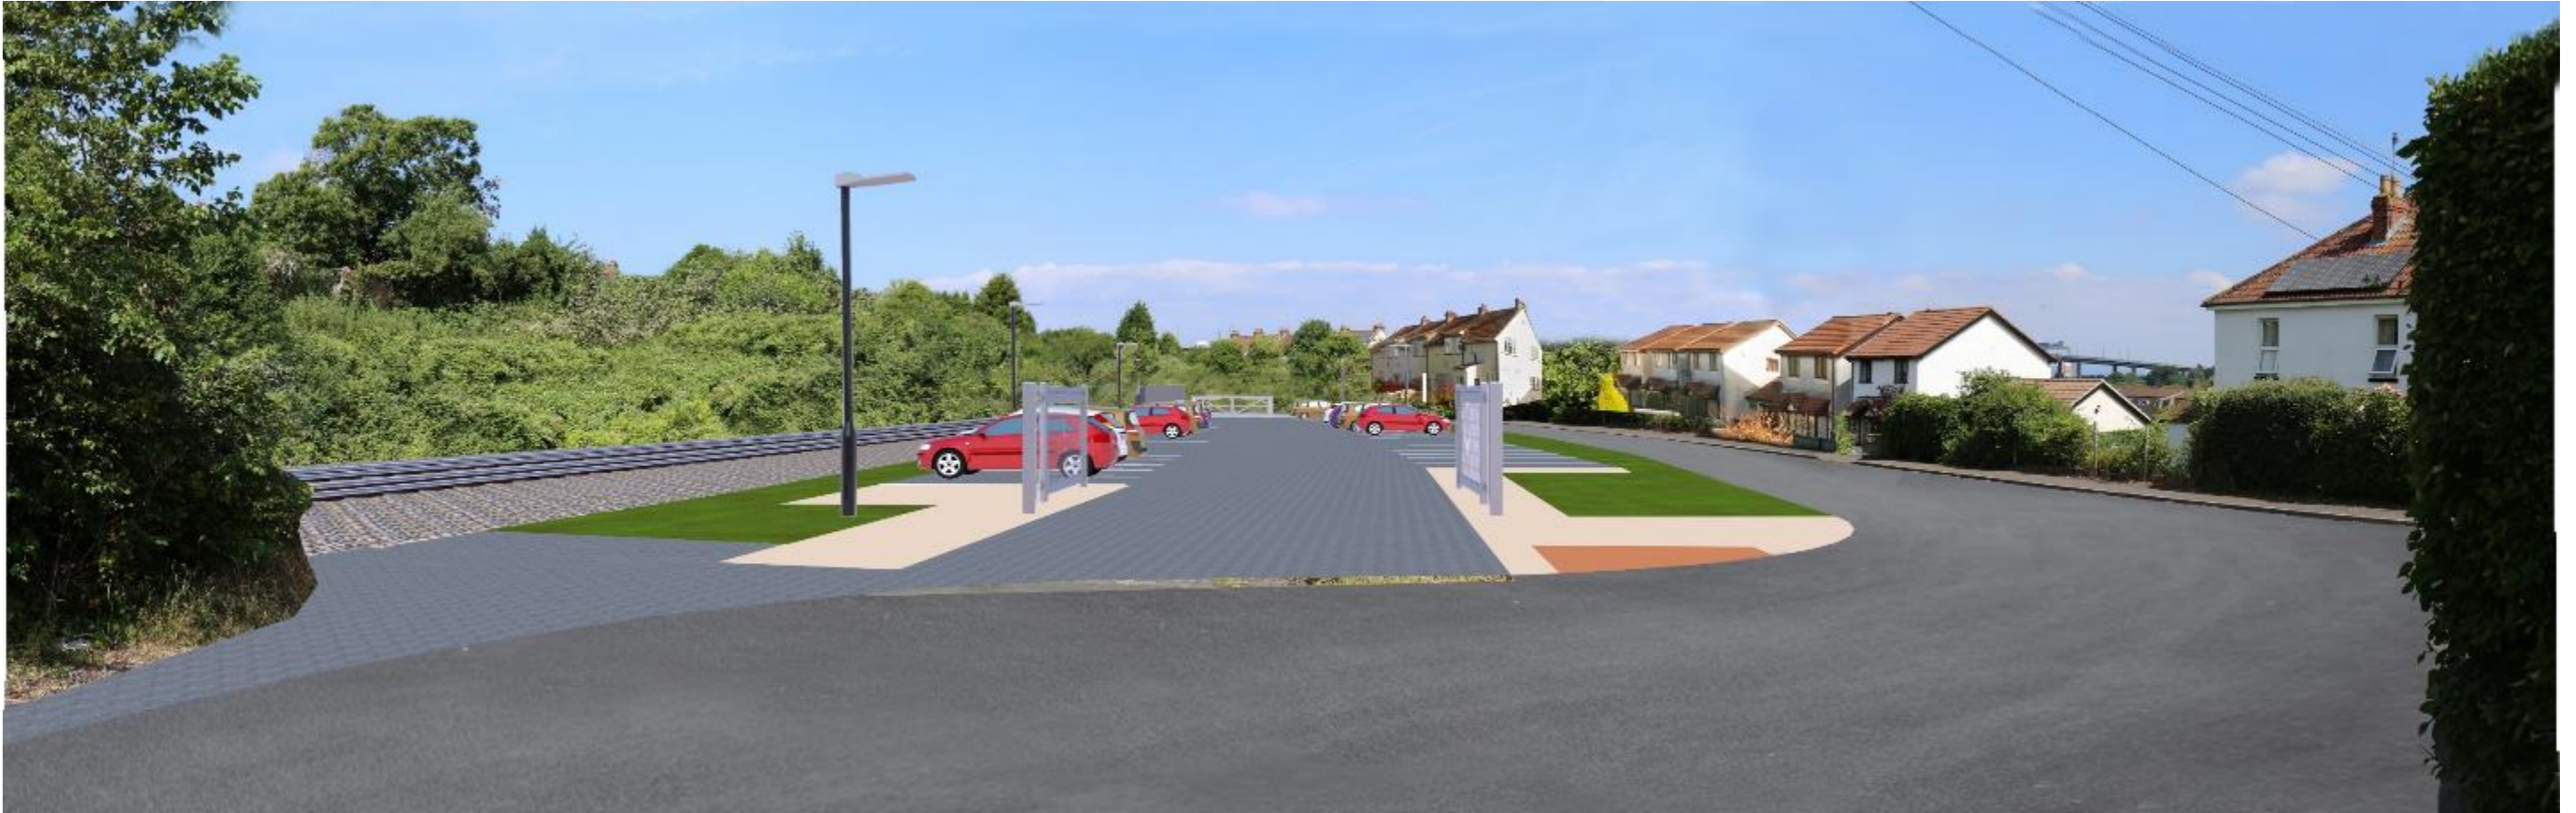
3.4.6 Additional render showing supplementary detail such as cars, fences and gates.

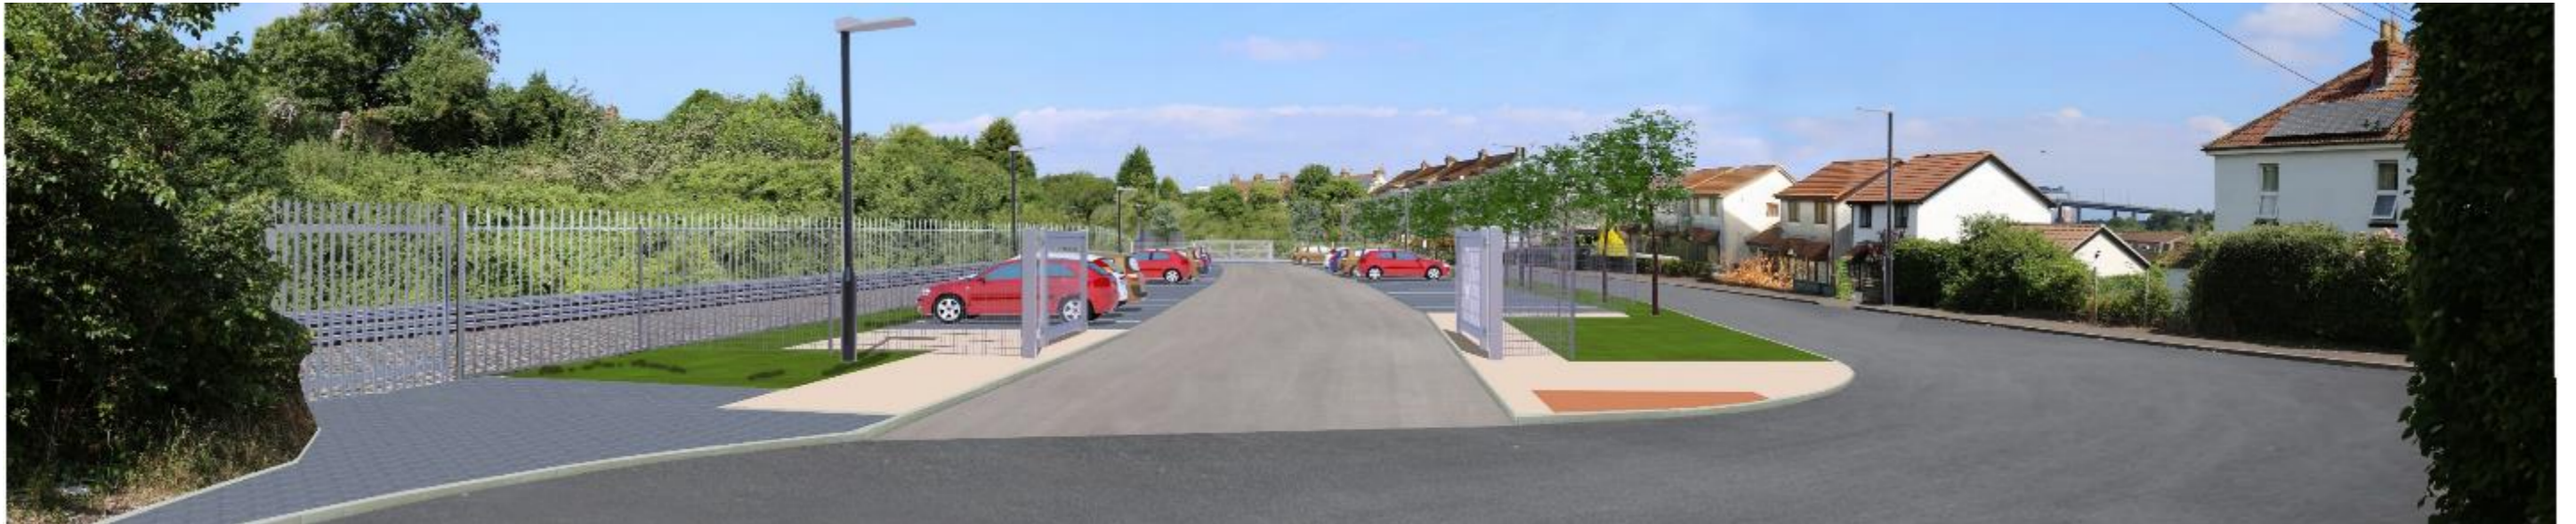
3.4.7 Photomontage stage in progress.

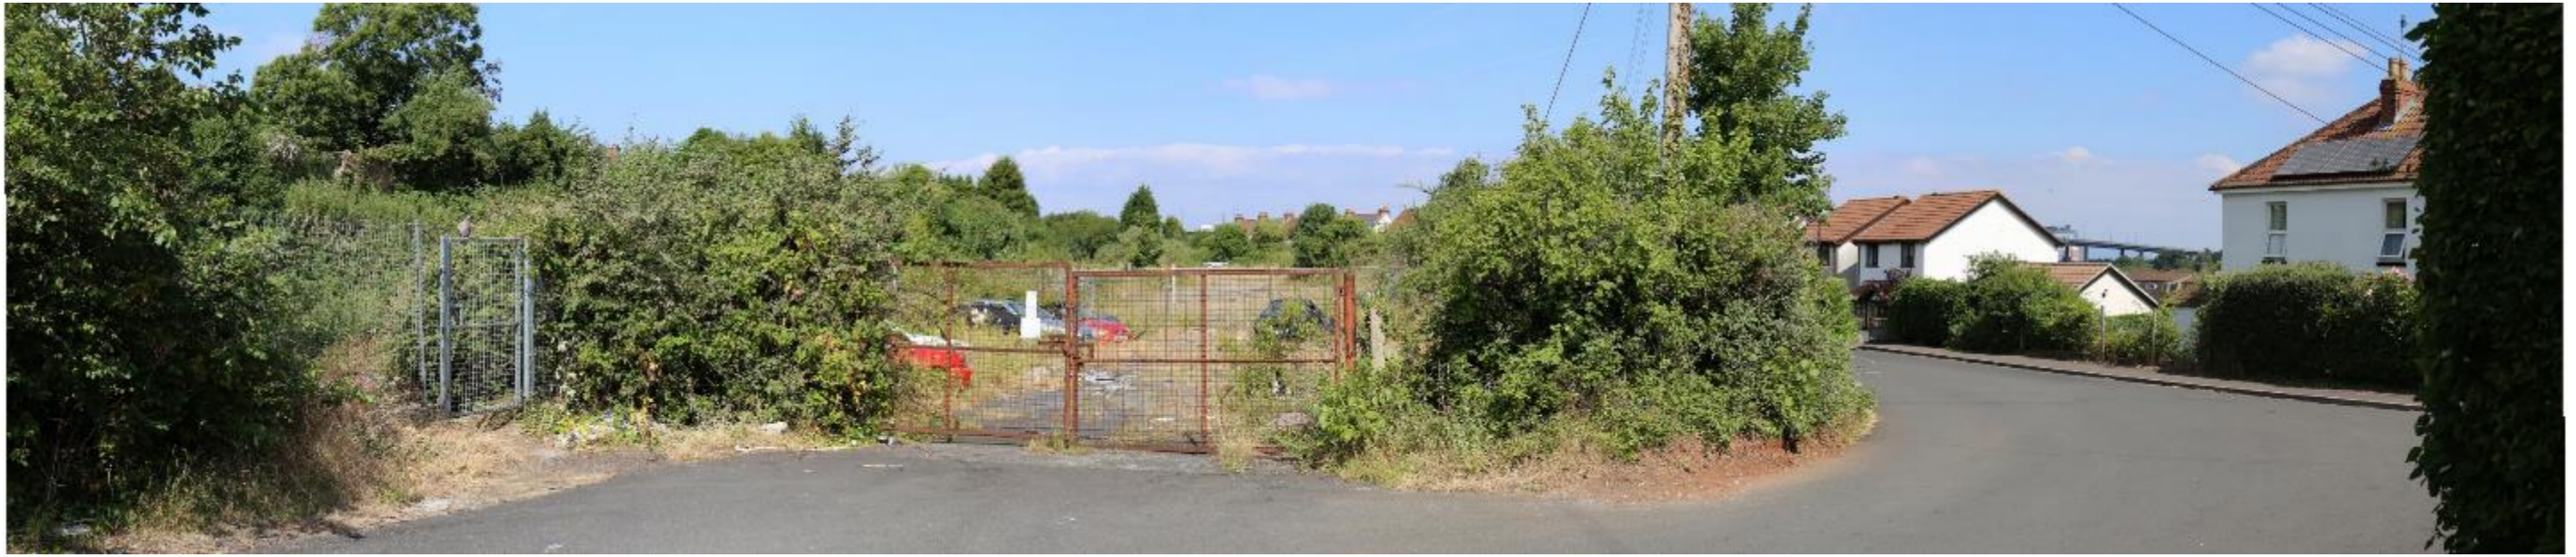
3.4.8 Existing Photograph

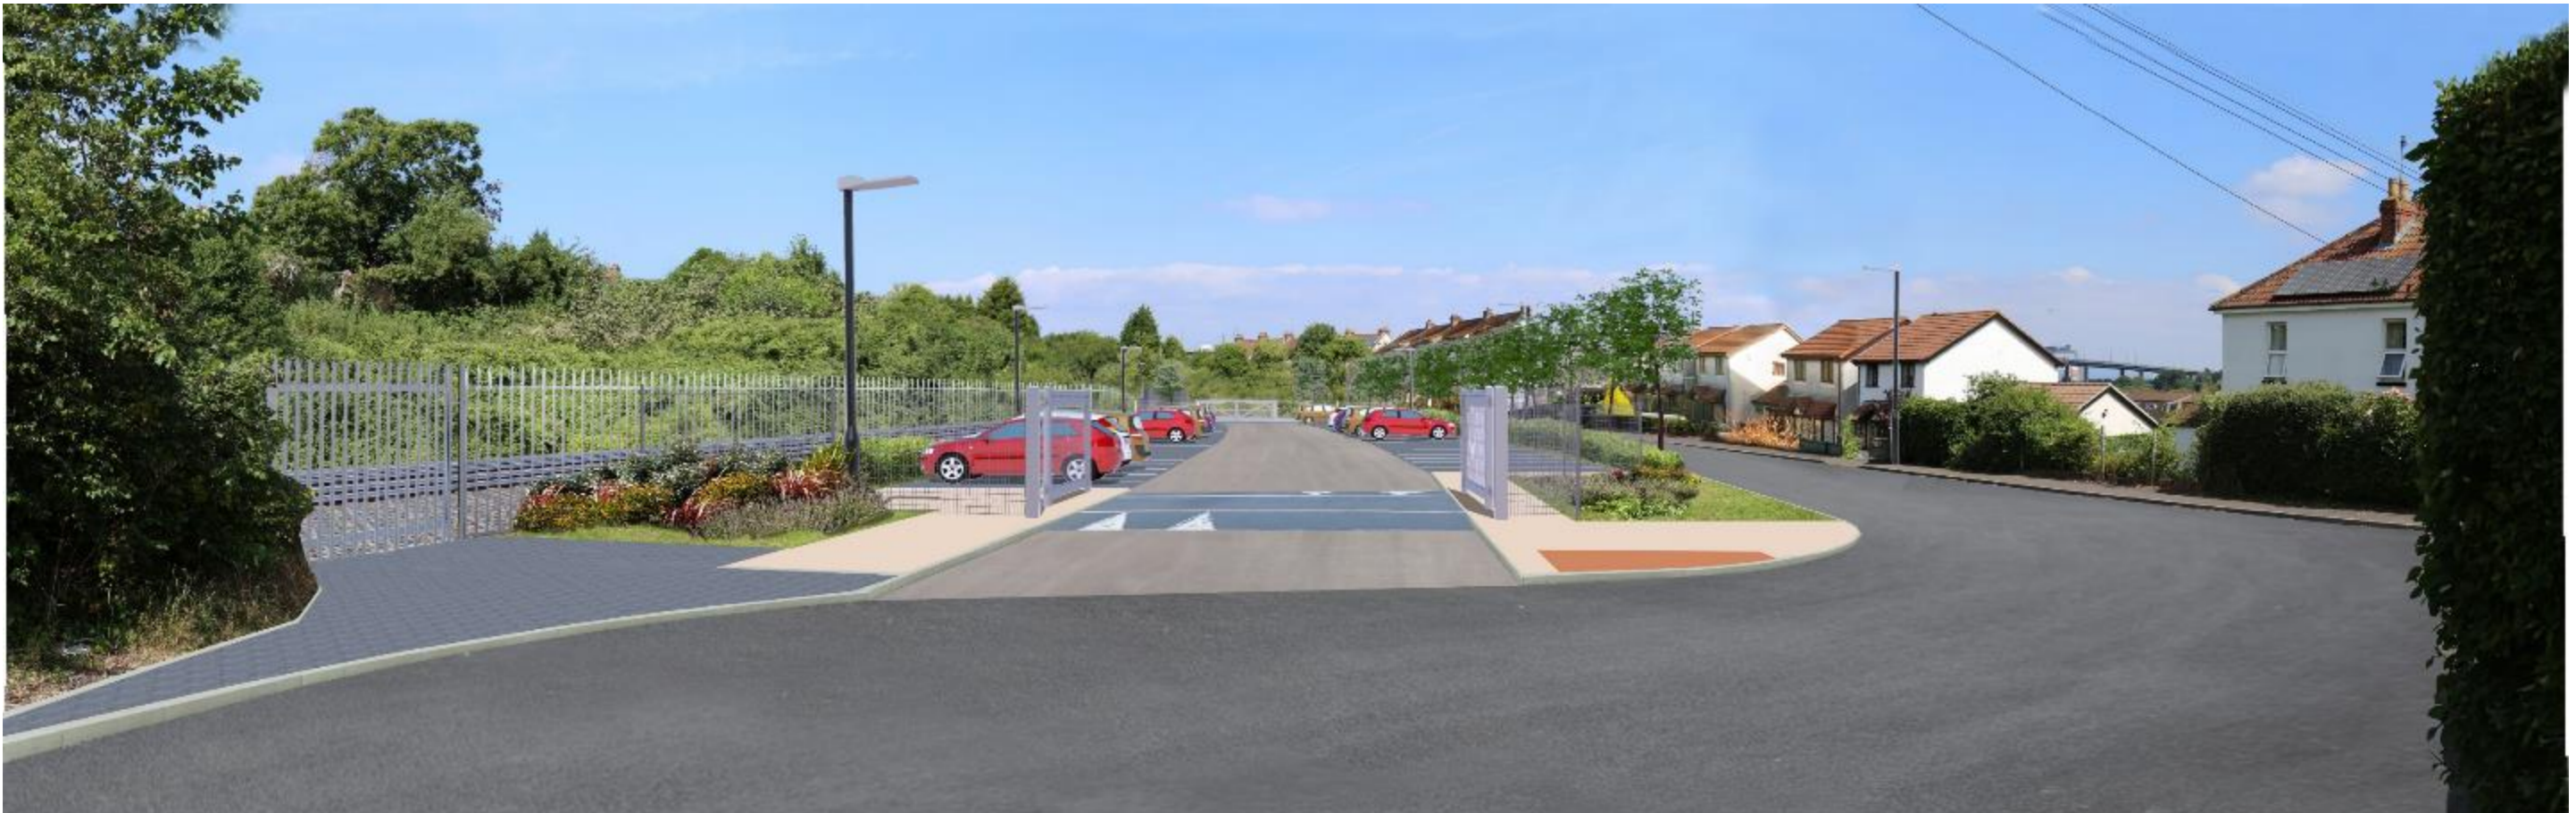
3.4.9 Photomontage 9. This view assumes the worse case situation in which the existing hedgerow around the site has to be removed and new vegetation replanted.
