Appendix 3 Personal Injury Accident Assessment Technical Note

M1J15 NORTHAMPTON GATEWAY
STRATEGIC RAIL FREIGHT INTERCHANGE

PERSONAL INJURY ACCIDENT ASSESSMENT
TECHNICAL NOTE

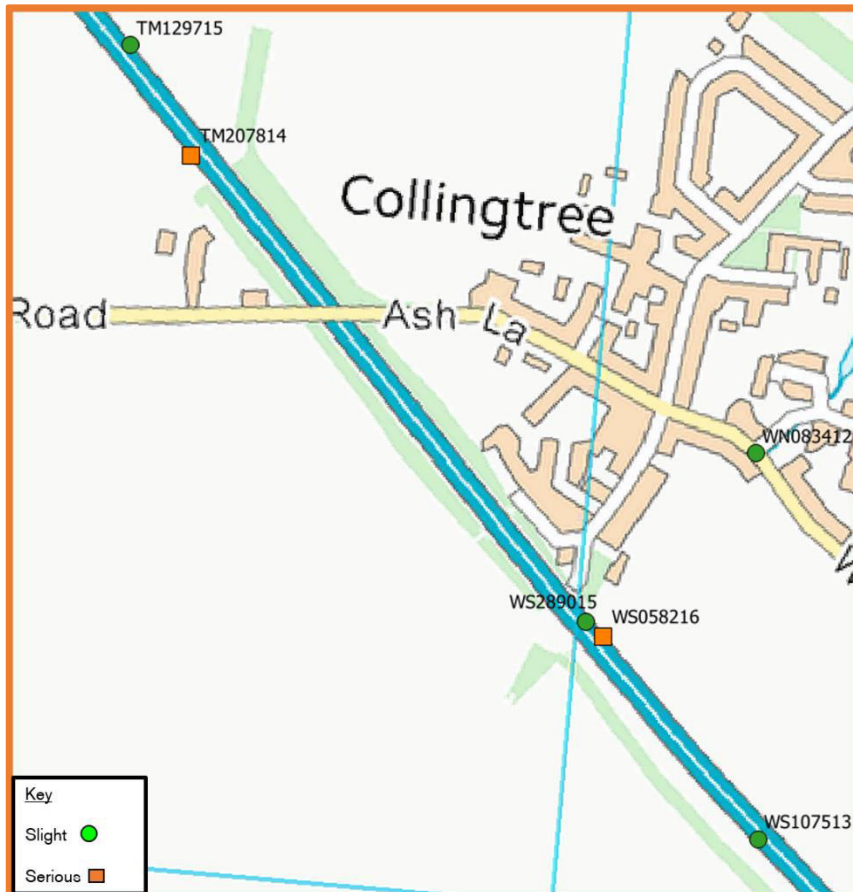
Figure 3: location of respective accidents in along the M1 – north of M1 J15

- 3.1 As shown in **Figures 3 and 4**, a total of five and 17 accidents occurred north and south of M1 J15 respectively. 17 PIAs were classified as slight severity, four were categorised as serious and the remaining accident resulted in a fatality. **Table 3** provides a casualty breakdown of the 22 recorded PIAs at the study area.

3.8 In summary, as **Figures 3 and 4** illustrate, the respective accidents of the study area are located sporadically apart from the cluster of three accidents as shown in **Figure 4**, travelling southbound along the M1. The accidents were a combination of rear end collisions and driver error which is a reflection of the busy nature of this stretch of motorway, where the likelihood of driver error and rear end shunts increases due to high speeds and stop/start caused by congestion and roadworks.

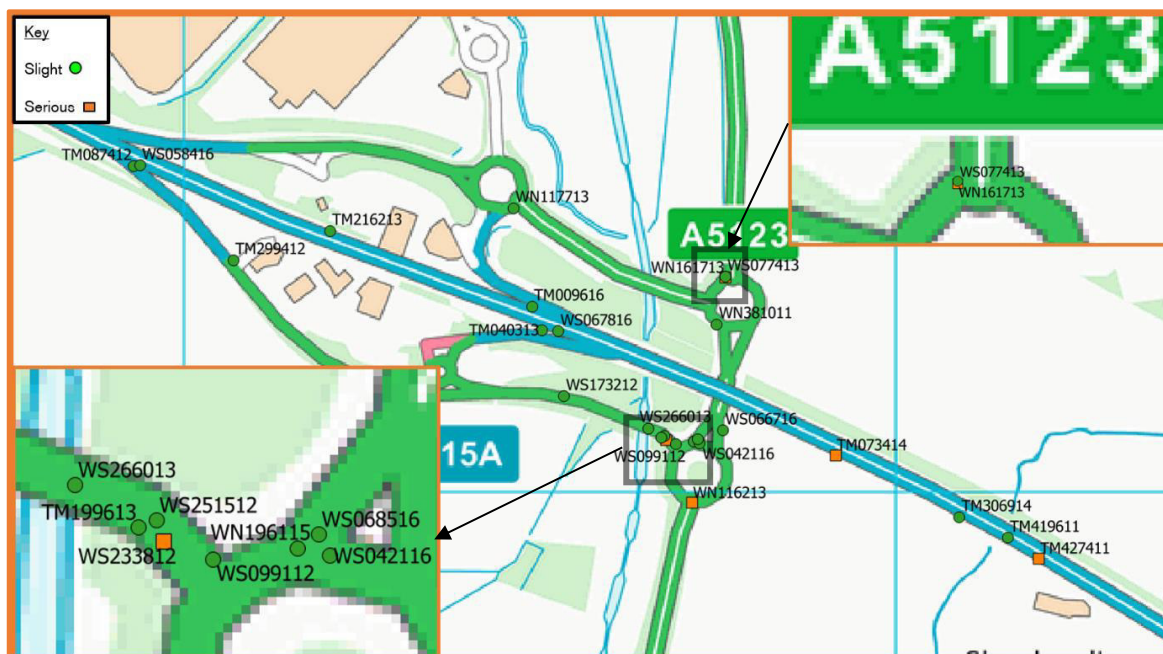
Figure 5: location of respective accidents in study area

4.1 As shown in **Figure 5**, a total of 26 accidents occurred at the M1 J15A study area. 21 PIAs were classified as slight severity, and the remaining five were classified as serious in severity. **Table 4** provides a casualty breakdown of the 26 recorded PIAs at the study area.

4.4 There is however, a cluster of five accidents including two accidents already described above (WS233812, WS266013) which occurred at the western arm of the A43/M1 roundabout of J15A as shown in the bottom inset of **Figure 5**:

4.5 Further, there is also a small cluster of three accidents located at the northern arm of the A43/M1 roundabout as shown in the bottom inset of **Figure 5**:

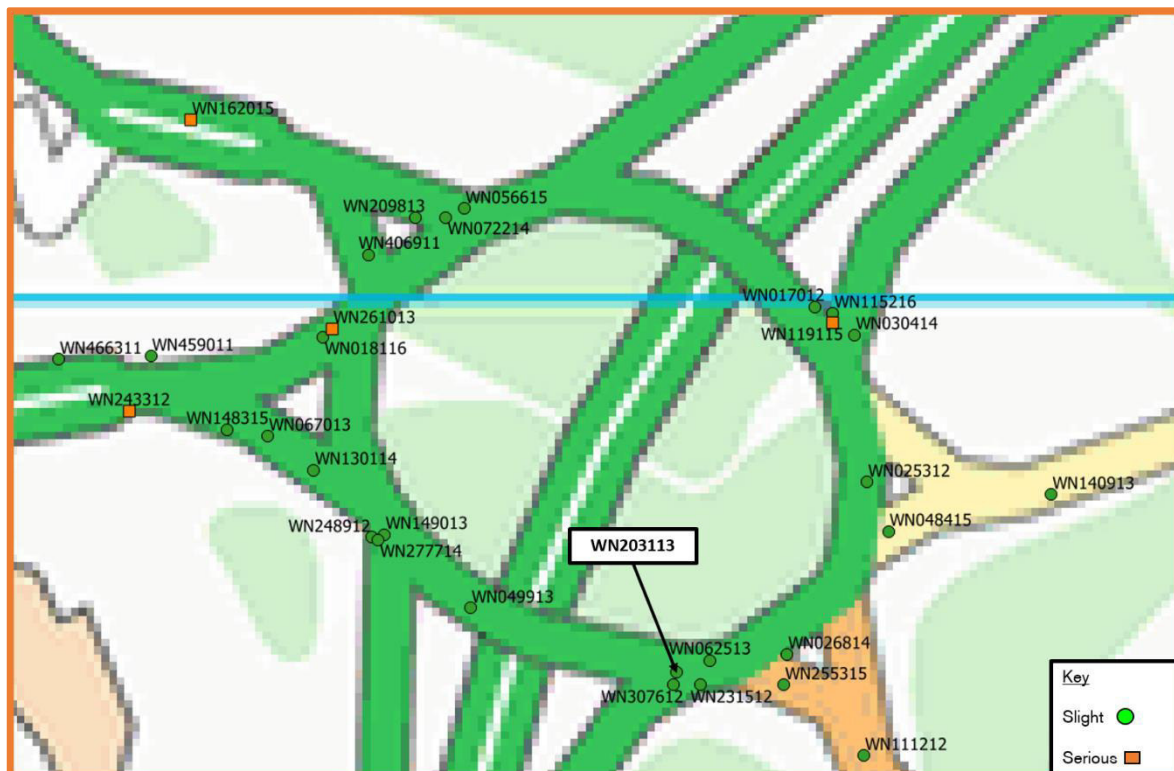
Figure 7: location of recorded accidents at the Queen Eleanor Interchange

- 5.2 As shown in **Figure 7**, 31 of the 64 accidents within the study area occurred at the Queen Eleanor Interchange. 27 of the PIAs at the Queen Eleanor Interchange were slight in severity and the remaining four accidents were classified as serious severity. Whilst this appears a high number of PIAs, it is in line with the average expected over a 5-year period for a 6 arm junction such as this.

- 5.3 As shown in **Figure 7**, there is not a locational trend in the four accidents of serious severity at the Queen Eleanor Interchange. A summary of the four PIAs is provided below:

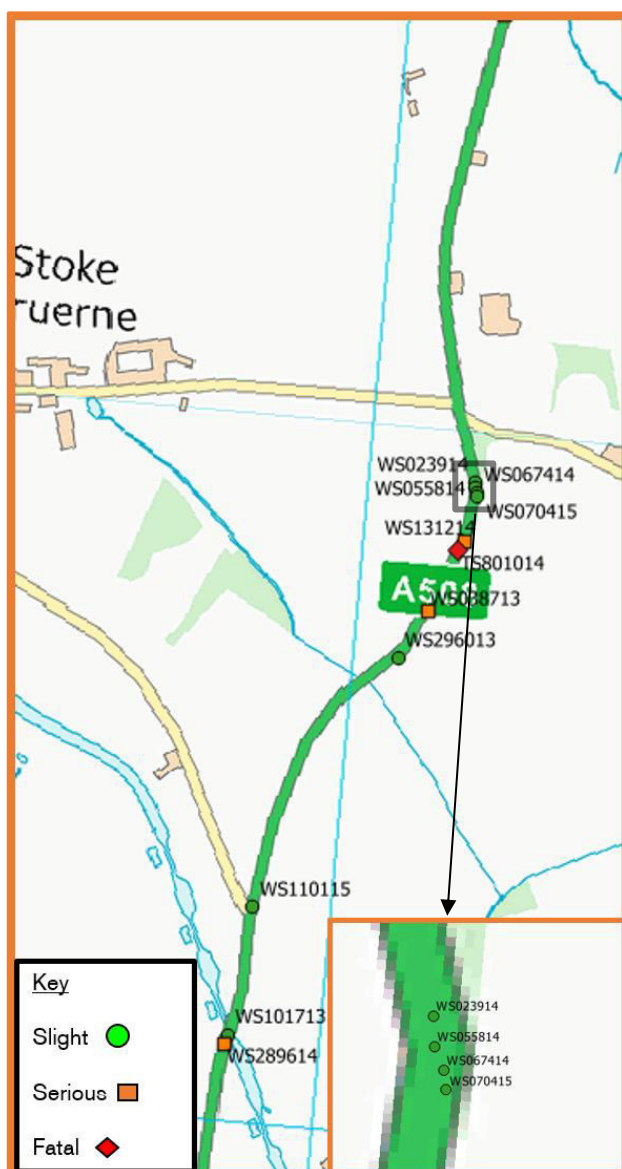
Figure 10: location of respective accidents in study area

- 8.1 As shown in **Figure 10**, 11 accidents were recorded over the five-year period for the south of Roade study area. **Table 8** provides a breakdown of the 11 recorded PIAs at the study area. Seven PIAs were slight in nature and three of serious severity with the remaining accident resulting in a fatality.

- 8.3 Five other accidents (WS023914, WS055814, WS067414, WS131214, WS070415) also involved vehicles losing control, including all of the accidents in the cluster shown in the inset of **Figure 10** on the bend in the road. These are described below:

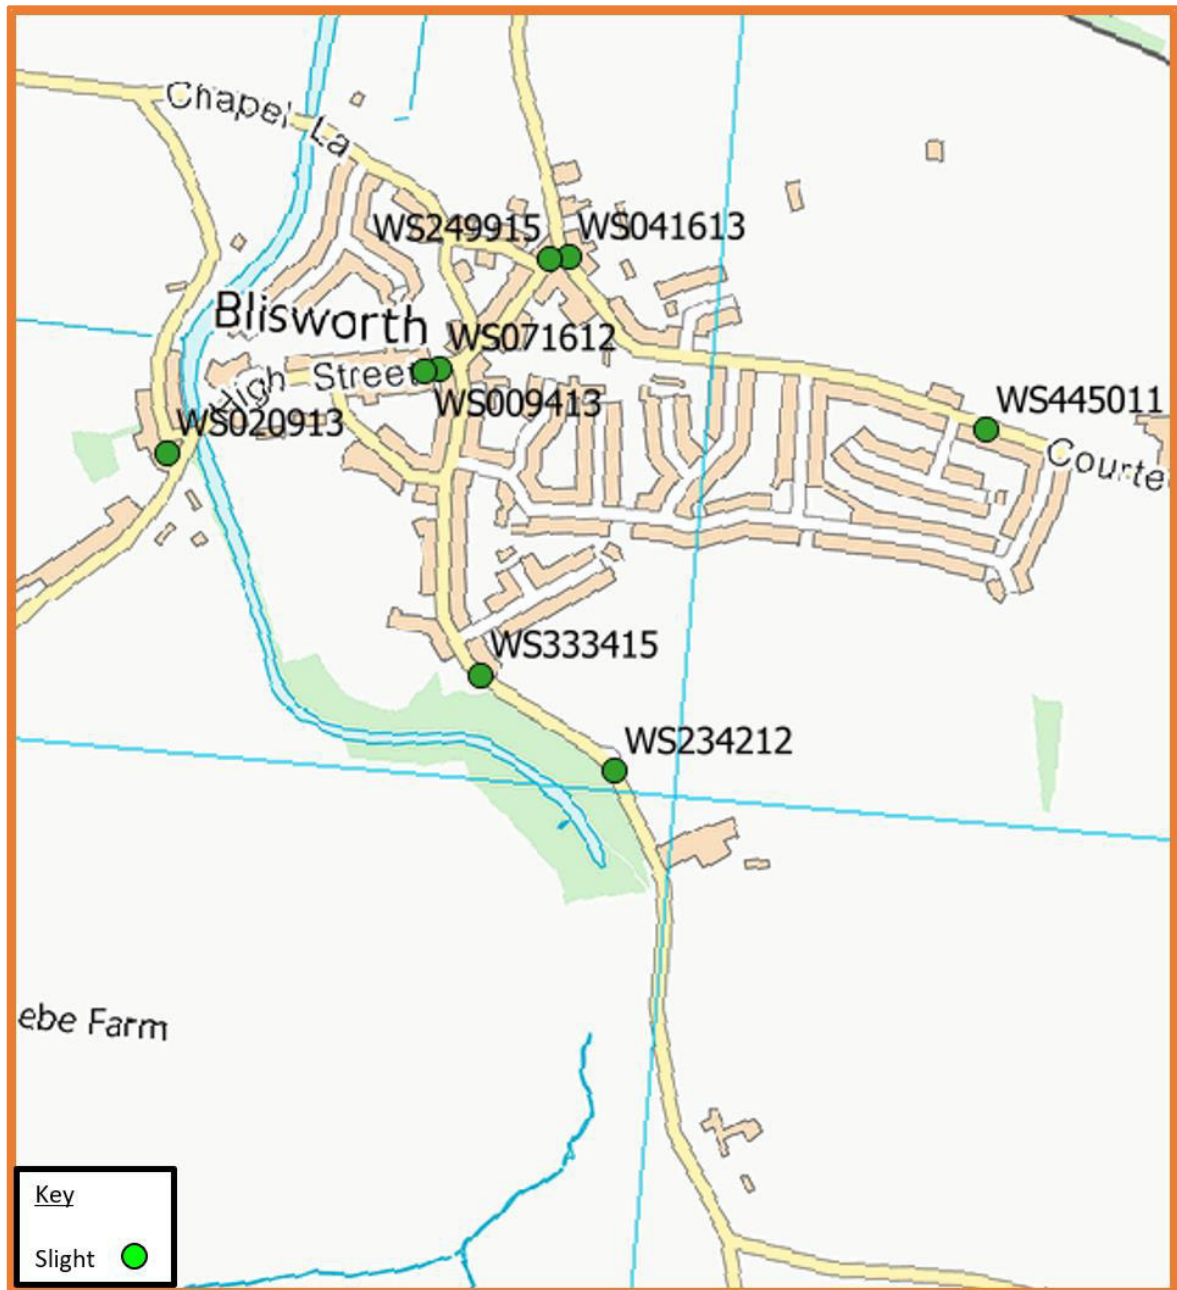
Figure 13: location of respective accidents in study area

11.1 As shown in **Figure 13**, a total of eight PIAs occurred at the Blisworth study area. All eight accidents were classified as being of slight severity. **Table 11** provides a casualty breakdown of the eight recorded PIAs at the study area.
