APPENDIX SES2.2

PIPELINE RISK ASSESSMENT

PINS document reference: 14.6.2.2

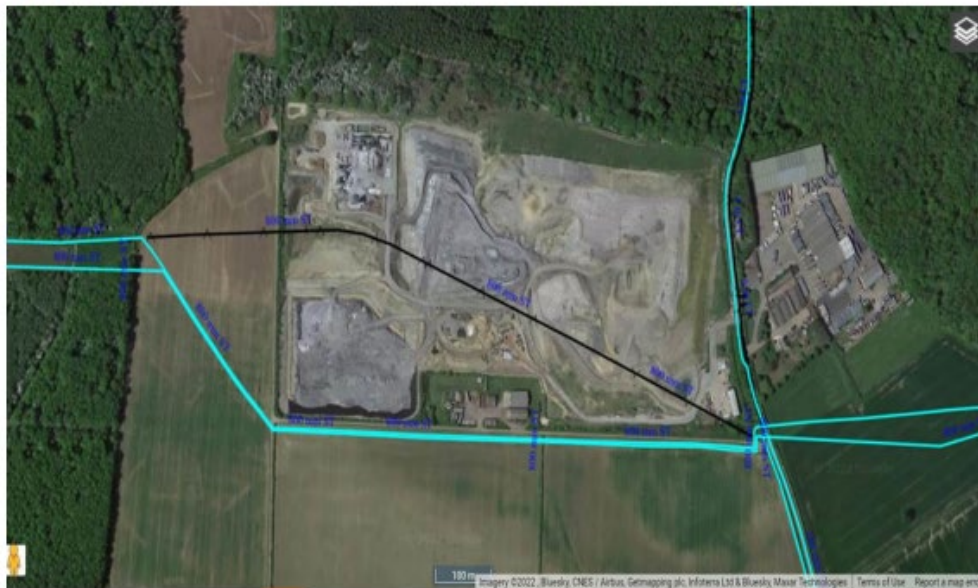
Plan of the Mains

- 2.1 The water pipelines convey potable water for human consumption from Wing Water Treatment Works to supply part of Peterborough. The water supply previously was conveyed by a single pipe along the approximate route shown by the black line on a plan provided in the Anglian Water April 2022 'Proof of Evidence' (the April PoE) which is reproduced below.

- 2.2 The water pipes along the previous route (the black line in the plan above) comprised only a single pipe and the pipe was diverted and replaced with two pipes in around 2000 when the original landfill operations in the current ENRMF site were developed. The previous diversion took place as the landfill in Phases 1 to 11 (the current landfill site) was designed to fill the area in which the water pipe was formerly located as the site could not be designed in a practical way to stand away from the pipe. This diversion took place before Augean took over the operation of the facility. The diverted pipeline and the new, second pipeline which was added (to increase the level of resilience and increase capacity) are located approximately 15m to 20m to the south of the excavation boundary of the current site which is designed to the same principles and filled with the same wastes as proposed for the western extension area. A gas pipeline runs parallel to, and approximately 4m to the south of the southern water pipeline. The route of the pipelines through the western extension area in the natural ground between two separate areas of landfilling and a cross

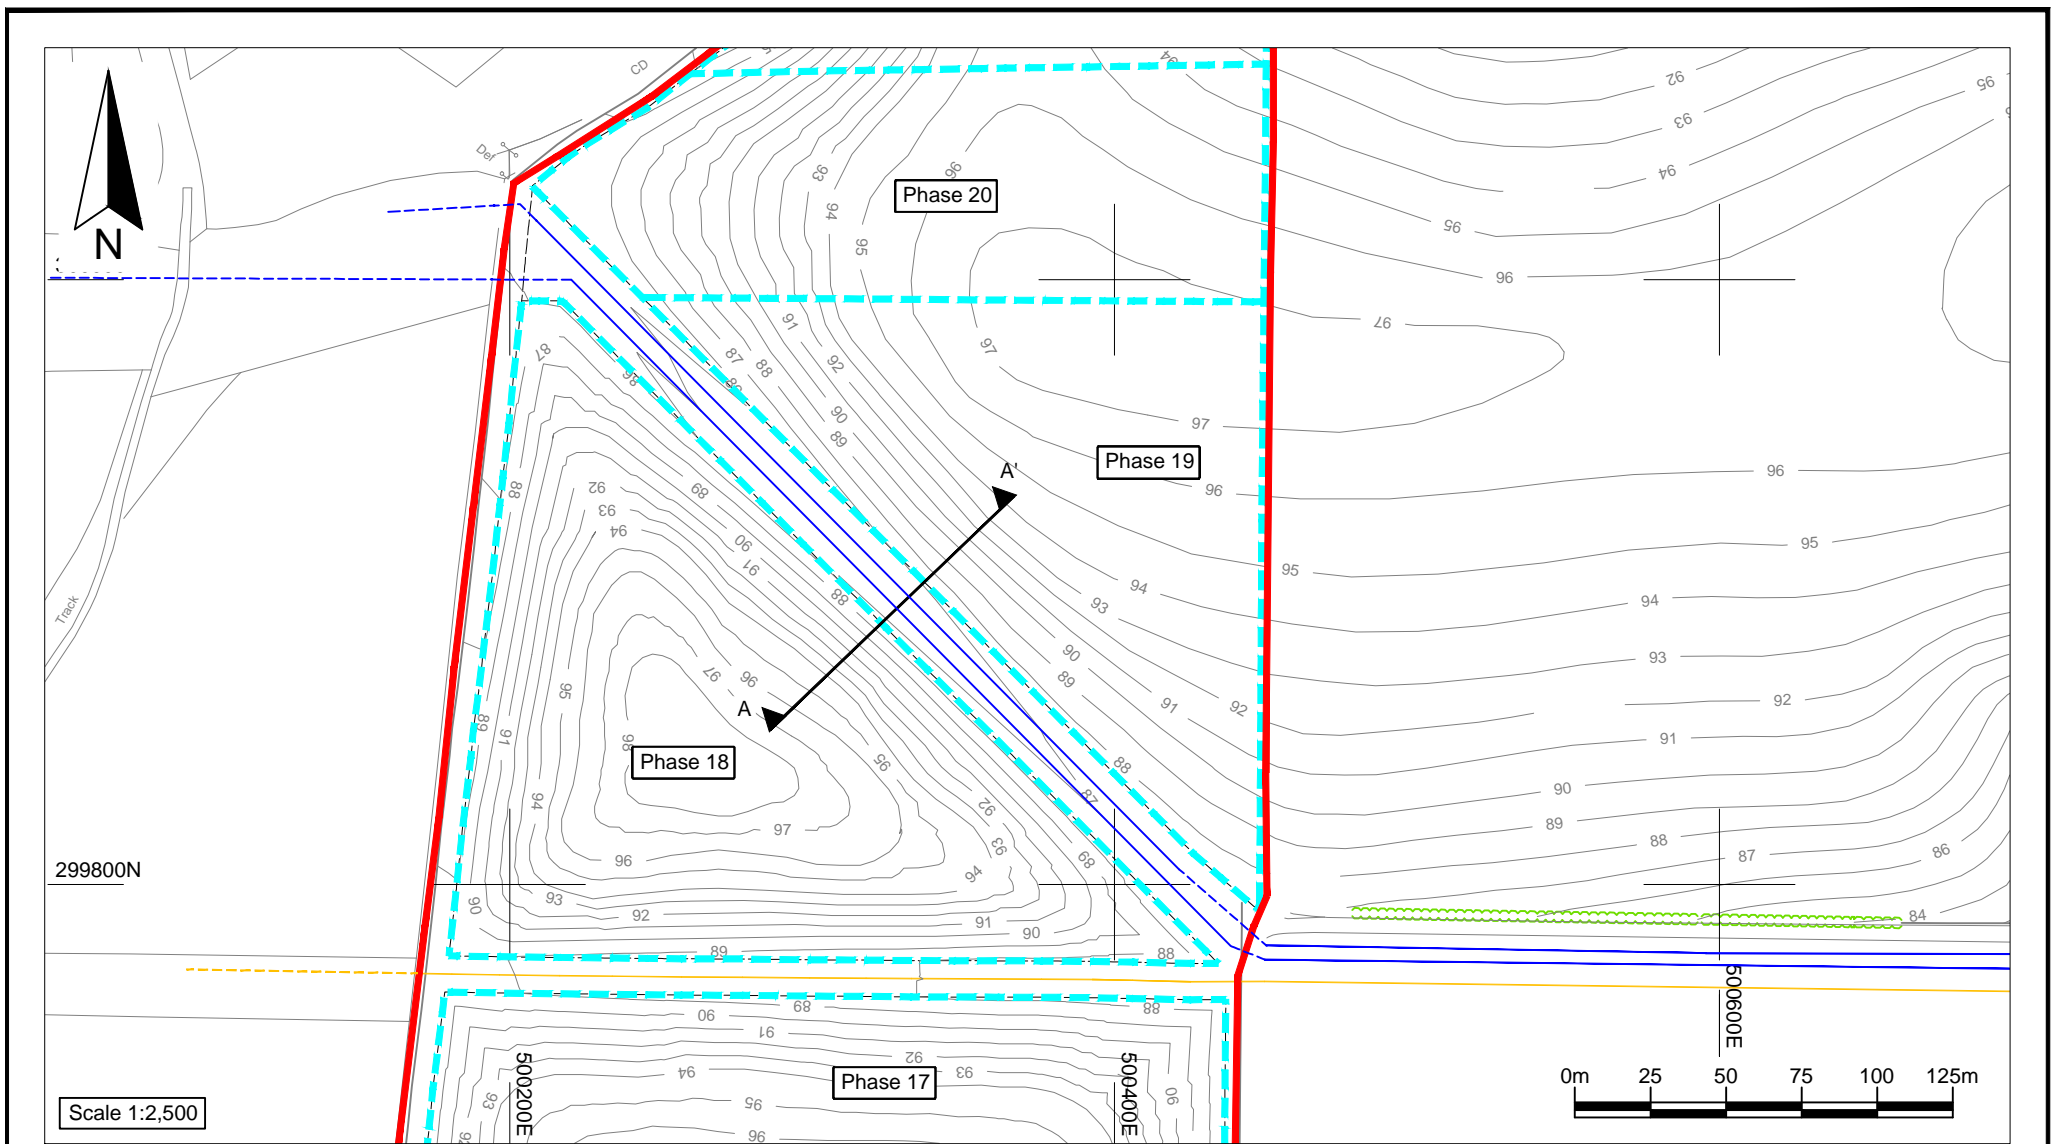
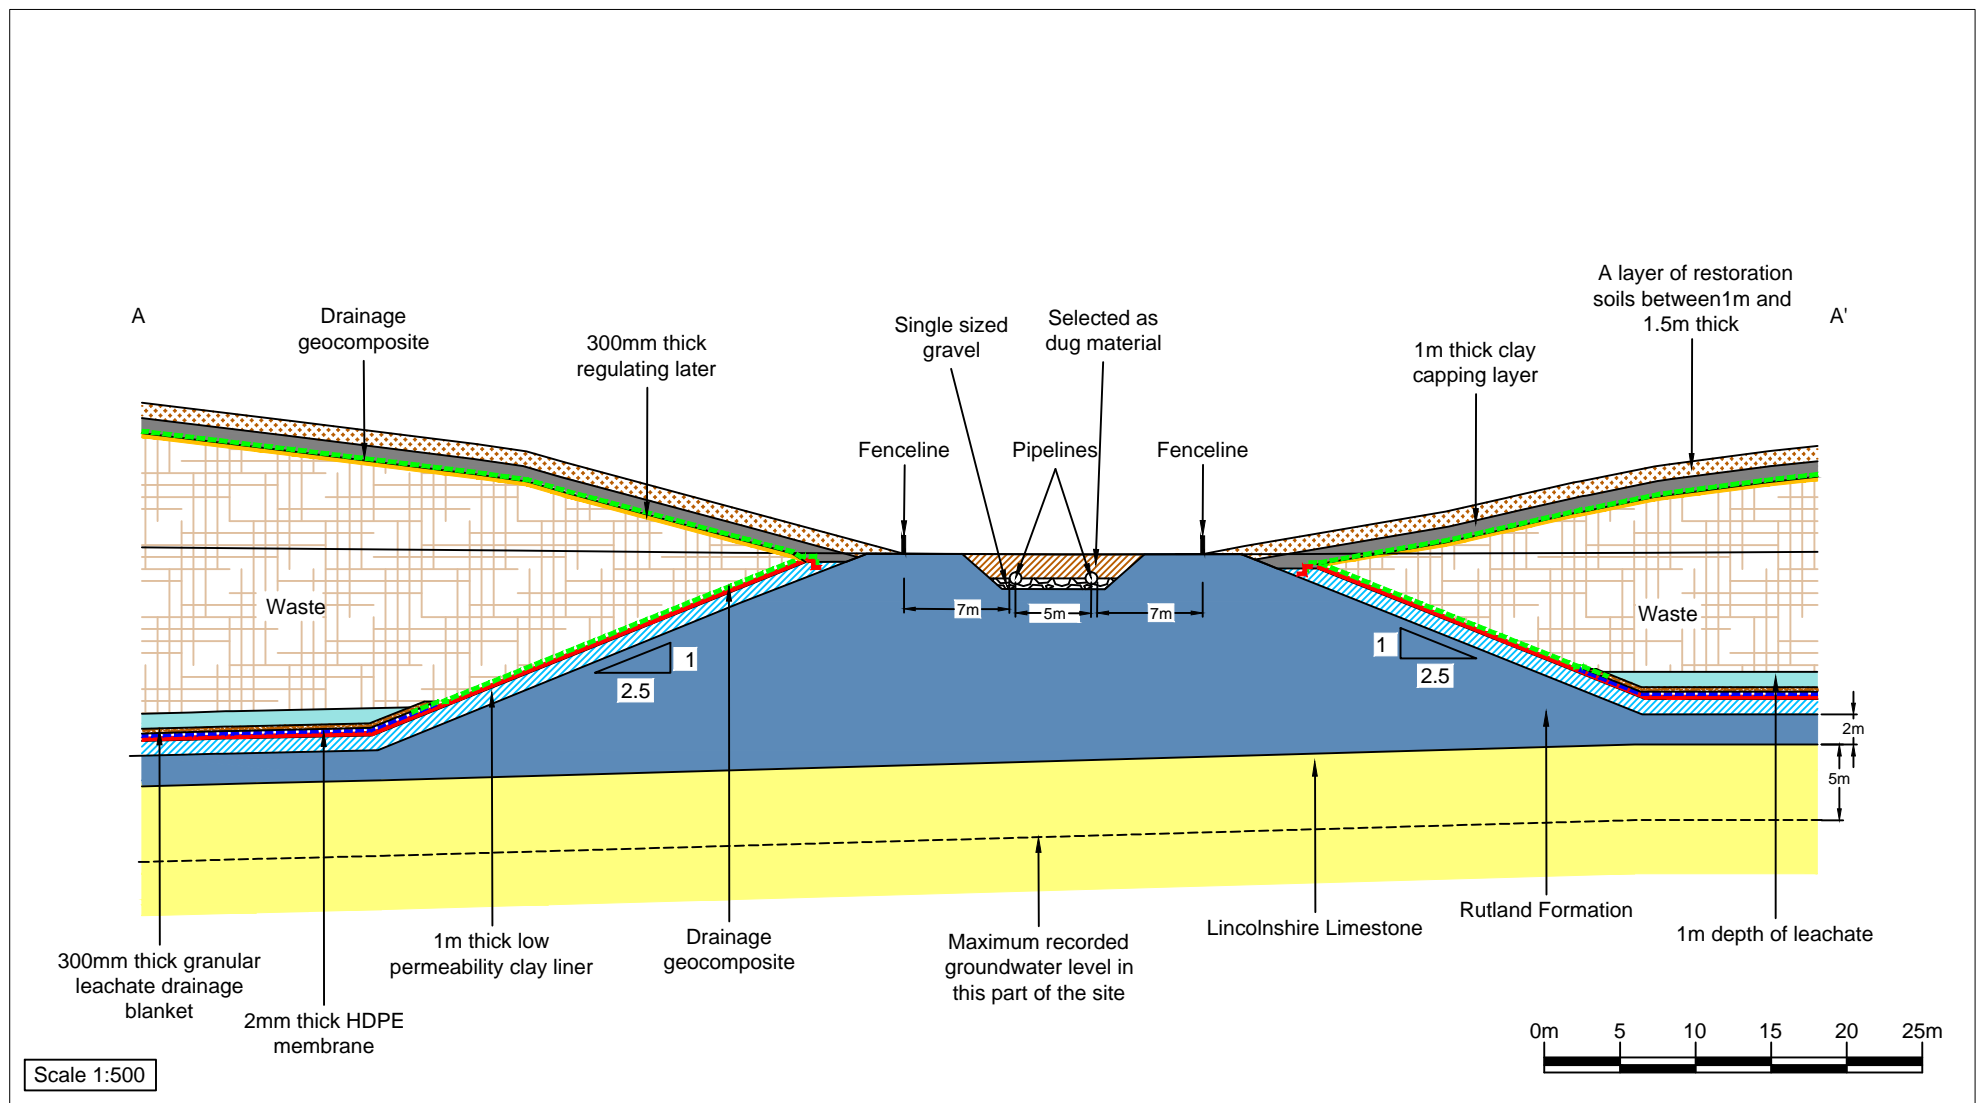
- ▭ Proposed western extension to the ENRMF hazardous waste landfill Environmental Permit
- - - - Approximate phase boundary in the proposed Western Extension
- ▲ Cross section location
- Water main taken from Service information from drawing number 2603.SWM.02C dated 24 September 2007 provided by Egniol Limited
- - - - Approximate location of the gas pipeline extrapolated from the topographical survey information
- Gas pipeline
- - - - Top of Bank
- - - - Top of Ditch
- 18 — Contours (mAOD)

Notes:
 Drawing based on LSS models references AU-KCW-15872.LSS, MARCH21_ENRMF_FINAL RESTORATION LANDFORM_SCENARIO 1B provided by DB Landscape Consultancy on 1 March 2021, AU-US-16318.LSS, AU-KCW-15984.LSS, AU-KCW-15987.LSS and AU-KCW-15990.LSS.

Figure PRA1 Cross section showing the proposed landfill operations in the vicinity of the water pipelines in the proposed western extension (drawing reference AU/KCW/05-22/23129)

section through the location showing the landfill cells constructed in the adjacent landfill phases are shown on Figure PRA1.

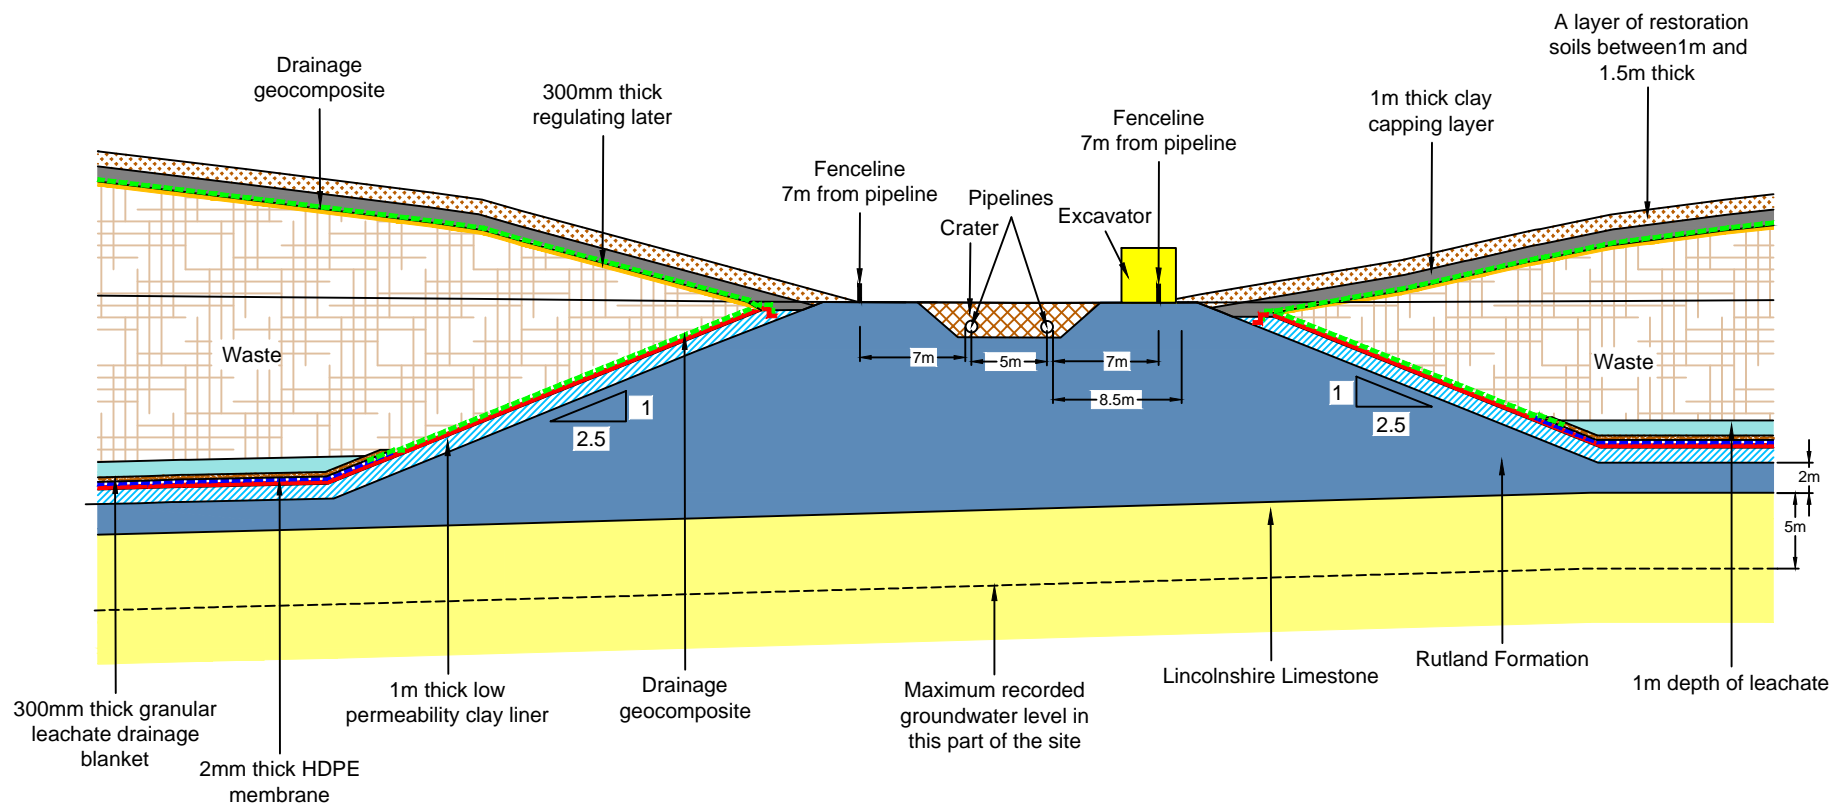
7m standoff from pipeline to the fence

Figure PRA3 Schematic drawing showing access for Anglian Water pipeline maintenance/replacement works (drawing reference AU/KCW/05-22/23173)

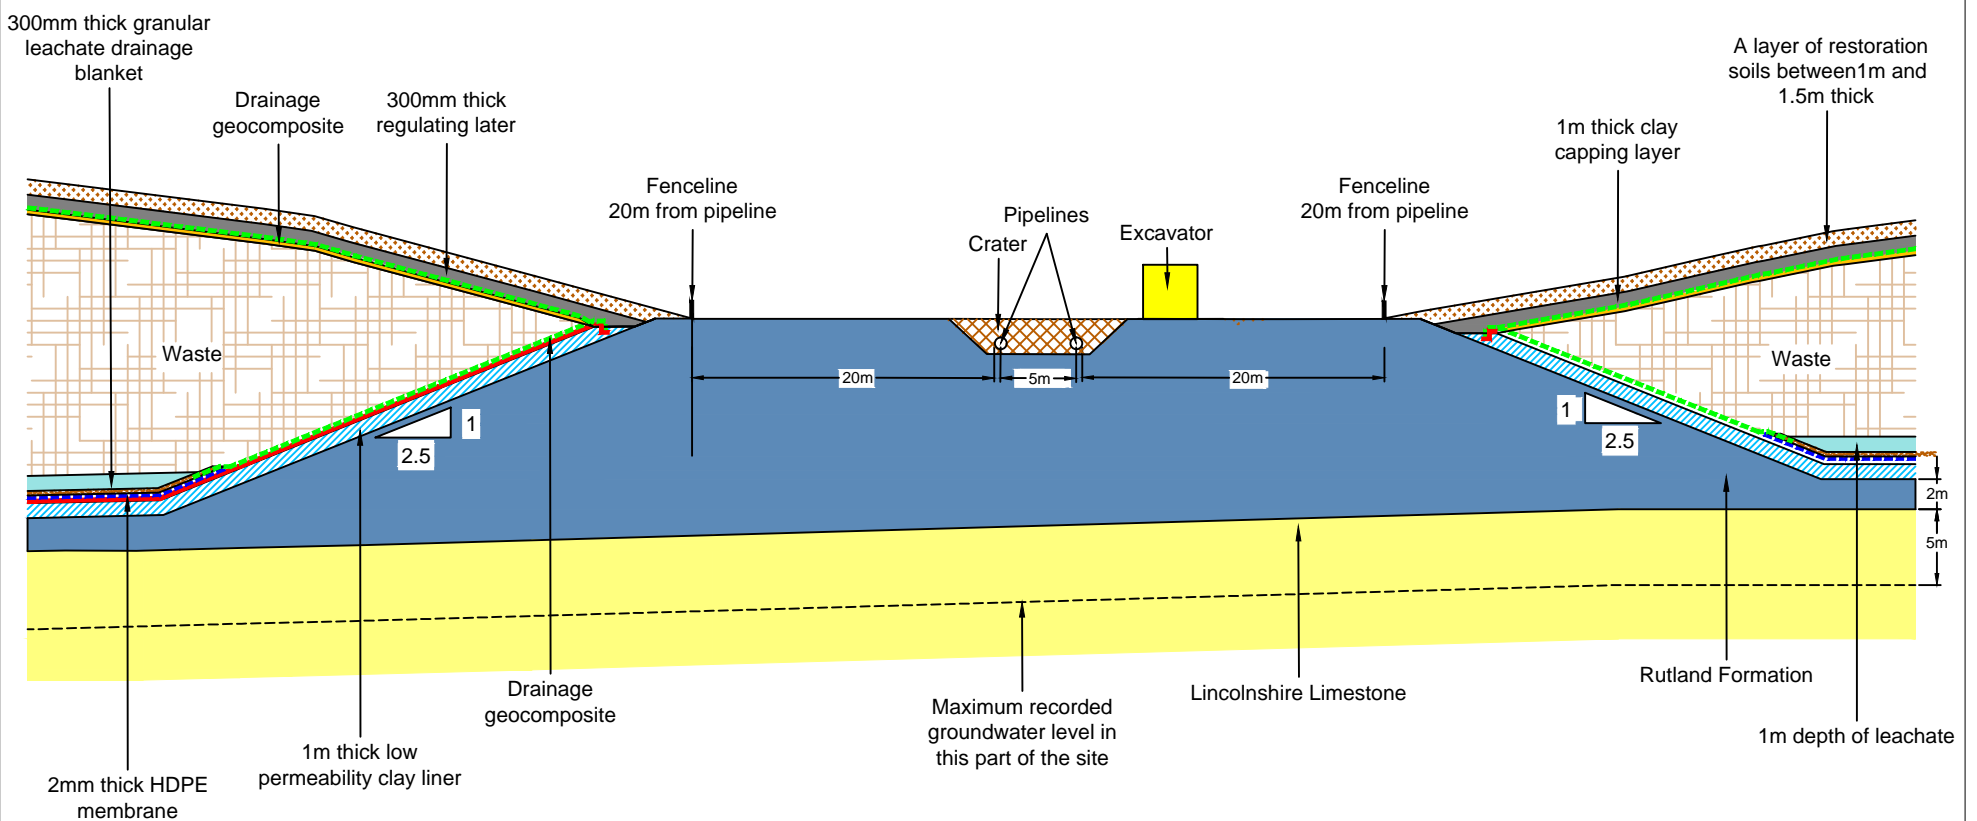
20m standoff from pipeline to the fence

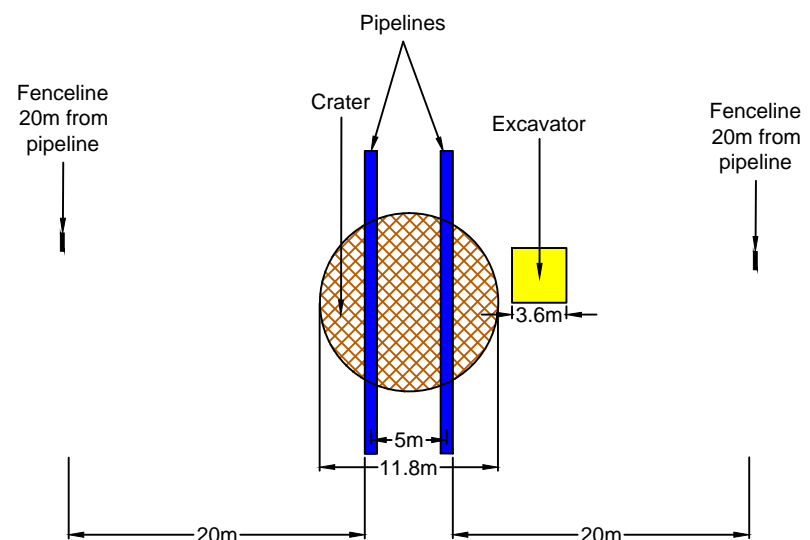
Birds eye view/plan view
