Cambridge Waste Water Treatment Plant Relocation Project
Anglian Water Services Limited

Appendix 8.22: Natural England Ghost Licence Method Statement Water Vole

Application Document Reference: 5.4.8.22
PINS Project Reference: WW010003
APFP Regulation No. 5(2)a

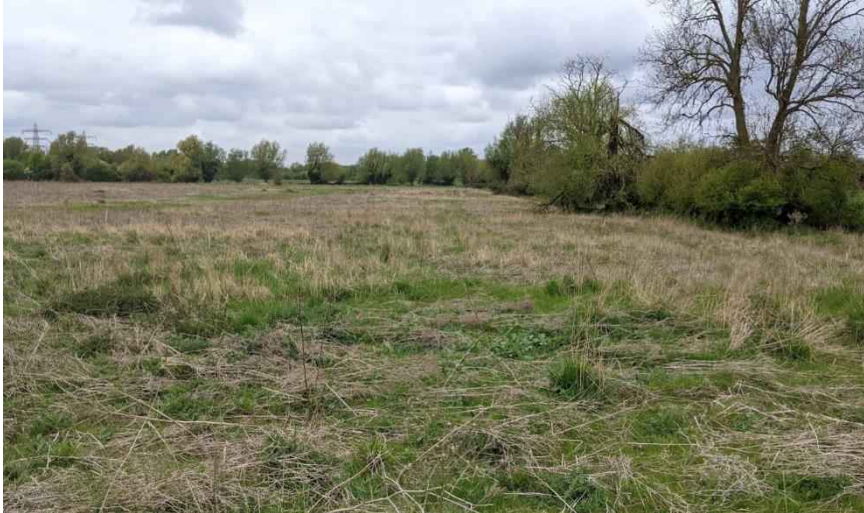
Photograph 1: Approximate location of new mitigation ditches (looking towards River Cam)

- 6.1.2 Land adjacent to the River Cam and located at TL 48458 61723 will be used to create new habitat for water vole. This area will contain a new ditch which will be approximately 84m in length dedicated for water vole with an additional 271m of ditch which will be suitable for water vole created for the purpose of Biodiversity Net Gain (BNG) which will provide enhancement for water vole. Photograph 1 below shows the approximate location where the new ditches will be created.
