Sheringham Shoal and Dudgeon Offshore Wind Farm Extension Projects

Environmental Statement

Appendix 20.13 – Riparian Mammals (Water Vole and Otter) Survey Report (Revision B) (Clean)

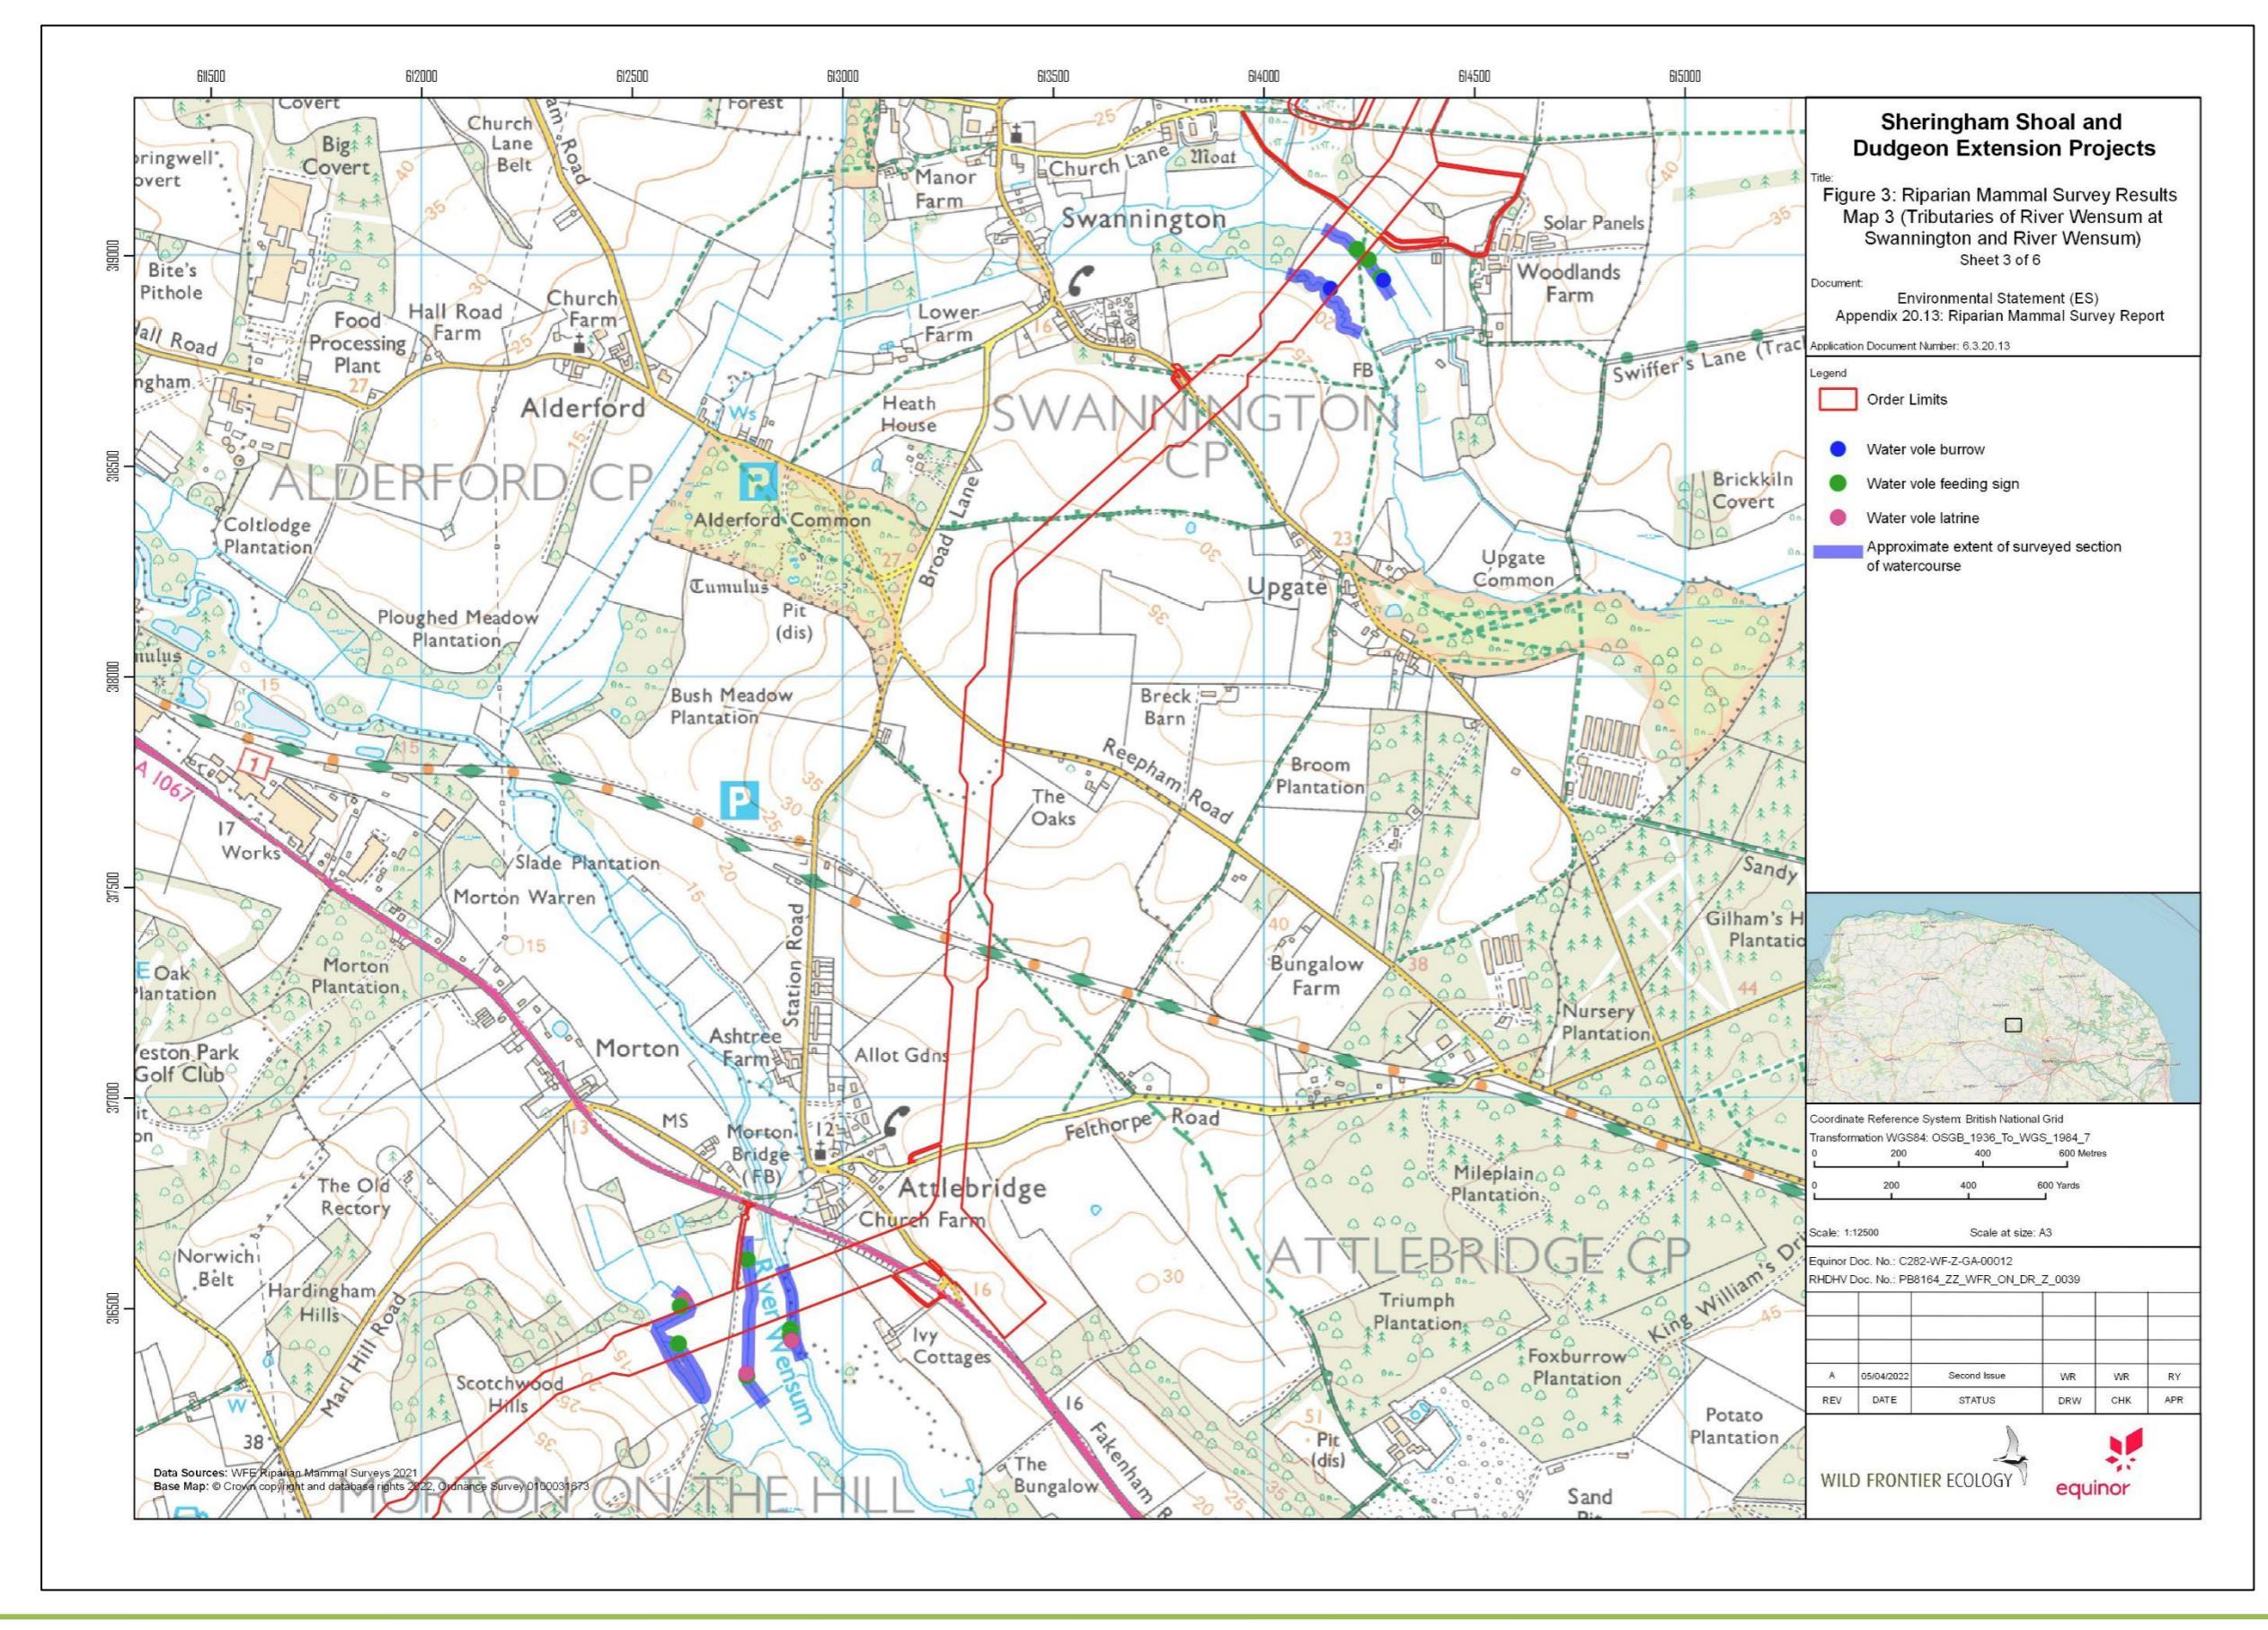
Figure 3: Riparian Mammal Survey Results Map (Tributary of River Wensum at Swannington and River Wensum)

| Watercourse | Approximate survey location description | Approximate central National Grid Reference | Otter signs | Water vole signs |
|---|--|---|---|---|
| Unnamed tributary of River Wensum | South of Church Lane, east of Swannington | TG 1410 1893 | None | Burrows and feeding signs |
| River Wensum | South of the A1067 Fakenham Road at Attlebridge | TG 1288 1650 | None | Latrines and feeding signs |

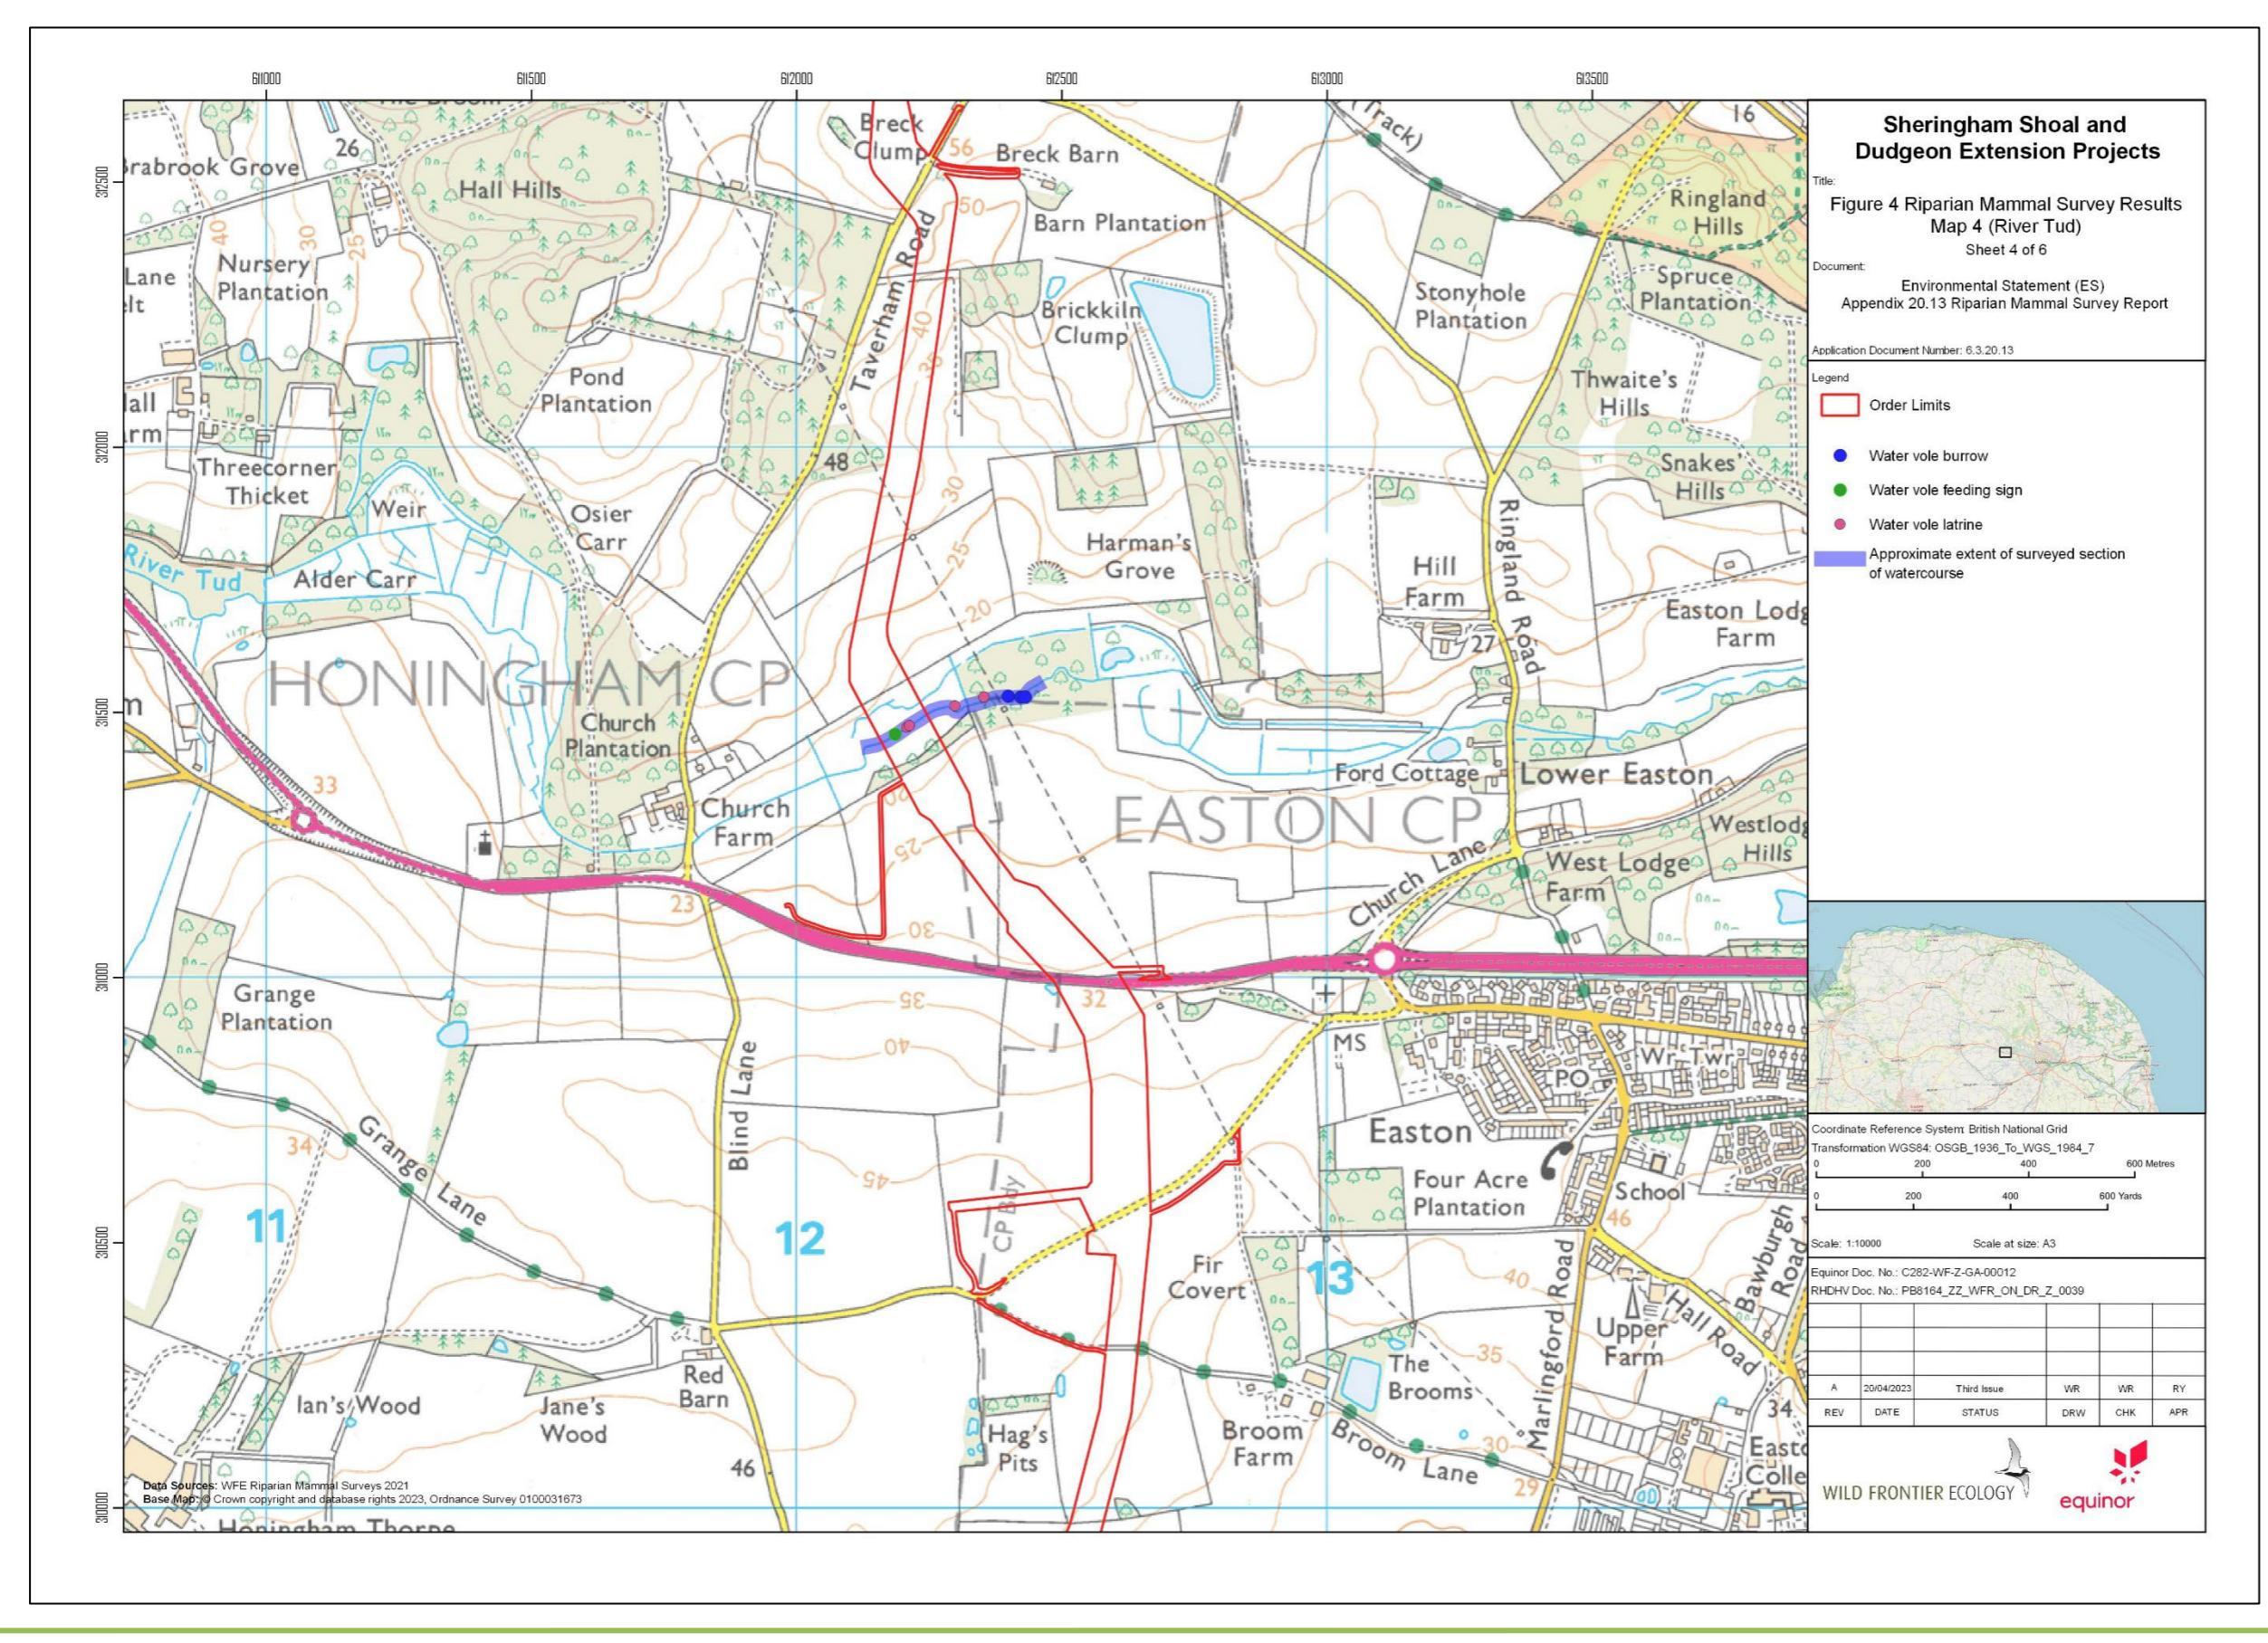
Figure 4: Riparian Mammal Survey Results Map (River Tud)

| Watercourse | Approximate survey location description | Approximate central National Grid Reference | Otter signs | Water vole signs |
|---|--|---|---|---|
| River Tud | Unnamed plantation woodland north-west of Easton | TG 1245 1154 | None | Burrows, latrines and feeding signs |

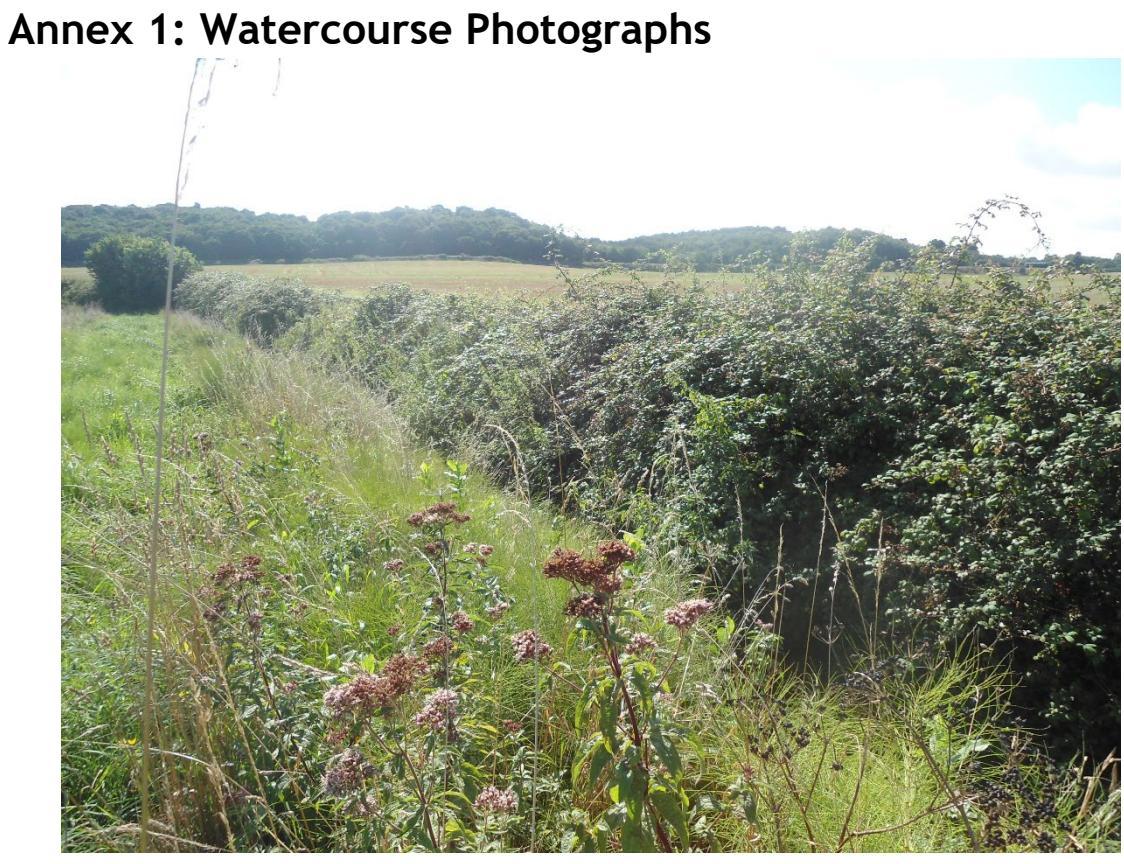
Photo 1: Spring Beck south of Weybourne, at the approximate DCO boundary intersection.

| Watercourse | Approximate survey location description | Approximate central National Grid Reference | Otter signs | Water vole signs |
|---|--|---|---|---|
| | West of Station Road, south of Weybourne | TG 1144 4210 | None | None |

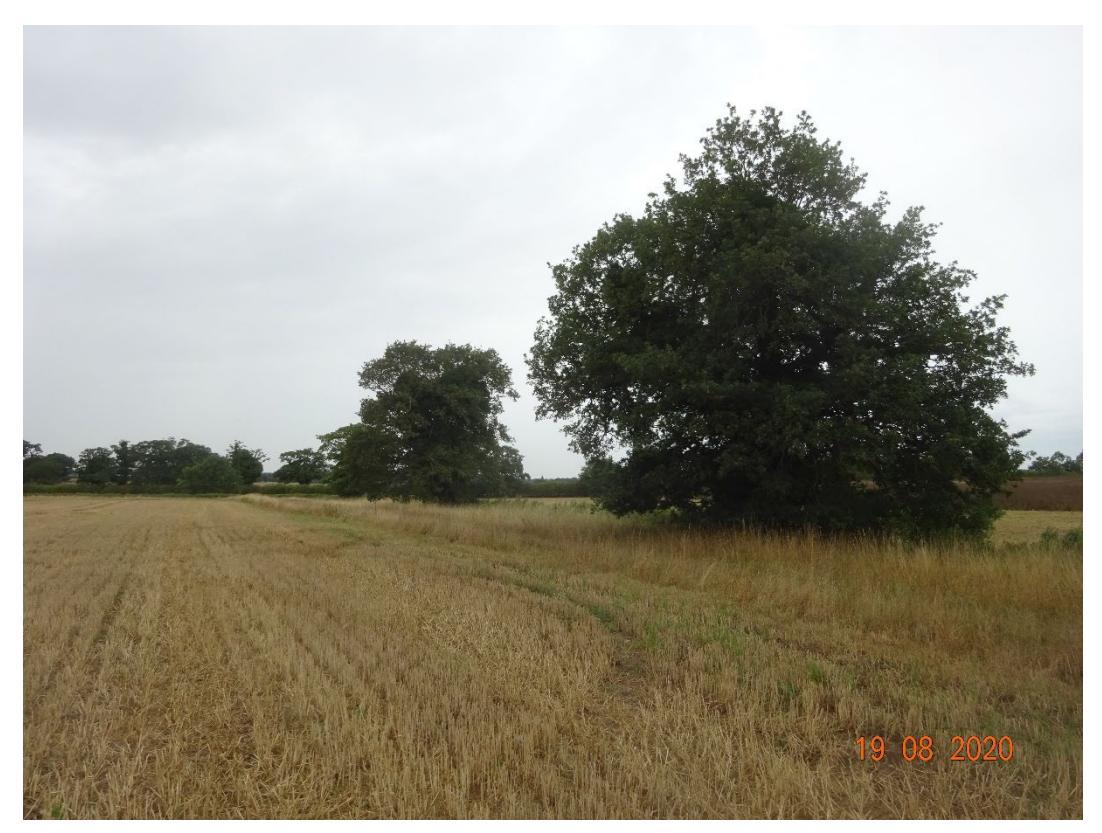
Photo 2: Ditch south of Little Barningham (aligned with trees).

| Watercourse | Approximate survey location description | Approximate central National Grid Reference | Otter signs | Water vole signs |
|---|--|---|---|---|
| Ditch near Little Barningham | South of Little Barningham | TG 1350 3269 | None | Feeding signs |

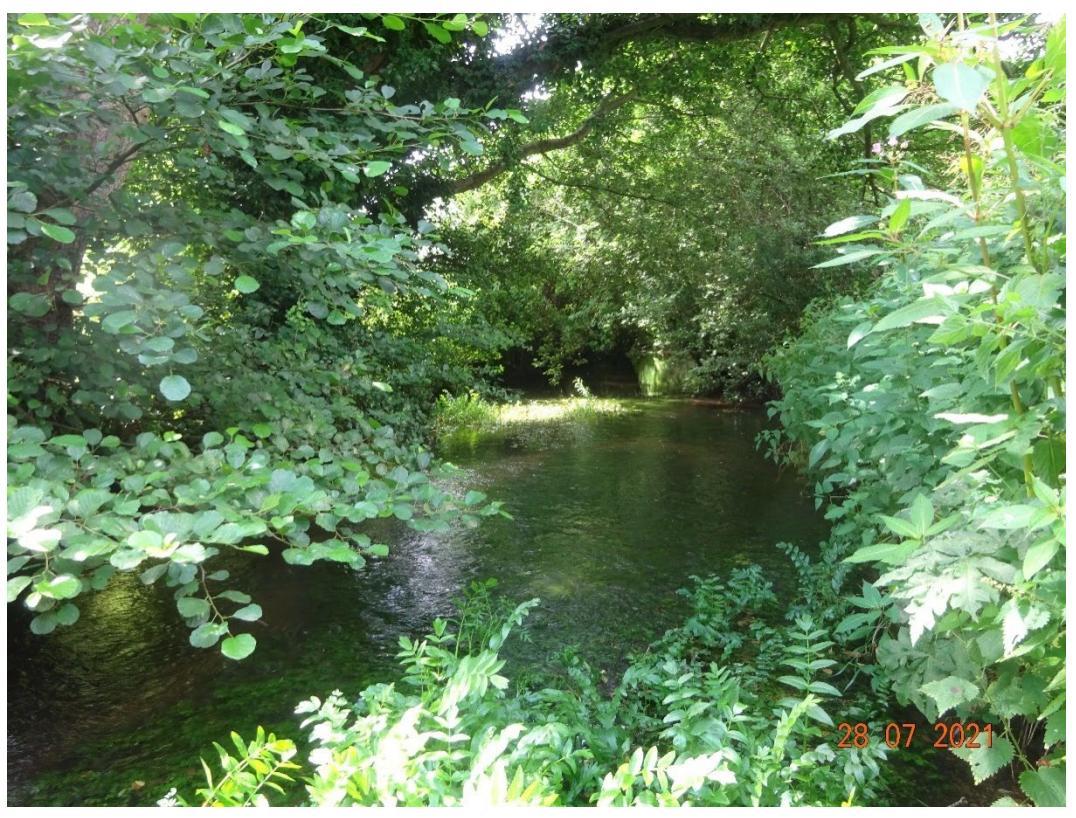
Photo 3: River Bure at the approximate DCO boundary intersection.

| Watercourse | Approximate survey location description | Approximate central National Grid Reference | Otter signs | Water vole signs |
|---|--|---|---|---|
| River Bure | At Saxthorpe Hall, east of Saxthorpe | TG 1308 2987 | None | Burrows, latrines and feeding signs |

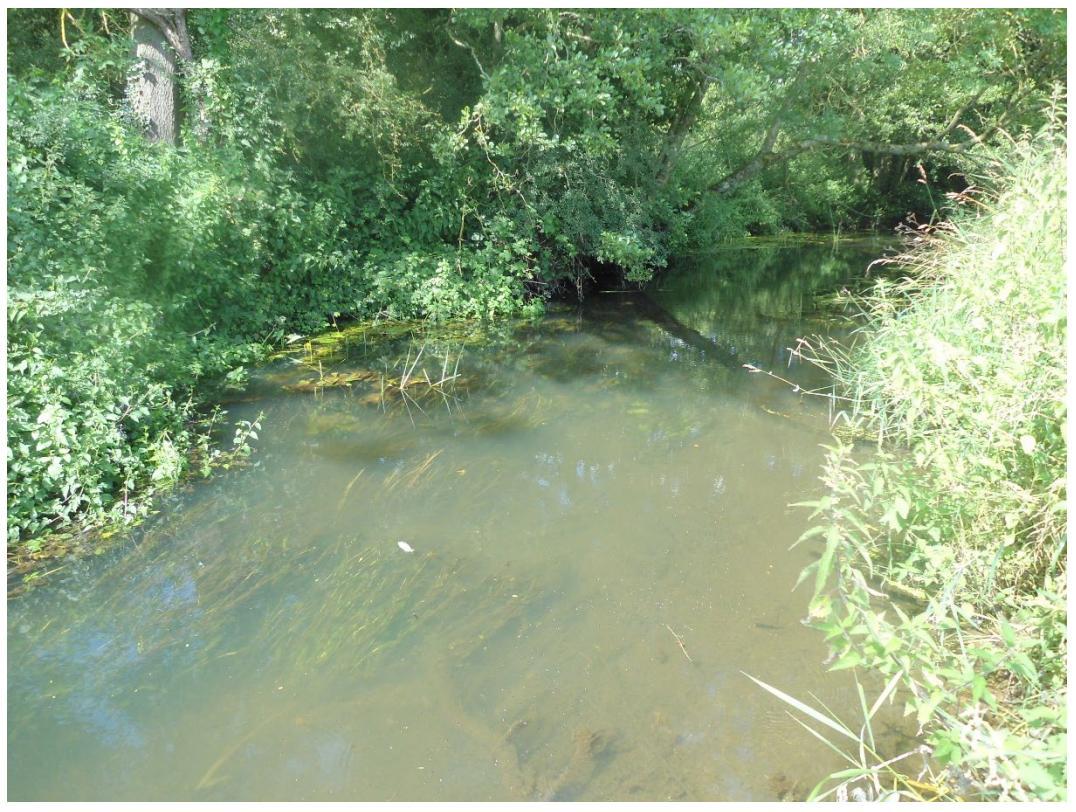
Photo 7: The River Yare at the approximate DCO boundary intersection.

| Watercourse | Approximate survey location description | Approximate central National Grid Reference | Otter signs | Water vole signs |
|---|--|---|---|---|
| River Yare | South-east of Colton Wood | TG 1186 0847 | None | Burrows |

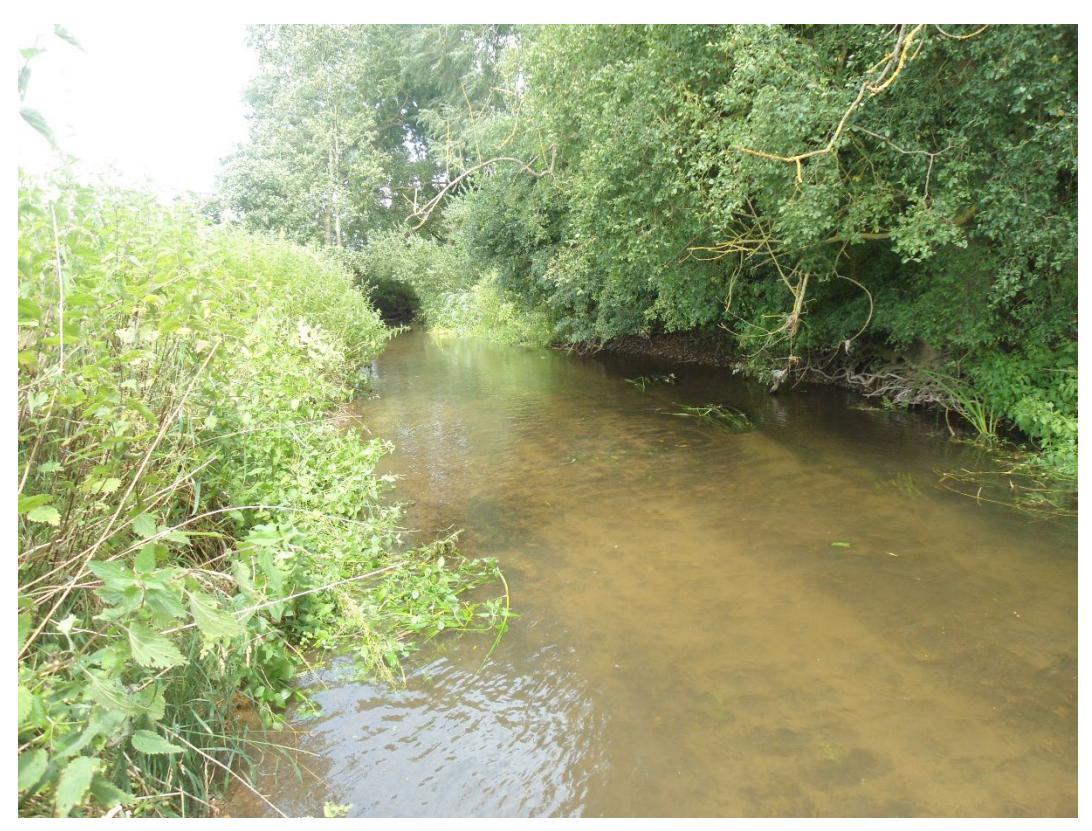
Photo 8: The River Tiffey at the approximate DCO boundary intersection.

| Watercourse | Approximate survey location description | Approximate central National Grid Reference | Otter signs | Water vole signs |
|---|--|---|---|---|
| River Tiffey | East of Barford | TG 1195 0757 | Spraints | Burrows and feeding signs |

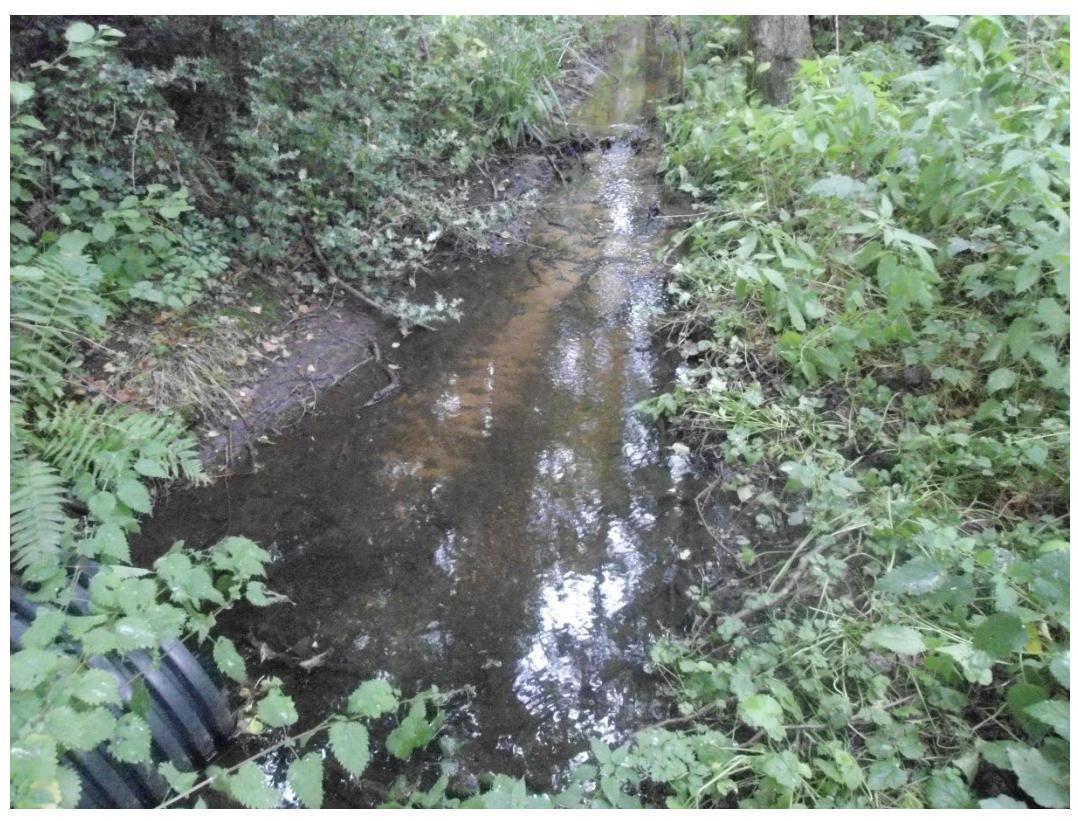
Photo 9: Unnamed tributary of the River Yare in Furze Meadow near Ketteringham at the approximate DCO boundary intersection.

| Watercourse | Approximate survey location description | Approximate central National Grid Reference | Otter signs | Water vole signs |
|---|--|---|---|---|
| Unnamed tributary of River Yare | Furze Meadow, east of Ketteringham | TG 1772 0304 | None | None |

If adopting and observing a CEZ around the unnamed tributary of the River Yare at Furze Meadow near Ketteringham proves to be problematic for construction, the requirement for the CEZ could be removed. However, this would only be acceptable if an updated survey completed within no more than 12 months prior to construction works commencing (scheduled for 2024-25) reconfirms the absence of both otters and water voles from this watercourse. Other than this possible scenario at the Furze Meadow near Ketteringham watercourse, there is considered to be no requirement for further surveys for riparian mammals. The adoption of HDD and the CEZs around watercourses will effectively mitigate any realistic risks posed to otters and water voles and therefore negate any requirement for the survey data to be updated prior to construction works commencing.

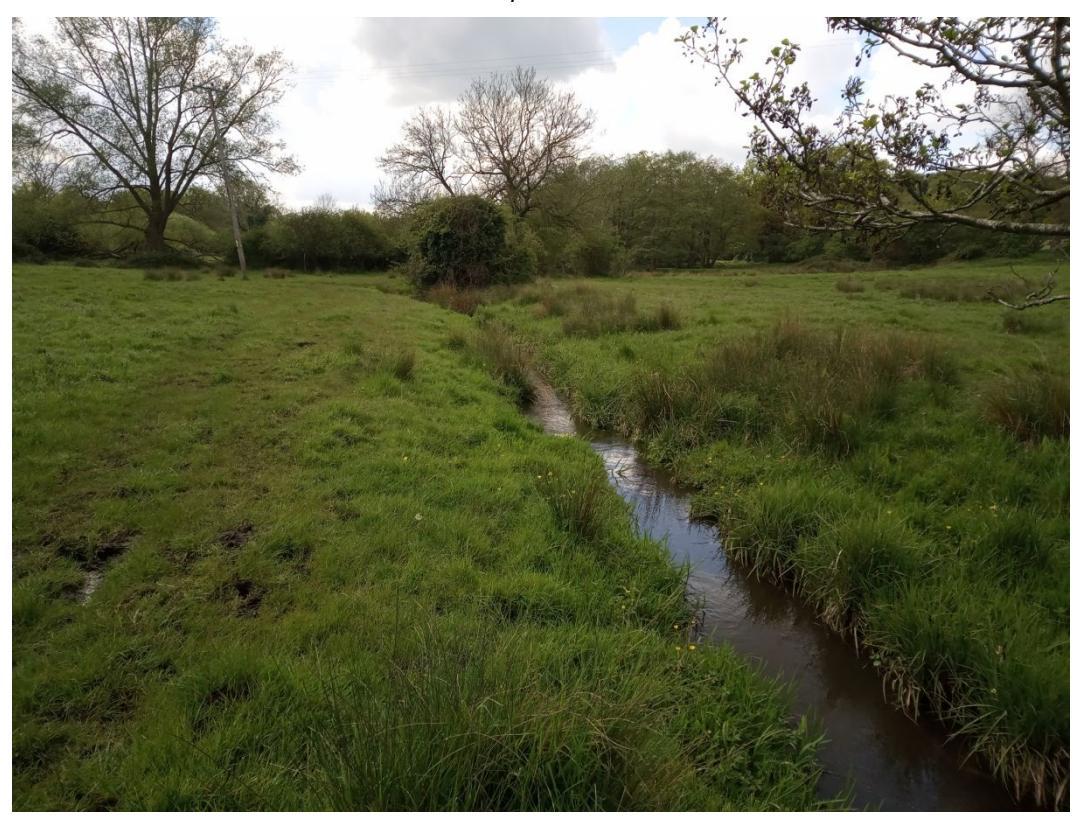
Photo 10: Unnamed tributary of the River Yare south of Valley Farm, Swardeston at the approximate DCO boundary intersection.

| Watercourse | Approximate survey location description | Approximate central National Grid Reference | Otter signs | Water vole signs |
|---|--|---|---|---|
| Unnamed tributary of River Yare | South of Valley Farm, west of Swardeston | TG 1937 0264 | None | Limited feeding signs |

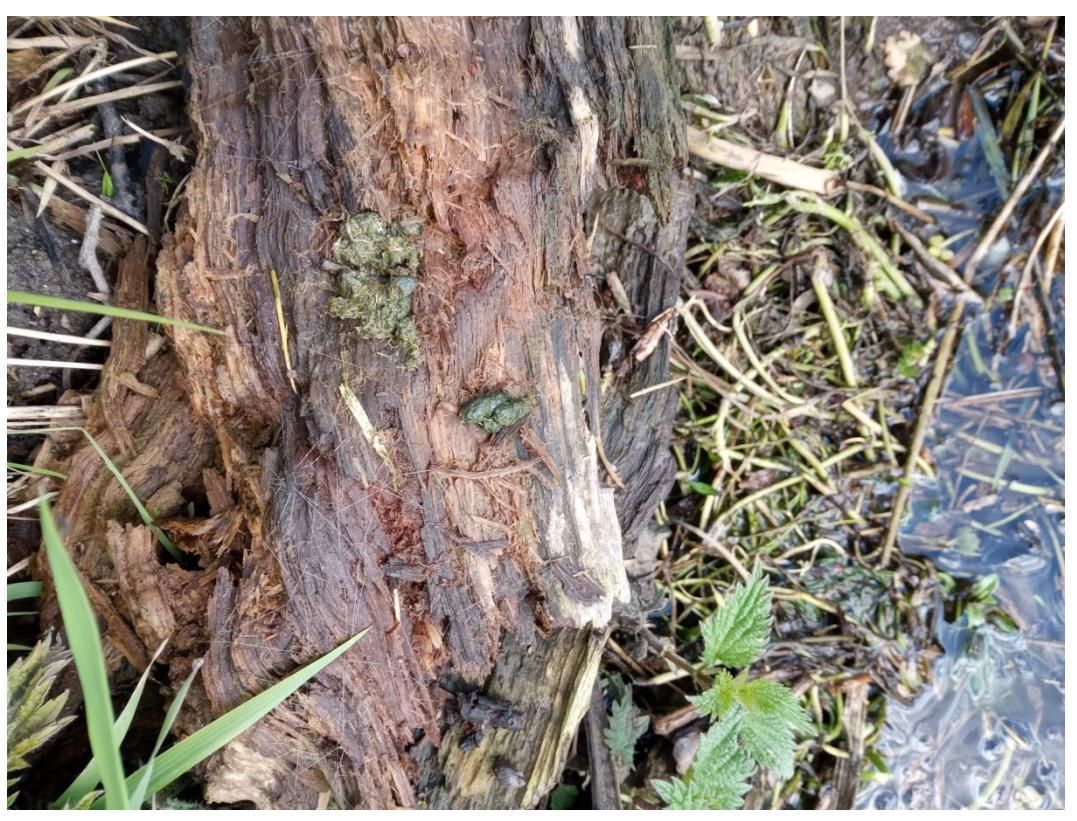
Photo 11: Water vole latrine on the banks of the River Tud.

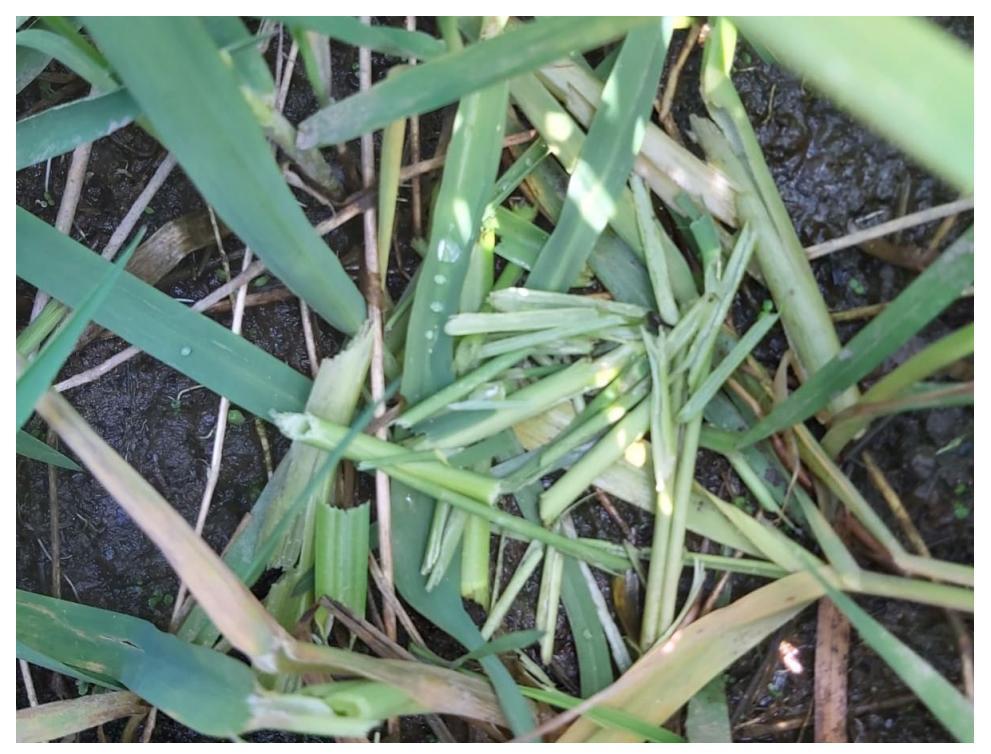
Photo 12: Water vole feeding signs on the banks of the River Tiffey.

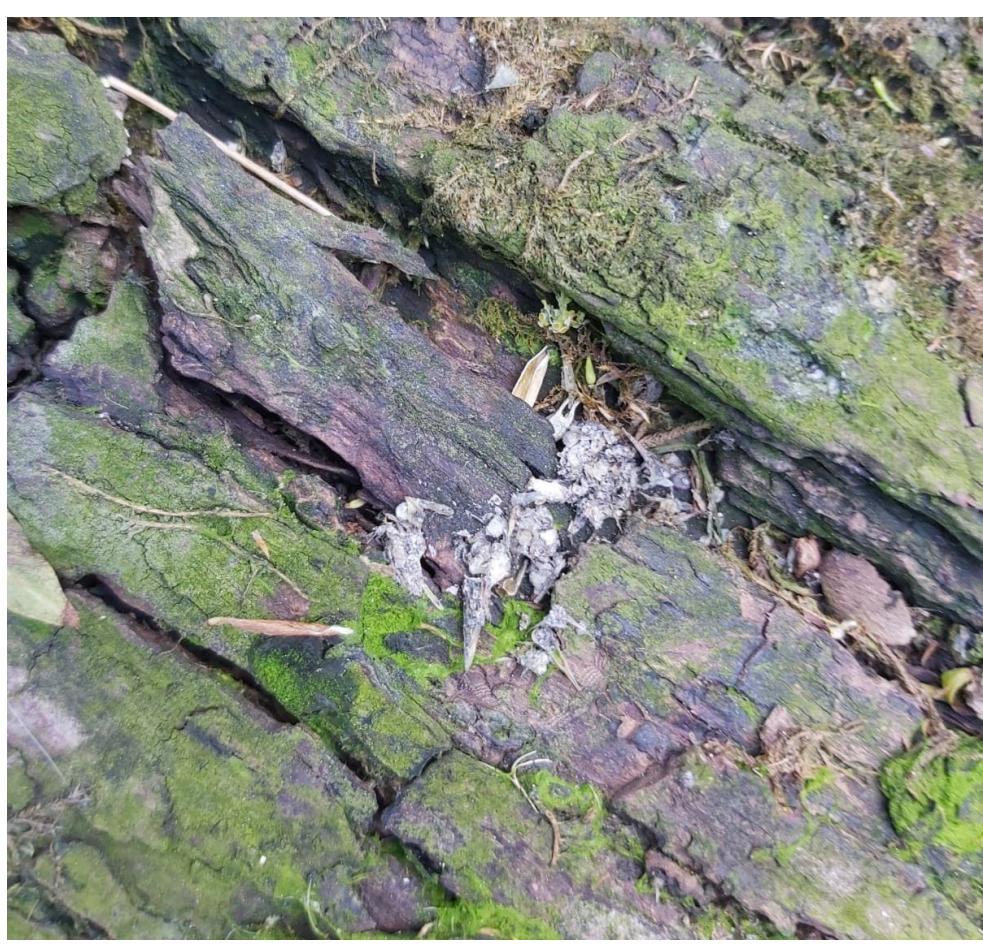
Photo 13: Otter spraints on the banks of the River Tiffey
