The London Resort Development Consent Order

Appendix 18.5 – Phase 1 Geo-environmental Assessmen, Essex Project site

Desk Study - Essex Project Site

0042936-BHE-XX-XX-RP-YG-0001

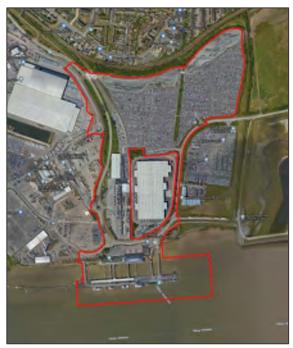
Figure 1-1 - Aerial photograph of the site (Google Maps, 2020).

The Essex Project Site covers some 29.9 ha. It is located in Tilbury, in the borough of Thurrock, Essex, RM18 7ND, at National Grid Reference (NGR) TQ 66438 75459. The site lies to the immediate east of the container Port of Tilbury and south of Tilbury Town station. An aerial photograph of the site is shown by Figure 1-1 and its location by Figure 1-2.

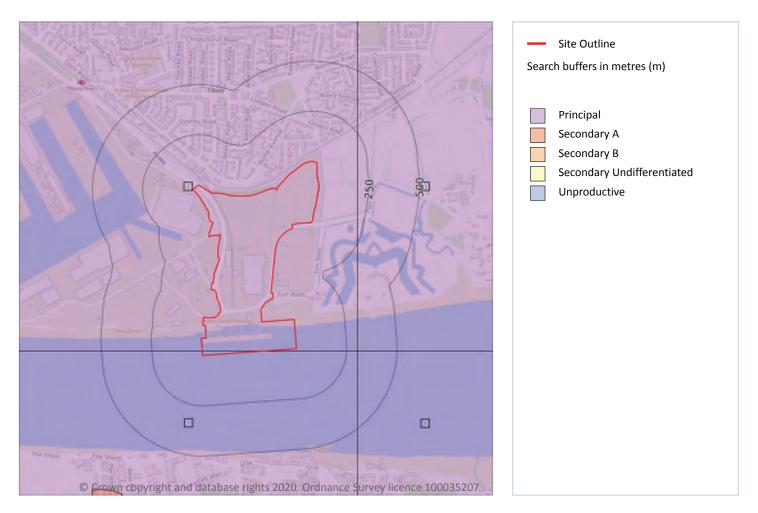
Bedrock aquifer

Records within 500m 4				
A	Aquifer status of groundwater held within bedrock geology.				
Fe	eatu	ires are dis	played on the Bedroc	ck aquifer map on page 72	
I	D	Location	Designation	Description	
1	L	On site	Principal	Geology of high intergranular and/or fracture permeability, usually providing a high

2
 On site
 Principal
 Geology of high intergranular and/or fracture permeability, usually providing a high level of water storage and may support water supply/river base flow on a strategic scale. Generally principal aquifers were previously major aquifers
