East Anglia ONE North Offshore Windfarm

Appendix 20.5

Geomorphological Baseline

Environmental Statement Volume 3

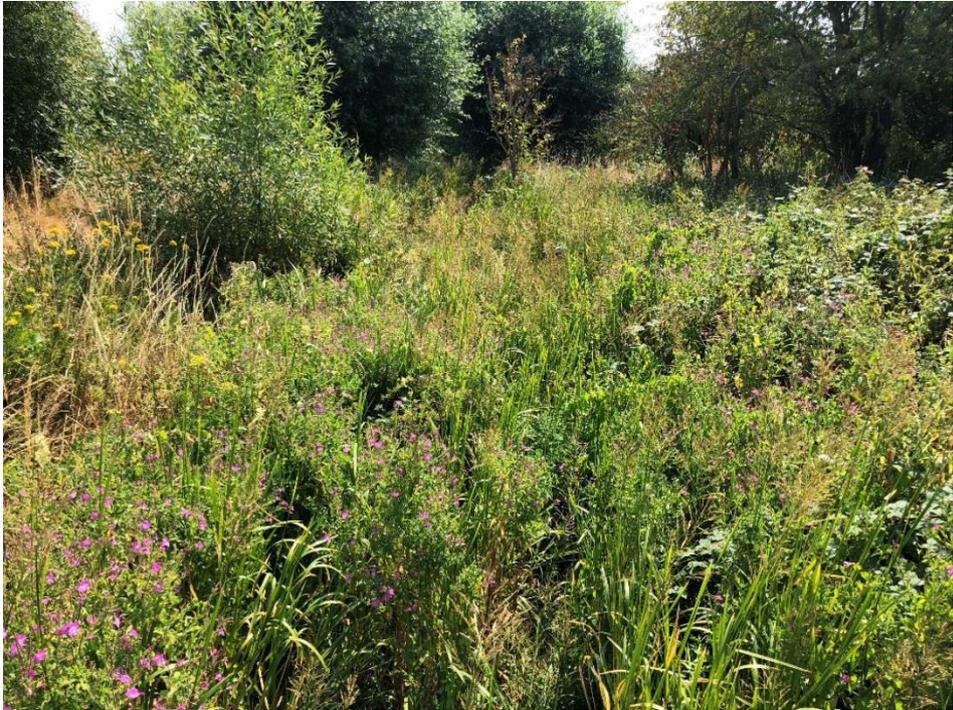
In-channel and riparian vegetation	The channel was dominated by extensive vegetation growth (including reeds) at the time of the survey (Plate A20.1).
Character photograph

<p>Plate A20.1 Extensive Vegetation Growth in Dry, Shallow Channel</p>

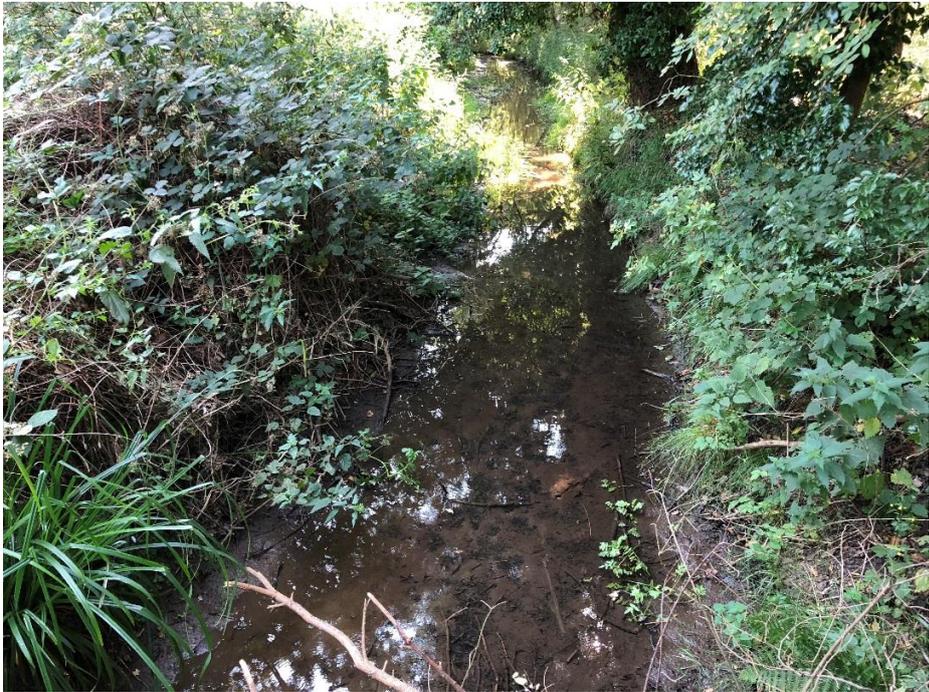
Floodplain characteristics	In the upstream part of the reach, the narrow floodplain is bounded by domestic gardens and grassland. The floodplain becomes wider and better connected to the floodplain further downstream, where it is bounded by woodland and arable fields.
In-channel and riparian vegetation	Very little vegetation was observed in the channel, although some emergent and marginal plants have colonised stable silt bars in the channel margins.
Character photograph

<p>Plate A20.2 Low-Energy Flows in Silt-Bed Channel</p>

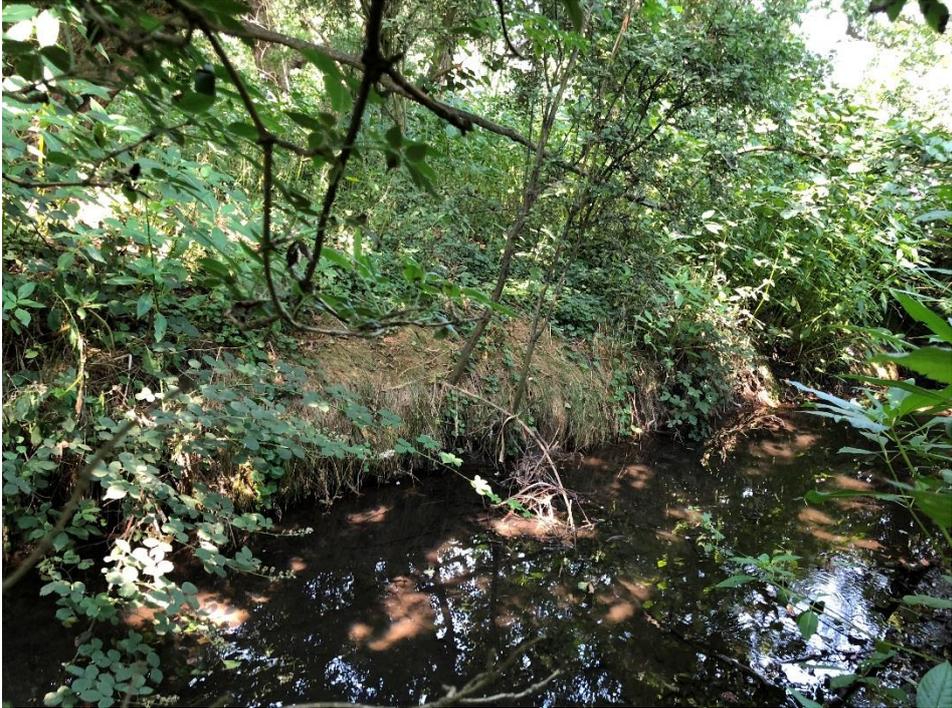
Parameter	Main characteristics
Planform	The river has a gently meandering planform in this reach, with low-amplitude meanders and evidence of historical re-sectioning. As with upstream reaches, analysis of historical mapping suggests that this occurred prior to the 1880s.
Channel form	The banks are shallow and steep, and are much lower than in the upstream reach. They are largely stable and well-vegetated, although evidence of toe scour was observed in parts of the reach. The channel is very uniform, with limited geomorphological diversity (Plate A20.3).
Substrate conditions	The bed and banks are both composed of fine sediments (e.g. silts and fine sands). Areas of fine sediment deposition were observed throughout the reach.
Flow conditions	This reach is largely characterised by shallow water with barely perceptible glide flows. Turbidity was generally low at the time of the survey, although this increased in areas where flow energy was further reduced (e.g. by fallen tree limbs).

<p data-bbox="406 1059 1342 1093">Plate A20.3 Wide, Shallow Silt-Bed Channel with Low Energy Glide Flows</p>

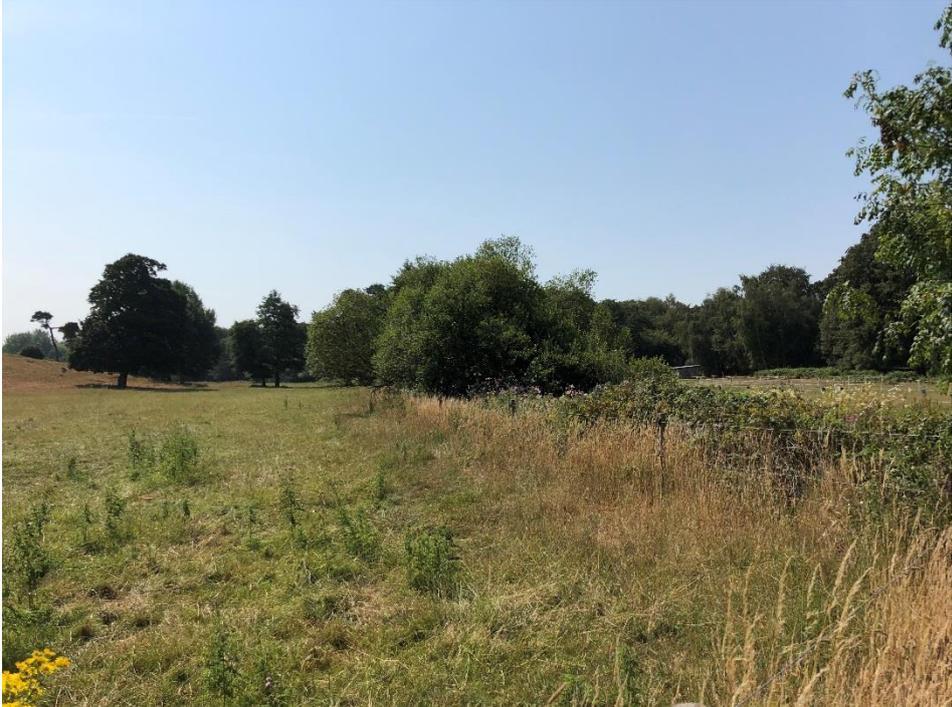
Floodplain characteristics	In the upstream end of the reach, the floodplain is wider than in upstream reaches, and dominated by grazing land and areas of woodland (Plate A20.4). The floodplain is drained by an extensive ditch system which is well connected with the main river channel. The floodplain becomes much wider at the downstream end of the reach, where the channel flows through floodplain wetlands (The Fens).
In-channel and riparian vegetation	Extensive areas of in-channel vegetation growth are interspersed with reaches with clear open water were observed during the survey (Plate A20.3 and Plate A20.5). Considerable vegetation growth was apparent in the riparian zone, including Himalayan balsam (<i>Impatiens glandulifera</i>) at the upstream end of the reach, near the proposed crossing point.

<p data-bbox="406 1877 1377 1910">Plate A20.4 Locally Wide Floodplain with Dense Riparian Vegetation Growth</p>

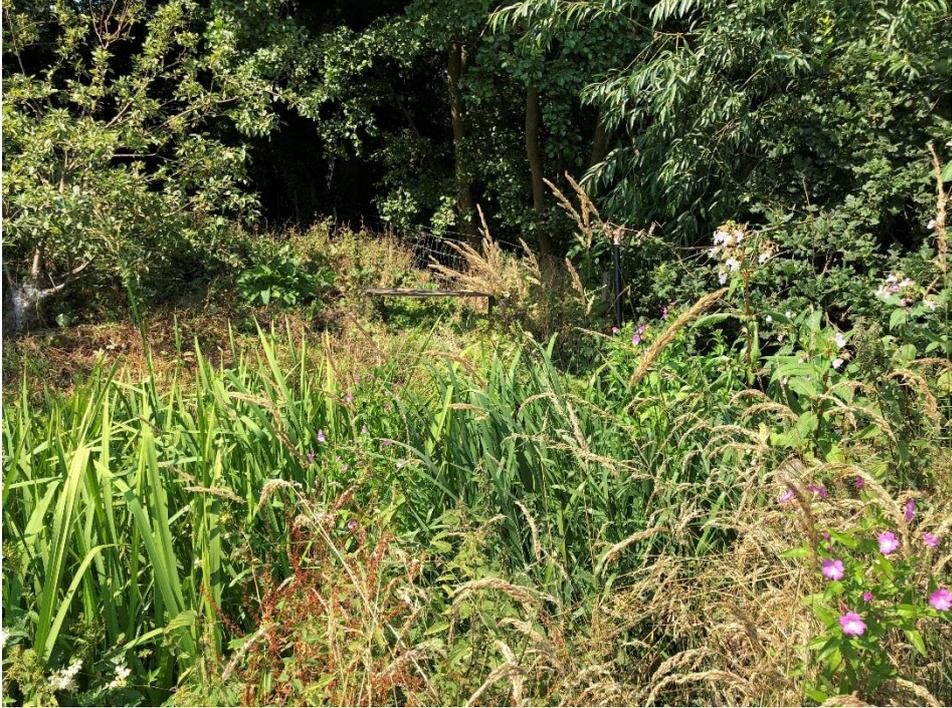
<p data-bbox="406 1048 1385 1081">Plate A20.5 Extensive Growth of In-Channel Vegetation in Parts of the Reach</p>

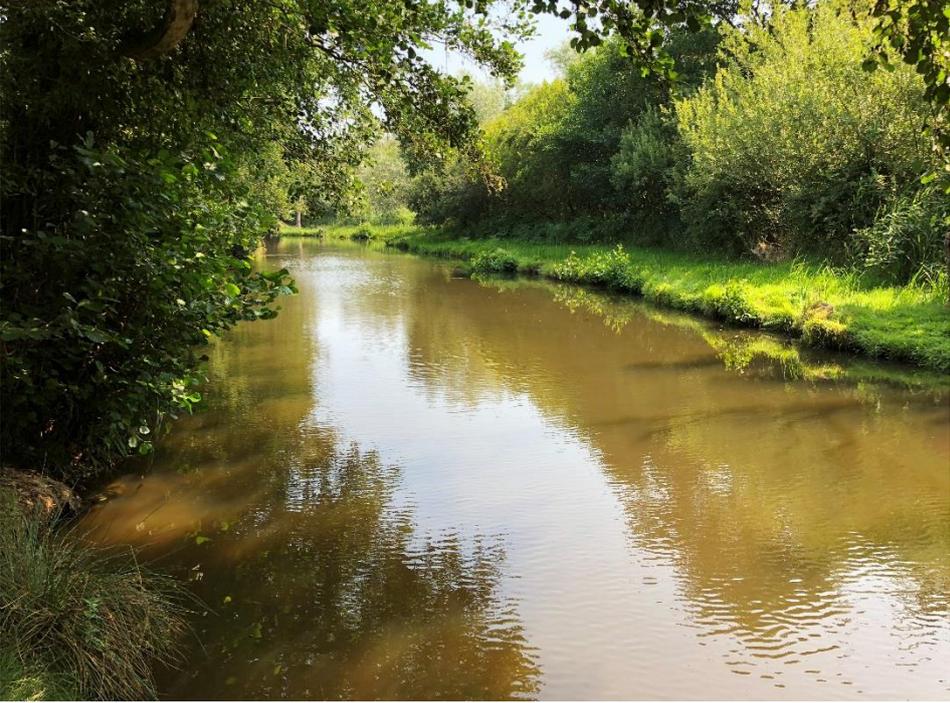
Flow conditions	Flow conditions were dominated by uniform, low energy glides (Plate A20.6). The reach upstream of the weir is impounded. The water was highly turbid at the time of the survey.

<p data-bbox="408 1355 1230 1391">Plate A20.6 Wide, Shallow Channel with Low Energy Glide Flows</p>
