SPR EA1N and EA2 PROJECTS

DEADLINE 11 – COMMENTS ON THE DRAWINGS IN THE DESIGN AND LAYOUT OF THE SUBSTATIONS SUBMISSION IN RESPONSE TO R17QE ISSUED ON 13 MAY 2021

Interested Party: SASES PINS Refs: 20024106 & 20024110

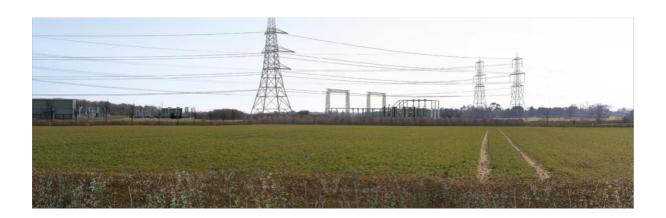
Substation Photomontages: Figure 29.17 Update Viewpoint 5 Public Rights of Way, near Moor Farm (REP8-057)

2. This includes a photomontage of the proposed western substation and National Grid GIS substation which shows the westernmost cable sealing end with two gantries.

- 3. There are a number of errors.
 - a) The OHLs end on the right hand pylon, when of course they continue on
 - b) The quad core OHLs are shown as thin cables
 - c) The cables are inaccurately positioned on the tension pylon, they should be much higher
 - d) None of the OHL insulators are shown (they will be especially prominent on the tension pylon by the western most sealing end)
 - e) The many cables and insulators and hardware from the sealing ends and gantries up to the OHL are not shown.
- 4. Photographs of complete sealing ends are shown on page 111 of Chapter 6 of the Environmental Statement, Project Description

- 5. These show how much more visible the typical final solution is. Further the westernmost cable sealing end has two gantries and two sets of conductors from the gantries up to the OHLs compared to the single one shown in these photographs.
- 6. Further it is not clear whether these photomontages reflect the larger footprint and more robust design of the four new pylon towers (including the one additional pylon tower) which are shown reflected in the drawings attached to the Applicants' Design and Layout of the Substations submission referred to below.

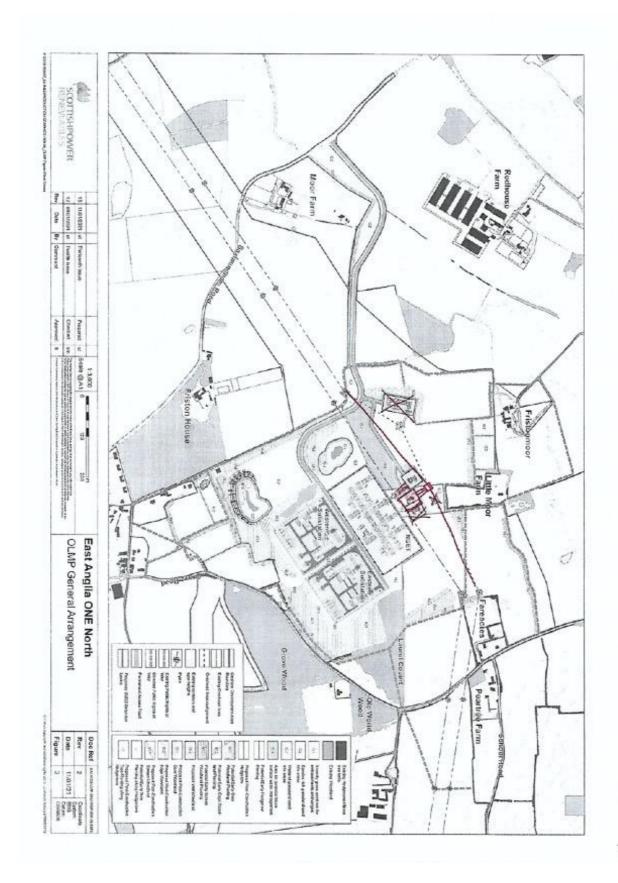
- 7. The series of drawings attached to the submission shows in addition to the substations, two smaller cable sealing ends, the larger cable sealing end which includes a circuit breaker, and four new pylons. However in none of these drawings is the connection between the two smaller sealing ends and the pylons shown.
- 8. The attached plan shows such connections and how the cable sealing ends might be configured assuming that the larger cable sealing end (including circuit breaker) is not required for these projects and particularly if only one project is consented or developed.
