EAST ANGLIA ONE NORTH

EAST ANGLIA TWO

SEAS comments on the APPLICANT'S RESPONSE to

THORPENESS CLIFFS and CORALLINE CRAG SEAS comments on the APPLICANT'S RESPONSE to ExA WQ1s and WRITTEN REPRESENTATIONS

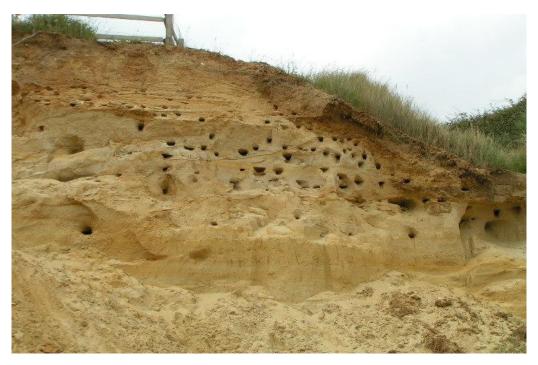
Sandmartins at Thorpeness, Suffolk

Notwithstanding the erosion of the cliff, or perhaps because of it, the Sandmartins have found something super-soft to create their nests in at Thorpeness. ©Barry Hughes ⁸ 18/07/2005

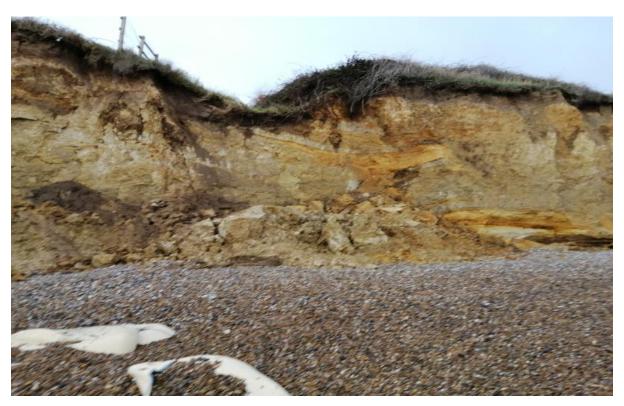
The recent high winds of 9 and 10 November 2020 saw a further cliff fall and the seasonal winter storms haven't even begun. Stormy high tides eat at the shore line leaving an overhang which inevitably collapses from sheer weight.

The Sandmartins nests are no longer there. © G Robertson 14/11/2020

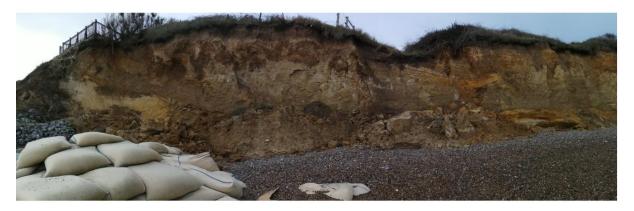
No matter what defences are installed in this particular part of the shoreline, the sea reclaims them at a rapid rate. © G Robertson 14/11/2020

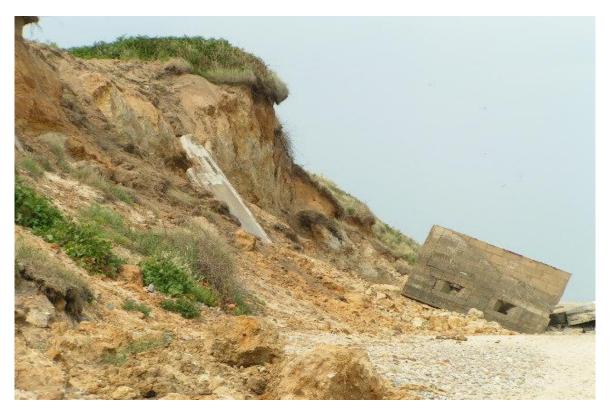
Coastal Erosion at Thorpeness, Suffolk

This wartime "pillbox" was at least 50ft from the cliff edge when I first saw it in 1997. No doubt it was even farther inland in the 1940s.
©Barry Hughes 9 18/07/2005

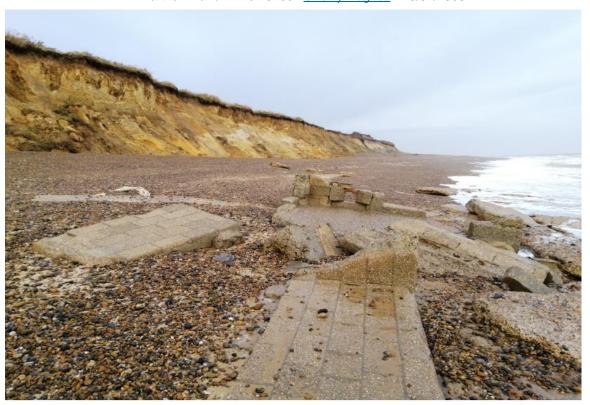
The pillbox is reclaimed by the sea. © G Robertson 14/11/2020
