SPR EA1N & EA2 PROJECTS – DEADLINE 12

SUBMISSION OF IAN & MARY SHIPMAN
of [REDACTED]

Recent flooding in Friston

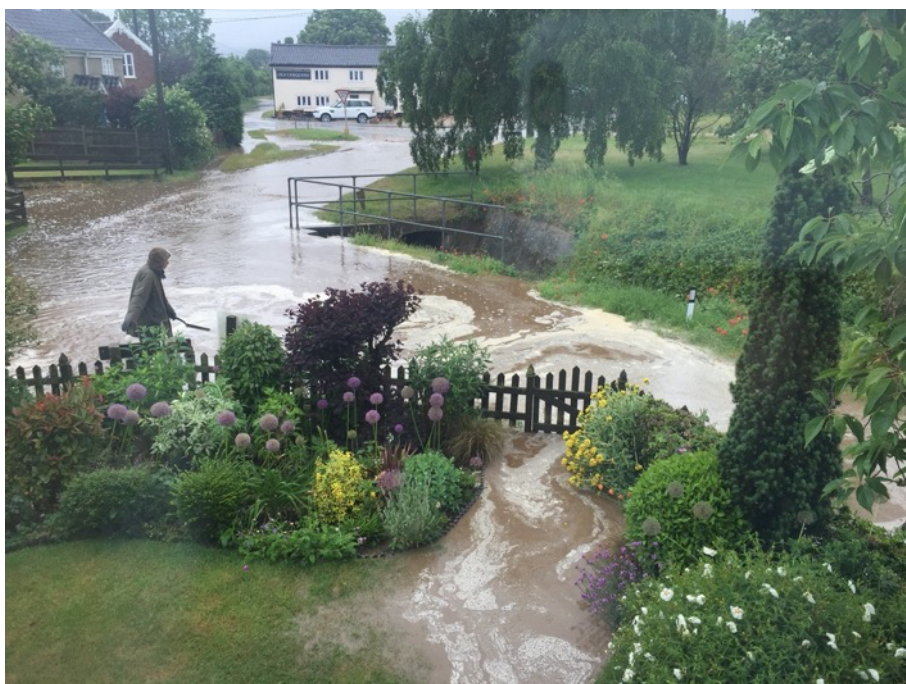
4. The storm on 18th June was peaking at midday when the following photograph was taken from our 1st floor window. It was at this point that we noticed the water entering the front hall of our house. We will submit a video we took at ground level, which demonstrates the force and extent of the water, as a separate document at Deadline 12. We have also made a report of the internal flooding to SCC via their online portal.

Junction of Church Path/Grove Road – 18th June 2021

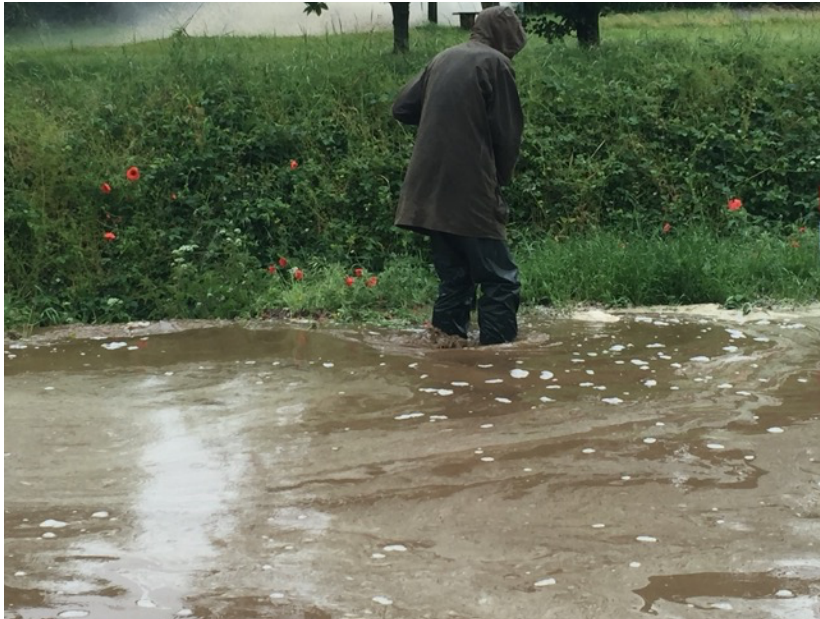
5. The water was approximately 225mm deep as can be appreciated by the photo below.

Flood in Church Path overtopping into Friston Watercourse – 18th June 2021

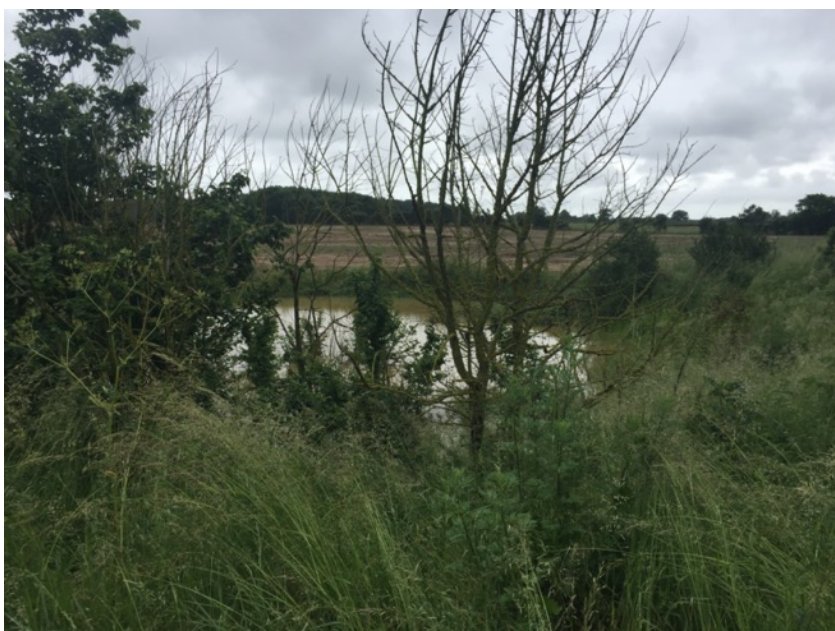
Northern pit on substation site – 19th June 2021

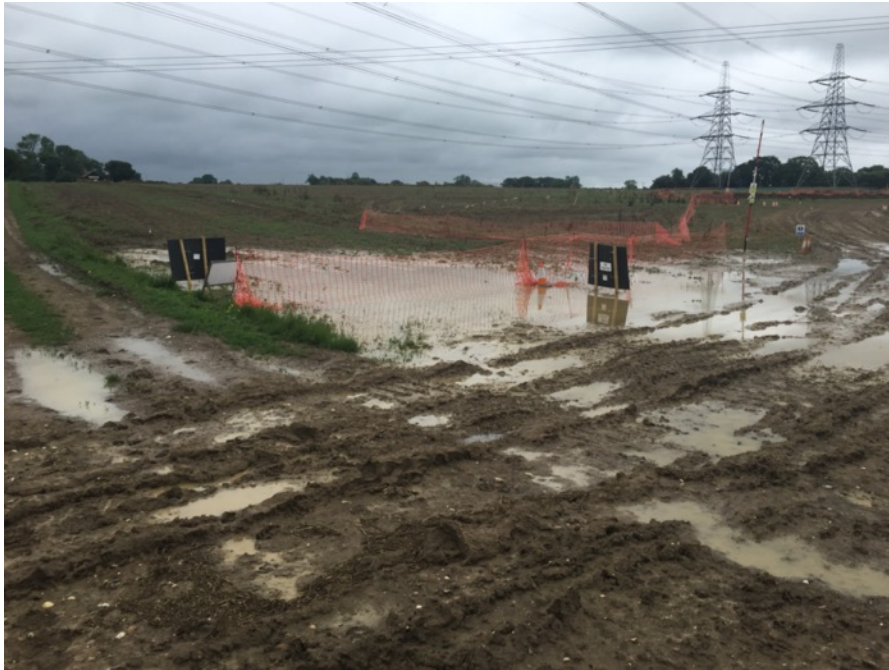
Substation site – 19th June 2021

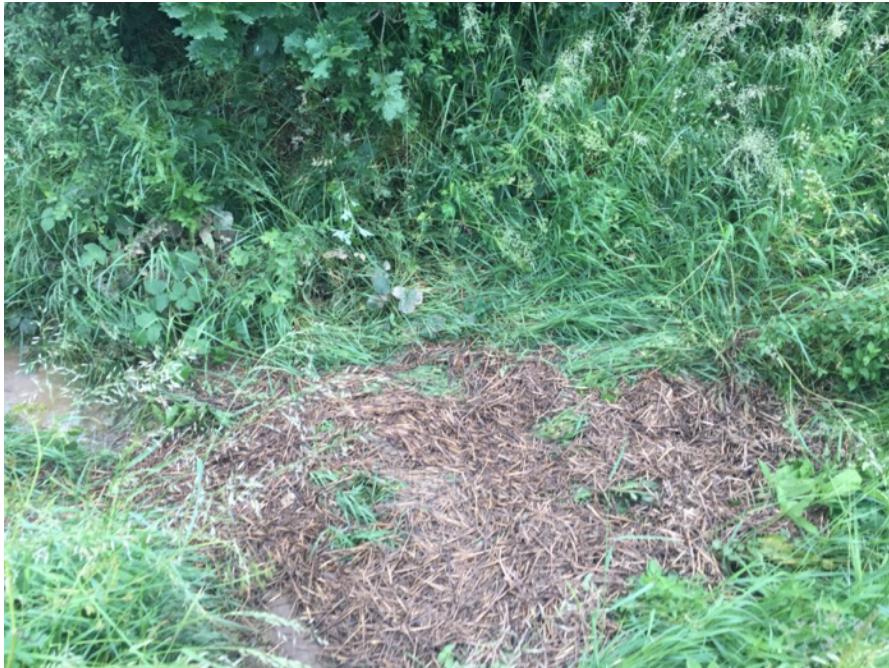
Blockage in watercourse adjacent to Footpath 17 and substation site - 19th June 21

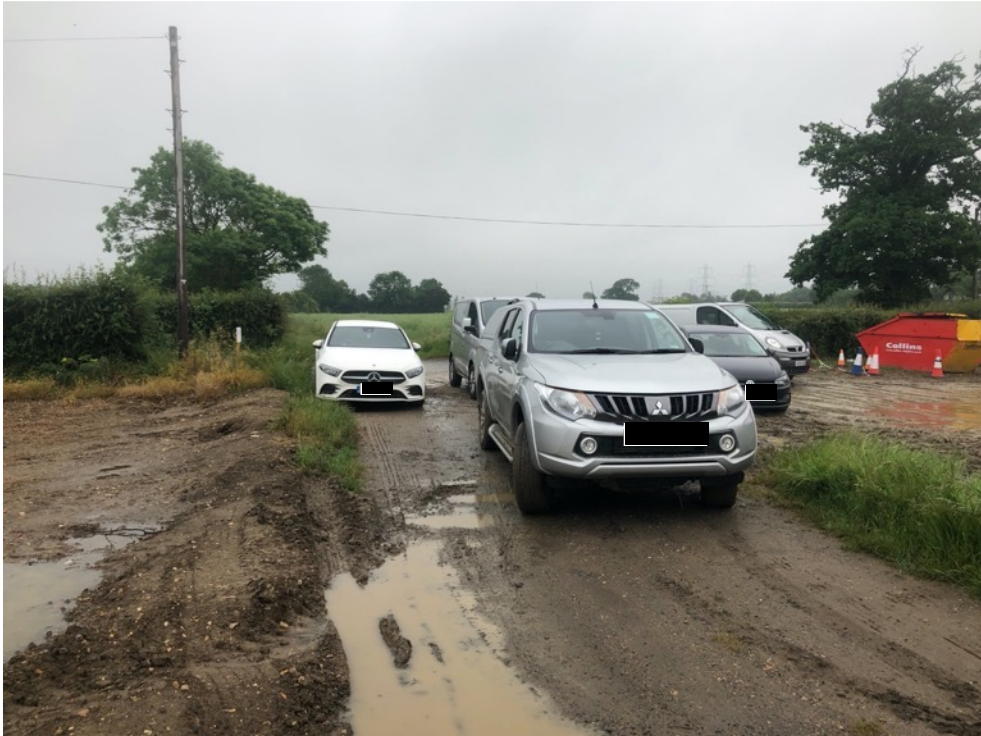
*Site Investigations' northern works access off Grove Road – 18th June 2021
Site workers' vehicles parked on access track to Little Moor Farm*

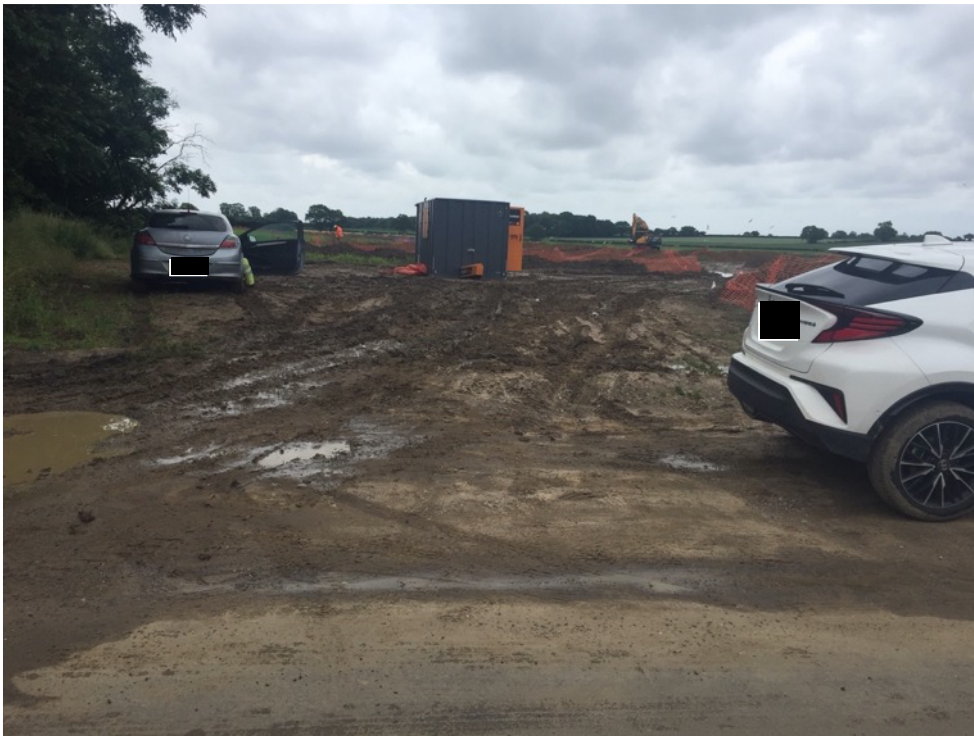
Southern Grove Road access for site investigations – 21st June 2021. Mud can be seen on the road itself.

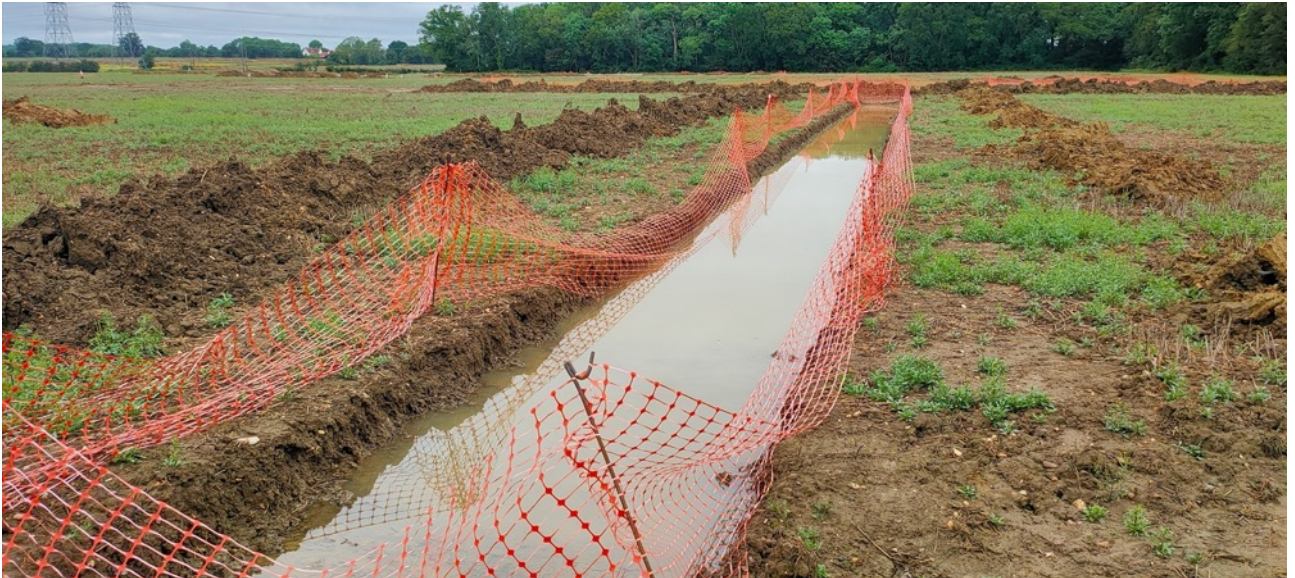
Archaeological trial trench on substation site – Saturday 19th June demonstrating poor drainage of flooding which occurred 24 hours earlier.

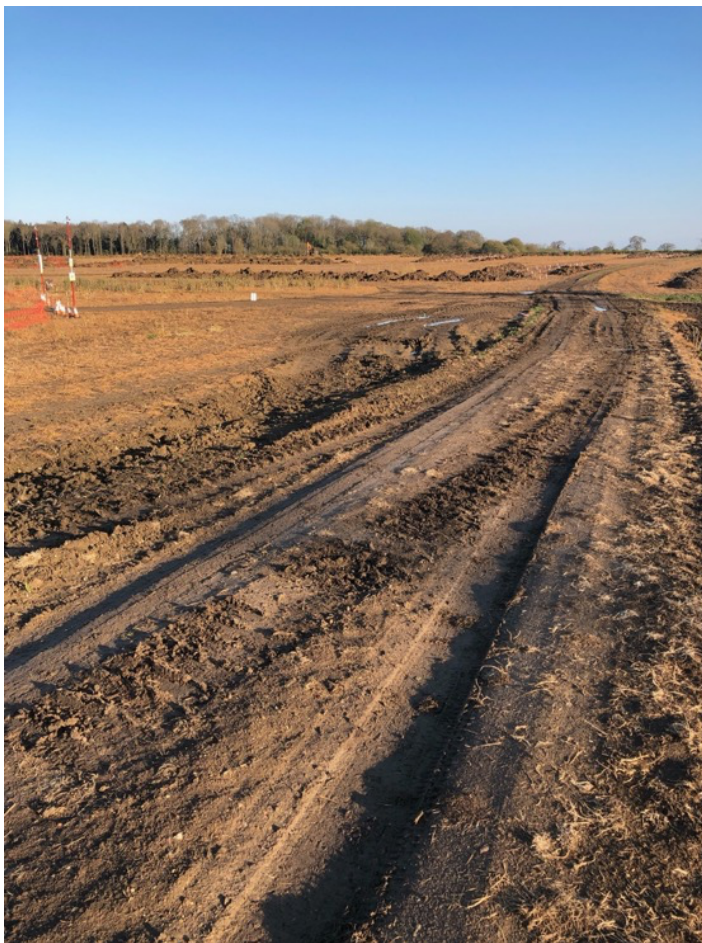
Footpath 6 on substation site – site de-vegetated and damaged by vehicles

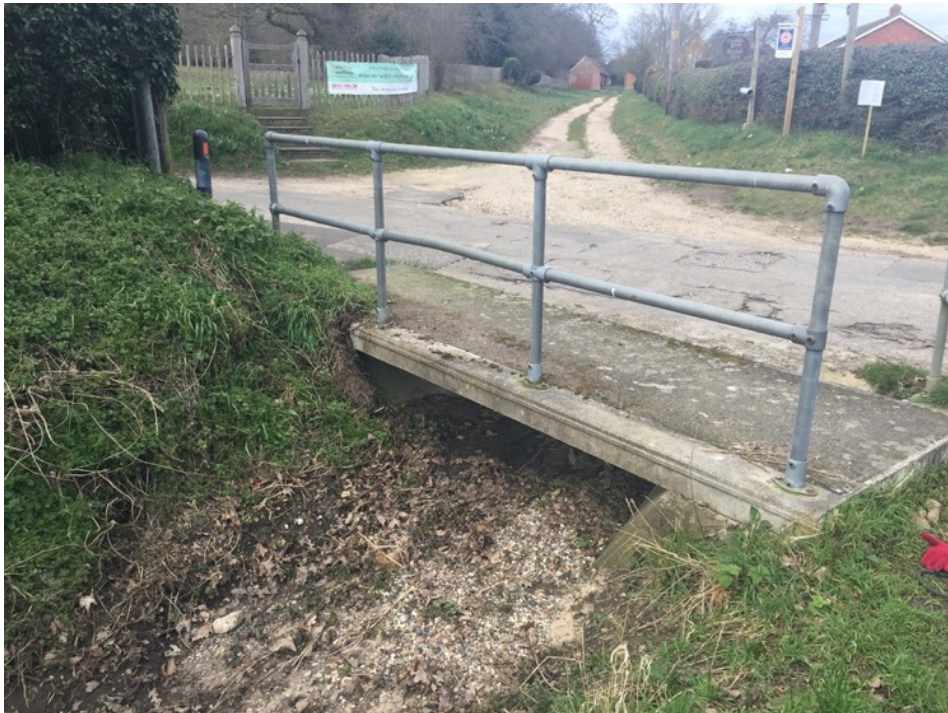
11. We have serious doubts that a connection can effectively be made at the Church Road ford, due to on-going problems of silting and vegetation growth in this shallow channel. We do not believe that 'regular' maintenance by the Environment Agency or any other organisation will resolve this, as the silting can take place very quickly at any time due to weather conditions, when the overland flow down Footpath 17 adjacent to Woodside Farm deposits silt and gravel into the watercourse during heavy or prolonged rain.

Ford in Church Road – proposed shallow connection point to Friston Watercourse. Stones and silt are washed down farm track during heavy rain.

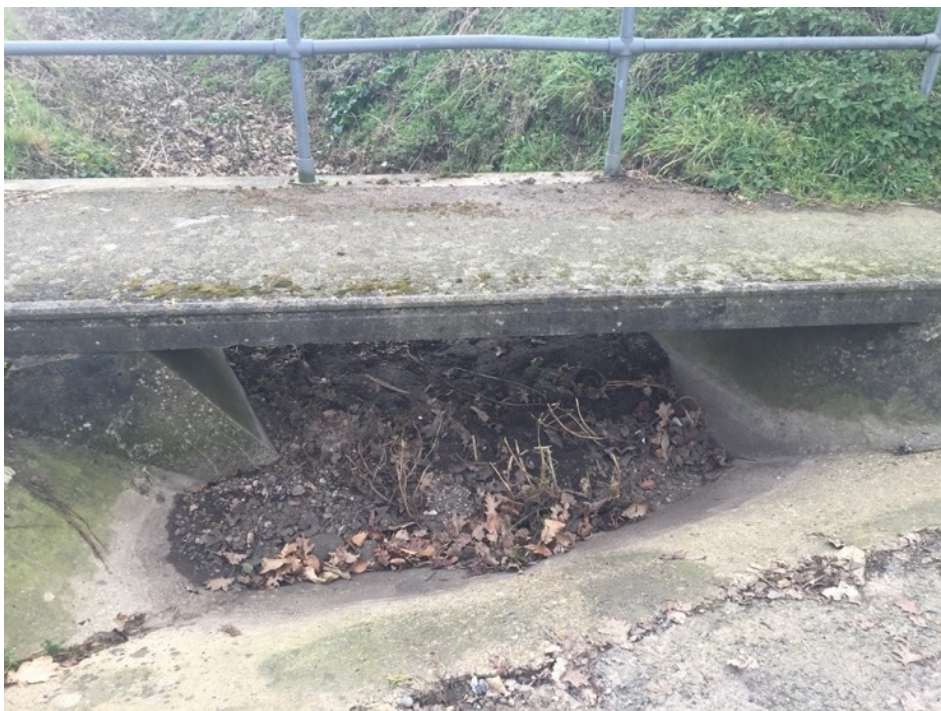
Ford as seen from Church Road – note silting, shallow depth and vegetation

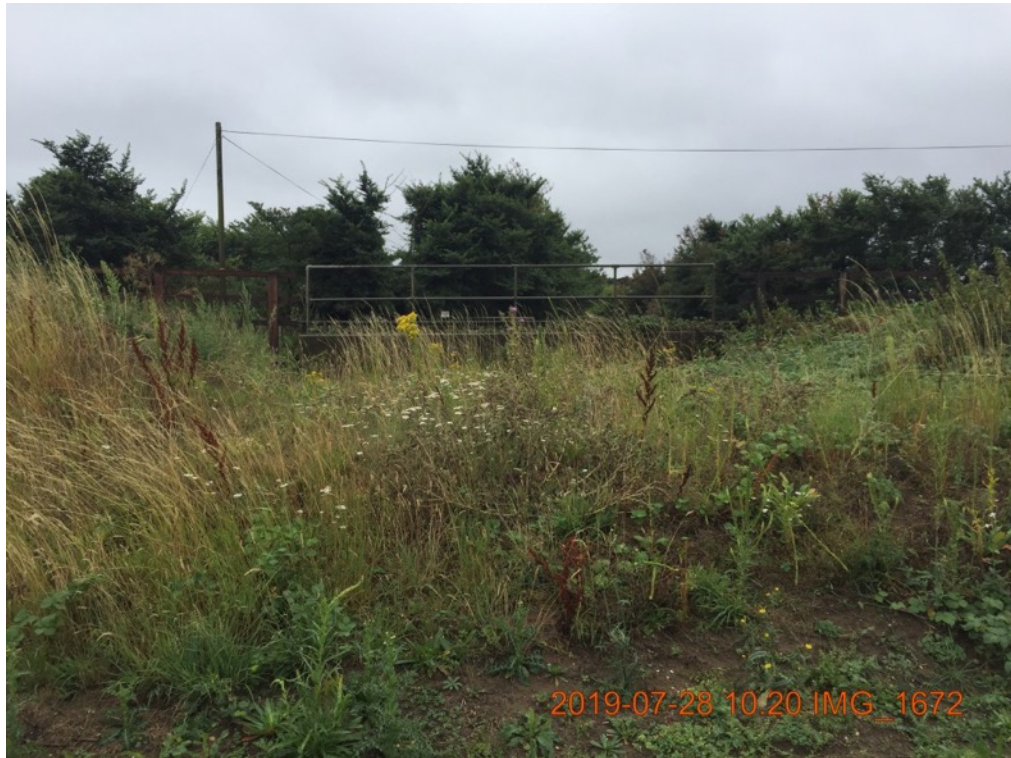
Bund adjacent to A1094

12. We are also concerned that there is not a continuous flow-path of the Friston Watercourse, which is effectively dammed at the A1094. Any increased total flows will simply cause additional flooding to the field adjacent to the weir and bund. There is no regular discharge from the Friston Watercourse to the estuary of the River Alde unless in very abnormal circumstances, when the weir, which is approximately 900mm high would overtop. This feature was designed into the 1993 Flood Alleviation Scheme.

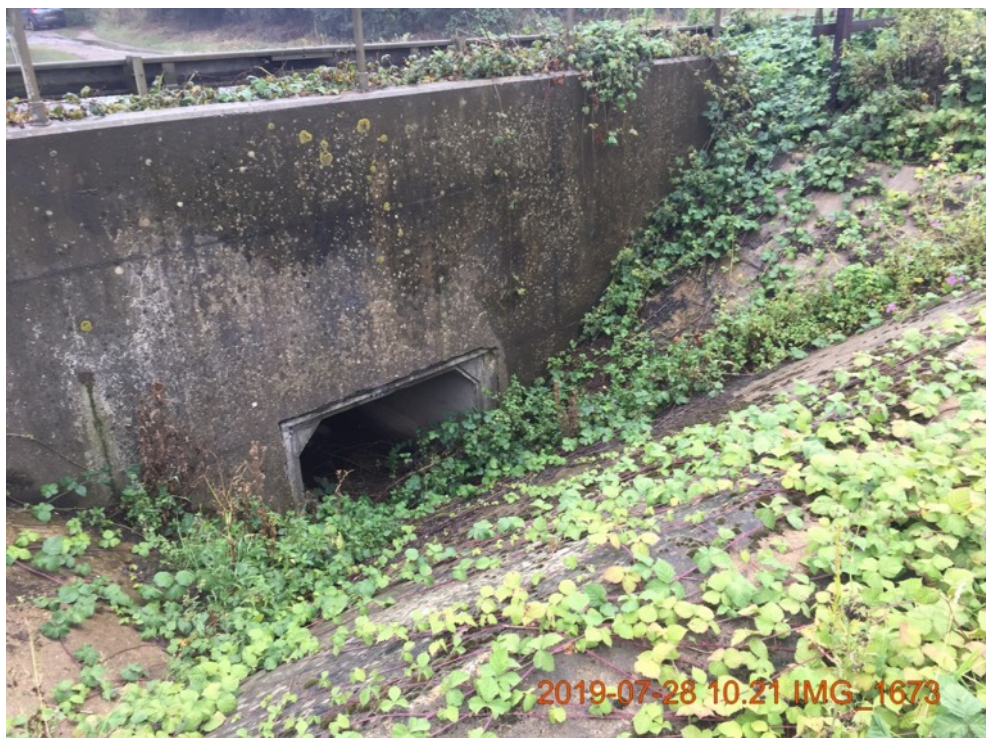
Weir and channel under A1094 to prevent flooding to properties further south

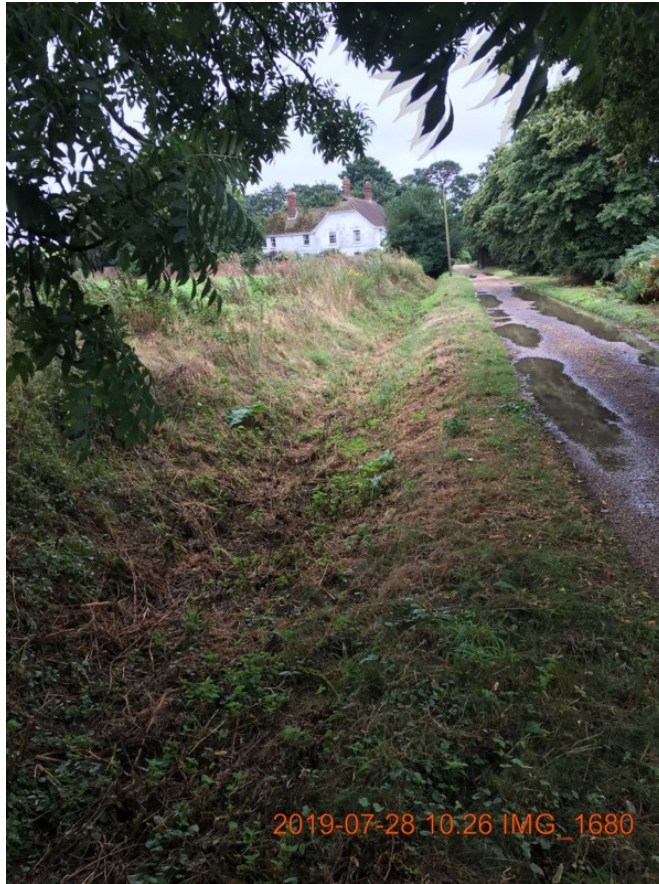
Watercourse south of A1094 towards Firs Farm, which was previously regularly flooded before creation of the dam and weir.
