## Hornsea Project Three Offshore Wind Farm

Response to the Secretary of State's Consultation Appendix 5 - Updated MCZ Assessment  
Environmental Statement: Volume 5, Annex 2.3 – Marine Conservation Zone Assessment

PINS Document Reference: A6.5.2.3 - Updated February 2020

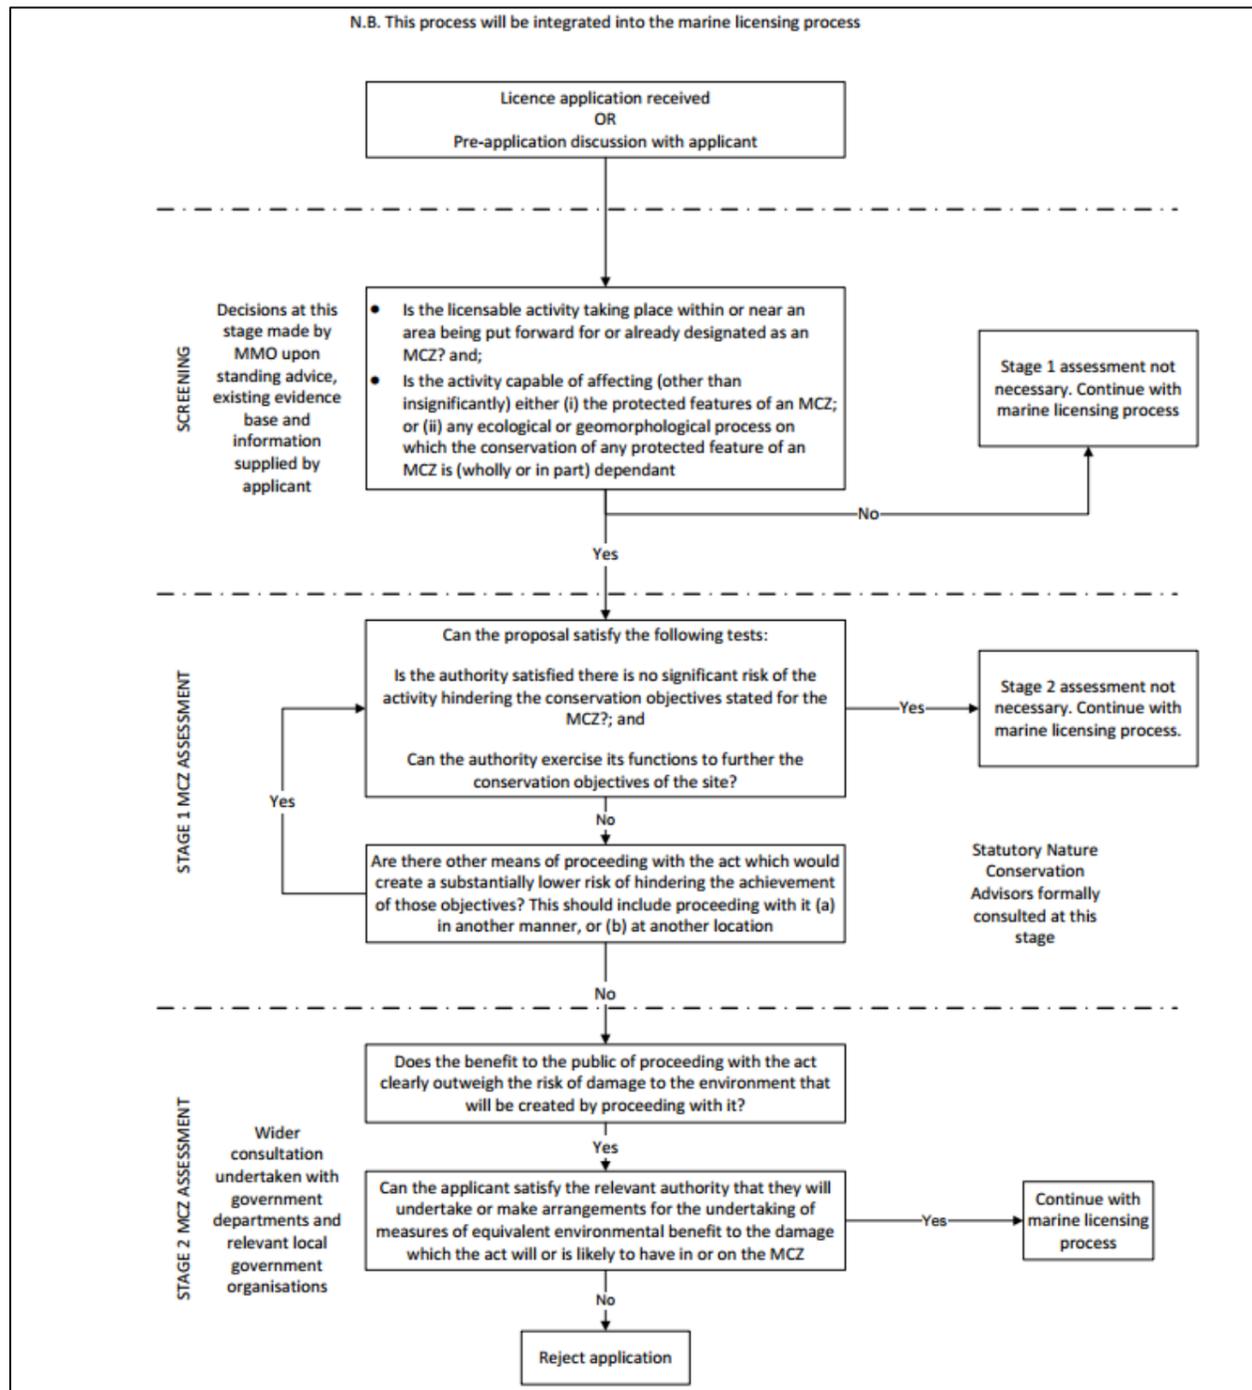
Figure 2.1: Flow chart summary of the MCZ Assessment process used by the MMO during marine licence determination (MMO, 2013).

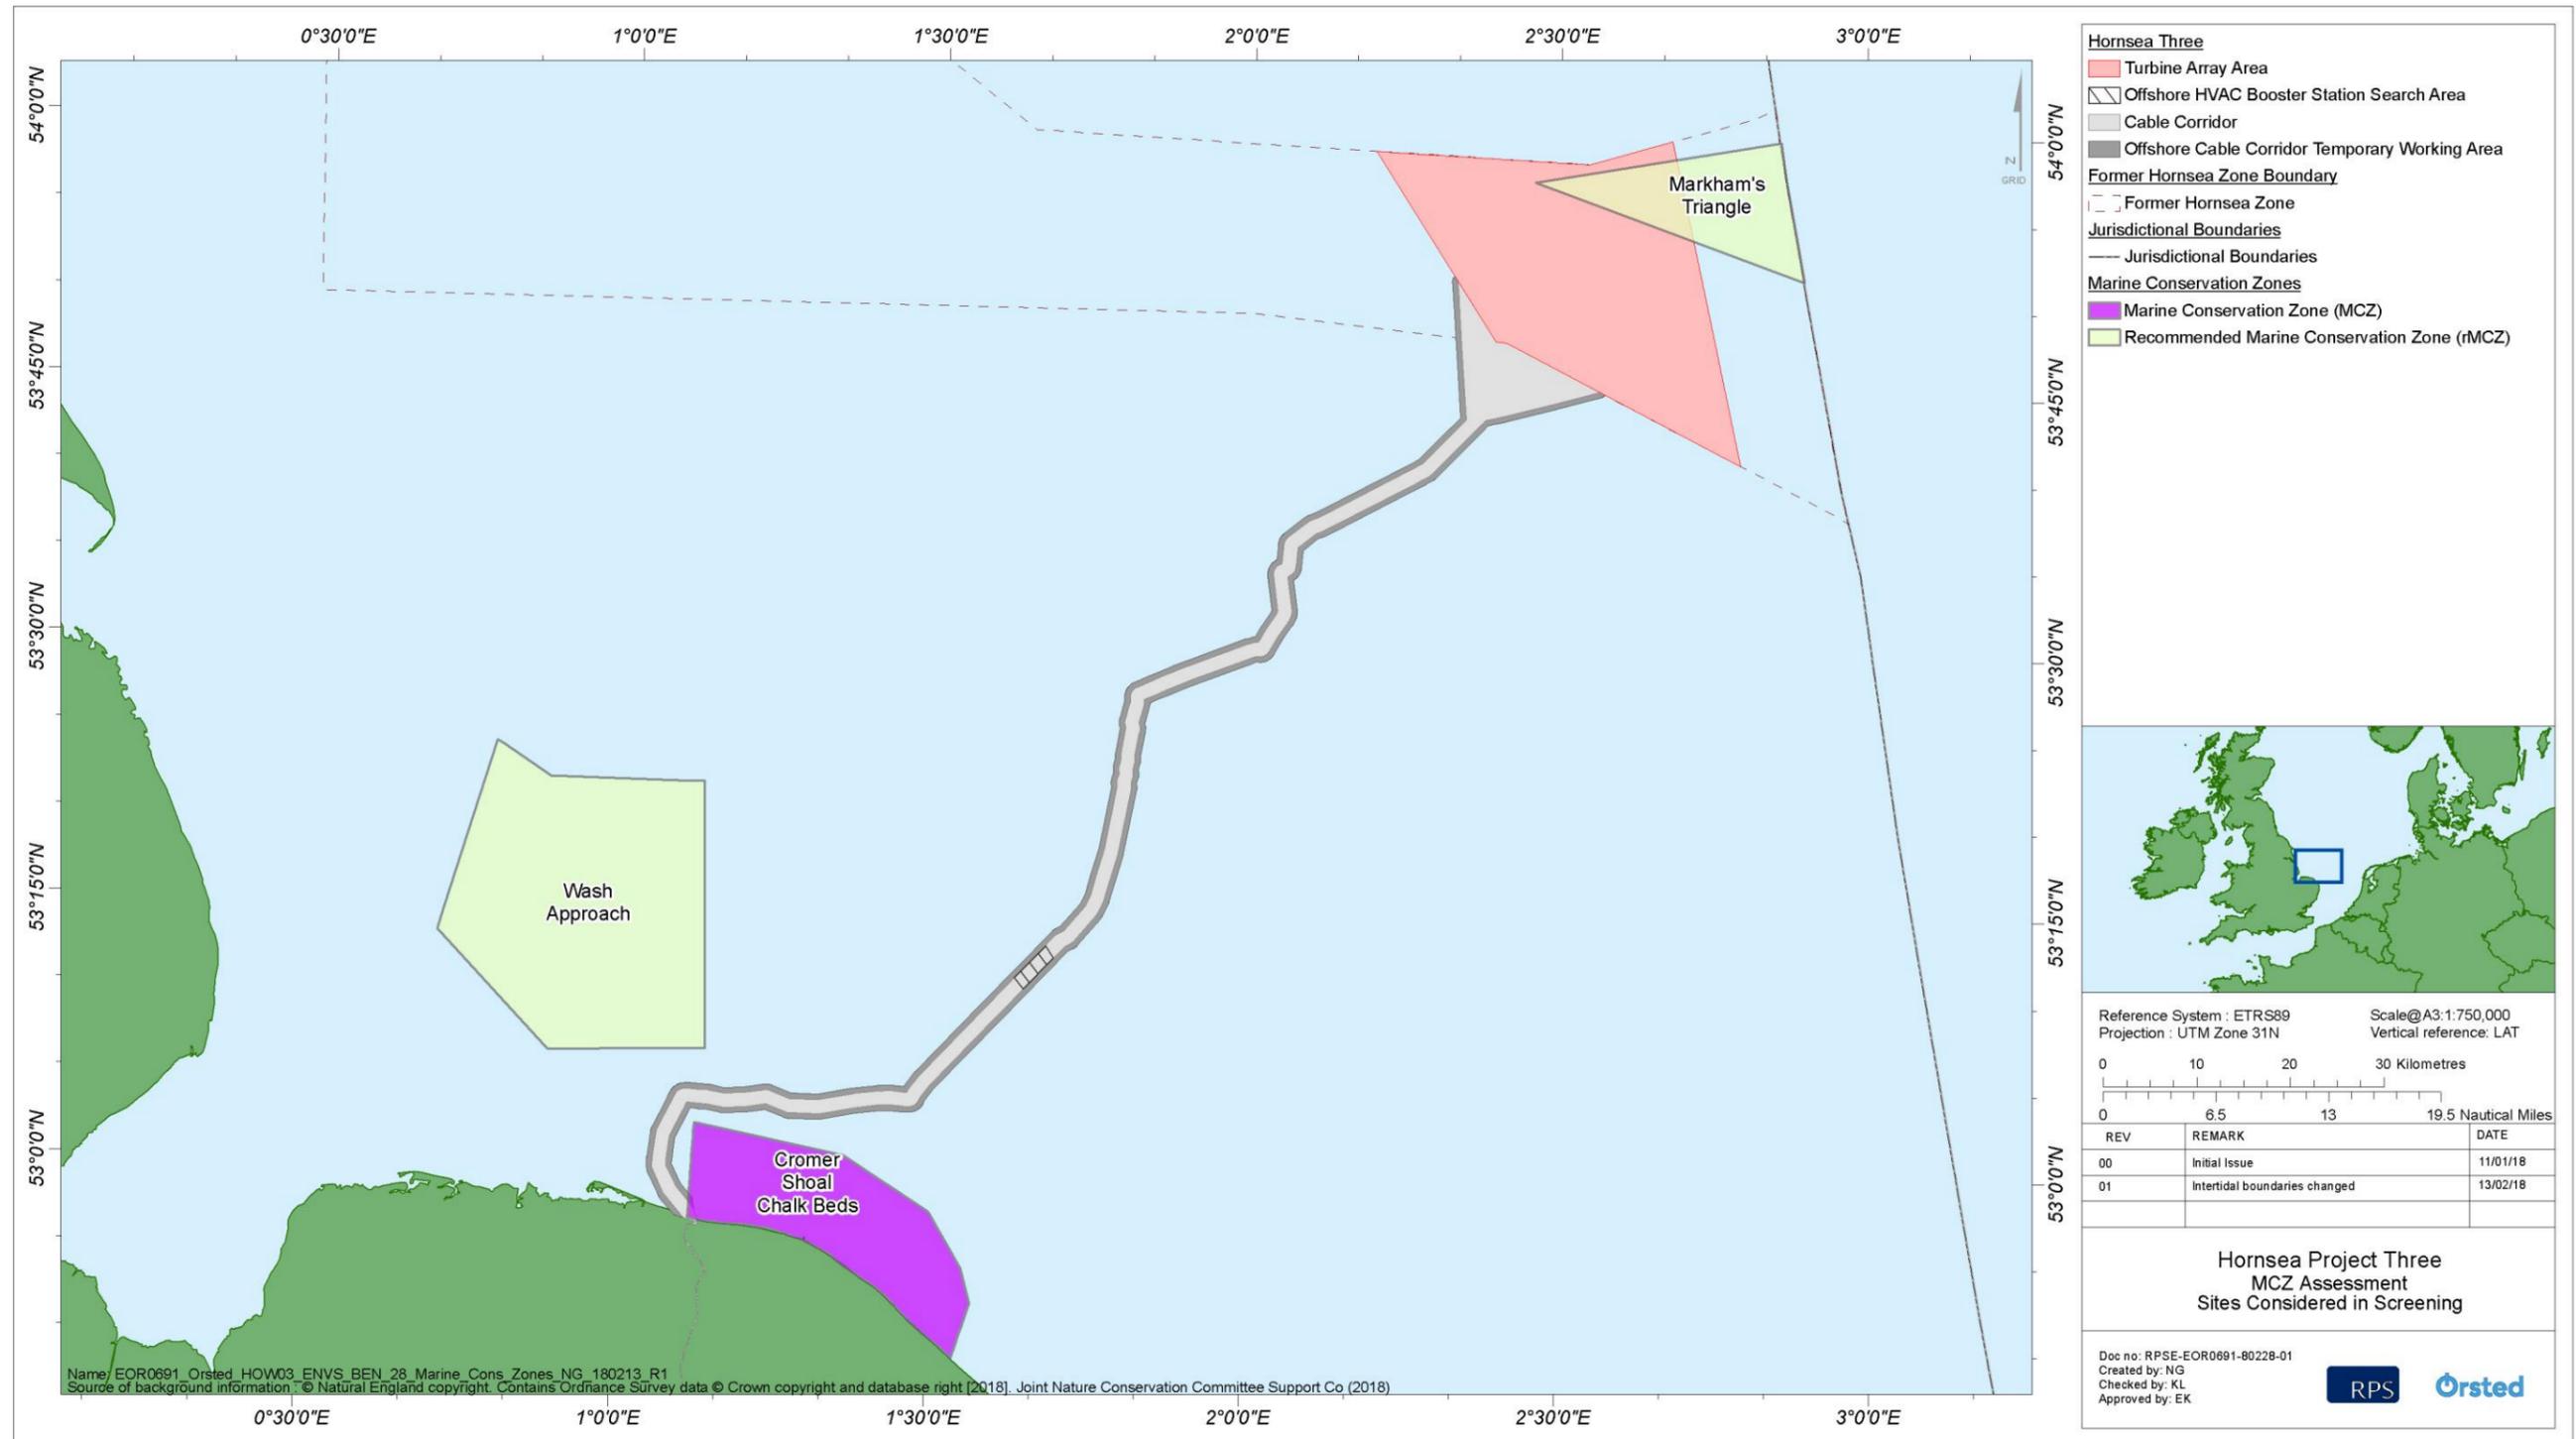
Figure 3.1: Marine Conservation Zones (MCZs) and recommended Marine Conservation Zones (MCZs) overlapping Hornsea Three or within one tidal excursion of Hornsea Three with relevant protected/proposed features.

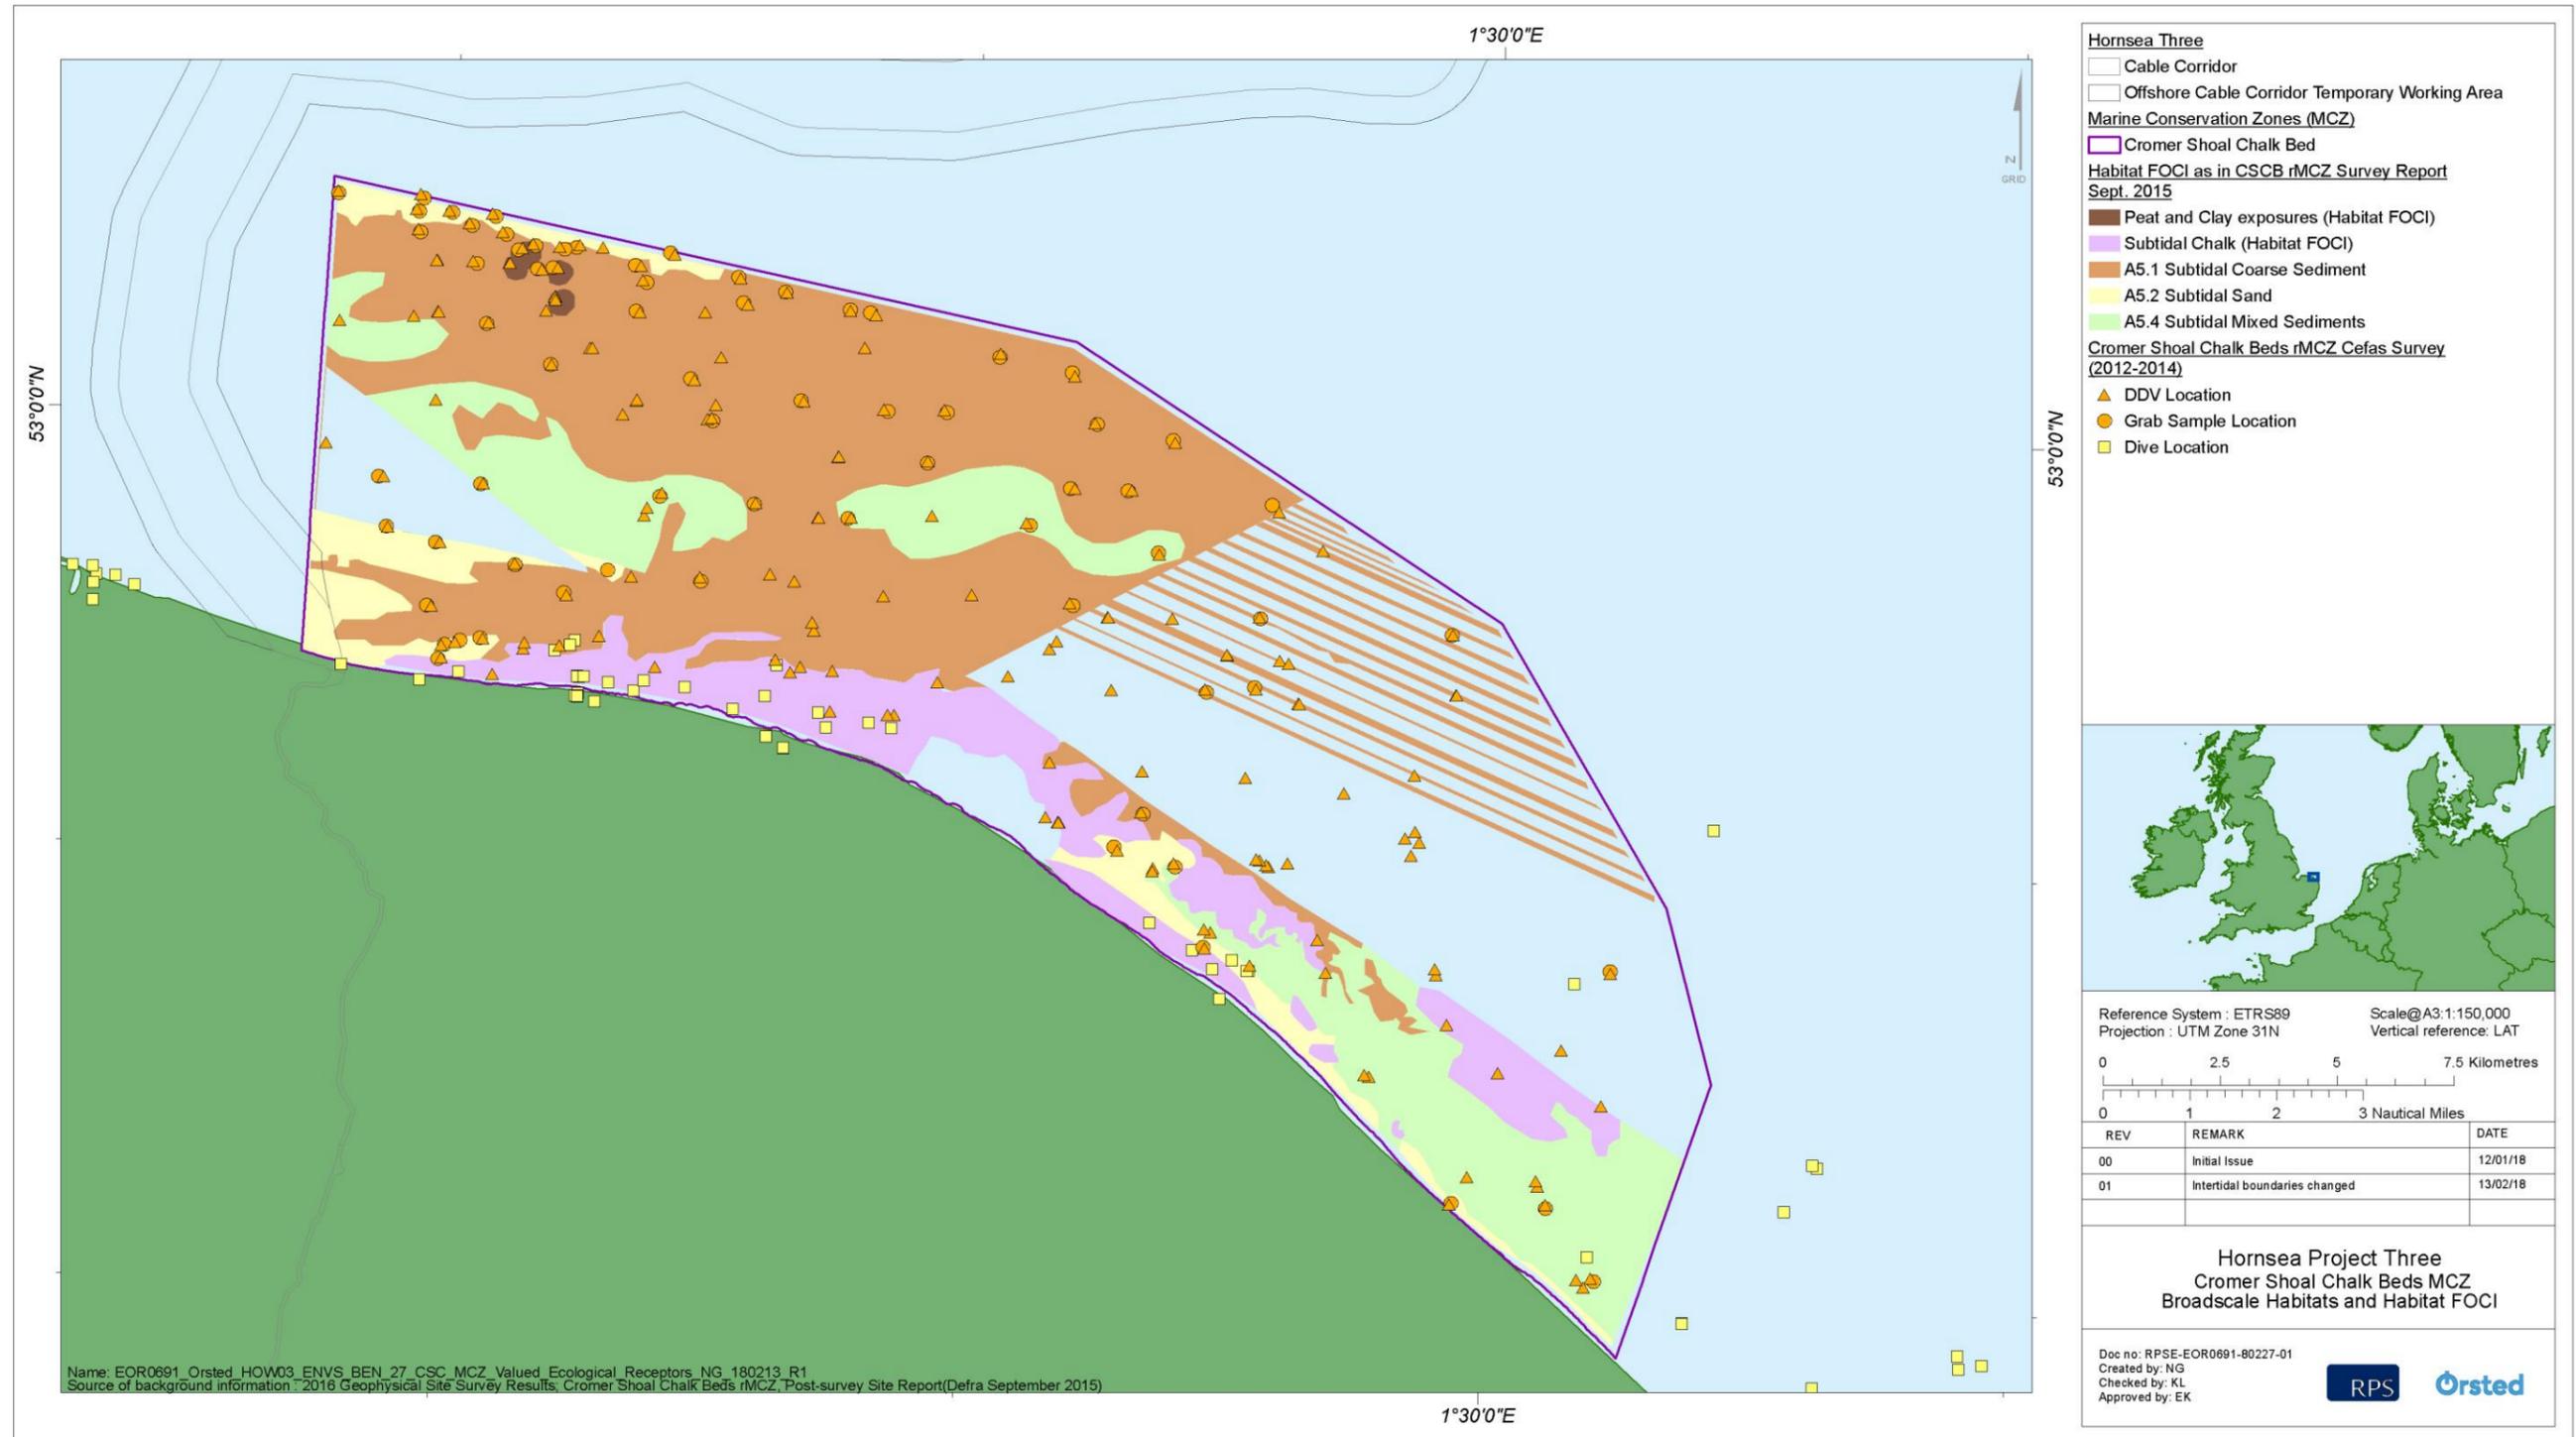
Figure 4.1: Hornsea Three offshore cable corridor and Cromer Shoal Chalk Beds MCZ broadscale habitat features and habitat FOCI.

**Table 4.1: Protected features of the Cromer Shoal Chalk Beds MCZ, recorded extents (see Figure 4.1) and general management approach.**

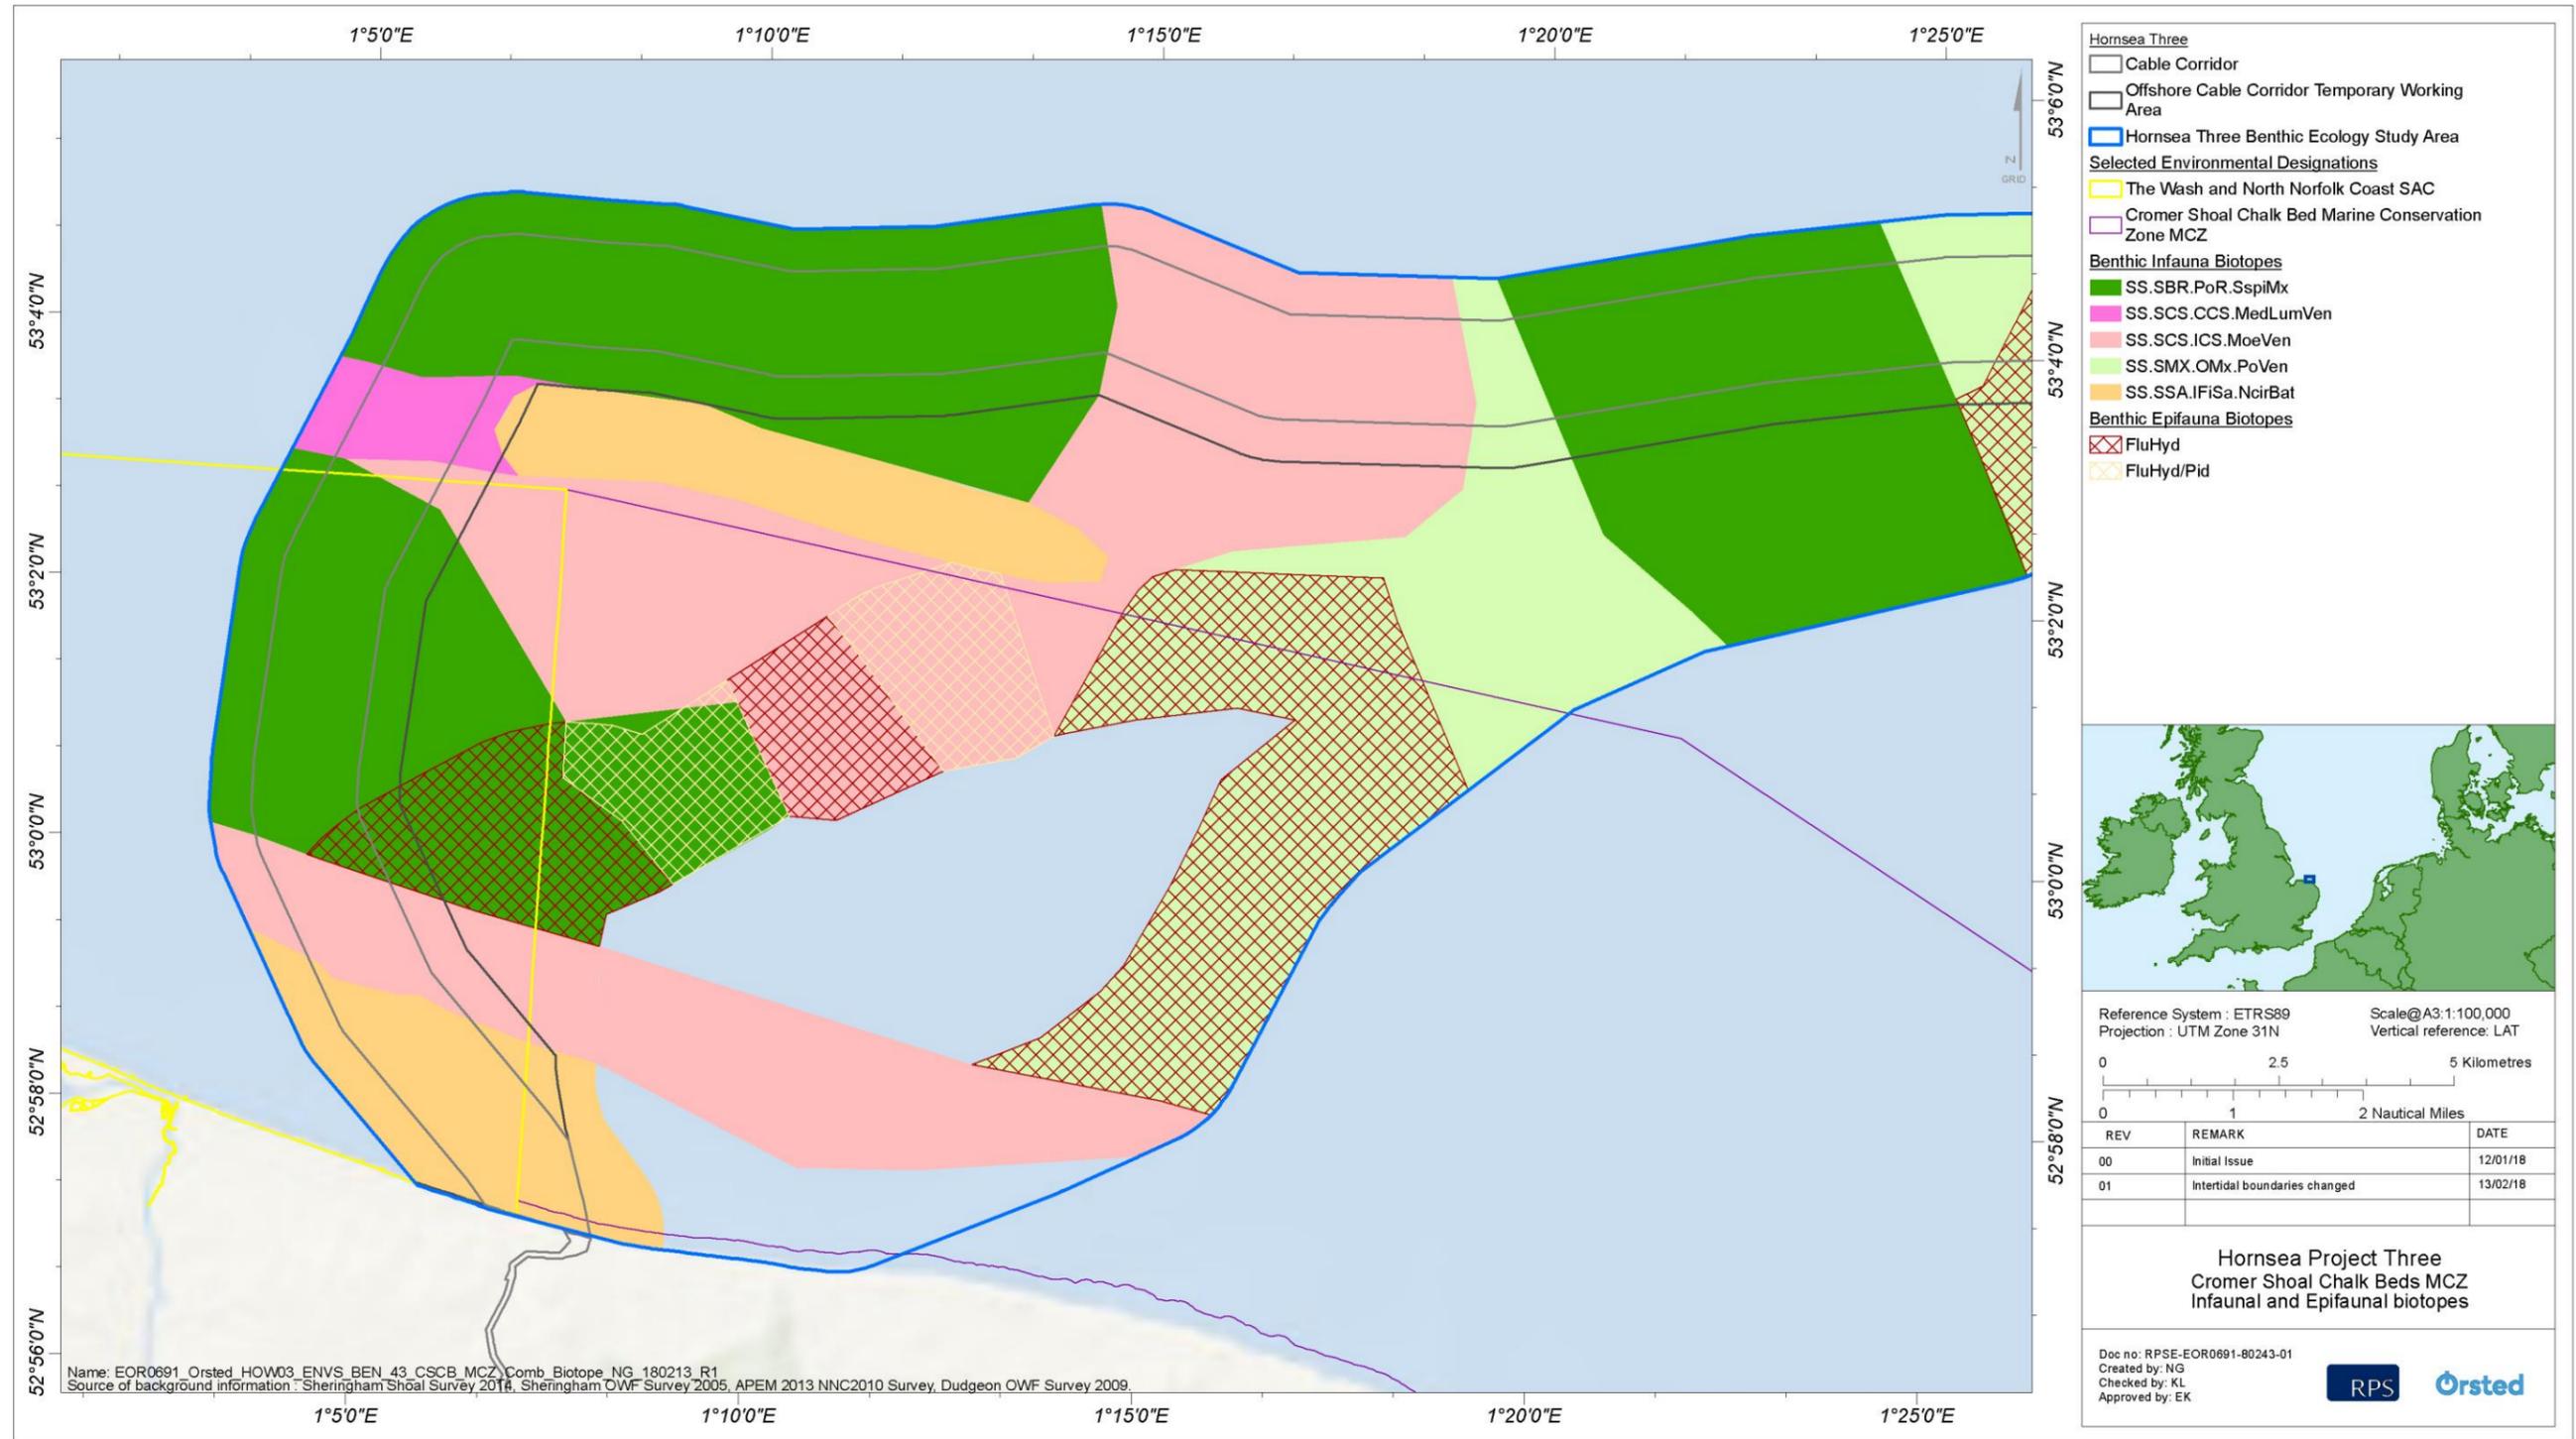
Figure 4.2: Infaunal and epifaunal biotopes in the nearshore section of the Hornsea Three offshore cable corridor, including within the Cromer Shoal Chalk Beds MCZ.

4.2.1.8 The main mixed sediment biotope (i.e. Subtidal Mixed Sediment broadscale habitat feature) within the Cromer Shoal Chalk Beds MCZ and near the Hornsea Three offshore cable corridor was the *Sabellaria spinulosa* on stable circalittoral mixed sediment biotope (SS.SBR.PoR.SspiMx, hereafter referred to as SspiMx). This biotope is typically more diverse than the aforementioned biotopes and was characterised by the tube building polychaete *S. spinulosa* and a range of other polychaete species (e.g. *Lumbrineris cingulata*, *Owenia* sp., *Harmothoe impar* and *Polycirrus* sp.), molluscs (e.g. *Abra prismatica*, *Rissoa parva*) and crustaceans (e.g. *Ampelisca spinipes* and *Pisidia longicornis*). This biotope was also characterised by epifaunal species including the tubeworm *S. lamarcki* and the ascidians *Dendrodoa grossularia* and *Asciidiella aspersa*. This biotope occurred in the west of the MCZ (see Figure 4.2).

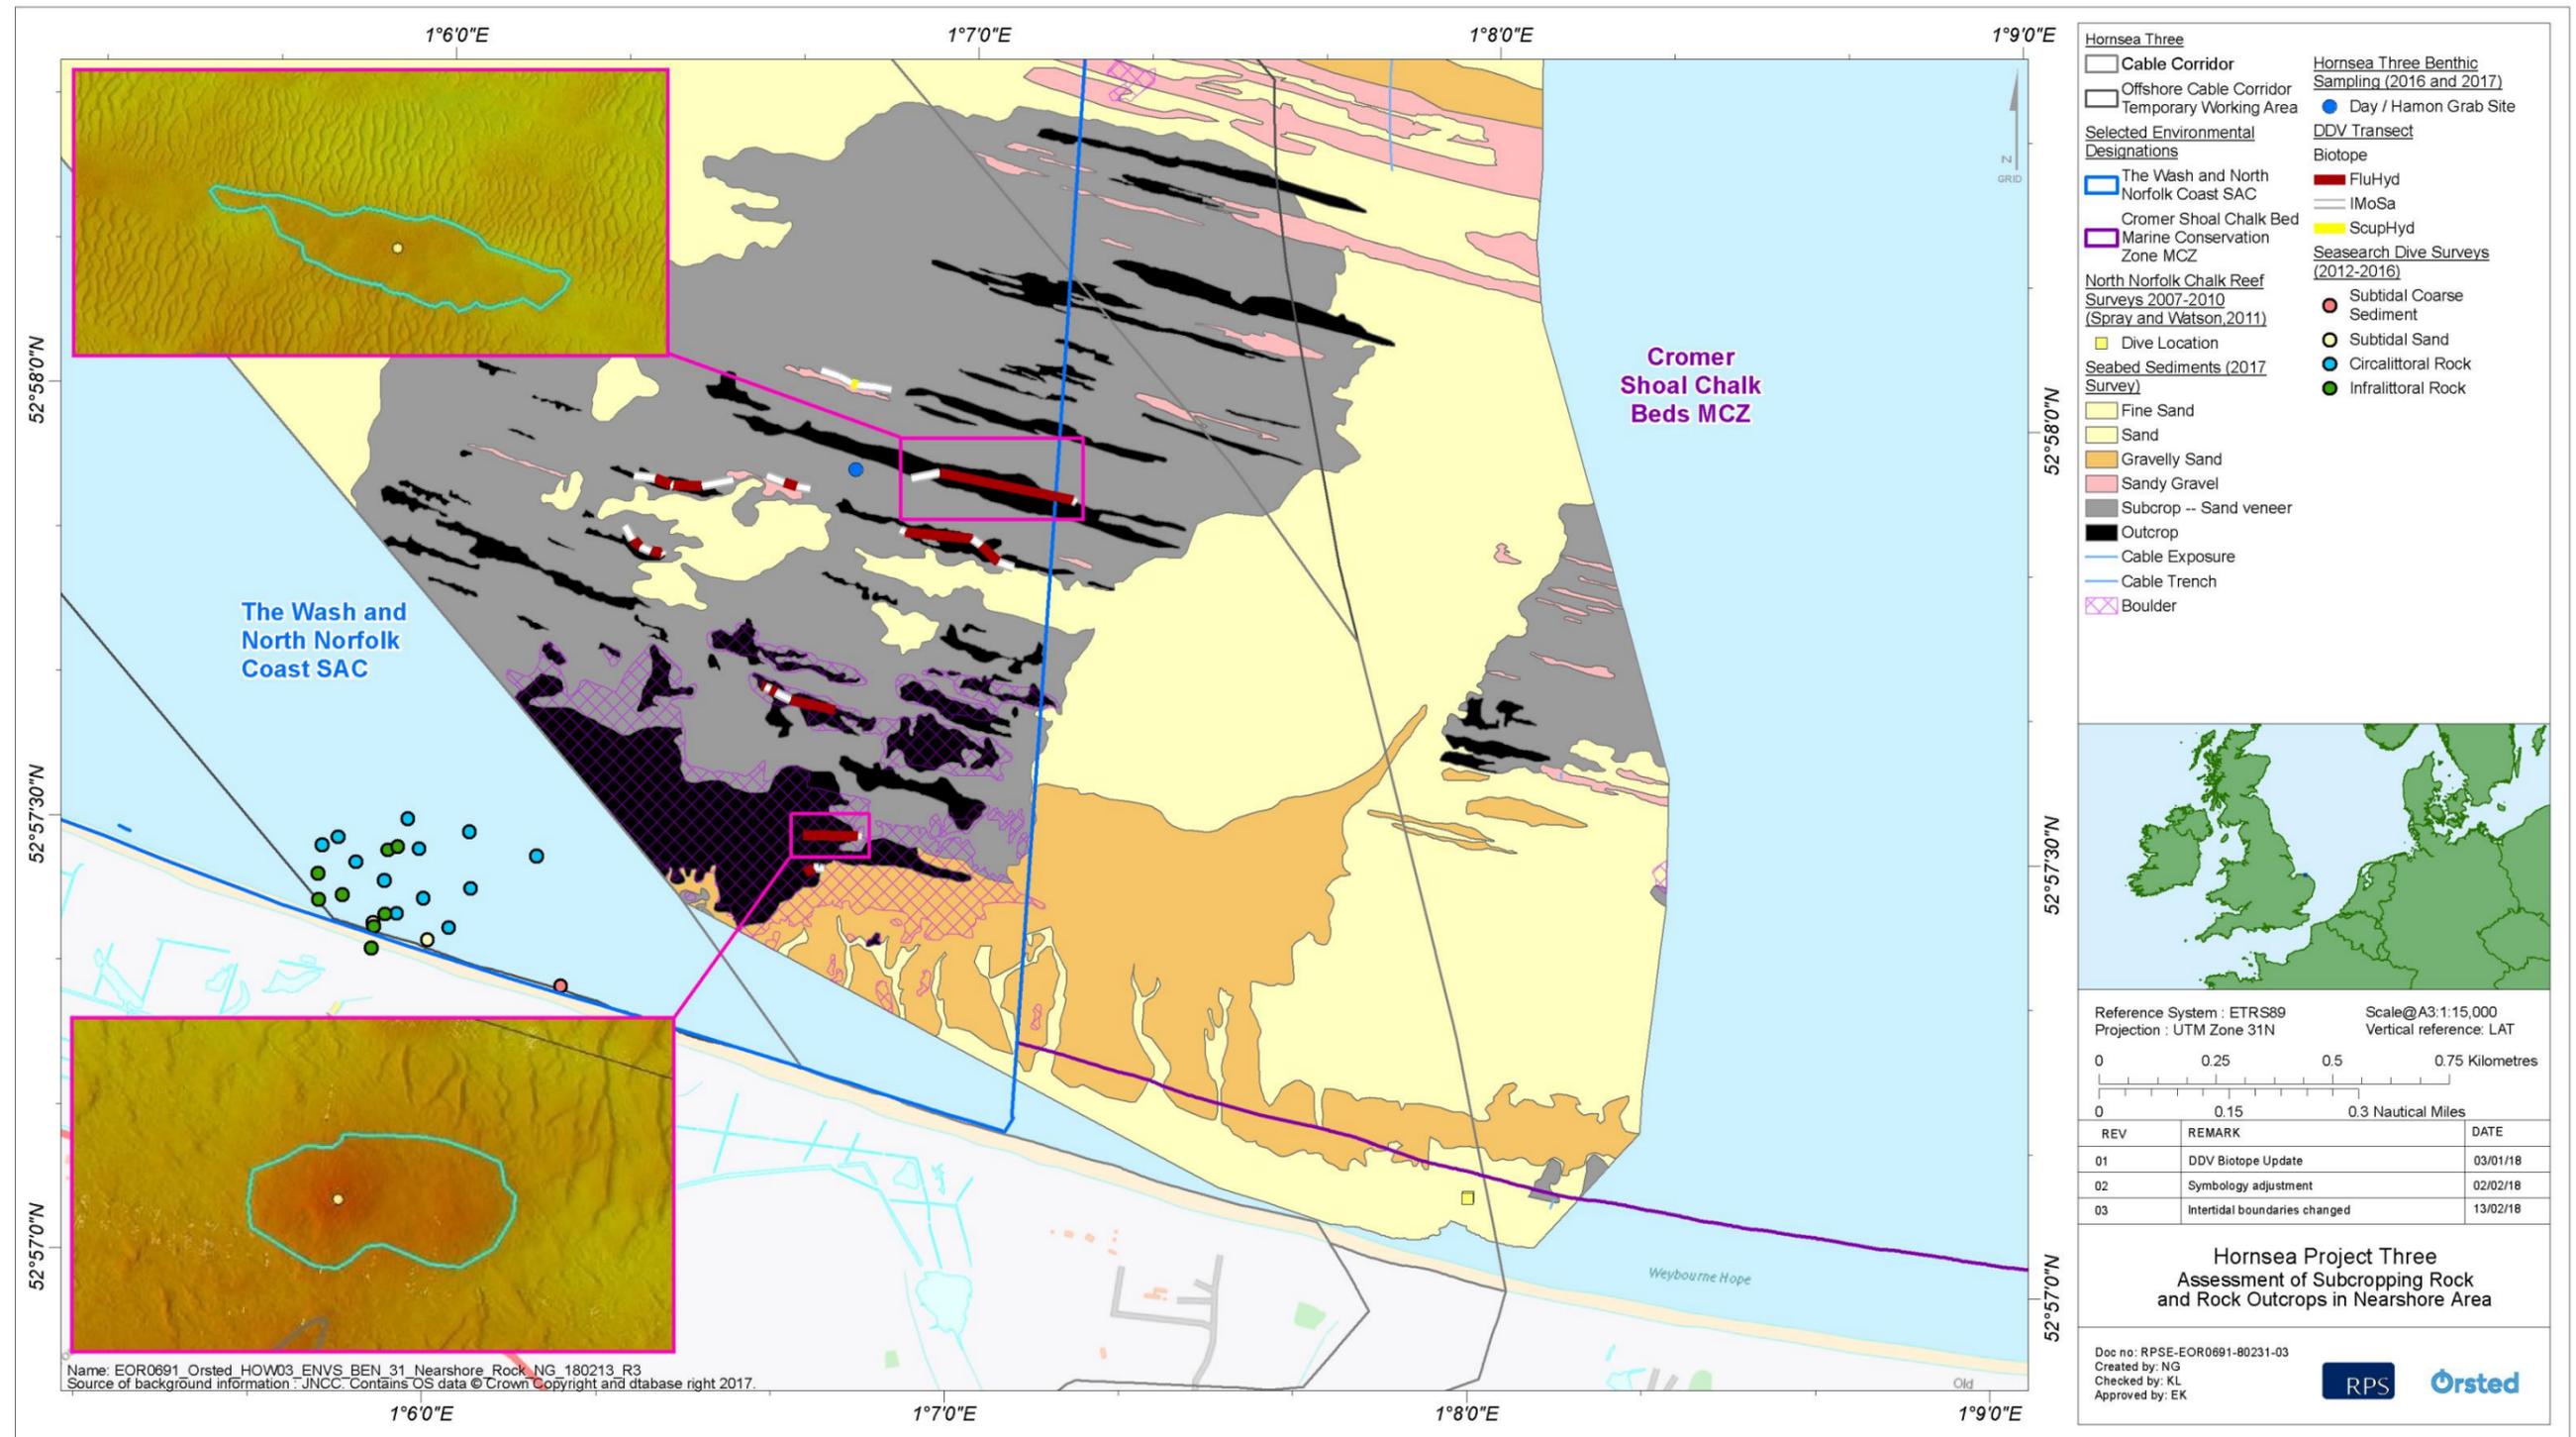
Figure 4.3: Hornsea Three nearshore geophysical seabed interpretation showing subcropping rock (grey) and areas of potential outcrop (black), DDV ground truthing transects with epifaunal biotopes identified and historic records of infralittoral and circalittoral rock in the nearshore area (Note: these historic records of infralittoral and circalittoral rock are outside the boundary of the Cromer Shoal Chalk Beds MCZ).

- 4.2.1.13 The DDV transects confirmed that the inshore area was characterised primarily by sandy sediments (i.e. the NcirBat biotope as described in paragraph 4.2.1.6), with rippled sand recorded in both the DDV transects and in the geophysical survey interpretation (see Figure 4.3 and Figure 4.4). Where the subcropping rock was interpreted from the geophysical datasets as being close to the surface (i.e. sediment veneer of <0.2 m; black areas shown in Figure 4.3), increased proportions of mixed coarse sediments, including gravel, cobbles and occasional boulders, were recorded in the DDV footage (see Figure 4.4). With respect to the 'chalk reefiness' all the areas investigated via the DDV transects were classified as "not a reef" according to the qualitative descriptions of chalk reef provided by Natural England. The communities associated with these patches of coarse sediments were primarily epifaunal, with faunal turfs comprising hydroids (e.g. *Tubularia indivisa*, *Nemertesia antennina* and *H. falcata*) and bryozoans (e.g. *Alcyonidium diaphanum* and *F. foliacea*) and other epifauna including barnacles, tubeworms (e.g. *Spirobranchus* sp.), low abundances of sponges and the soft coral *Alcyonium digitatum*. Sea anemones were also recorded during DDV surveys within these areas of coarser sediments, including, *Sagartia* sp., *Urticina* sp. and *Metridium* sp. Red seaweeds were also recorded, although these were rare. Mobile species recorded in this area included the crustaceans *Necora puber* and *C. pagurus* and the sea stars *C. papposus* and *Asterias rubens*. The communities in these areas were consistent with the FluHyd epifaunal biotope overlay. As indicated in Figure 4.4, DDV transects showed that where these coarse sediments were observed, these were limited in extent and patchy, with areas of rippled sand with no epifauna (i.e. Infralittoral mobile clean sand with sparse fauna; SS.SSa.IFiSa.IMoSa) of tens of metres observed in DDV footage separating discrete areas of coarse sediments.

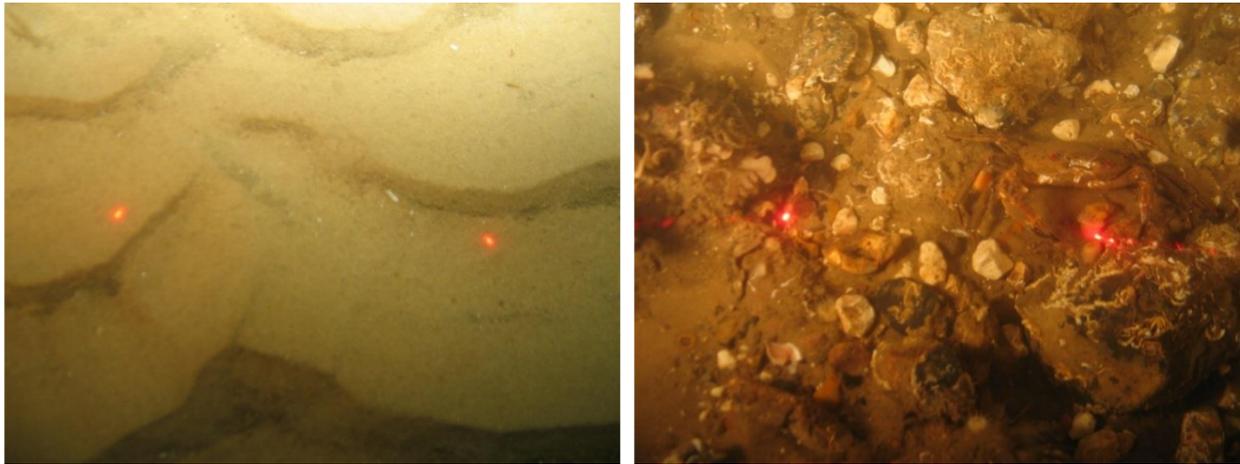
Figure 4.4: Representative images of seabed substrates in inshore areas from DDV transects in areas of subcropping rock (see Figure 4.3). Left image shows rippled sand with no epifaunal communities; right image shows coarse, mixed sediments of shell, gravel and occasional cobbles, with associated epifaunal communities.

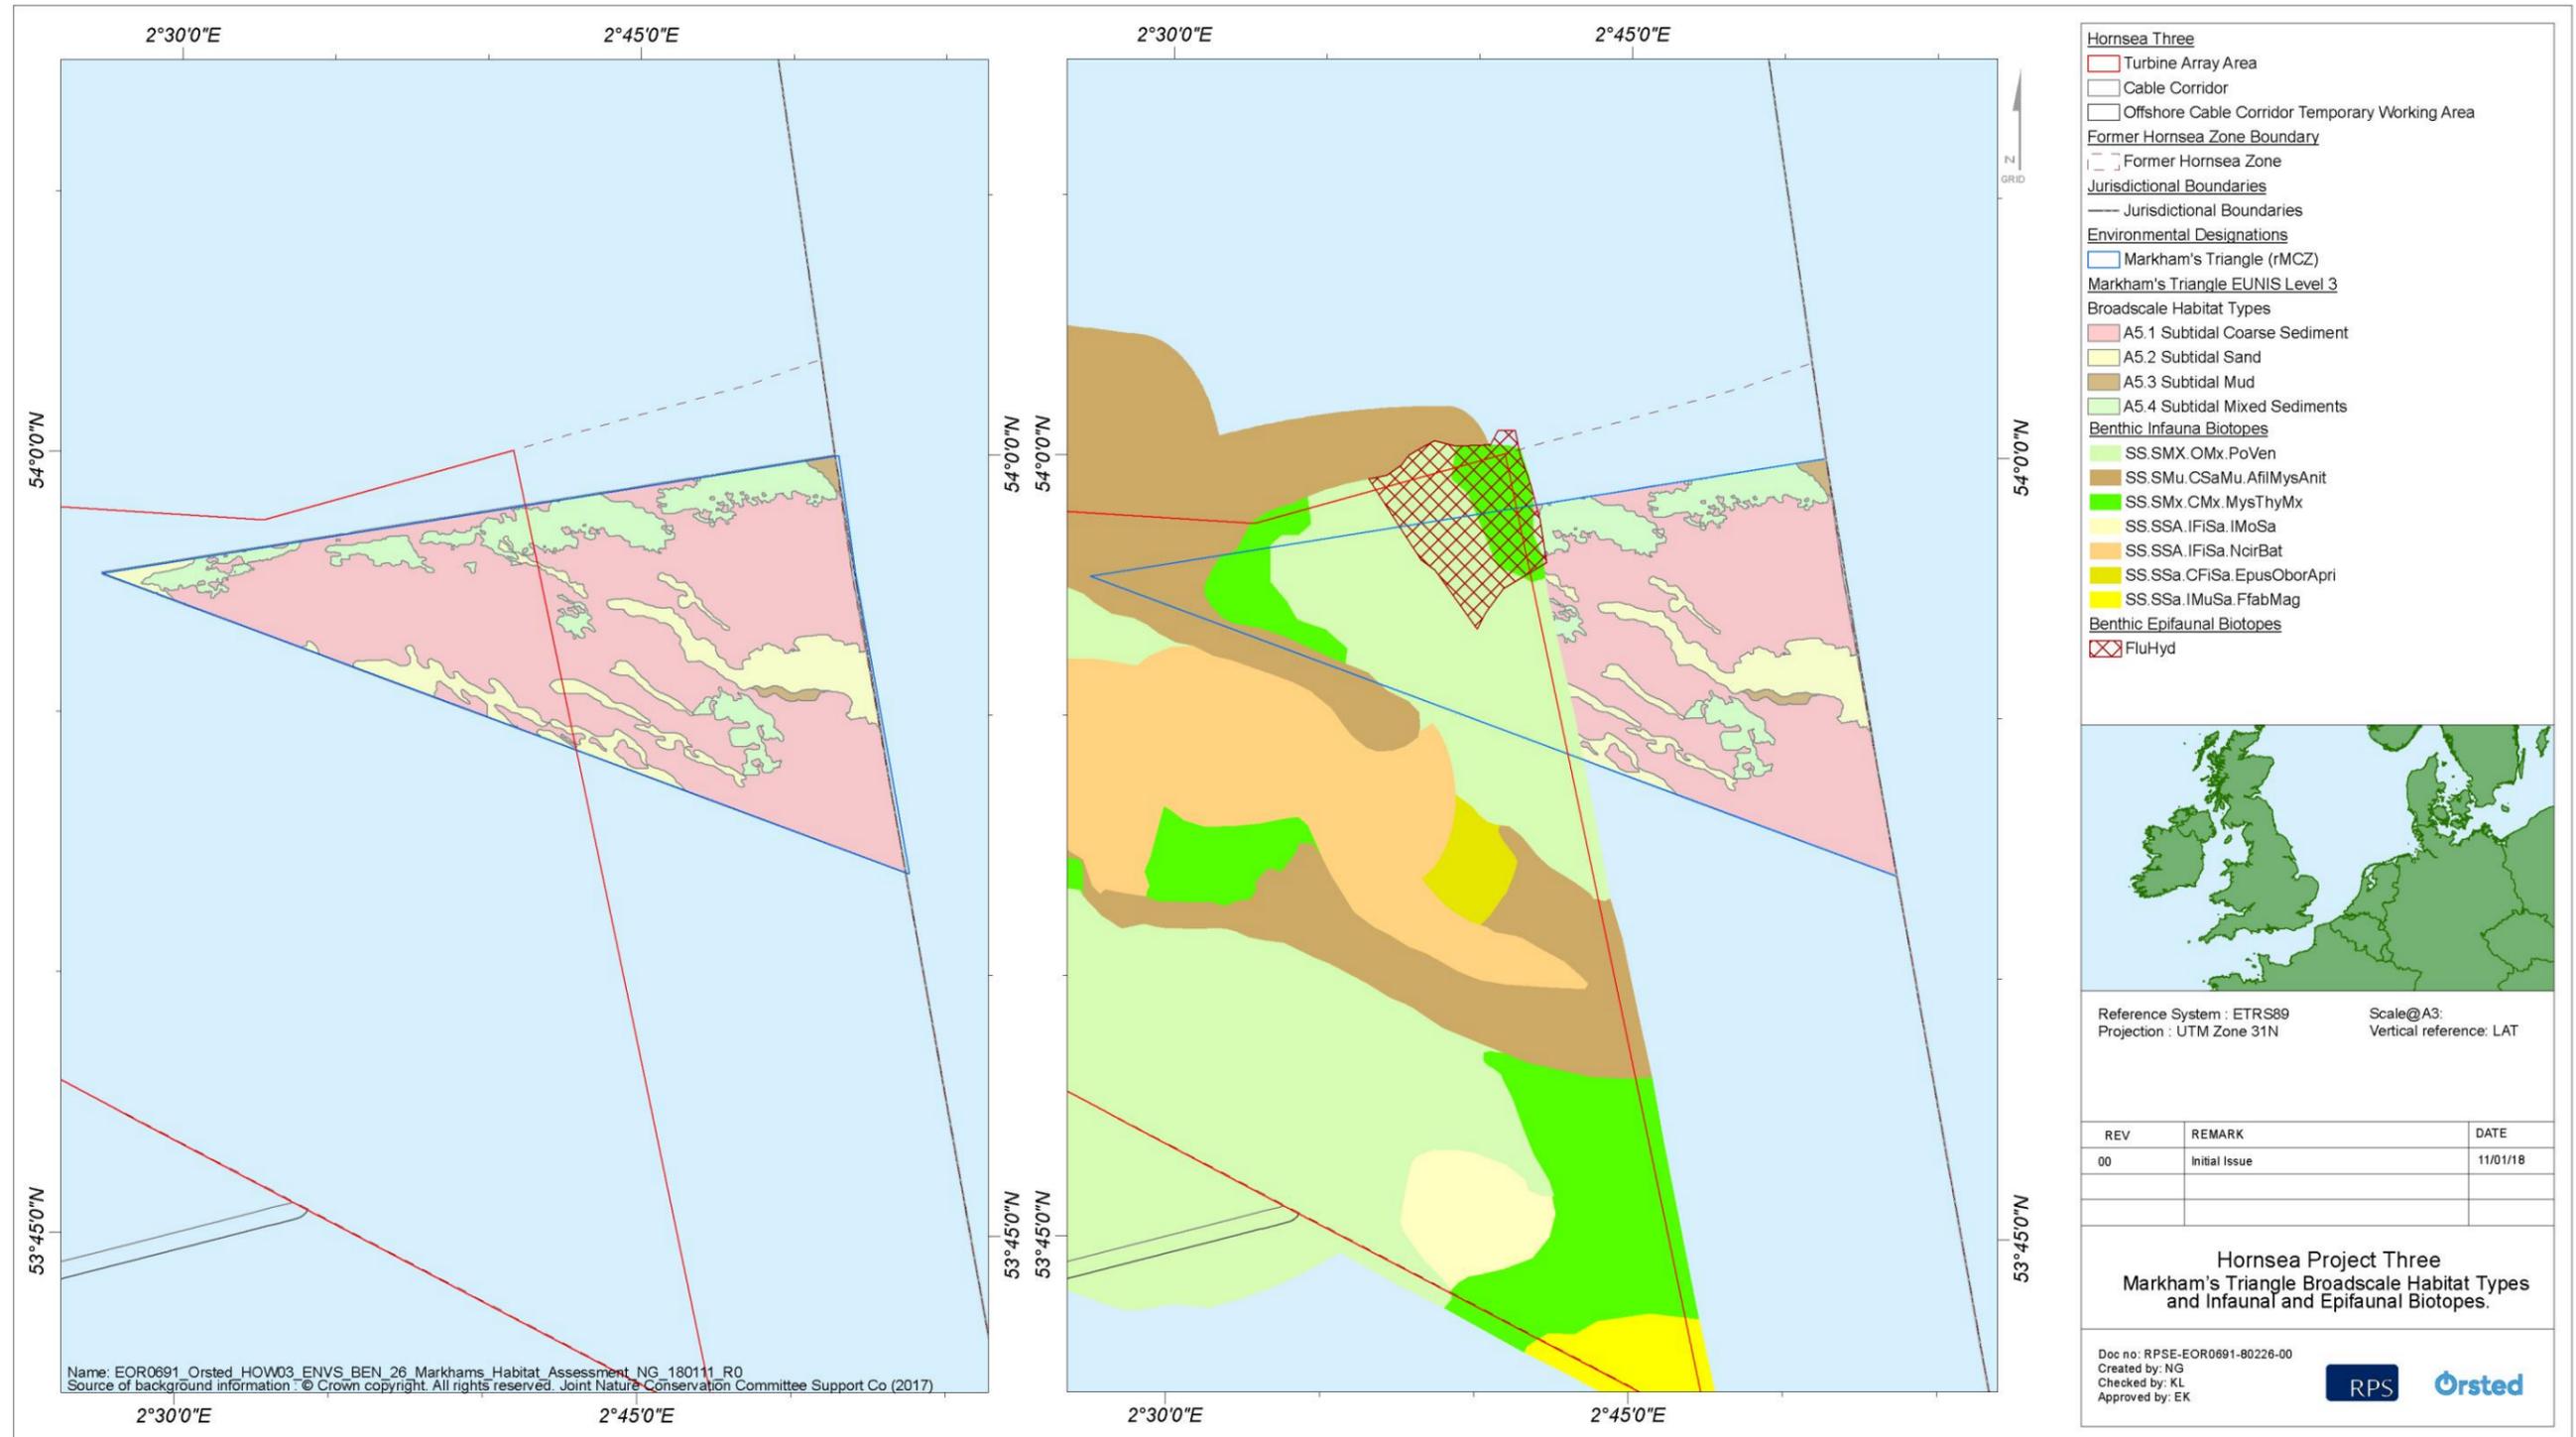
Figure 4.5: Markham's Triangle MCZ broadscale habitat types and infaunal and epifaunal biotopes identified within the Hornsea Three array area.

4.3.1.3 The broadscale habitat Subtidal Coarse Sediment was dominant throughout the Markham's Triangle MCZ, covering approximately three quarters of the site (Defra, 2014; Figure 4.5; Table 4.2). Subtidal Sand and Subtidal Mixed Sediments broadscale habitats were less prevalent. Mixed sediments were mostly confined to a swathe spanning the northern boundary of the MCZ area, while bands of sand were found across the central section of the site, along the southern boundary and in the western corner of the MCZ (Figure 4.5). Subtidal Mud was only reported by Defra (2014; 2019) in the east of the MCZ, outside the Hornsea Three boundary, and therefore this feature has not been considered further in this assessment, as agreed through the MCZ Working Group (see Table 1.2). Shallow sandy sediments are a suitable habitat for sandeels (*Ammodytes* spp.; a species of conservation importance) which are an important food source for a range of marine species including fish, birds and marine mammals (see volume 5 annex 3.1: Fish and Shellfish Technical Report), however this species is not proposed as a feature of the MCZ.
