CLEVE HILL SOLAR PARK

Appendix 12 – Allianz Risk Consulting – Tech Talk Volume 26: BESS

BATTERY ENERGY STORAGE SYSTEMS (BESS) USING LI-ION BATTERIES

ALLIANZ RISK CONSULTING

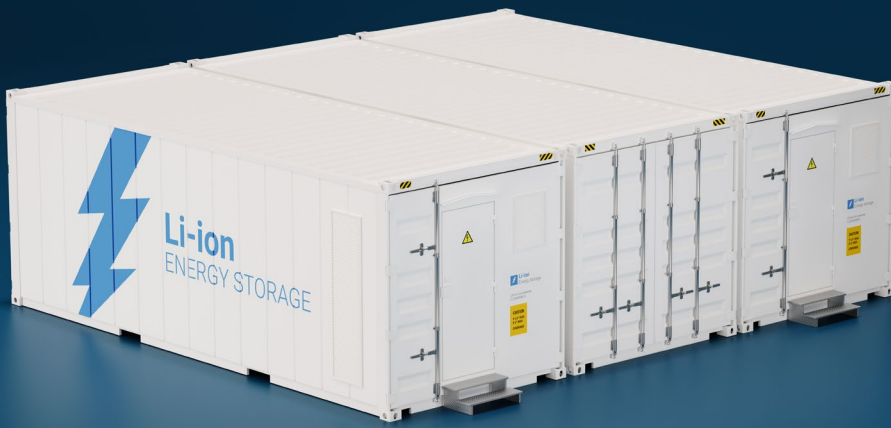
Battery energy storage system made of shipping containers

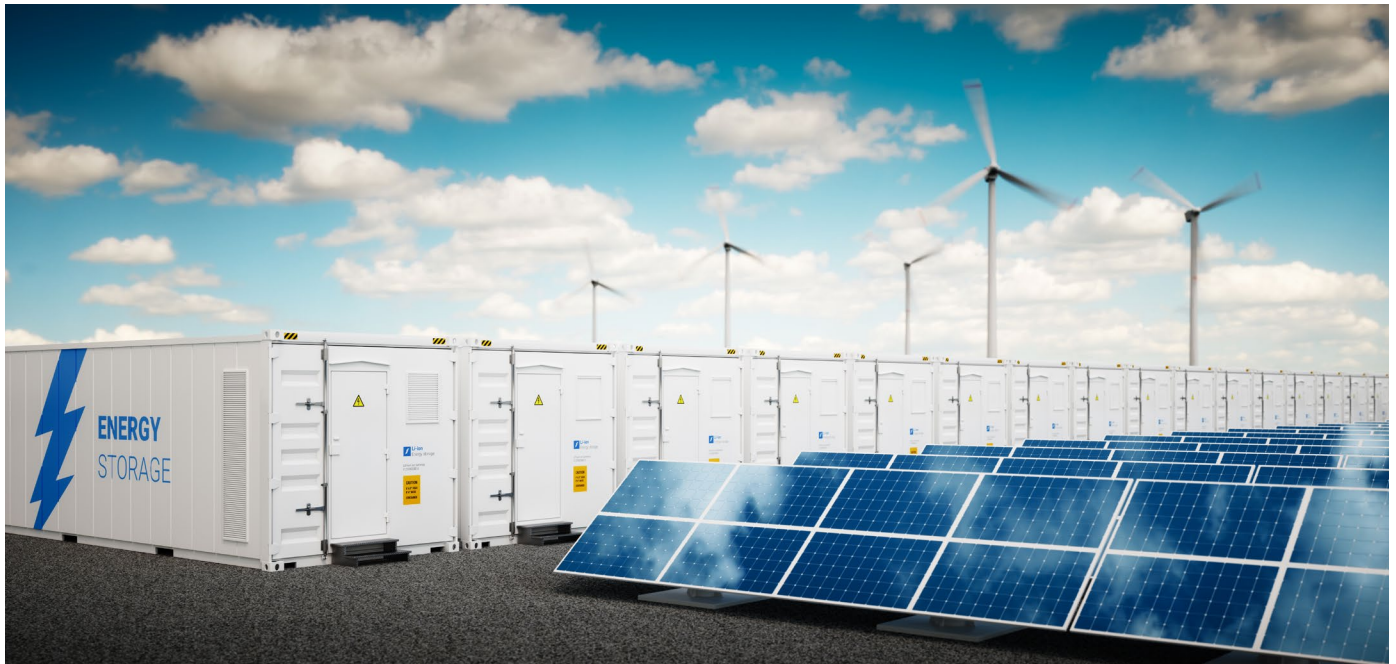
Renewable energy power plants - photovoltaics, wind turbine farm and battery container.
