## **Norfolk Boreas Offshore Wind Farm**

# Appendix 28.4

Heritage Settings Assessment Workings (Onshore Project Substation and Associated Infrastructure)

Applicant: Norfolk Boreas Limited Document Reference: 6.3.28.4

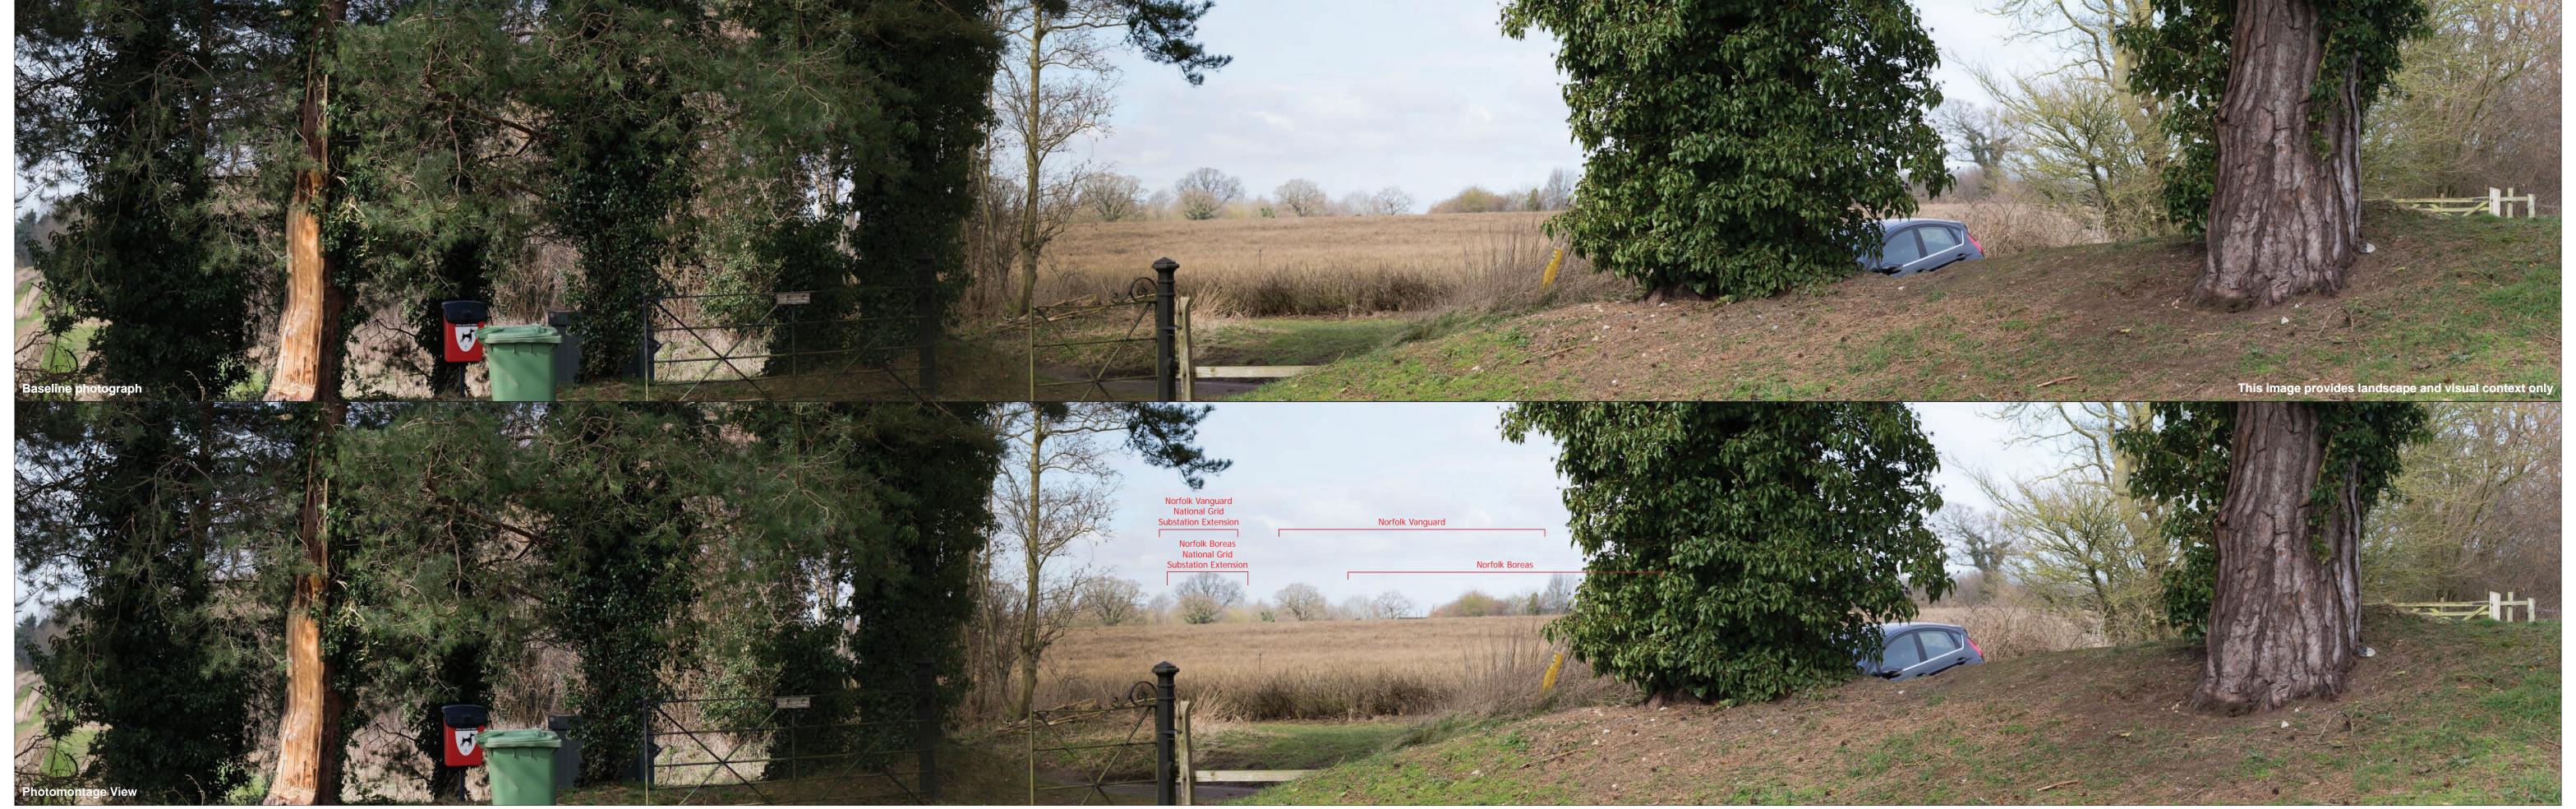
Viewpoint CH1: Church of St. Andrew, Bradenham

591713 E 309141 N 62 m AOD OS reference: Eye level: Direction of view: 303°
Nearest substation: 1.58 km

Horizontal field of view: 90° (cylindrical projection)
Principal viewing distance: 522 mm

Canon EOS 5D Mark II 50mm (Canon EF 50mm f/1.4) 1.5 m AGL 25/03/2018, 10:59:28

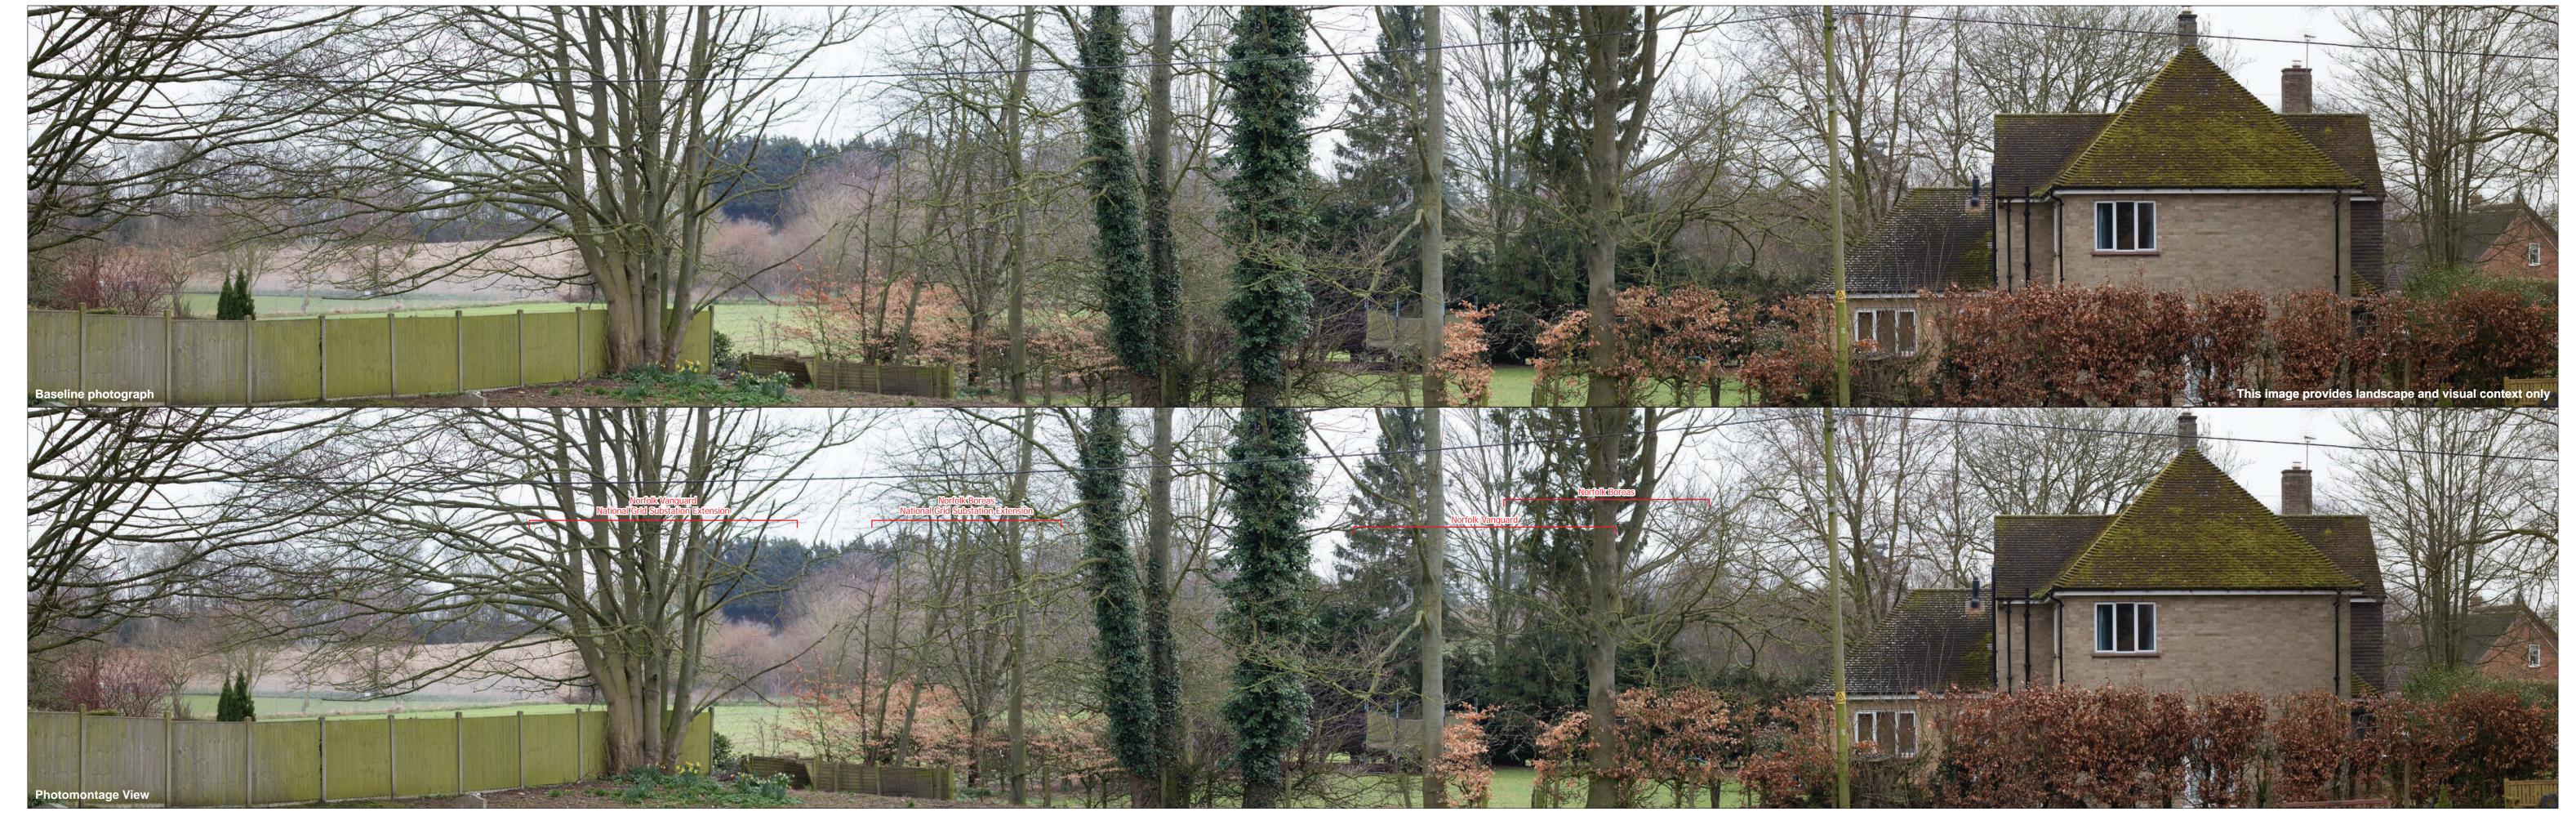
Viewpoint CH2: All Saints, Necton

587880 E 309757 N 51.8 m AOD OS reference: Eye level: Direction of view: 67°
Nearest substation: 2.1 km

Horizontal field of view: 90° (cylindrical projection)
Principal viewing distance: 522 mm

Canon EOS 5D Mark II 50mm (Canon EF 50mm f/1.4) 1.5 m AGL 25/03/2018, 10:06:09

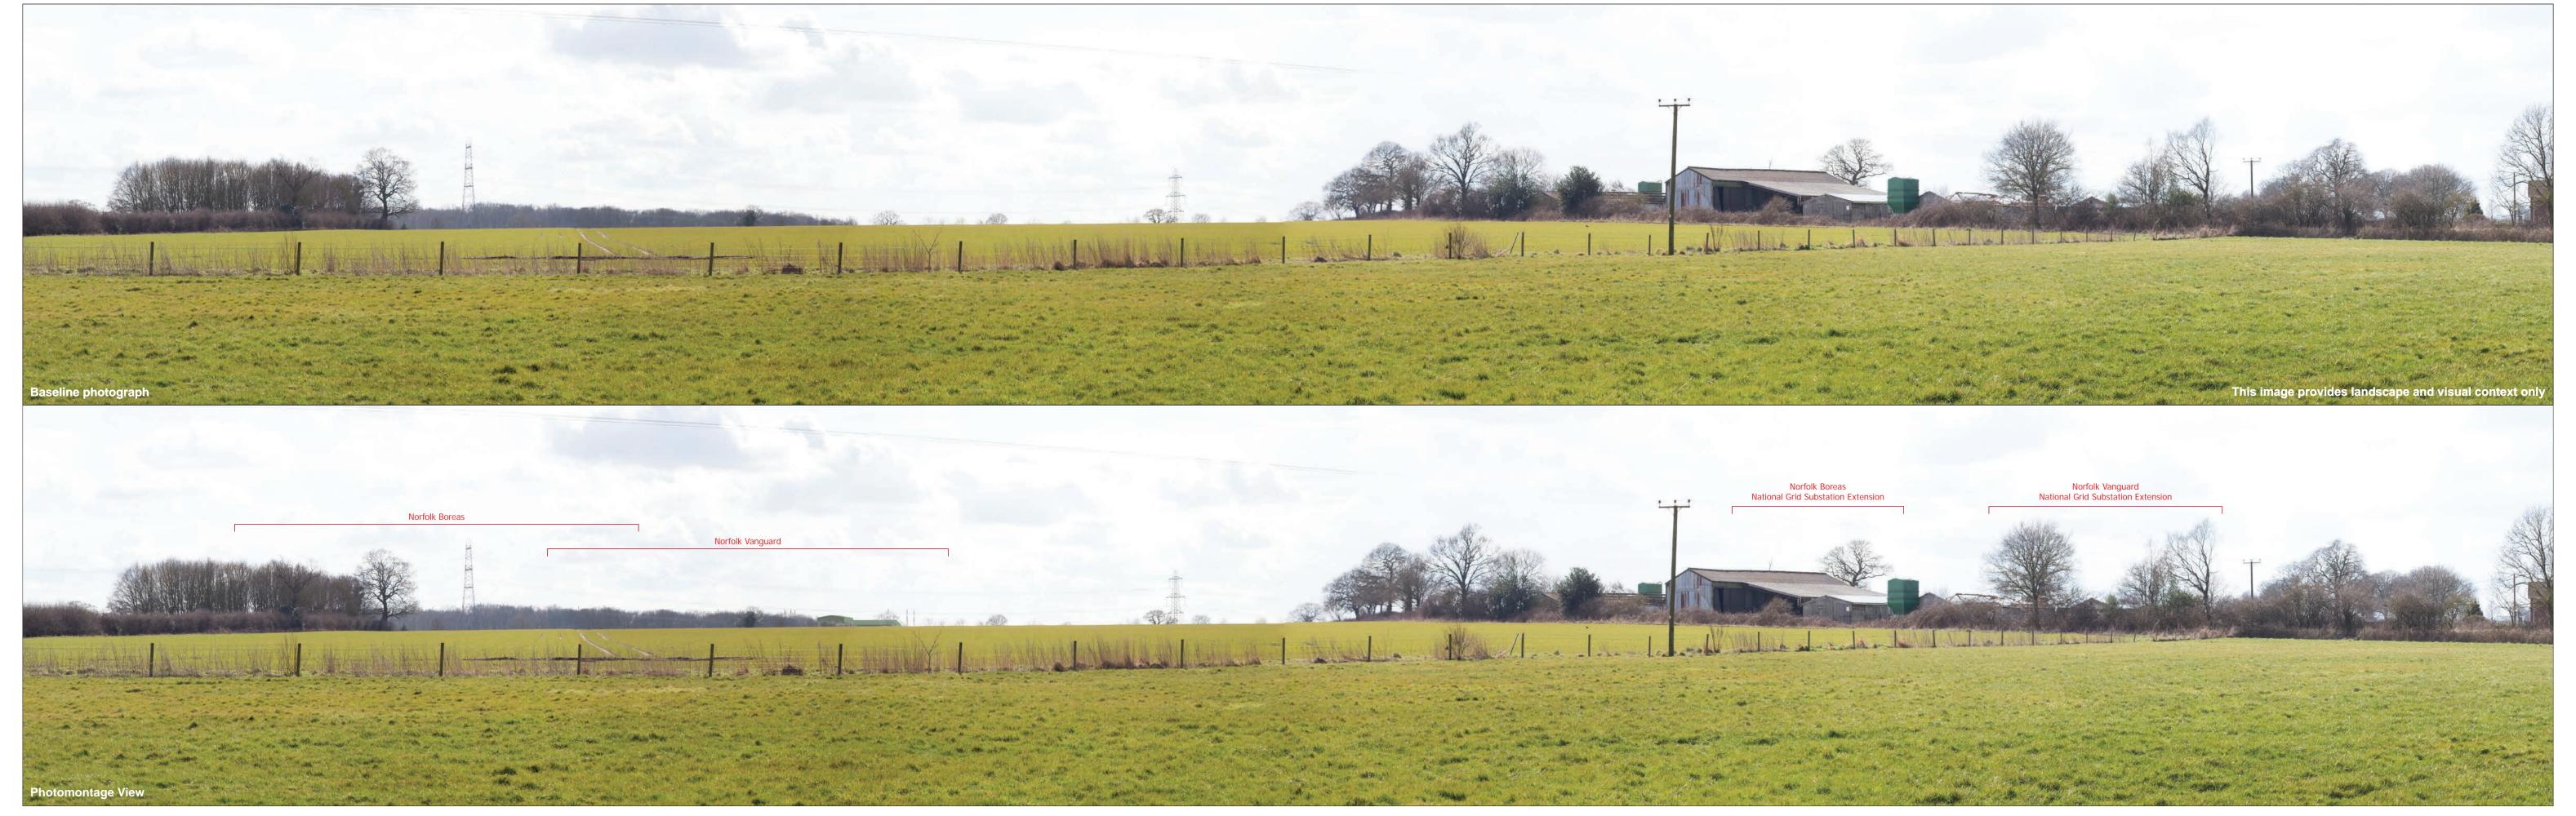
Viewpoint CH3: Old Hall, Fransham

590191 E 311793 N 76.3 m AOD Direction of view: Nearest substation: 1.26 km

Horizontal field of view: 90° (cylindrical projection)
Principal viewing distance: 522 mm

Canon EOS 5D Mark II 50mm (Canon EF 50mm f/1.4) 1.5 m AGL 25/03/2018, 12:44:25

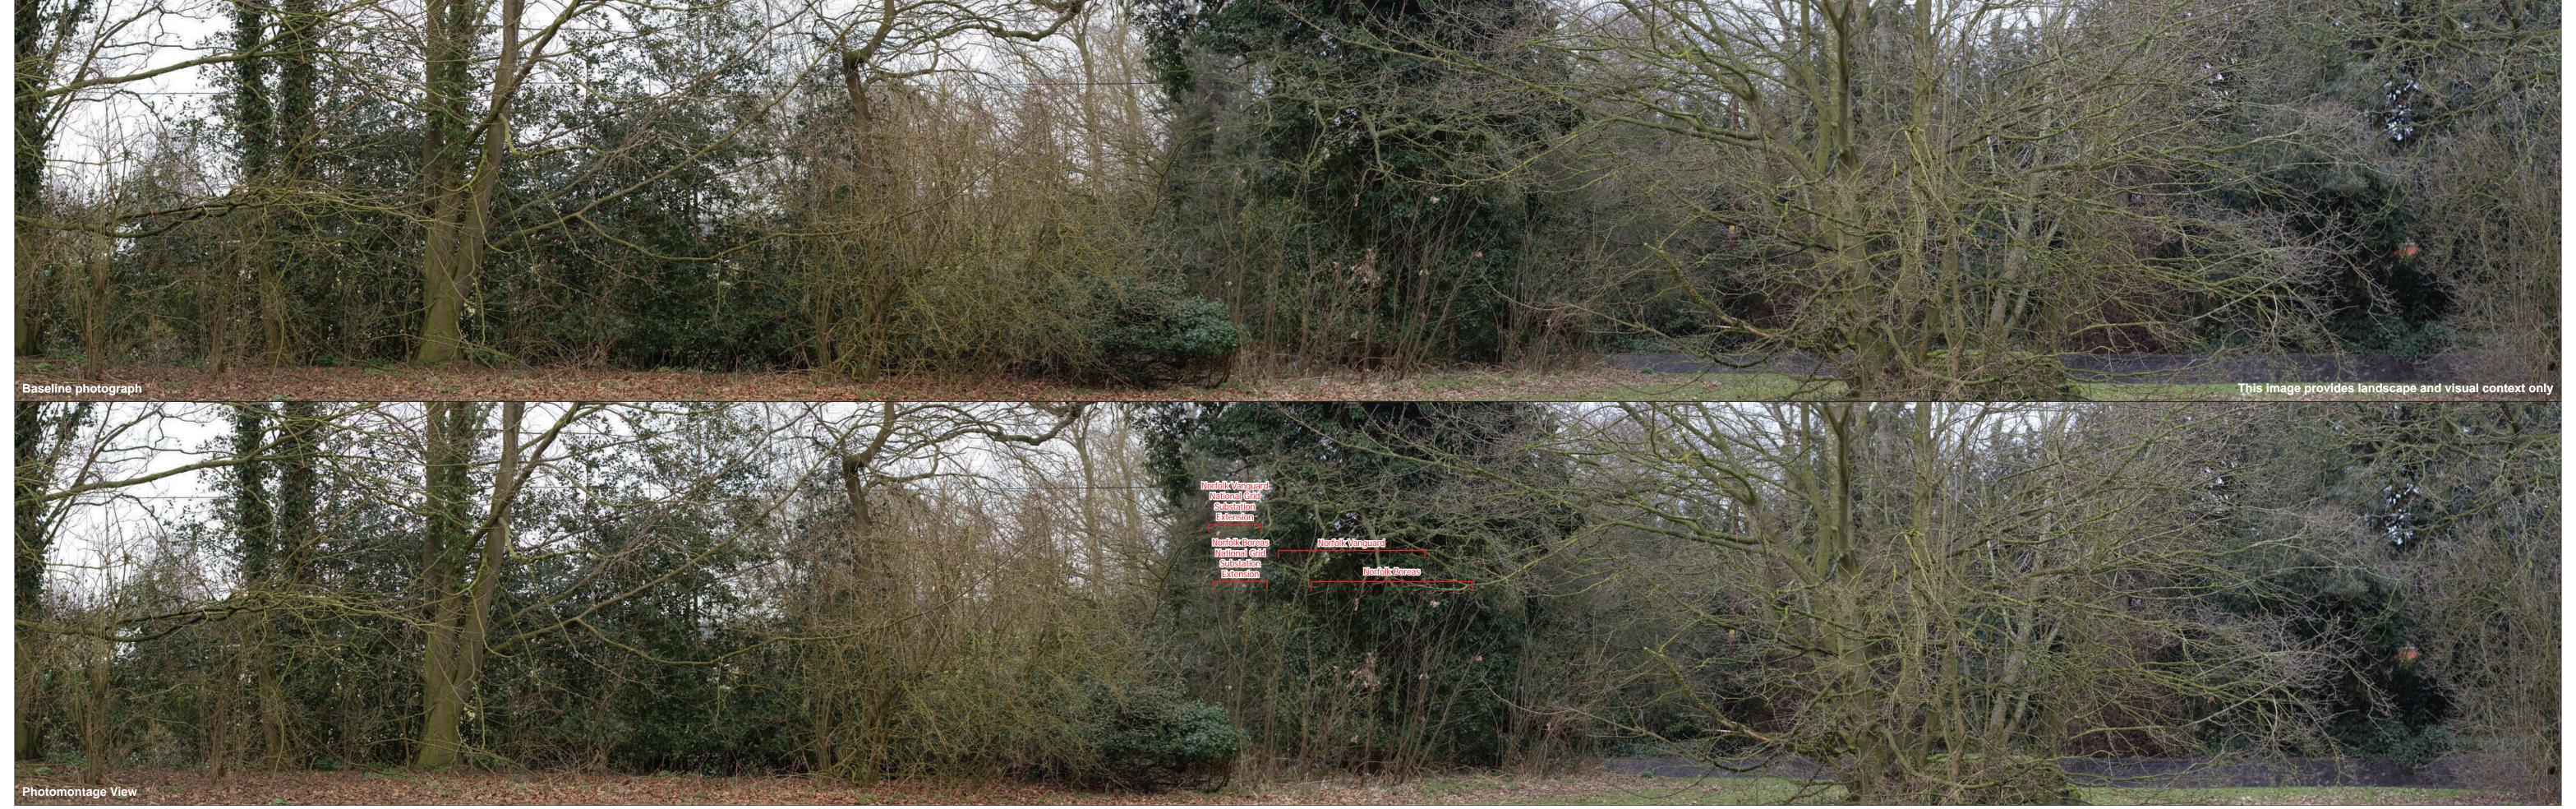
Viewpoint CH4: The Church of Mary, Bradenham

593069 E 308410 N 65 m AOD OS reference: Eye level: Direction of view: 301°
Nearest substation: 3.11 km

Horizontal field of view: 90° (cylindrical projection)
Principal viewing distance: 522 mm

Canon EOS 5D Mark II 50mm (Canon EF 50mm f/1.4) 1.5 m AGL 25/03/2018, 10:42:47

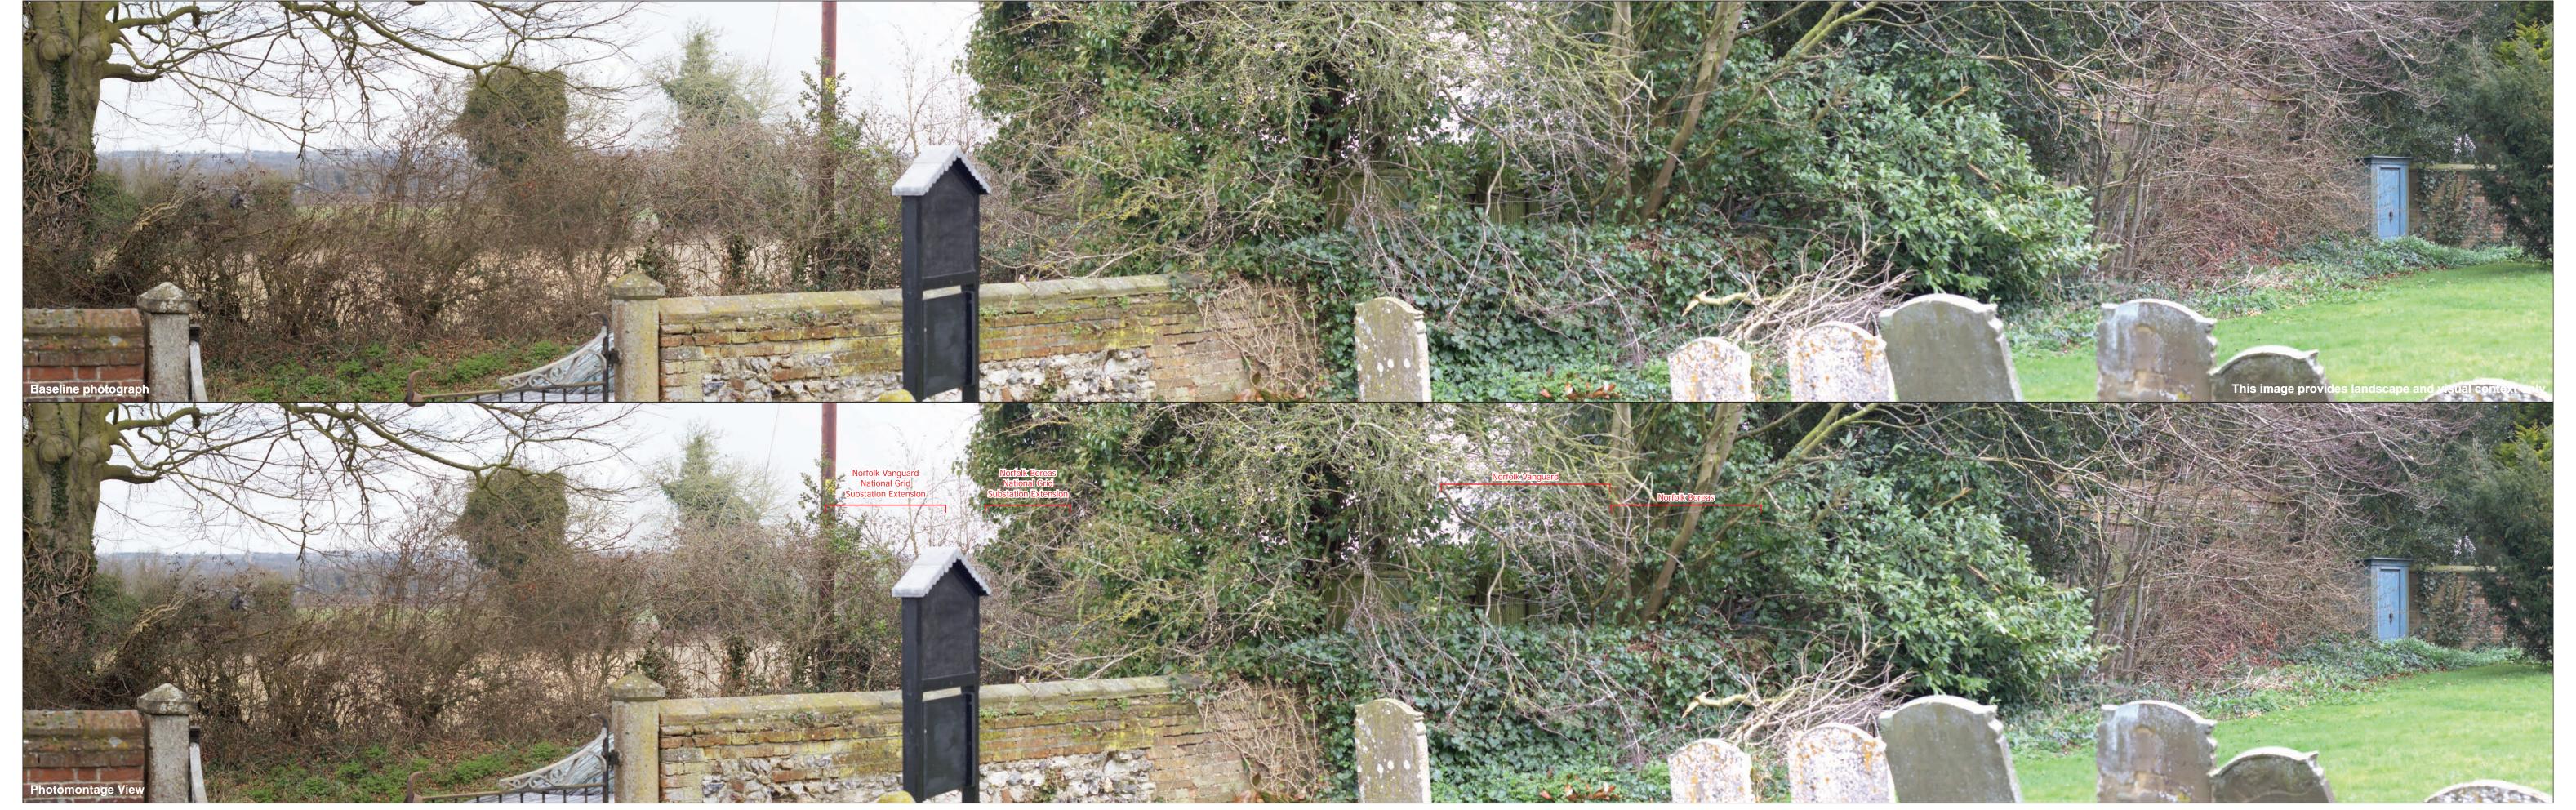
Viewpoint CH5: The Church of St Andrew, Holme Hale

588712 E 307541 N 53.6 m AOD OS reference: Eye level: Direction of view: 17°
Nearest substation: 3.02 km

Horizontal field of view: 90° (cylindrical projection)
Principal viewing distance: 522 mm

Canon EOS 5D Mark II 50mm (Canon EF 50mm f/1.4) 1.5 m AGL 25/03/2018, 10:24:05 Date and time:

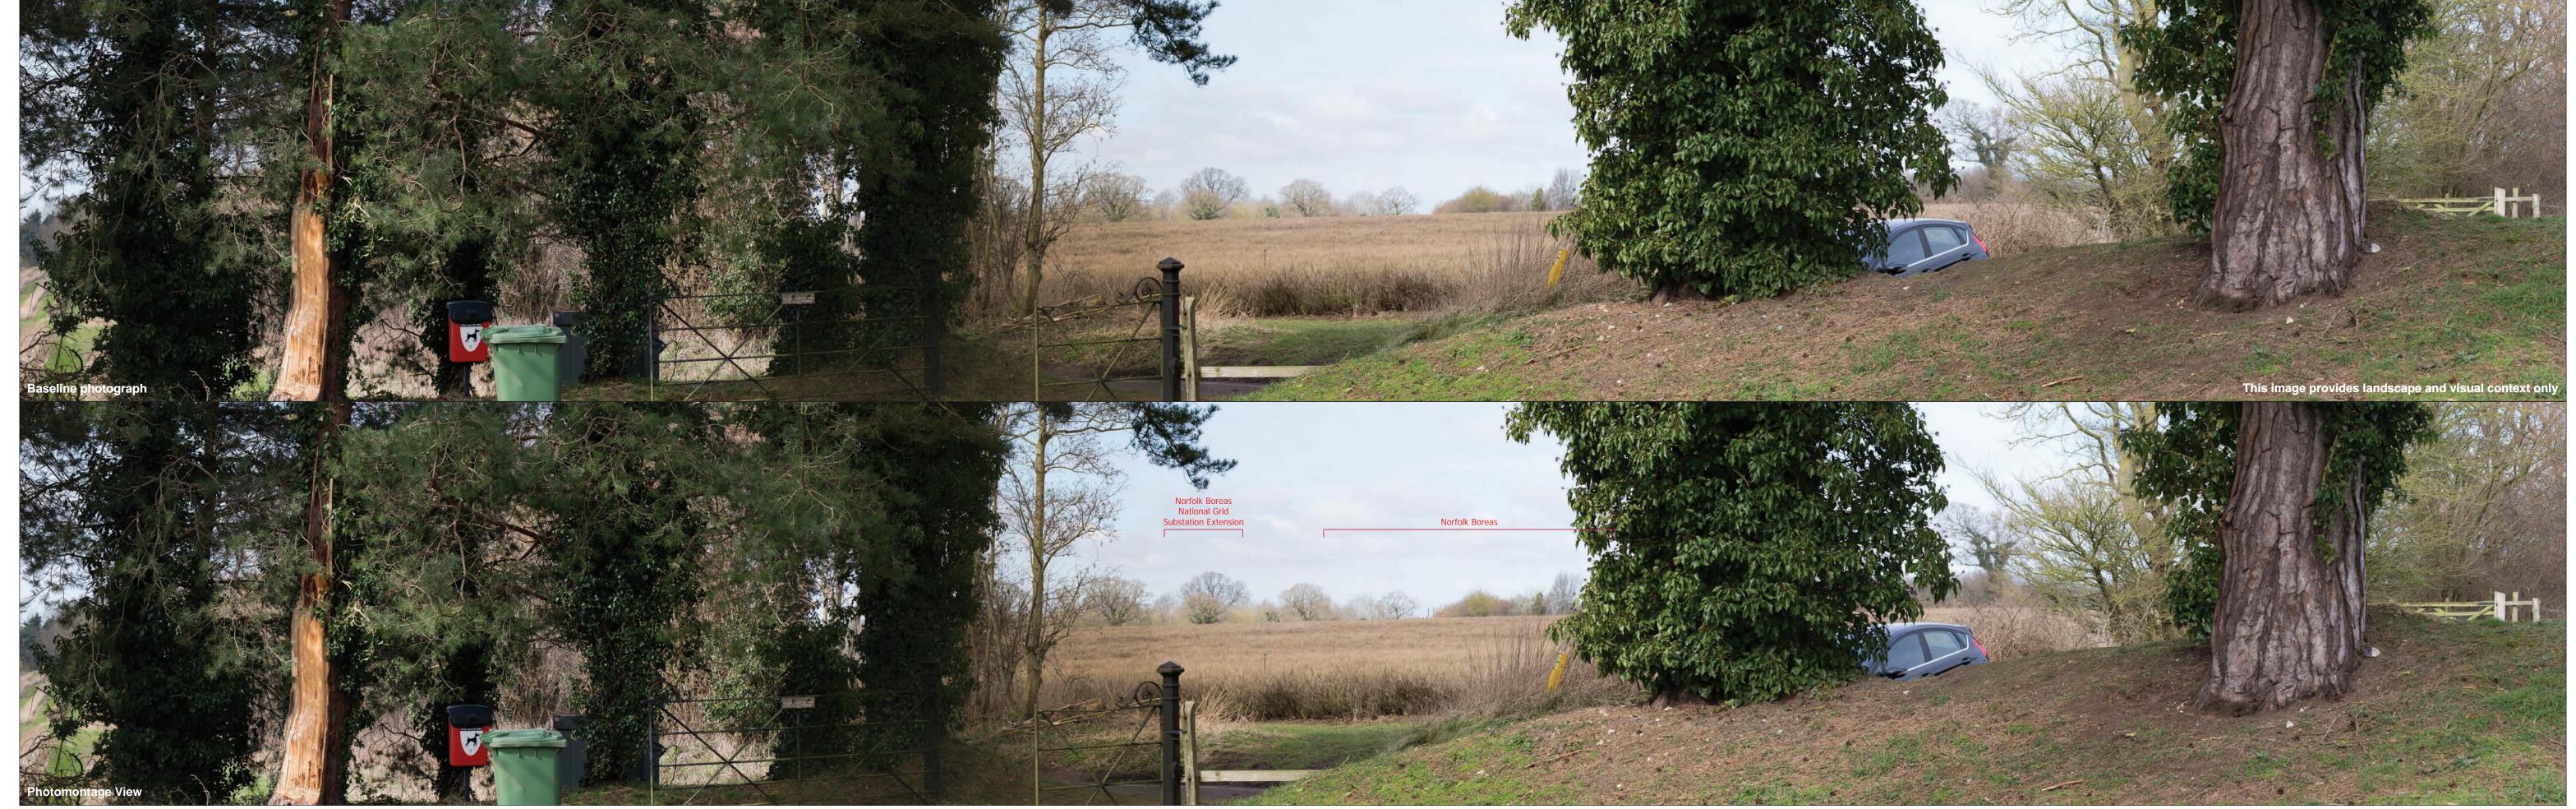
Viewpoint CH1: Church of St. Andrew, Bradenham

591713 E 309141 N 62 m AOD OS reference: Eye level: Direction of view: 303°
Nearest substation: 1.58 km

Horizontal field of view: 90° (cylindrical projection)
Principal viewing distance: 522 mm

Canon EOS 5D Mark II 50mm (Canon EF 50mm f/1.4) 1.5 m AGL 25/03/2018, 10:59:28 Date and time:

- 36. Photomontages have been produced for the Cultural Heritage viewpoints, using Adobe Photoshop software, to provide a realistic image of the appearance of the proposal. Only in viewpoint CH 1, these include the introduction of the onshore project substations, as this is the only component visible. The location and scale of the computer-generated model has been verified using markers such as the existing transmission towers, the existing substations, church towers and other fixed built features in the landscape.

- 37. Each photomontage is presented on A1 width paper in planar projection with a 53.5 degree horizontal field of view and an image size of 260mm x 820mm. These should be viewed flat at a comfortable arms-length.

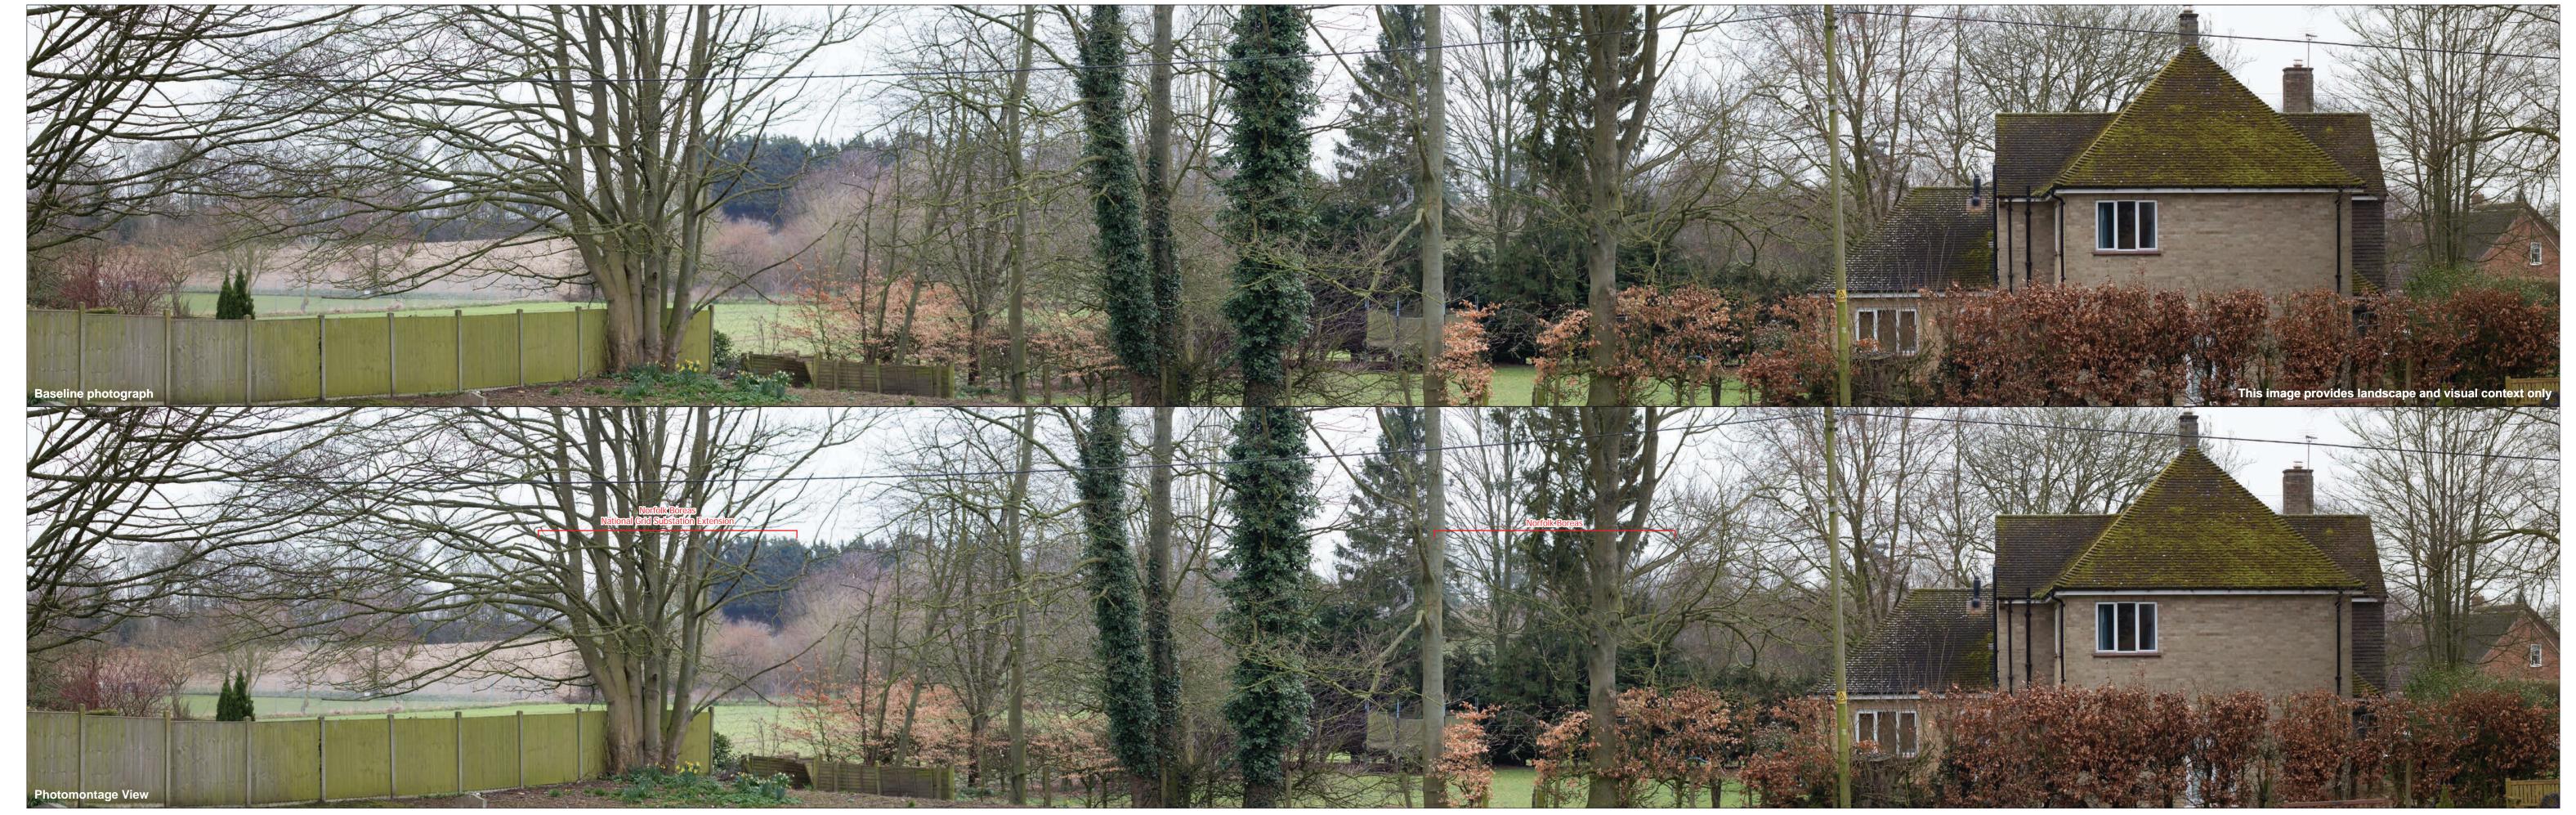
Viewpoint CH2: All Saints, Necton

587880 E 309757 N 51.8 m AOD OS reference: Eye level: Direction of view: 67°
Nearest substation: 2.1 km

Horizontal field of view: 90° (cylindrical projection)
Principal viewing distance: 522 mm

Canon EOS 5D Mark II 50mm (Canon EF 50mm f/1.4) Camera height: 1.5 m AGL 25/03/2018, 10:06:09 Date and time:

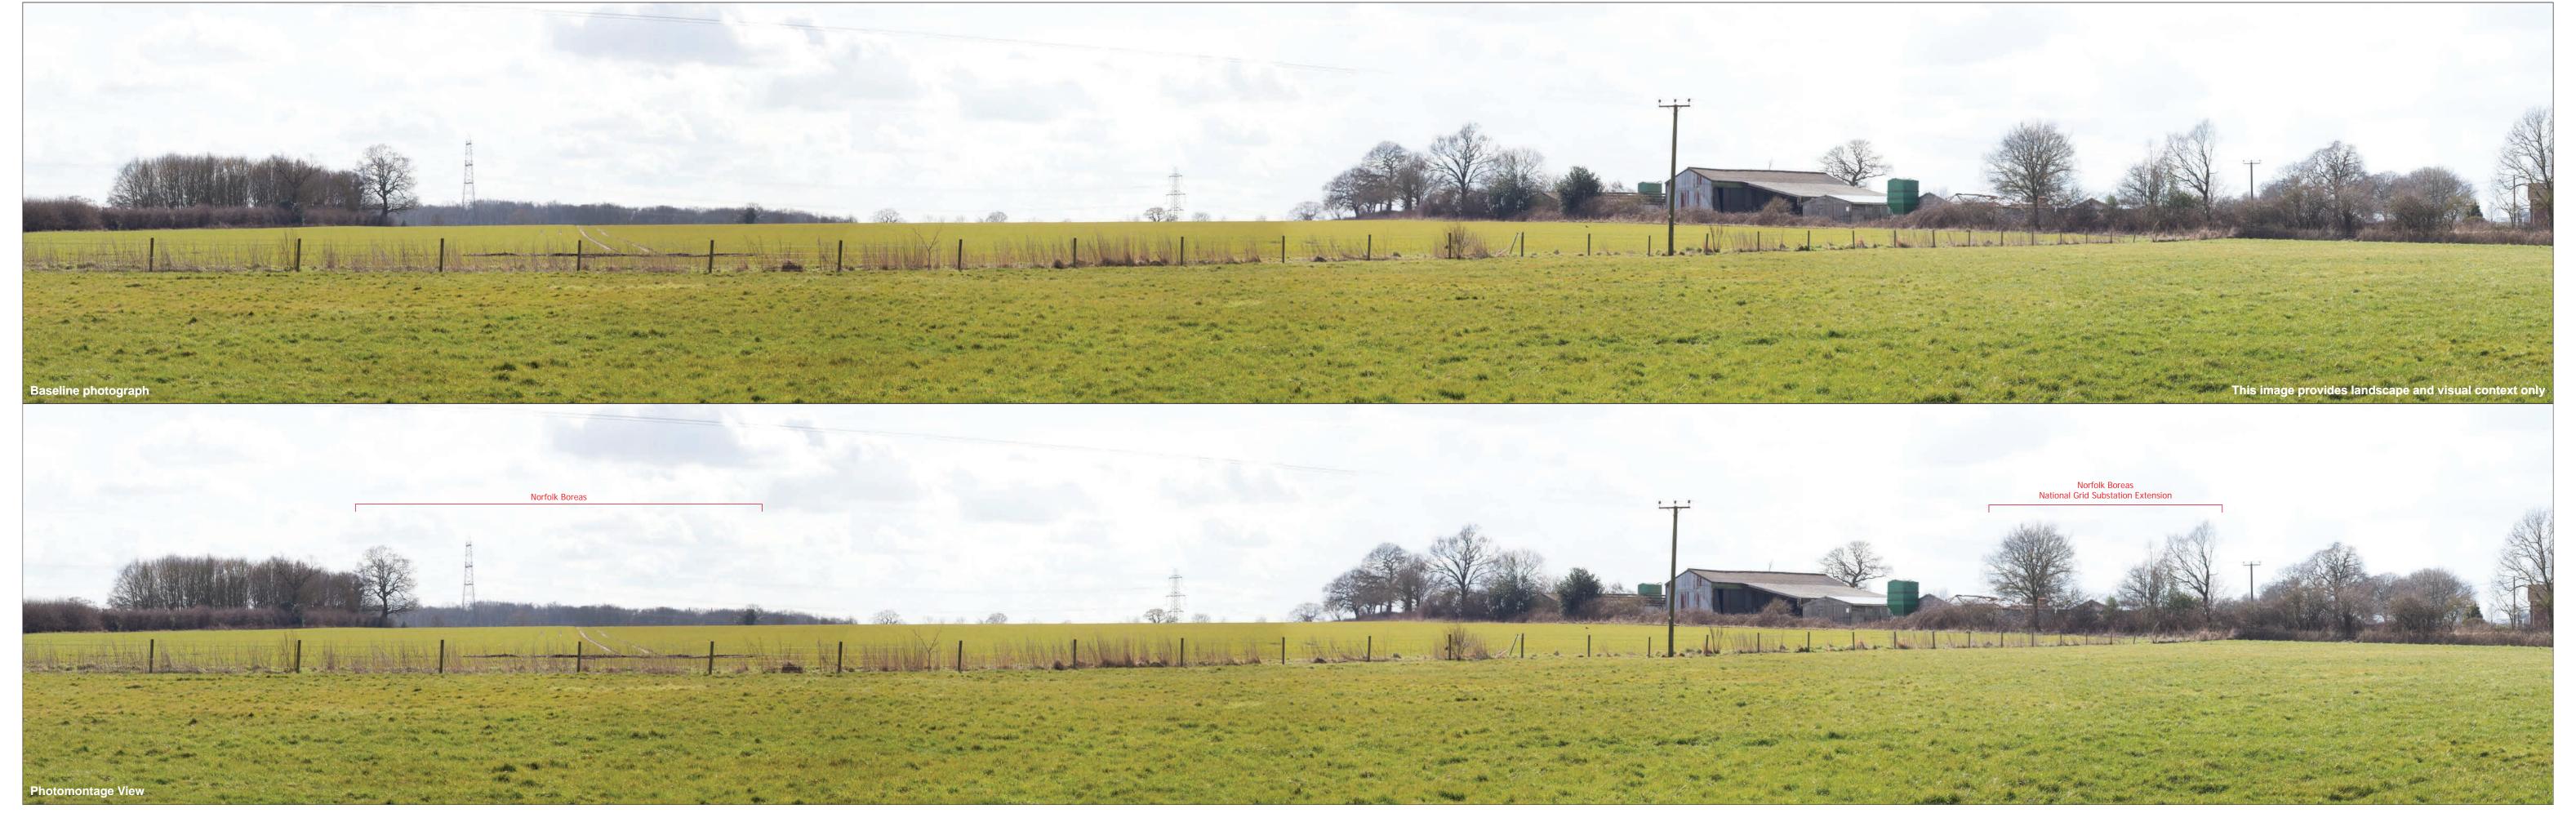
Viewpoint CH3: Old Hall, Fransham

590191 E 311793 N 76.3 m AOD Direction of view: Nearest substation: 1.26 km

Horizontal field of view: 90° (cylindrical projection)
Principal viewing distance: 522 mm

Canon EOS 5D Mark II 50mm (Canon EF 50mm f/1.4) 1.5 m AGL 25/03/2018, 12:44:25

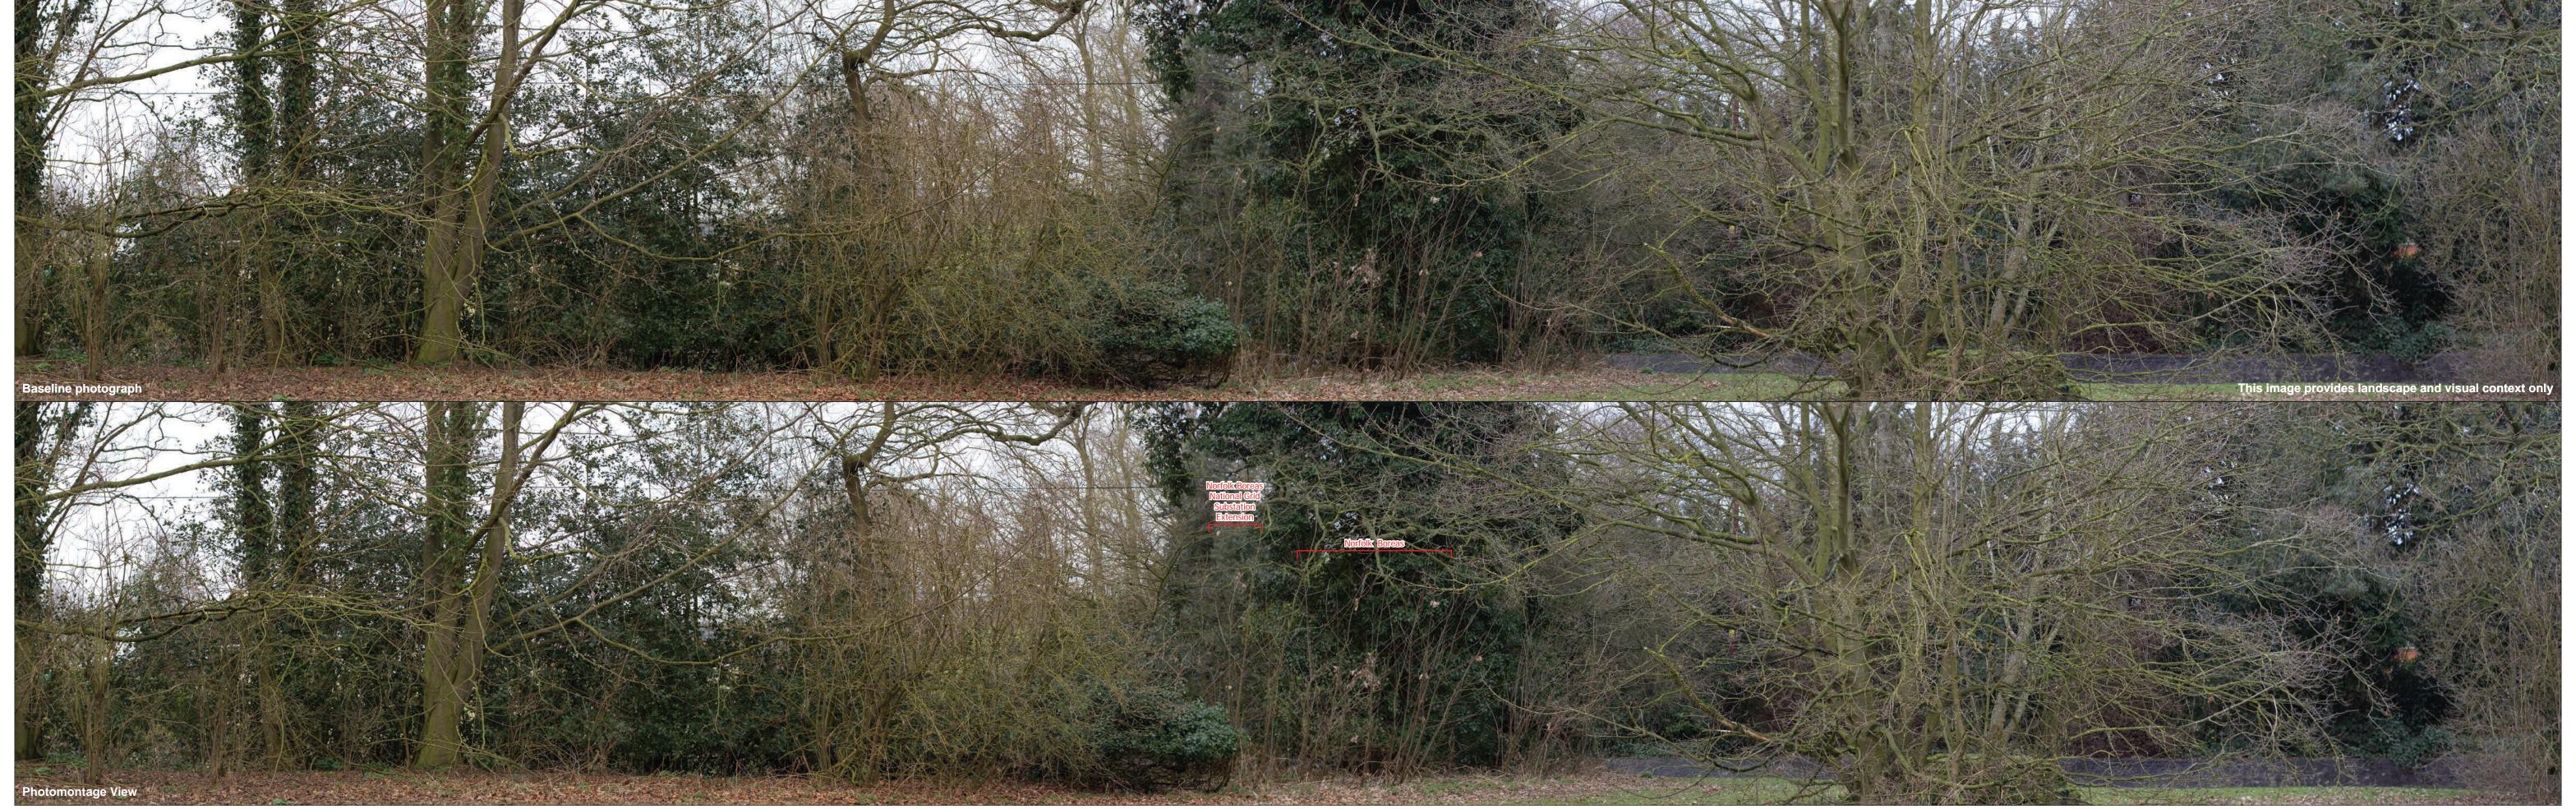
Viewpoint CH4: The Church of Mary, Bradenham

593069 E 308410 N 65 m AOD OS reference: Eye level: Direction of view: 301°
Nearest substation: 3.11 km

Horizontal field of view: 90° (cylindrical projection)
Principal viewing distance: 522 mm

Canon EOS 5D Mark II 50mm (Canon EF 50mm f/1.4) 1.5 m AGL 25/03/2018, 10:42:47

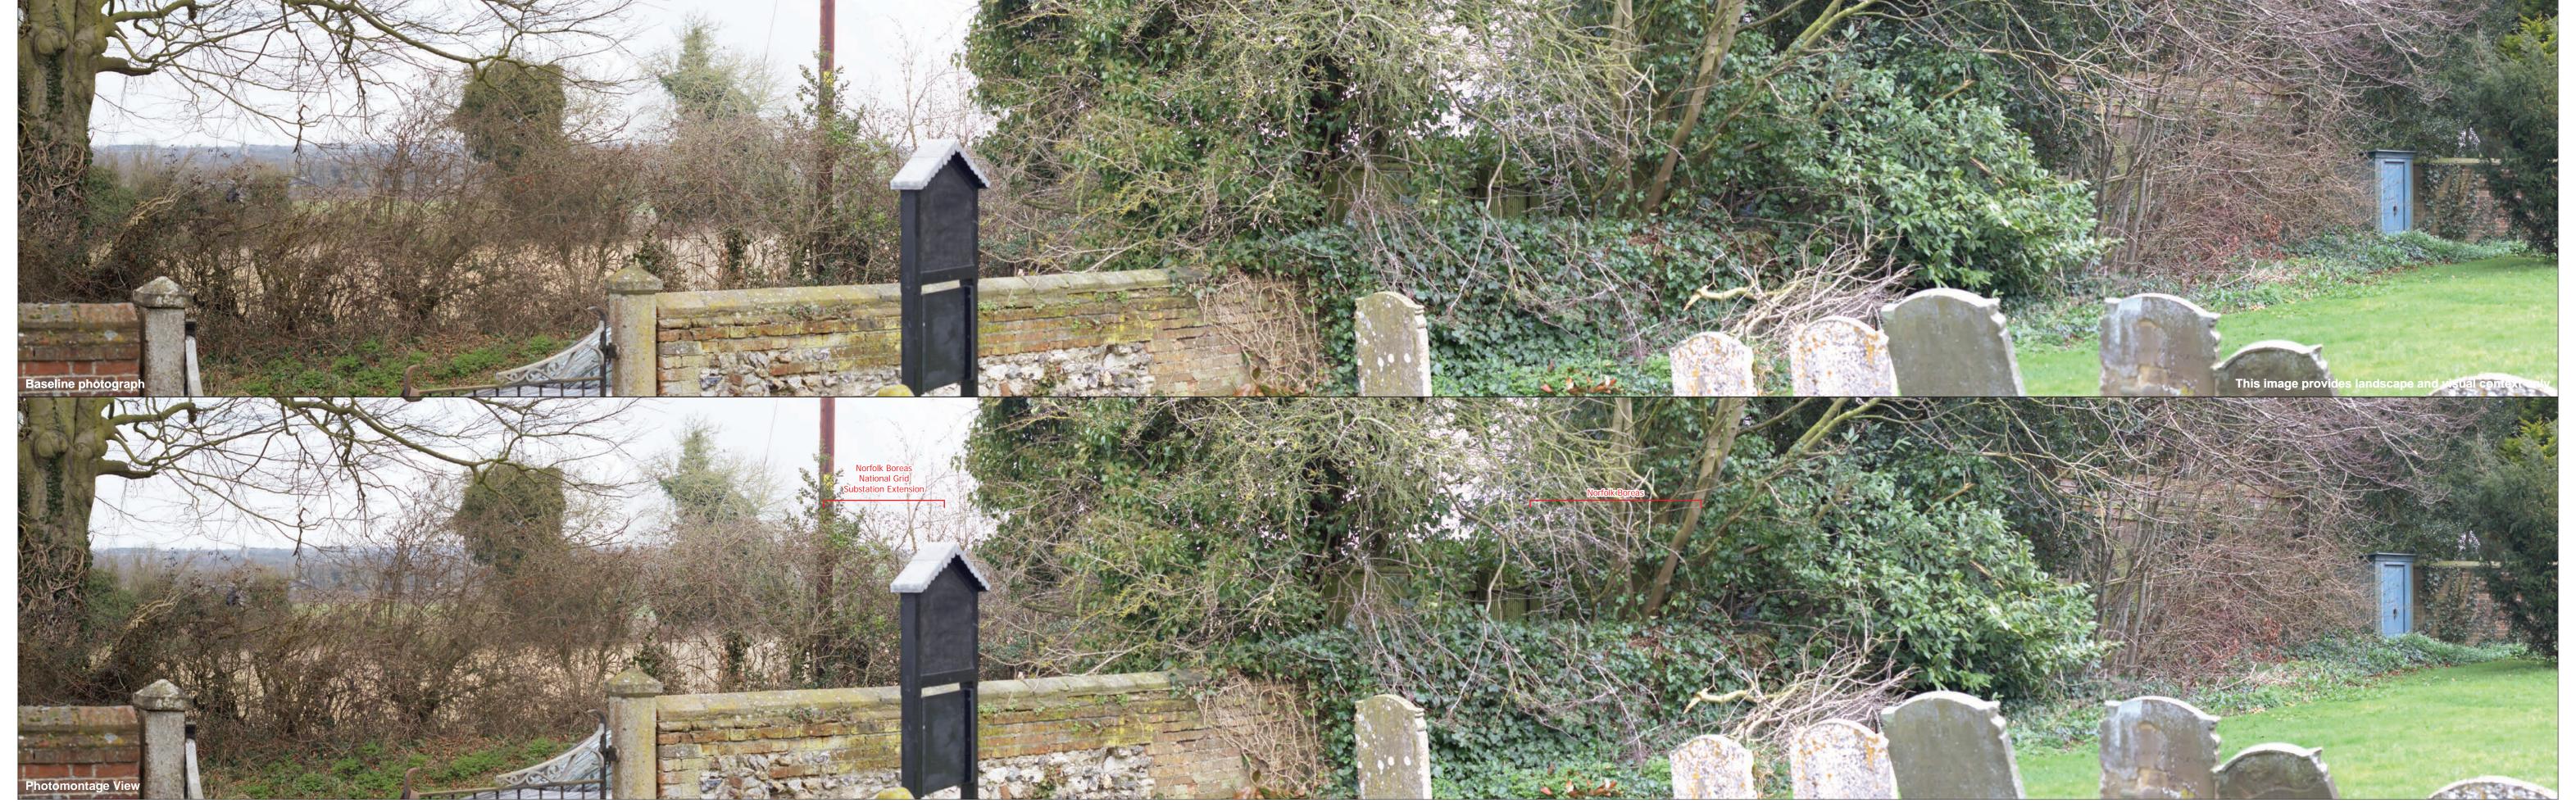
Viewpoint CH5: The Church of St Andrew, Holme Hale

588712 E 307541 N 53.6 m AOD OS reference: Eye level: Direction of view: 17°
Nearest substation: 3.02 km

Horizontal field of view: 90° (cylindrical projection)
Principal viewing distance: 522 mm

Canon EOS 5D Mark II 50mm (Canon EF 50mm f/1.4) 1.5 m AGL 25/03/2018, 10:24:05 Date and time:
