# OAKLANDS FARM SOLAR PARK

Appendix 7.1 – Historic Environment Assessment

Document Ref: EN010122/APP/6.1/Appx 7.1

## Appendix 7.1: Historic Environment Assessment

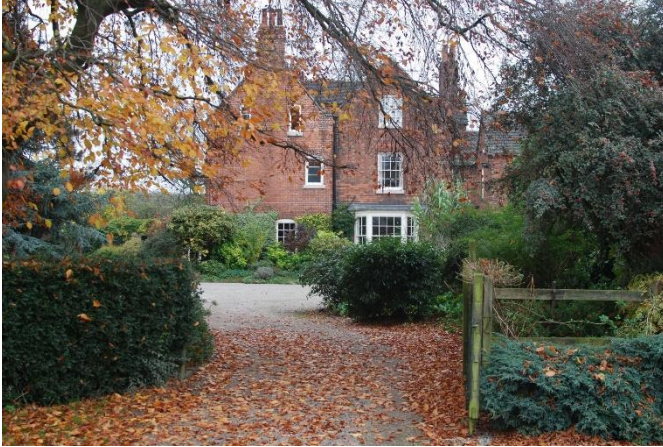
**Figure 4.1: Park Farm, looking southeast**

**4.28** The heritage significance of Park Farm derives from its role as the centre of an enclosure period farmstead. As a Grade II listed building it is of national importance. The core of this heritage significance stems from a combination of evidential and historical (illustrative) values. In evidential terms, the farmhouse physically documents how a domestic building at the core of a farmstead has evolved since the 18th through its retention of original fabric and the layers of subsequent extension and alteration which have been undertaken to modify it as needs have changed over this period. In historical (illustrative) terms, the farmhouse demonstrates the move by some farmers away from the settlement at the core of their parish following enclosure to living amongst their holdings. It also shows how the changing demands of farm life were accommodated through enlarging and modifying the farmhouse over multiple generations of resident farmers and how it continues to be used for this purpose. If Park Farm was part of the Drakelow estate, it may also have illustrative (associative) value with the Gresley family. The level of mature vegetation in the gardens around Park Farm and the presence of ranges of agricultural buildings immediately abutting its western end mean that the farmhouse is best appreciated at close range, e.g. from the farmhouse end of driveway from Walton Road, and it is not widely visible from the surrounding landscape.

**4.29** The setting of Park Farm has been altered in the later 20th century through modernisation of the fields immediately east of the farmhouse and the installation of two OHLs within these fields at relatively close proximity to the building. Although Park Farm is not experienced in a wholly unaltered post-medieval landscape, the setting of the farmhouse contributes to its

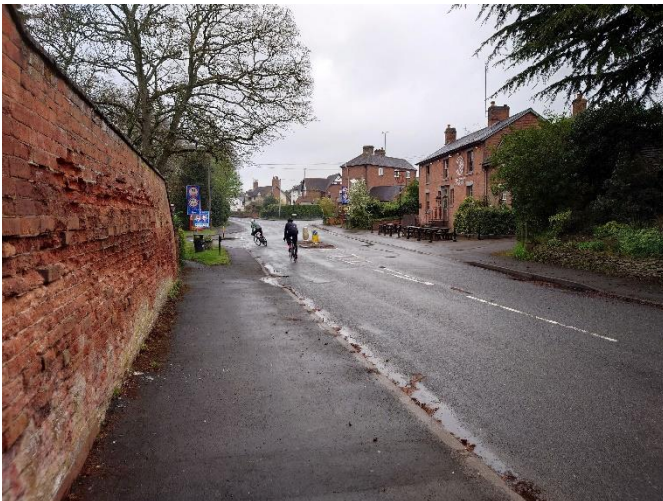
**Figure 4.2: Walton-on-Trent Conservation area, crossroads of Main Street with Station Lane and Coton Road, looking northeast.**

**4.37** The built form of the village and the surrounding landscape, including trees along banks of the Trent adjacent to the village, act to prevent appreciation of the buildings from outside the village itself. This means that the setting of the buildings within the conservation area is relatively discrete. This aspect of their setting feeds into the heritage significance of the buildings by underscoring their origin as components of this historic village.

**4.38** The setting of the conservation area – between the river and a fieldscape of significant time-depth, both of which historically supported the village – contributes to its significance. It does this by allowing by allowing an appreciation of these key aspects in the village's development. These qualities can be most readily appreciated from the approaches to the village from the south and north. From these, the conservation area and is visible in the landscape context which supported it which adds to the understanding of that it is a historic rural village. This is not as appreciable from the eastern approaches as the recent housing around Rosliston Road intervenes between the village core and its fieldscapes. Although the river is key to the origin and growth of the river, it is not actually possible to appreciate the presence of the village until actually at the bridge over the Trent. This is due to mature hedgerows and trees along Station Lane which screen visibility of the village.

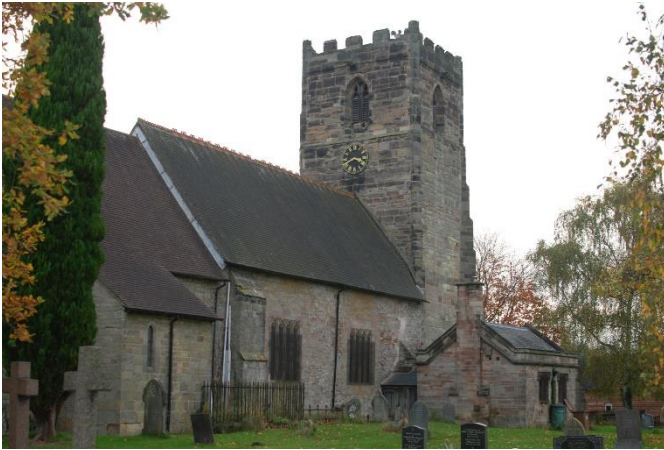
**Figure 4.3: Church of St. Laurence, Walton-on-Trent, looking southwest**

**4.39** The Church of St Laurence (Grade II\* listed building: List Entry No. 1159347) lies at the western edge of the village, between Main Street and the River Trent. As a designated heritage asset it is of national importance (High value). The church is of largely medieval date with its earliest elements of 12-14th century date, it was restored in the 1860s. It has a tower but no spire. Its heritage significance is a combination of evidential, historical, aesthetic and communal values. The evidential value of the church derives from the fabric of the building and the way in which this provides direct physical evidence for the evolution of the church since at least the 12th century. It also provides evidence of changing fashions in church architecture, and the trend for extensive work to churches under the banner of 'restoration' in the Victorian period. The historical value of the church comes from both illustrative and associative elements. In illustrative terms, the architectural quality of both the medieval and more recent elements show the importance of the church to the community. This shows that it warranted expenditure on costly stone buildings and the involvement of skilled masons and, latterly, architects. In associative terms, the church has connections to both local noble families, who patronised the church and were buried and memorialised within it, including the Gresleys and Ferrers. The Victorian and later work is also associated with key figures in the Gothic Revival with the restoration being overseen by the architect G.E. Street, designer of the Law Courts in London among many works, and including stained glass by the leading Birmingham firm Swaine Bourne. Further replacement stained glass installed in the 1930s, also in a gothic style, was designed by C. Webb – a leading designer of church stained glass. The aesthetic value of the church derives from the architectural sophistication and detailing used in the various phases of the building and the quality of execution and the way in which these sit harmoniously against one another. Communal value comes from the church's role as the focus of community life from at least the 12th century. Owing to the level of vegetation – around the church itself, in the village and around the river – and the relatively squat nature of the church tower, the church is not widely visible away from its immediate environs. The main exception to this is the approach to the village from the north along Main Street, the church is clearly visible at the edge of the village adjacent to the river from the stretch between Warren Farm and the northern edge the village.

**4.40** The church's setting contributes to its heritage significance by underscoring its central role in the historic village and allowing appreciation of this.

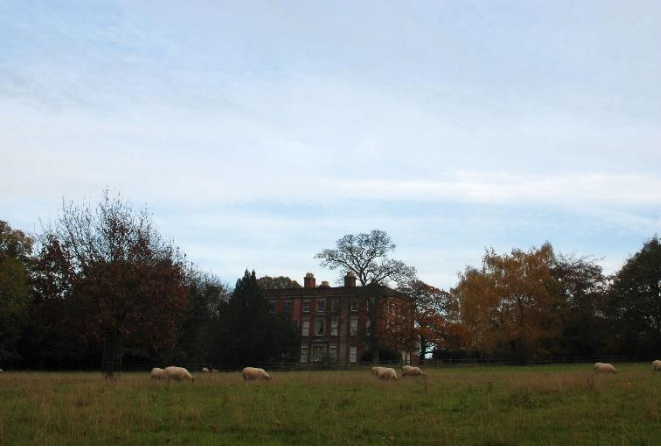
**Figure 4.4: Walton Hall, looking southeast**

**4.41** Walton Hall is a small country house set in a small parkland and lies at the southern edge of the village and forms the southern section of the Walton-on-Trent Conservation Area. It was built in the 1720s for the Sheriff of Derbyshire, William Taylor, and replaced an earlier manor house, the site of which had been in use since at least the 14th century. The Hall and its associated stables and garden walls are a Grade II\* listed building (List Entry No. 1159300). A further hall outbuilding is a Grade II listed building (List Entry No. 1096427) and the parkland is not designated. The parkland appears 18th century and later in date and comprises formal gardens (immediately adjacent to the Hall), tree-studded lawns and, at the south of the park, arable fields edged by plantation woodland. The Hall lies c.1 km northwest of the Site, with the edge of the parkland, which also forms the conservation area boundary, c. 410 m northwest of the Site. The hall and associated listed buildings, as designated heritage assets, are of national importance. The parkland is laid out on the valley side and shoulder of the high ground which forms the Trent-Mease watershed. The Hall sits on high ground within the centre of northern section of the park with the land falling away to the valley floor to its east. The parkland consists of formal gardens immediately adjacent to the hall which then give way to tree-studded lawns to the south and east with the remaining, southern, section of the park in use as arable fields. The south and east edges of the park are defined by plantation woodland. The parkland appears to contain no particularly notable features and is similar in character to the parks surrounding many minor gentry houses of this period. As such it is assessed as being of local importance.

**4.42** The heritage significance of Walton Hall and its associated buildings is a combination of evidential, historical, and aesthetic values. In evidential and historical (illustrative) terms, the buildings document and show the nature of domestic and ancillary buildings built for, and used by, the upper echelons of society in the 18th century. They also show the way these have been altered and used over the subsequent centuries as the Hall has changed in ownership. The buildings also have historical (associative) value due to their construction for an important local family, the Taylors, and particularly with William Taylor for whom the house was built when he was the Sheriff of Derbyshire. In aesthetic terms, the use of a retained, classically-influenced, design executed in brick of a higher quality than in contemporary buildings in the village mean that the hall is distinctive. The establishment of a park around the Hall adds to this aesthetic

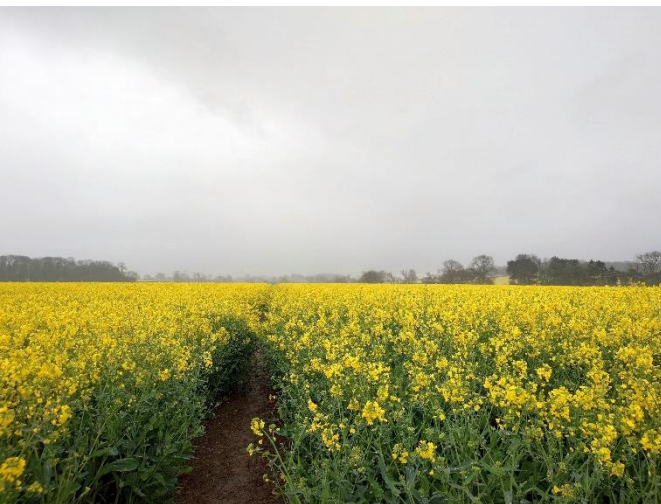
**Figure 4.5: Walton Hall parkland, looking southeast toward the Site from footpath south of the hall**

value by placing it in a controlled and attractive private preserve and this aspect of the setting of the Hall contributes strongly to its heritage significance. The layout of the park means that the Hall is only clearly visible from within the park itself and in glimpses on the approaches to the village from the south. The placement of the Hall on a high point within the park means that it can be seen to loom above these approaches, underscoring the status of the Hall as the residence of the controller of the manor. This aspect of its setting contributes to its significance by making an eloquent declaration of the power of the hall and its occupants.

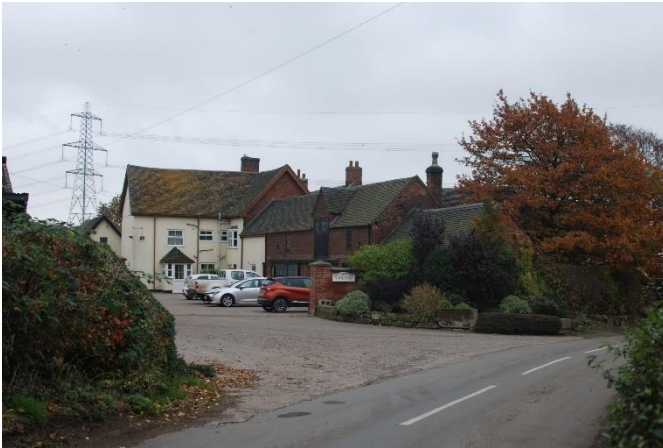
**Figure 4.6: Oaklands Farm, looking southeast**

**4.46** Oaklands Farm lies c.140m southwest of the Site boundary. Oaklands Farm (farmhouse and attached storage range) is shown on historic mapping from at least the early 19th century and surviving buildings at the farm appear to be of roughly this date. Oaklands Farm Cottages lie on the opposite side of Coton Road to Oaklands Farm. They are first shown on the first edition Ordnance Survey and appear to be a range of agricultural workers' cottages of late 19th century date. Although much extended, a two-storey brick farmhouse and attached storage range is still visible at Oaklands. The courtyard of farm buildings which previously stood to their north has been replaced with large, modern agricultural sheds and barns and a range of bungalows constructed to the west of these by Coton Road. Land south of the farmhouse is in use as gardens and contains several mature trees. A separate detached house, Twin Oaks House, was built immediately east of the farmhouse in the 1960s. The level of development and mature vegetation around Oaklands Farm means that the farmhouse is not generally visible from the surrounding landscape. The chief exception to this is on the approach to the farm from the south along Coton Road where both the farmhouse and Oaklands Cottages Farm are clearly visible. Despite the extent of later development, the related nature of Oaklands Farm and Oaklands Farm Cottages remains legible from Coton Road, particularly immediately adjacent to Oaklands Farm.

**4.47** Oaklands Farm and Oaklands Farm Cottages are non-designated heritage assets and ascribed a local level of importance. Like Park Farm, Oaklands Farm is an enclosure period farmstead and its heritage significance stems from a similar combination of evidential and historical (illustrative) values. In evidential terms, the farmhouse physically documents how a domestic building at the core of a farmstead has evolved since the 19th century through retention of both original fabric and that associated with subsequent extension and alteration. In historical (illustrative) terms, the farmhouse demonstrates the away from the settlement at the core of the parish following enclosure to living in the centre of newly created farm holdings. It also shows how the changing demands of farm life were accommodated through enlarging and modifying the farmhouse over multiple generations of resident farmers and how it continues to be used for this purpose. Oaklands Farm Cottages' heritage significance stems from evidential and historical (illustrative) values. The addition of these cottages to the farm complex in the late

**The proposed scheme will heavily alter the setting of these assets. The scheme will wrap around the north, east and southwest sides of Oaklands Farm meaning that it is experienced largely in the context of a solar farm, rather than fields, and this will include views out from the farmhouse to the southeast (i.e. from what appears to be its main frontage). This will erode to an extent how the farmhouse can be understood in its historic rural context and cause some harm. Oaklands Farm Cottages will experience a similar, but slightly less extensive, change in their setting causing a similar erosion of how this asset can be understood and a similar level of harm. For both assets, the presence of the scheme would leave the ability to perceive their functional relationship unaffected. The role of setting in the significance of these assets has already been eroded to an extent by development to their north and southeast. The fundamental aspects of their heritage significance, derived from the form and appearance of the buildings and how these document and show Oaklands Farm's role since the early 19th century will remain unaltered. As such, the change in setting is considered to result in less than substantial harm to these Low value assets.**

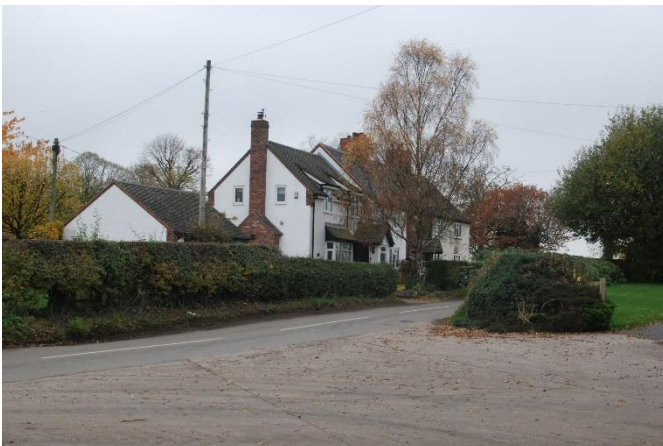
**Figure 4.7: Oaklands Farm Cottages, looking northwest**

19th century documents and shows the novel forms of rural housing adopted to service farms which were more remote from the main settlement.

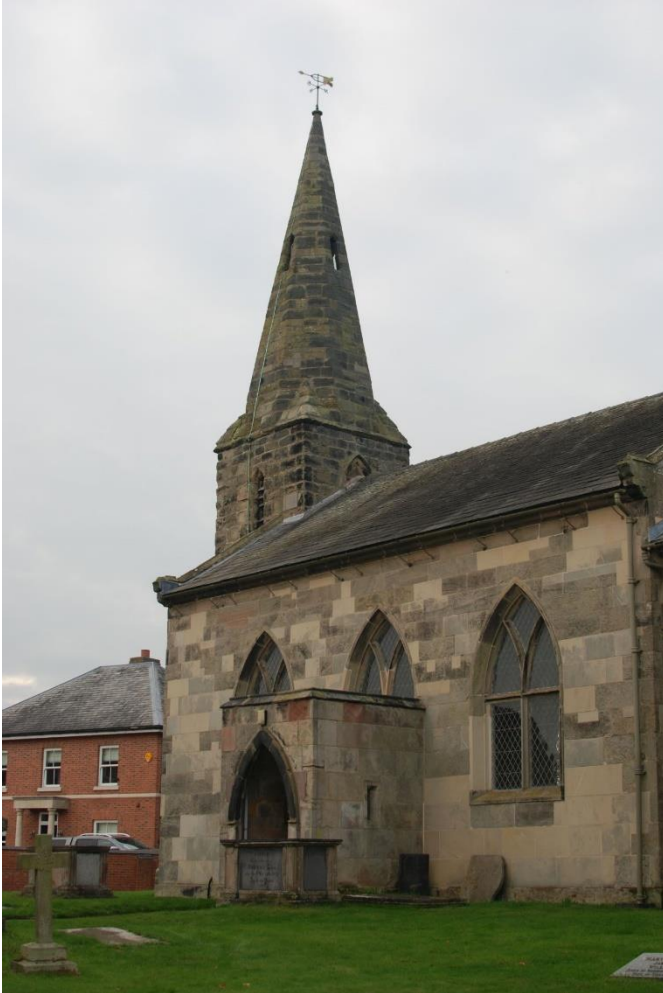
**Figure 4.8: Church of St. Mary, Rosliston, looking northwest**

**4.49** The Church of St Mary, Rosliston, is a Grade II\* listed building (List Entry No. 1159242). It lies within the village of Rosliston c.420m east of the Site within a rectangular churchyard. The church is of medieval origin but the chief surviving element of this date is the 14th century tower and spire. The nave and chancel were rebuilt in a plain gothic style in 1819. This was in part financed by a grant from the Society for the Enlargement and Building of Churches and Chapels. Rosliston is a village of at least medieval original and is a linear village, laid out along Main Street.

**4.50** Historically the village was fairly strung out along Main Street with numerous undeveloped gaps between the buildings within the village. Infill development since the 20th century means that these gaps are no longer present and the village is perceived as a largely modern settlement. This is particularly evident around the church where only the buildings immediately south of the church around Main Street are pre-20th century. Recent housing abuts the churchyard on its east and west sides and a public open space, formed of fields converted to recreational use, lies immediately north of the churchyard. The church and churchyard is approached up a short alleyway from Main Street which runs between historic buildings. The degree of development adjacent to the church means that it is largely screened from view when in the village unless in the immediate vicinity of the church. As such, it feels tucked away and

secluded. Owing to the presence of a spire, the church is also visible from many locations in the surrounding countryside.

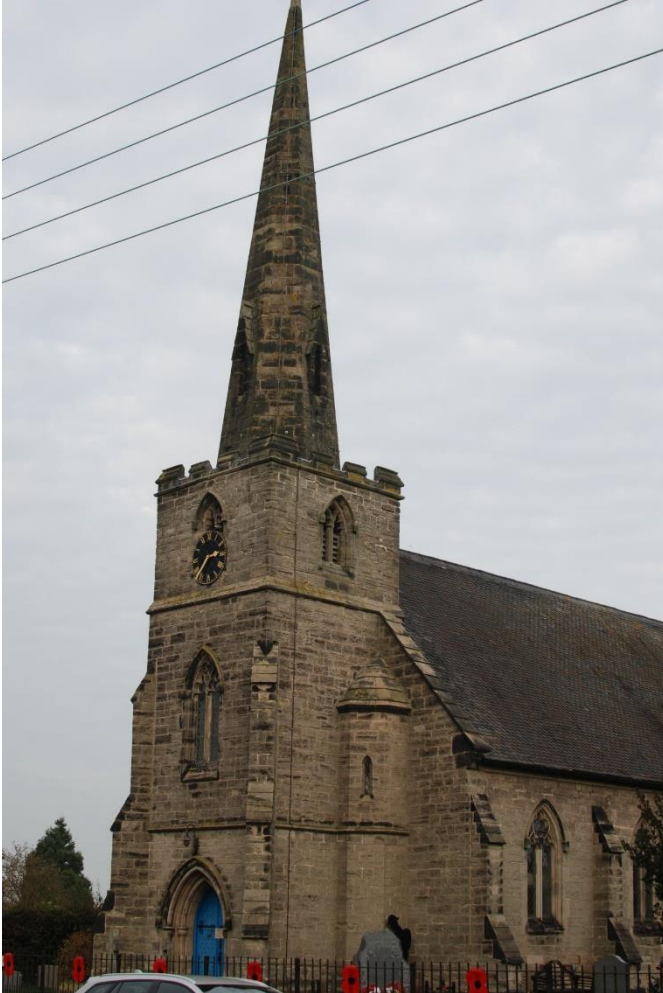
**Figure 4.9: Church of St. Mary, Coton in the Elms, looking southwest**

**4.53** The Church of St Mary, Coton in the Elms, is a Grade II listed building (List Entry No. 1096452). It lies c.1 km to the southeast of the Site and toward the northern end of the village. The church was built in the 1840s to designs of H.I. Stevens of Derby and is in a restrained gothic style and has a tower and spire. It was a wholesale replacement of the previous parish church, on an entirely new site. As with Rosliston, Coton is a linear village of medieval origin. It too contained numerous gaps between buildings but has also seen infill development since the 20th century remove these. Whilst much of the village is perceived as a modern settlement, there are some surviving historic buildings in the immediate vicinity of the church. Recent housing abuts the churchyard on its east and north sides. Owing to the relatively low-rise nature of this development and the churchyard fronting directly onto Church Street, the church is relatively visible within this section of the village. It is also possible to see out from the churchyard to the fields north of the village. The presence of a spire means the church is also visible from many locations in the surrounding countryside.

**4.54** As a designated heritage asset, the Church of St Mary, Coton in the Elms, is of national importance. Its heritage significance is a combination of evidential, historical, aesthetic and communal values. The evidential value of the church derives from the fabric of the building and the way this provides direct physical evidence for the religious practices of the Church of England in the 19th century. It also provides evidence for the trend for churches to be wholly rebuilt in the 19th century if the preceding church building was in disrepair or no longer felt to be appropriate for the needs of its congregation and patron. The historical value of the church comes from both illustrative and associative elements. In illustrative terms, its architectural quality shows the importance of the church to the community such that it warranted rebuilding under supervision of an architect. In associative terms, the church has connections to H.I. Stevens, a major regional architect who was responsible for many church buildings and civic works. Like St Mary's Rosliston, this church is also connected to the Society for the

Enlargement and Building of Churches who contributed part of the funds for its construction. The aesthetic value of the church derives from the architectural sophistication and detailing used in the building and the quality of execution. Communal value comes from the church's role as the focus of community life from at the mid-19th century.
