OAKLANDS FARM SOLAR PARK

Appendix 6.14 – Arboricultural Survey Report

**ARBORICULTURAL
IMPACT
ASSESSMENT**

Oaklands Farm Solar Park
(NSIP)

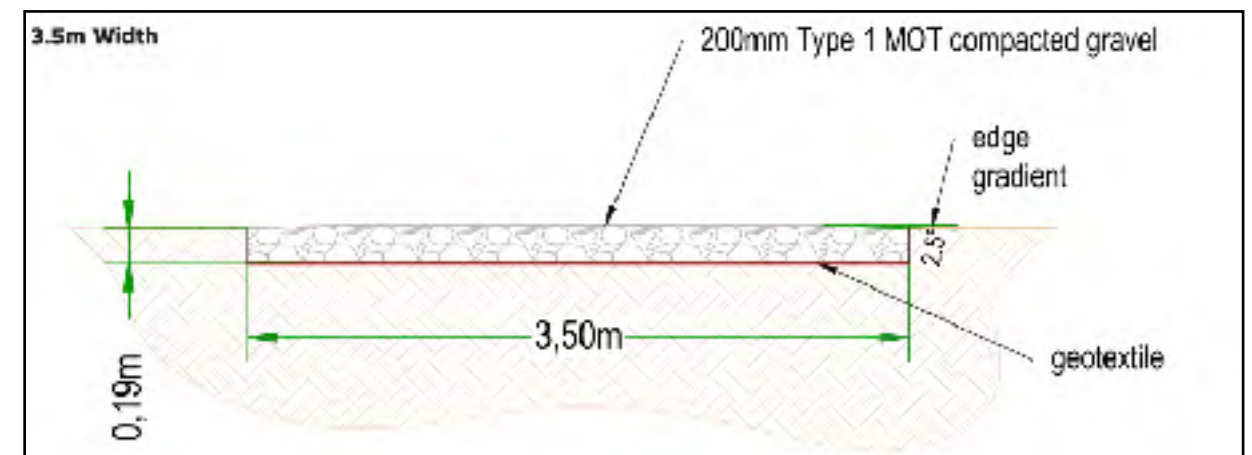
Figure 1: 3.5m track cross-section

6.13. It will also be necessary to establish some new access, temporary construction and operation/maintenance tracks within the Site interior. The construction and operation tracks are to be constructed as per the below specification/cross sections (See Figures 1 and 2) below taken from the drawing titled '04_detail_gravel_road_3.5m' and '04_detail_gravel_road_6m':

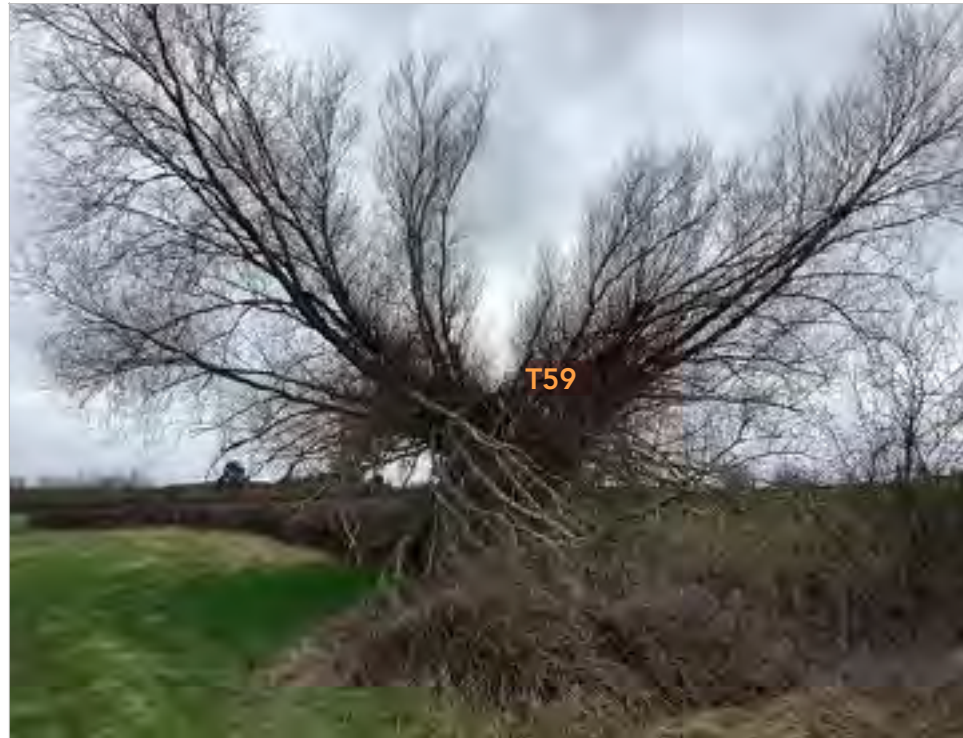
IMAGE 1: T59 a willow pillars categorised as 'Ancient' due its large stem diameter.

4.7. Crack willow T59, English oak T56 and English oak T57 were identified as 'ancient' trees due to their exceptionally large stem diameters and presence of features described above. This is a good indicator of their notable maturity, these trees are significantly older than most other trees within the The Site.

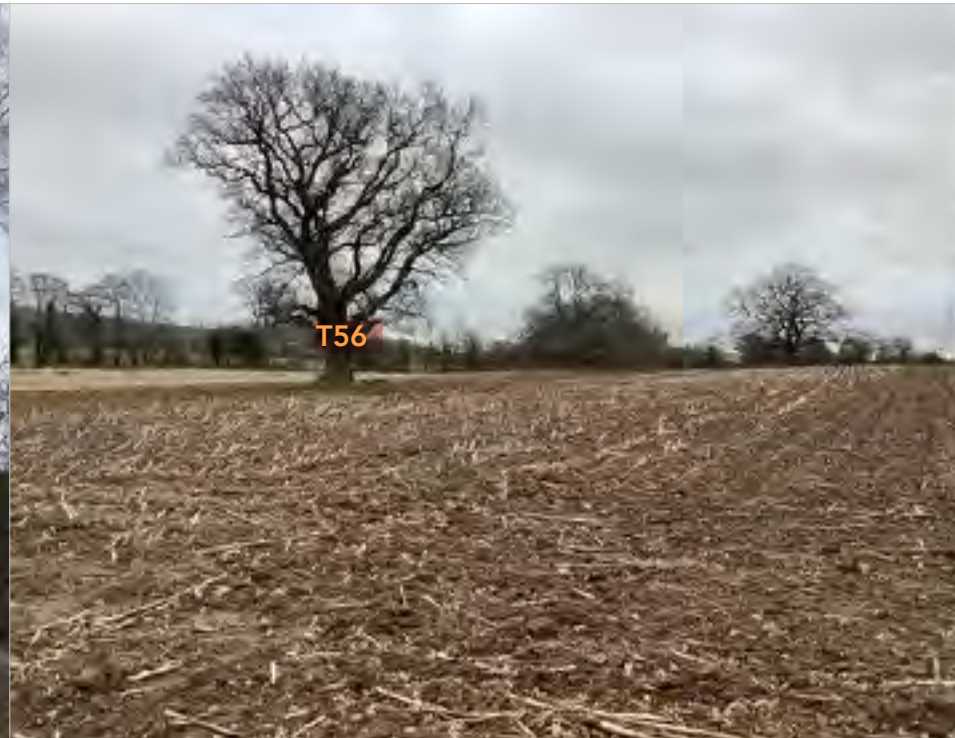
IMAGE 2: Looking south at ancient English oak trees T56 & T57.

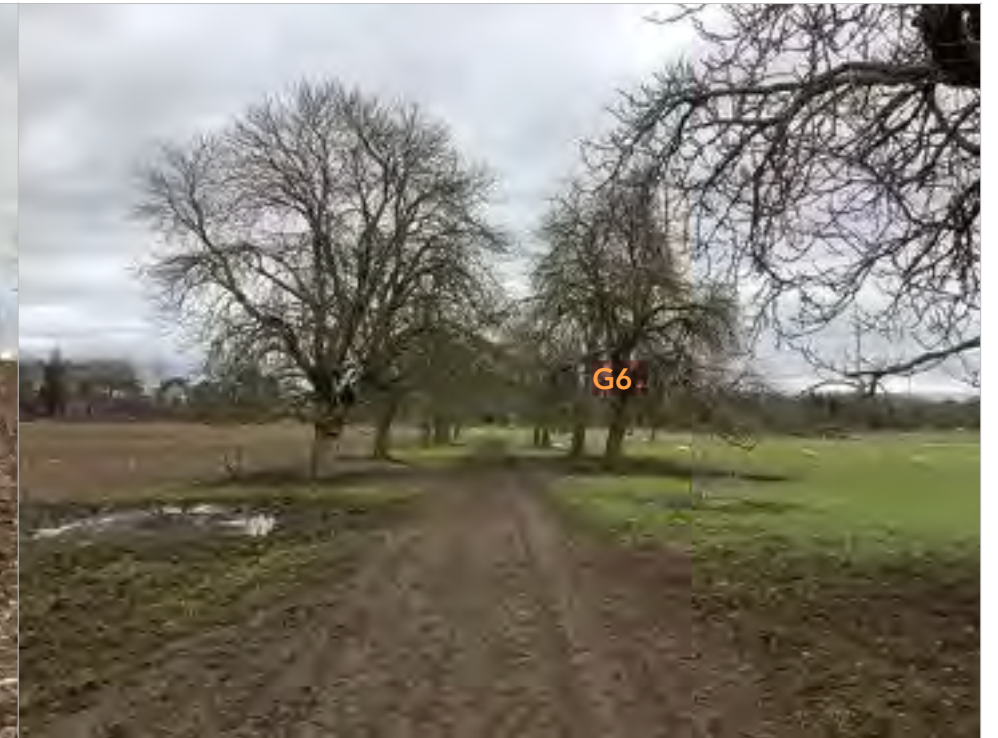
IMAGE 3: G6 & G8 forming a prominent avenue of Horse chestnut trees.

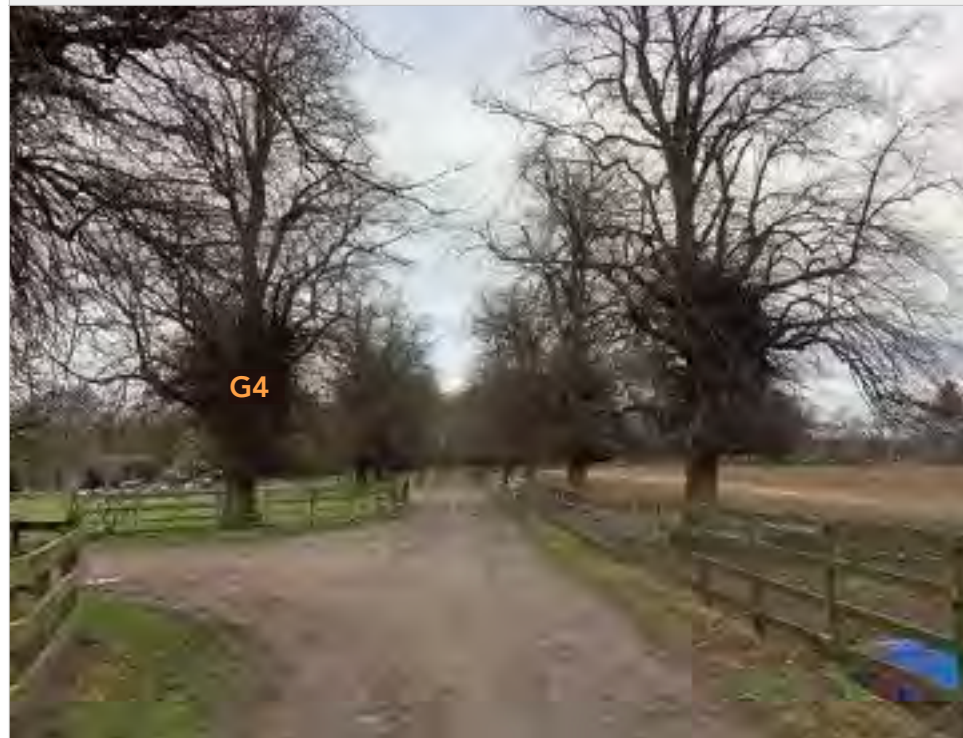
IMAGE 4: G2 & G4 forming a prominent avenue of Common lime trees.

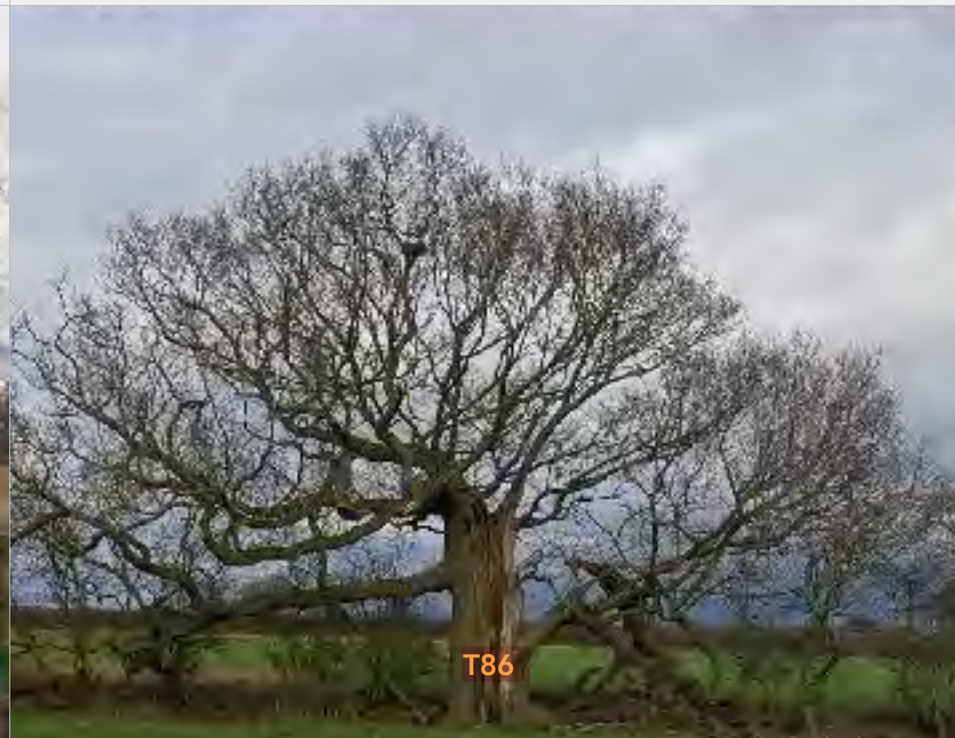
IMAGE 5: Looking north at Veteran English oak tree T86.

4.6. Common lime T30, English oak T32 and English oak T86 were identified as 'veteran' trees due to their large stem diameters, very large cavities in main stems, fungal associations, large diameter branch stubs and extensive deadwood habitat. All of the aforementioned characteristics provide significant niche habitats that are considered defining features of a 'veteran' tree. These trees have been identified as veterans by virtue of their large stem girths (as per Fig. 1.3 in Lonsdale, 2013²). They have also been assessed as being veteran trees using the characteristic features found on veteran trees in paragraph 2.1.1 in Read, 2000³).

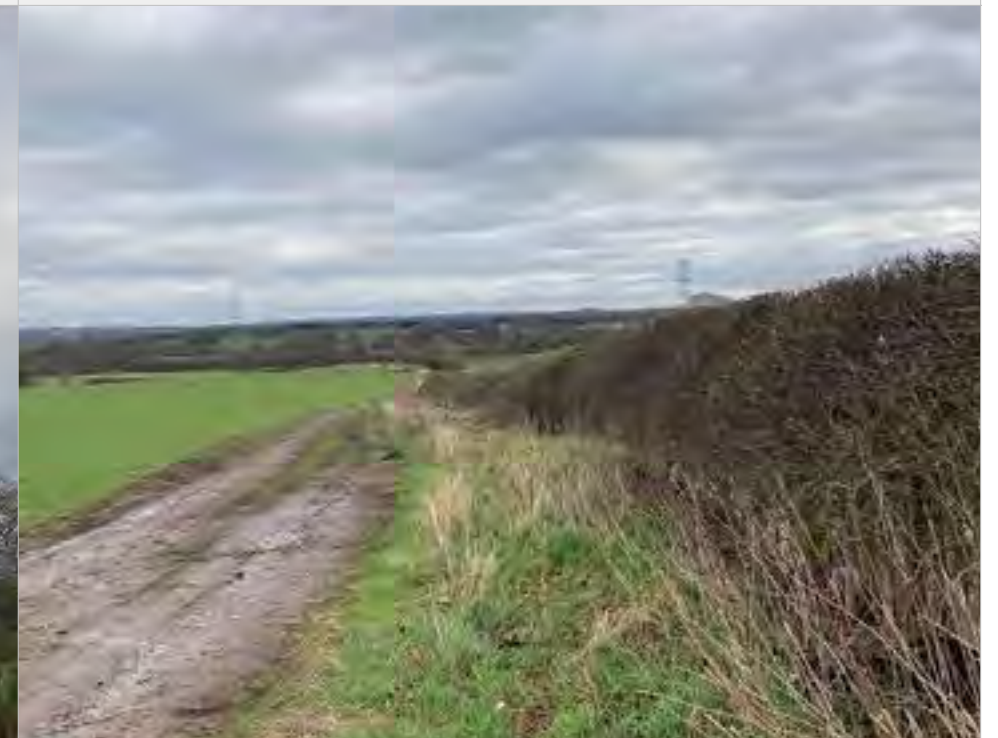
IMAGE 6: Typical hedgerow and existing farm track with the southern parcel of farmland.
