Annex A Special Order AIL Swept Path Analysis

Volume 3, Appendix 27.1: Transport Assessment

Outer Dowsing Offshore Wind Environmental Statement

SLR Project No.: 410.V05356.00013

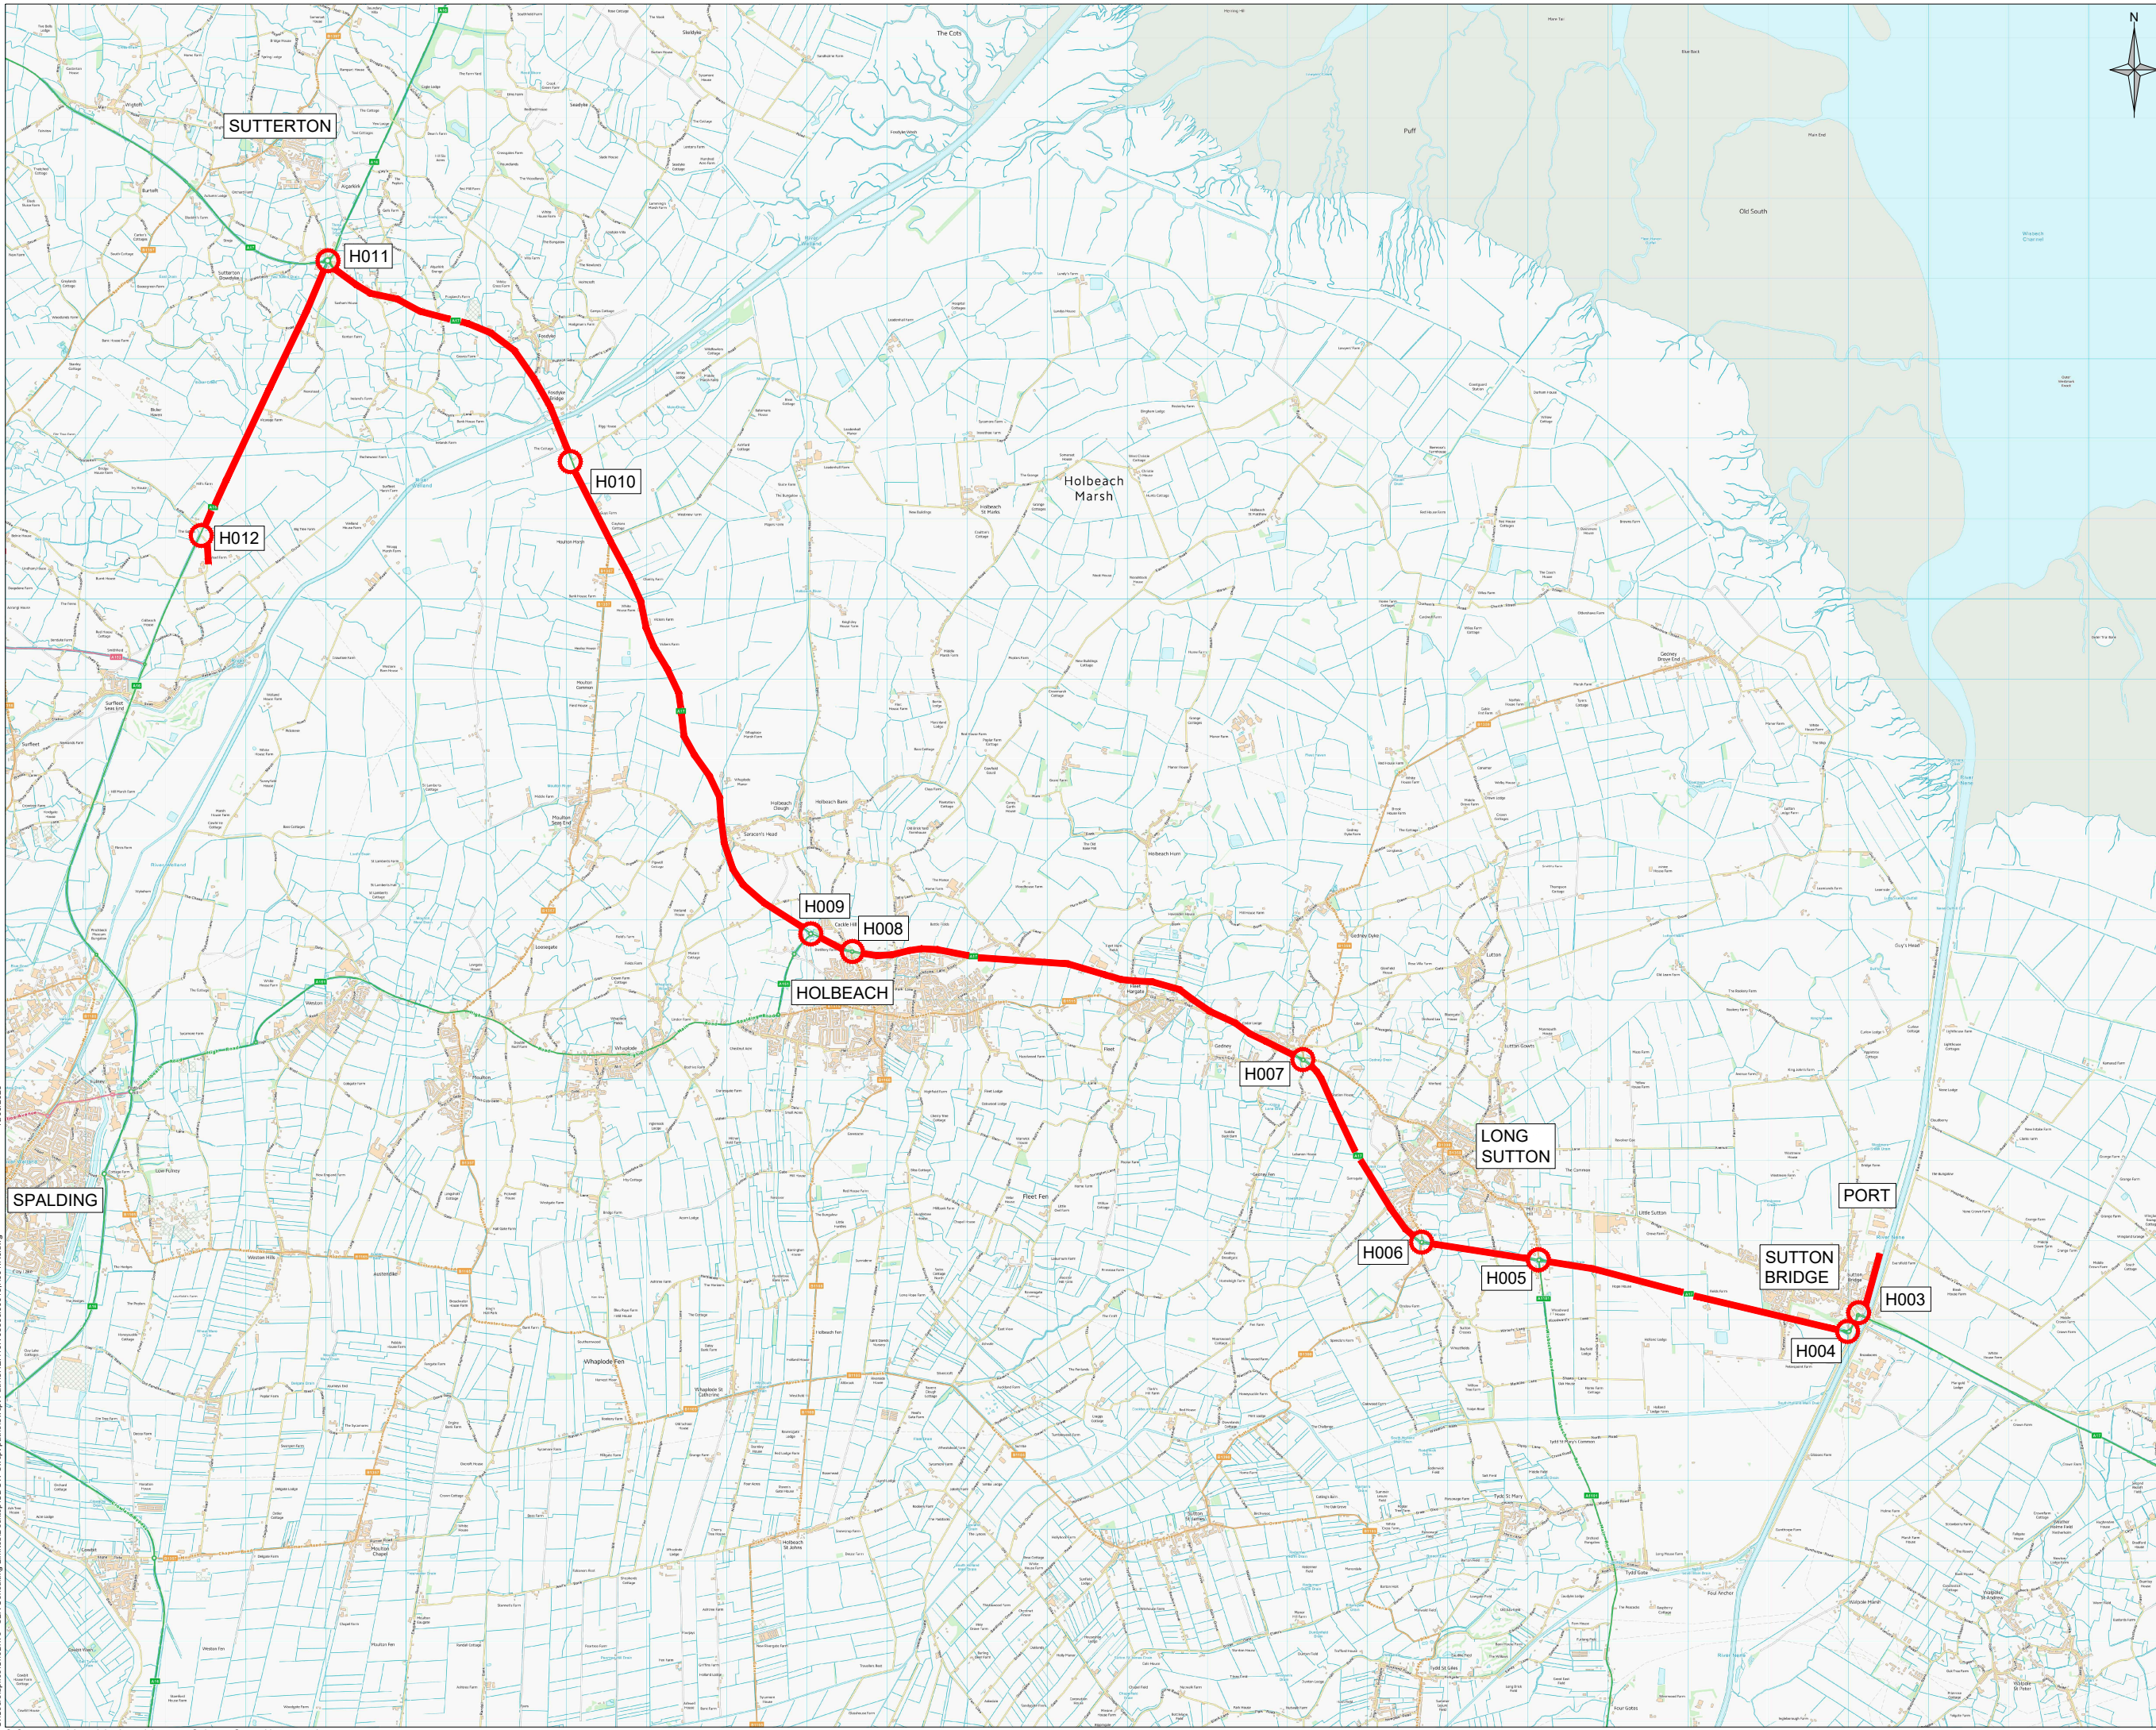
Scale 1:75,000	@ A3	SLR Project No. 410.V05356.00013-0003
Designed DPP	Drawn DPP	Checked DM
Date JUNE 23	Date JUNE 23	Date JUNE 23
Drawing Number SHE.410.V05356.00013-H001	Rev. R0

Drawing Title
 SWEEP PATH ANALYSIS
 ROUTE DETAILS

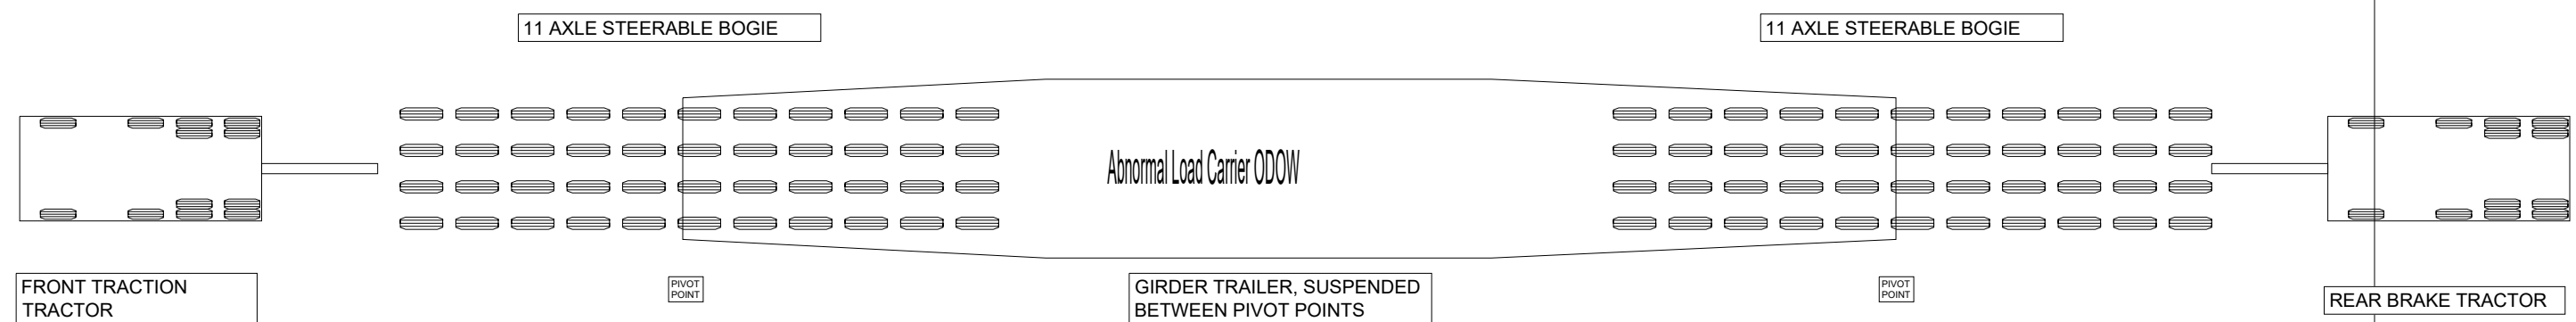
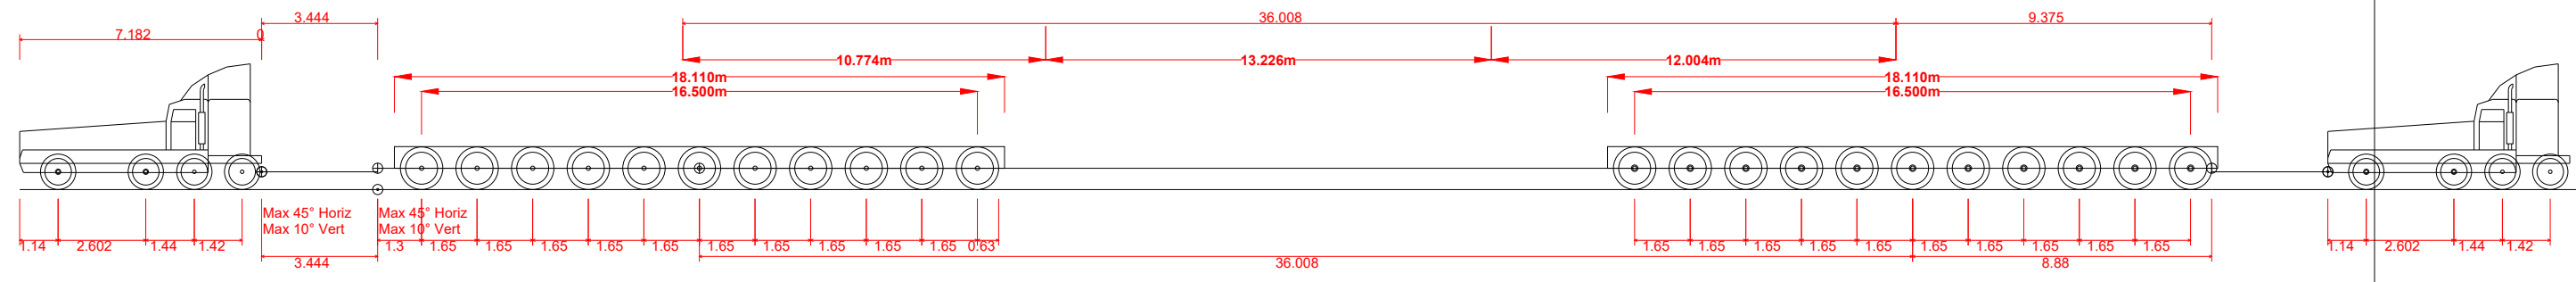
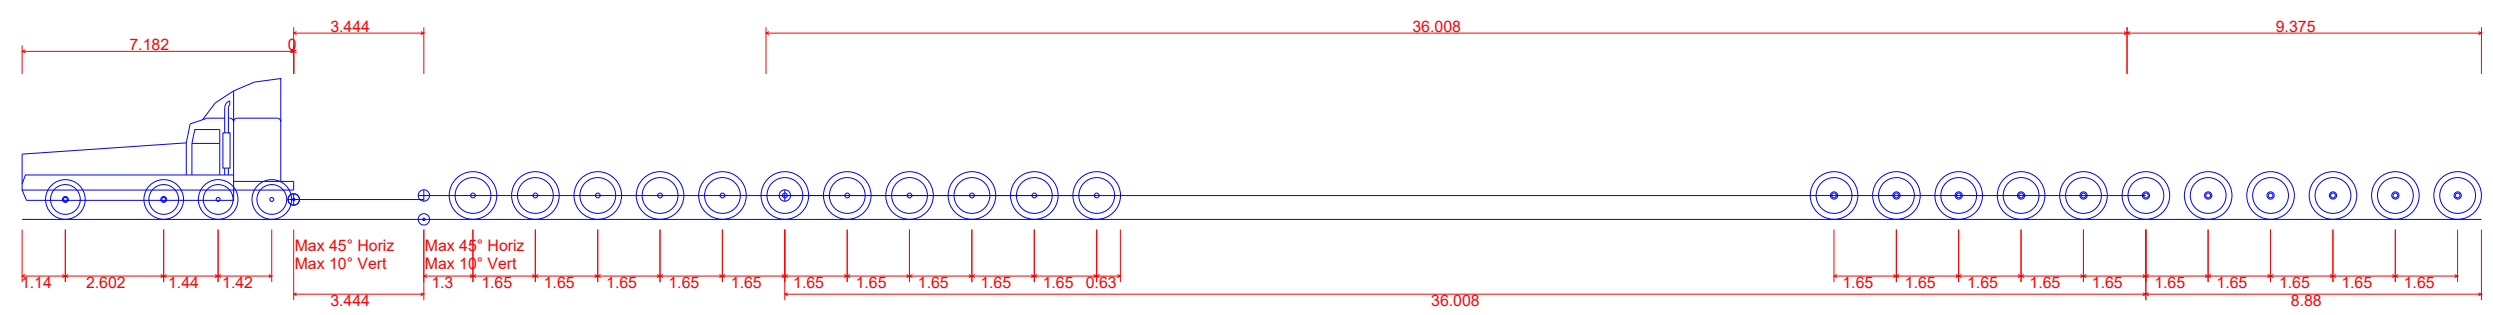
Drawing Number SHE.410.V05356.00013-H002 Rev. R0

Abnormal Load Carrier ODO
 Overall Length 65.064m
 Overall Width 5.300m
 Overall Body Height 3.725m
 Min Body Ground Clearance 0.505m
 Max Track Width 3.600m
 Lock to lock time 6.00s
 Wall to Wall Turning Radius 9.800m

Abnormal Load Carrier start again 01
 Overall Length 65.064m
 Overall Width 5.300m
 Overall Body Height 3.725m
 Min Body Ground Clearance 0.505m
 Max Track Width 3.600m
 Lock to lock time 6.00s
 Wall to Wall Turning Radius 9.800m

REAR BRAKE TRACTOR NOT MODELED IN VEHICLE USED FOR SWEEP PATHS. UNABLE TO GET LINKAGE TO MAIN VEHICLE TO WORK ADEQUATELY.

Drawing Title
SWEEP PATH ANALYSIS
VEHICLE DETAILS

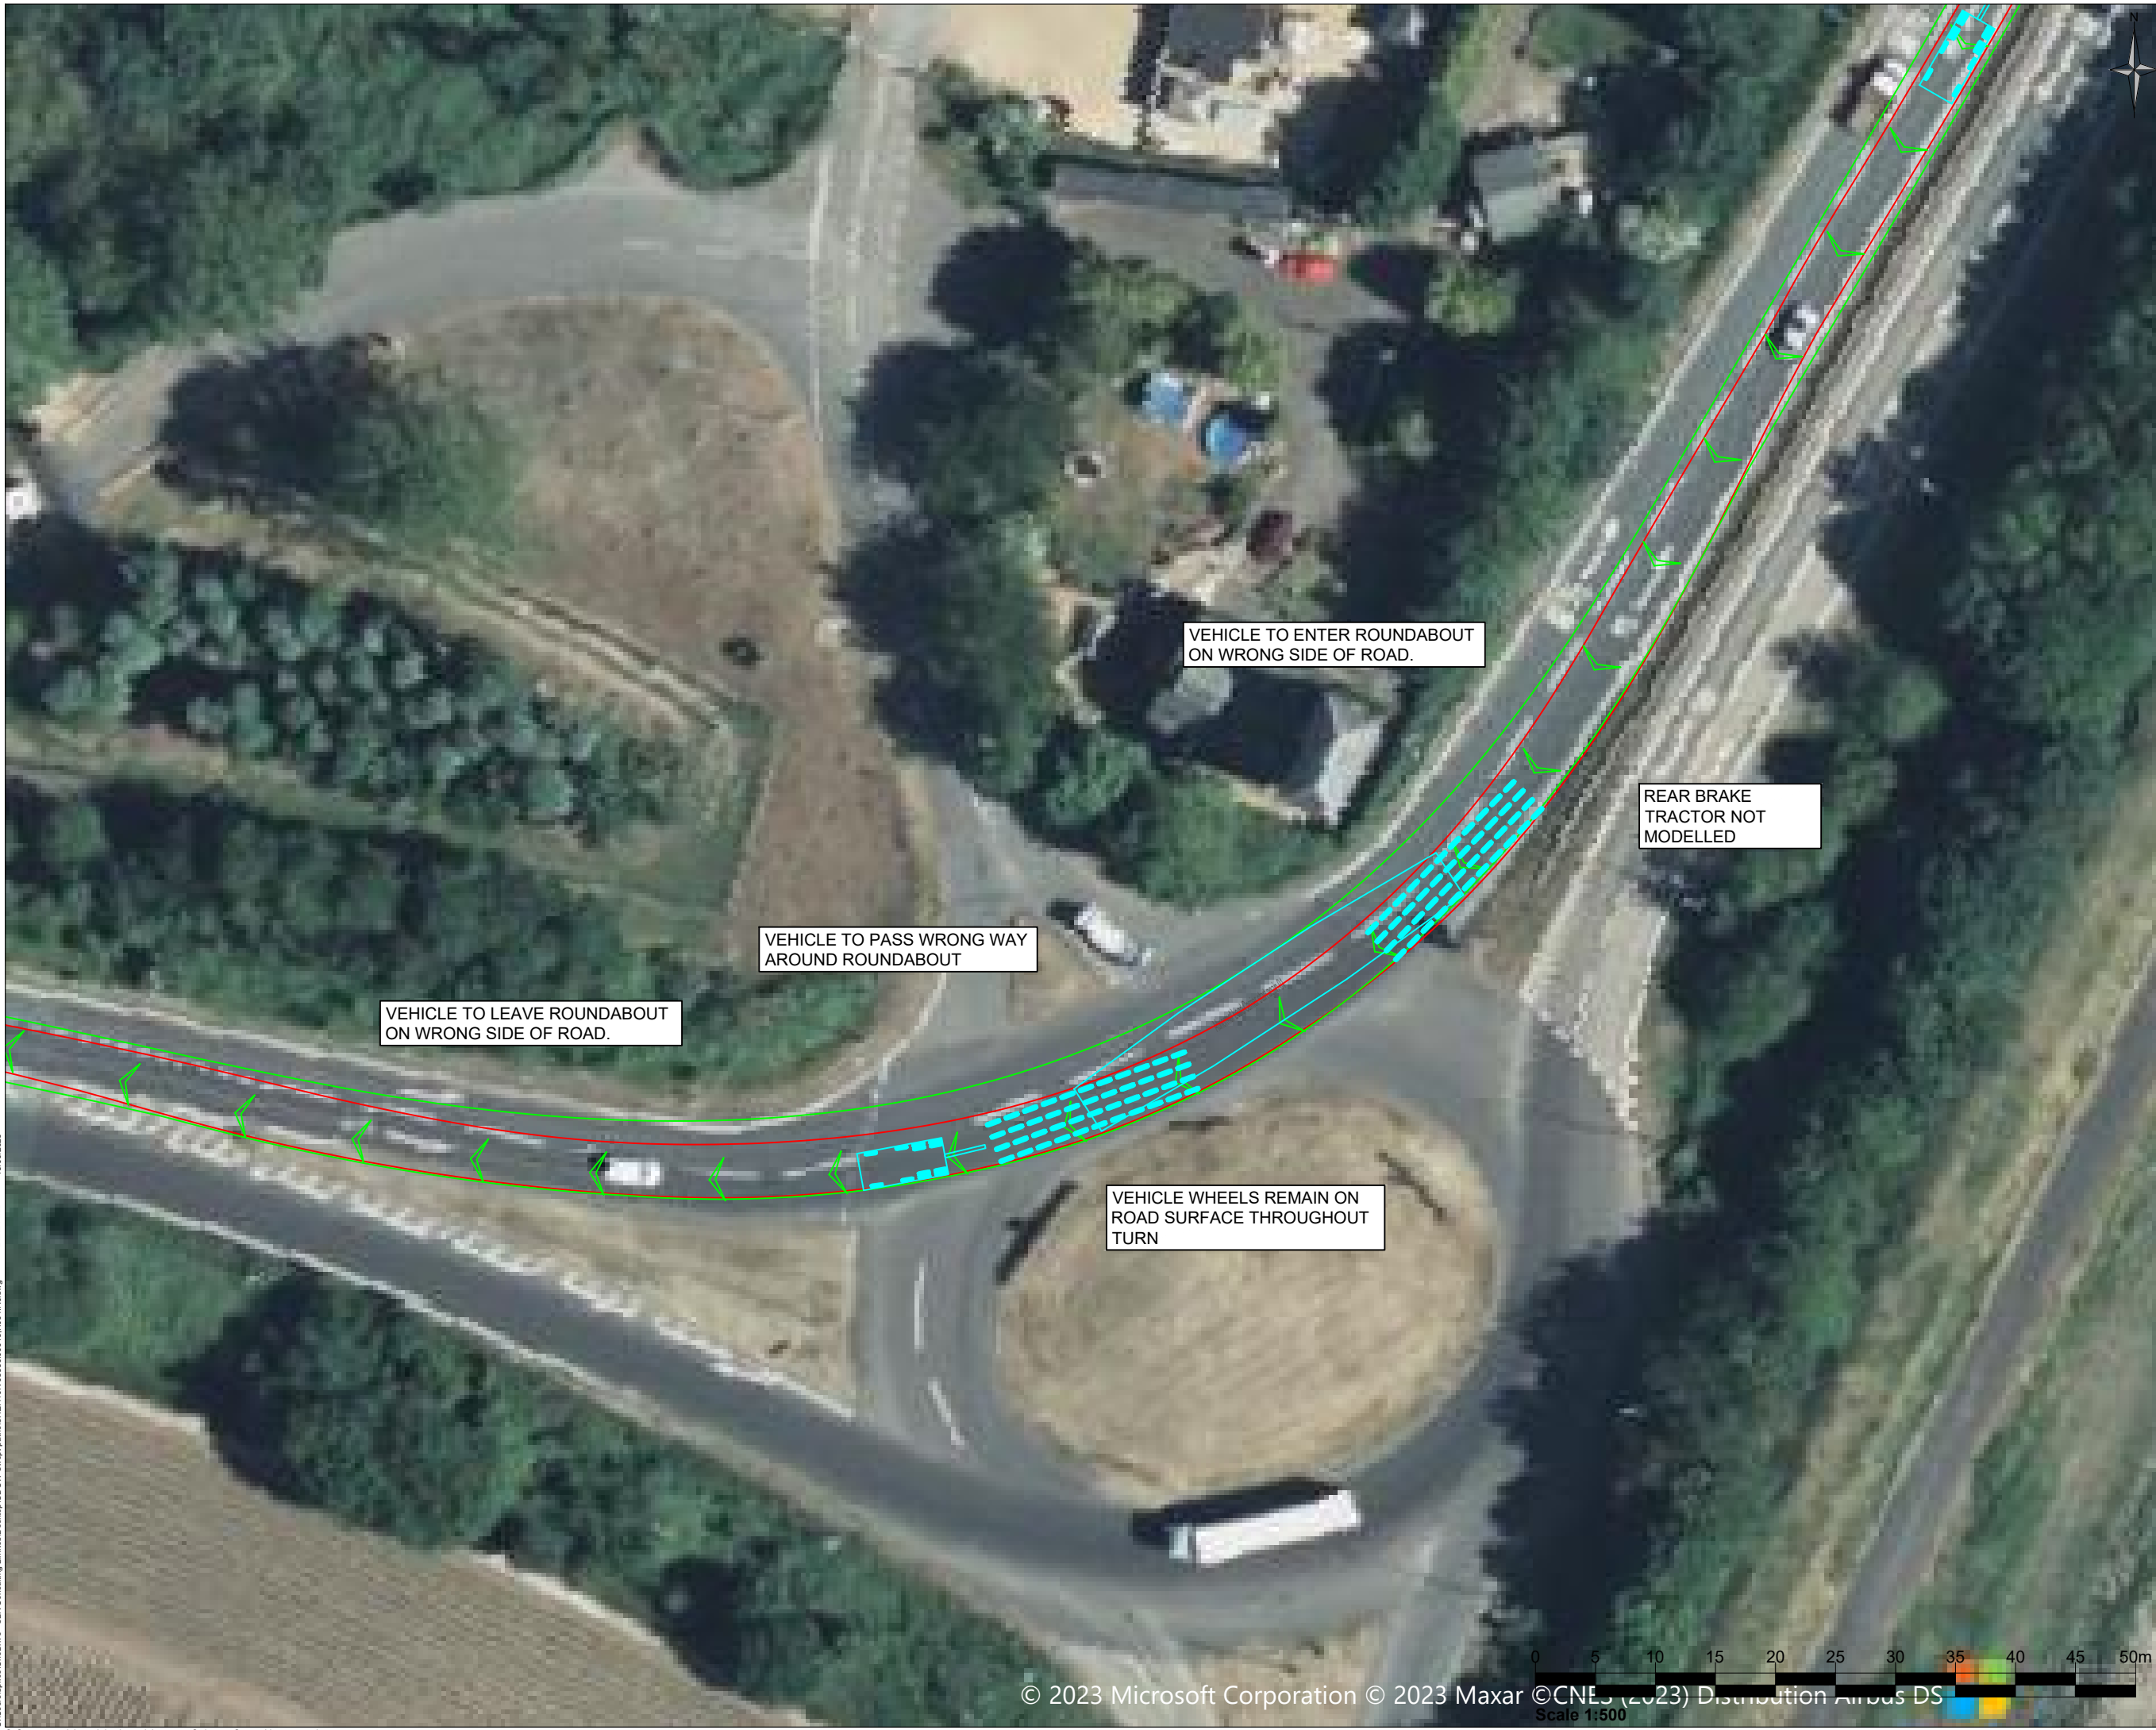
Drawing Number
 SHE.410.V05356.00013-H004 Rev.
 R0

VEHICLE TO ENTER ROUNDABOUT ON WRONG SIDE OF ROAD.

VEHICLE TO PASS WRONG WAY AROUND ROUNDABOUT

VEHICLE TO LEAVE ROUNDABOUT ON WRONG SIDE OF ROAD.

VEHICLE WHEELS REMAIN ON ROAD SURFACE THROUGHOUT TURN

Drawing Title
 SWEPT PATH ANALYSIS
 SUTTON BRIDGE
 A17 ROUNDABOUT

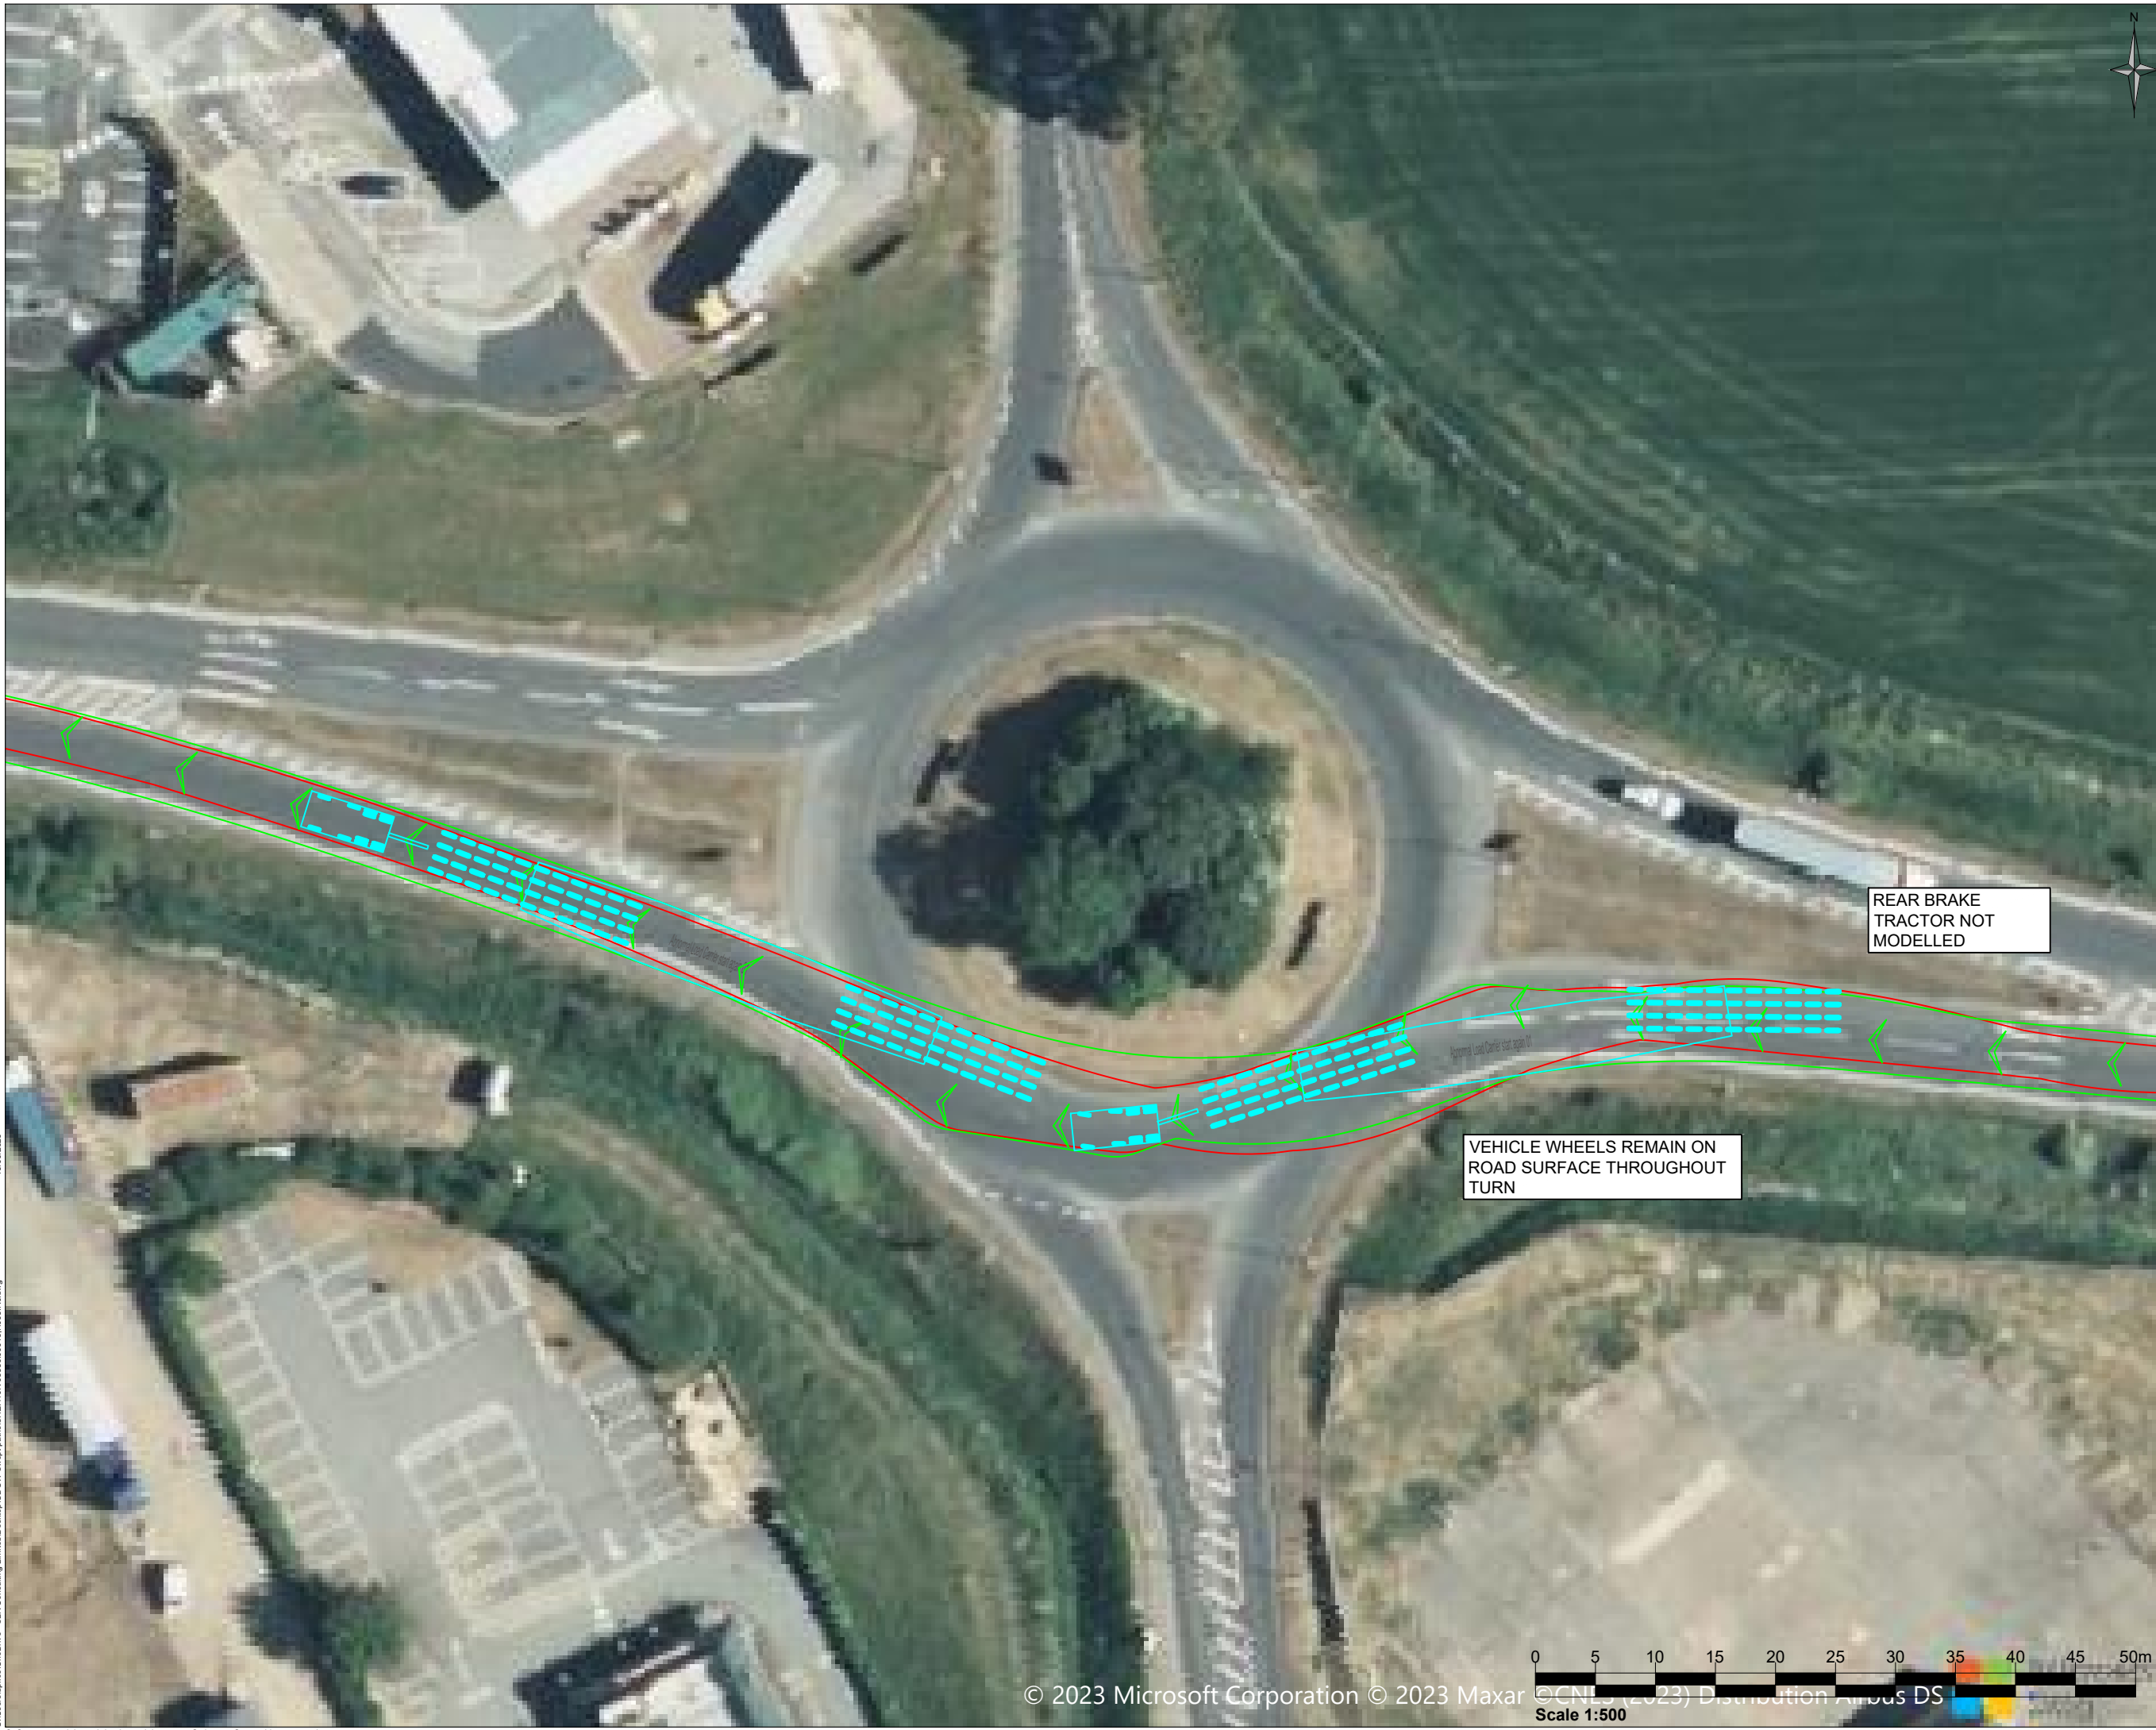
Drawing Number
 SHE.410.V05356.00013-H005 Rev.
 R0

VEHICLE WHEELS REMAIN ON ROAD SURFACE THROUGHOUT TURN

Drawing Title
 SWEEP PATH ANALYSIS
 SUTTON BRIDGE
 A17 ROUNDABOUT

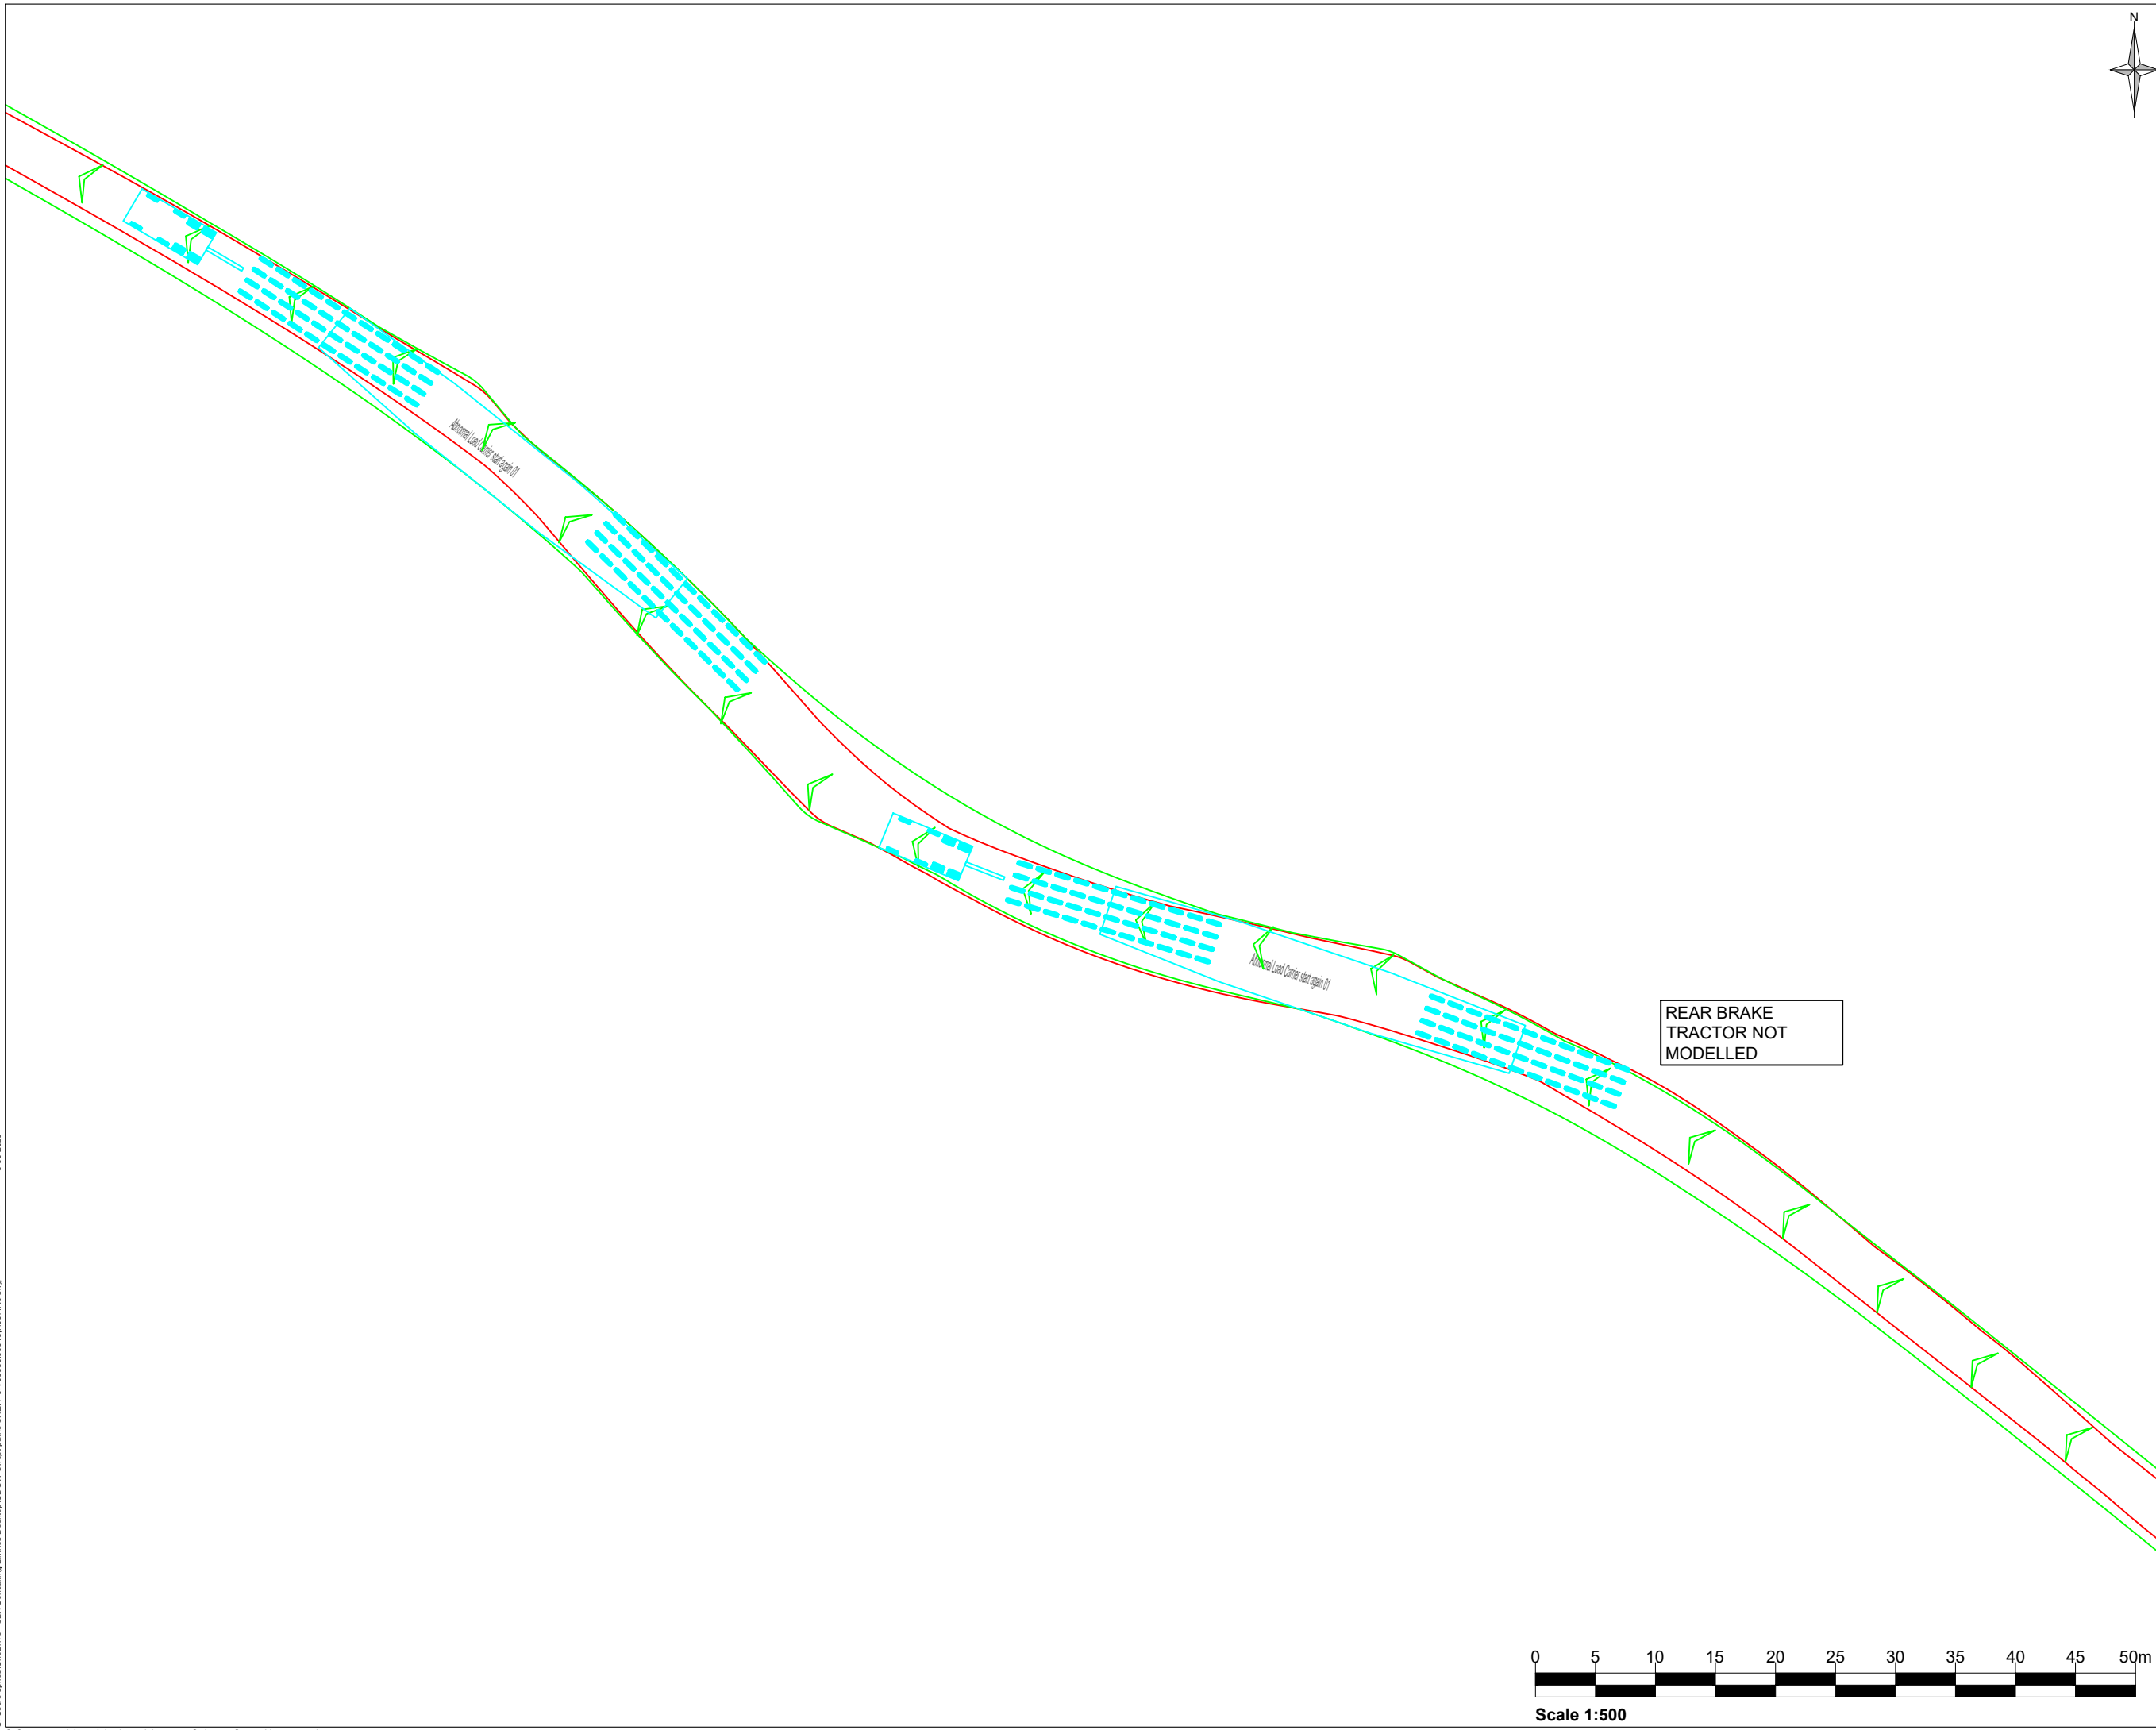
Drawing Number
 SHE.410.V05356.00013-H007 Rev.
 R0

REAR BRAKE
TRACTOR NOT
MODELLED

Drawing Title
 SWEPT PATH ANALYSIS
 SUTTON BRIDGE
 A17/B1359 ROUNDABOUT

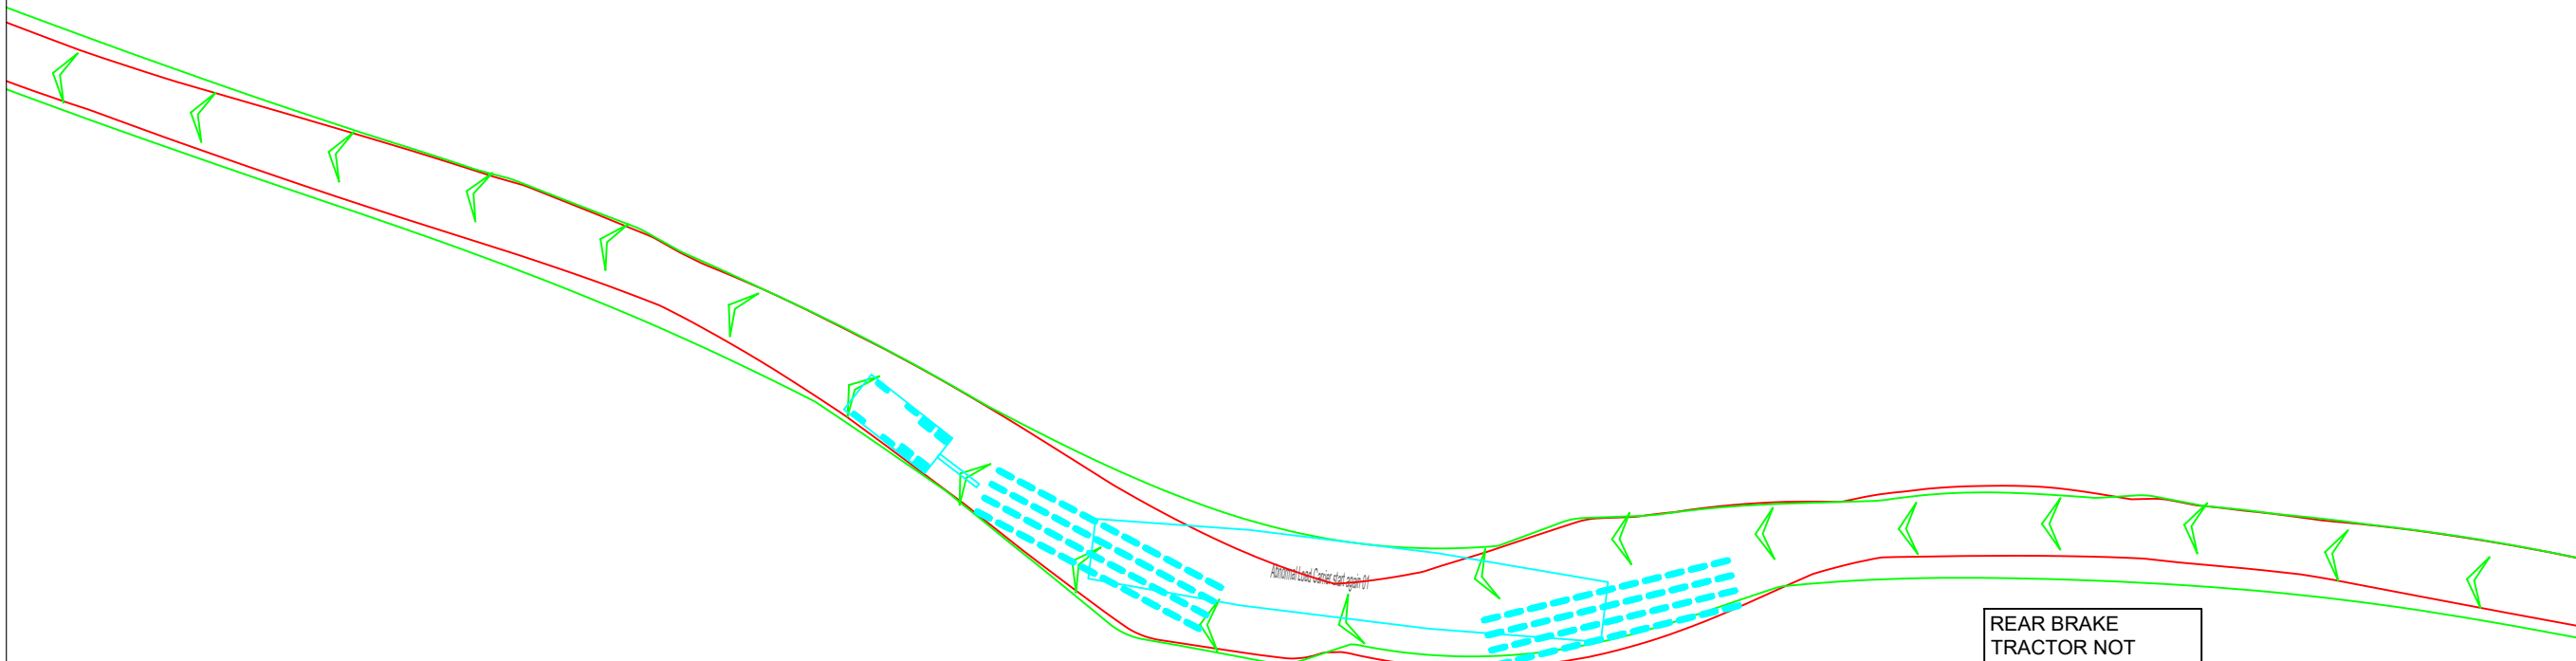
Drawing Number
 SHE.410.V05356.00013-H008 Rev.
 R0

VERGE PROTECTION
REQUIRED

Drawing Title
 SWEPT PATH ANALYSIS
 HOLBEACH
 A17/B1168 ROUNDABOUT

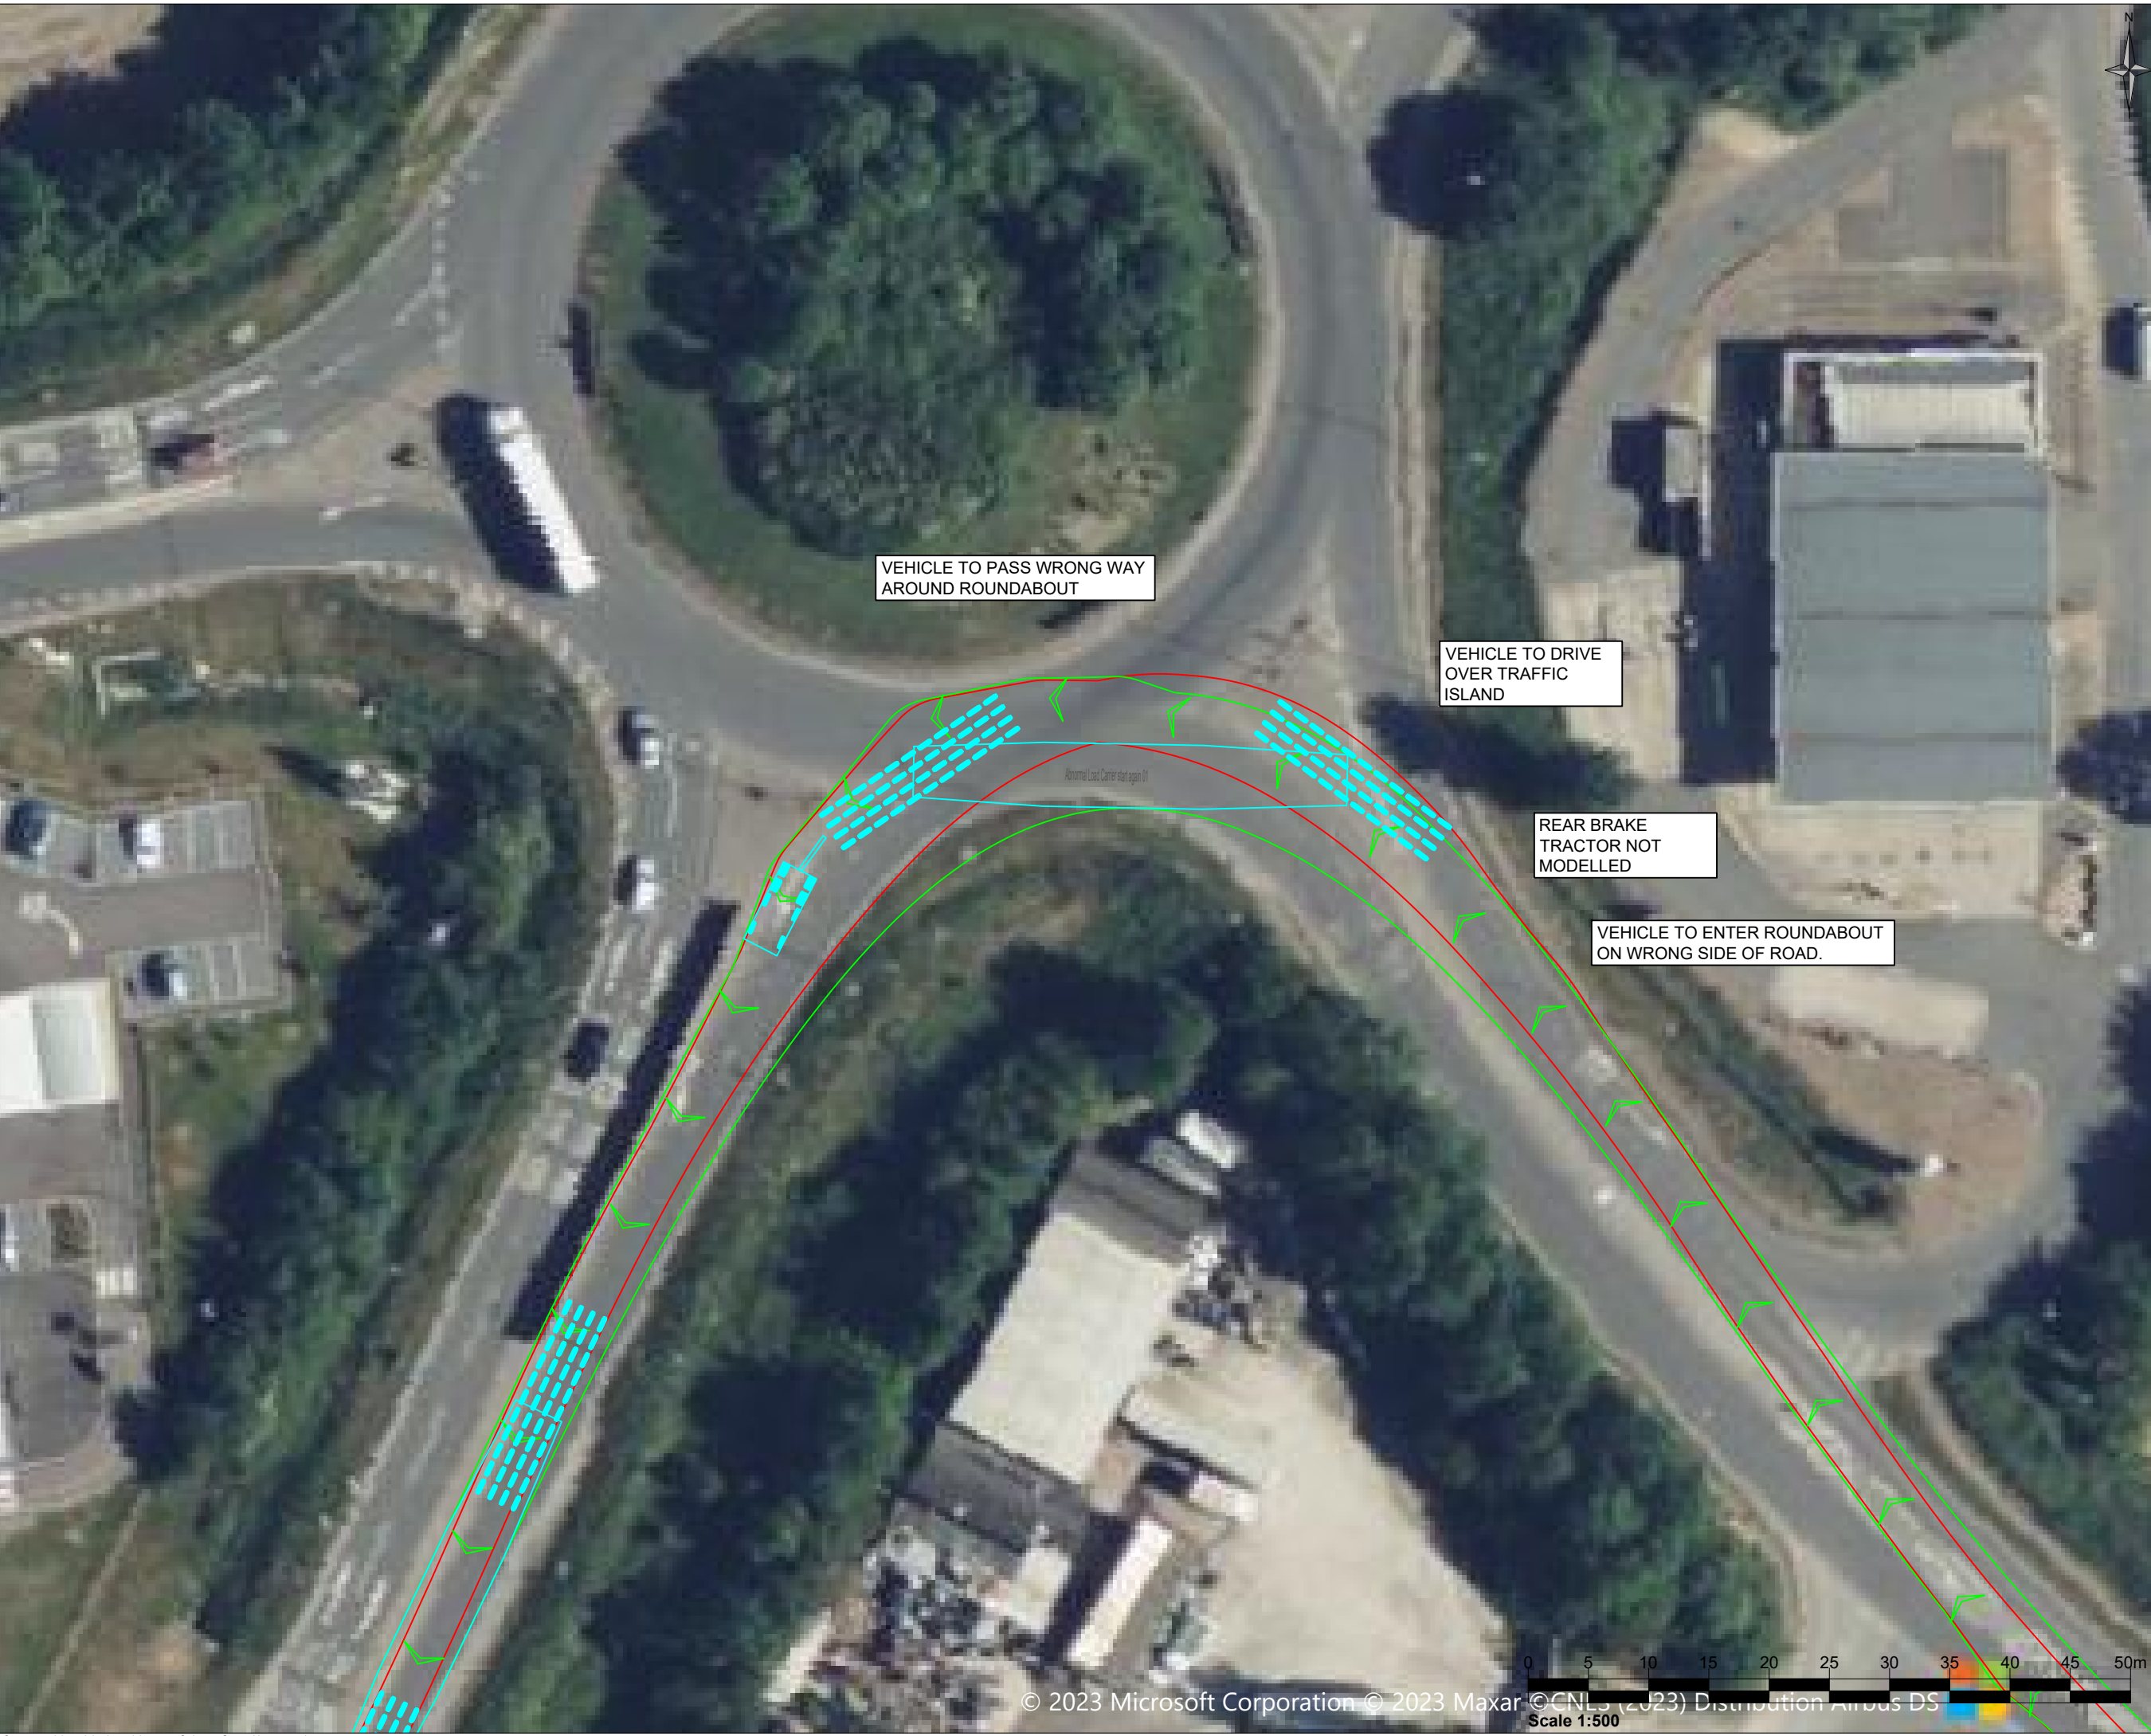
Drawing Number
 SHE.410.V05356.00013-H011 Rev.
 R0

Drawing Title
 SWEEP PATH ANALYSIS
 SUTTERTON
 A17/A16 SUTTERTON ROUNDABOUT
