Cottam Solar Project

Environmental Statement Appendix 14.1: Transport Assessment Revision A

Prepared by: Transport Planning Associates
November 2023

Transport Assessment

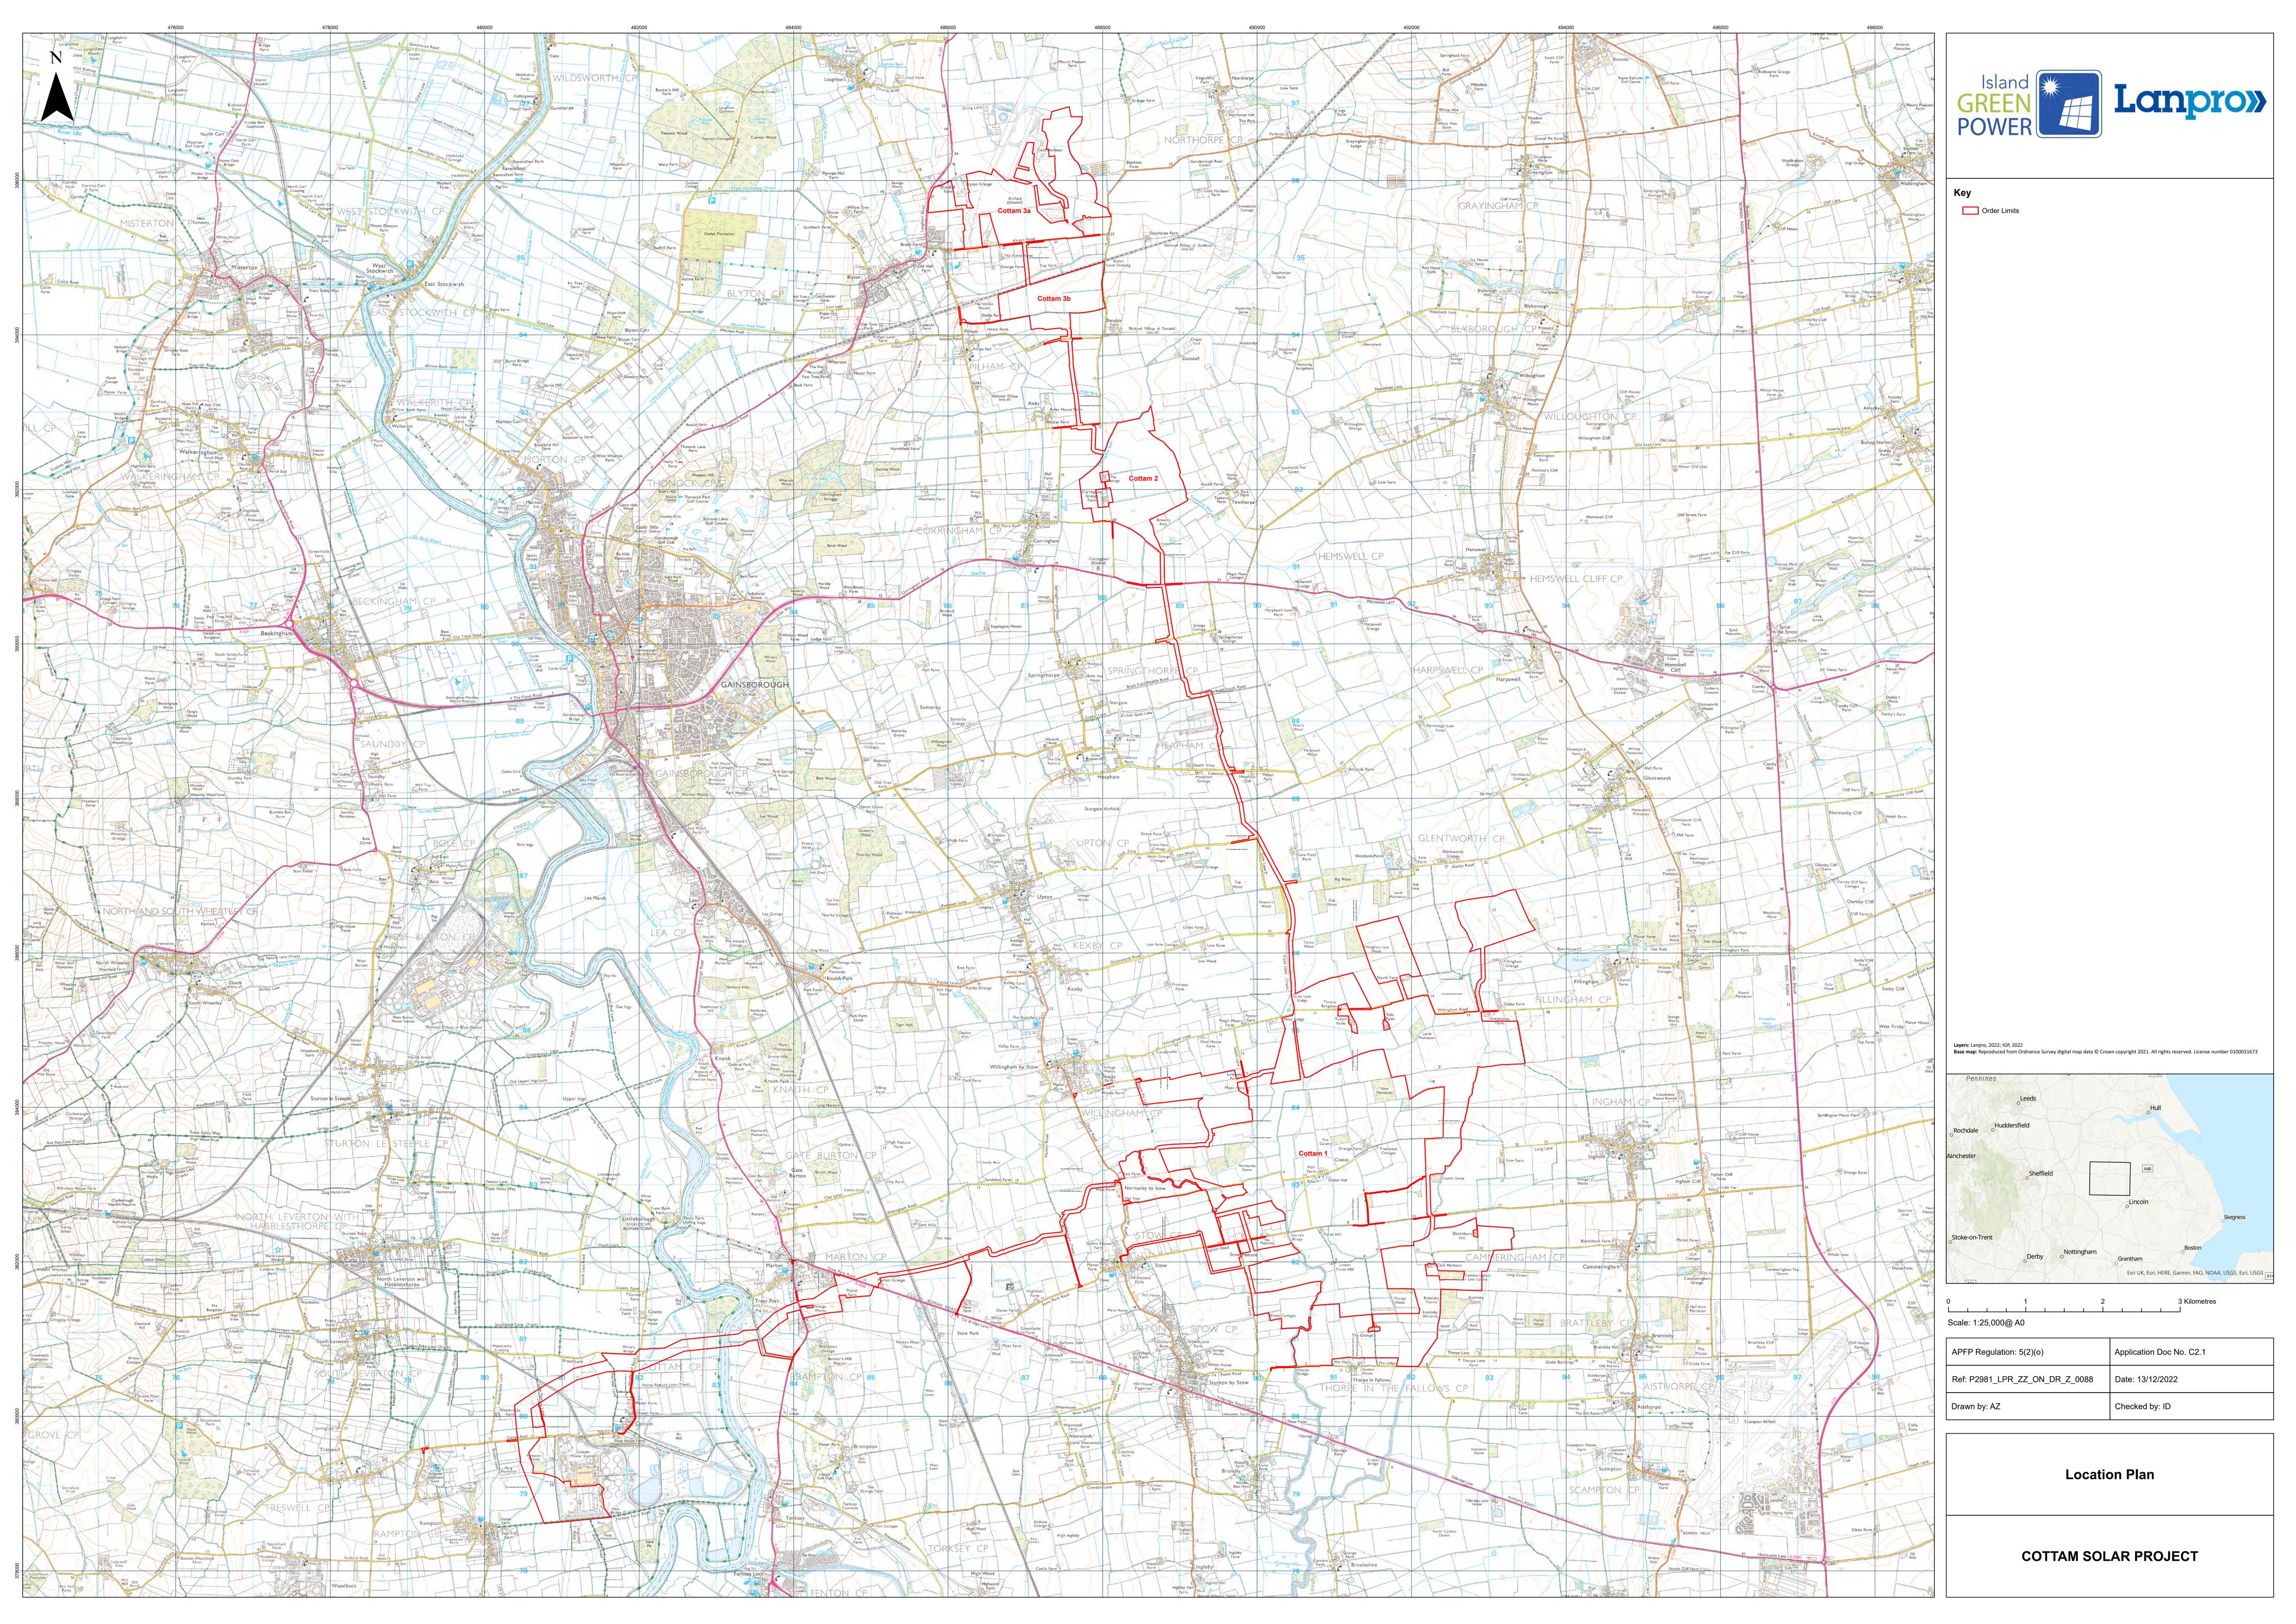
APPENDIX A

- 1.7 The Order Limits (Location Plan) is shown in **DCO Core Plan 1** [EN010133/APP/C2.1]. This is shown in **Appendix A**.
- 1.8 A full overview of the Scheme can be found in ES Chapter 3 on the 'Order Limits' [EN010133/APP/C6.2.3], and ES Chapter 4 on the 'Scheme Description' [EN010133/APP/C6.2.3].

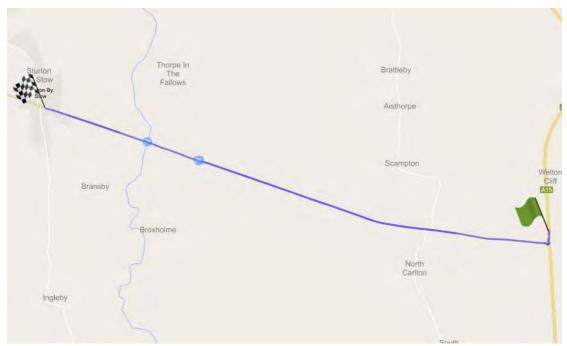
A1500 structures on ESDAL?

Further to my email below I have tried to call you and Ian a few times over the last week but the numbers just ring out. I am looking at completing an interim report to my client next week. In addition to the missing structures I mentioned before I see that there are others, for example on A1500 and A57 as per ESDAL screenshots below.

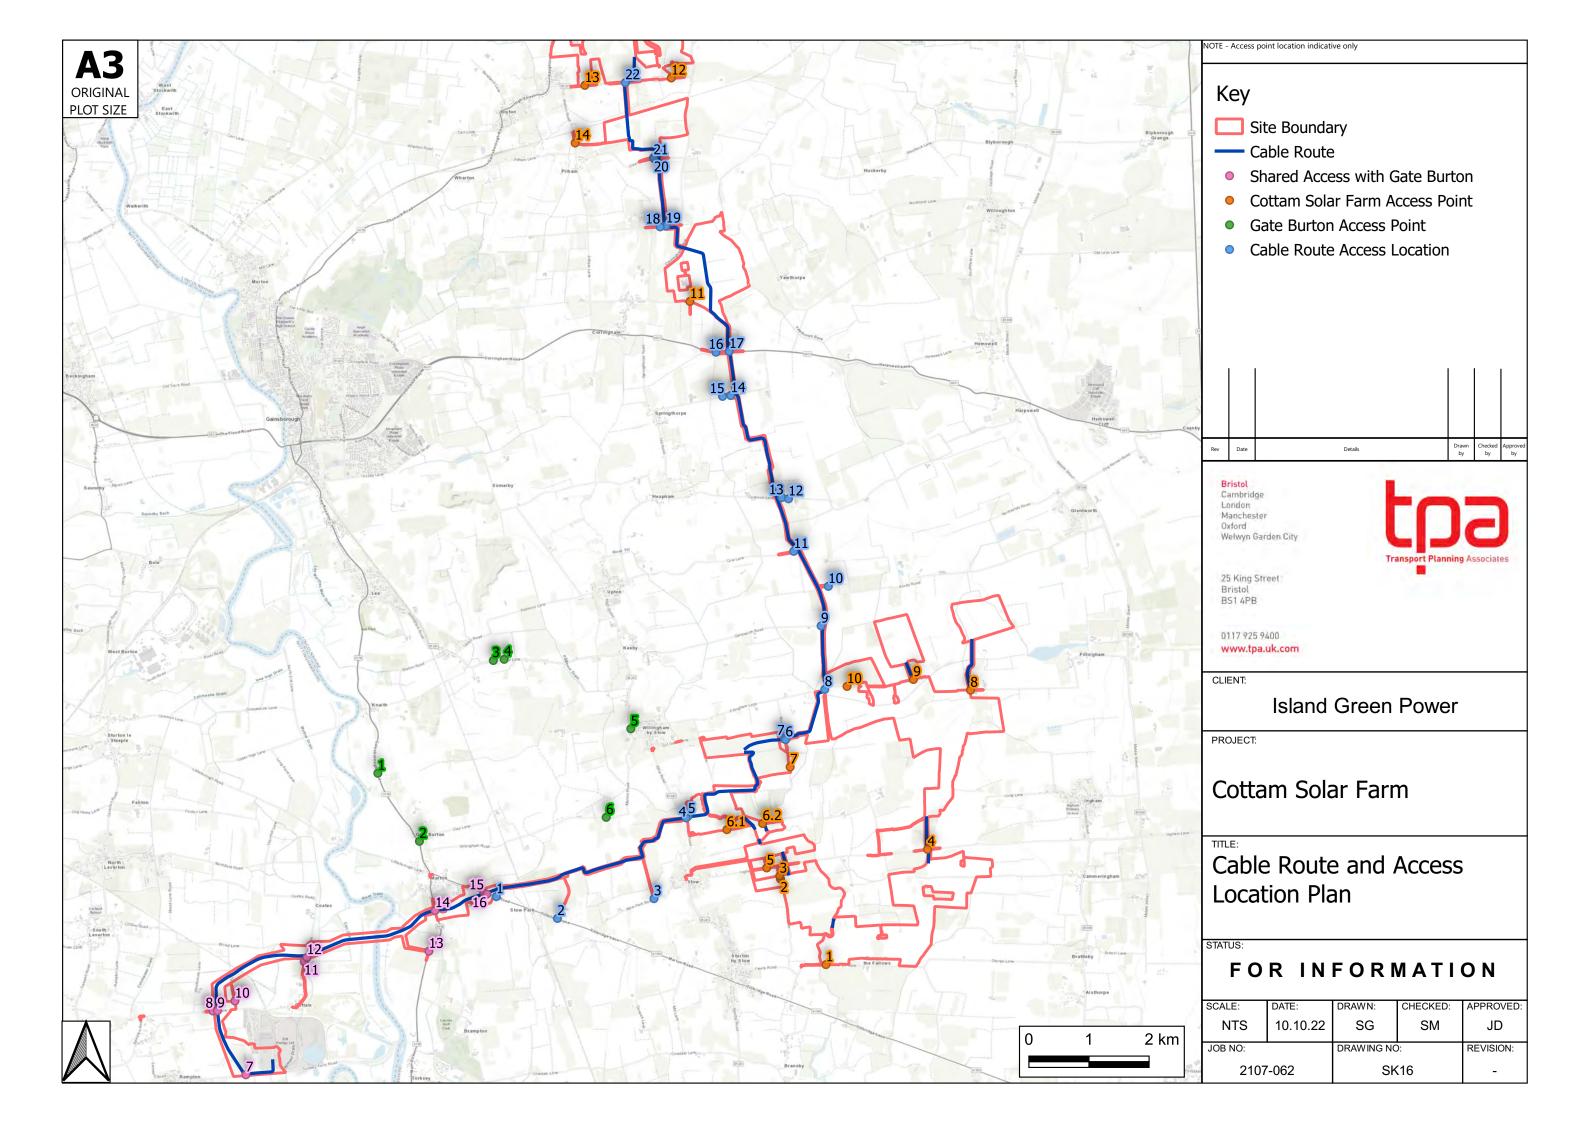
Review of possible cable drum AlL access points for Cottam Solar Farm

- 5.10. The sites highlighted in Red are advised as not negotiable without major remedial works but temporary access solutions for AILs are proposed to be via the internal haul roads within the cable route corridor.

- 5.11. The sites highlighted in Orange are expected to be accessible with remedial works in the public highway. In the event that any of the other SPAs identify that third party land is in fact needed, and third party land access can not be agreed then there are further remedial actions that are feasible including the use of smaller sections of cable and thus smaller cable drums and delivery vehicles. Therefore although there are some issues to confirm, access to the sites detailed is considered feasible in principle.
