Cottam Solar Project

Environmental Statement Appendix 14.1: Transport Assessment Revision BA

Prepared by: Transport Planning Associates

Transport Assessment

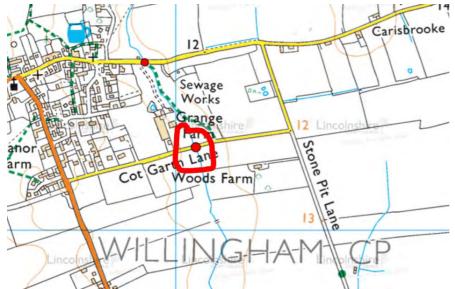
Cot Garth Bridge -88/84/02 – 30HB 11m span - on route to Cottam 1near Willingham by Stowe

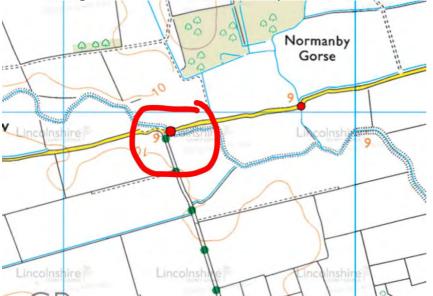
Coates Bridge - 88/92/39 - 30HB 12.5m span - on alt route to Cottam 1 south of site north east of Stowe

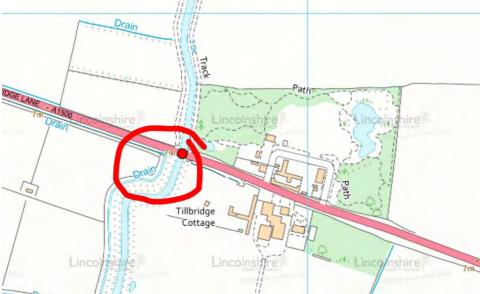
Till Bridge - 97/09/77 - 38HB 9.25m span - A1500 on approach to Sturton by Stow

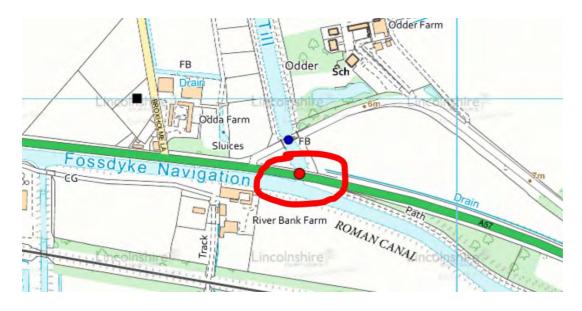
Odder Bridge – 97/14/78 – 45HB 8.75m span – On A57 near Saxilby on route to West Burton 2 site (<u>I don't anticipate this structure being an issue with it being on the A57</u>)

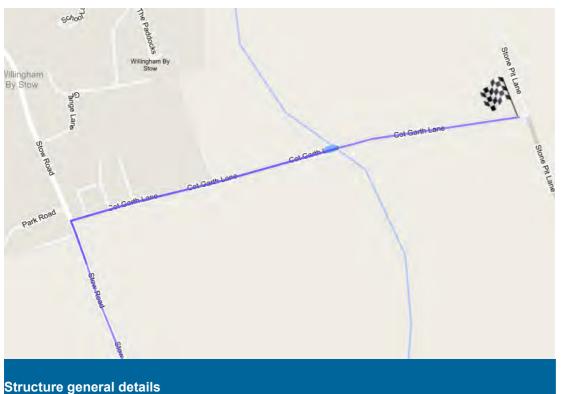
ESRN : S-SK880842-1

Route Ref COT1 1 to Cottam 1. You are quite correct to highlight that Cot Garth Lane is limited physically. However, I do think that there is a structure on this section. See below ESDAL extract showing Cot Garth Lane Bridge ID 88/84/02.

Name : Cot Garth Lane Bridge

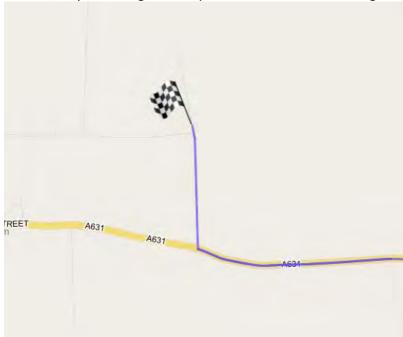
Approach to Cottam 2. Load moves away from camera. Note culvert under road on both sides.

ESDAL does not show the structures here, see screenshot below. I guess this may either be because it is less than 1.5m or, maybe it is regarded as private to the farm or drainage? Are you able to advise please.

It is noted that there are 2 culverts under the junction at the approach to Corringham Grange Farm. These culverts do not show on the ESDAL AIL notification system. Confirmation of ownership and suitability has been sought from Lincolnshire County Council and advice is there are 2 bridges, one is a brick arch (1.3m span width) and another is a corrugated steel pipe (800mm span width), both owned by Lincolnshire County Council who do not have any assessment data on either detailing the weight limits of the bridges. An assessment would be required to determine the weight capacities and suitability for proposed loads.

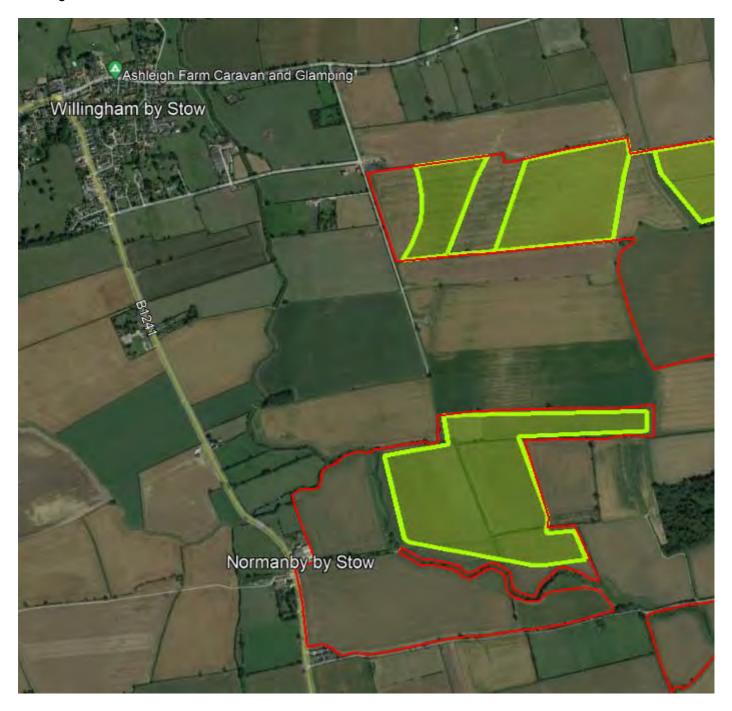
Our initial thoughts are that the easiest way to access this site will be to develop access west from the A15 heavy load route which is used for heavy loads from Sheffield and Worksop areas to the Port of Immingham. I attach typical loaded trailers for info as well. These are 2 frame trailers for 157te nett transformer loads plus a flattop which I would like to see if we could look at on the high load route from Immingham and also a 5bed5 trailer for the smaller STGO loads for other sites.
