Cottam Solar Project

Environmental Statement Appendix 14.1: Transport Assessment Revision C

Prepared by: Transport Planning Associates February 2024

Transport Assessment

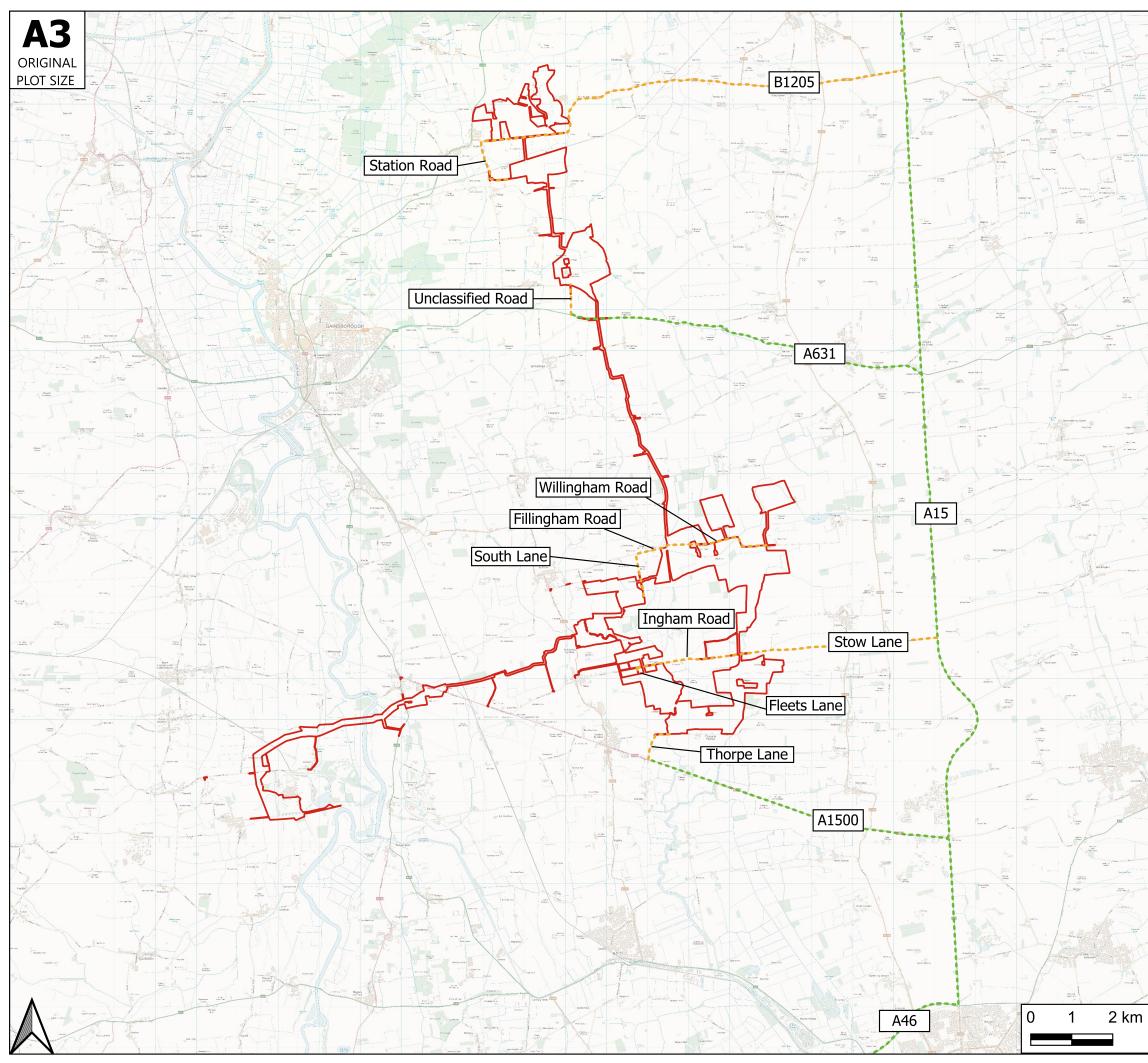
Reproc	luced in	JIII				
Key Site Boundary Highway Network Links Strategic Highway Network and A-Roads						
		ocal Highwa	-			
Rev	Date		Details		awn Checked Approved by by by	
C: Li O:	<mark>ristol</mark> ambrid ondon xford /elwyn (ge Garden City			6	
В	5 King ristol S1 4PE				Associates	
-	117 925 / ww.t p	5 9400 ba.uk.com				
	ENT: Otta	am Solar	[.] Projec	cts Lim	ited	
PRO	OJECT					
Cottam Solar Project						
тіті	LE:					
Highway Network						
FOR INFORMATION						
SCAL	_E:	DATE:	DRAWN:	CHECKED:	APPROVED:	
N	ITS	23/01/24	AC	RR	JD	
JOB			DRAWING NO		REVISION:	
	21	07-062	Figu	re 2.1	-

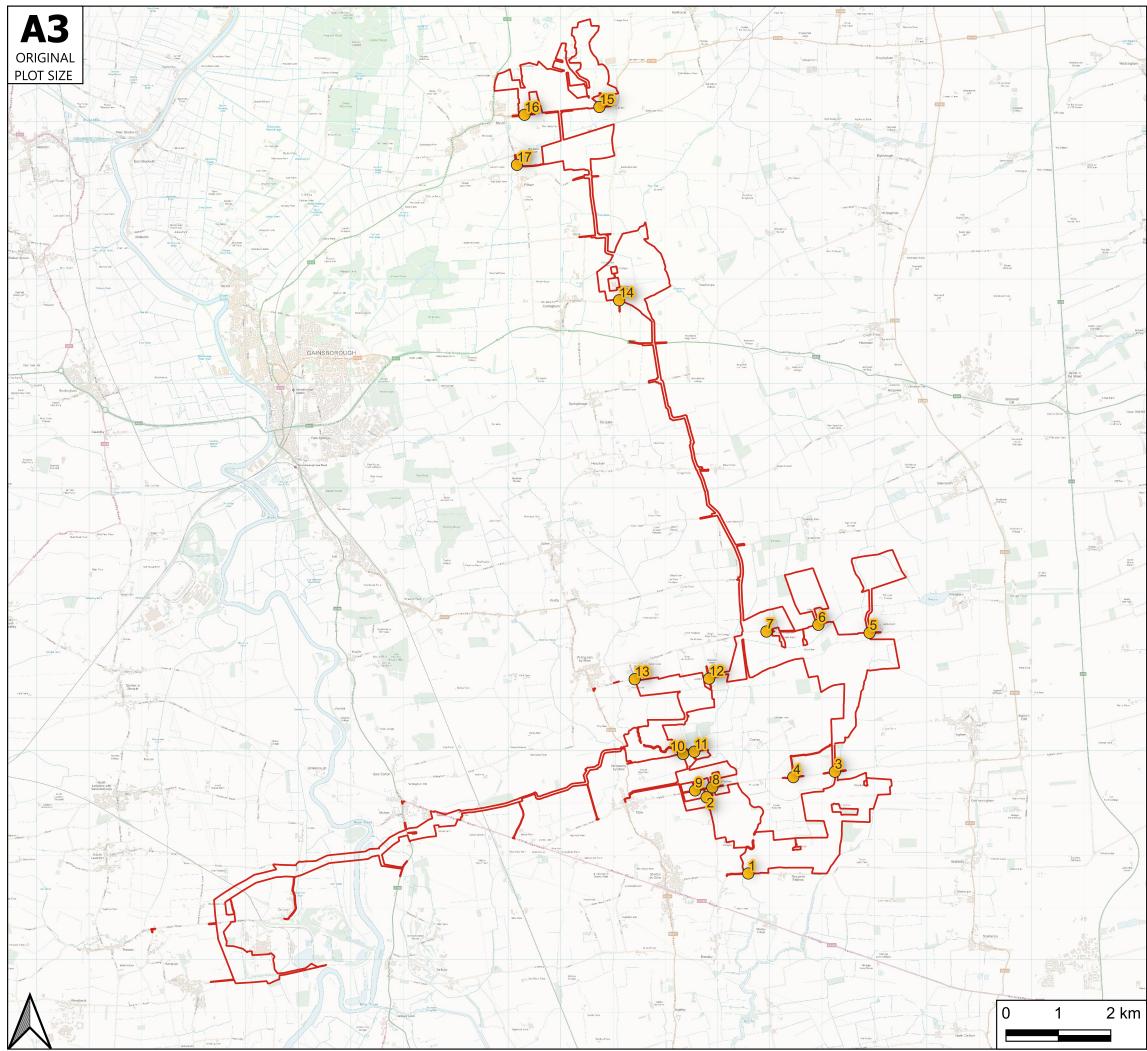
Reproc	luced fro	om				
		te Bound ottam Sol	•	Access Loca	ations	
Rev	Date		Details	Dra	wn Checked Approved by by by	
	5 King S ristol S1 4PB 117 925	Barden City Street		L D Transport Plannin	B Associates	
С	otta		ar Proje	ects Limi	ited	
Cottam Solar Project						
Access Locations - Cottam 1, 2 and 3						
FOR INFORMATION						
	ITS	DATE: 23/01/24		CHECKED: RR	APPROVED:	
JOB		07-062	DRAWING F	^{NO:} ure 4.1	REVISION: -

- 4.17 During construction, the Scheme will be accessed via the creation of temporary access junctions to the Solar Farm Sites (Cottam 1, 2, 3a and 3b) and the cable corridor. All accesses will be taken from the public highway. Where possible, existing agricultural accesses will be utilised. These will be widened and formalised as appropriate. Visibility splays will be kept clear.
- 4.18 Some of the accesses will be retained for use by maintenance vehicles, once the Scheme is operational. The remainder will be returned to their original condition.
- 4.19 A description of each access is described below.

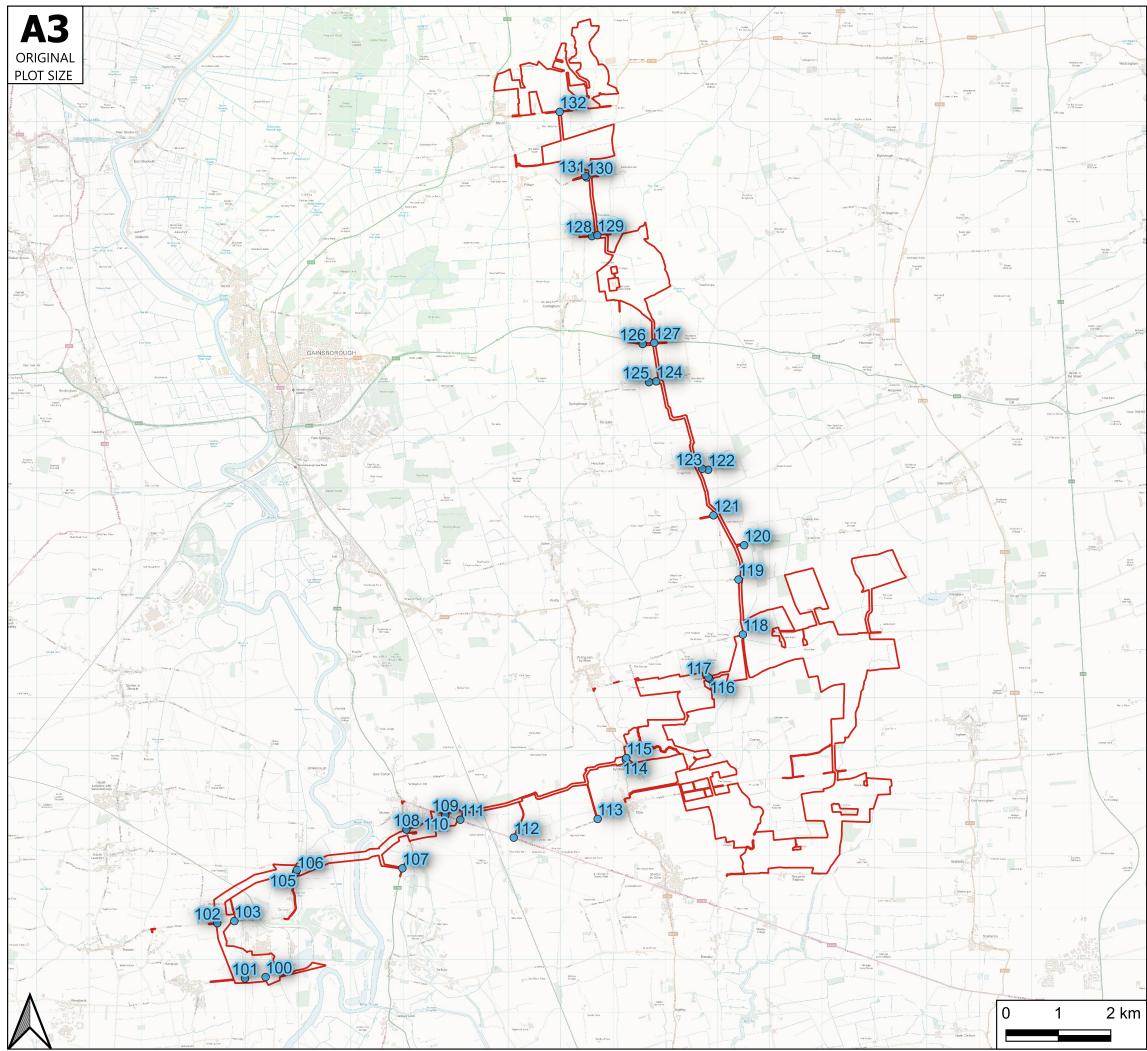
Reprod	Reproduced from						
Ke] Si	ite Bounda able Route	-	ocations			
Rev	Date		Details	Drav b			
C: Lc 0: W 2! B B B	5 King ristol S1 4PE	Garden City Street 3	Tra	ansport Planning	Associates		
CLIENT: Cottam Solar Projects Limited PROJECT: Cottam Solar Project							
TITLE: Access Locations - Cable Route Corridor STATUS: FOR INFORMATION							
SCALE: DATE: DRAWN: CHECKED: APPROVED: NTS 23/01/24 AC RR JD JOB NO: DRAWING NO: REVISION: 2107-062 Figure 4.2 -

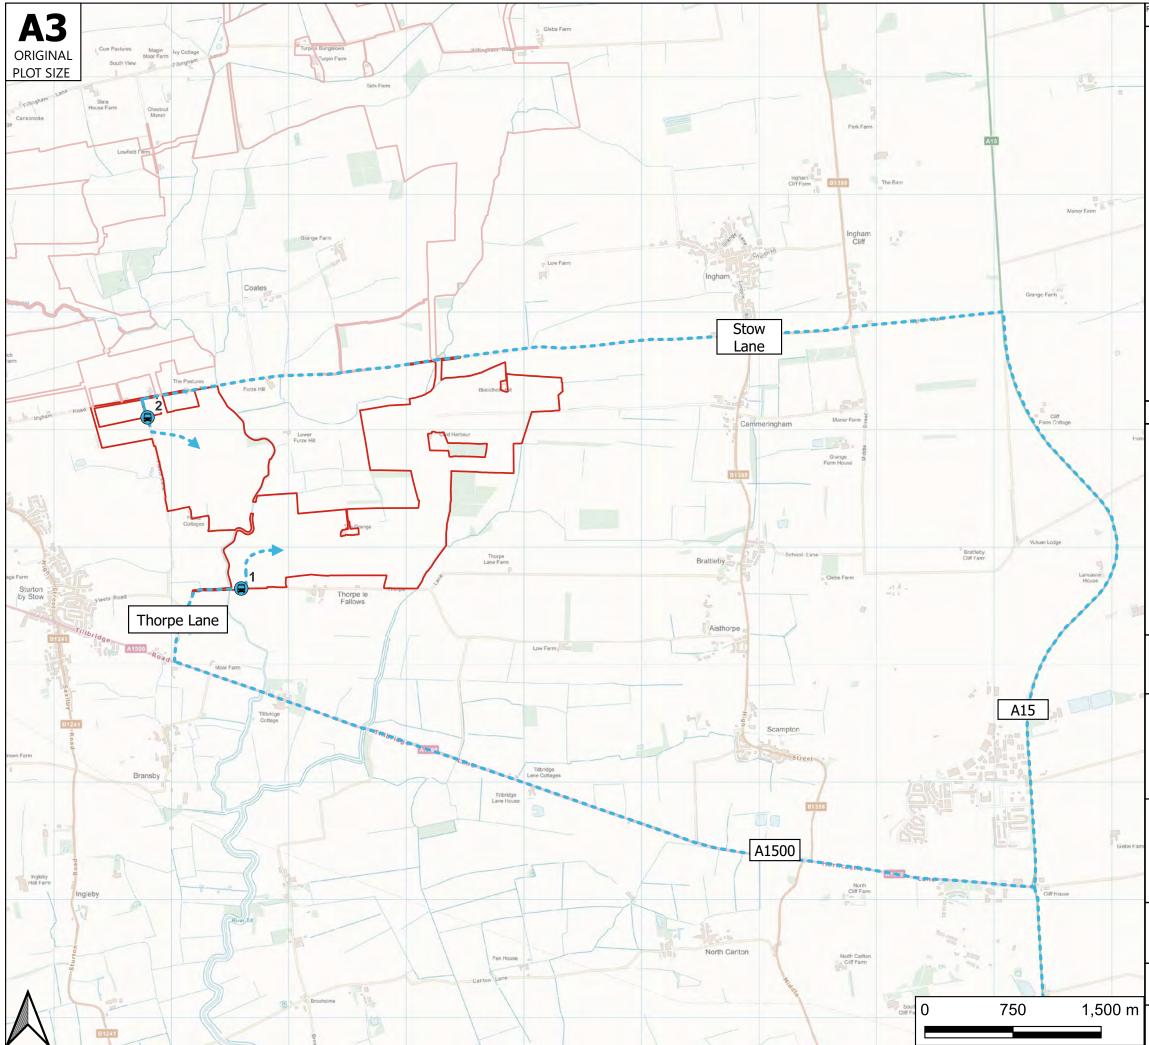
Reproduced from						
Key Site Bour Construc Site Acce	tion	Traffic R	oute			
Rev Date		Details	Drive	awn Checked Approved		
Bristol Cambridge London Manchester Oxford Wetwyn Garden City		l		3		
25 King Street Bristol BS1 4PB						
0117 925 9400 www.tpa.uk.com						
CLIENT: Cottam Sc	lar	Projec	ts Limi	ted		
PROJECT: Cottam Solar Project						
Construction Vehicle Route - Cottam 1 South						
FOR INFORMATION						
SCALE: DATE: NTS 14/12	/22	DRAWN: AC	CHECKED: RR	APPROVED:		
INTS I4/12/22 AC RR JD JOB NO: DRAWING NO: REVISION: 2107-062 Figure 6.1 -

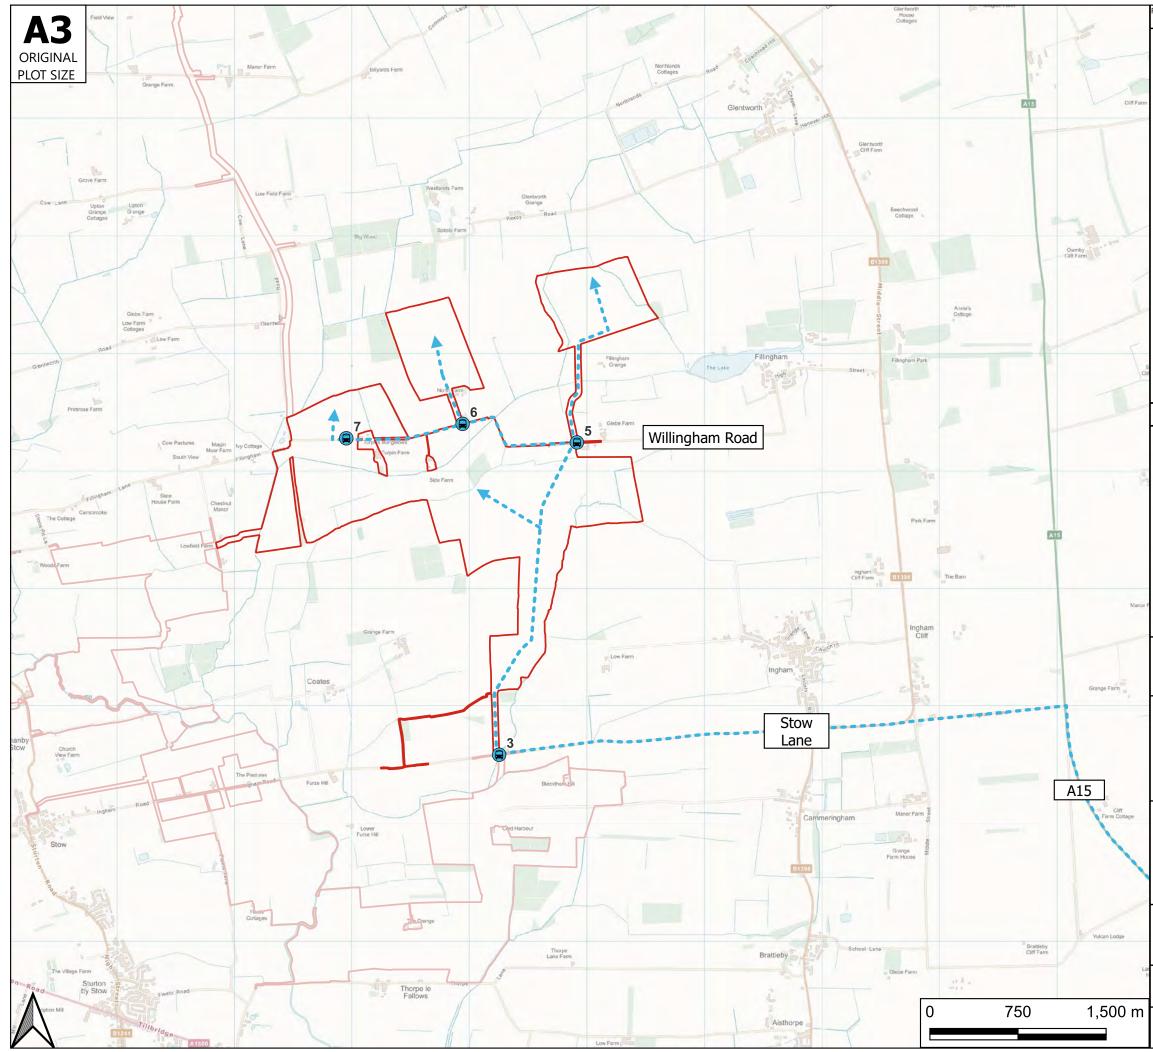
Reproduced from							
Key Site Bound Constructi	on Traf	-	oute				
Rev Date	Details		Dra				
Bristol Cambridge London Manchester Oxford Welwyn Garden City		l		6			
25 King Street Bristol BS1 4PB							
0117 925 9400 www.tpa.uk.com CLIENT:							
Cottam Sol	ar Pro	ojec	ts Limi	ted			
PROJECT:	olar F	Proj	ect				
TITLE: Construction Vehicle Route - Cottam 1 North							
FOR I	N F O	R	NATI	ΟΝ			
SCALE: DATE: NTS 14/12/2		C	CHECKED: RR	APPROVED:			
JOB NO: 2107-062	DRAW	Figui	b: re 6.2	REVISION: -

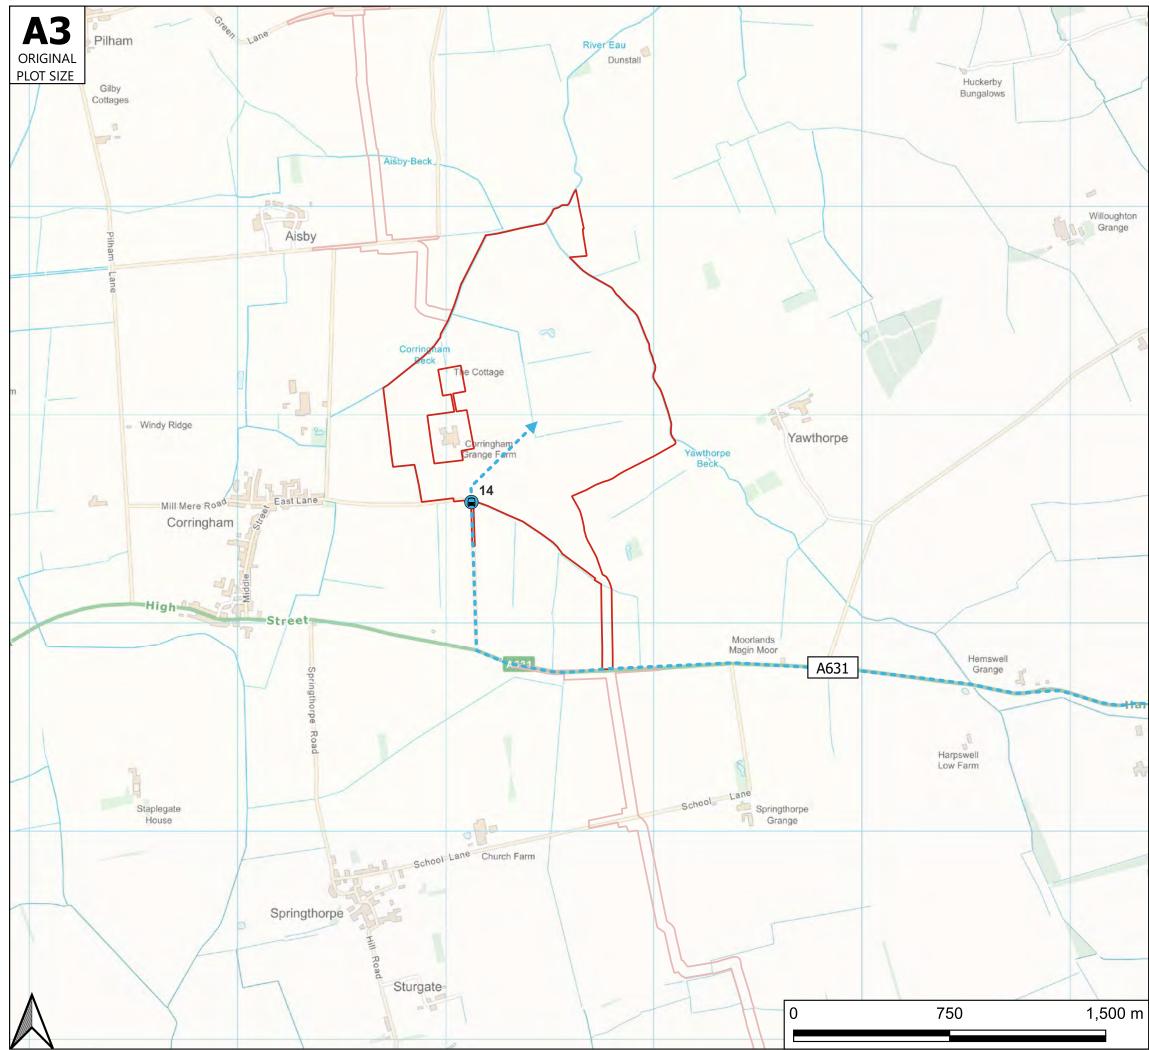
Reproduced from								
Key Site Bounda Construction Site Access	n Traffic R	oute						
Rev Date	Details	Dra						
Bristol Cambridge London Manchester Oxford Welwyn Garden City	I	בו ח	3					
25 King Street Bristol BS1 4PB		ansport Planning	Associates					
0117 925 9400 www.tpa.uk.com								
CLIENT: Cottam Solar	r Projec	ts Limi	ted					
PROJECT: Cottam Sol	ar Proj	ect						
Construction Vehicle Route - Cottam 2								
FOR IN	FORM	ITAN	O N					
SCALE: DATE: NTS 14/12/22	DRAWN: AC	CHECKED: RR	APPROVED:					
JOB NO: 2107-062	DRAWING NO Figur	re 6.4	REVISION: -

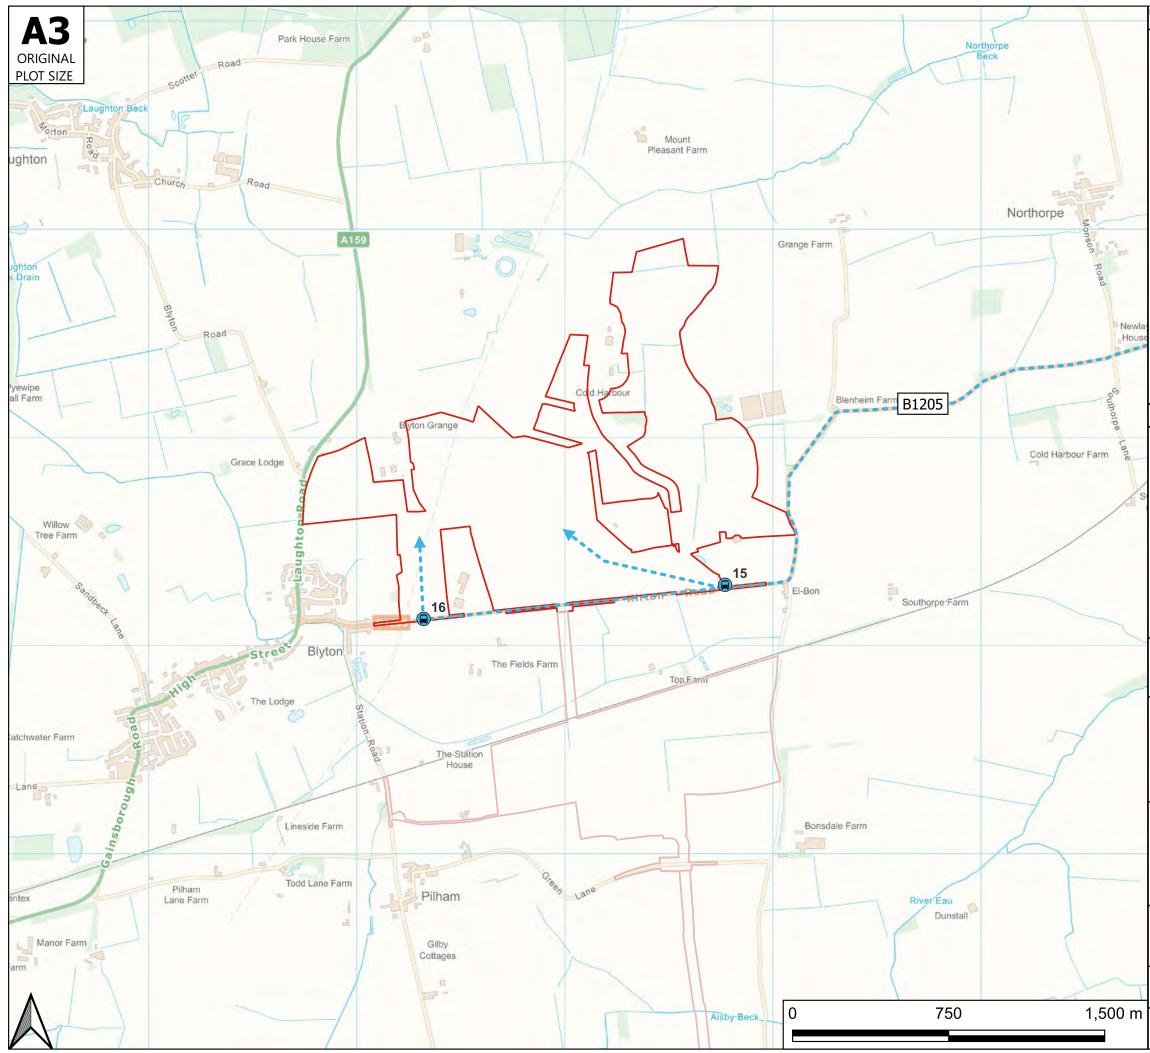
Reproduced from								
>Cons		y Traffic R .ocations	oute					
Rev Date		Details	Draby					
Bristol Cambridge London Manchester Oxford Welwyn Garde	n City	I		Basociates				
25 King Stree Bristol BS1 4PB	t.							
0117 925 9400 www.tpa.uk								
CLIENT: Cottam	Solar	Projec	ts Limi	ted				
PROJECT: Cottar	n Sola	ar Proj	ect					
Construction Vehicle Route - Cottam 3A								
status: F O F	RIN		ΙΤΑΝ					
NTS	DATE: 14/12/22	DRAWN: AC	CHECKED: RR	APPROVED: JD				
JOB NO: 2107-(062	DRAWING NO Figur	e 6.5	REVISION: -

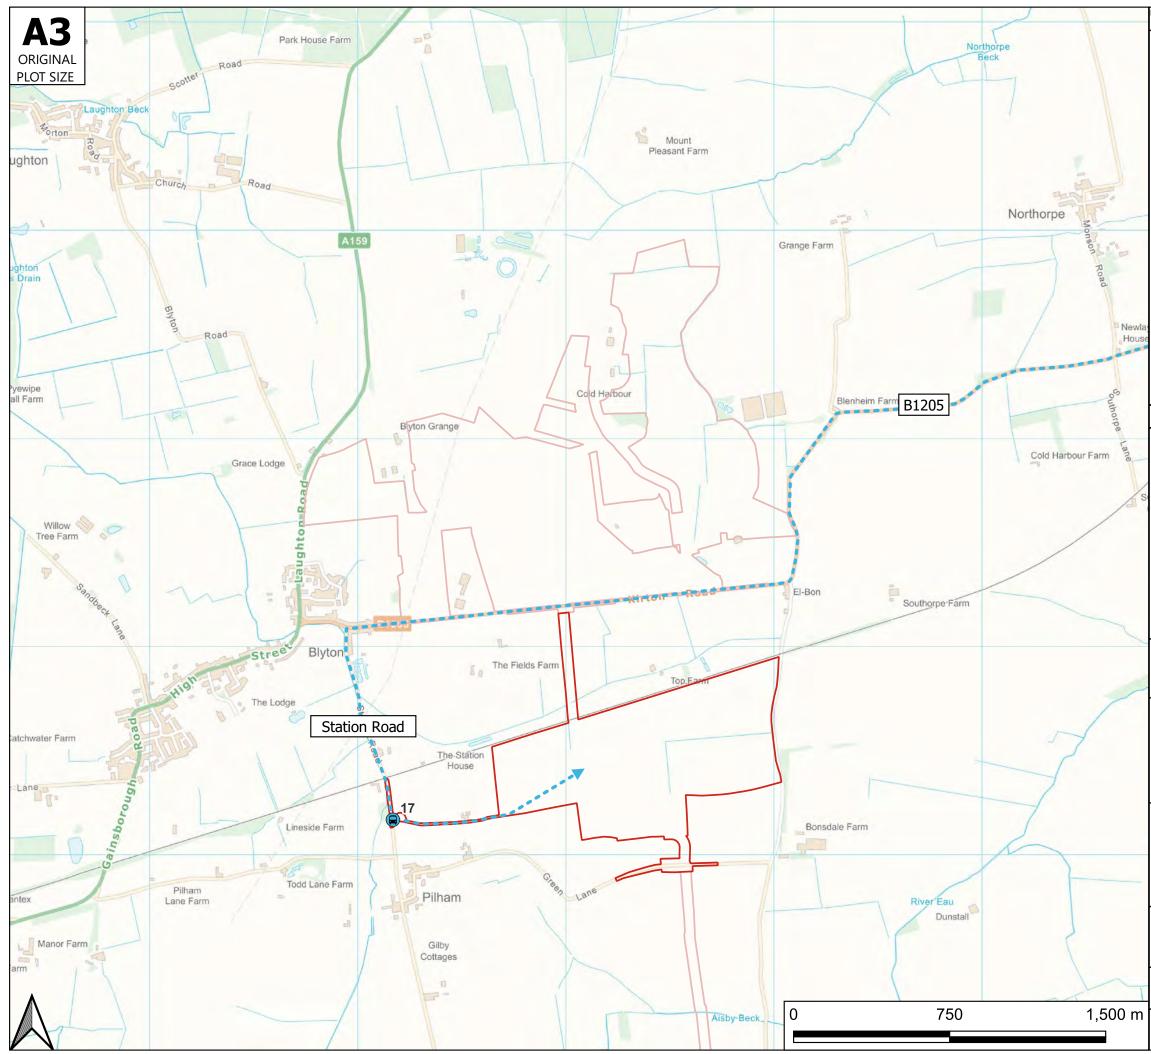
Reproduced from			
Key Site Bounda Construction Site Access	n Traffic R	oute	
Rev Date	Details	Dra br	
Bristol Cambridge London Manchester Oxford Welwyn Garden City	Tr		Jassociates
25 King Street Bristol BS1 4PB		211	
0117 925 9400 www.tpa.uk.com CLIENT:			
Cottam Sola	r Projec	ts Limi	ted
Cottam Sol	ar Proj	ect	
Construction Cottam 3B	on Vehi	cle Ro	ute -
FOR IN	FOR	NATI	ΟΝ
SCALE: DATE: NTS 14/12/22		CHECKED: RR	APPROVED: JD
JOB NO: 2107-062	DRAWING NO Figui	o: re 6.6	REVISION: -

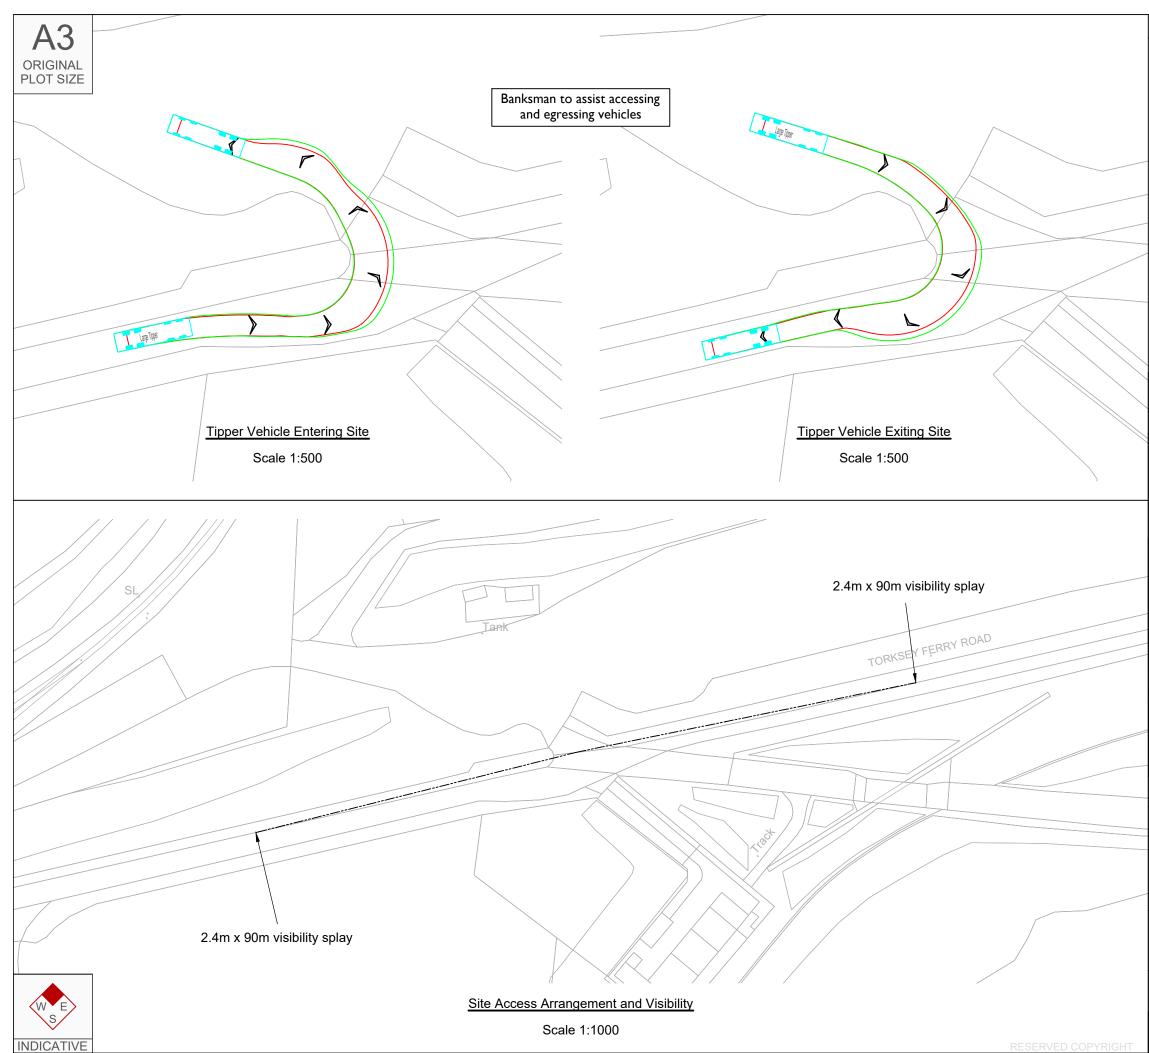
om Ordnance Survey S Stationery Office. Cro					ler of
	NOTES:							
	1. The existing posted speed limit on Torksey Ferry Road is 30mph							
	2. OS base to be confirmed with topographical survey

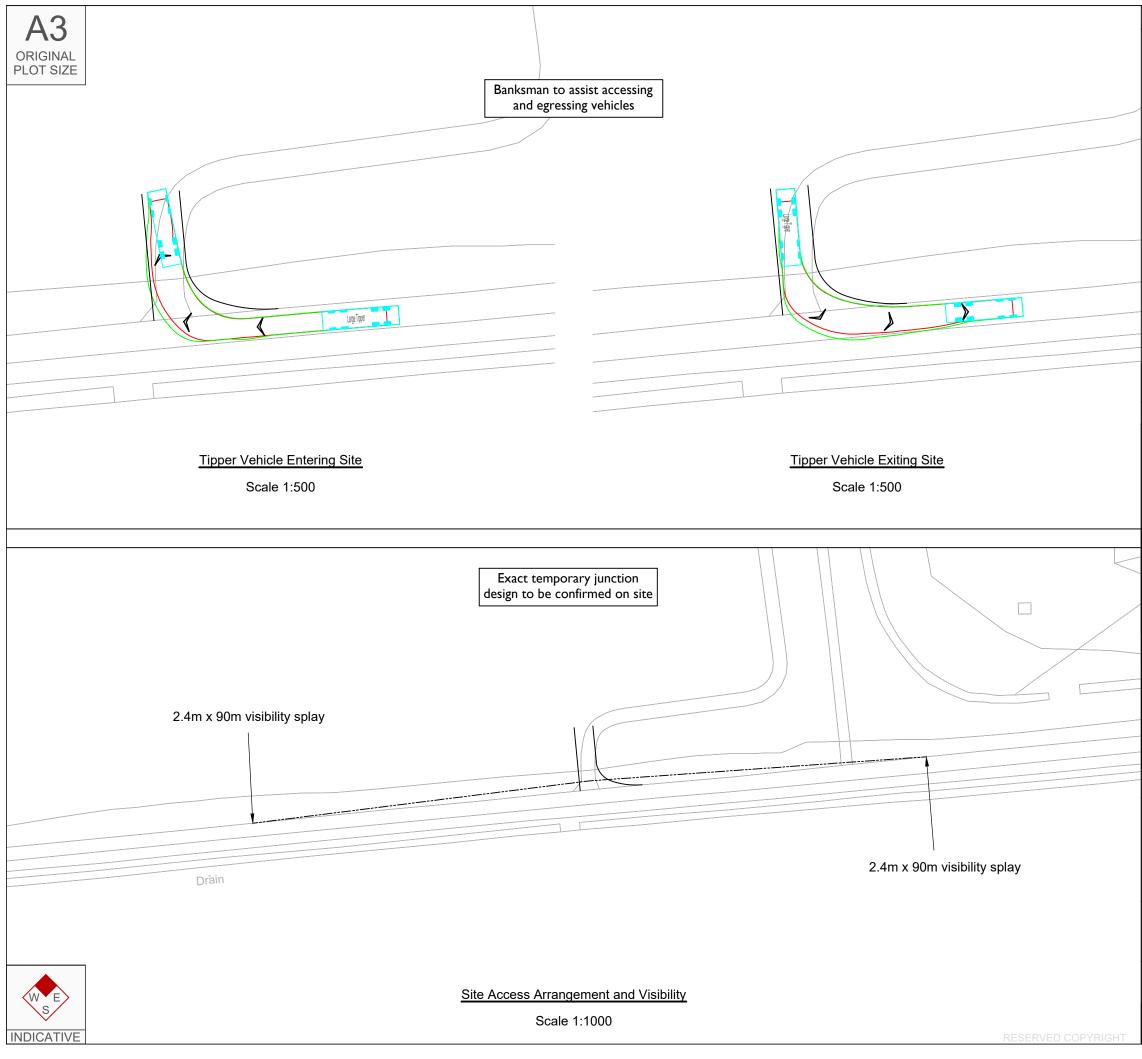
Stationery Office. Cro				
NOTES:					
1. The existi	ng posted speed li	imit on Torksey	Ferry Road is 3	30mph	
2. OS base	to be confirmed wi	ith topographica	l survey		
3. Highway I	boundary to be co	nfirmed			
3. mgiiway i	10.201 10.201	9-69- 1.524	10.201m 2.495m 0.341m 2.471m 6.00s 11.550m		
A 07.12.23	Access handed to sh	now vehicle driving to/fr	rom the east.	SW RR JD	
Rev Date		Details		awn Checked Approved by	
Bristol Cambridge London Oxford Welwyn Garden City 25 King Street Bristol BS1 4PB 0117 925 9400 www.tpa.uk.com					
	AM SOLA	AR PRO	JECT L	IMITED	
COTTAM SOLAR FARM					
Cable Route Access Point 01					
INFORMATION					
SCALE: As Show	DATE: 18.10.22	DRAWN: SG	CHECKED:	APPROVED:	
JOB NO: DRAWING NO: REVISION 2107-062 SK 101 A				REVISION: A

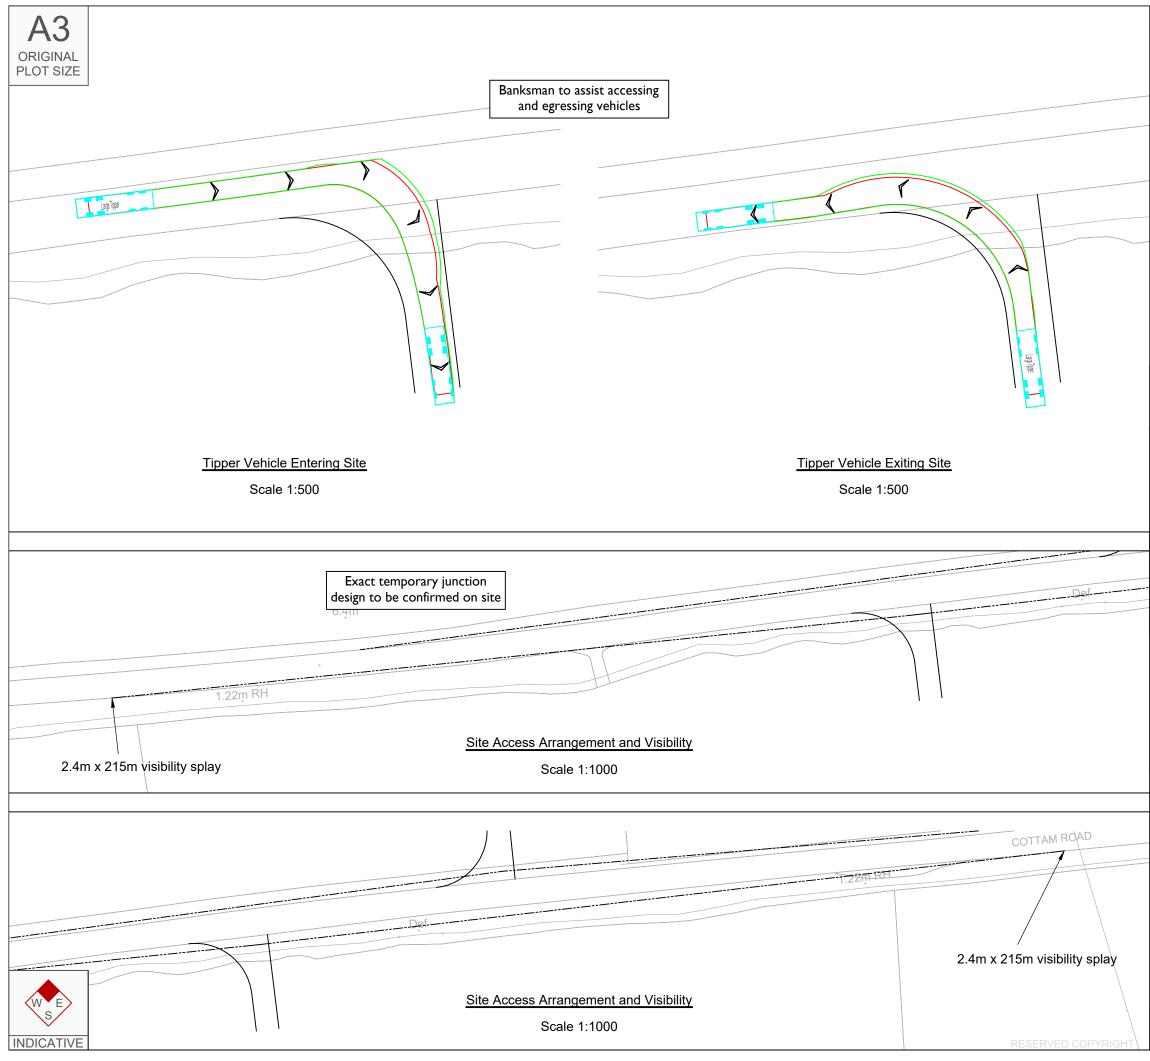
Reproduced from Ordnance Survey Her Majesty's Stationery Office. Cro				oller of	
NOTES:					
1. The existing posted speed I (60mph)	imit on Cottam I	Road is Nation	al Speed I	_imit

2. OS base to be confirmed w	ith topographica	Il survey			
3. Highway boundary to be confirmed					
Large Tipper Overall Length Overall Width Overall Width Overall Body Height Track Width Lock to lock time Kerb to Kerb Turning		10.201m 2.495m 2.890m 0.341m 2.471m 6.00s 11.550m			
A 21.07.23 Access relocated to al	ign with Gate Burton a	ccess location. P	2SW RR	JD	
Rev Date	Details		rawn Checked by by	Approved by	
Bristol Cambridge London Manchester Oxford Welwyn Garden City 25 King Street Bristol BS1 4PB 0117 925 9400 www.tpa.uk.com	Tra	ansport Plannin	g Associat	es	
	AR PRO	JECT L	IMIT	ED	
COTTAM S	OLAR	FAR	M		
Cable Rout	e Acce	ess Po	oint ()2	
	RMA	ATIC	JN	J	
SCALE: DATE: As Shown 18.10.22	DRAWN: SG	CHECKED: SM	APPRO		
JOB NO: DRAWING NO: REVISIO 2107-062 SK 102 A			-

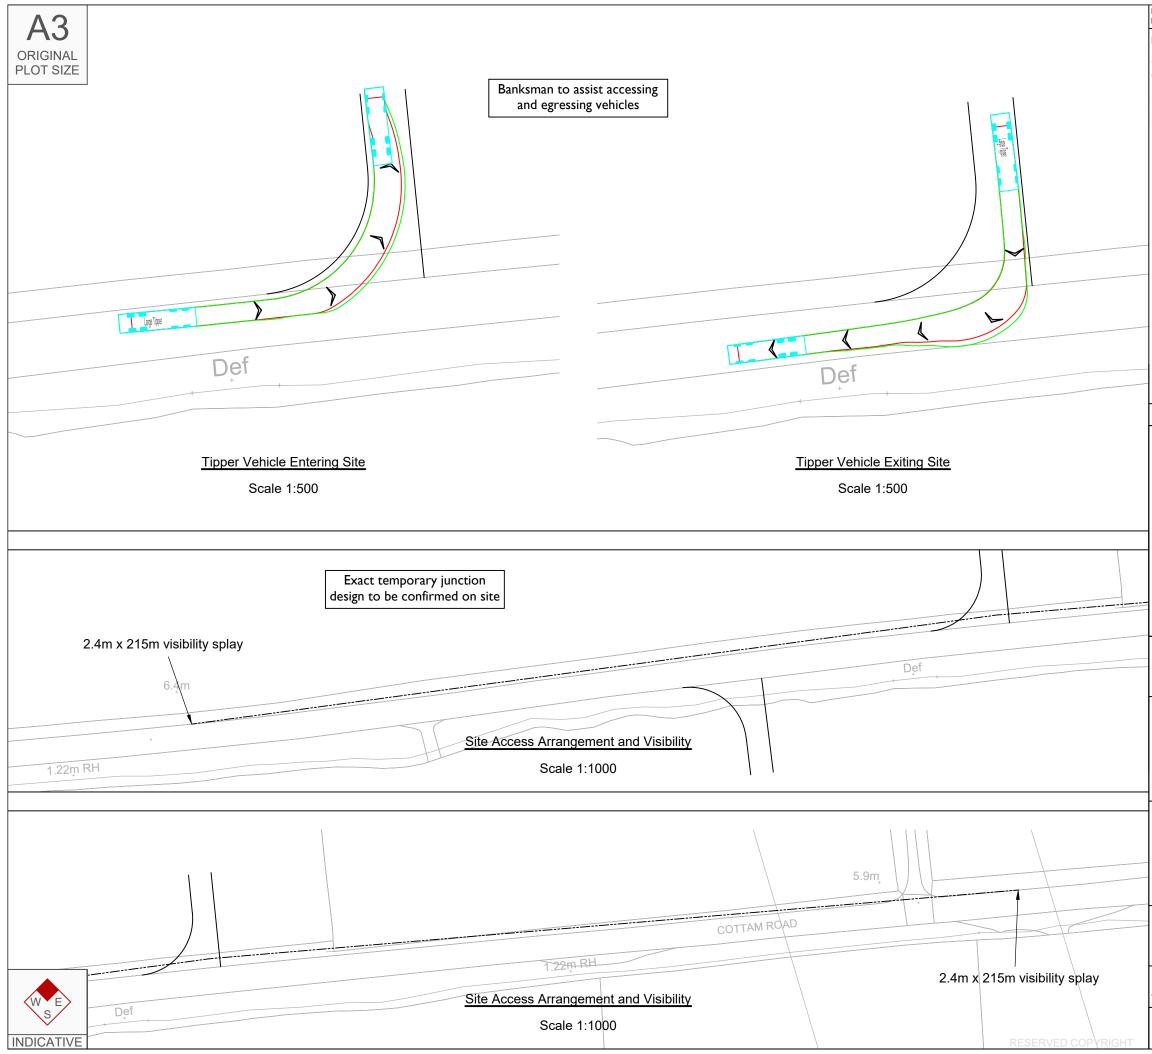
Reproduced from Ordnance Survey S Her Majesty's Stationery Office. Cro					
NOTES:					
1. The existing posted speed I (60mph)	imit on Cottam I	Road is Nationa	al Speed Limit

2. OS base to be confirmed w	ith topographica	ll survey			
3. Highway boundary to be co	nfirmed				
Large Tipper Overall Length Overall Body Height Min Body Ground Cle Track Width Lock to lock time Kerb to Kerb Turning		10.201m 2.495m 0.341m 0.341m 6.00s 11.550m			
A 21.07.23 Access relocated to al	ign with Gate Burton a	ccess location. P	SW RR JD		
Rev Date	Details		awn Checked Approved by by		
Bristol Cambridge London Manchester Oxford Welwyn Garden City 25 King Street Bristol BS1 4PB 0117 925 9400 www.tpa.uk.com	Tra	ansport Plannin	Associates		
CLIENT:	AR PRO	JECT L	IMITED		
COTTAM S	OLAR	FAR	Л		
Cable Route	e Acce	ess Po	int 03		
STATUS: INFORMATION					
SCALE: DATE: As Shown 18.10.22	DRAWN: SG	CHECKED: SM	APPROVED:		
			REVISION:

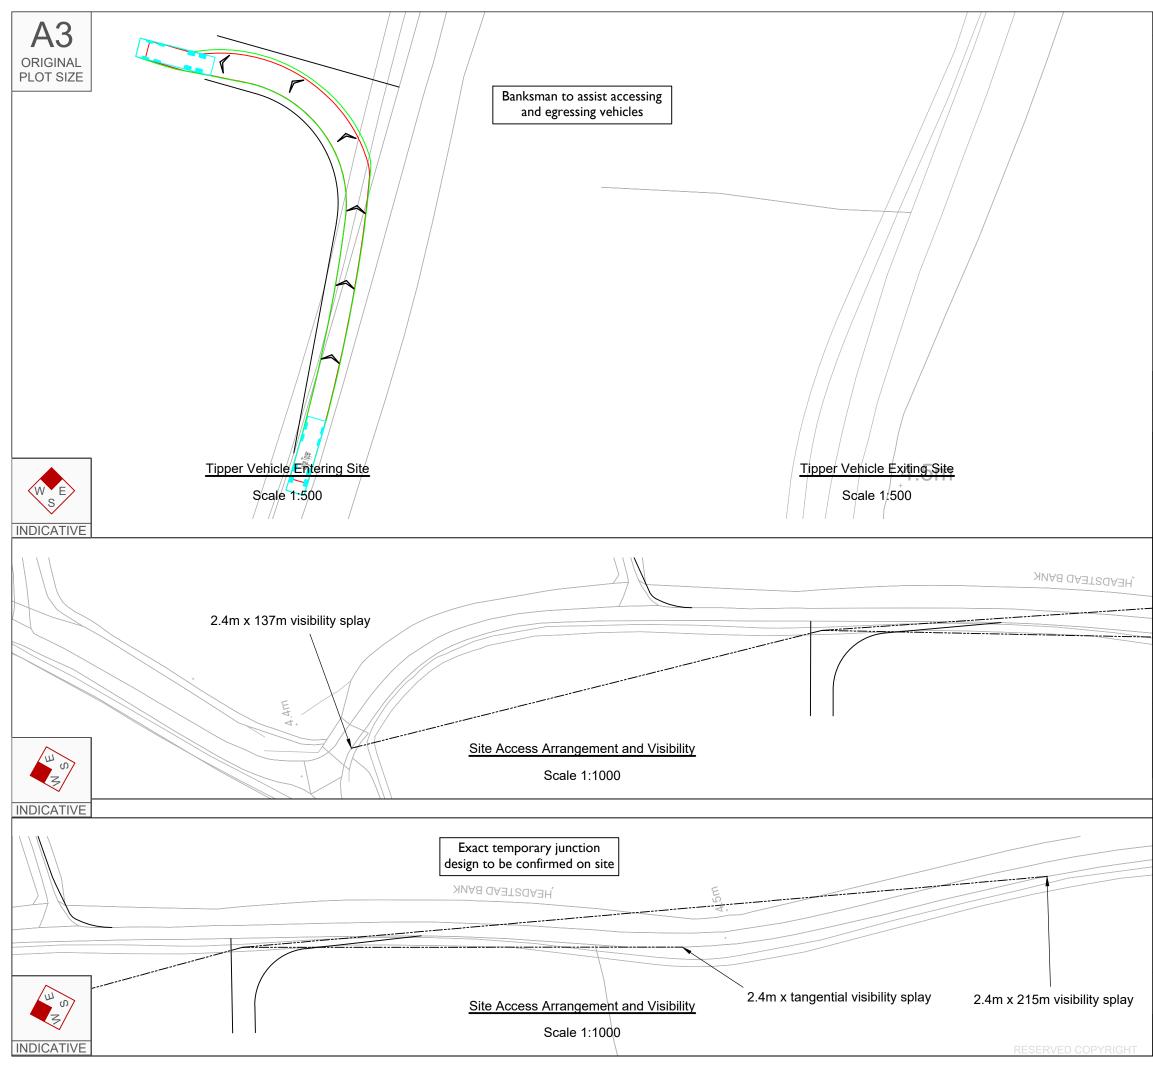
Reproduced from Ordnance Survey S Her Majesty's Stationery Office. Crow				
NOTES:				
1. The existing posted speed li Limit (60mph)	imit on Headste	ad Bank is Nati	onal Speed

2. OS base to be confirmed wi	ith topographica	l survey		
3. Highway boundary to be co	nfirmed			
Large Tipper Overall Length Overall Body Height Min Body Ground Cle Track Width Lock to lock time Kerb to Kerb Turning		10.201m 2.495m 0.341m 0.341m 6.00s 11.550m		
A 20.07.23 Access relocated to all	ign with Gate Burton a	ccess location. PS	SW RR JD	
Rev Date	Details		awn Checked Approved	
Bristol Cambridge London Manchester Oxford Welwyn Garden City 25 King Street Bristol BS1 4PB 0117 925 9400 www.tpa.uk.com	Tra	ansport Planning	Associates	
CLIENT:	AR PRO	JECT L	IMITED	
COTTAM SOLAR FARM				
TITLE: Cable Route Access Point 05				
INFORMATION				
SCALE: DATE: As Shown 18.10.22	DRAWN:	CHECKED: SM	APPROVED:	
JOB NO: DRAWING NO: REVISION: 2107-062 SK 105 A

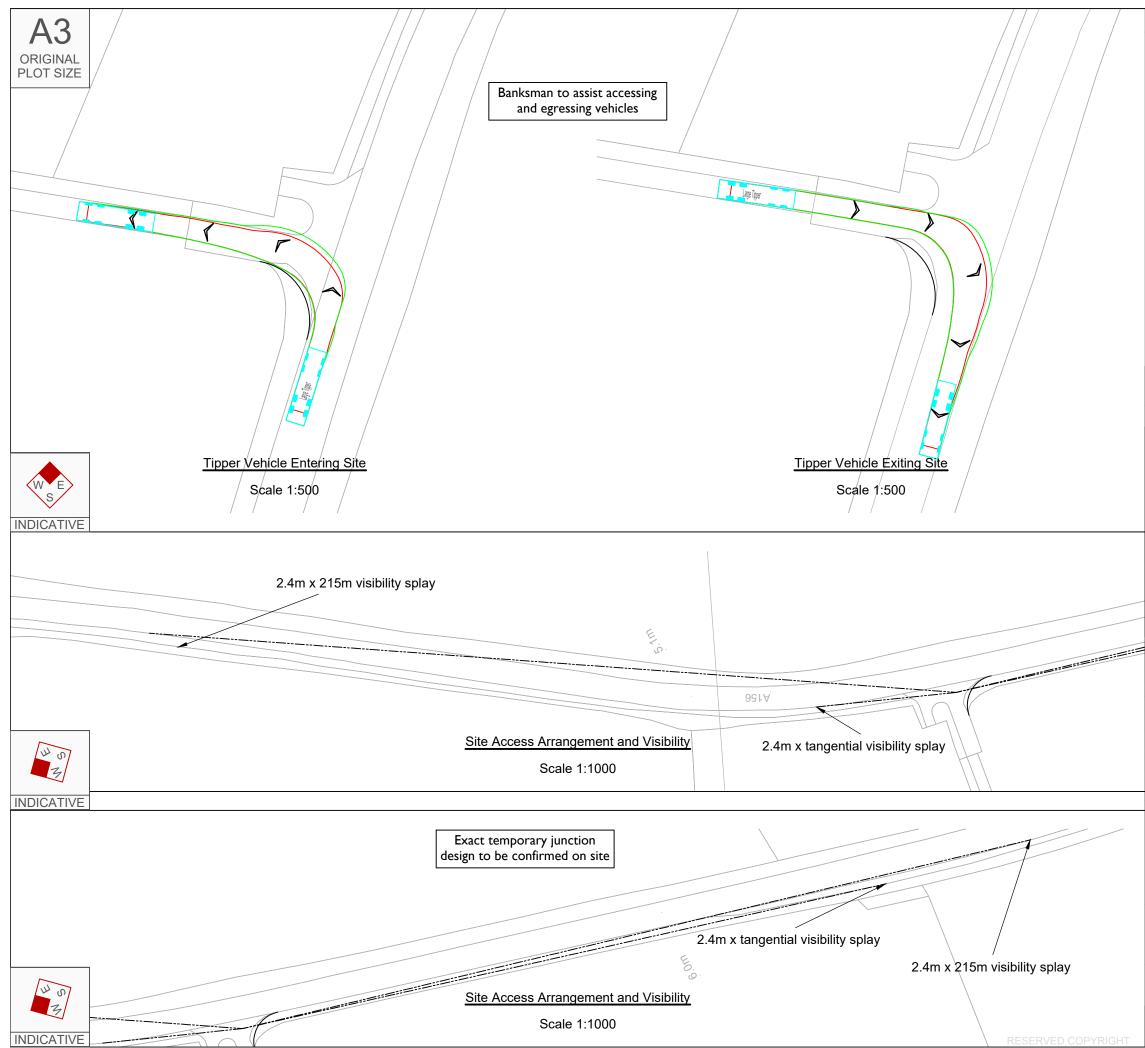
Reproduced from Ordnance Survey Her Majesty's Stationery Office. Cro				
NOTES:				
1. The existing posted speed	limit on A156 is	National Speed	Limit (60mph)	
2. OS base to be confirmed w	ith topographica	I survey		
3. Highway boundary to be co	onfirmed			
Large Tipper Overall Length Overall Width Overall Body Height Min Body Ground Cl Track Width Lock to lock time Kerb to Kerb Turning	earance	10.201m 2.495m 2.890m 0.341m 2.471m 6.00s 11.550m		
	-			
Rev Date	Details	Dra b		
Bristol Cambridge London Manchester Oxford Welwyn Garden City 25 King Street Bristol BS1 4PB 0117 925 9400 www.tpa.uk.com	Tra	ansport Planning	Associates	
COTTAM SOL	AR PRO	JECT L	IMITED	
PROJECT: COTTAM SOLAR FARM				
Cable Route Access Point 07				
STATUS: INFORMATION				
SCALE: DATE: As Shown 18.10.22	DRAWN: SG	CHECKED: SM	APPROVED: JD	
JOB NO:	DRAWING NO):	REVISION:	
2107-062	SK 1	107	-

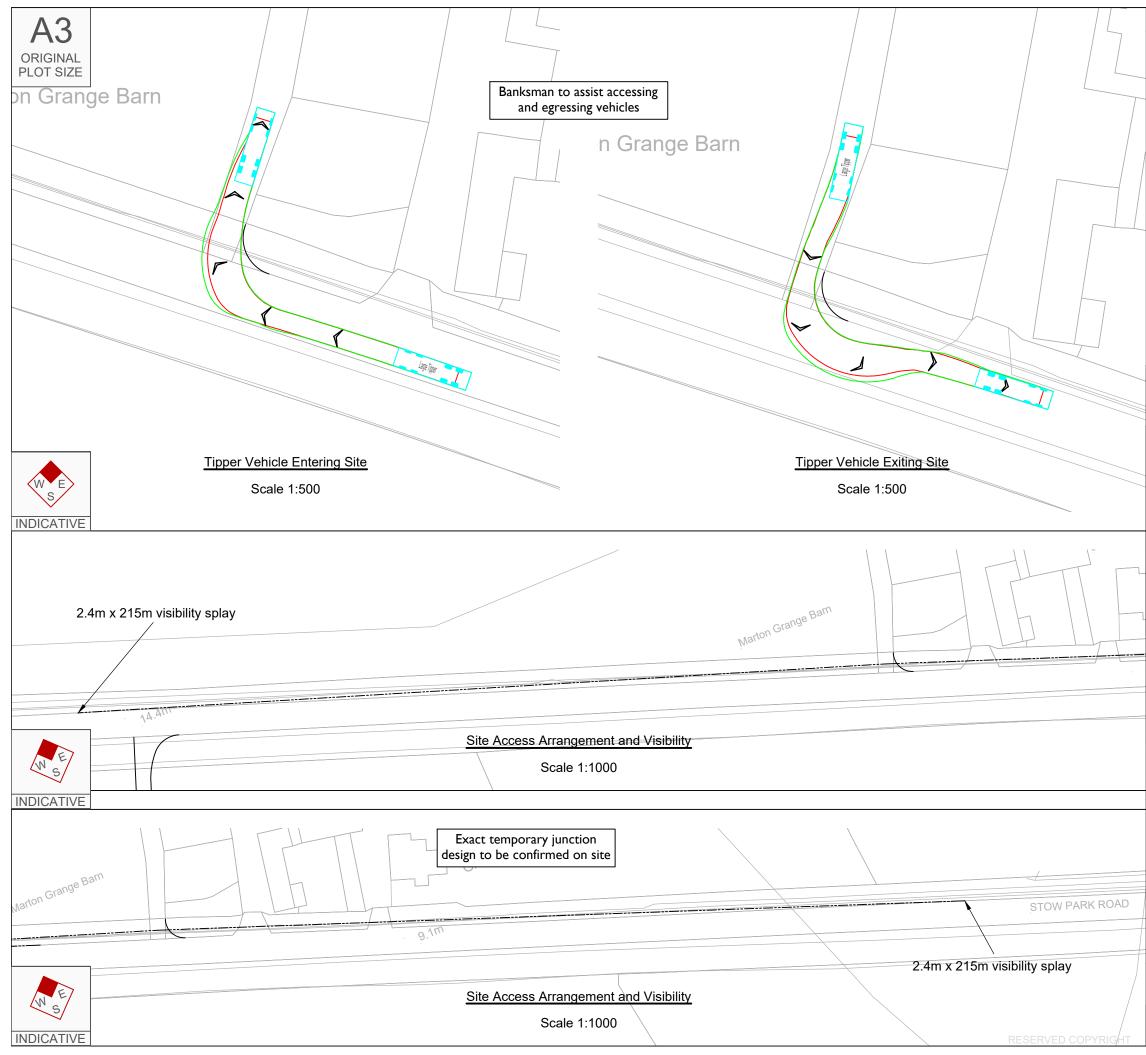
om Ordnance Survey S Stationery Office. Crov			
NOTE	ES:				
1. The existing posted speed limit on Stow Park Road is National Speed Limit (60mph)					
2. OS	base	to be confirmed wi	th topographica	al survey	
3. Hig	hway	boundary to be co	nfirmed		
		Large Tipper Overall Weight Min Body Ground Cle Track Width Lock to lock time Kerb to Kerb Turning		10.201m 2.495m 0.341m 2.471m 6.00s 11.550m	
-	-		-		
Rev	Date		Details		rawn by Checked Approved by by
C M O W 29 B B O V V	5 King ristol S1 4F 117 92 /ww.t	ster Garden City I Street	Tra	ansport Plannin	g Associates
	ENT: DTT	AM SOLA	AR PRO	JECT L	IMITED
PROJECT: COTTAM SOLAR FARM					
Cable Route Access Point 11					
INFORMATION					
scai As S	^{le:} Show	DATE: 18.10.22	DRAWN: SG	CHECKED: SM	APPROVED: JD
JOB		·	DRAWING NO		REVISION:
	210)7-062	SK '	111	-

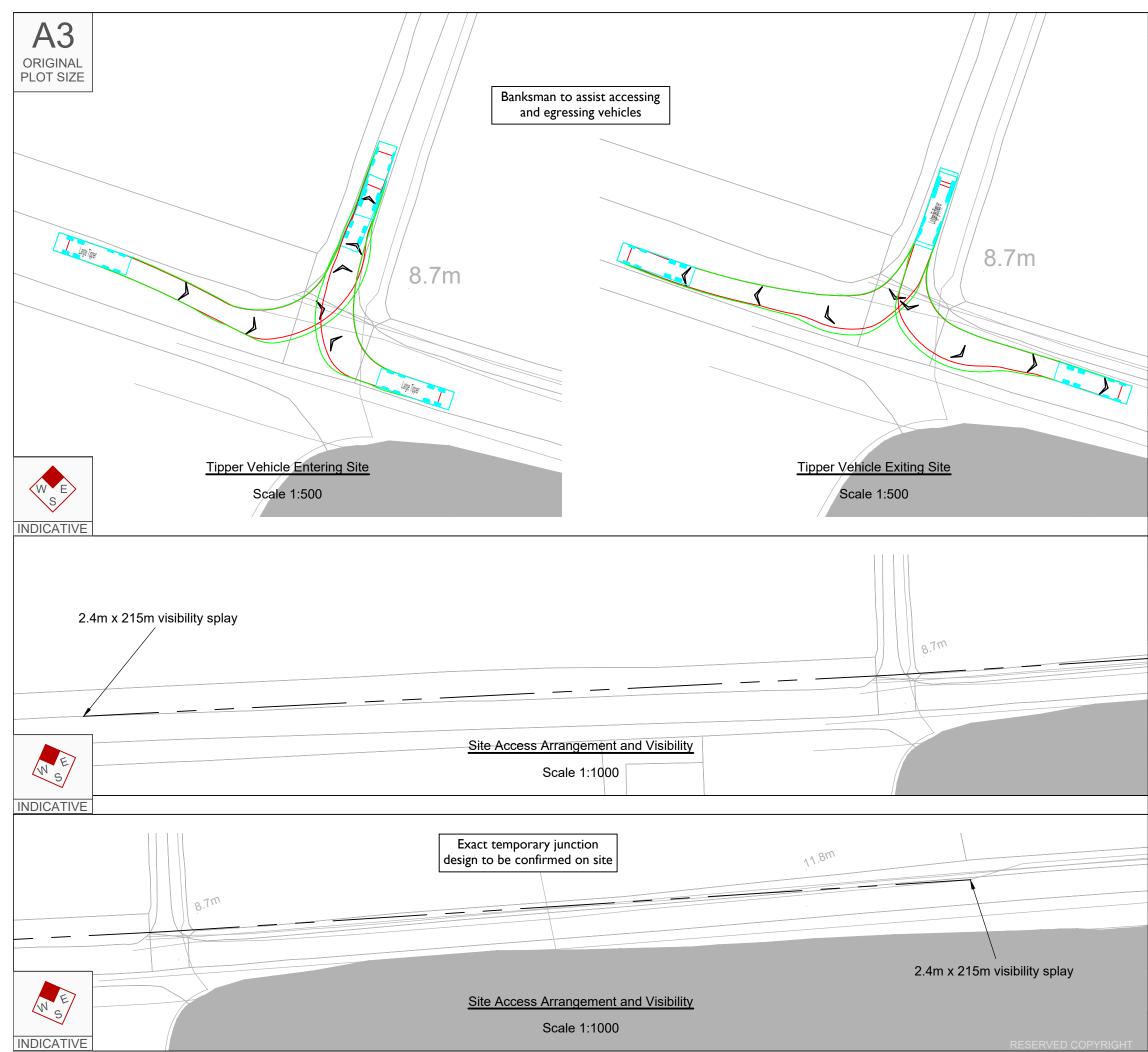
om Ordnance Survey S Stationery Office. Cro			
NOTE	S:				
 The existing posted speed limit on Till Bridge Lane is National Speed Limit (60mph) 					
2. OS base to be confirmed with topographical survey					
3. Highway boundary to be confirmed					
		10.201 295 1.81 4.125 Large Tipper Overall Length Overall Width Overall Width Overall Width Coverall Body Height Min Body Ground Cle Track Width Lock to lock time Kerb to Kerb Turning		10.201m 2.495m 0.341m 2.471m 6.00s 11.550m	
_	_		_		
Rev	Date		Details	Dra	
Lo M O W 23 B B O	5 King ristol S1 4F 117 92	ster Garden City Street	Tra	ansport Planning	Associates
-	ENT: DTT	AM SOLA	AR PRO	JECT L	IMITED
COTTAM SOLAR FARM					
TITLE: Cable Route Access Point 12					
	TUS:	IFOF	RMA		DN
scai As S	^{le:} Show	DATE: /n 18.10.22	DRAWN: SG	CHECKED: SM	APPROVED: JD
JOB NO: DRAWING NO: REVISION: 2107-062 SK 112 -					REVISION: -
