Cottam Solar Project

Environmental Statement Appendix 14.1: Transport Assessment Revision C

Prepared by: Transport Planning Associates February 2024

Transport Assessment

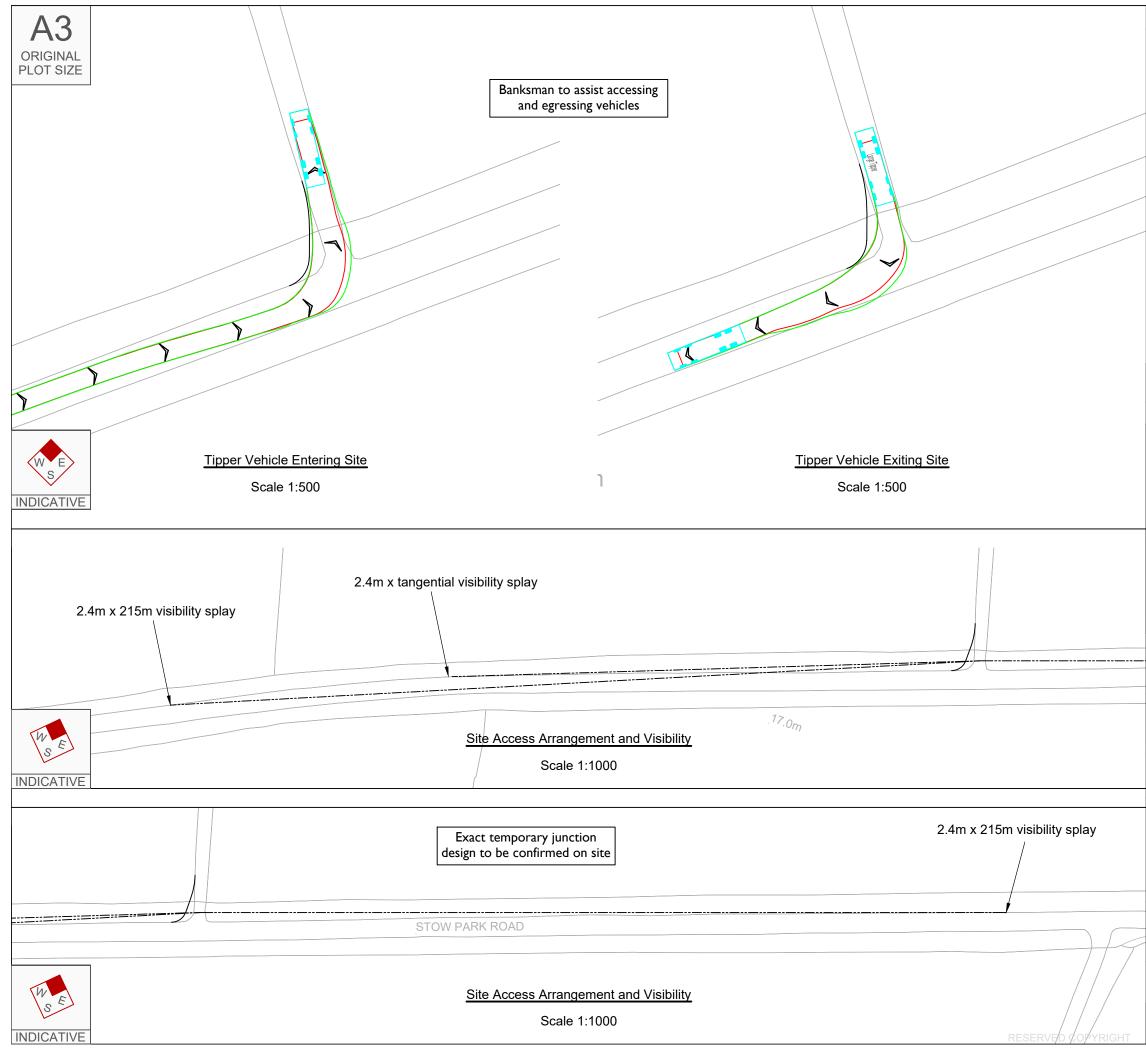
om Ordnance Survey S Stationery Office. Crov			
NOTE	ES:				
1. The existing posted speed limit on Stow Park Road is National Speed Limit (60mph)					
2. OS	base	to be confirmed wi	th topographica	ll survey	
3. Hig	hway	boundary to be co	nfirmed		
		Large Tipper Overall Length Overall Body Height Min Body Ground Cle Track Width Lock to lock time Kerb to Kerb Turning	arance	10.201m 2.495m 0.341m 2.471m 6.00s 11.550m	
-	-		-		
Rev	Date		Details		rawn by Checked Approved by by
C M O W 29 B B O V V	5 King ristol S1 4P 117 92 /ww.t	ster Garden City I Street	Tra	ansport Plannin	g Associates
	ENT: DTT	AM SOLA	AR PRO	JECT L	IMITED
COTTAM SOLAR FARM					
Cable Route Access Point 13					
scai As S	_{le:} Show	DATE: /n 18.10.22	DRAWN:	CHECKED: SM	APPROVED: JD
JOB	NO:		DRAWING NO):	REVISION:
	210	7-062	SK ²	113	-

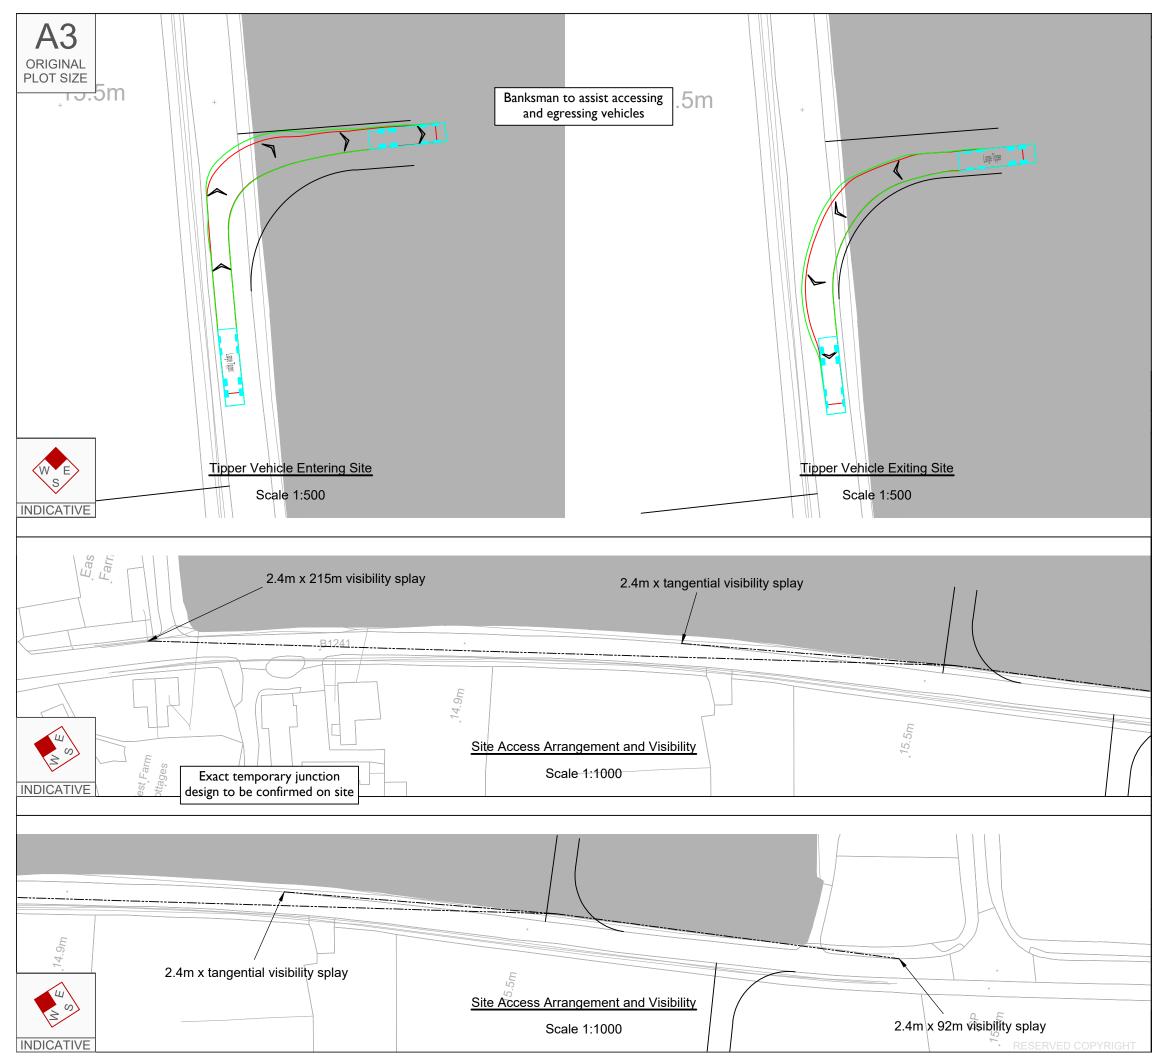
10.201 208 1.81 4.128 Large Tipper Overall Length Overall Sody Height Min Body Ground Cle Track Width Lock to lock time Kerb to Kerb Turning		10.201m 2.495m 0.341m 2.471m 6.00s 11.550m			
A 06.11.23	Access reloca	ted to suit amended re		PSW	RR	JD
Rev Date		Details		Drawn by	Checked by	Approved by
25 King Bristol BS1 4P 0117 92	Garden City Street B	Tra	ansport Plannir	ng As	sociat	es
CLIENT:						
сотт	AM SOL	AR PRO	JECT L	_IN	1ITE	ED
COTTAM SOLAR FARM						
STATUS:						
IN	IFOF	RMA	YTIC	\bigcirc		J
SCALE: As Show	DATE: n 18.10.22	DRAWN: SG	CHECKED: SM	A	PPRO JC	
JOB NO:		DRAWING NC	l):	R	EVISI	ON:
210	7-062	SK 1	115		А

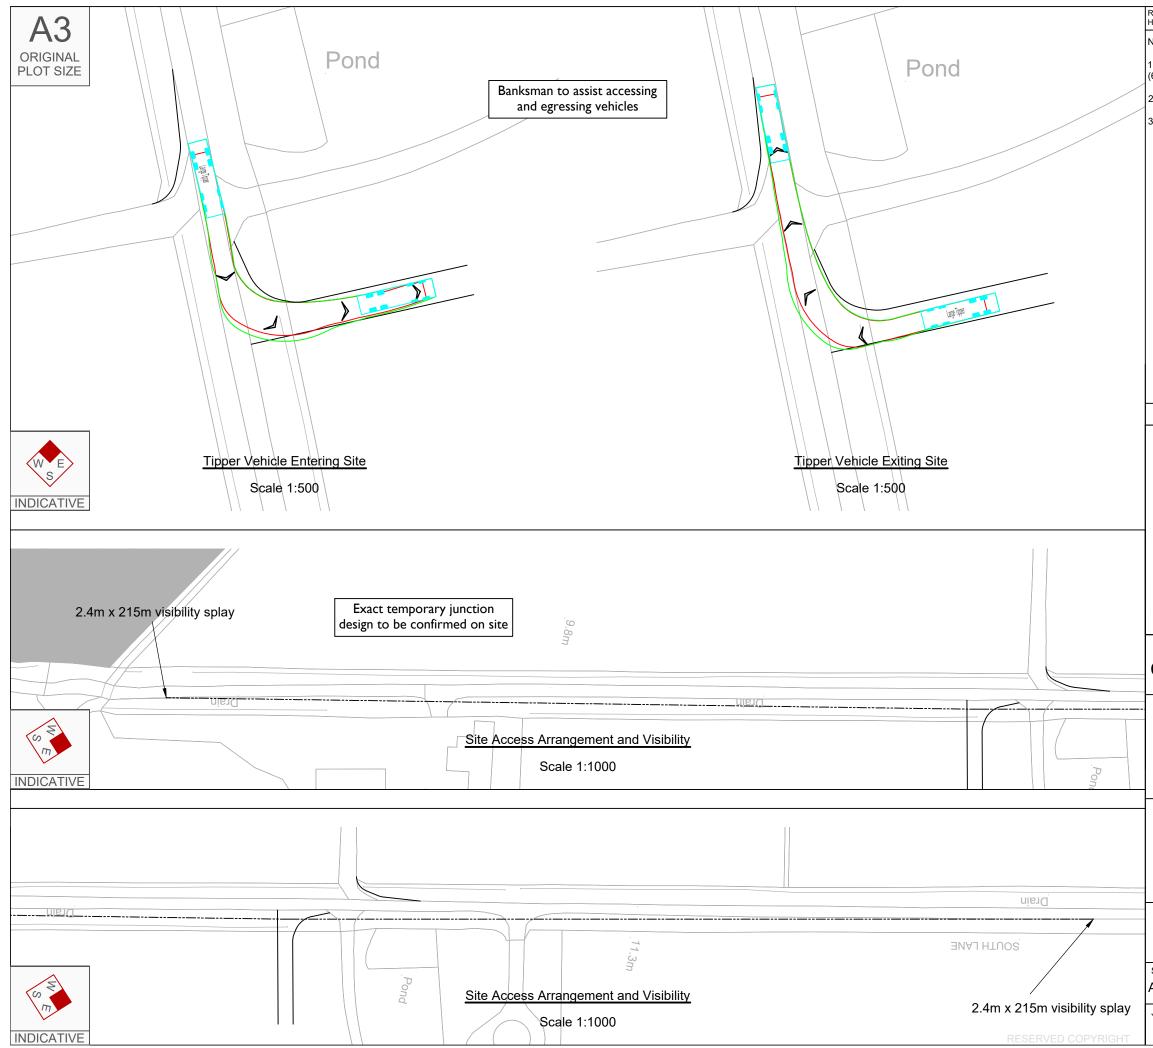
m Ordnance Survey S tationery Office. Cro			
NOTES	S:				
1. The e (60mph		g posted speed li	mit on South La	ane is National :	Speed Limit
2. OS base to be confirmed with topographical survey					
3. Highway boundary to be confirmed					
		10.201		10.201m 2.495m 0.341m 2.471m 6.00s 11.550m	
1	1				
-	-				
Rev	Date		Details	Dra	
					y by by
Lon Mar Oxf We 25 Bris BS 011	King stol 1 4PE 17 923	er Sarden City Street	Tra	ansport Planning	Associates
		AM SOL/	AR PRO	JECT L	IMITED
COTTAM SOLAR FARM					
Cable Route Access Point 16					
STATUS: INFORMATION					
SCALE	≣:	DATE:	DRAWN:	CHECKED:	APPROVED:
As Sł	howi	n 18.10.22	SG	SM	JD
JOB N	0:		DRAWING NC):	REVISION:
	2107-062 SK 116 -

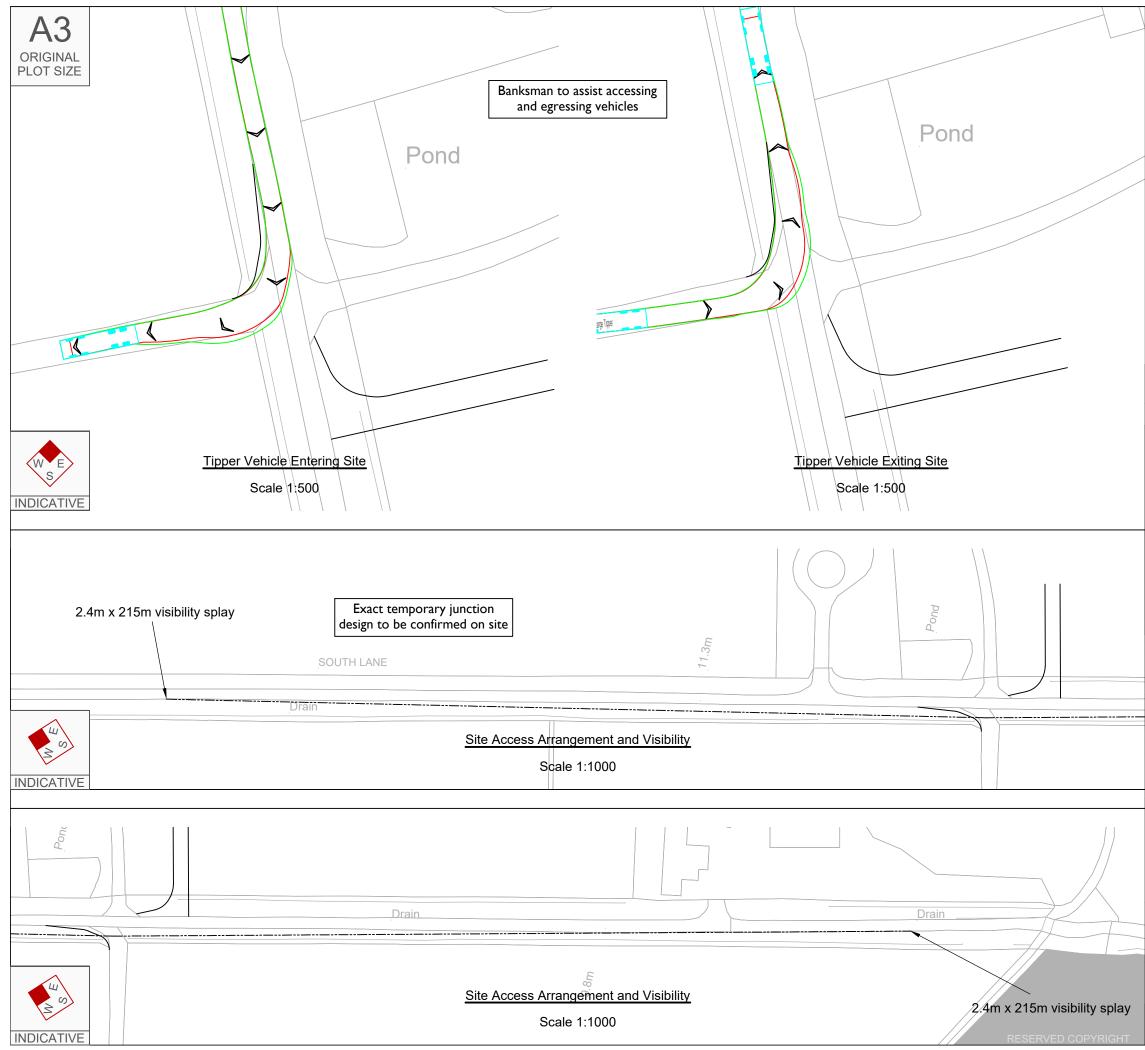
om Ordnance Survey S Stationery Office. Crov			
NOTE	ES:				
1. The (60m		ng posted speed li	mit on South La	ane is National \$	Speed Limit
2. OS	base	to be confirmed wi	th topographica	l survey	
3. Hig	hway	boundary to be co	nfirmed		
		Large Tipper Overall Length Overall Width Overall Body Height Min Body Ground Cle Track Width Lock to lock time Kerb to Kerb Turning		10.201m 2.495m 0.341m 2.471m 6.00s 11.550m	
-	-				
Rev	Date		Details	Dra	
2 B B 0	5 King ristol S1 4F 117 92 /ww.t	ster Garden City Street	Tra	ansport Planning	Associates
-	ENT: DTT	AM SOLA	AR PRO	JECT L	IMITED
-	OJECT	TAM S	OLAR	FARN	Л
С		le Route	e Acce	ess Po	int 17
		IFOF	RMA	τις	DN
sca As S	^{le:} Show	DATE: /n 18.10.22	DRAWN: SG	CHECKED: SM	APPROVED: JD
JOB		07-062	DRAWING NC		REVISION: -

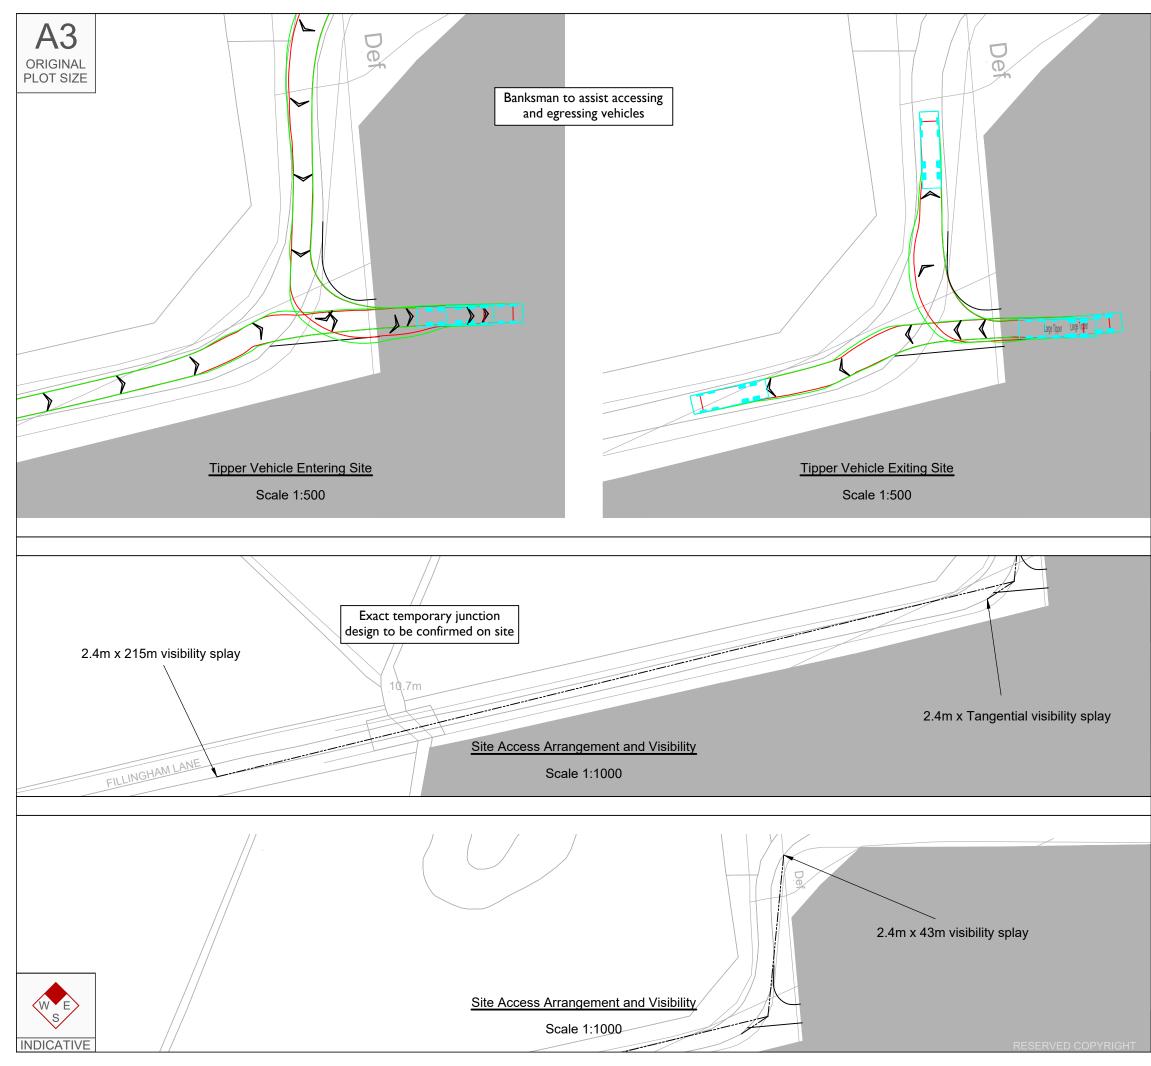
om Ordnance Survey S Stationery Office. Crow			
NOTE	ES:				
	e existi (60mpl	ng posted speed li า)	imit on Fillingha	m Lane is Nati	onal Speed
2. OS	base	to be confirmed wi	th topographica	al survey	
3. Hig	ghway I	poundary to be co	nfirmed		
		10.201 288 1.51 4.128 Large Tipper Overall Length Overall Width Overall Sody Height Min Body Ground Cle Track Width Lock to lock time Kerb to Kerb Turning		10.201m 2.495m 2.890m 0.341m 2.471m 6.00s 11.550m	
_	-				
Rev	Date		Details		rawn Checked Approved
C L L M V V Z B B O V	5 King ristol S1 4P 117 92	ter Garden City Street	Tra	ansport Plannin	B Associates
		AM SOL	AR PRO	JECT L	IMITED
	OJECT	TAM S	OLAR	FARM	N
TITT C		e Route	e Acce	ess Po	int 18
		IFOF	RMA	λTIC	NC
sca As S	^{le:} Show	DATE: n 14.12.22	DRAWN: SG	CHECKED: SM	APPROVED: JD
JOB		7.000			REVISION:
	Z10	7-062	l SK ′	IIÖ

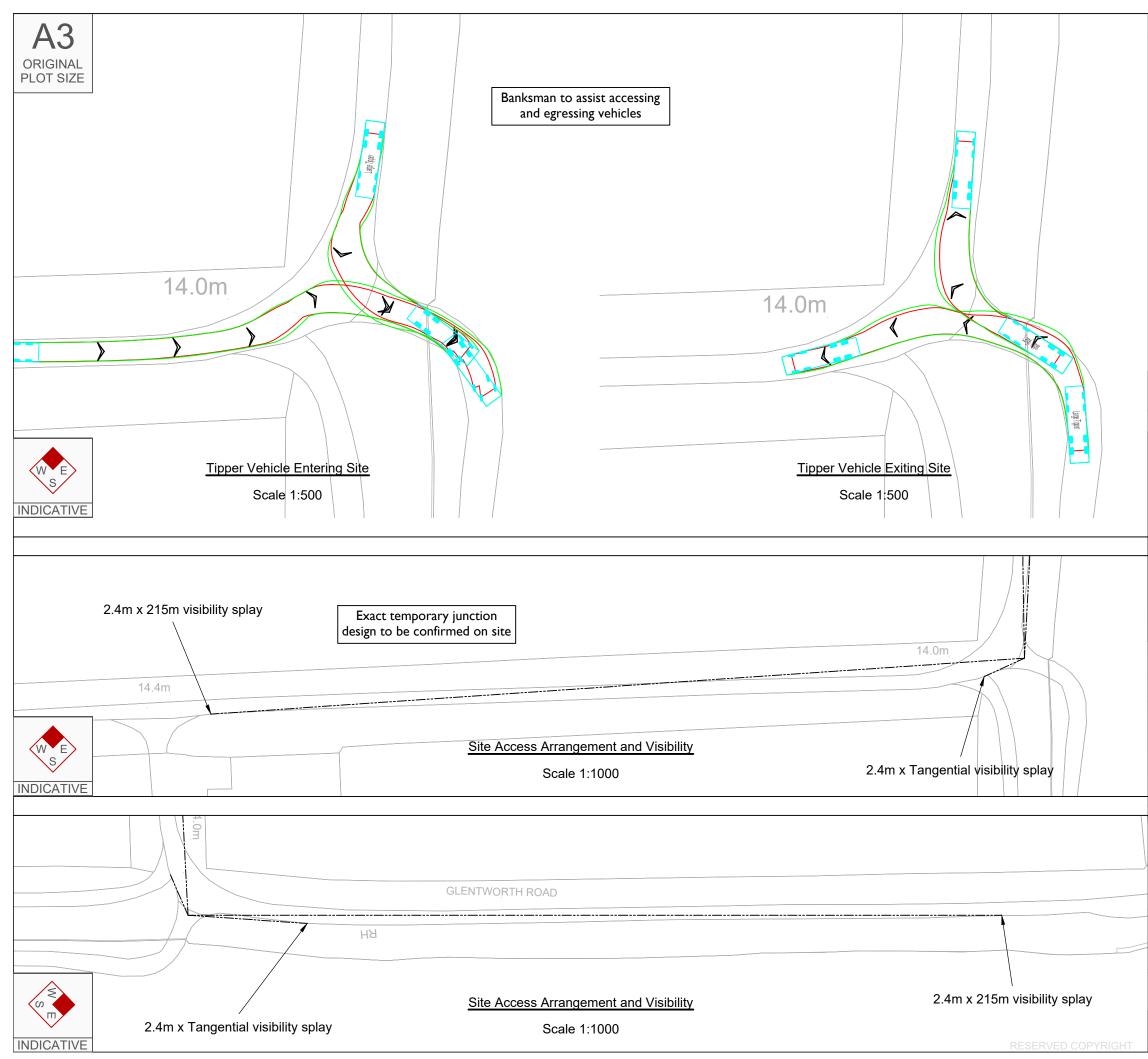
om Ordnance Survey S Stationery Office. Crov			
ΝΟΤΙ	ES:				
	e existi (60mp	ng posted speed li h)	mit on Glentwo	rth Road is Nat	ional Speed
2. OS	6 base	to be confirmed wi	th topographica	al survey	
3. Hiç	ghway	boundary to be co	nfirmed		
		Large Tipper Overall Length Overall Sody Height Min Body Ground Cle Track Width Lock to lock time Kerb to Kerb Turning		10.201m 2.495m 2.890m 2.341m 2.471m 6.00s 11.550m	
-					
Rev	Date		Details		awn Checked Approved
C N C V 2 B B 0	5 King Fristol S1 4P	ter Garden City Street	Tra	ansport Plannin	A ssociates
	ENT: DTT	AM SOLA	AR PRO	JECT L	IMITED
		TAM S	OLAR	FARM	Л
С	ab	le Route	e Acce	ess Po	int 19
		IFOF	RMA	λTIC	NC
SCA As S	LE: Show	DATE: 18.10.22	DRAWN:	CHECKED: SM	APPROVED: JD
JOB			DRAWING NO		REVISION:
	210	7-062	SK '	119	-

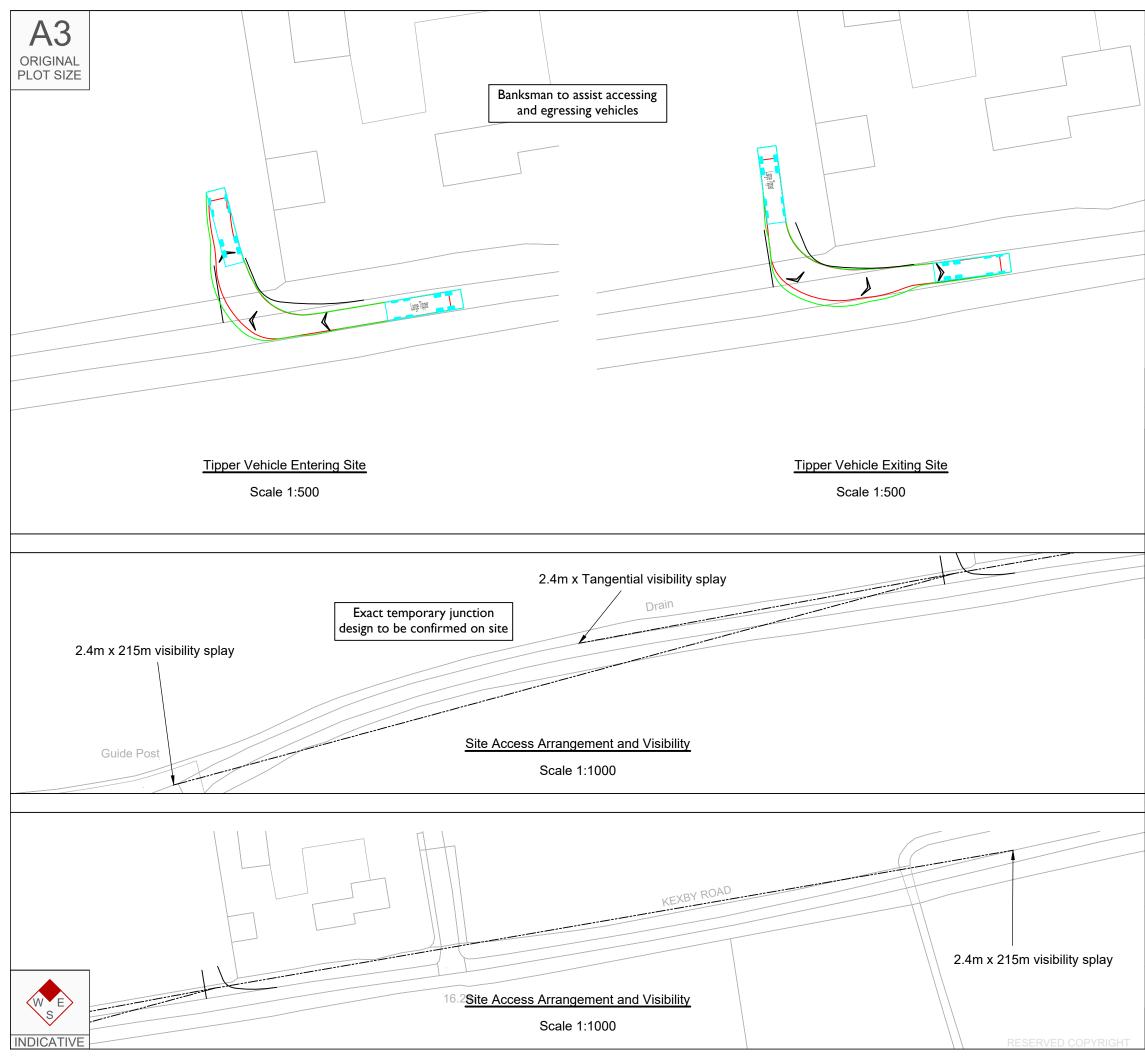
with the permission of icence No. AL10003	
NOTES:				
1. The ex (60mph)	isting posted spe	ed limit on Kexby	/ Road is Nationa	l Speed Limit
2. OS ba	se to be confirme	d with topograph	ical survey	
3. Highw	ay boundary to be	e confirmed		
	Large Tipper Overall Length Overall Body He Min Body Verdull Body He Min Body Koroun Track Width Lock to lock time Kerb to Kerb Tur	ight d Clearance	10.201m 2.495m 2.890m 0.341m 2.471m 6.00s 11.550m	
- ·	to	- Details	D	rawn Checked Approved
Rev Da	le	Details		by by by
Lond Manc Oxfor Welw Brist BS1 0117	oridge on dester d ryn Garden City ing Street ol 4PB 7925 9400 v.tpa.uk.com		Transport Plannin	g Associates
	TAM SC	LAR PR	OJECT L	.IMITED
PROJE CC	•••	SOLAI	R FARI	M
		ute Acc	ess Pc	oint 20
-		RM	ΑΤΙΟ	NC
SCALE: As Sh	DATE: 2000 18.10.2	DRAWN: 22 SG	CHECKED: SM	APPROVED: JD
ЈОВ NO 2	: 107-062	DRAWING	NO: (120	REVISION:

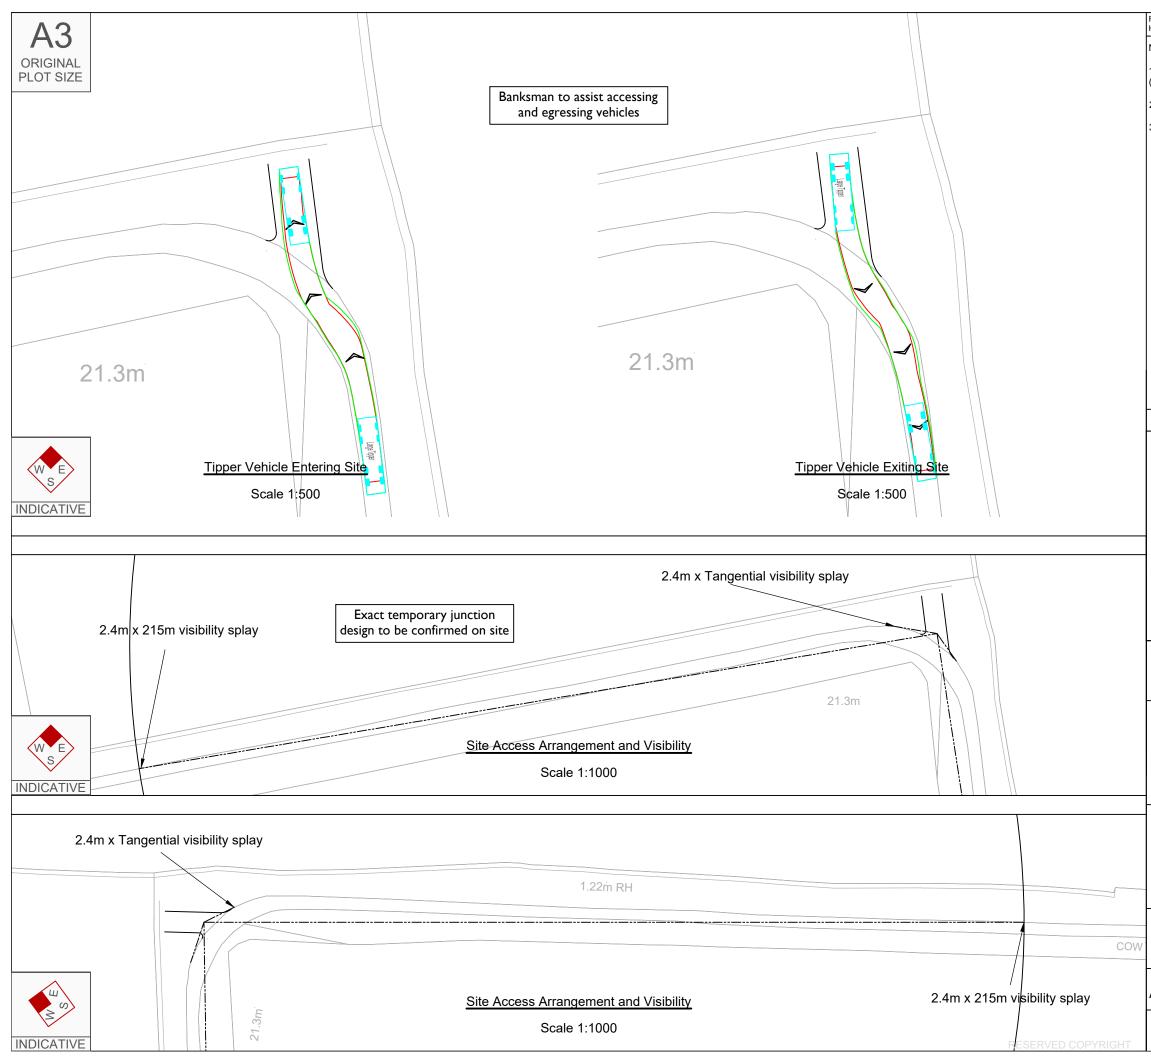
om Ordnance Survey S Stationery Office. Crov			
NOTES:				
1. The existi (60mph)	ing posted speed li	mit on Cow Lar	ie is National Sj	beed Limit
2. OS base	to be confirmed wi	th topographica	l survey	
3. Highway	boundary to be co	nfirmed		
Rev Date	10.201 2995 1.51 4.125 Large Tipper Overall Length Overall Width Cock time Kerb to Kerb Turning	e e e e e e e e e e e e e e e e e e e	10.201m 2.495m 0.341m 2.471m 6.00s 11.550m - - - -	
25 King Bristol BS1 4P 0117 92	ster Garden City Street	Tra	ansport Planning	Associates
	AM SOLA	AR PRO	JECT L	IMITED
PROJECT	TAM S	OLAR	FARN	Л
TITLE:	le Route	e Acce	ess Po	int 21
STATUS:	IFOF	RMA	τις	DN
SCALE: As Show	DATE: /n 14.12.22	DRAWN: SG	CHECKED: SM	APPROVED: JD
JOB NO: 210)7-062	DRAWING NO		REVISION: -

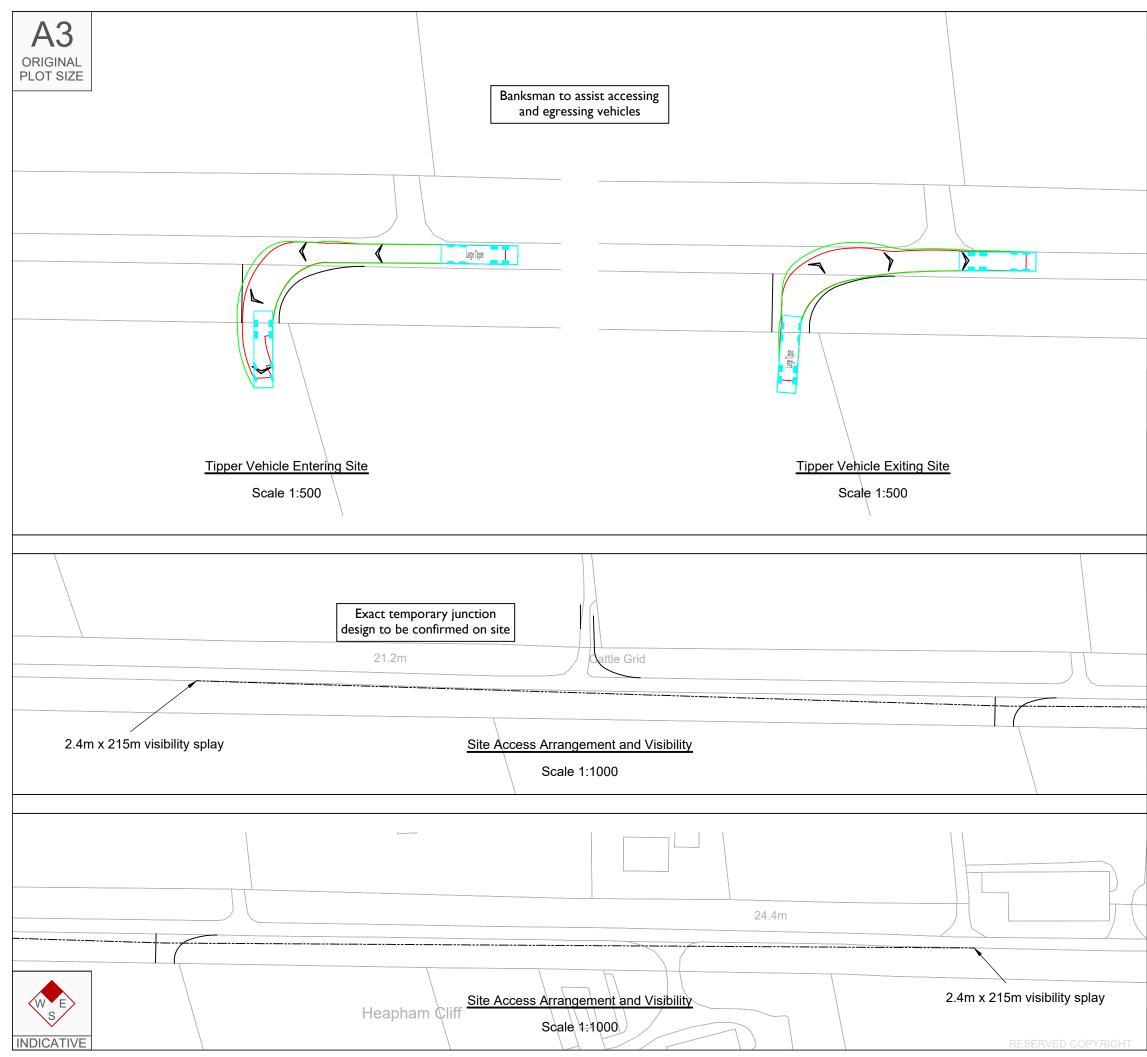
om Ordnance Survey S Stationery Office. Crow			
NOTE	S:				
1. The (60mp		ng posted speed li	imit on Commor	h Lane is Natior	nal Speed Limit
2. OS	base	to be confirmed wi	th topographica	l survey	
3. Hig	hway l	boundary to be co	nfirmed		
Rev B C C L C U C C O O	Date ristol ondon anchese xford	Large Tipper Overall Length Overall Midth Overall Width Lock to lock time Kerb to Kerb Turning	erance Radius	10.201m 2.4950m 0.341m 6.00s 11.550m	
	5 King ristol	Street			
В	S1 4P	-			
		25 9400			
W	/ww.tj	oa.uk.com			
-	ENT: DTT	AM SOLA	AR PRO	JECT L	IMITED
	OJECT	TAM S	OLAR	FARM	Л
TITL	.E:				
С	ab	le Rout	e Acce	ess Po	int 22
		IFOF	RMA		DN
scai As S	^{le:} Show	DATE: n 18.10.22	DRAWN: SG	CHECKED: SM	APPROVED: JD
JOB	NO:		DRAWING NC):	REVISION:
	210	7-062	SK 1	22	-

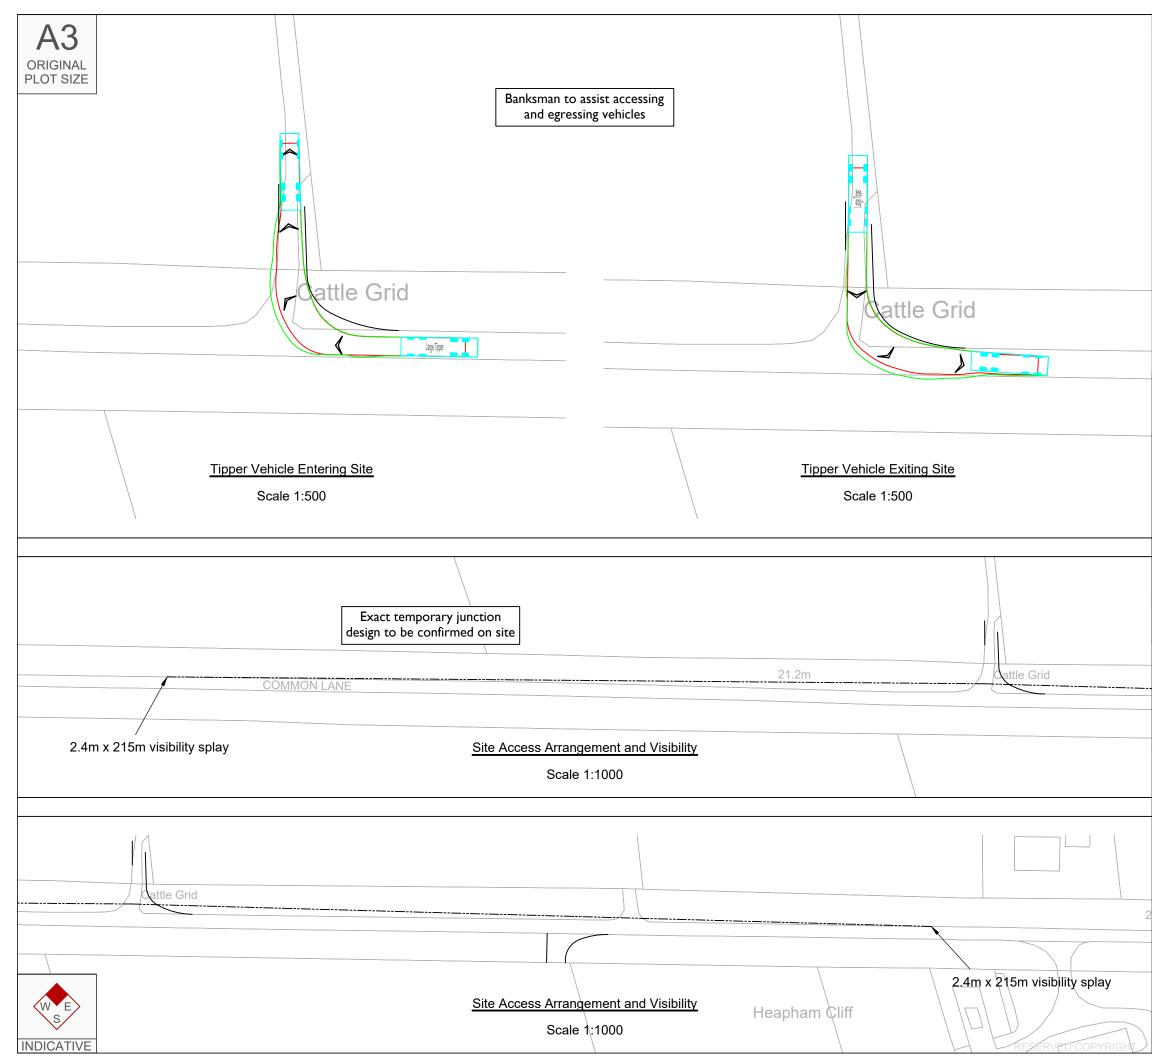
om Ordnance Survey S Stationery Office. Crov			
NOTE	ES:				
1. The (60m)		ng posted speed li	mit on Commor	n Lane is Natior	nal Speed Limit
2. OS	base	to be confirmed wi	th topographica	l survey	
3. Hig	Jhway	boundary to be co	nfirmed		
		Large Tipper Overall Length Overall Width Overall Width Overall Body Height Min Body Ground Cle Track Width Lock to lock time Kerb to Kerb Turning		10.201m 2.495m 0.341m 2.471m 6.00s 11.550m	
-	-				
Rev	Date		Details	Dra	
Lu M O W 2 B B O	5 King ristol S1 4F 117 92	ster Garden City Street	Tra	ansport Planning	Associates
-	ENT: DTT	AM SOLA	AR PRO	JECT L	IMITED
-	OJECT	TAM S	OLAR	FARM	Л
TITL C		le Route	e Acce	ess Po	int 23
		IFOF	RMA	τις	DN
sca As S	^{le:} Show	DATE: /n 18.10.22	DRAWN: SG	CHECKED: SM	APPROVED: JD
JOB)7-062	DRAWING NC		REVISION: -

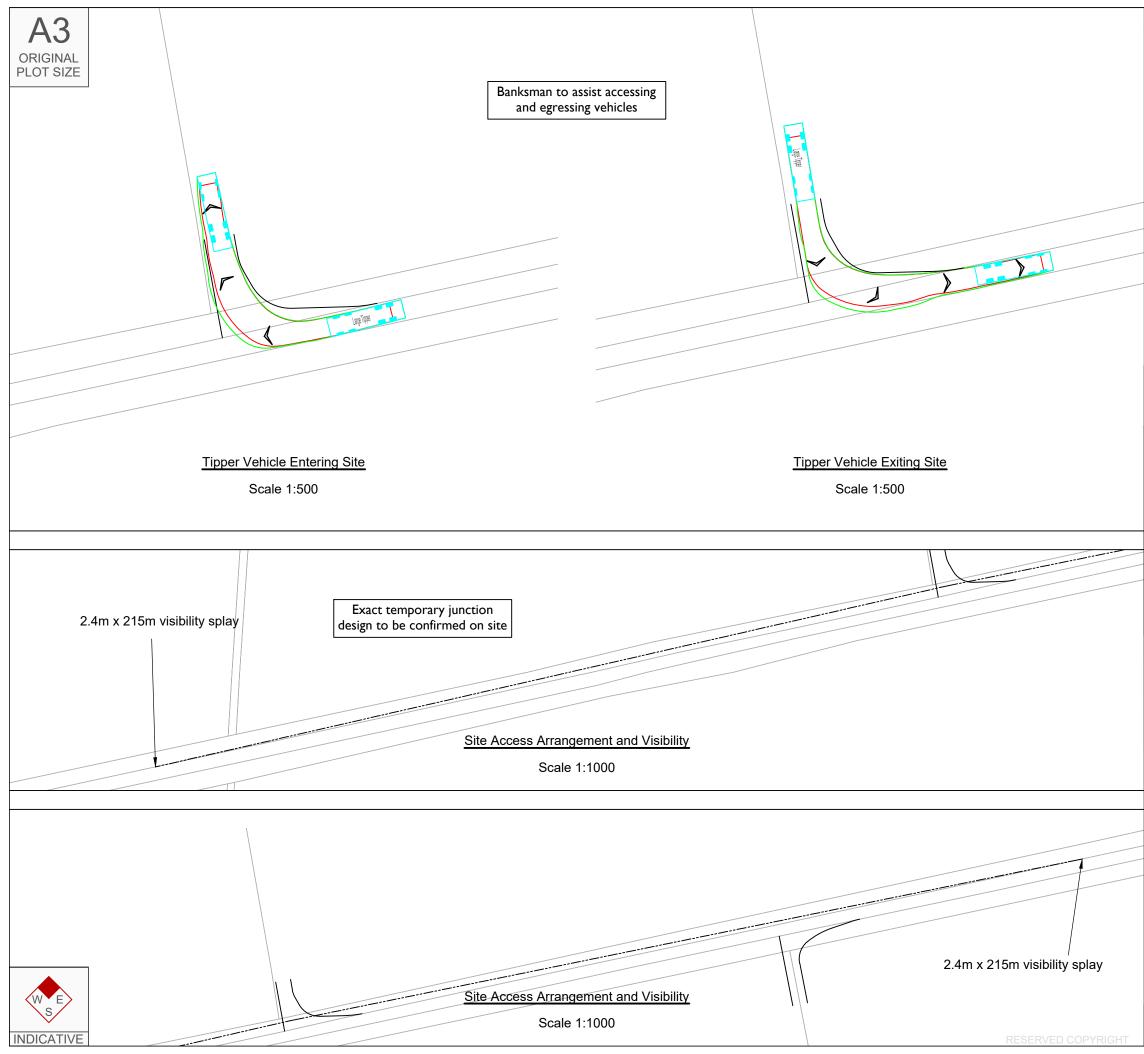
om Ordnance Survey S Stationery Office. Crov			
NOTES:				
1. The exist (60mph)	ing posted speed li	mit on School L	ane is National.	Speed Limit
2. OS base	to be confirmed wi	th topographica	ll survey	
3. Highway	boundary to be co	nfirmed		
 Rev Date Bristol	Large Tipper Overall Length Overall Body Height Min Body Ground Cle Track Width Lock to lock time Kerb to Kerb Turning	e contraction of the second se	10.201m 2.495m 0.341m 2.471m 6.00s 11.550m	
Cambrid London Manche: Oxford Welwyn 25 King Bristol BS1 4F 0117 92	ster Garden City 9 Street	Tra	ansport Planning	Associates
CLIENT:				
СОТТ	AM SOLA	AR PRO	JECT L	IMITED
PROJECT COT	TAM S	OLAR	FARM	Л
Cab	le Route	e Acce	ess Po	int 25
STATUS:	IFOF	RMA	ATIC	DN
SCALE: As Show	DATE: /n 18.10.22	DRAWN: SG	CHECKED: SM	APPROVED: JD
JOB NO: 21()7-062			REVISION:
- 10				1

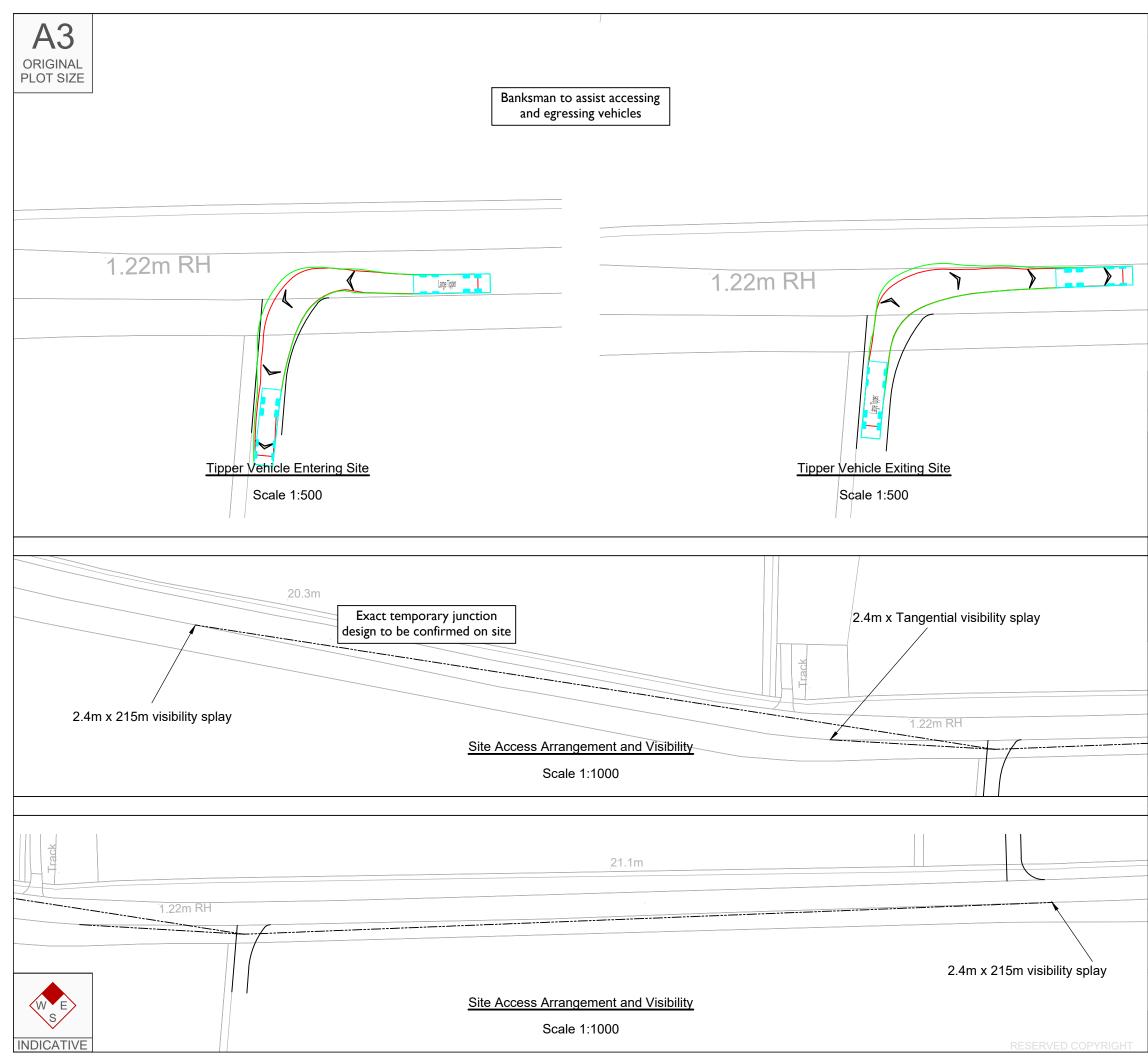
d from Ordnance Survey y's Stationery Office. Cro			
NOTES:				
1. The ex	isting posted speed	limit on A631 is	National Speed	Limit (60mph)
2. OS ba	se to be confirmed w	vith topographica	ll survey	
3. Highw	ay boundary to be co	onfirmed		
	10.201			
	1.298 1.61 4.128			
	Large Tipper Overall Length		10.201m	
	Overall Width Overall Body Height Min Body Ground C	learance	2.495m 2.890m 0.341m	
	Track Width Lock to lock time Kerb to Kerb Turning	g Radius	2.471m 6.00s 11.550m	
	1		I.	1 1
		-	-	
Rev Da	e	Details	Dra	
Oxfor Welw 25 K Brist BS1 0117	ridge m hester d yn Garden City ng Street ol 4PB 925 9400 7.tpa.uk.com	Tra	ansport Planning	Associates
	TAM SOL	AR PRO	JECT L	IMITED
PROJE	TTAM S	SOLAR	FARN	Л
TITLE:				
Ca	ole Rout	e Acce	ess Po	int 26
STATU				
11	NFO	RMA		DN
SCALE: As Sho	DATE:	DRAWN: SG	CHECKED: SM	APPROVED: JD
JOB NO				SD REVISION:
	107-062	SK 1		-

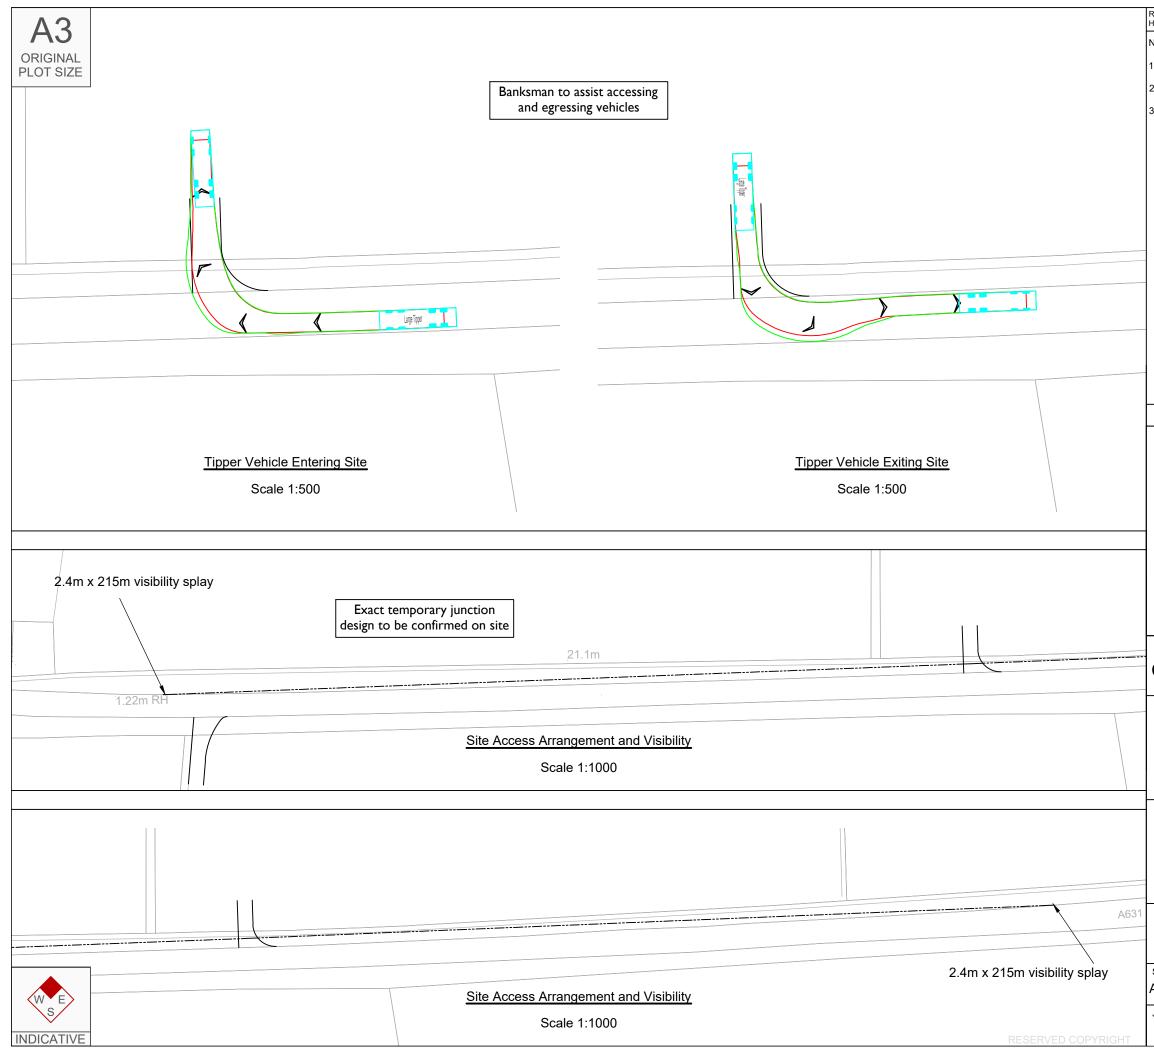
om Ordnance Survey S Stationery Office. Crow			
NOTE	ES:				
1. The	e exist	ing posted speed li	imit on A631 is	National Speed	Limit (60mph)
2. OS	base	to be confirmed wi	th topographica	al survey	
3. Hig	ghway	boundary to be co	nfirmed		
Rev B C C L L M M O V V S B B B	Date Iristol Iambrid Velwyn 5 King Iristol S1 4F	10.201 Large Tipper Overall Length Overall Midth Overall Midth Lock to lock time Kerb to Kerb Turning ge ster Garden City g Street	earance Radius		 awn Checked Approved by by by Associates
W	ww.t	pa . uk.com			
CLIE	ENT:				
-		AM SOL	AR PRO	JECT L	IMITED
С		TAM S	OLAR	FARM	Л
		le Route	e Acce	ess Po	int 27
		IFOF	RMA	λτις	DN
sca As S	^{le:} Show	DATE: /n 18.10.22	DRAWN: SG	CHECKED: SM	APPROVED: JD
JOB			DRAWING NO		REVISION:
	210)7-062	l SK ′	127	-

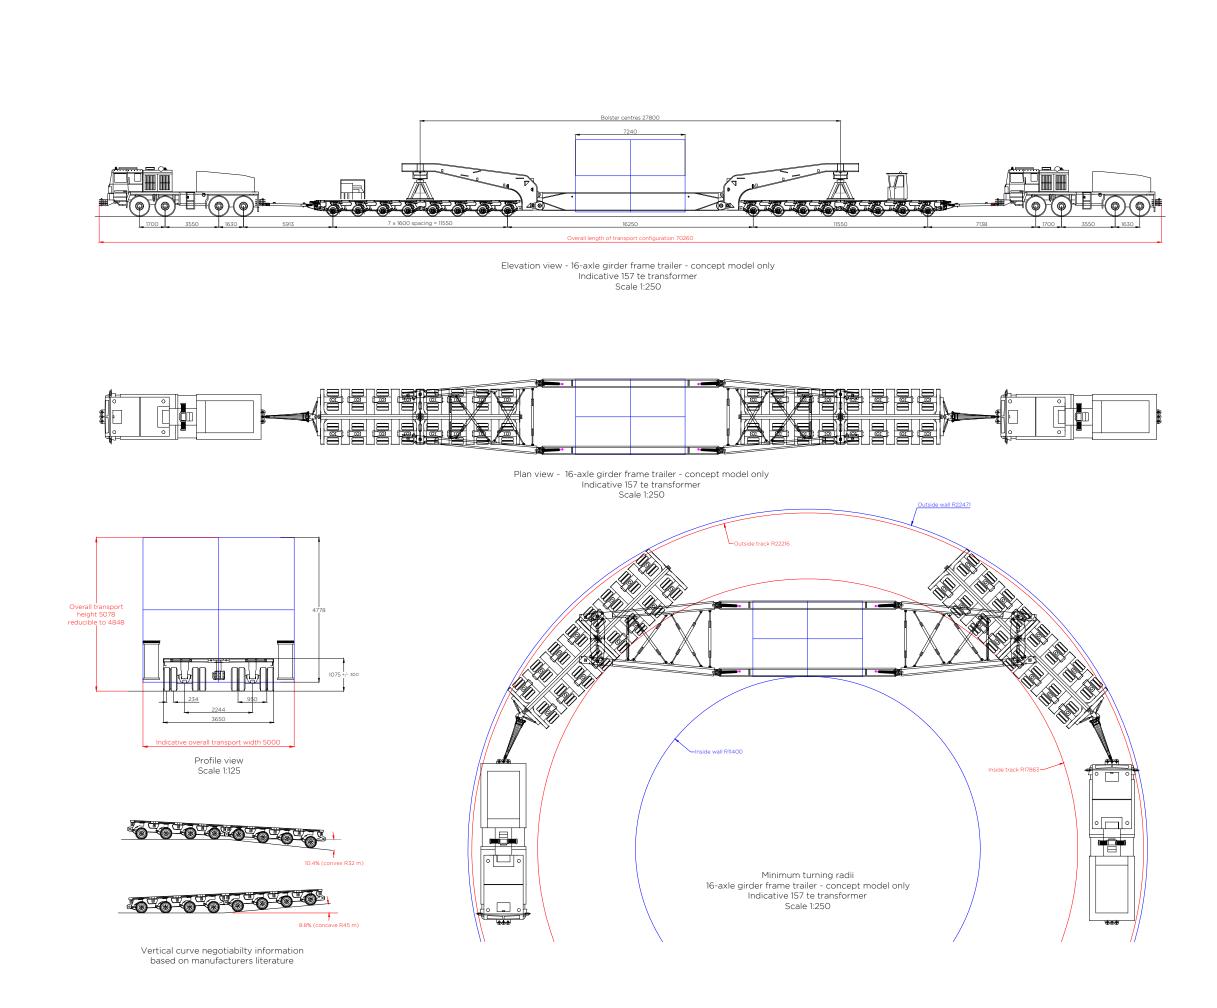
Load table							
	16-axl	e airder	frame tra	iler			
Self weigh	nt of transform			157.0 te			
	nt of trailer			92.0 te			
Self weigh	nt of aux. stee	0.0 te					
	nbined weight			249.0 te			
Load per				124.5 te			
Load per				15.56 te			
Load per	axie wheel (4 per a			7.78 te 1.95 te			
	ound bearing			3.05 te/m ²			
o voran gr			(40 +-)	3.03 (0) 11			
		ractor(s)	(48 le)	1			
Front axle				9.0 te			
Second s				9.0 te			
Rear axle				15.0 te 15.0 te			
Rear axle				15.0 te			
of th Howe vary t should [2] A and r deper [3] A stated	e figures s ne transp ver, as tra then the la d be treate nean runr nding on m	port co actor an bads and d as pro ensions, ning heig anufactu neasures	nfiguratic d trailer d dimens bable valu including ght, may urer of tra in milli	axle spacing vary slightly iler deployed. metres unless			
1 0	24.02.22	ls	sued for a	comment			
Rev.	Date		Amendi	ments			
		Revis	ions				
Prepared I	21/:

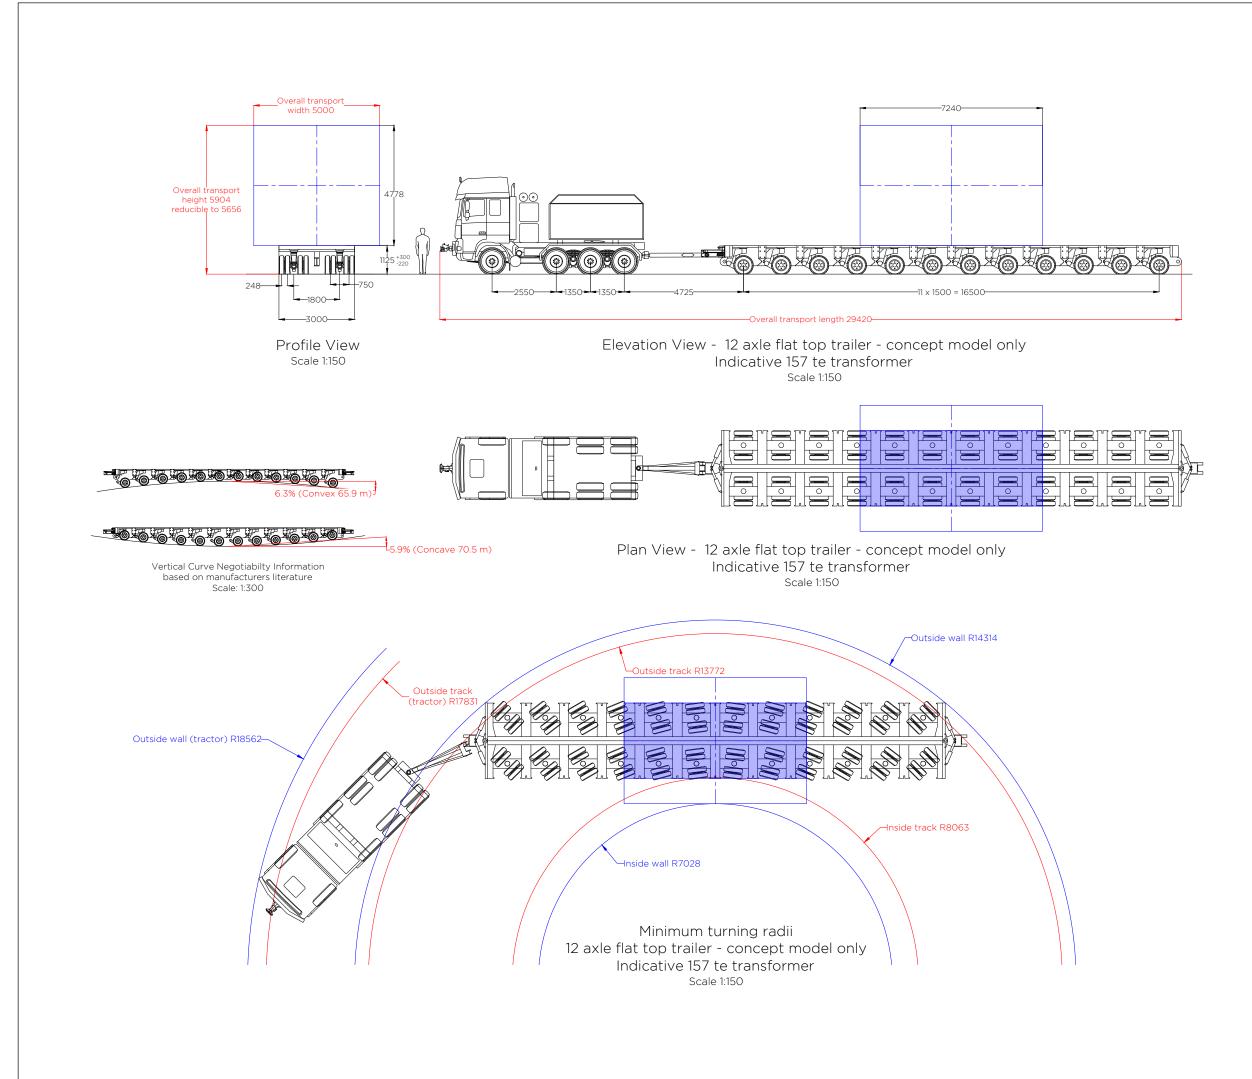
Load Table		
12 axle flat top trailer		
Self weight of load	157.0 te	
Self weight of trailer	38.9 te	
Total combined weight	195.9 te	
Load per axle line	16.33 te	
Load per axle	8.16 te	
Load per wheel (4 per axle)	2.04 te	
Overall ground bearing pressure	3.96 te/m²	
Tractor (42 te)		
Front axle	8.0 te	
Second steer	10.0 te	
Rear axle	12.0 te	
Rear axle	12.0 te	
Notes:-		
 [1] The figures shown representative of the transport portrayed however, as tractor

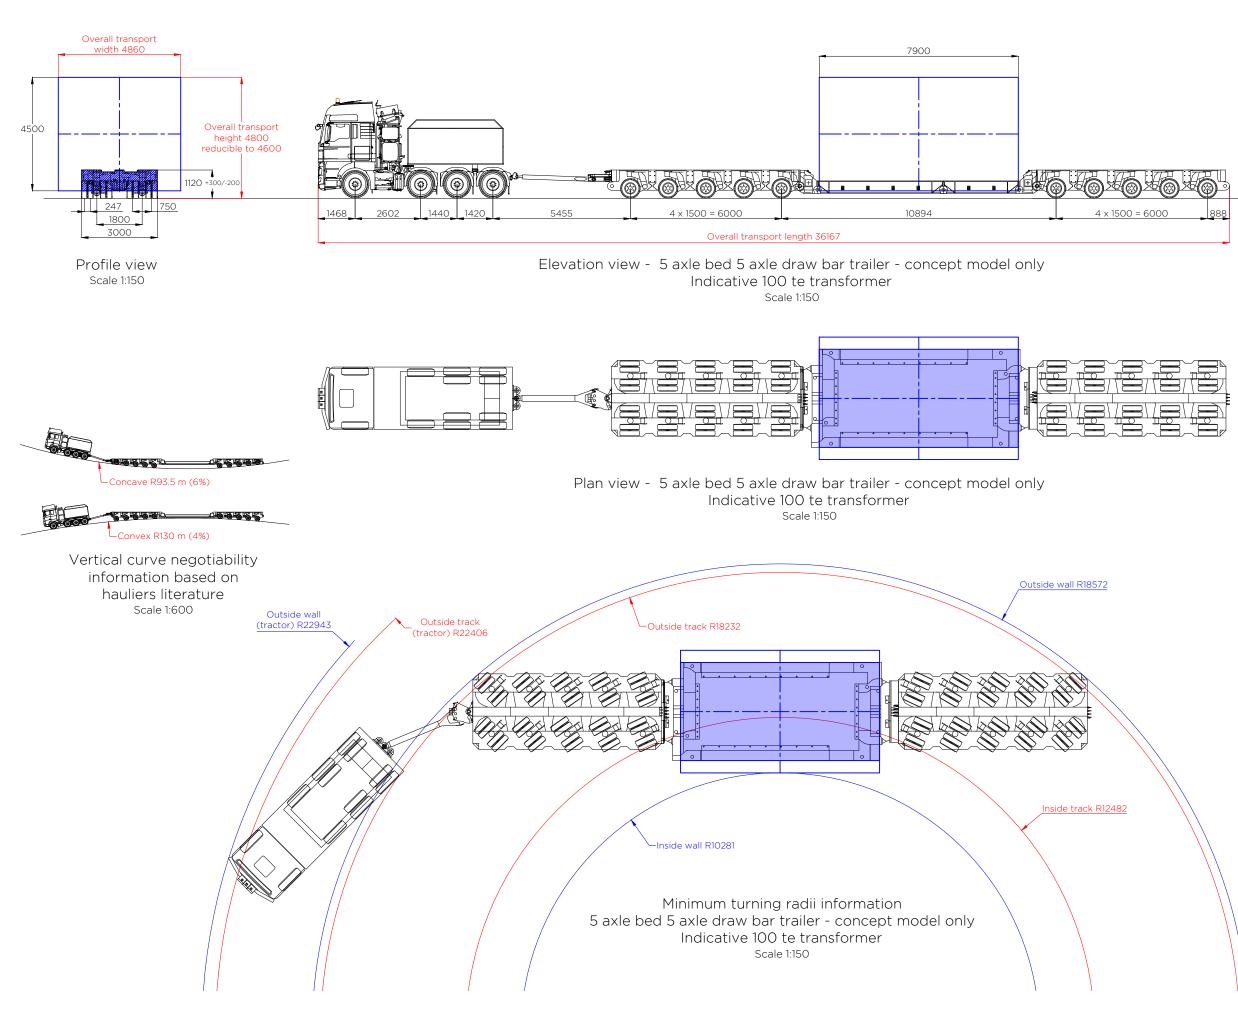
Load table		
5 axle bed 5 axle draw bar trailer		
100.0 te		
Say 46.0 te		
0.0 te		
146.0 te		
14.6 te		
7.3 te		
1.83 te		
4.06 te/m²		
Tractor (40 te)		
7.0 te		
7.0 te		
13.0 te		
Rear axle 13.0 te
