Cottam Solar Project

Environmental Statement Appendix 14.1: Transport Assessment Revision C

Prepared by: Transport Planning Associates February 2024

Transport Assessment

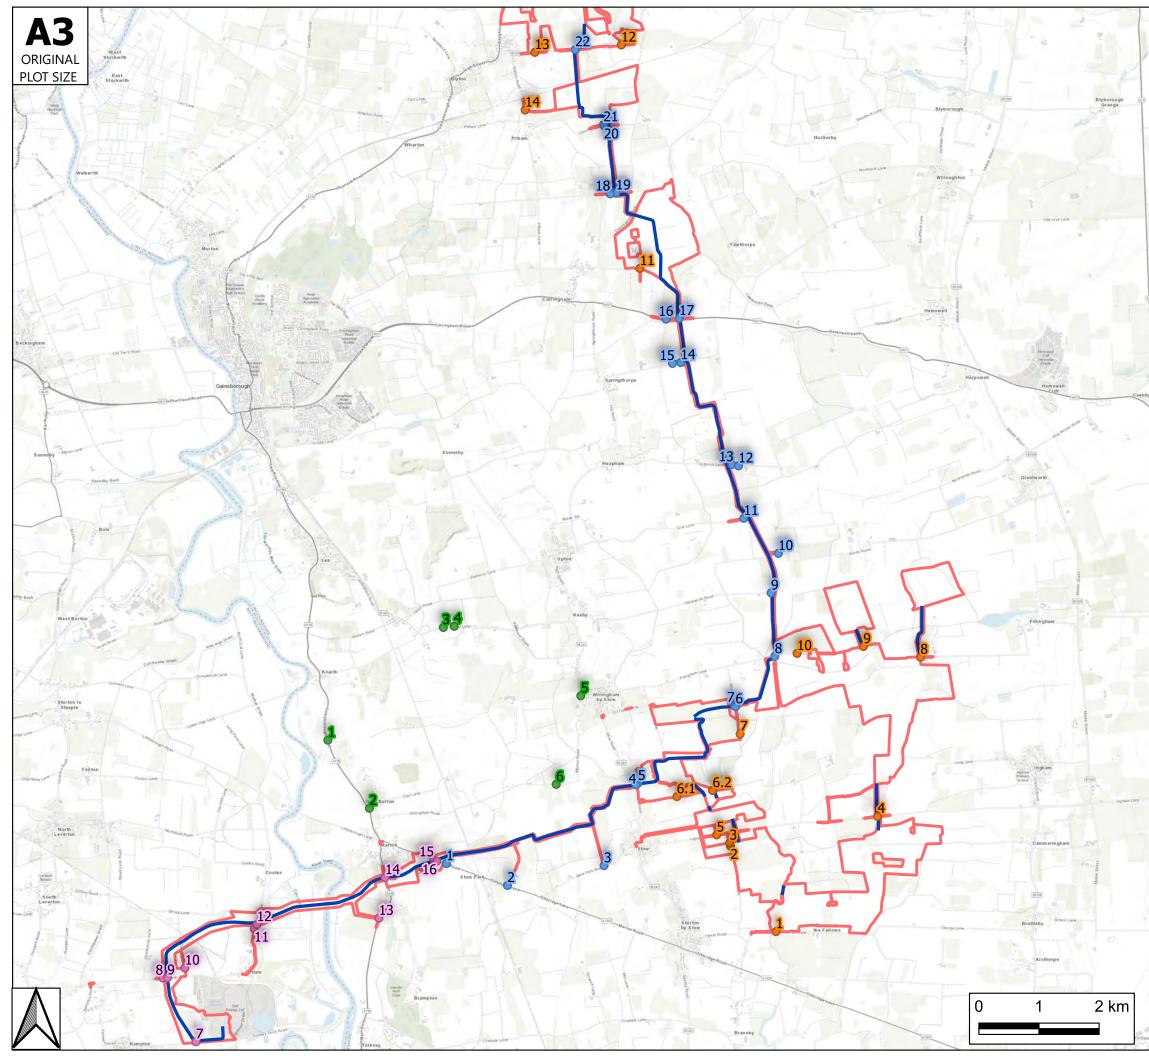
NOTE - Access point location indicative only								
Key Site Boundary Cable Route Shared Access with Gate Burton Cottam Solar Farm Access Point Gate Burton Access Point Cable Route Access Location								
Rev Date Details Drawn Checked Approved by								
Bristol Cambridge London Manchester Oxford Welwyn Garden City 25 King Street Bristol BS1 4PB								
CLIENT: Island Green Power								
PROJECT: Cottam Solar Farm								
TITLE: Cable Route and Access Location Plan								
FOR INFORMATIONSCALE:DATE:DRAWN:CHECKED:APPROVED:NTS10.10.22SGSMJDJOB NO:DRAWING NO:REVISION:2107-062SK16-
