DOCUMENT 5.10.2.1

Historic Environment Desk Study Report

National Grid (North Wales Connection Project)

Document 5.10.2.1 Appendix 10.1 Historic Environment Desk Study Report

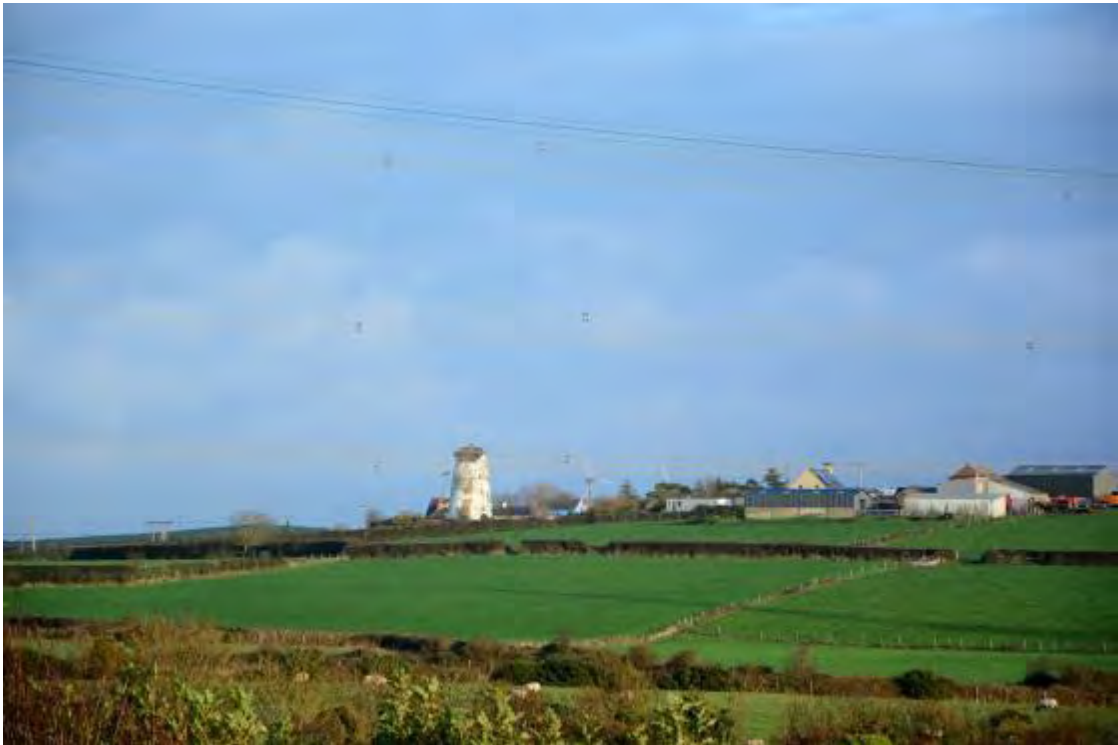
Photo 1: Cemaes Mill (LB5344) from northwest

- 4.1.38 Beyond the town of Llanfechell, the most prominent building is the listed Grade II former Cemaes windmill (LB 5344). The mill sits on the northern slopes of a small hill, but due to its height is clearly visible from the surrounding landscape. The building is in a moderate condition, without sails, and has been converted to residential use.

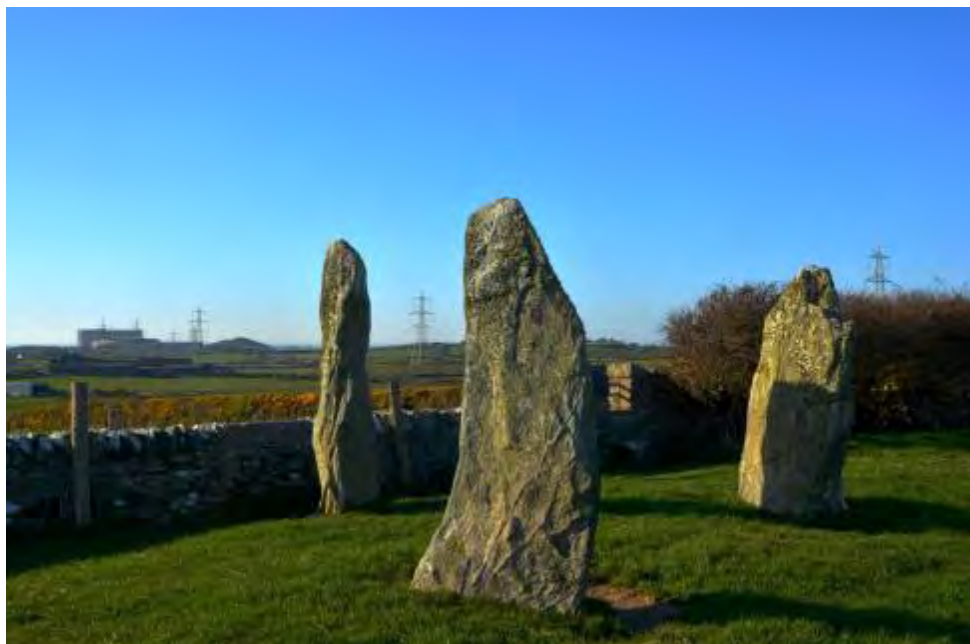
Photo 4: Standing Stones (AN030) looking north with Wylfa in background

- 4.1.13 Further upstanding prehistoric remains are located around the village of Llanfechell, in the form of a single standing stone (HER3048, AN080) to the north-east of the village and a group of three upright stones (HER3047, AN030) to the north-west. The stone to the north-east of the village has been subject to archaeological excavation following its natural toppling in 2009. Excavations revealed the socket and packing stones for what is acknowledged as an unusually squat standing stone. A probable cup and ring marked stone was also found in the packing material. Such artefacts are rare in Wales. Scientific dating was problematic despite the in situ nature of the foundation deposits. Only fragments of probable heather were recovered from the foundation pit itself which returned an Iron Age date of 550-390 cal BC. However, a sample of hazel recovered from the stone packing pit returned a date of 4460-4330 cal BC, putting it in the Mesolithic/Neolithic transition. This wide range of dates suggests some form of disturbance or contamination as standing stones are generally attributed to the Bronze Age (2200-750 BC).

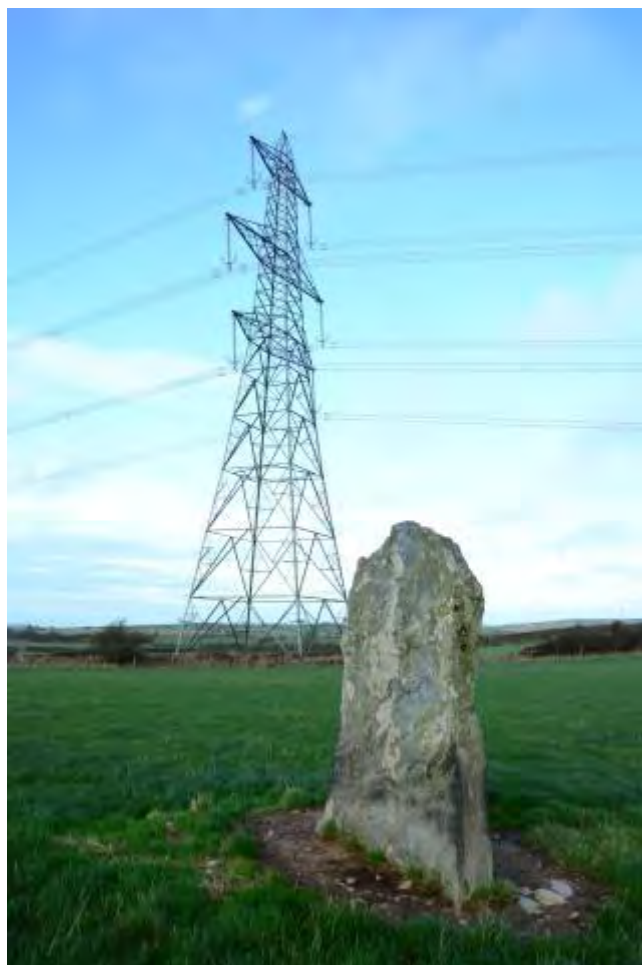
Photo 6: Standing Stone 410m North of Church (AN080) with closest existing pylon

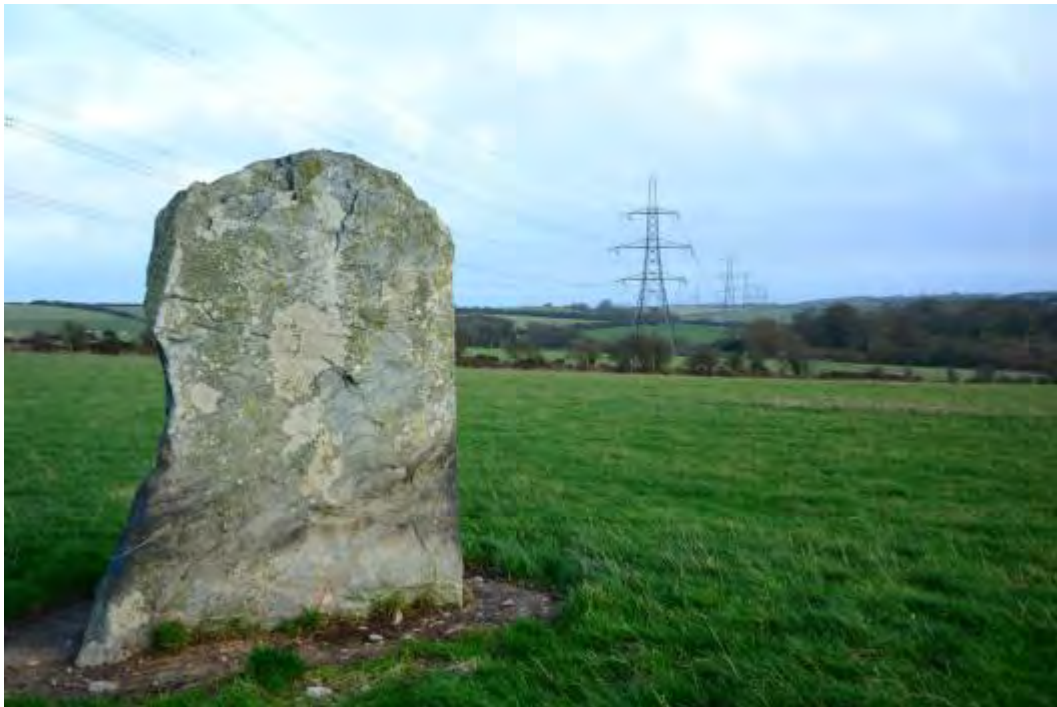
Photo 7: Standing Stone 410m North of Church (AN080) looking southeast

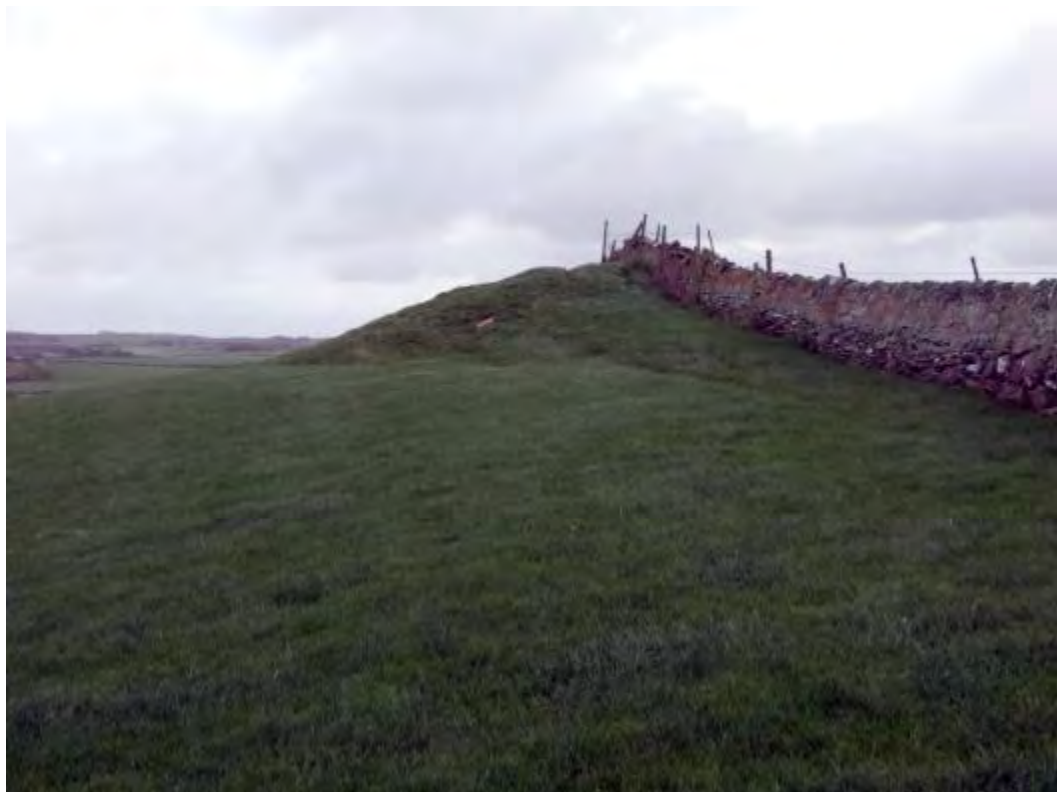
Photo 8: Pen-y-Morwyd Round Barrow (AN110) from north

- 4.1.17 A badly plough-damaged but Scheduled round barrow (SAM AN110, HER3055), is recorded on the summit of Pen-y-morwydd, one of the most prominent hills in the area, reaching a height of 70 mAOD. There may also have been a standing stone at one end, but this was removed before the site was scheduled. However the HER record also cast doubt on the nature of the monument itself, as it is also suggested that there are a number of pillow mounds, but the earthworks have been so degraded by ploughing that little remains visible.

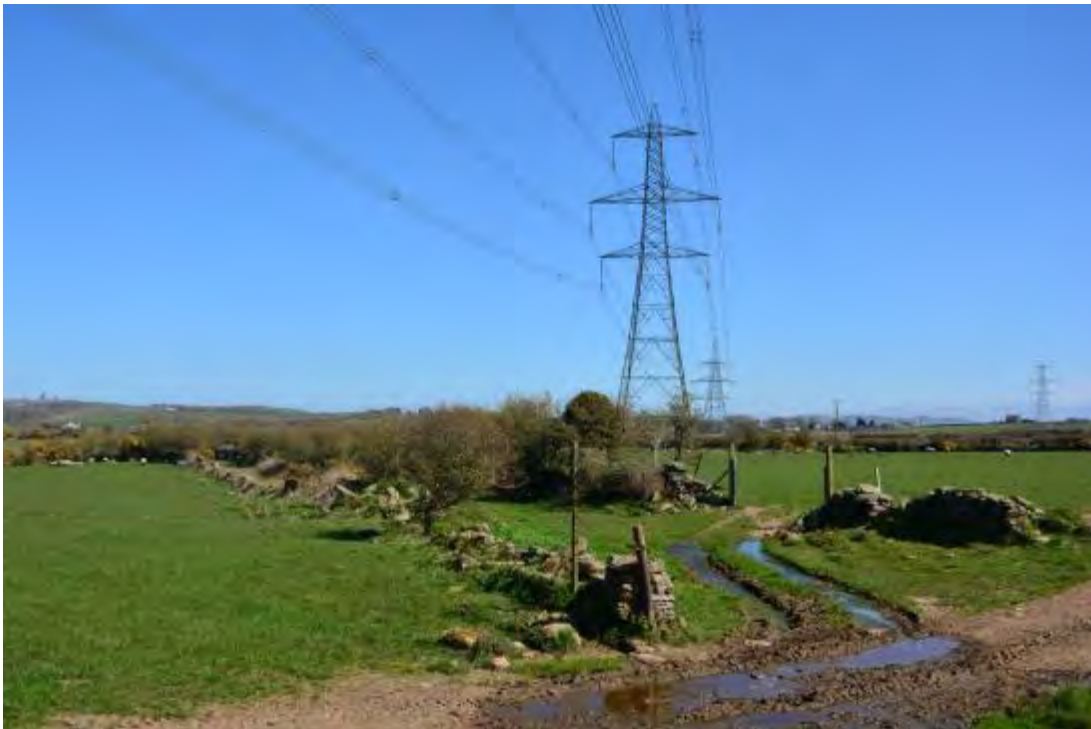
Photo 13: Ty'n-yr-allt Farmstead showing derelict cloddiau defined lane.

- 4.1.50 The walkover survey did not identify any new discrete heritage assets within the scoping corridor. However traditional field boundaries (Cloddiau) were identified throughout the Section A. It was noted that these are characteristic and variable in their construction, suggesting an element of chronological phasing (Byrne, 1996).

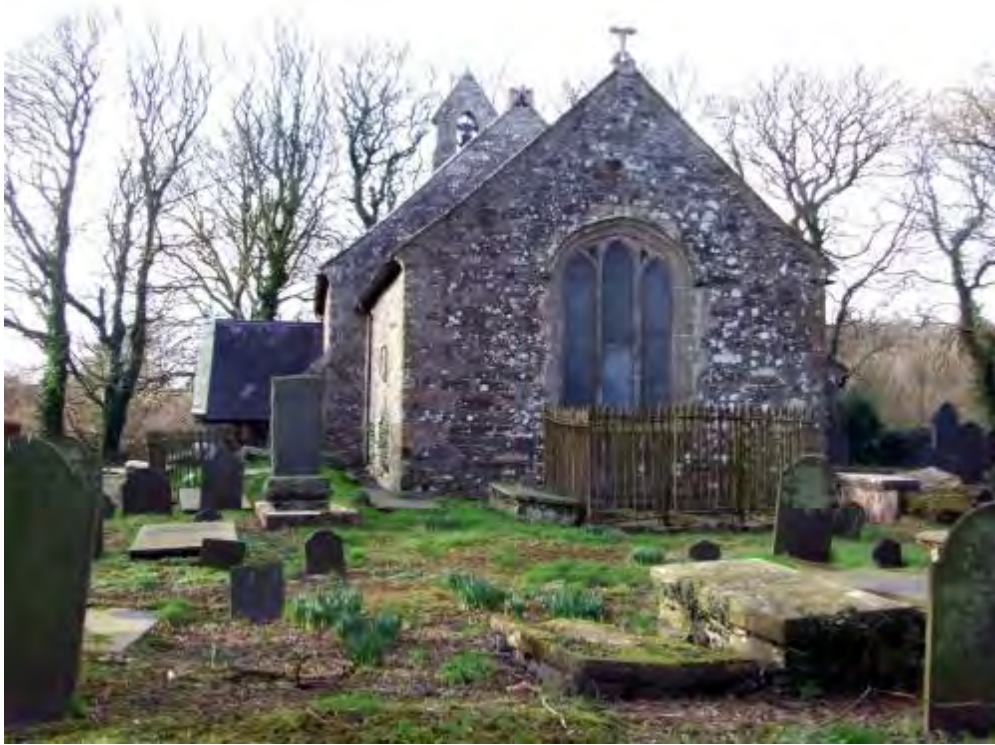
Photo 15: Church of St Tyfrydog (LB5360), Llandfydog

- 4.2.22 There are few recorded heritage assets dating to the medieval period. The Grade II* listed church (HER2096, LB 5361) is dedicated to St. Tyfrydog, a 5th or 6th century North Wales Christian who was later venerated as a Saint and said to have founded a church here. It sits within the small wooded settlement of Llandyfrydog. The historian Angharad Llwyd wrote in the 19th century that the church was established around AD450, and further documentary evidence refers to the church at Llandyfrydog in 1089 and 1254¹³, but the earliest datable fabric currently visible dates to around c1400 AD. Given the presence of a church since the mid-5th century it is likely that a contemporary settlement grew up around it, however that settlement did not develop into a larger village in the post medieval period.

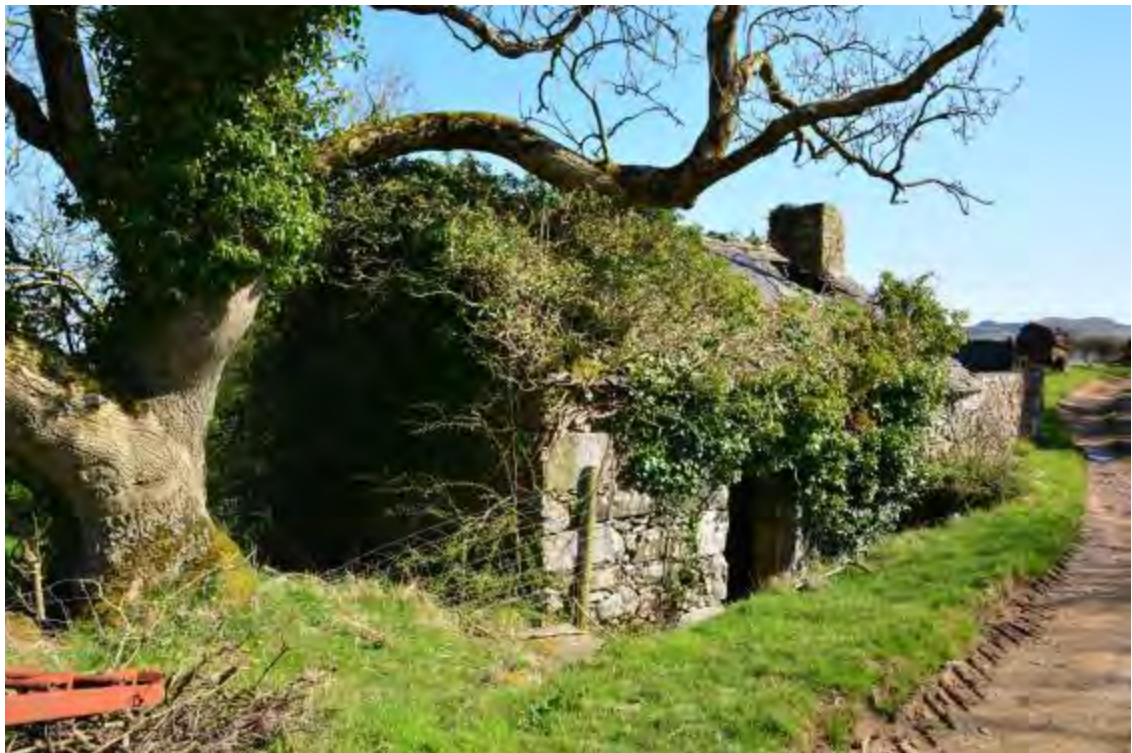
Photo 18: Watermill at Clorach Fawr (Amec ref 166)

4.3.34 The walkover survey within Section C did not identify any new discrete heritage assets within the survey area. Fields 102-113 were restricted due to these areas being marshland. While no heritage assets could be perceived, the potential for palaeoenvironmental deposits within this marshy ground are high. However access through the farm Clorach-fawr revealed a previously unrecorded undershot watermill and millpond (**Annex H, Photo 18**). Both were in a derelict and overgrown condition. The mill building was single storey and of stone rubble construction. The undershot waterwheel was still in situ, though also in poor condition. Assessment of historic mapping showed that the building was present on the 1888 OS map, but the tithe map did not record the farmstead in sufficient detail to identify specific buildings. However a sales particular for Clorach-fawr dated 26th July 1894 refers to a fulling mill on the site¹⁶.

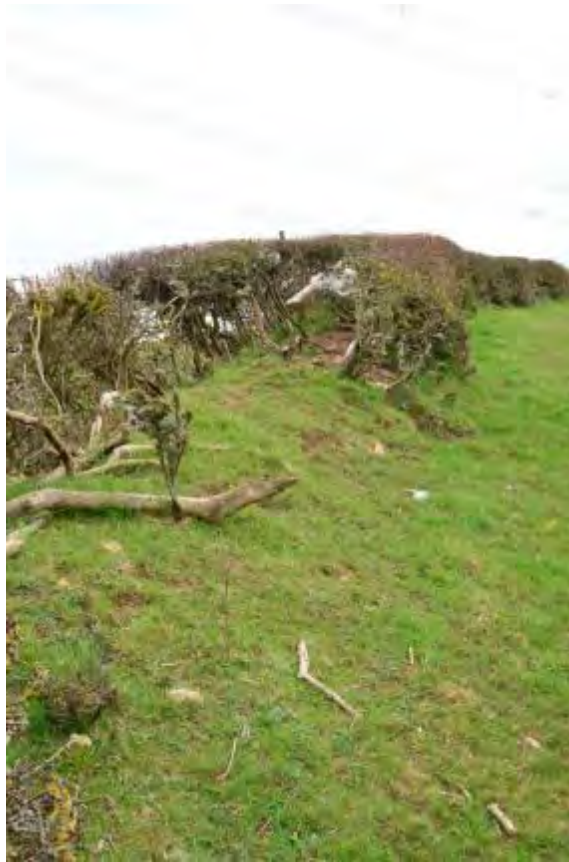
Photo 24: Example of section of Cloddiau, at SH486750

4.4.21 The walkover survey did not identify any significant discrete heritage assets within Section D, but did confirm that elements of this historic cloddiau defined field pattern survive, and were in many cases in poor condition (**Annex G, Photo 24**). At SH48397679 at the southern end of a rock outcrop a stone (with later brick additions) spring head was identified (**Annex G, Photo 26 & 27**). The hut circle settlement at Cefn Poeth Bach could not be identified as it was covered in thick vegetation.

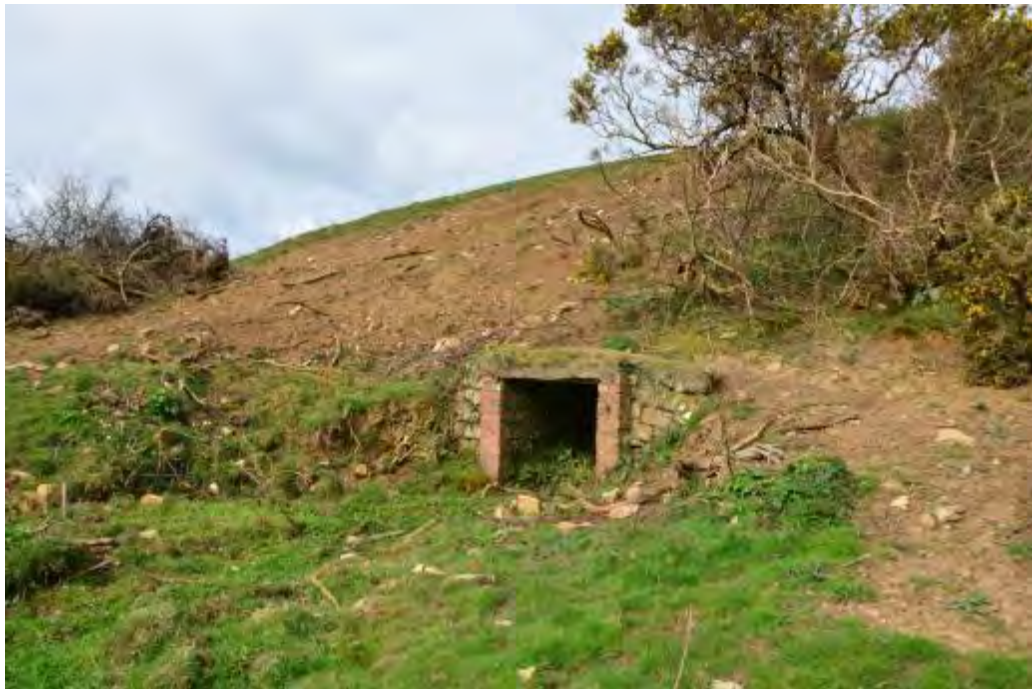
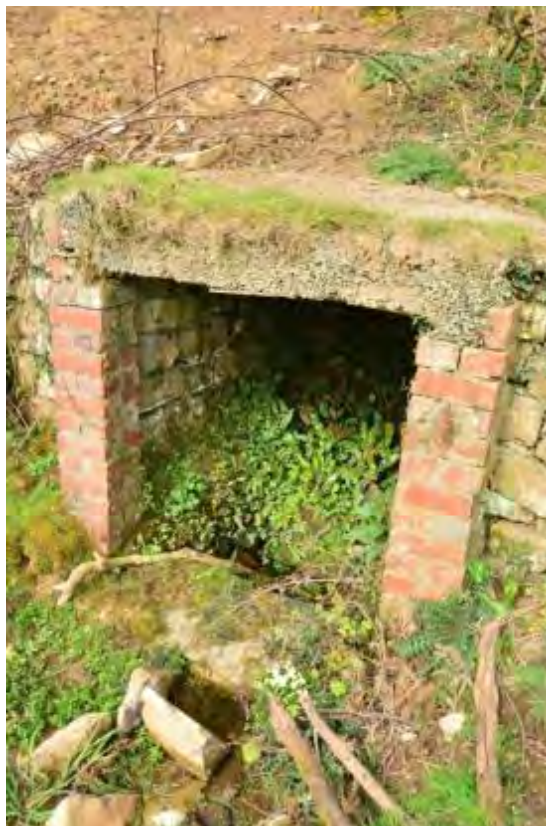
Photo 26: Spring head at SH48397679

Photo 27: Spring head at SH48397679 (detail)

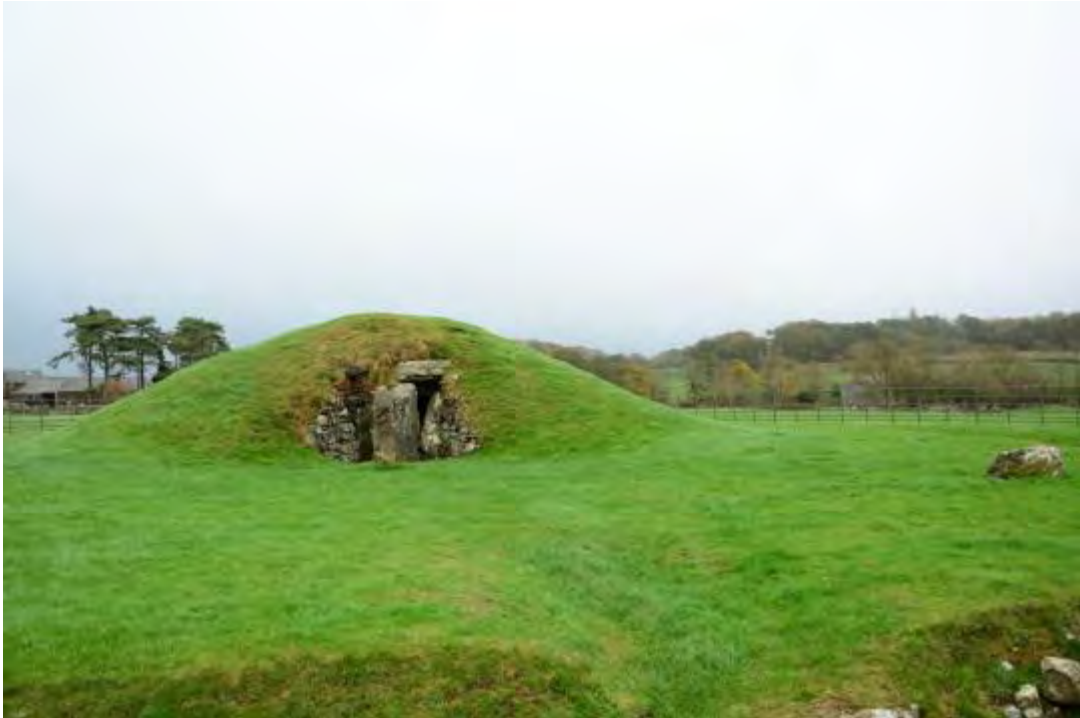
Photo 28: Bryn-Celli-Ddu Burial Chamber (AN002) from west

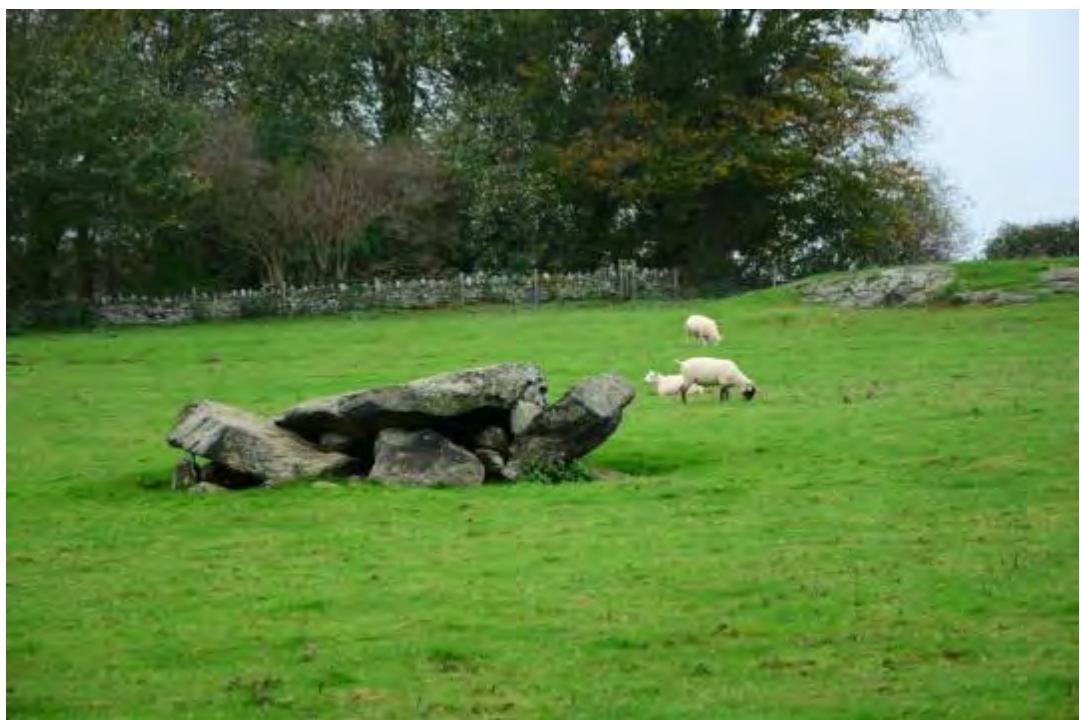
Photo 29: Burial Chamber 180m NE of Pen-y-Berth (AN037) from south
