~~ENVIRONMENTAL STATEMENT~~ ~~(VOLUME II)~~ ENVIRONMENTAL STATEMENT (VOLUME III)

Appendix 9-11 Arboricultural Impact Assessment (Tracked)

HyNet Carbon Dioxide Pipeline DCO

Document Reference Number D.6.3.9.11

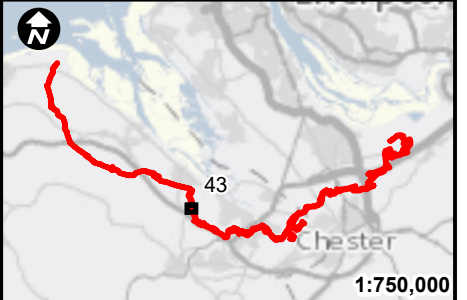
DRAWING NUMBER
EN070007-PA-PEI-3.1-Sheet 42

Section 6

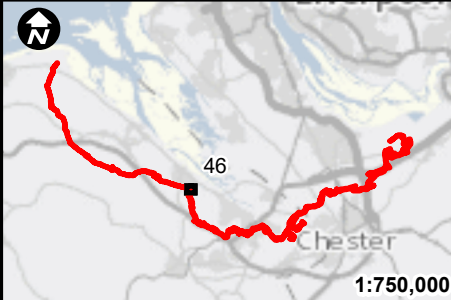
DRAWING NUMBER
EN070007-PA-PEI-3.1-Sheet 45

- New Infrastructure Development Boundary
- Areas Not Surveyed
- Proposed Sections
- BS 5837 Tree Category Grading**
- A A
- B B
- C C
- U U
- Preliminary Removals
- Root Protection Areas (RPA)**
- Root Protection Areas (RPA)
- Veteran Trees - RPA's**
- Veteran Tree to be Retained
- Veteran Tree at Risk, aiming to Retain
- Preliminary RAG Impact Assessment**
- Red - Removed
- Amber - At Risk
- Green - Retained
- Constructions Layers**
- Proposed Development Design
- Trenchless Crossing
- Centralised Compound
- Open-cut trench Crossings
- Trenchless Crossing Compound
- Construction Access – Existing Access Point
- Construction Access – New Access Point
- Localised Compound
