## ENVIRONMENTAL STATEMENT (VOLUME III)

### Appendix 18.1 Baseline Information

HyNet North West Carbon Dioxide Pipeline DCO

Document Reference Number D.6.3.18.1

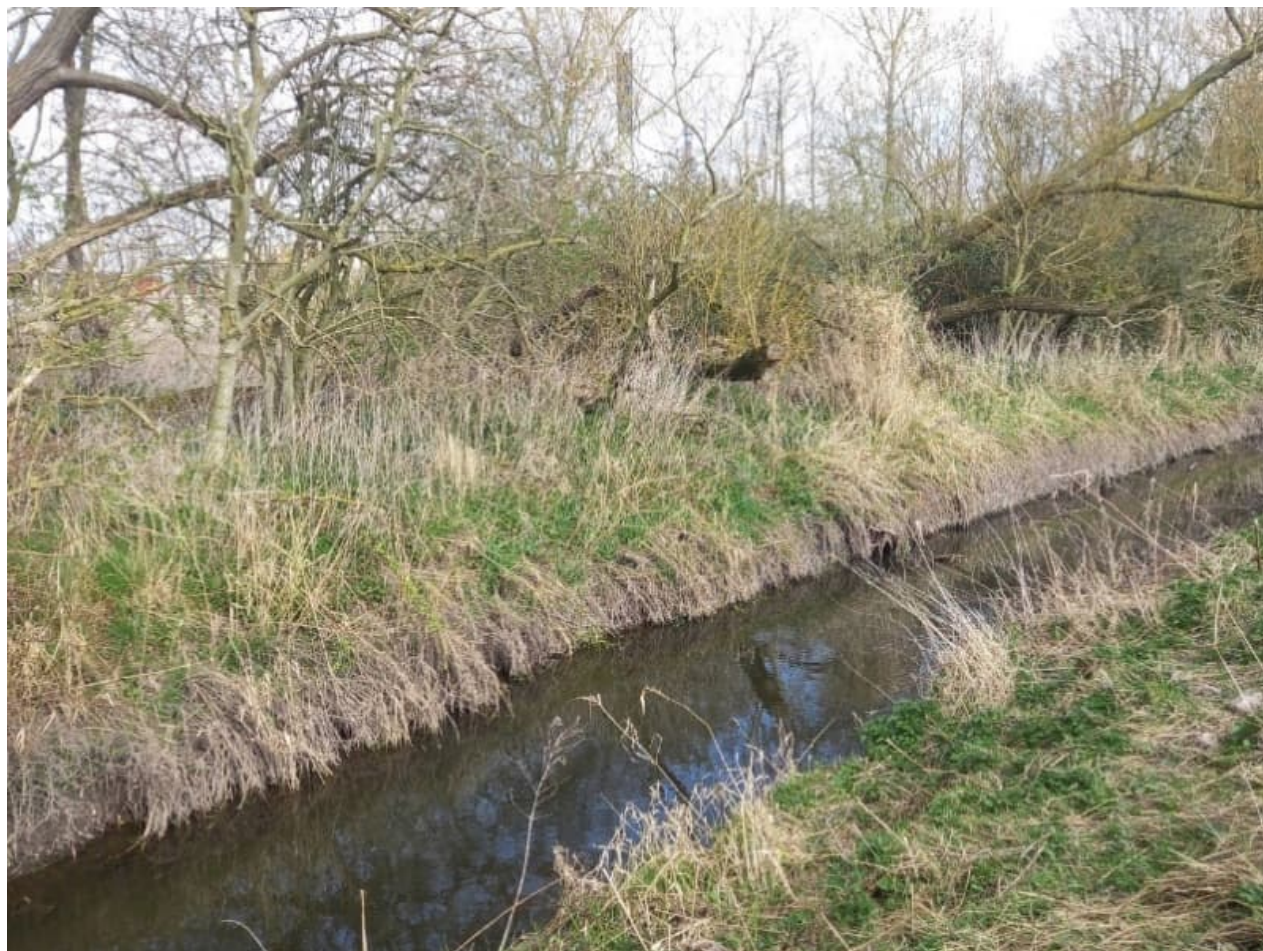
### 2.1. EAST CENTRAL DRAIN

<b>Catchment area</b>	1.02km <sup>2</sup>
<b>Key hydraulic connections</b>	Flows into West Central Drain
<b>River Condition Score</b>	Moderate
<b>Catchment description</b>	The catchment mostly comprises grassland with some arable and horticultural land uses. A smaller proportion of built-up land cover and woodland. The catchment has an elevation between -4.9 - 40 mAOD).
<b>Study reach description</b>	The watercourse is a trapezoidal artificial channel which is incised and not connected with the floodplain. Water depth is between 0.5 – 0.8m whilst bankfull width is 5- 6.5m.  Bed material is silt and organic matter.

<p>The riparian zone on the left bank is grazed, whilst the right bank is woodland. In-channel vegetation is limited.</p> <p>The East Central Drain has provided drainage for the Ince Marshes since at least 1885. The East Central Drain has maintained a similar planform since 1885, to present day.</p>
<p><b>Interaction with the DCO Proposed Development</b></p>	<p>Ince AGI is located within 8m of this watercourse and the surface water drainage system from this AGI will connect to this watercourse.</p>

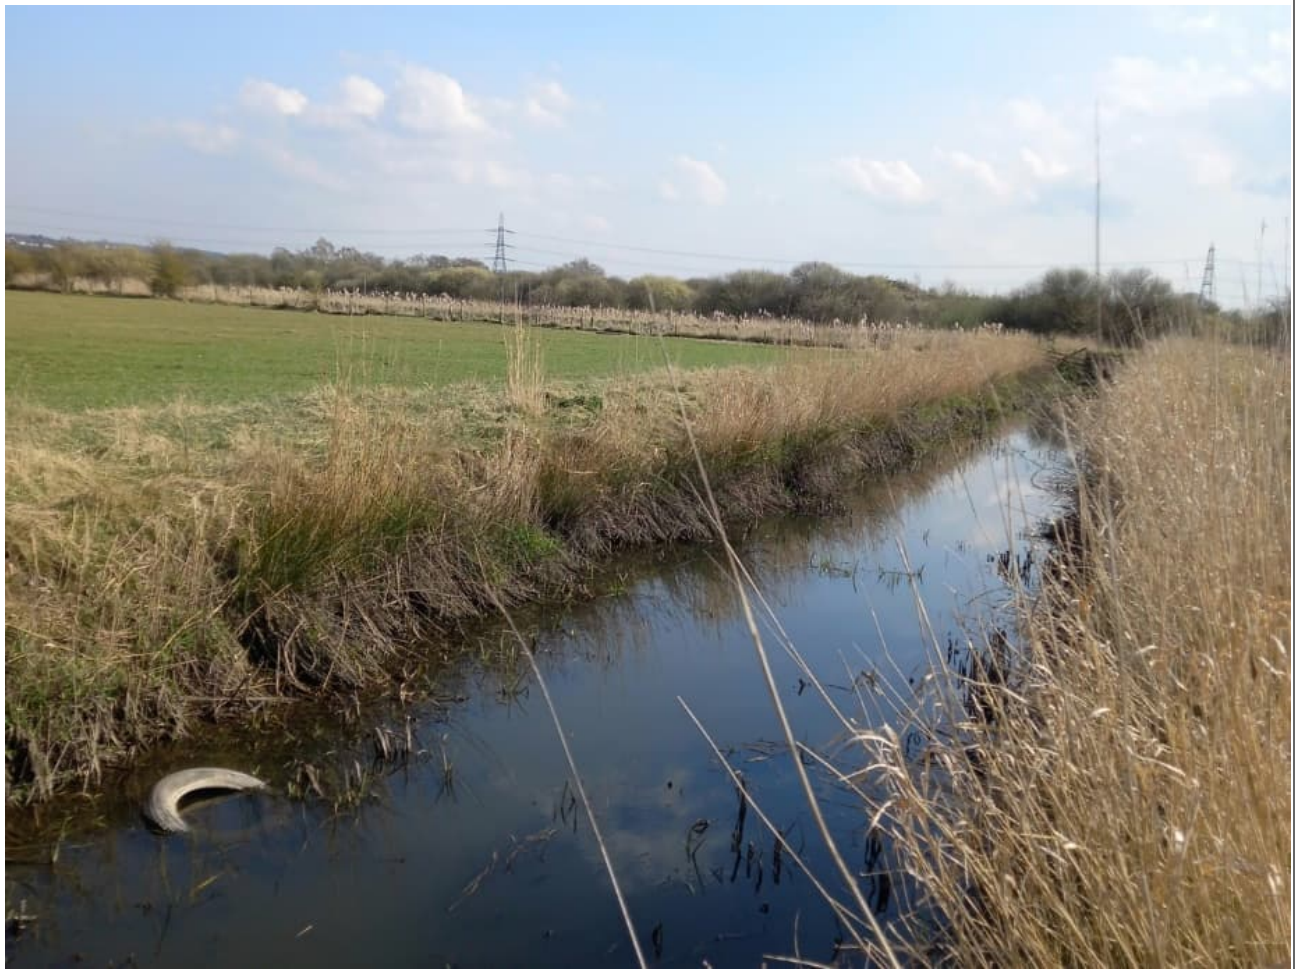
## 2.2. WEST CENTRAL DRAIN

<b>Catchment area</b>	0.55km <sup>2</sup>
<b>Key hydraulic connections</b>	Drains the Elton Marsh Drains (1-13), joined by Hapsford Brook and East Central Drain at Ince Marshes. Flows northwards towards the Manchester Ship Canal where water is pumped into the canal at high flows. The watercourse discharges to Hoolpool Gutter.
<b>River Condition Score</b>	Fairly Poor
<b>Catchment description</b>	The West Central Drain forms the main stem off the Elton Marsh Drains (1 –13). The channel drains a small catchment of farm and agricultural land.
<b>Study reach description</b>	The watercourse is a trapezoidal artificial channel with bankfull width varying between 5-6m and water depth approximately 0.8m. It has a

<p>mixture of steep and shallow banks through the Newbuild Infrastructure Boundary.</p> <p>Bed material is predominantly silt and organic matter. The riparian zone comprises grazed grassland which is frequently wet. There are tall grasses along both banks of the watercourses.</p> <p>The West Central Drain has provided drainage for the Ince Marshes since at least 1885. The Western Central Drain has maintained a similar form since 1914.</p>
<p><b>Interaction with the DCO Proposed Development</b></p>	<p>West Central Drain will be crossed by the Newbuild Carbon Dioxide Pipeline in one location via open cut. The watercourse would also be crossed by vehicles using existing access tracks over existing culverts in the Newbuild Infrastructure Boundary.</p>

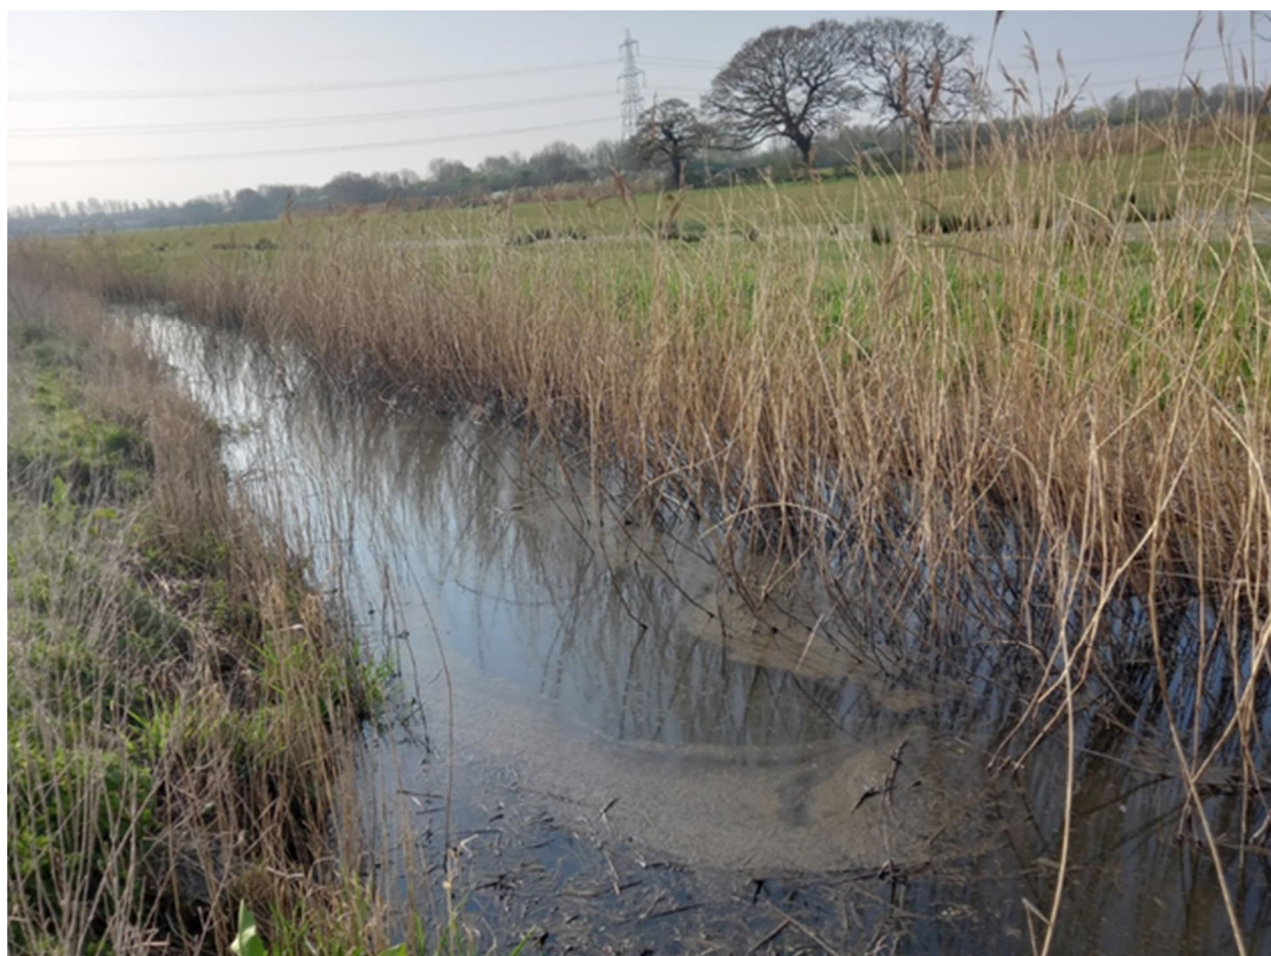
## 2.3. HAPSFORD BROOK

<b>Catchment area</b>	2.87km <sup>2</sup>
<b>Key hydraulic connections</b>	The Hapsford Brook drains the Elton Marshes between Hapsford Lane and the M56, connecting to Elton Marsh Drains 9 to 13 in peak flow and discharging to West Central Drain.
<b>River Condition Score</b>	Moderate
<b>Catchment description</b>	The channel drains a catchment consisting of arable and horticultural grasslands, with some areas of development (Hapsford and Elton). The source of the Hapsford Brook rises from Dunham-on-the-Hill (40.1 -60 mAOD).
<b>Study reach description</b>	The watercourse is a trapezoidal cut channel with a bankfull channel width of 5.5 m and depth of 0.4 m. The watercourse is ungauged.

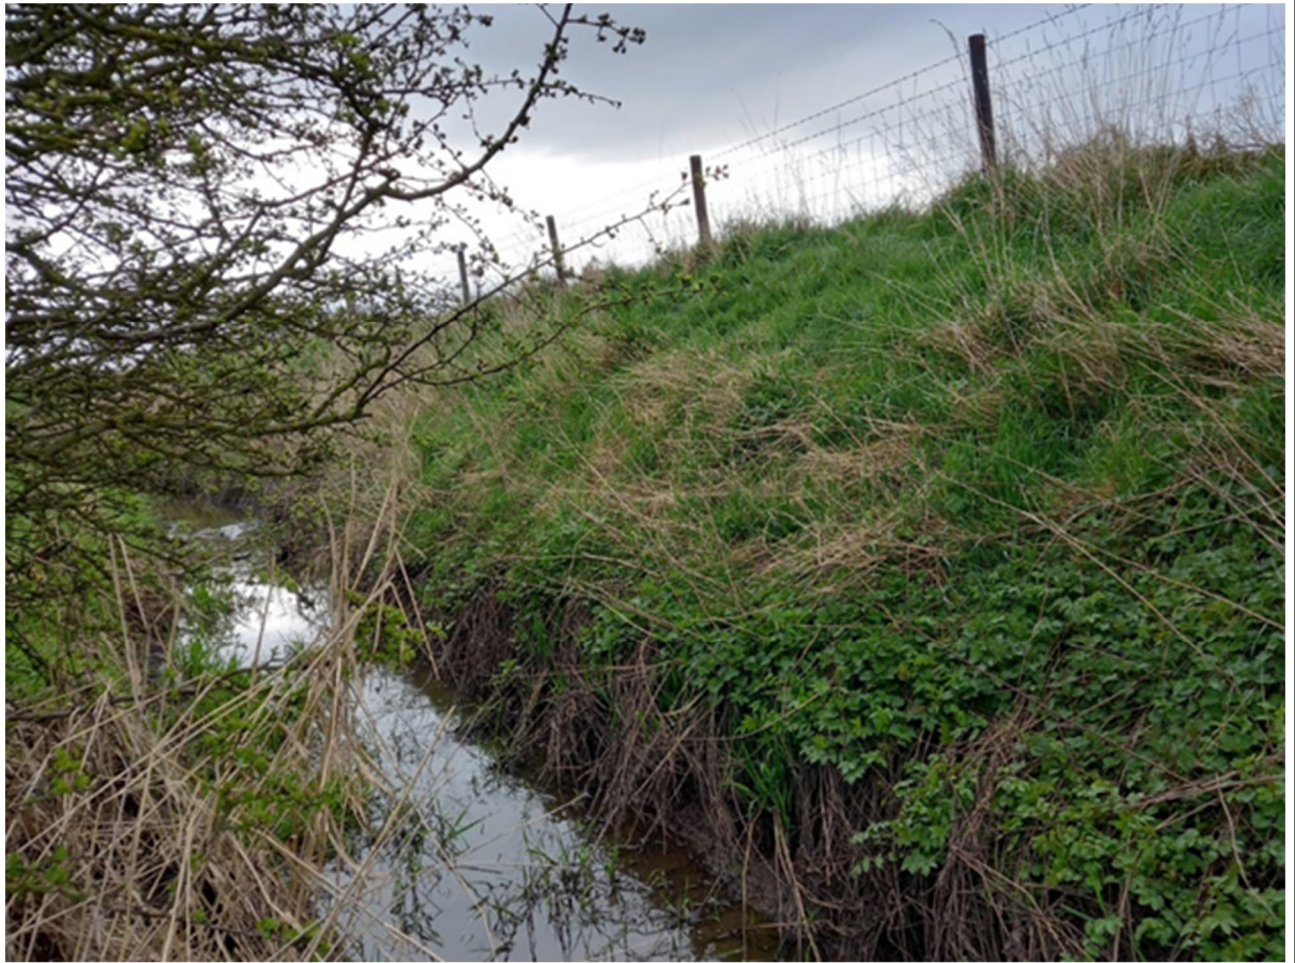
## 2.4. GALE BROOK

<b>Catchment area</b>	6.64km <sup>2</sup>
<b>Key hydraulic connections</b>	The Gale Brook drains into the River Gowy. The channel is disconnected from its floodplain as it is incised and flows through a network of culverts.
<b>River Condition Score</b>	Moderate
<b>Catchment description</b>	<p>The Gale Brook drains agricultural and pastoral land in the headwaters and urban/ suburban areas at its confluence with the Gowy. The land use is mostly arable and horticultural.</p> <p>The Gale Brook flows northwest to the River Gowy, with headwaters starting around 1.18 km north west of Dunham-on-the-Hill (10 mAOD).</p>

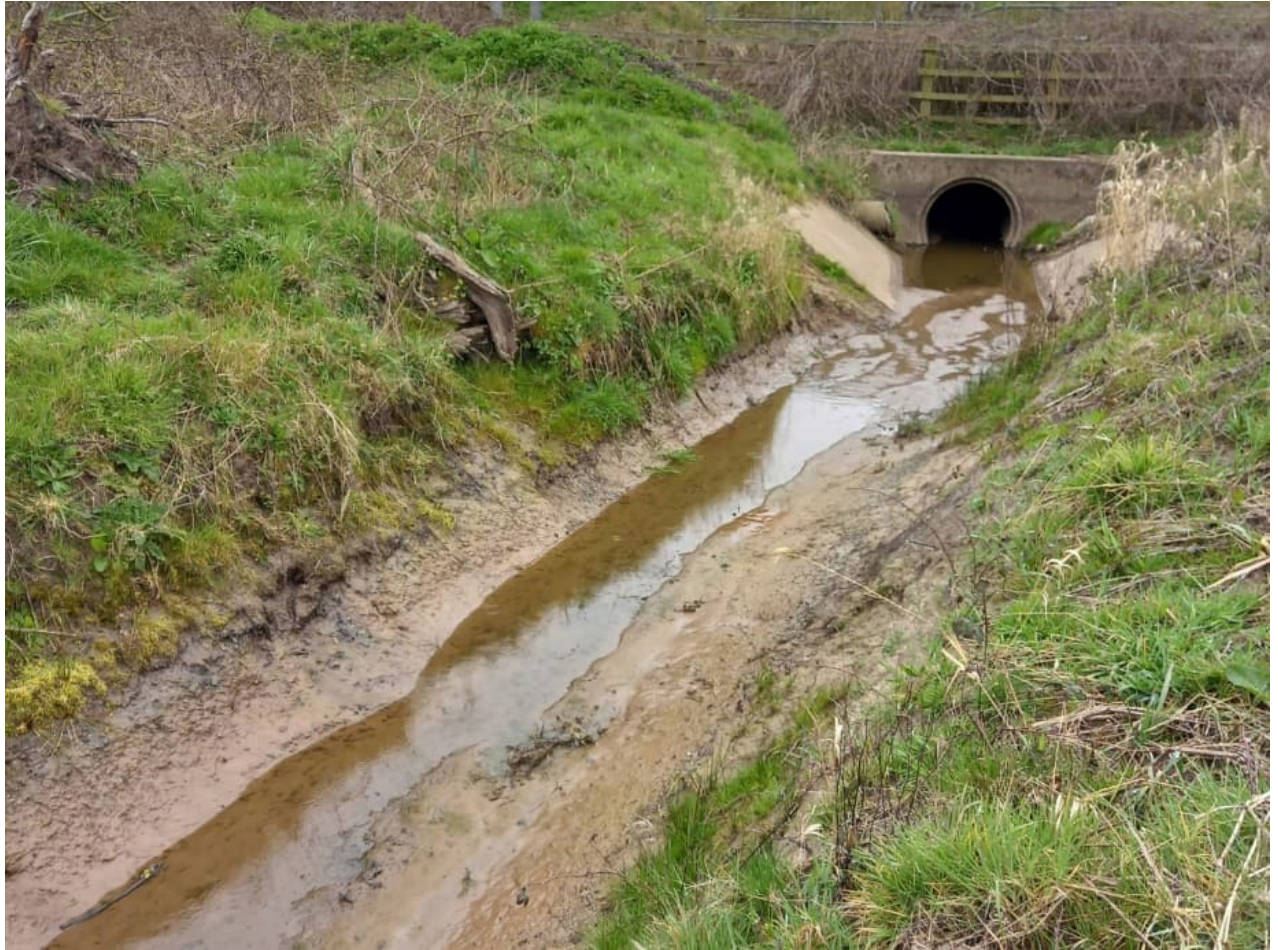
## 2.5. THORNTON UPLANDS

<b>Catchment area</b>	2.32km <sup>2</sup>
<b>Key hydraulic connections</b>	Thornton Uplands flows northwards to River Gowy. It is joined by Halls Green Lane Brook and Thornton Marsh Central.
<b>River Condition Score</b>	Fairly Poor
<b>Catchment description</b>	Thornton Uplands drains agricultural and pastoral land in the headwaters and is culverted as it flows under Ince Lane and track lanes. The channel rises from farm ditches, around 1.4 km southwest of Dunham-on-the-Hill (10 mAOD).
<b>Study reach description</b>	The watercourse is a trapezoidal cut channel, with obviously reshaped earth banks, with bankfull width between 3- 3.5 m and water depth approximately 0.03 m (within Newbuild Infrastructure Boundary).

<p>The bed material is a mixture of sediment, with the presence of gravel – pebble sized sediments. There is evidence of some sand, with extensive silt and clay components. No organic materials were present at the time of survey.</p> <p>The riparian zone is mostly farmland with some residential and farm building. The banks comprise extensive bare earth, with some short creeping herbs and grasses, tall herbs and grasses. Scrubs, shrubs and a few trees and saplings were also noted on the bank top.</p> <p>The channel has maintained a similar planform since 1884 – 1900.</p>
<p><b>Interaction with the DCO Proposed Development</b></p>	<p>Thornton Uplands will be crossed by the Newbuild Carbon Dioxide Pipeline via open trench.</p>

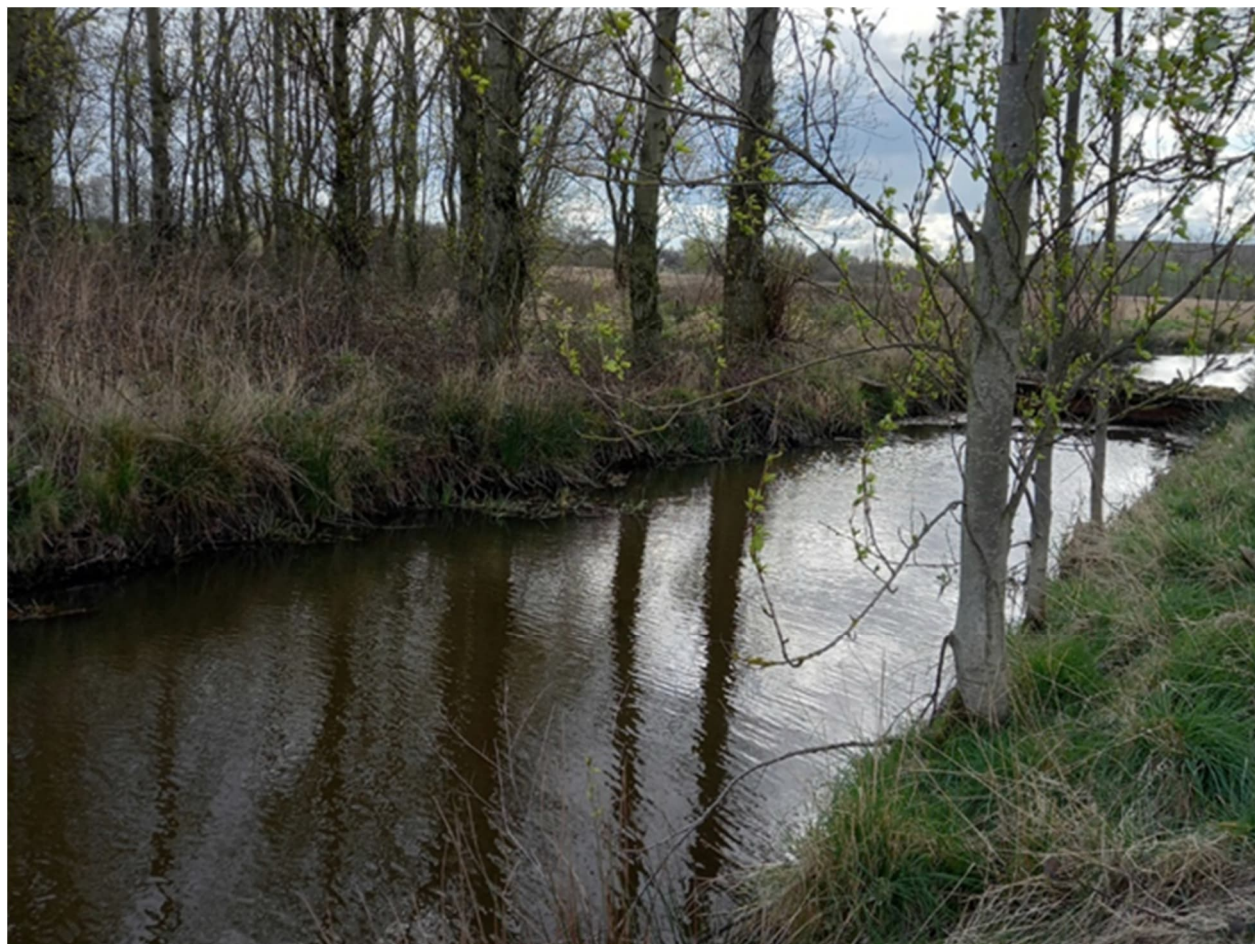
## 2.6. THORNTON MAIN DRAIN

<b>Catchment area</b>	3.00km <sup>2</sup>
<b>Key hydraulic connections</b>	Thornton Ditches 5 – 12 drain into the Thornton Main Drain. The Thornton Main Drain joins the River Gowy at the A5117.
<b>River Condition Score</b>	Fairly Poor
<b>Catchment description</b>	<p>Thornton Main Drain drains agricultural and pastoral land in its headwaters, with the surrounding land uses being farmland, agricultural buildings and settlement, a landfill site, and a peat bog.</p> <p>The channel rises from farm ditches, around 0.7 km northwest of Wimbolds (6 mAOD).</p>

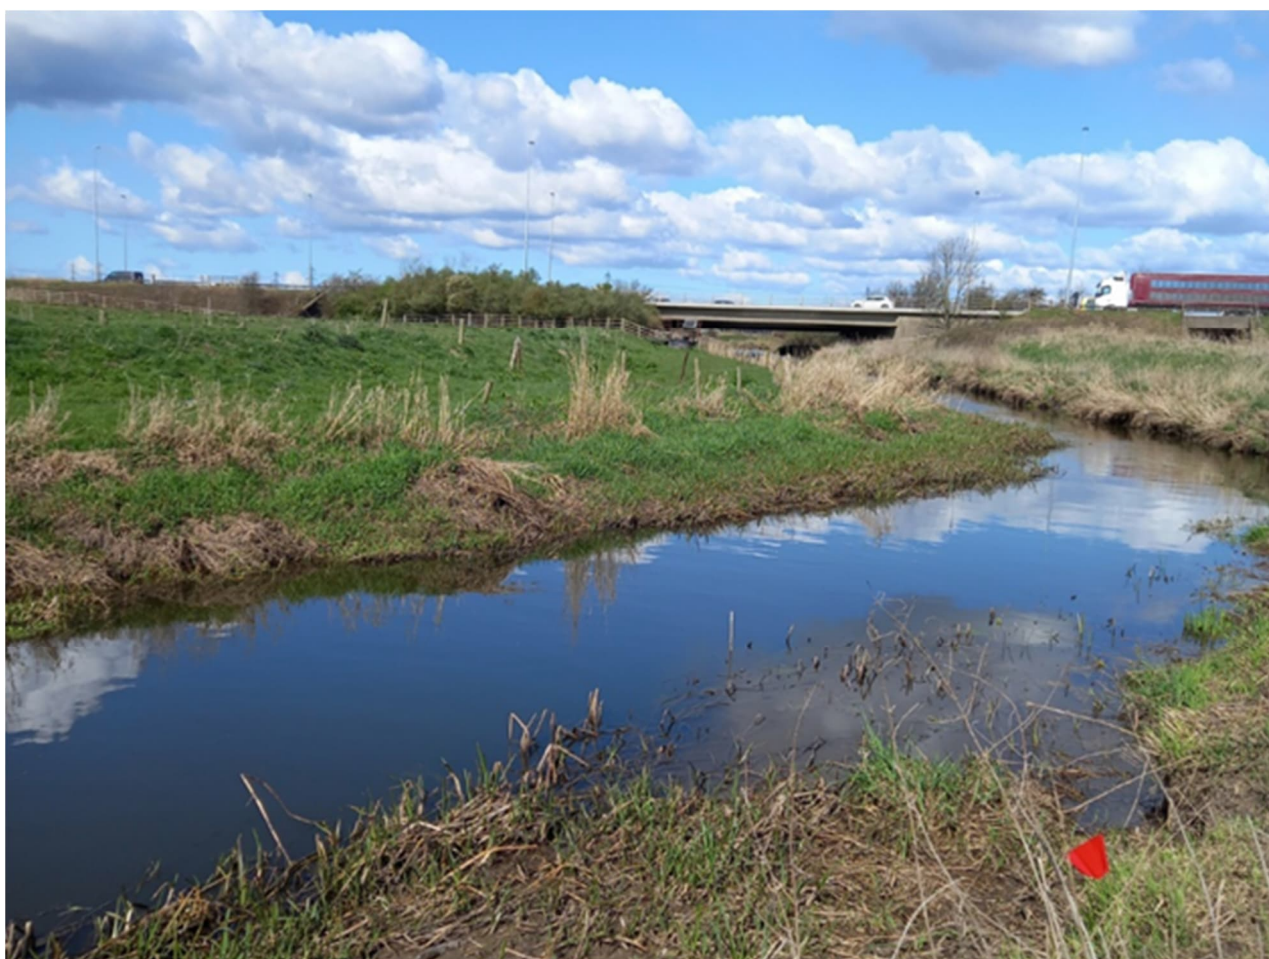
## 2.7. RIVER GOWY

<b>Catchment area</b>	150km <sup>2</sup>
<b>Key hydraulic connections</b>	<p>The River Gowy is fed by the Barrow Brook, Back Brook, Milton Brook, Salters Brook and Ashton Brook upstream of the DCO Proposed Development. Downstream of the DCO Proposed Development, the River Gowy is joined by Thornton Main Drain, Thornton Uplands, Stanney Mill Brook and Gale Brook. The River Gowy flows into the River Mersey.</p> <p>The river is disconnected from its floodplain due to flood defences through most of its middle and lower course.</p>
<b>River Condition Score</b>	Moderate
<b>Catchment description</b>	The River Gowy drains the surrounding arable and horticultural land, in addition to a landfill site, settlement and peat bog.

<p>There are a variety of geomorphic pressures (e.g. poor soil, nutrient, and livestock management, contaminated land, ecological discontinuity, ground water abstraction, pollution from wastewater industry and landfill). The catchment has a maximum elevation of 43 m ASL (Helsby Hill).</p>
<p><b>Study reach description</b></p>	<p>The channel is heavily modified, with generally shallow channel banks, obviously reshaped, and with set-back embankments. Bankfull width is 6.5 - 8 m and water depth is 0.8 - 1m. Some berms and eroding cliffs were noted within the Newbuild Infrastructure Boundary. Nest holes were observed in the channel banks.</p> <p>Bed material is silt with extensive cover of unvegetated bare sediment and some emergent and submerged aquatic vegetation. The riparian zone is mostly grazed pasture comprising predominantly grasses, creeping herbs and taller vegetation. The riparian zone is frequently wet.</p> <p>The confluence of the Gowy and Mersey has remained in the same place since at least 1892. However, the course of the Gowy upstream of this point has been heavily modified with evidence of straightening and realignment. The middle course of the channel has been canalised and flood embankments existing on both banks of the Gowy through the study reach.</p>

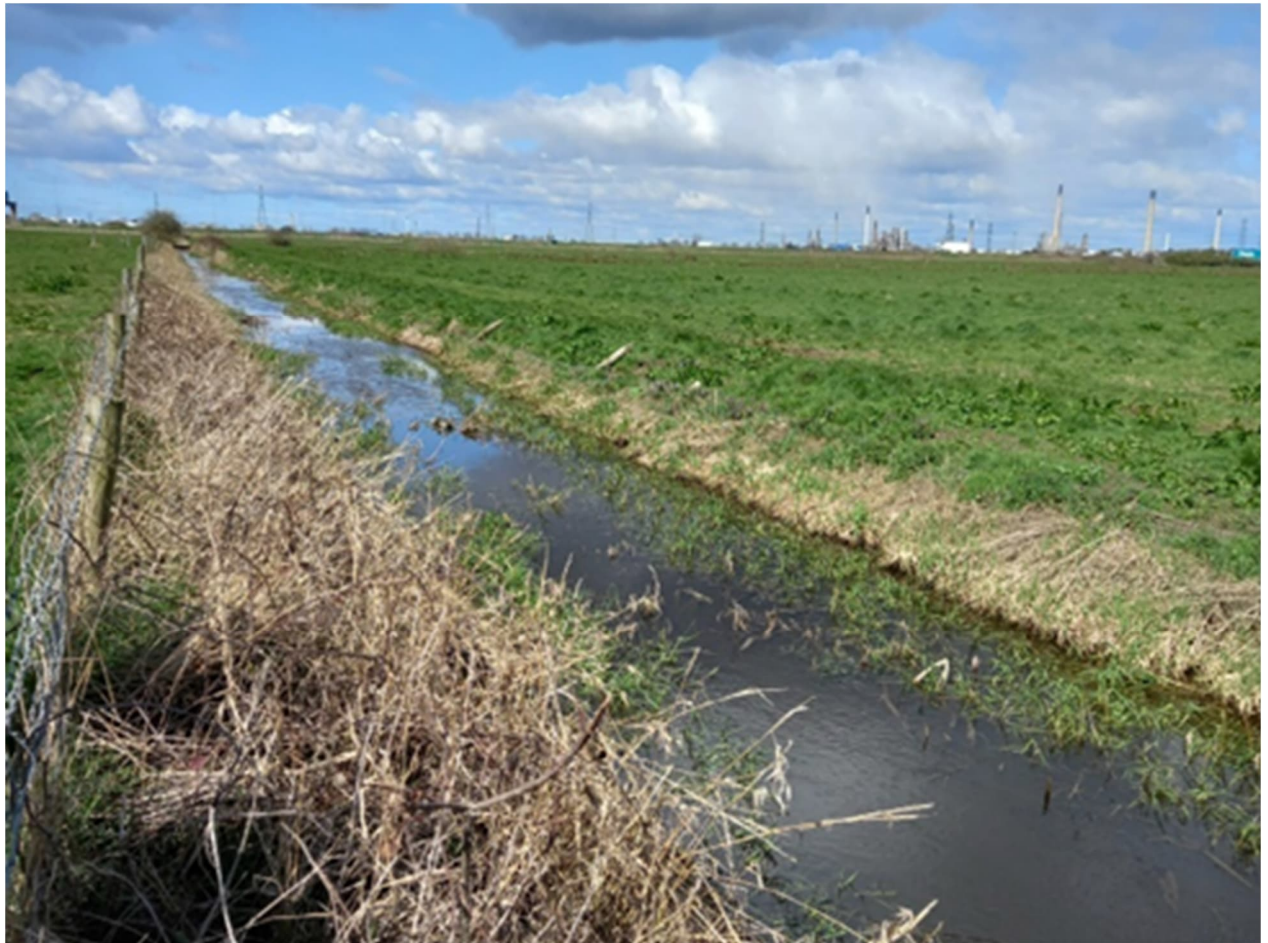
## 2.8. STANNEY MAIN DRAIN

<b>Catchment area</b>	<1km <sup>2</sup>
<b>Key hydraulic connections</b>	This is an artificial drain within the River Gowy floodplain. It is connected to Thornton Ditch (1,2), Mill Brook, Mill Brook Tributary (1,2) and Gowy Tributary (1,2). It joins the River Gowy at the A5117.
<b>River Condition Score</b>	Fairly Poor
<b>Catchment description</b>	Stanney Main Drain drains agricultural and pastoral land in its headwaters, with the surrounding land use being farmland, agricultural buildings and roadways. The catchment is boggy in the headwaters. The channel rises from farm ditches, around 0.47 km west of Bridge Trafford. It has a maximum catchment altitude of 6 mAOD.
<b>Study reach description</b>	Stanney Main Drain is a trapezoidal, cut and over deepened ditch that appears to have been artificially straightened. Bankfull width is

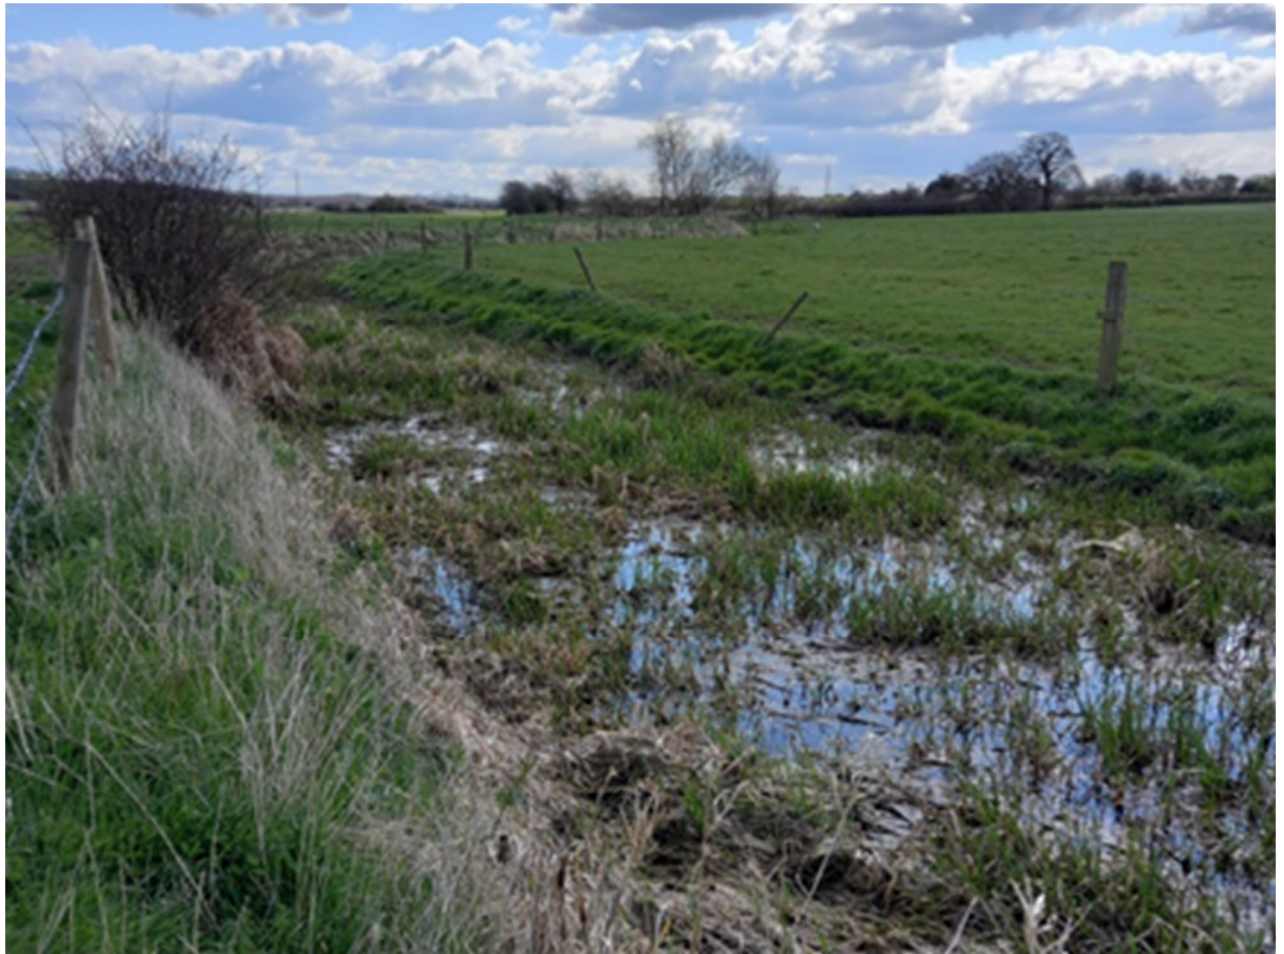
## 2.9. STANNEY MILL BROOK

<b>Catchment area</b>	6.95km <sup>2</sup>
<b>Key hydraulic connections</b>	<p>Gowy Tributary 2 connects Stanney Mill Brook and Stanney Main Drain. Picton Brook flows into the Stanney Mill Brook. The Stanney Mill Brook drains into the Gowy downstream of the A5117.</p> <p>There is a wastewater treatments works on the Stanney Mill Brook south of the A5117 into which the watercourse may outfall, though this is unconfirmed.</p> <p>Within the Newbuild Infrastructure Boundary the watercourse is disconnected from its floodplain.</p>
<b>River Condition Score</b>	Moderate – Fairly Poor

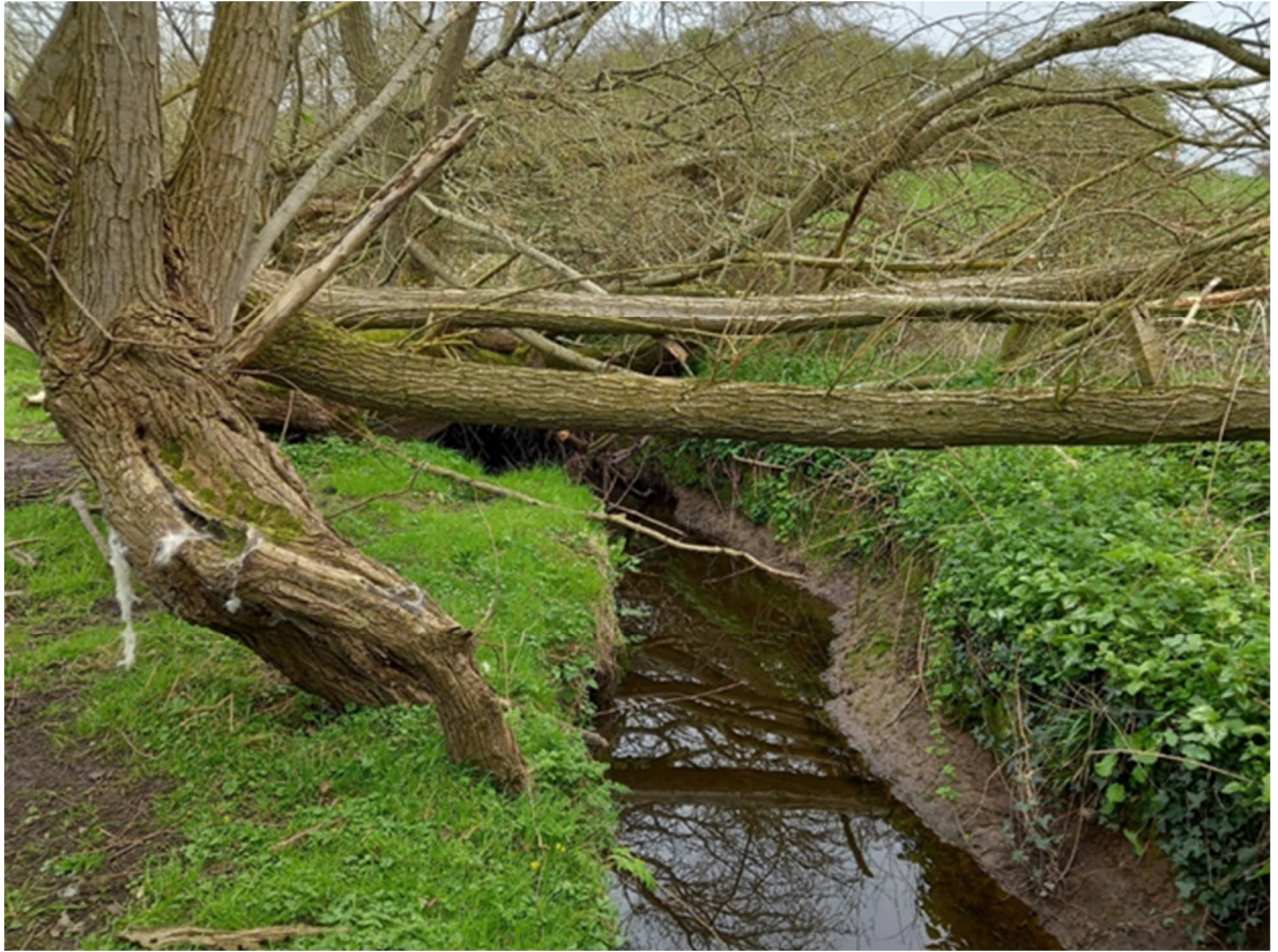
## 2.10. BACKFORD BROOK

<b>Catchment area</b>	4.97 km <sup>2</sup>
<b>Key hydraulic connections</b>	There are three tributaries of Backford Brook which drain land south of Dunkirk and the M56. Backford Brook is culverted beneath the Shropshire Union Canal and then joins Finchetts Gutter.
<b>River Condition Score</b>	Fairly Good upstream of field culvert. Fairly Poor downstream of field culvert.
<b>Catchment description</b>	The catchment is predominantly rural, with the main land uses being pasture, grassland, and woodland. Elevation varies from 38m to 19mAOD.
<b>Study reach description</b>	Upstream of the field culvert, the channel varies in width and depth, but it has approximately 0.5m and bankfull width is approximately 1.1m throughout the studied reach. The Backford Brook has a sinuous channel, with step-pools created by log jams, thus providing good in-

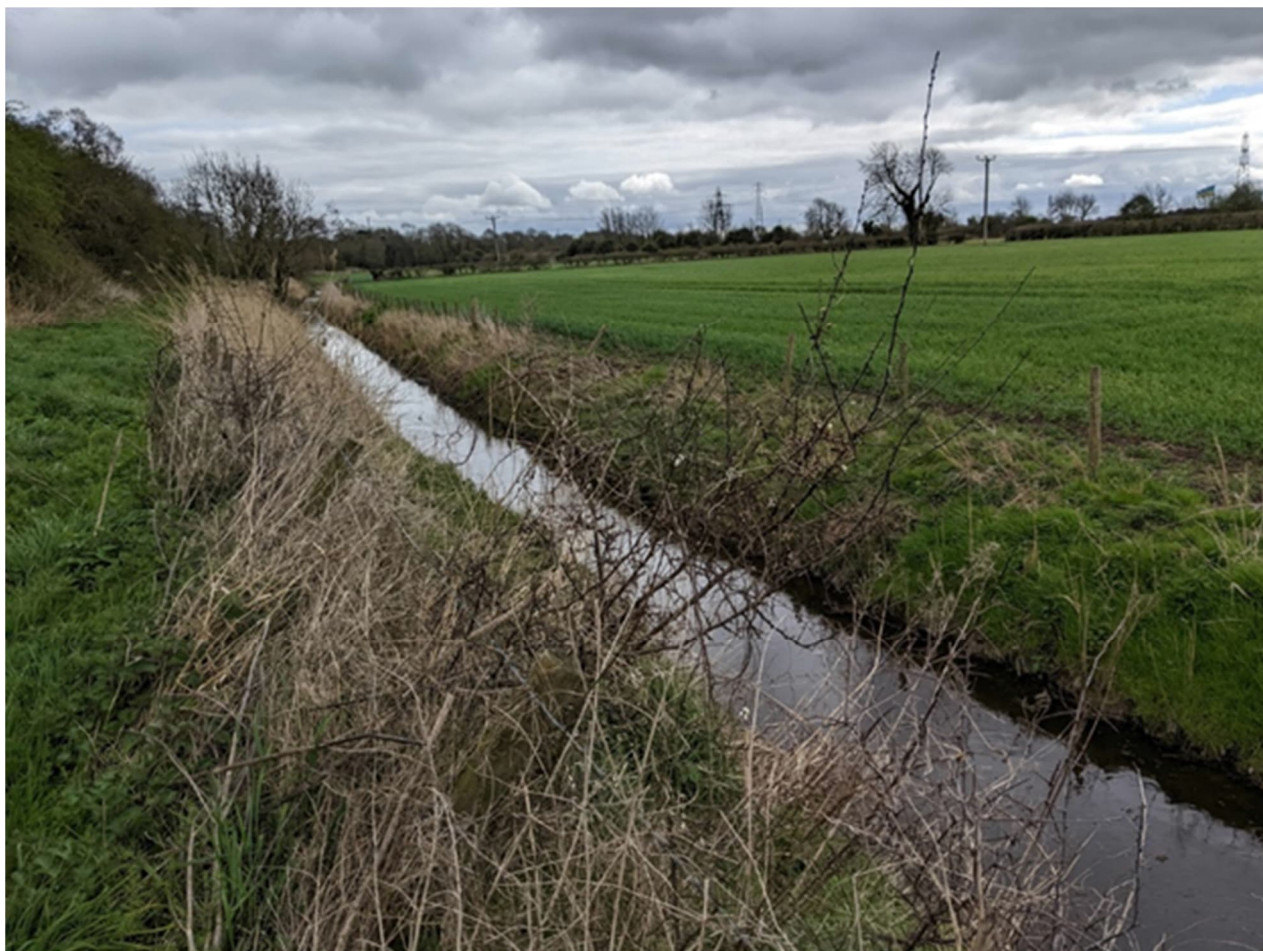
## 2.11. SEAHILL DRAIN

<b>Catchment area</b>	3.03 km <sup>2</sup>
<b>Key hydraulic connections</b>	This watercourse has several tributaries and merges with the Garden City Gutter before reaching the River Dee.
<b>River Condition Score</b>	Fairly poor
<b>Catchment description</b>	The Seahill Drain catchment has a high degree of human influence on watercourses and landscape, with the land use being arable agriculture and permanently vegetated recreational. Elevation varies from ~ 25m to 5mAOD.
<b>Study reach description</b>	Seahill Drain is a linear watercourse, with no significant variation in water depth and along the investigated reach. Mean water depth and width are 0.45m and 2.1m, respectively.

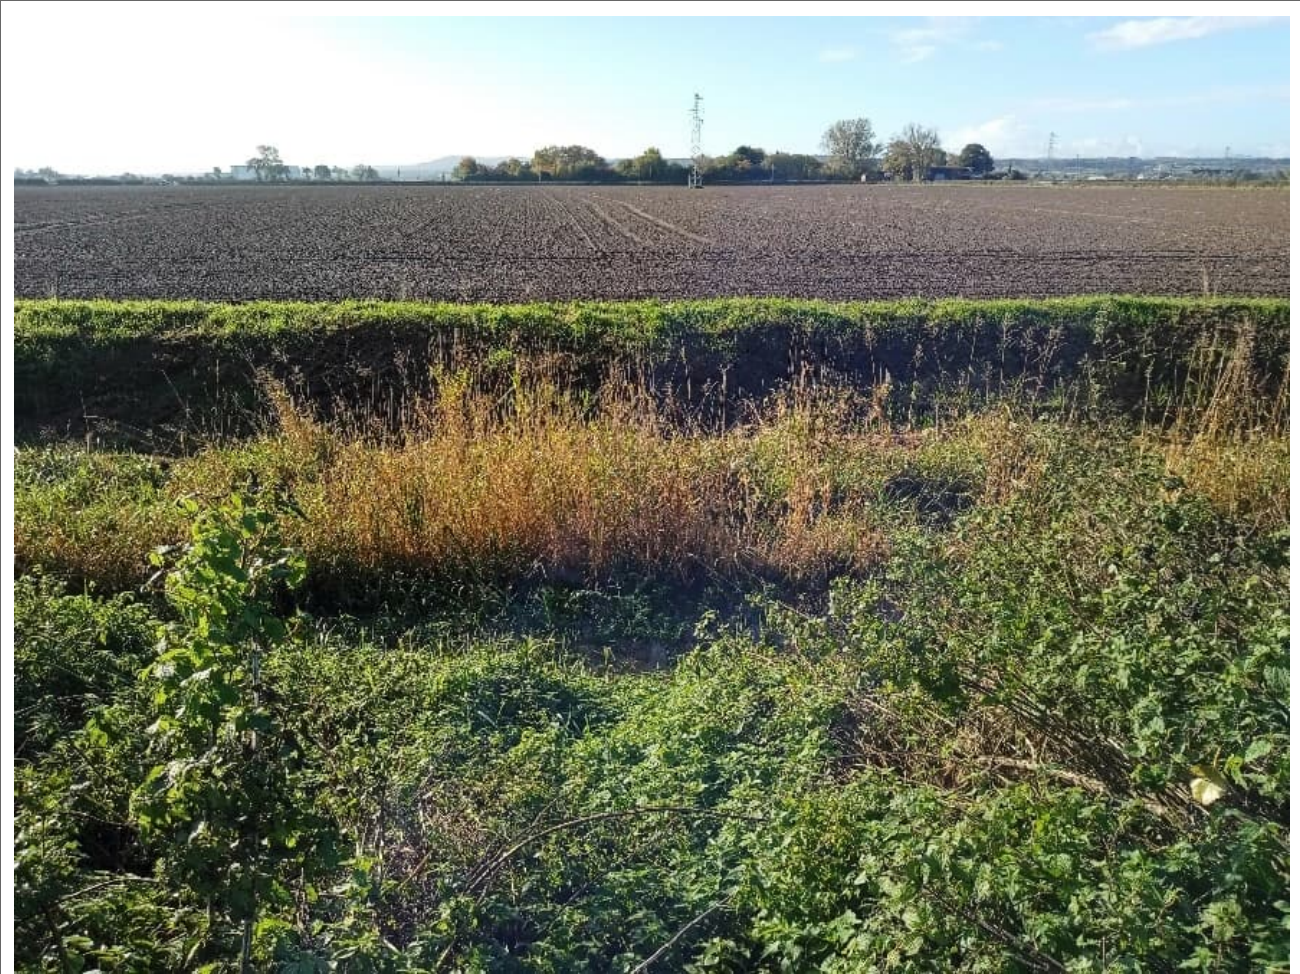
## 2.12. SEALAND MAIN DRAIN

<b>Catchment area</b>	6.74km <sup>2</sup>
<b>Key hydraulic connections</b>	The Sealand Main Drain receives water from the Seahill Drain and the Garden City Gutter before flowing to the River Dee. The watercourse is disconnected from its floodplain.
<b>River Condition Score</b>	Fairly poor
<b>Catchment description</b>	The catchment is marked by several artificial watercourses; therefore, it is unlikely to reflect the original geometry. The current catchment drains tilled farm land, pasture, grassland, woodland, and urban areas.
<b>Study reach description</b>	The channel is artificially incised in order to store and channel flood flows to the River Dee, with watercourse geometry minimal. Water width is ~ 1.1m, and water depth is ~ 0.15m.

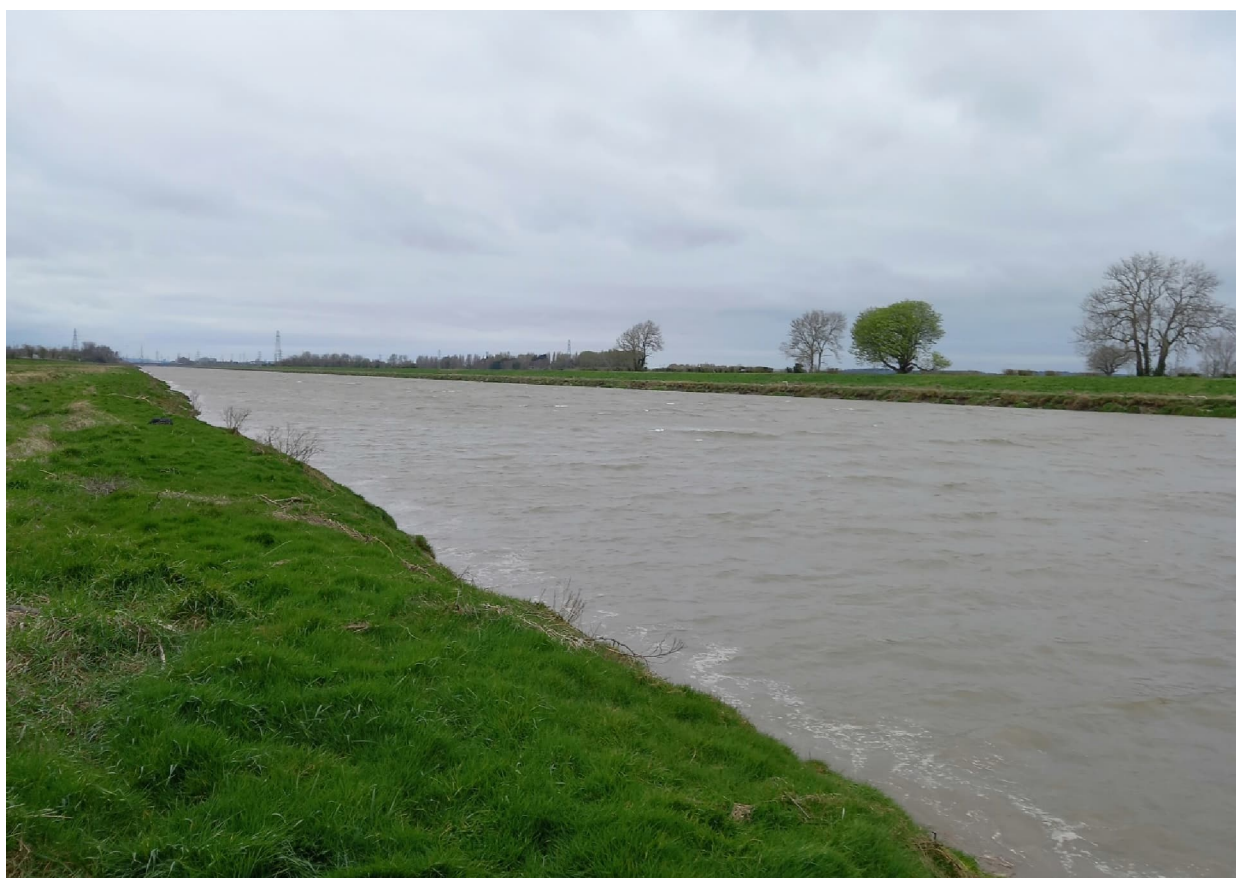
## 2.13. DEE ESTUARY

<b>Catchment area</b>	136.7 km <sup>2</sup>
<b>Key hydraulic connections</b>	The Dee is the downstream receptors of many watercourses scoped into this assessment. The Dee is tidal up to Chester and flows out to the North Wales coastal water body.
<b>River Condition Score</b>	Moderate
<b>Catchment description</b>	<p>Major estuary with extensive mudflats and saltmarsh habitat, with entire estuary area designated as a SAC, SSSI and SPA. Land use is a mix of rural agriculture, industrial, urban areas (Flint, West Kirby, Neston, Heswall, Connah's Quay and the City of Chester at the historic head of the estuary).</p> <p>Estuary is macrotidal, with a 7.7mAOD tidal height on a spring tide and a 4.1mAOD tidal height on a neap tide. Approximately 90% of the estuary area is estimated to dry out in a large spring low tide.</p>

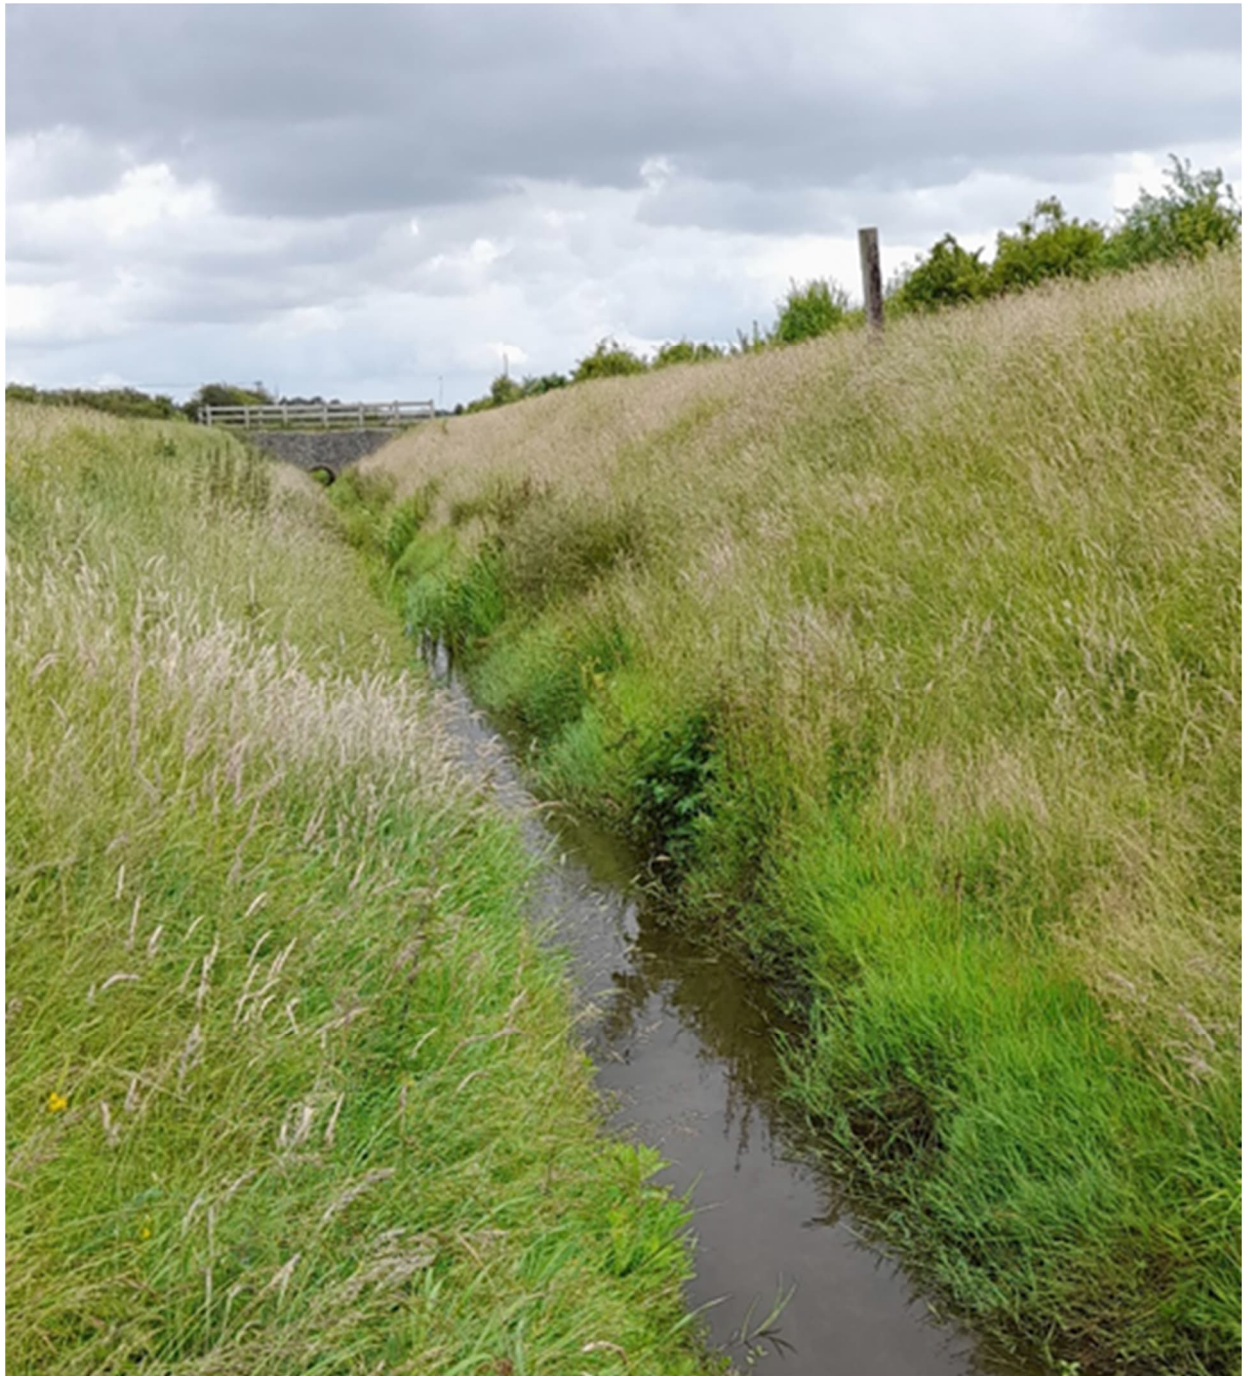
## 2.14. HAWARDEN BROOK

<b>Catchment area</b>	<1km <sup>2</sup>
<b>Key hydraulic connections</b>	The Hawarden Brook discharges to the River Dee. There is a flow control structure on the confluence of the watercourse with the Dee to prevent tidal flows from entering Hawarden Brook.

<b>River Condition Score</b>	Not surveyed due to land access restrictions
<b>Catchment description</b>	This watercourse and its small low-lying catchment have been heavily modified by the constriction of the Dee and draining of the floodplain. The predominant land use is pastoral farming and the airfield.
<b>Study reach description</b>	Downstream of the B5129 the watercourse flows through an artificially incised, re-sectioned channel with a trapezoidal cross section.  Whilst the channel is mostly unchanged since 1988, the catchment was heavily modified by the construction of the Airbus factory and runway.
<b>Interaction with the DCO Proposed Development</b>	The watercourse is not crossed by the Newbuild Carbon Dioxide Pipeline It will be crossed via a new temporary crossing during the construction phase.

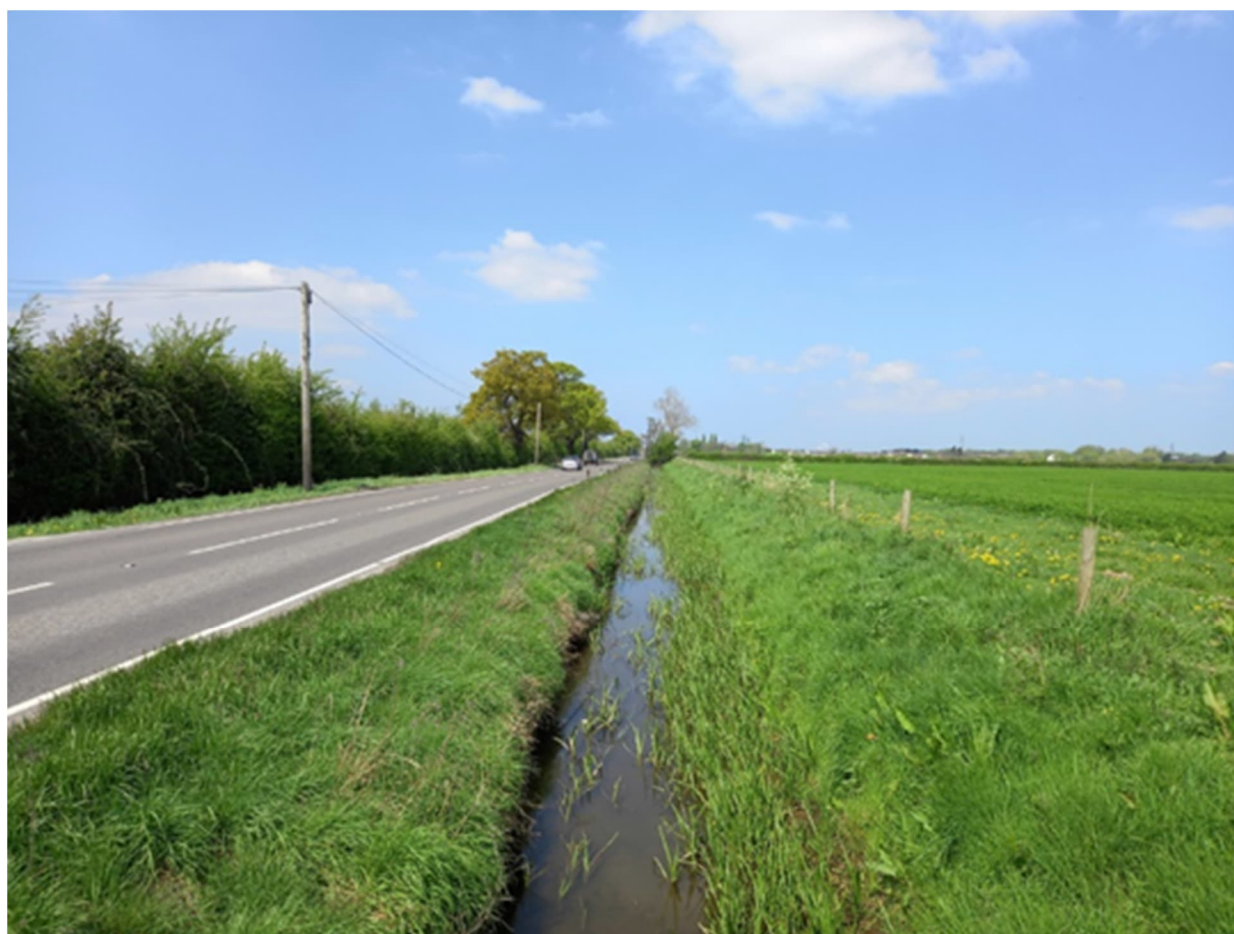
## 2.15. BROUGHTON BROOK

<b>Catchment area</b>	11.72km <sup>2</sup>
<b>Key hydraulic connections</b>	<p>The Broughton Brook flows to the River Dee at Station Road. Along the B5129 it is joined by several tributaries flowing north-eastwards from Hawarden. There are drains along Chester Road which connect to the Broughton Brook prior to it joining the River Dee.</p> <p>The watercourse is disconnected from its floodplain as it is within an incised channel.</p>
<b>River Condition Score</b>	Fairly Poor
<b>Catchment description</b>	The catchment has a high degree of human influence on watercourses and the landscape, with the surrounding land use predominantly arable farming, improved grassland and woodland. Elevation varies from ~ 157 mAOD to 8mAOD.
