## ENVIRONMENTAL STATEMENT (VOLUME III)

### Appendix 18.1 Baseline Information

HyNet North West Carbon Dioxide Pipeline DCO

Document Reference Number D.6.3.18.1

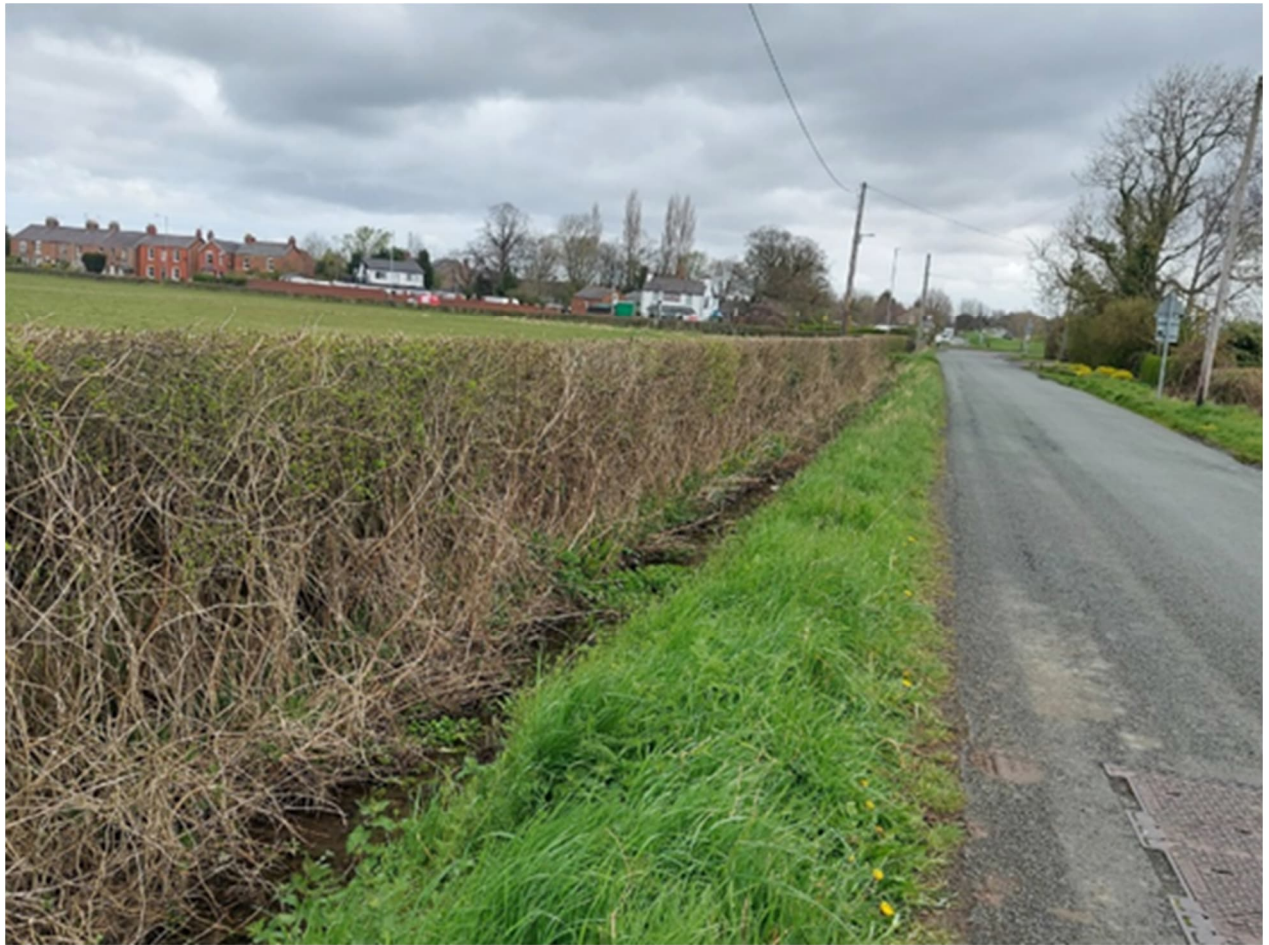
## 2.16. SANDYCROFT DRAIN

<b>Catchment area</b>	2.99km <sup>2</sup>
<b>Key hydraulic connections</b>	Onward connection into Broughton Brook. It receives flows from roadside ditches of Moor Lane.
<b>River Condition Score</b>	Fairly Poor
<b>Catchment description</b>	The catchment drains the surrounding roads, urban areas, and arable fields and is relatively flat, with the elevation varying from 80 - 8 mAOD.
<b>Study reach description</b>	<p>The channel is a cut trapezoidal drainage ditch that appears to have been artificially straightened. The channel has a consistent bankfull width and water depth (1m and 0.05m, respectively).</p> <p>The bed material is predominantly silt with some sands. Whilst the channel bed sediment is bare, there are some emergent broadleaved and amphibious plants. The riparian zone is homogenous, with a</p>

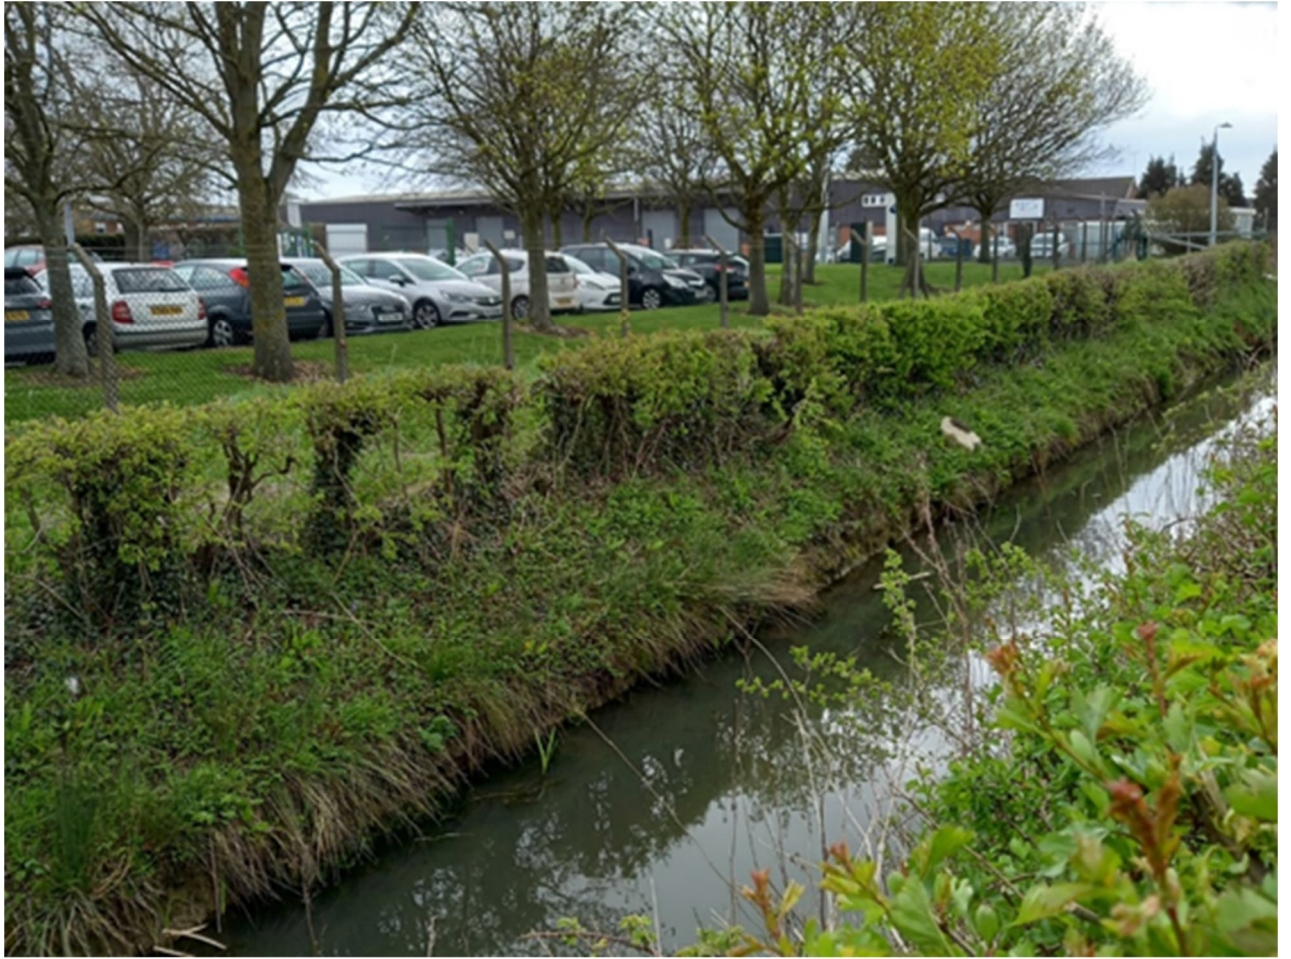
## 2.17. CHESTER ROAD DRAIN NORTH

<b>Catchment area</b>	1.67 km <sup>2</sup>
<b>Key hydraulic connections</b>	This watercourse is hydraulically connected to both the Broughton Brook (southeast) and Aston Hall Brook (Northwest). The channel is not connected to the floodplain.
<b>River Condition Score</b>	Poor
<b>Catchment description</b>	The catchment drains farmland and arable fields, with extensive urbanisation north of the watercourse. The catchment is relatively flat catchment, with the elevation varying from 80 – 8 mAOD.
<b>Study reach description</b>	Large sections of the watercourse are culverted or in an artificially incised channel with steep banks, with no variation in channel width (bankfull width 4 m) and depth (0.3 m) within the study area.

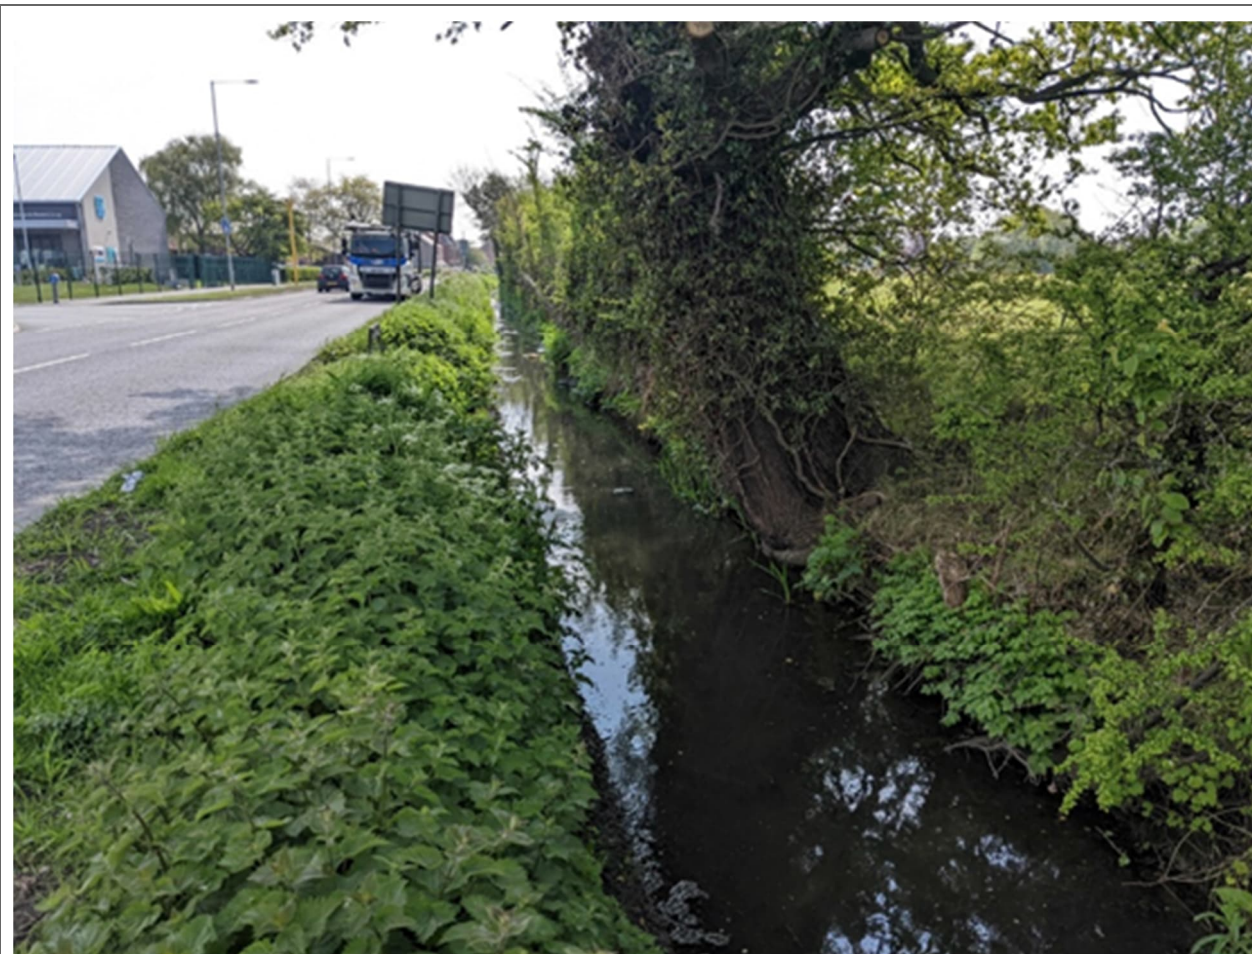
## 2.18. CHESTER ROAD DRAIN TRIBUTARY 1 AND 2

<b>Catchment area</b>	<1km <sup>2</sup>
<b>Key hydraulic connections</b>	Onwards connection to Chester Road Drain North. The channel is not connected to the floodplain.
<b>River Condition Score</b>	Fairly Poor
<b>Catchment description</b>	The catchment drains farmland and arable fields with extensive urbanisation to the north of the watercourse. It has a relatively flat catchment, with elevation varying from 80 - 8 mAOD.
<b>Study reach description</b>	The channel has a rectangular cross section with a consistent bankfull river width of 2.5m and water depth of 0.25m.

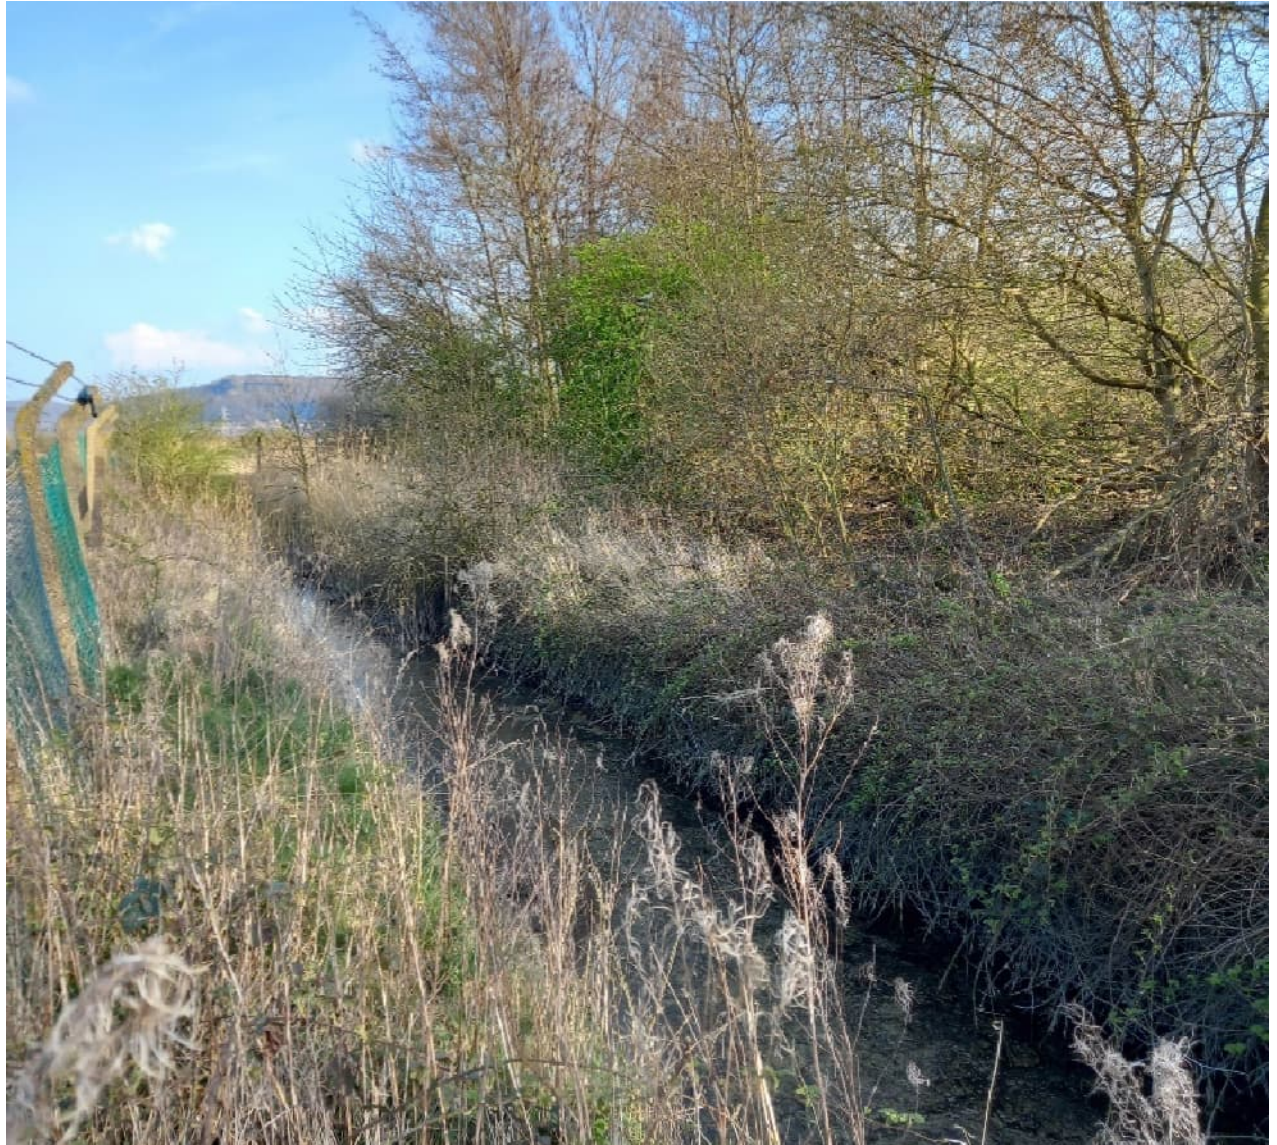
#### 3.1. GLASS FACTORY DITCH

<b>Catchment area</b>	1.41km <sup>2</sup>
<b>Key hydraulic connections</b>	Glass Factory Ditch connects to the West Central Drain and Ince Marshes.
<b>River Condition Score</b>	Fairly Poor

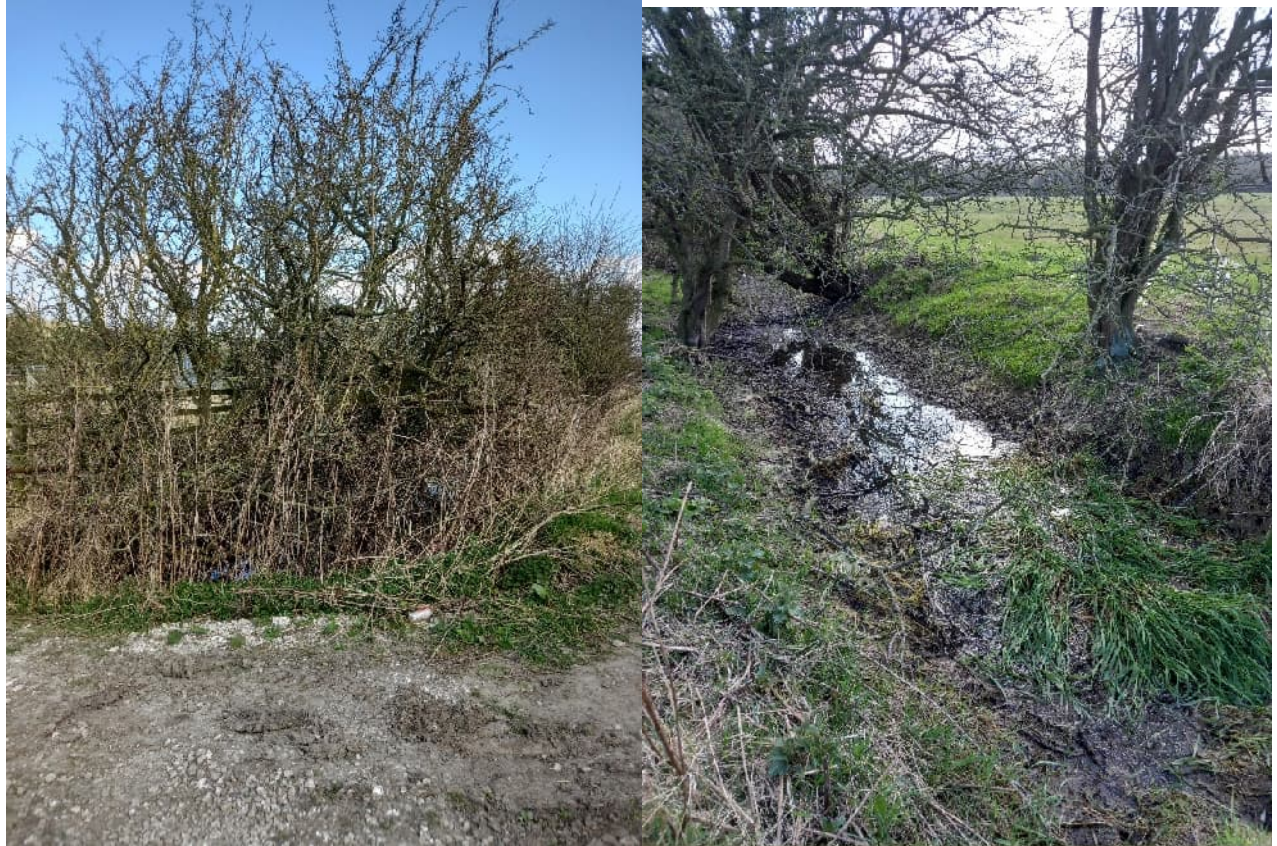
### 3.2. ELTON LANE DITCH 1, 2, 4 AND 6

<b>Catchment area</b>	<1km <sup>2</sup>
<b>Key hydraulic connections</b>	Ephemeral watercourses which connect to West Central Drain and East Central Drain
<b>River Condition Score</b>	Poor (Ditch survey) (Elton Lane Ditch 1, 2 and 6) Moderate (Ditch survey) (Elton Lane Ditch 4)
<b>Catchment description</b>	Grazed farmland which is historically coastal and fluvial marshland which has been drained via a series of ditches and pumping.
<b>Study reach description</b>	The ditches within the Newbuild Infrastructure Boundary are narrow channels artificially cut around field boundaries. These ditches are ephemeral and have simple vegetation structures.

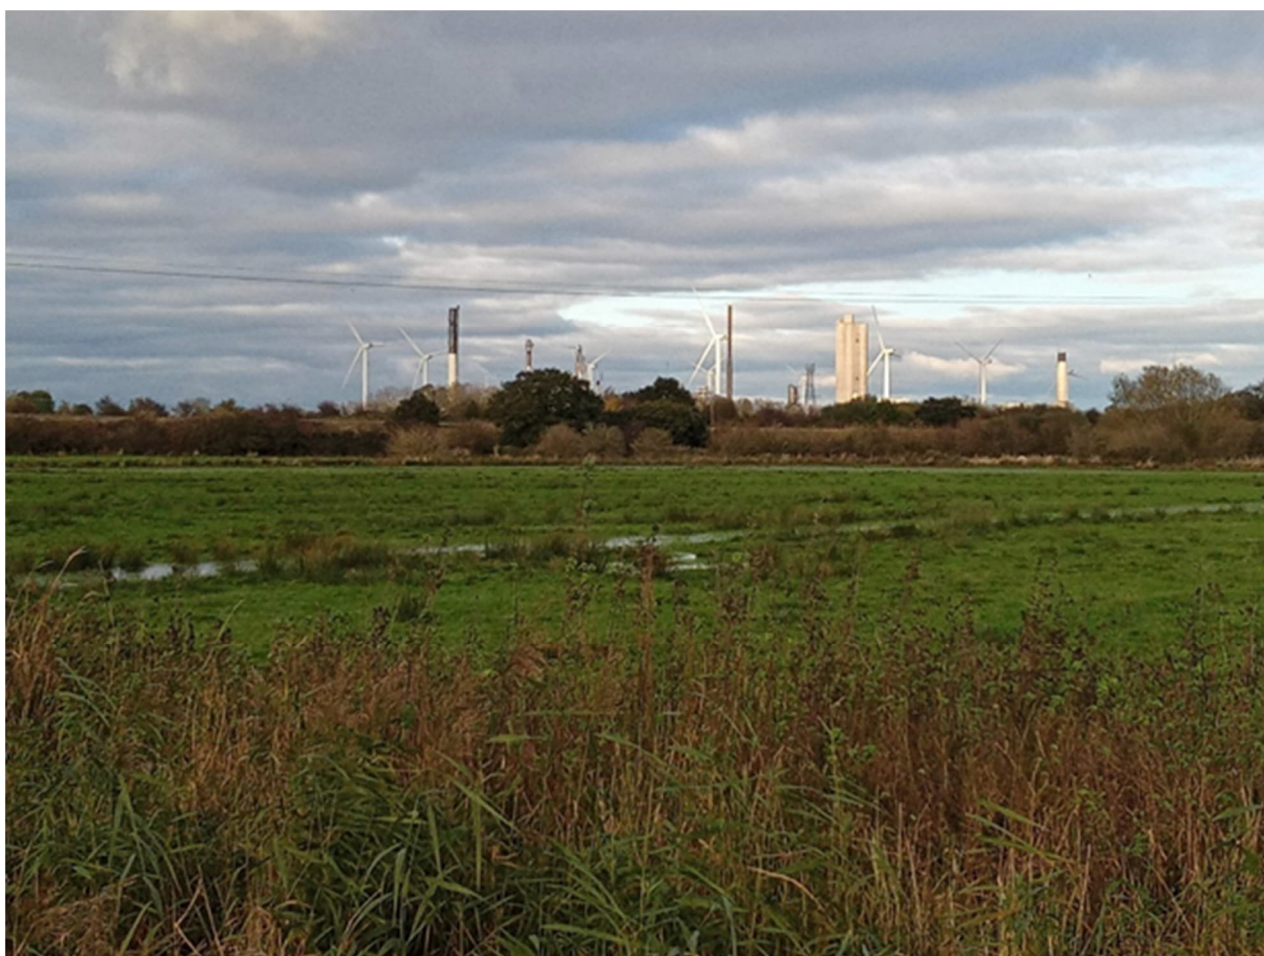
### 3.4. ELTON MARSH 1, 2, 3, 10, 11, 12, AND 13

<b>Catchment area</b>	<1km <sup>2</sup>
<b>Key hydraulic connections</b>	Elton marsh ditches are all connected to the West Central Drain which is part of the wider Ince Marshes.
<b>River Condition Score</b>	Poor (Ditch survey)
<b>Catchment description</b>	Grazed farmland which is historically coastal and fluvial marshland which has been drained via a series of ditches and pumping.
<b>Study reach description</b>	The ditches are straight shallow ephemeral channels which have been artificially cut in order to drain the marshland. The floodplain is frequently flooded.

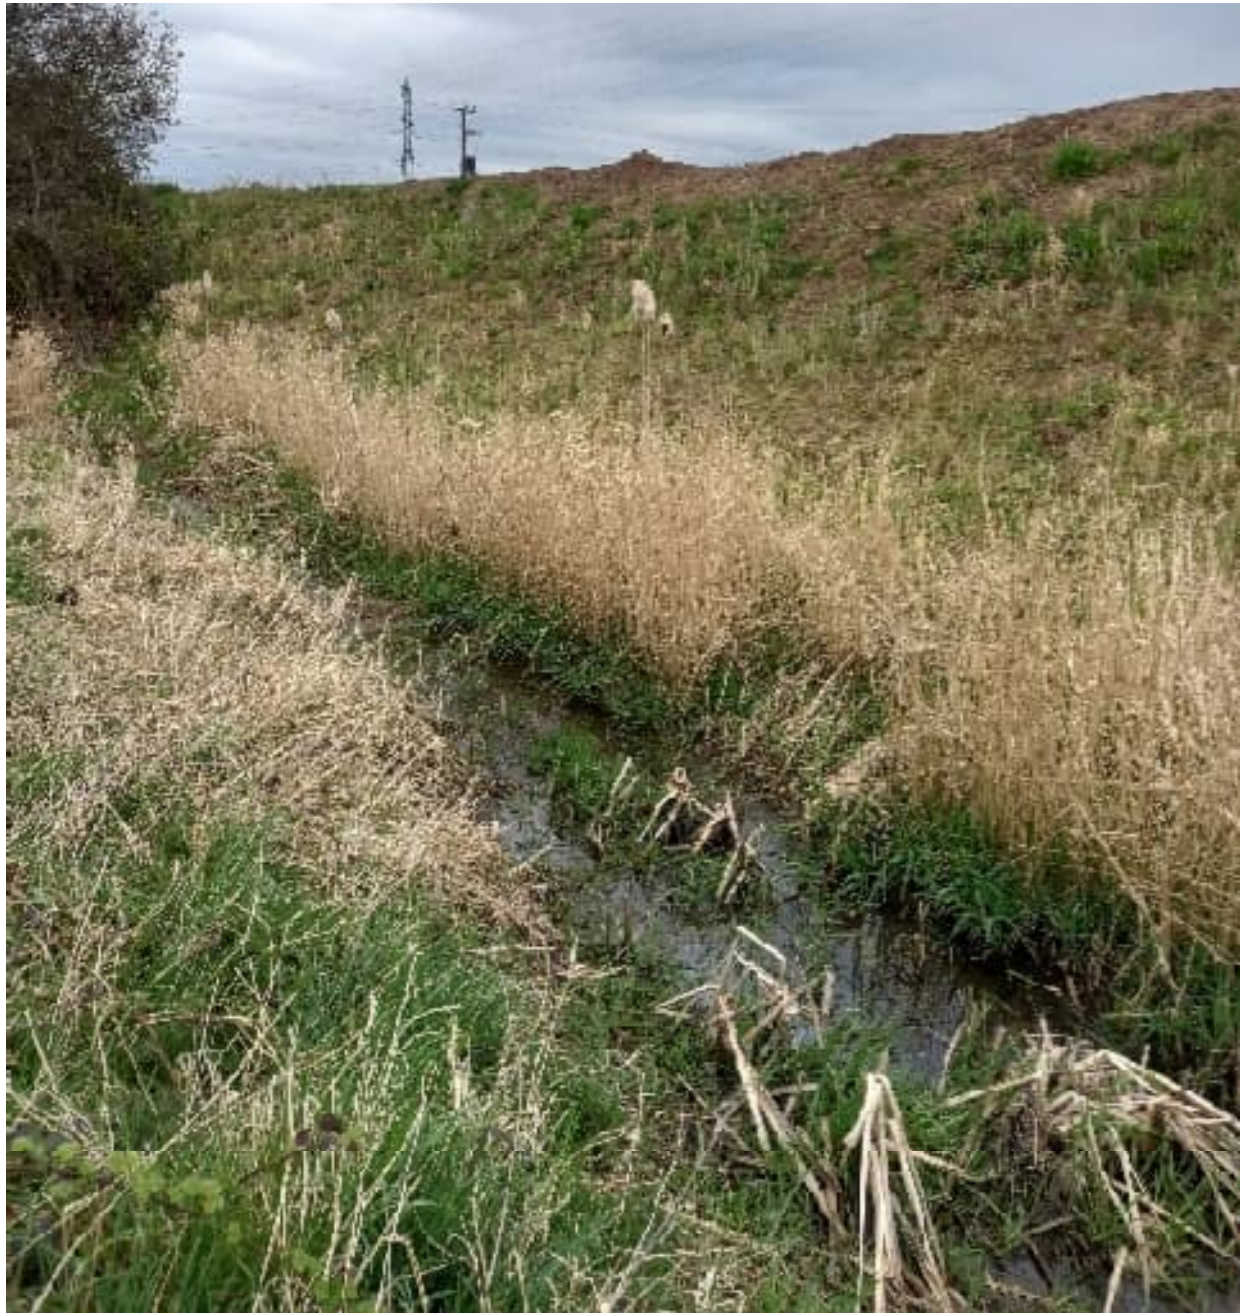
### 3.5. ELTON BROOK TRIBUTARY 1

<b>Catchment area</b>	<1km <sup>2</sup>
<b>Key hydraulic connections</b>	Flows westwards into Gale Brook. The ditch is disconnected from its floodplain by incision and artificial bunding.
<b>River Condition Score</b>	Poor

<b>Catchment description</b>	Elton Brook Tributary 1 drains arable and horticultural land to the south of the A5117 and includes both the Essar Stanlow Refinery and the suburb of Elton.
<b>Study reach description</b>	<p>The channel is a cut trapezoidal, cut ditch with bunding along its south bank. There is potential evidence of physical damage along the ditch. It is unlikely that water levels are maintained throughout the summer (likely less than 50cm in depth).</p> <p>The bed material is comprised of silt and organic accumulation. The riparian zone is characterised by a lack of both marginal and aquatic vegetation.</p> <p>The Elton Brook Tributary 1 was formed between 1965 –1970 and the channel has maintained its contemporary position since its construction. However, a travellers' site was constructed in the location of the drain between 2009 –2010 creating bunding on the south bank.</p>
<b>Interaction with the DCO Proposed Development</b>	Elton Brook Tributary 1 will be crossed by the Newbuild Carbon Dioxide Pipeline via trenchless methods (TRS-05 and TRS-06).

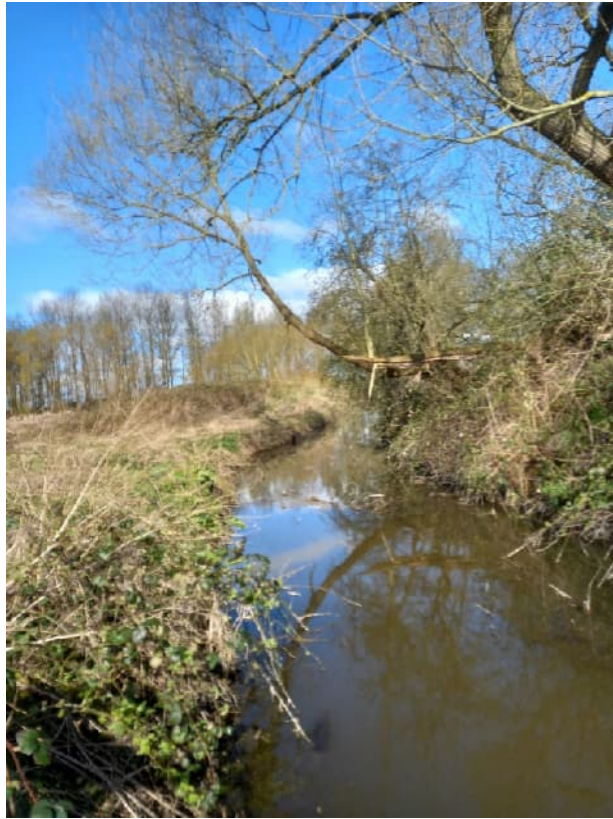
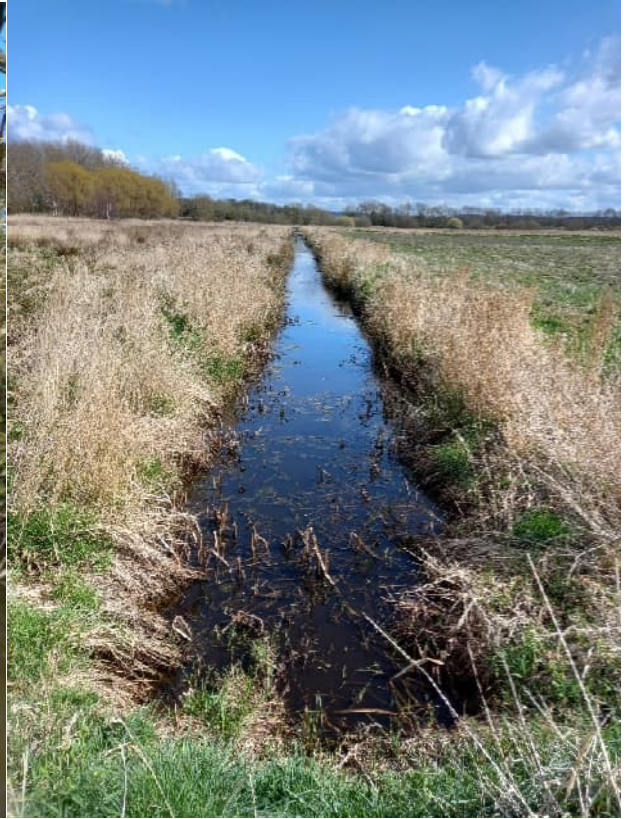
### 3.7. THORNTON DITCH 1, 2, 3, 4, 5 AND 6

<b>Catchment area</b>	<1km <sup>2</sup>
<b>Key hydraulic connections</b>	Thornton Ditches 1 and 2 connect to Stanney Main Drain whilst Thornton Ditches 3, 4, 5 and 6 connect to Thornton Main Drain, both of which discharge to the River Gowy north of the DCO Proposed Development.
<b>River Condition Score</b>	Thornton Ditch 1: Moderate (Ditch survey) Thornton Ditch 2, 3, 4, 5 and 6: Poor (Ditch survey)
<b>Catchment description</b>	The catchment is predominantly grazed farmland or peat bog, most of which is within the fluvial floodplain of the River Gowy and is frequently wet.
<b>Study reach description</b>	All the ditches are artificial straight trapezoidal channels designed to drain the floodplain so it can be used for agriculture.  Thornton Ditch 1 and 2 are ephemeral and covered in short grasses with some taller reeds.

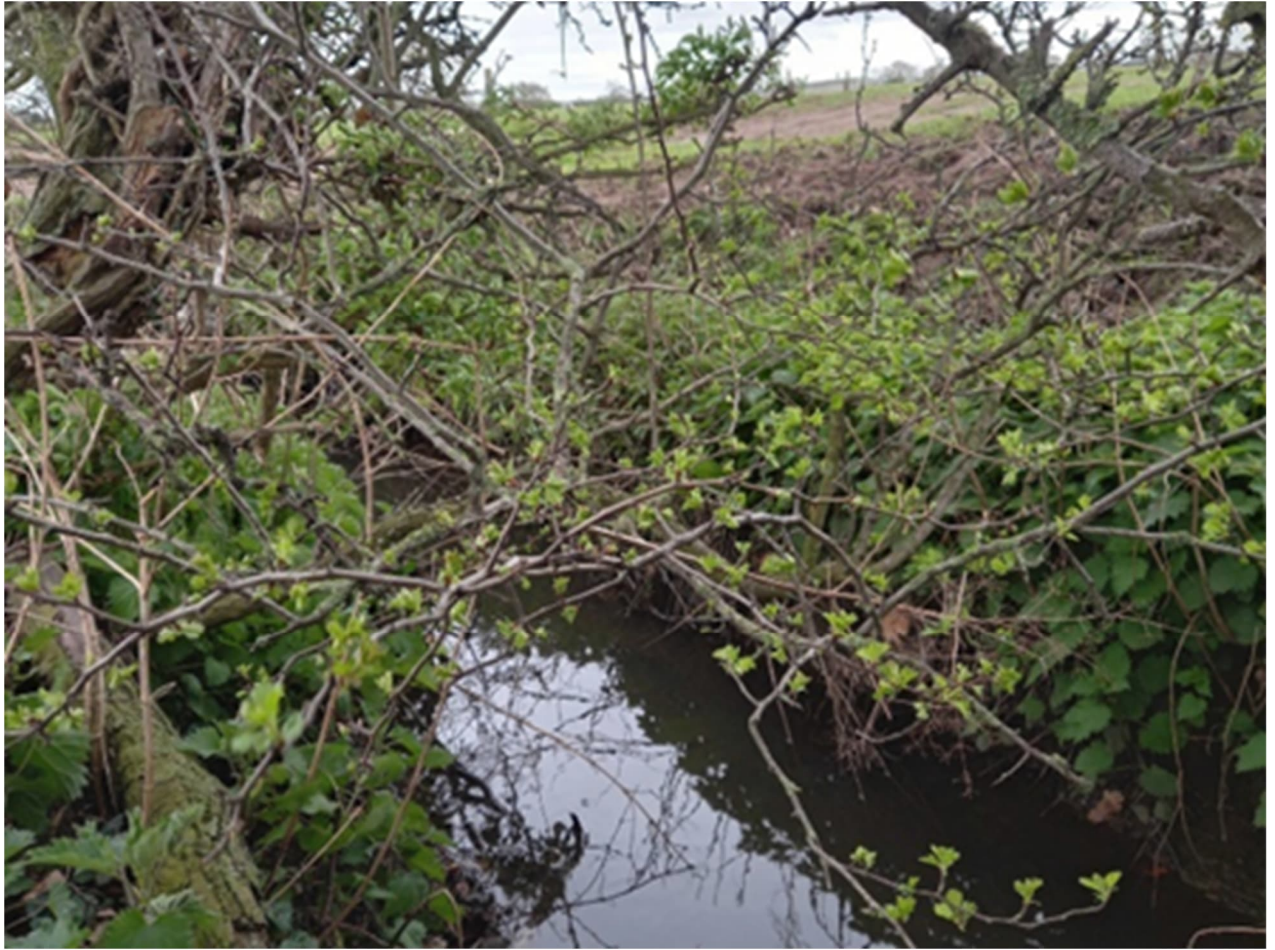
### 3.8. GOWY TRIBUTARY 2

<b>Catchment area</b>	1.1 km <sup>2</sup>
<b>Key hydraulic connections</b>	Gowy Tributary 2 flows into Stanney Mill Brook and the River Gowy. At the proposed site access crossing, for where vehicles will be crossing to access the working corridor, the channel is connected to its floodplain. Nearer to the Gowy, the watercourse is in an incised ditch and disconnected from the floodplain.
<b>River Condition Score</b>	Access reach: Moderate Stoak reach: Fairly Poor.
<b>Catchment description</b>	Gowy Tributary 2 drains the surrounding arable, horticultural, and suburban land. The channel rises west of Upton Health. It has a maximum catchment altitude of 42 mAOD.

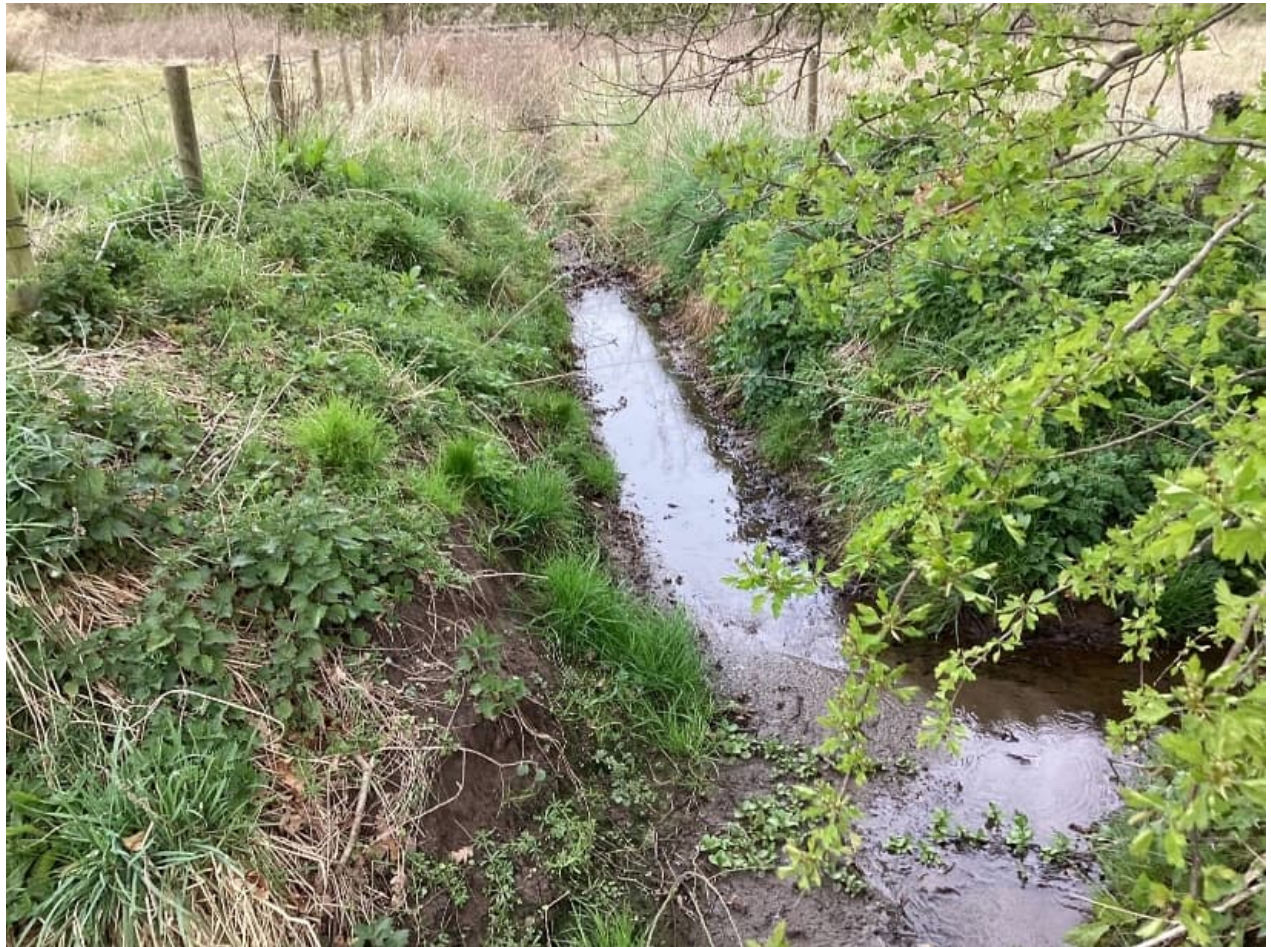
### 3.9. WERVIN HALL DITCH TRIBUTARY

<b>Catchment area</b>	<1km <sup>2</sup>
<b>Key hydraulic connections</b>	Flows into Wervin Hall Ditch which flows under the Shropshire Union Canal and joins Canal Ditch; part of Finchetts Gutter water body.
<b>River Condition Score</b>	Poor
<b>Catchment description</b>	Wervin Hall Ditch Tributary drains agricultural and pastoral land. The channel rises east of Caughall road, with a maximum catchment altitude of circa 39 mAOD. The surrounding land use is farmland, agricultural buildings, roadways, Shropshire Union Canal and plantation woodland.
<b>Study reach description</b>	The incised, cut channel appears to have been artificially straightened. The ditch is likely to be ephemeral.

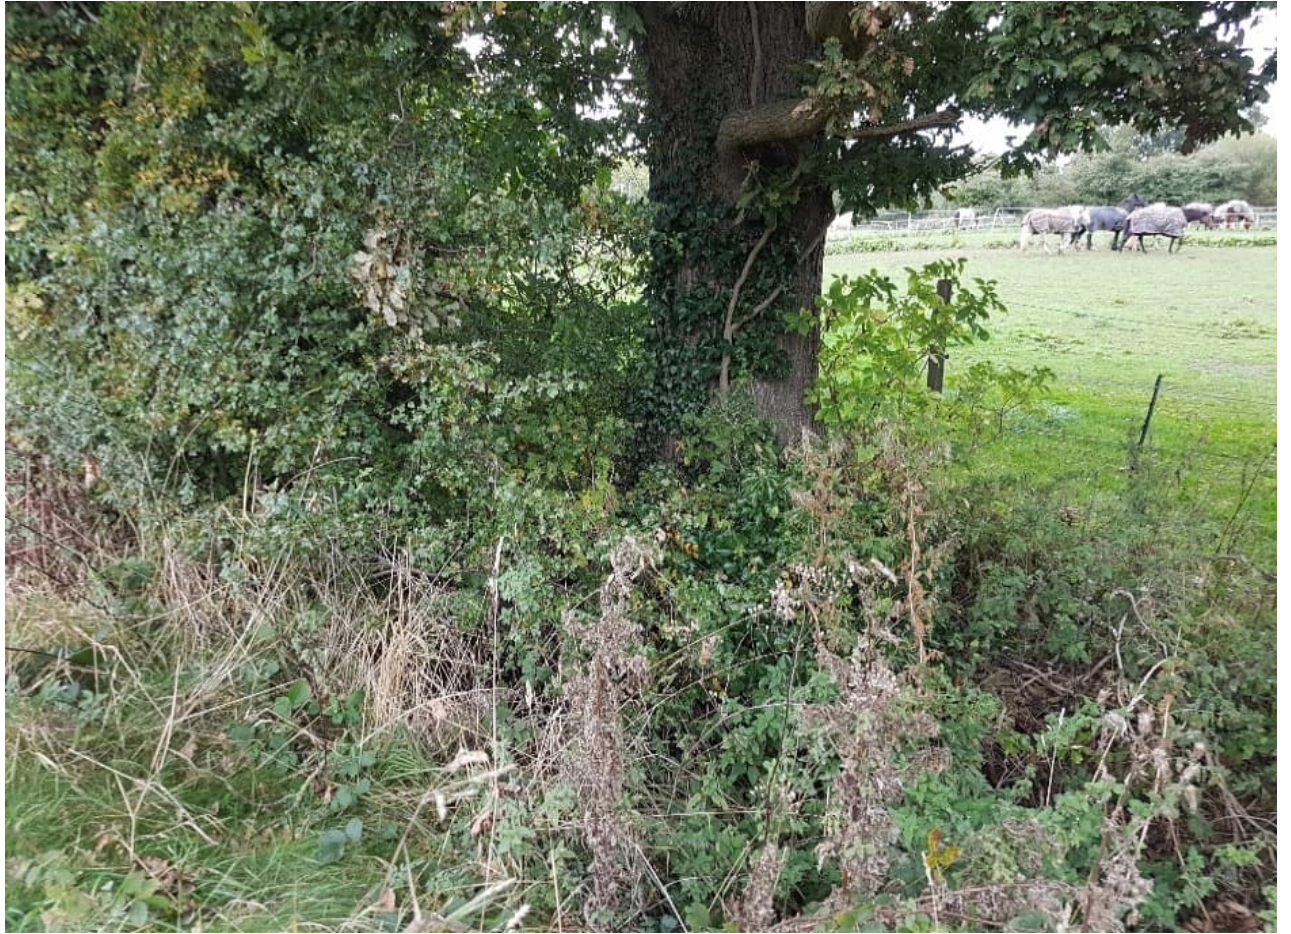
### 3.11. COLLINGE WOOD BROOK

<b>Catchment area</b>	<1km <sup>2</sup>
<b>Key hydraulic connections</b>	Onward connection to canal ditch and is likely culverted beneath Shropshire Union Canal to join Finchetts Gutter.
<b>River Condition Score</b>	Not surveyed
<b>Catchment description</b>	Drains agricultural and pastoral land. The surrounding land use is farm buildings and tracks, improved grassland, arable and horticultural land, some broadleaved and mixed and yew woodland.  Catchment altitude varies between ~ 42 mAOD - ~11mAOD.
<b>Study reach description</b>	The cut channel has been re-sectioned, over deepened and artificially straightened. The channel has rectangular and trapezoidal sections with gently sloping banks and a bankfull width of ~1.5m,

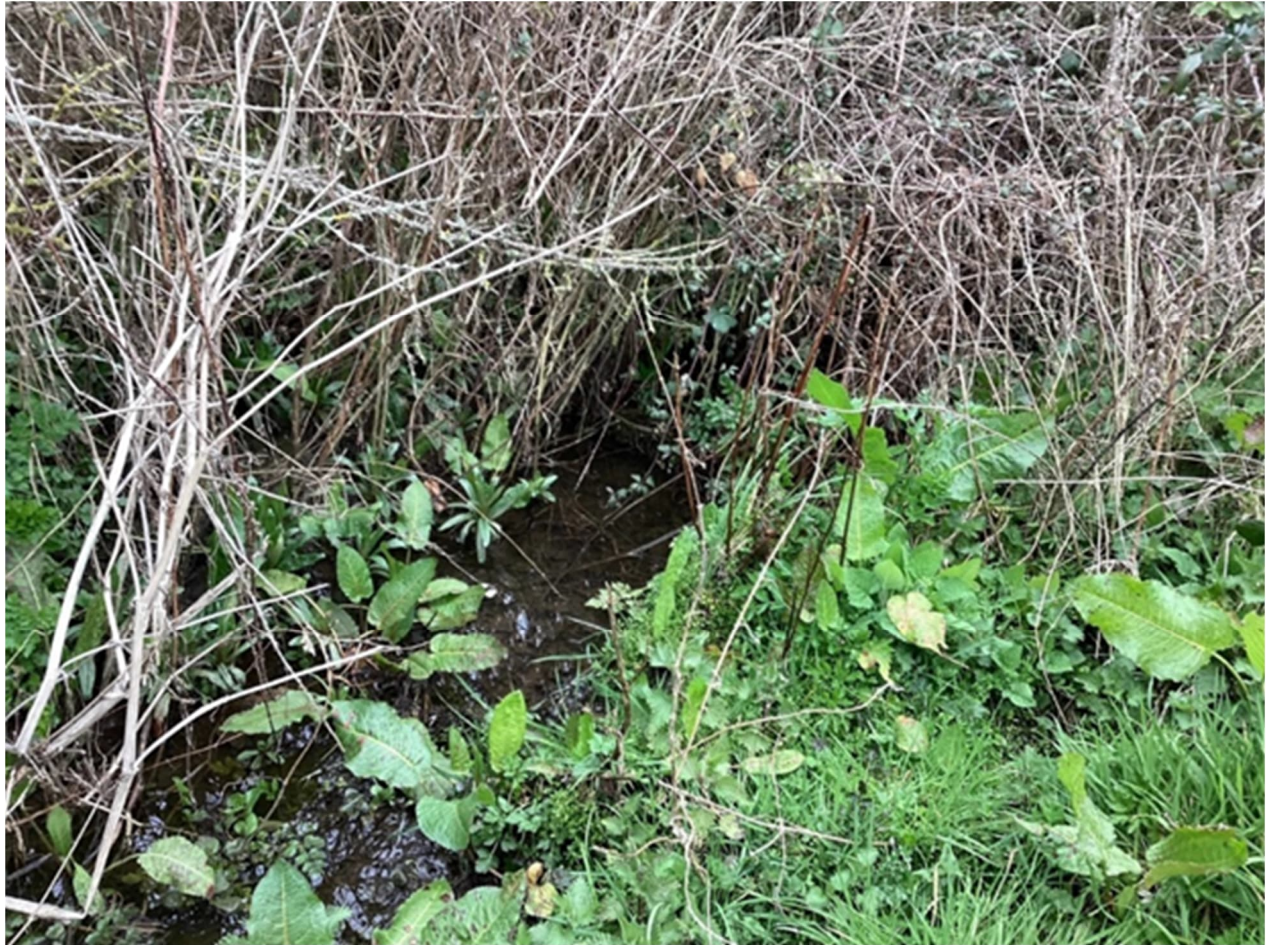
### 3.12. RAKE LANE BROOK

<b>Catchment area</b>	3.3km <sup>2</sup>
<b>Key hydraulic connections</b>	This watercourse flows beneath the Shropshire Union Canal and joins Finchetts Gutter.
<b>River Condition Score</b>	Moderate
<b>Catchment description</b>	The watercourse is ~ 0.7km long, with the surrounding land use being pasture, grassland, and woodland. Elevation varies from 24m to 20mAOD.
<b>Study reach description</b>	The watercourse has a shallow and narrow wetted channel. At the time of the survey it had a water depth of 0.05m. Channel width varied between 0.5 and 0.8m.

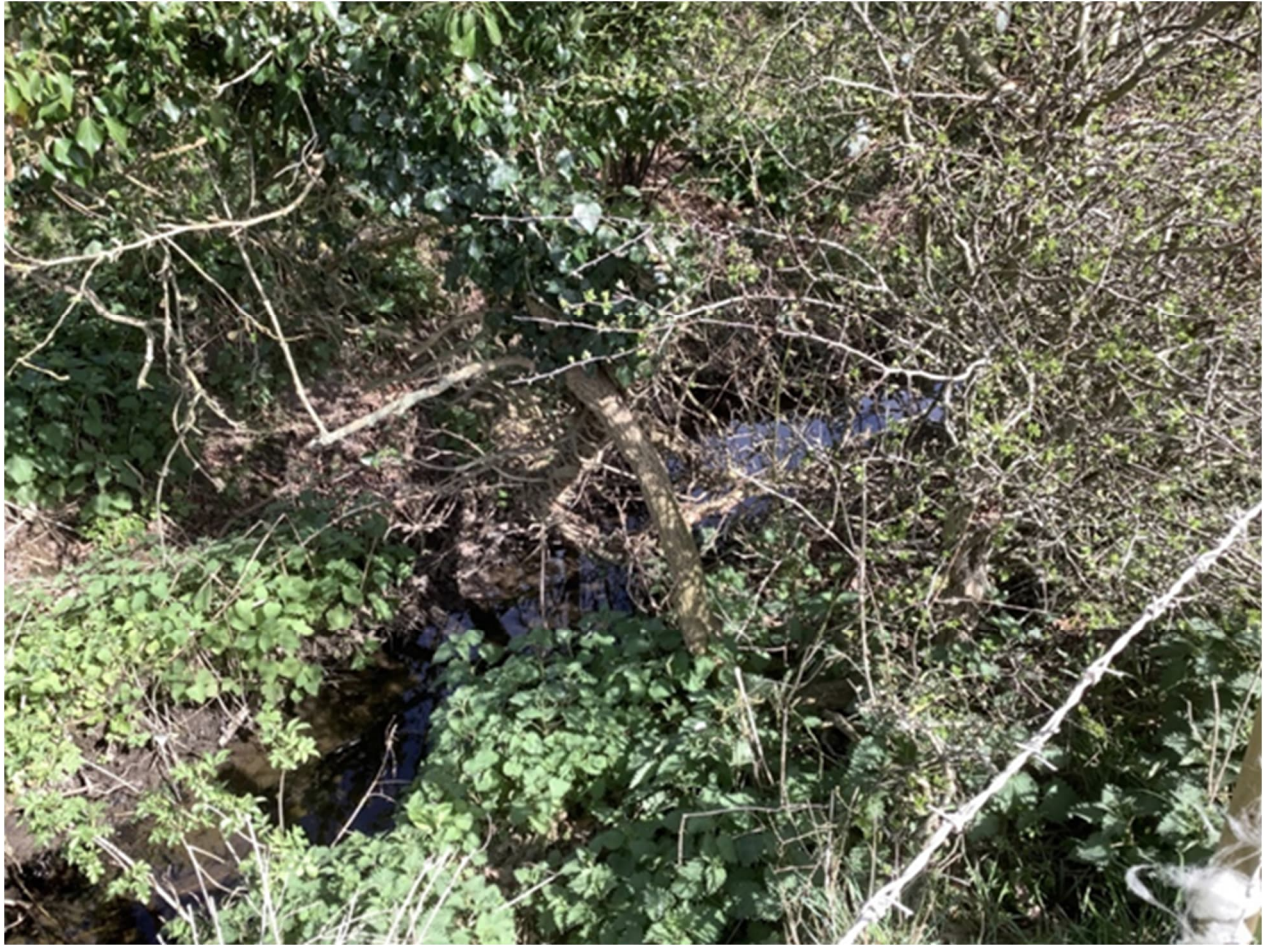
### 3.13. FRIARS PARK DITCH

<b>Catchment area</b>	0.135km <sup>2</sup>
<b>Key hydraulic connections</b>	This watercourse flows southeast, under the Shropshire Union Canal and connects to Finchetts Gutter.
<b>River Condition Score</b>	Fairly Good
<b>Catchment description</b>	The watercourse drains a catchment south of Lea-by-Backford in which the land use is characterised as pasture, grassland, and woodland. The elevation ranges from 12m to 25mAOD.
<b>Study reach description</b>	The watercourse is in a deep channel much lower than the surrounding pasture, with water depth varying from 0.03m to 0.15m, and river width from 0.3m to 0.5m.  The river bed substrate is dominated by silt with organic matter overlaying the silt. The riparian zone is primarily composed of

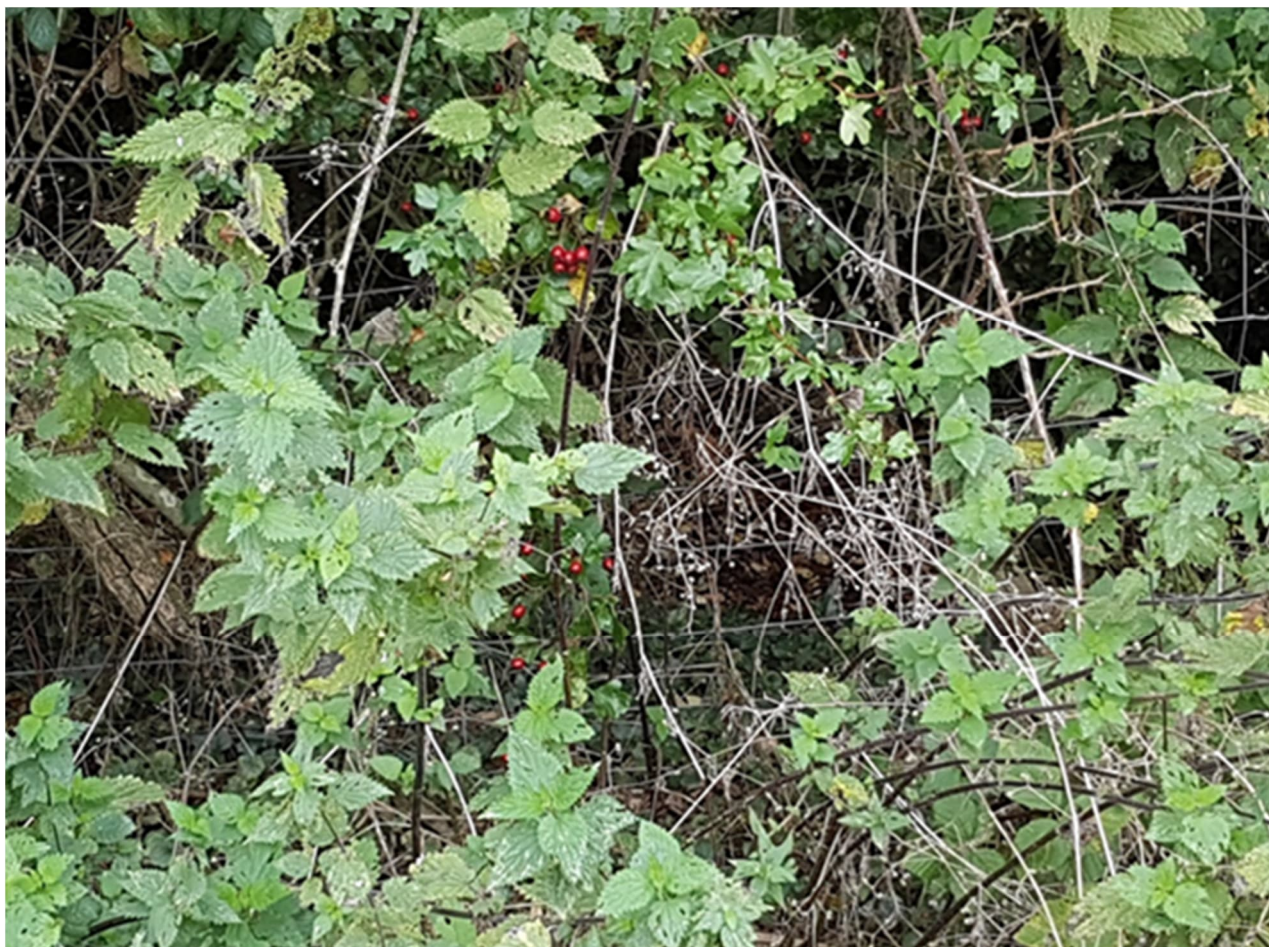
### 3.15. GYPSY LANE BROOK

<b>Catchment area</b>	1.51 km <sup>2</sup>
<b>Key hydraulic connections</b>	Network of hedgerow ditches, which flows southeast, beneath the Shropshire Union Canal and then joins Finchetts Gutter.  The watercourse is disconnected from the floodplain.
<b>River Condition Score</b>	No survey completed
<b>Catchment description</b>	The catchment includes local farmland and arable fields, along with the urban development Lea by Backford. It has an elevation range between 14 and 41 mAOD.
<b>Study reach description</b>	The watercourse has a straight channel planform and rectangular and trapezoidal cross section. It has been resectioned, over-deepened and

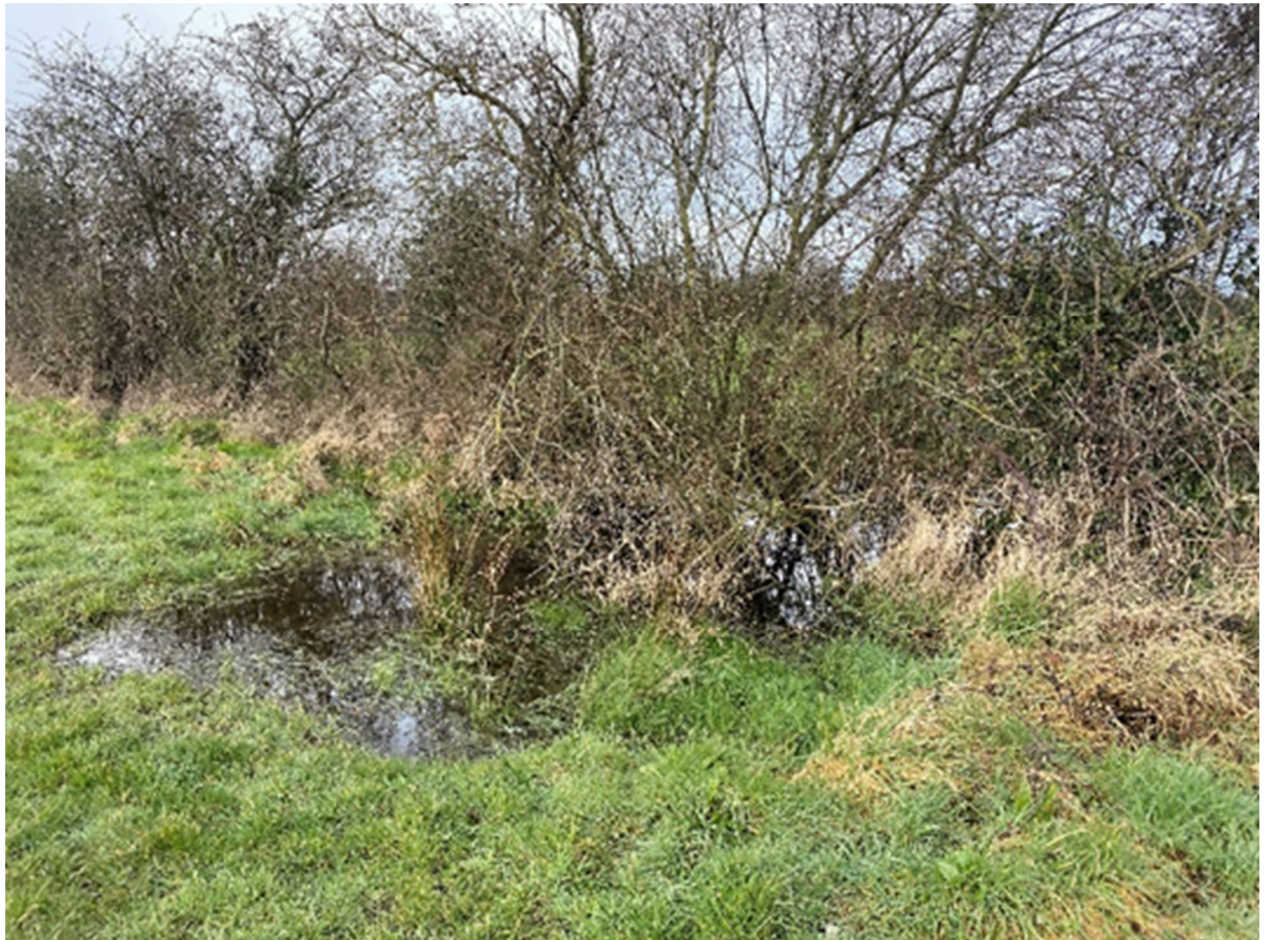
### 3.16. OVERWOOD DITCH

<b>Catchment area</b>	<1km <sup>2</sup>
<b>Key hydraulic connections</b>	Overwood Ditch flows southwards towards Finchetts Gutter Tributary. There is a pond which flows into Overwood Ditch.
<b>River Condition Score</b>	No survey completed.
<b>Catchment description</b>	This is a small catchment which is dominated by agricultural land uses.
<b>Study reach description</b>	<p>The watercourse has a straight channel planform and rectangular and trapezoidal cross section. It has been resectioned, over-deepened and artificially straightened.</p> <p>At time of survey there was an obscured view of the channel bed, precluding identification of the channel bed material. Based on catchment land use and gradients, bed material is likely to be fine material such as</p>

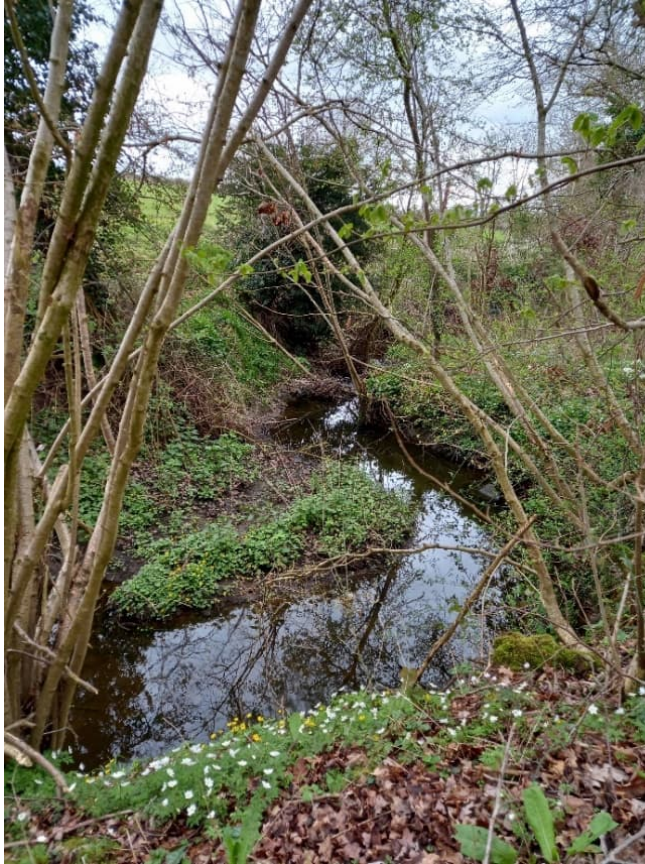
Fairly Good section within Newbuild Infrastructure Boundary

<b>Key hydraulic connections</b>	Finchetts Gutter Tributary flows southeast towards Blacon, under which it is culverted. It joins the Finchetts Gutter south of Saughall Road.
<b>River Condition Score</b>	Fairly good in the upper reach and moderate in the lower reach within the Newbuild Infrastructure Boundary.
<b>Catchment description</b>	<p>The catchment is rural in nature, with mainly open farmland and has some small areas of trees standing. Relatively shallow gradient and unconfined floodplain.</p> <p>The watercourse is approximately 7 km in length, with an elevation range between 10 and 46 mAOD. The catchment drains local farmland and arable fields</p>
<b>Study reach description</b>	<p>The channel is slightly sinuous, although it appears to have realigned for agriculture in the past. Bankfull width is up to 10m in some locations within the study reach. Water depths are shallow, at approximately 0.2m on average throughout surveyed reach.</p> <p>The bed material is primarily gravel and pebble, with areas of sand and silt present on channel bed. Within the riparian zone, the is channel lined with trees and scrub on both banks. Beyond the immediate treeline there is agricultural land on both banks.</p> <p>No significant changes in channel course since the 1<sup>st</sup> edition OS maps (1888)</p>
