## ENVIRONMENTAL STATEMENT (VOLUME III)

### Appendix 18.1 Baseline Information

HyNet North West Carbon Dioxide Pipeline DCO

Document Reference Number D.6.3.18.1

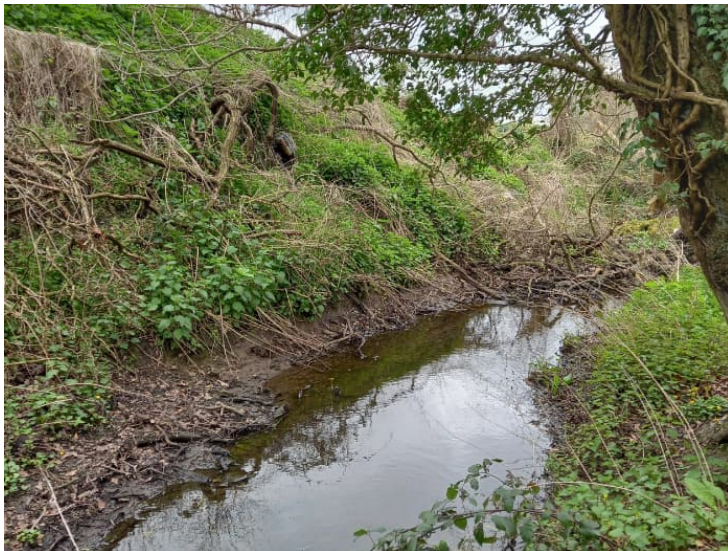
Moderate section within Newbuild Infrastructure Boundary

<b>Key hydraulic connections</b>	Finchetts Gutter Tributary flows southeast towards Blacon, under which it is culverted. It joins the Finchetts Gutter south of Saughall Road.
<b>River Condition Score</b>	Fairly good in the upper reach and moderate in the lower reach within the Newbuild Infrastructure Boundary.
<b>Catchment description</b>	<p>The catchment is rural in nature, with mainly open farmland and has some small areas of trees standing. Relatively shallow gradient and unconfined floodplain.</p> <p>The watercourse is approximately 7 km in length, with an elevation range between 10 and 46 mAOD. The catchment drains local farmland and arable fields</p>
<b>Study reach description</b>	<p>The channel is slightly sinuous, although it appears to have realigned for agriculture in the past. Bankfull width is up to 10m in some locations within the study reach. Water depths are shallow, at approximately 0.2m on average throughout surveyed reach.</p> <p>The bed material is primarily gravel and pebble, with areas of sand and silt present on channel bed. Within the riparian zone, the is channel lined with trees and scrub on both banks. Beyond the immediate treeline there is agricultural land on both banks.</p> <p>No significant changes in channel course since the 1<sup>st</sup> edition OS maps (1888)</p>

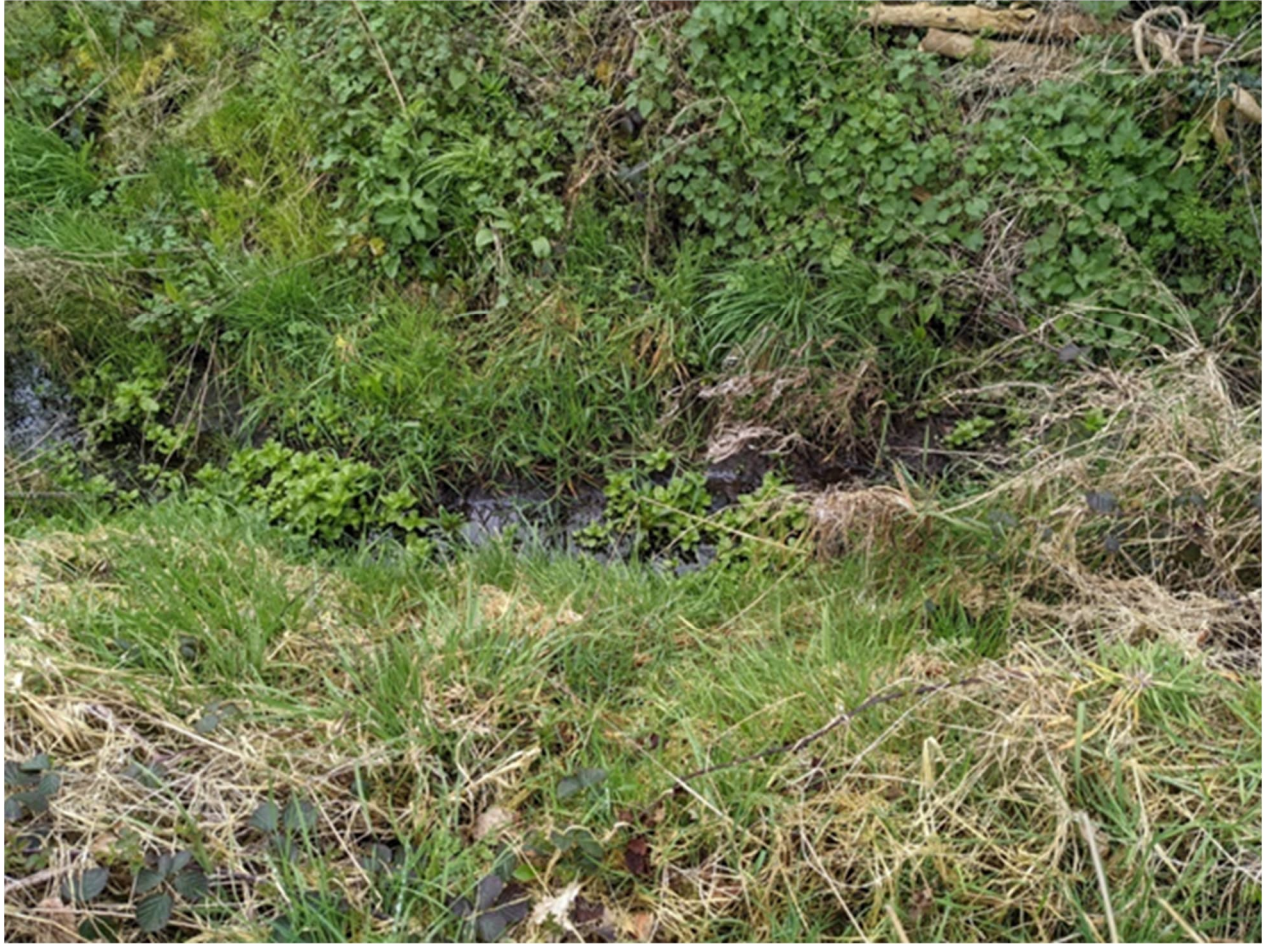
### 3.18. SEAHILL TRIBUTARY 2

<b>Catchment area</b>	0.270km <sup>2</sup>
<b>Key hydraulic connections</b>	This watercourse has no tributaries. This watercourse joins the Seahill Drain at its downstream end.
<b>River Condition Score</b>	Fairly poor
<b>Catchment description</b>	Highly modified catchment, in which the land use is arable agriculture. The total watercourse length is 0.5km, and the elevation changes from 5mAOD to 20mAOD.
<b>Study reach description</b>	Watercourse geometry is minimal throughout the study area. Water width is ~ 0.5m, and water depth is ~ 0.02m.  The bed is dominated by silt particles and low morphological diversity. The riparian zone is primarily arable agriculture.

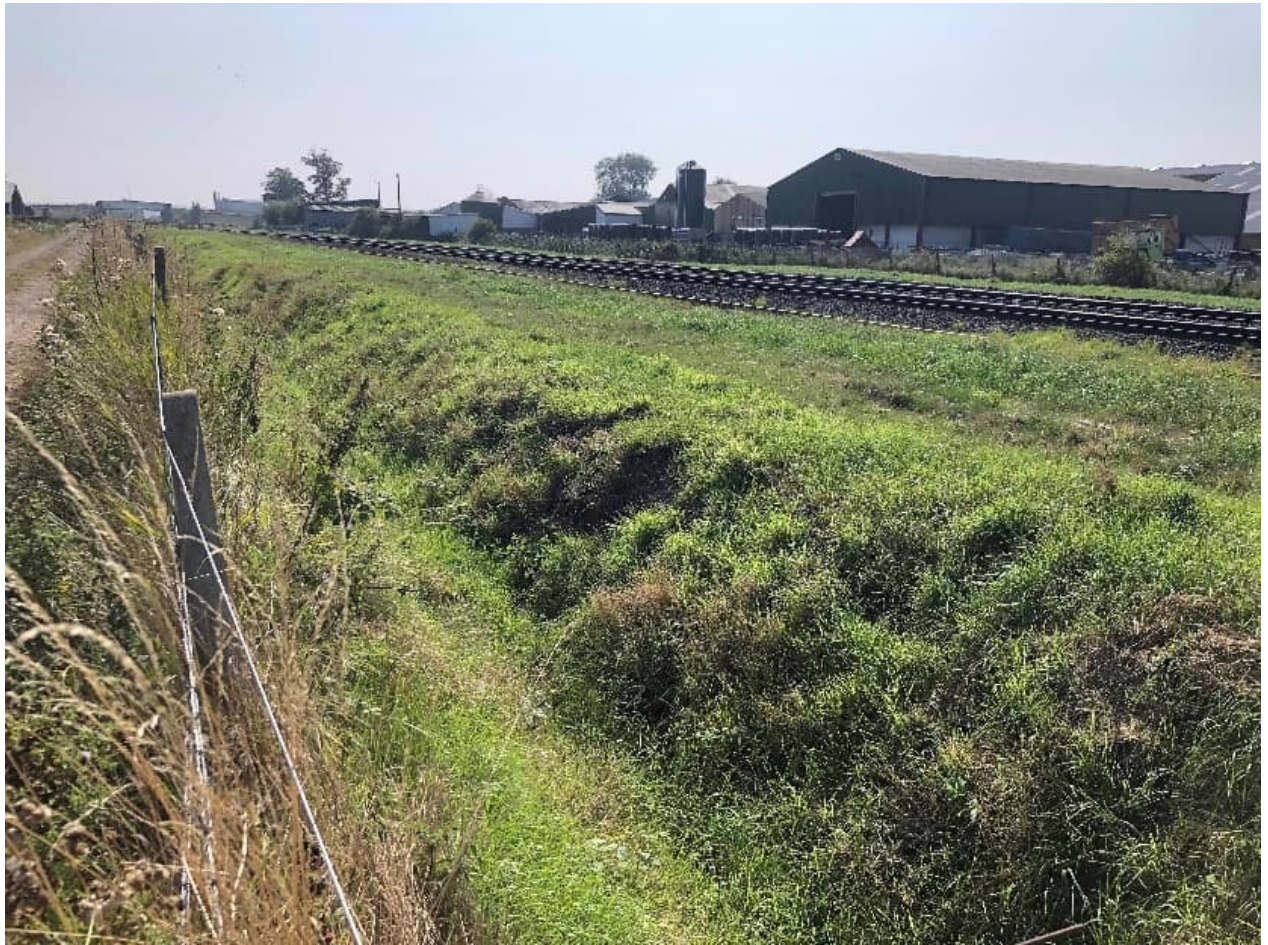
### 3.19. RAILWAY DITCHES 1 AND 2

<b>Catchment area</b>	<1km <sup>2</sup>
<b>Key hydraulic connections</b>	The railway ditches are ephemeral. It is assumed that they connect to Hawarden Brook which flows northwards to the Dee Estuary.
<b>River Condition Score</b>	Poor
<b>Catchment description</b>	Small catchment modified by artificial drains and the railway. The surrounding land use is predominantly arable and horticultural, with some urban development.
<b>Study reach description</b>	These are small ditches, and the bed material is mostly silt and organic matter. The riparian zone is heavily modified, a railway embankment on one side of the ditch and farmland on the other side. There is an absence of marginal vegetation along most of the ditches. Since 1913, the channel has retained its planform.

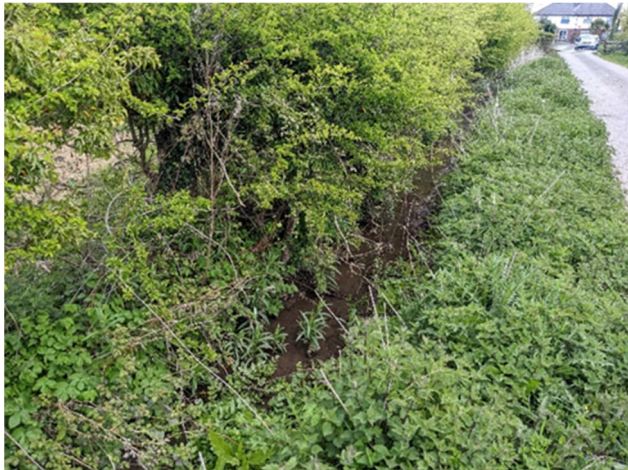
**Mancot Brook - Downstream Reach**

<b>Catchment area</b>	1.66km <sup>2</sup>
<b>Key hydraulic connections</b>	Onward connection into Chester Road Drain South, which flows beneath the B5129 to join the Broughton Brook.
<b>River Condition Score</b>	Moderate
<b>Catchment description</b>	<p>The catchment is predominantly rural, thus mostly draining farmland and arable fields. This comprises improved and neutral grassland, broadleaved, mixed and yew woodland.</p> <p>The catchment is relatively flat, with the elevation varying from 80 - 8 mAOD.</p>
<b>Study reach description</b>	<p>The channel is incised in places, with bankfull channel width varying between 1.5-3m, whilst water depth is between 0.05 – 0.07m.</p> <p>The channel has a silt substrate with extensive cover of bare earth. Some broad and linear leaved aquatic vegetation is present. At the location of the upstream proposed open cut crossing, the riparian zone is dominated by short grassland pasture. At the downstream proposed crossing location there is a hedge along the left bank and a private drive on the right bank within the riparian zone.</p> <p>Since 1913, the channel has retained its planform as a drainage channel to the surrounding arable land. The channel has been elongated to follow field boundaries, therefore resulting in a shallower gradient compared to its likely natural state.</p> <p>Mancot Brook Tributary is ephemeral and flows through a grazed pasture. It has extensive grass cover to bed and banks.</p>

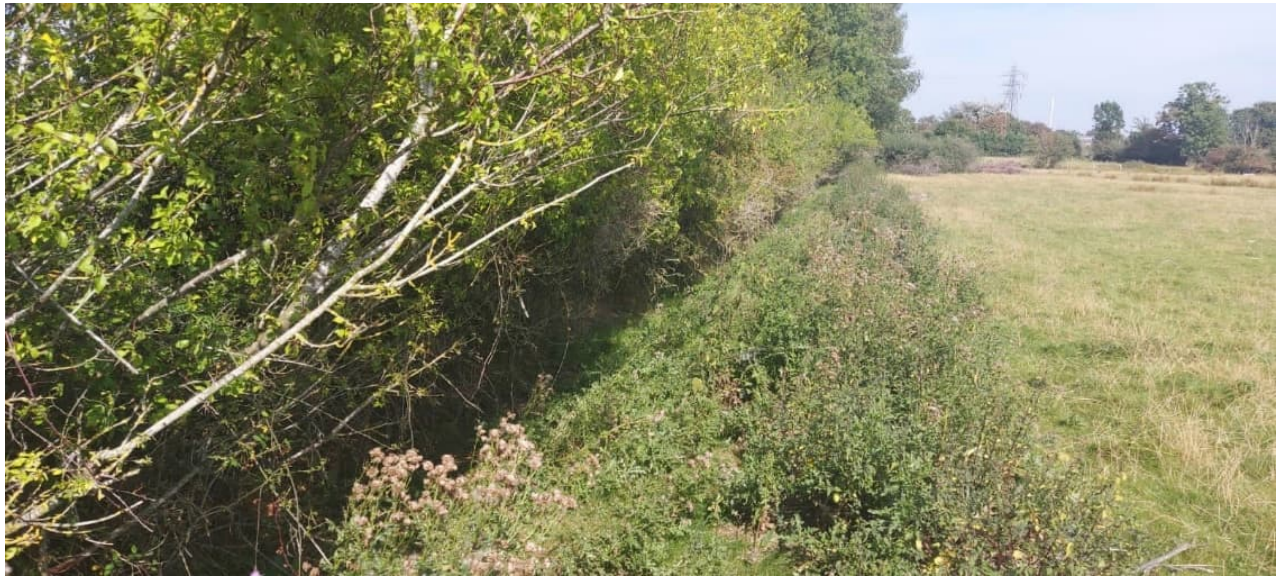
### 3.21. OAKFIELD DITCH 1 AND 3

<b>Catchment area</b>	<1km <sup>2</sup>
<b>Key hydraulic connections</b>	The exact connections of these ditches are unknown however it is likely that water drains toward Chester Road Drain North, Broughton Brook and the Dee.
<b>River Condition Score</b>	Not surveyed
<b>Catchment description</b>	Small catchment of arable and grazed farmland.
<b>Study reach description</b>	The watercourse flows along a field boundary. It has a hedgerow along one bank.
<b>Interaction with the DCO Proposed Development</b>	Oakfield Ditch 3 will be crossed by the Newbuild Carbon Dioxide Pipeline via open cut. Oakfield Ditch 1 is located within the Newbuild Infrastructure Boundary and may be crossed via open cut.

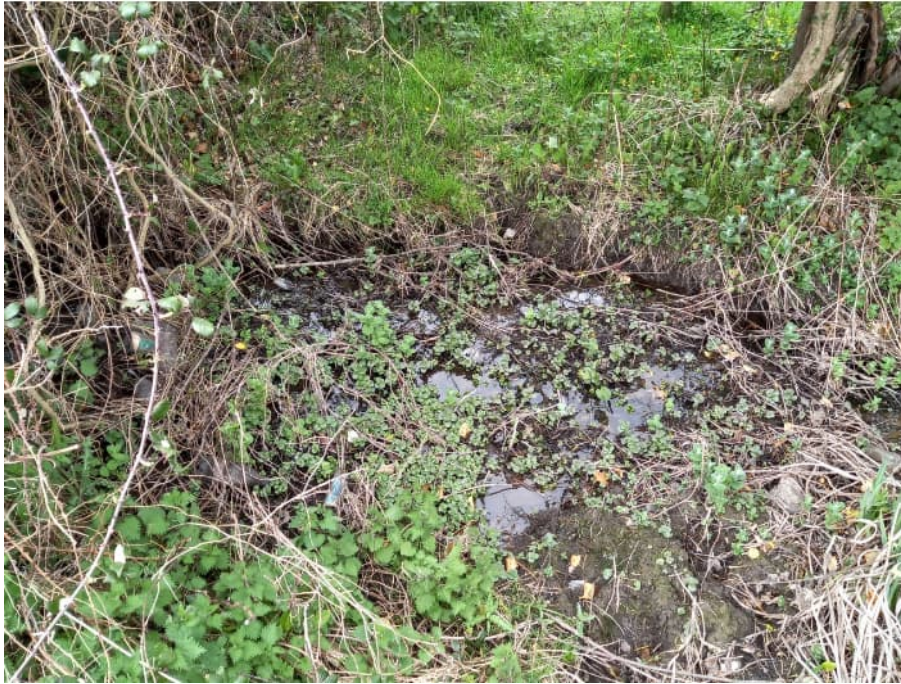
**Upstream Fairly Poor reach**

<b>River Condition Score</b>	Upstream reach is Fairly Poor Downstream reach is Moderate
<b>Catchment description</b>	Relatively small catchment comprising agricultural fields and residential estates. There is a small on-line pond in the upper catchment.
<b>Study reach description</b>	Bankfull channel width varies between 1m and 2m. Depth varies between 0.3 and 1.5m.  The substrate primarily comprises gravels and pebbles, with some silt and sand deposits, potentially introduced due to poaching activity.  The channel is extensively poached, with hardcore/rubble used for partial bank protection on the right bank. Riparian vegetation is mostly short grasses and isolated trees on the right bank with hedgerow on the left bank. The bank top land use is pastoral farming.
<b>Interaction with the DCO Proposed Development</b>	The watercourse will be crossed by the Newbuild Carbon Dioxide Pipeline via open cut.

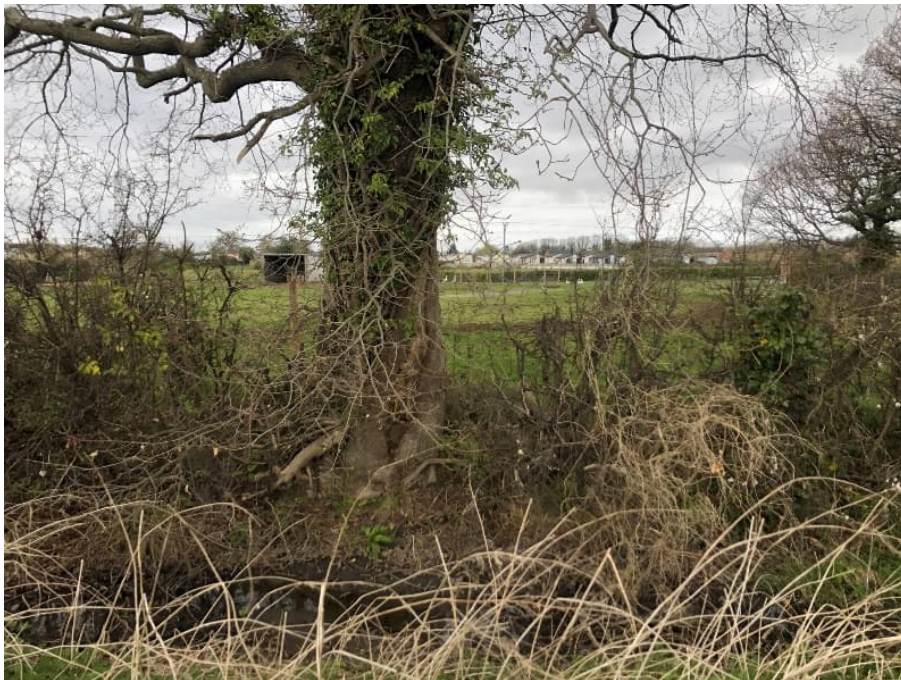
**Downstream Moderate reach**

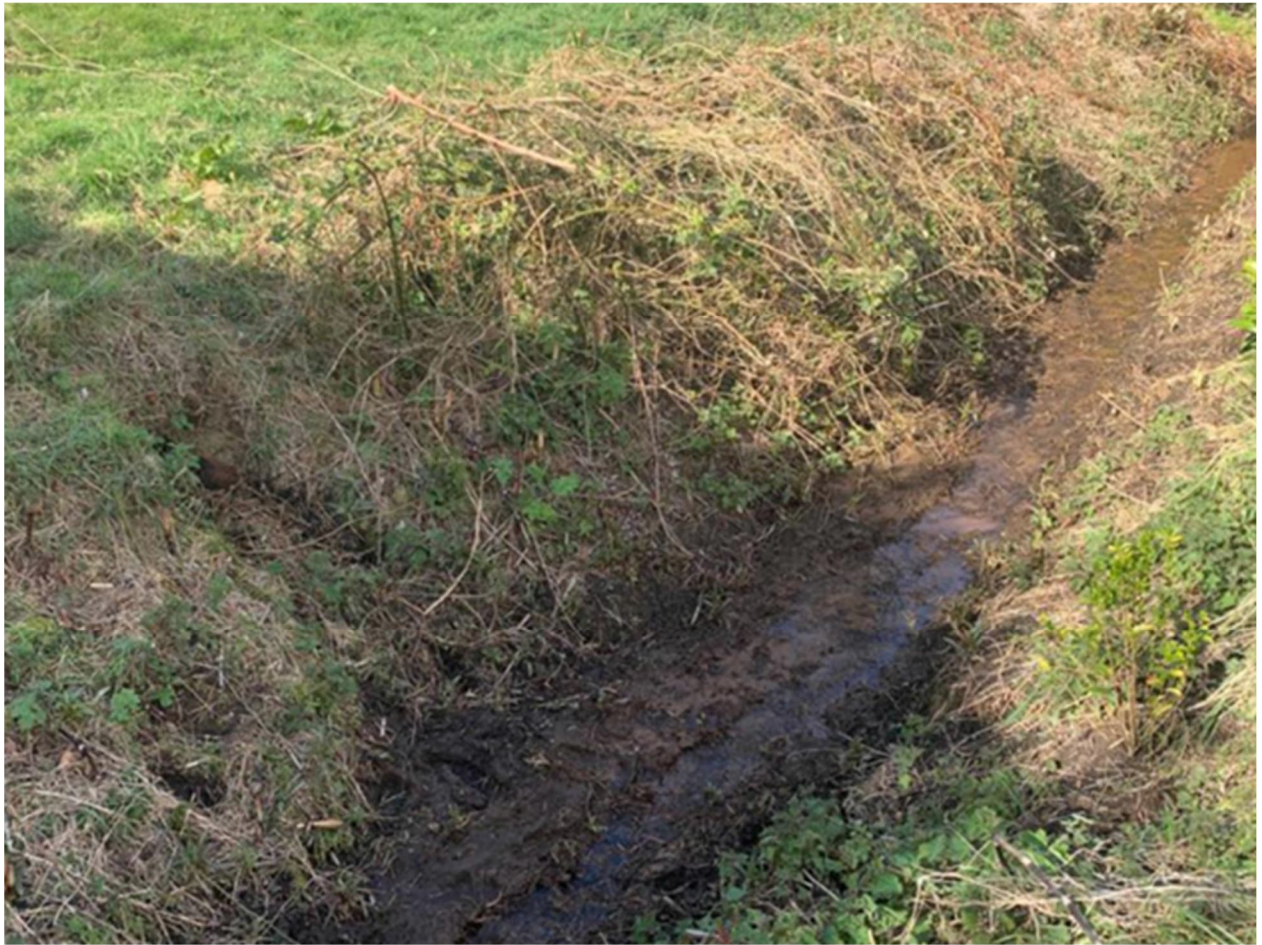
### 3.24. ASTON HALL BROOK

<b>Catchment area</b>	<0.5km <sup>2</sup>
<b>Key hydraulic connections</b>	This watercourse flows north-eastwards towards Deeside. It is joined by two tributaries before joining the Dee.  The valley is steep, so the watercourses is not connected to a floodplain.
<b>River Condition Score</b>	Fairly poor
<b>Catchment description</b>	The catchment is very small, with the surrounding land use predominantly rural farmland and suburban residential areas. The watercourse is potentially ephemeral.
<b>Study reach description</b>	The channel has been over deepened and had shallow water depth of approximately 0.05m at the time of survey. Bankfull width was observed to be between 1.5m and 3m.  The bed material is mainly composed of sand and silt, with some concrete reinforcement on bed through some private gardens. The

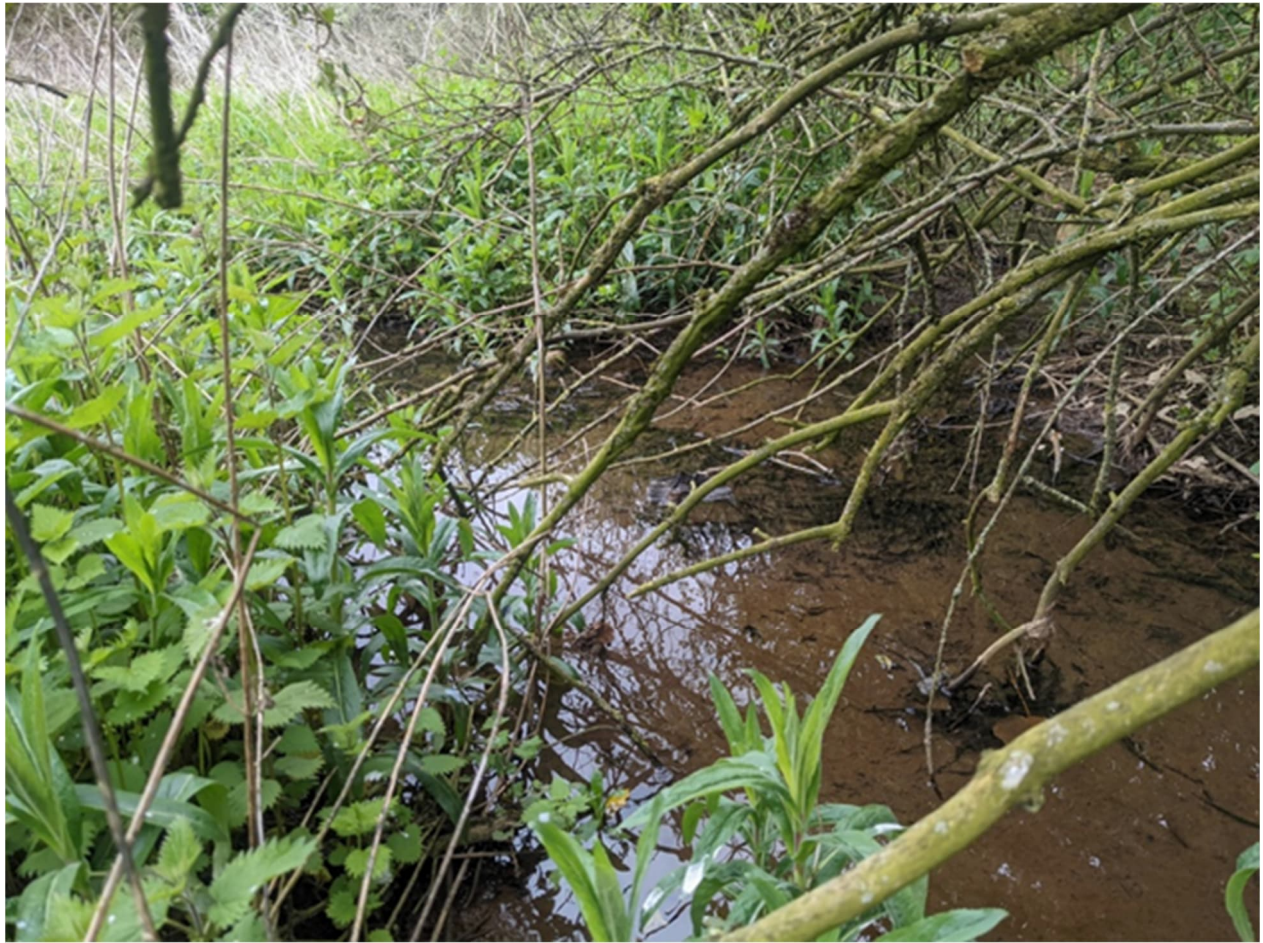
### 3.25. NEW INN BROOK

<b>Catchment area</b>	2.68km <sup>2</sup>
<b>Key hydraulic connections</b>	Downstream connectivity to Wepre Brook
<b>River Condition Score</b>	Fairly Good
<b>Catchment description</b>	<p>The catchment drains farmland and arable fields. The catchment is predominantly rural though there is extensive urbanisation in the upper catchment (Buckley).</p> <p>Elevation varies from 166 - 62 mAOD.</p>
<b>Study reach description</b>	<p>The watercourse has shallow channel banks, a bankfull width around 0.7m and channel depth around 0.2m. At the downstream end of the reach within the Newbuild Infrastructure Boundary the watercourse becomes multi-thread.</p>

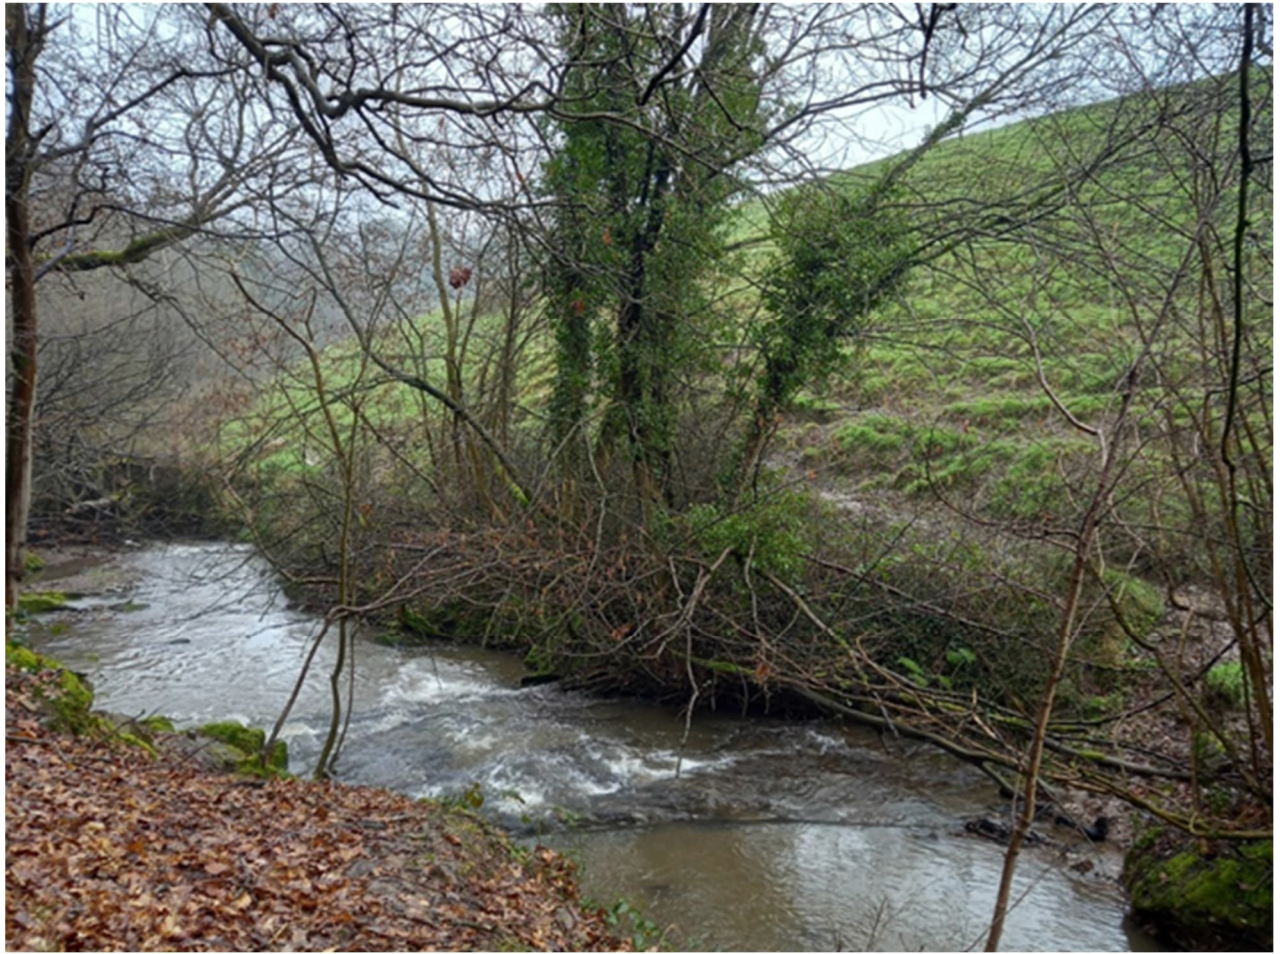
### 3.26. ALLTAMI BROOK

<b>Catchment area</b>	6.52 km <sup>2</sup>
<b>Key hydraulic connections</b>	The Alltami Brook joins Wepre Brook downstream of the Newbuild Infrastructure Boundary and has approximately 10 tributaries upstream of the study area.
<b>River Condition Score</b>	Fairly Good
<b>Catchment description</b>	The catchment drains farmland and arable fields. There is extensive urbanisation in the upper catchment (Buckley, New Brighton). Downstream the watercourse flows through a narrow gorge to Wepre Brook. There is a clay quarry within the catchment.  Elevation varies from 170 - 76 mAOD.
<b>Study reach description</b>	The watercourse flows through a naturally deep valley, with bankfull width varying between 6 – 7 m and water depth between 0.2 – 0.3 m. There is varied roughness through the reach which has pools, riffles,

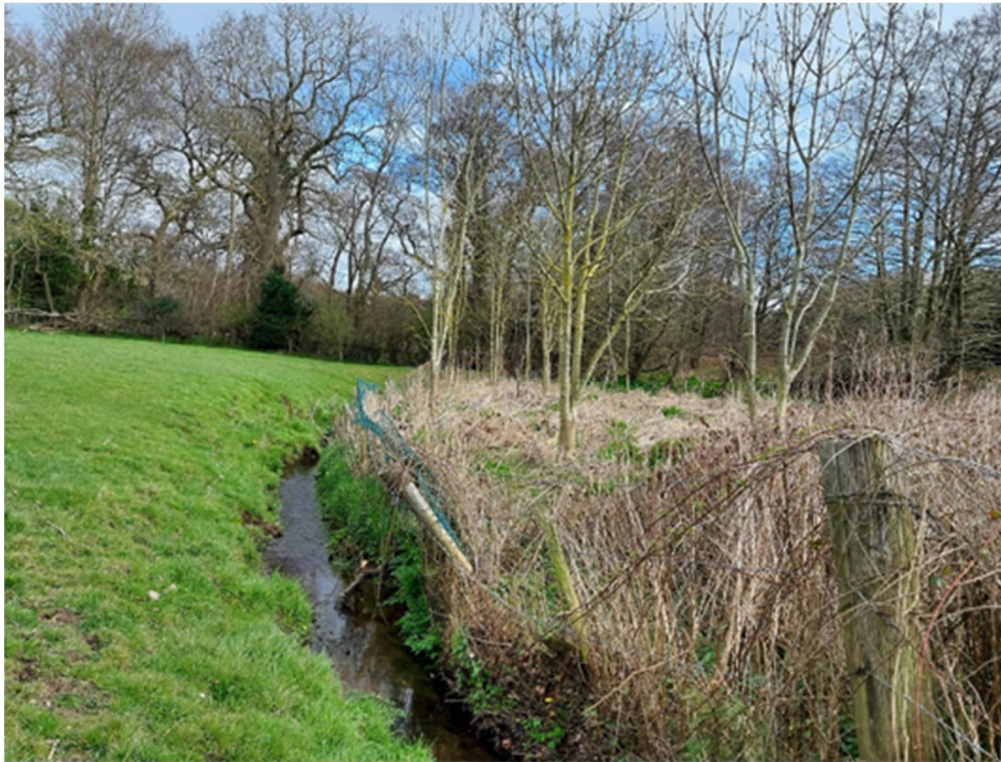
**Wepre Brook A55 reach**

<b>Catchment area</b>	9.57km <sup>2</sup>
<b>Key hydraulic connections</b>	Wepre Brook has several tributaries, mostly from the south of the catchment. The Alltami Brook and New Inn Brook both connect to the Wepre Brook downstream of the study area.
<b>River Condition Score</b>	A55 reach: moderate; Brookside reach: fairly poor; Northrop Hall reach: fairly poor
<b>Catchment description</b>	The majority of the catchment is rural and agricultural. There are small settlements in the catchment (Northop, Northop Hall and Soughton). The A55 and Brookside run parallel to the Wepre Brook through the study reach.
<b>Study reach description</b>	At the A55 reach the channel is narrow (approximately 1m width and 0.3m water depth). Through Brookside and Northop Hall reaches the watercourse is wider (width up to 2m and water depth 0.2m).  The bed material is well mixed generally, with areas of both gravel-pebble mix and cobbles. Some areas of sand were observed overlaying armoured substrate in the A55 reach.  At the A55 reach, the left bank is short grass pasture for grazing whilst the right bank is plantation woodland and scrub. Through Brookside and

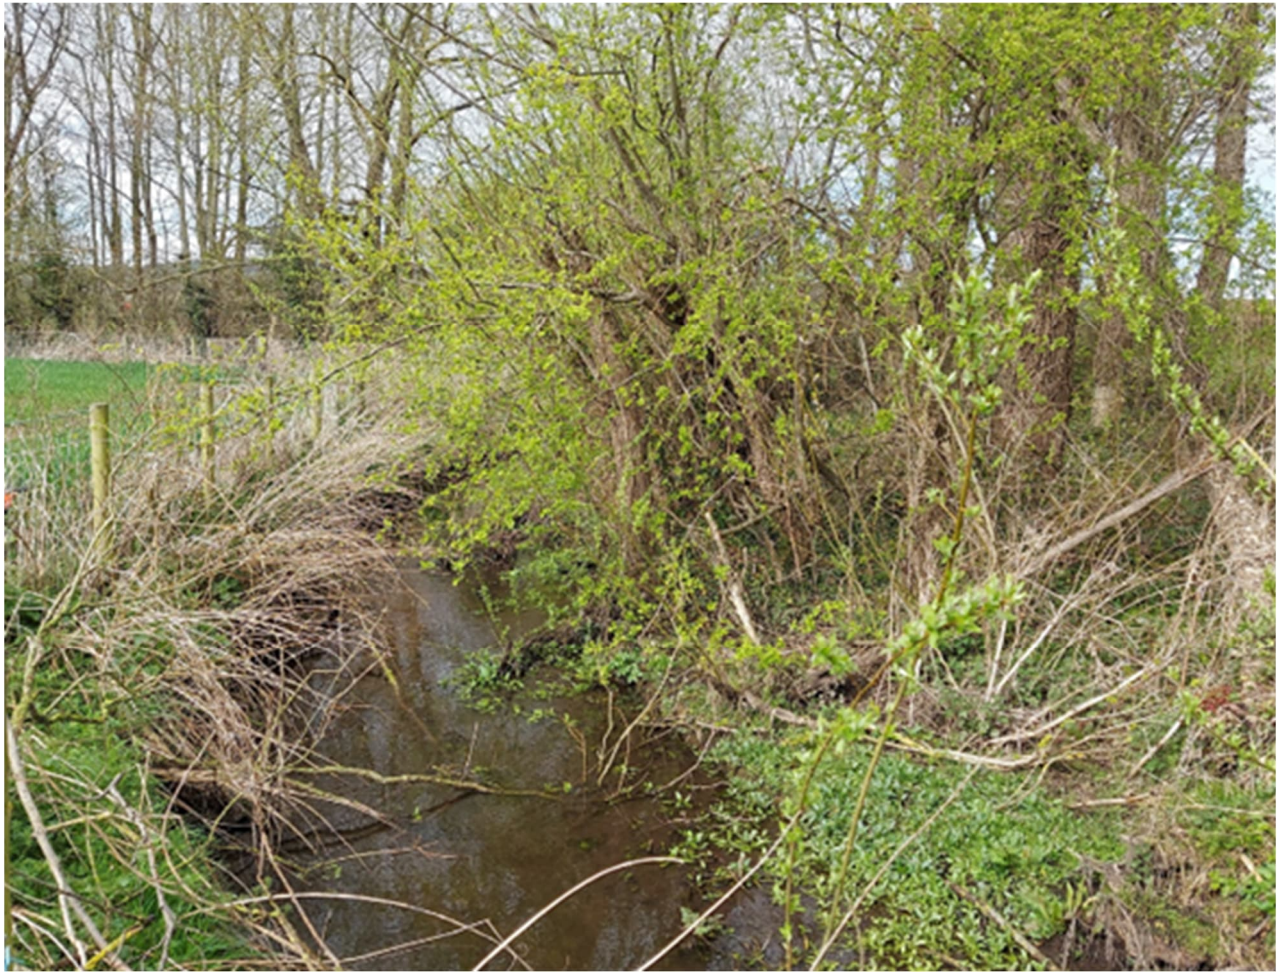
### 3.28. NORTHOP BROOK

<b>Catchment area</b>	0.98 km <sup>2</sup>
<b>Key hydraulic connections</b>	Northop Brook flows northwards and becomes the Lead Brook before joining the Dee.
<b>River Condition Score</b>	Moderate
<b>Catchment description</b>	<p>The catchment is predominantly rural with land used for pastoral and arable farming. The catchment is steep towards the Dee Estuary. The watercourse flows through agricultural land before entering a wooded gorge.</p> <p>There is an artificial lake/reservoir at the lower end of catchment, downstream of the surveyed reach, although this appears to have a limited backwater effect.</p>

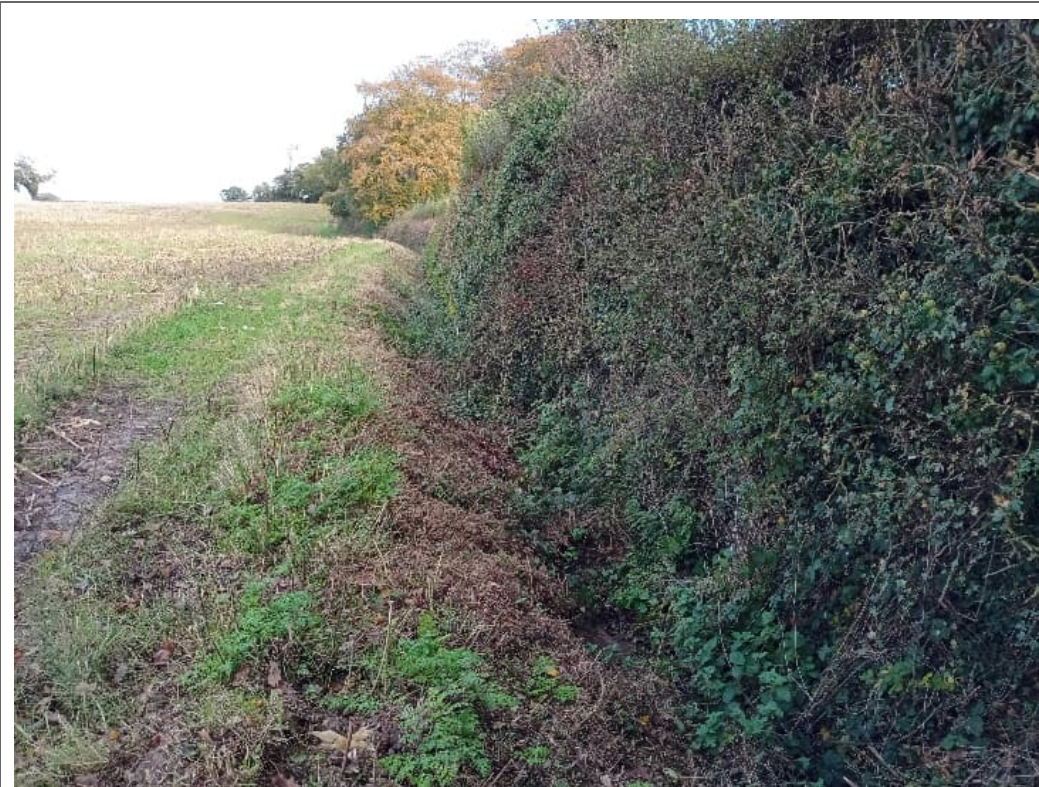
**Northop Brook Tributary 1**

<b>Catchment area</b>	Both <1km <sup>2</sup>
<b>Key hydraulic connections</b>	Both tributaries join the Northop Brook which flows northwards and becomes the Lead Brook before joining the Dee.
<b>River Condition Score</b>	Not surveyed
<b>Catchment description</b>	The catchments of these tributaries are predominantly arable farmland.
<b>Study reach description</b>	Both watercourses flow along field boundaries. They both have a hedgerow on the right bank. The watercourses are likely ephemeral and their riparian zones are dominated by tilled land.
<b>Interaction with the DCO Proposed Development</b>	Both watercourse will be crossed by the Newbuild Carbon Dioxide Pipeline via open trench.

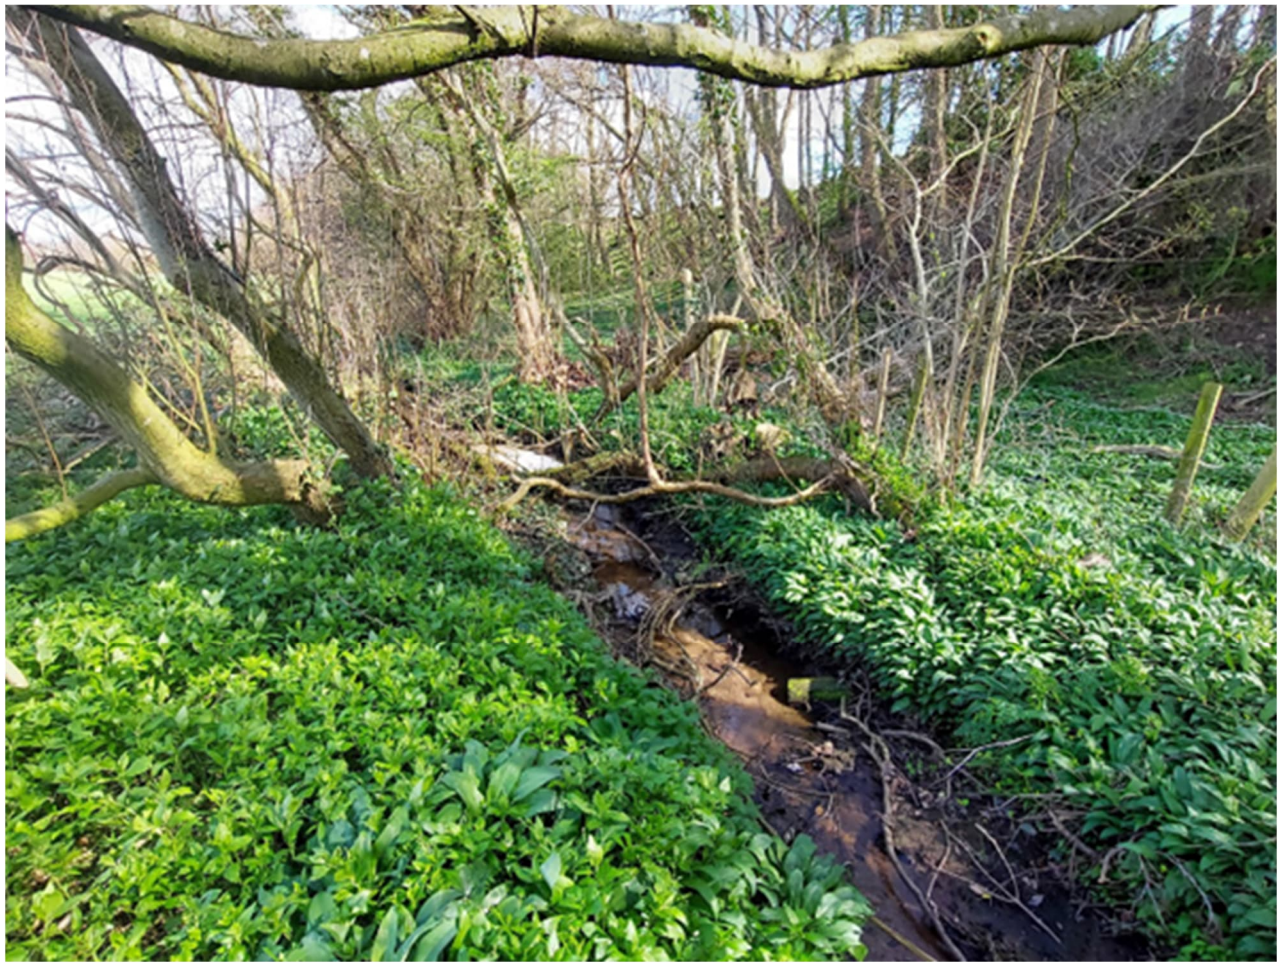
### 3.30. LITTLE LEAD BROOK

<b>Catchment area</b>	0.51 km <sup>2</sup>
<b>Key hydraulic connections</b>	This watercourse flows northwards towards the Dee Estuary
<b>River Condition Score</b>	Moderate
<b>Catchment description</b>	A small catchment which is dominated by agriculture with no suburban areas. This is a steep catchment which slopes towards the Dee. There is a small on-line pond attenuating flow upstream of the study reach.
<b>Study reach description</b>	Channel bankfull width is approximately 1m throughout the survey reach. Water depth is very shallow (0.05m). Channel bed composed of gravels and pebbles, with significant areas of sands and silts present. The riparian zone on the right bank is an ancient

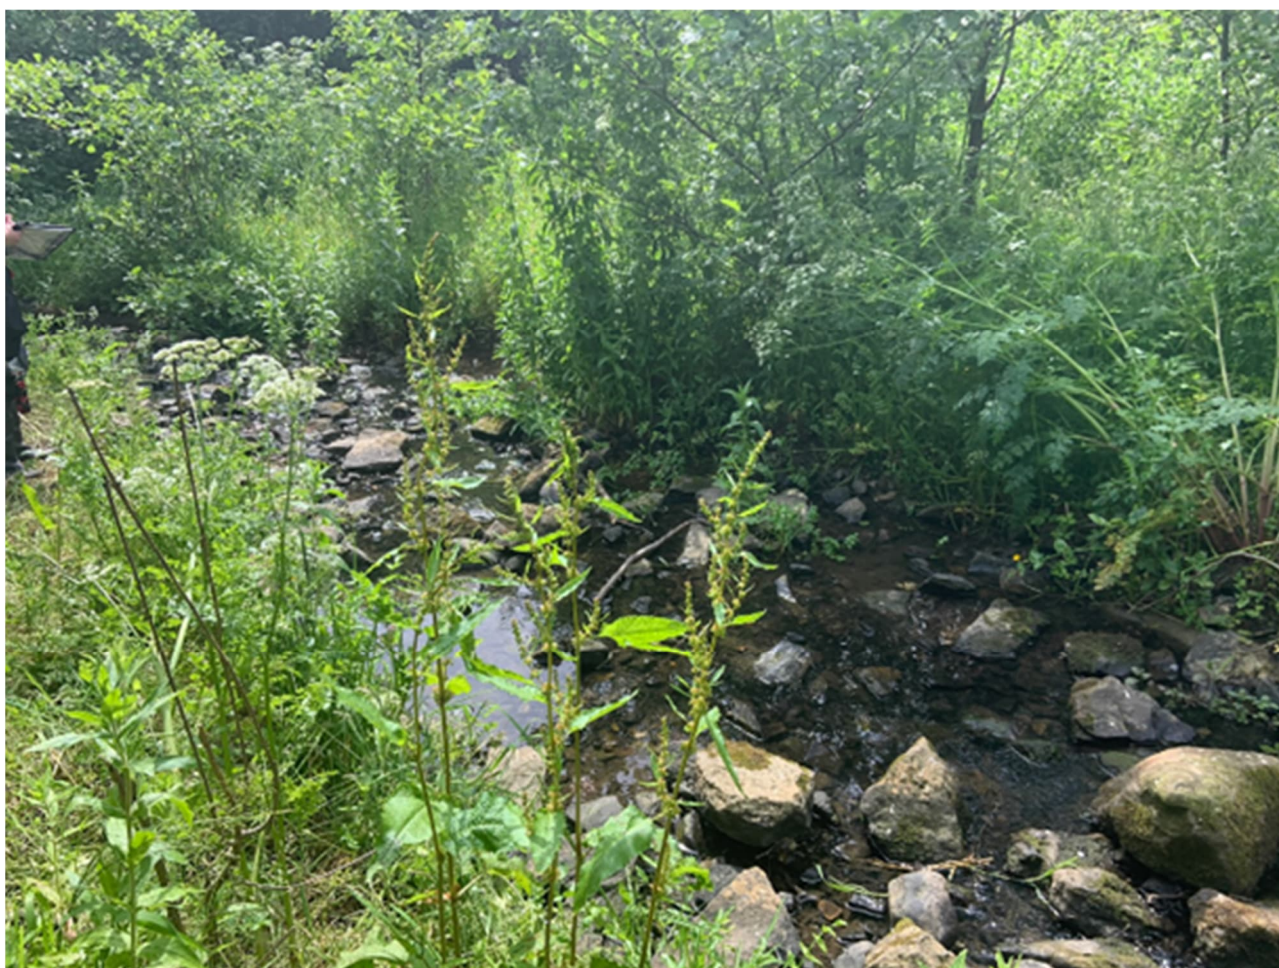
### 3.31. NANT-Y-FFLINT

<b>Catchment area</b>	4.31 km <sup>2</sup>
<b>Key hydraulic connections</b>	The Nant-y-Fflint has several unnamed tributaries mostly from the south of the catchment which join the watercourse upstream of the DCO Proposed Development.
<b>River Condition Score</b>	Fairly Good
<b>Catchment description</b>	The catchment is relatively steep, with a confined floodplain in a wooded valley. The catchment is predominantly rural farmland (arable and pastoral, forestry) with small settlements in Pentre Halkyn and Halkyn.
<b>Study reach description</b>	Bankfull width varies between 10 and 15m, with the surveyed wetted channel approximately 5m in width. Water depth is relatively shallow, between 0.1 and 0.2m in the surveyed reach.  The channel river bed is characteristic of steeper typologies, with step pool systems composed of cobbles and boulders, mixed with gravel and

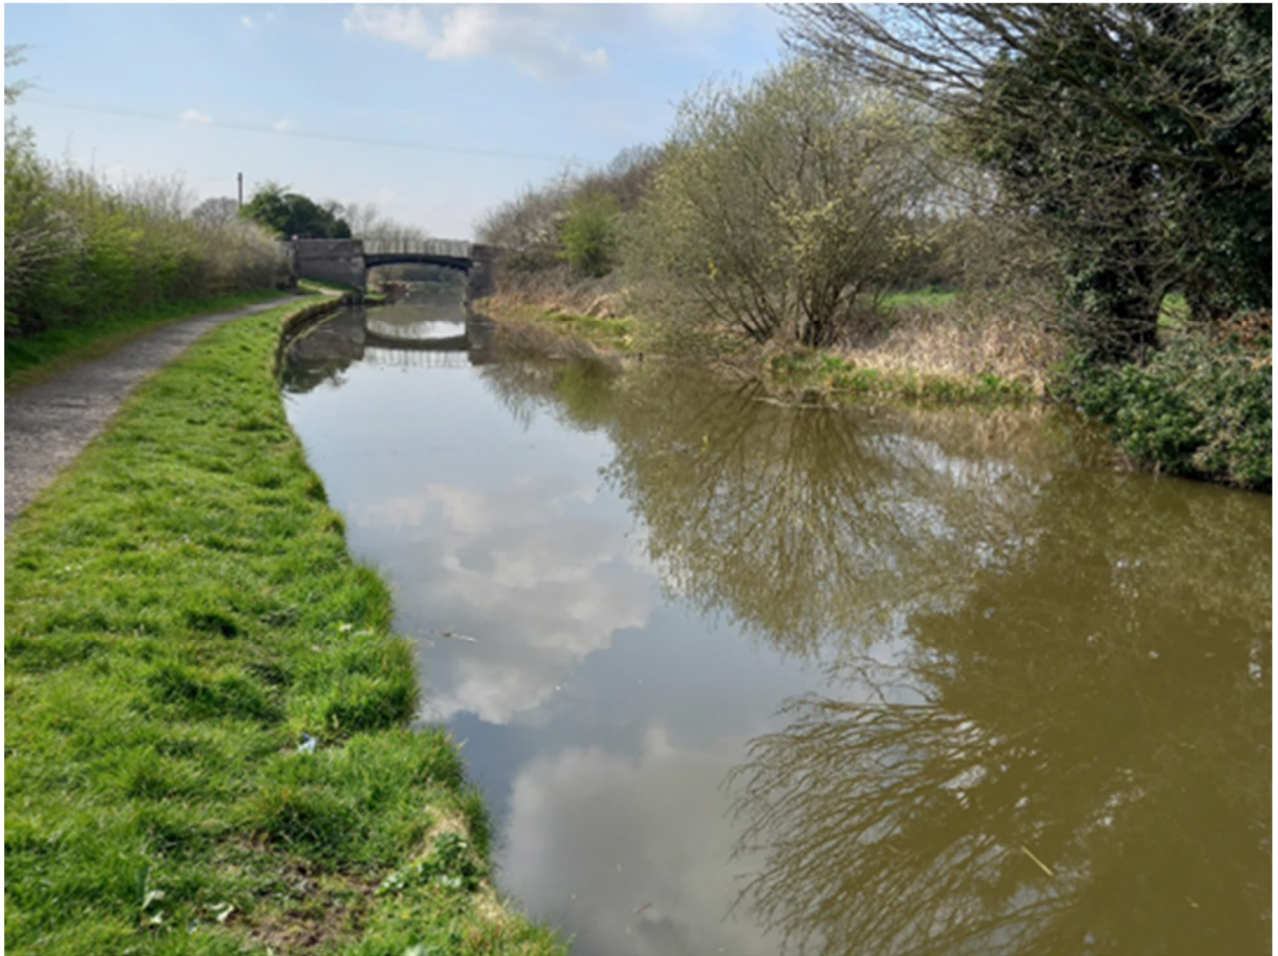
### 4.1. SHROPSHIRE UNION CANAL

<b>Catchment area</b>	n/a (artificial canal system)
<b>Key hydraulic connections</b>	The canal joins the Manchester Ship Canal to the River Dee at Chester.
<b>River Condition Score</b>	Fairly poor
<b>Catchment description</b>	<p>Artificial channel built in the late 18<sup>th</sup> century for industry and trade. Ellesmere and Chester canal branches. 16 locks separate Manchester Ship Canal from River Dee, whilst a series of locks and weirs control water level throughout the canal system.</p> <p>The surrounding land use is rural (farmland, arable and pastoral), woodland, urban, industrial and recreational (golf courses, etc).</p>

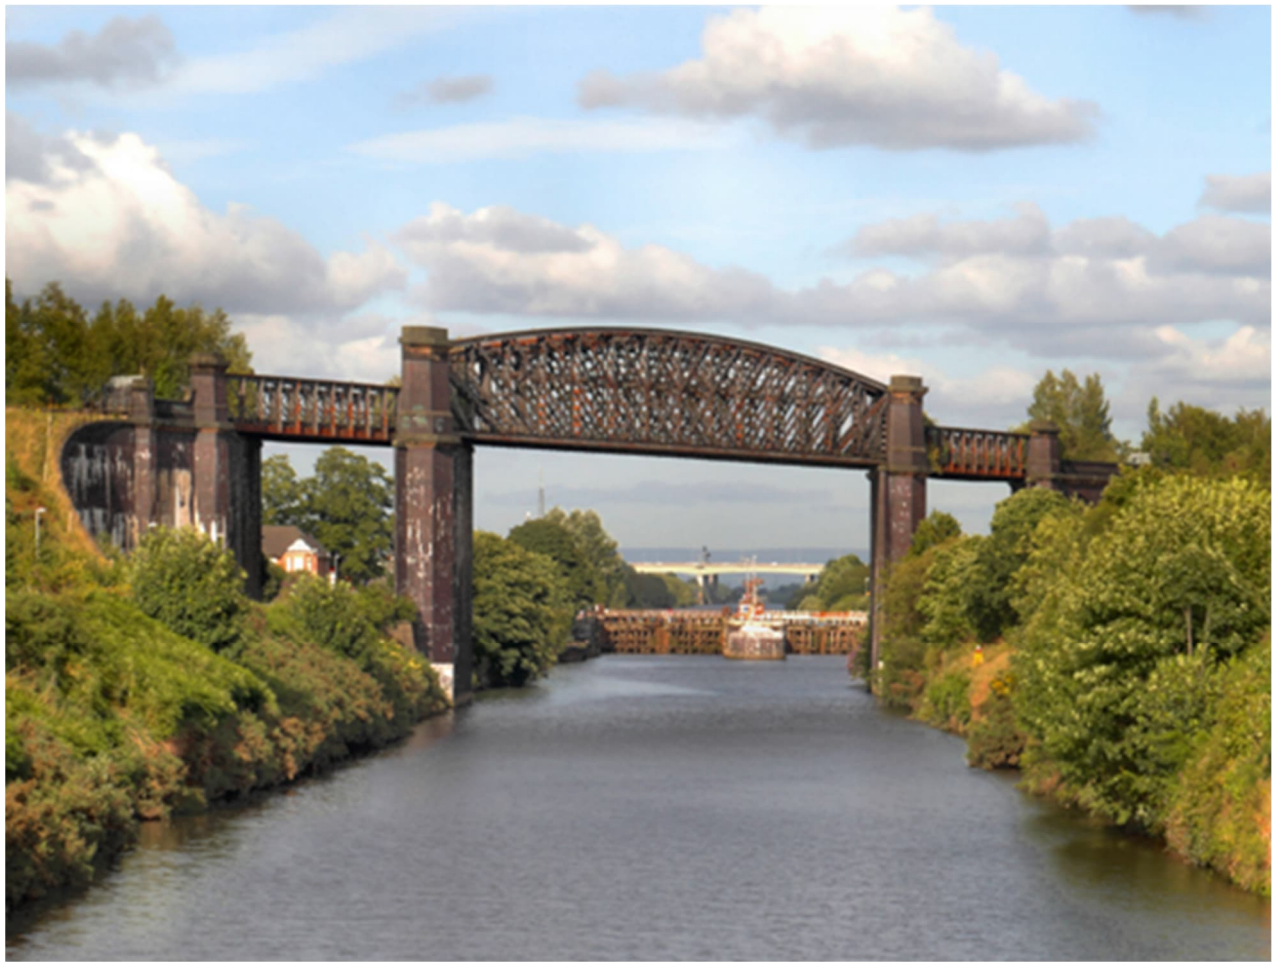
## 4.2. MANCHESTER SHIP CANAL

<b>Catchment area</b>	n/a (artificial canal)
<b>Key hydraulic connections</b>	River Irwell; River Irk; River Medlock
<b>River Condition Score</b>	Not surveyed
<b>Catchment description</b>	Major artificial canal, extensively used for shipping and trade. There are multiple locks and sluices to maintain water levels within the channel.
<b>Study reach description</b>	<p>The canal varies between 14 – 24m in width, and up to 9m in depth. The bed of the canal is likely to be silt and mud substrate.</p> <p>The riparian zone includes a tow path and other urban infrastructure, as well as recreational rural areas (fields, trees in country parks, golf courses etc).</p>
