A303 Amesbury to Berwick Down

**8.11 (Rev 3) – Draft Detailed Archaeological
Mitigation Strategy (DAMS)
(TRACKED CHANGES)**

Draft Detailed Archaeological Mitigation Strategy (DAMS)

Regulation Number:	Regulation 5(2)(q)
Planning Inspectorate Scheme Reference	TR010025
Application Document Reference	8.11 (Rev 3)
Author:	A303 Amesbury to Berwick Down Project Team, Highways England

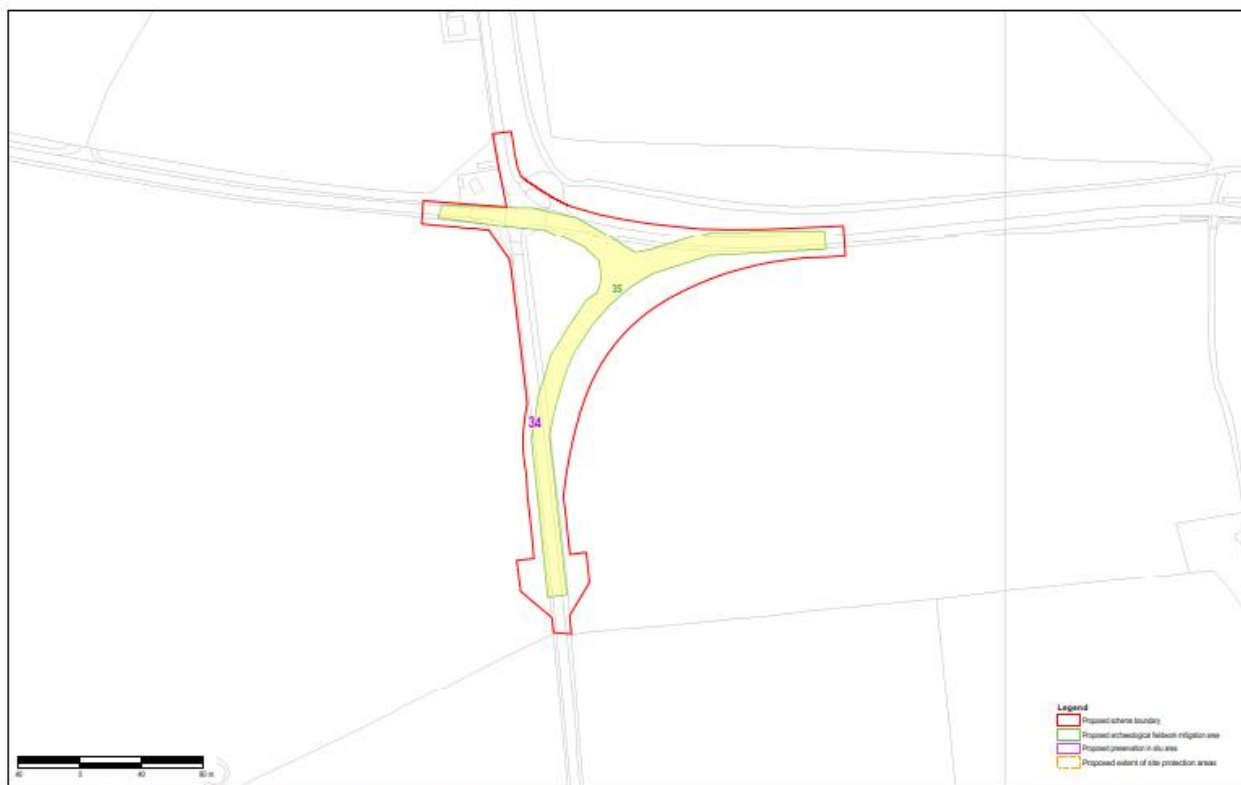
Site 35: Rollestone Corner – occasional tree throws containing material that could broadly be of Neolithic date.

Designation:	Non-designated
Reference IDs:	No UID
Location (NGR):	409720, 144570
Site area (approximate):	0.85ha

Site 35 comprises the footprint of the junction improvement at Rollestone Corner. It lies within the north-west corner of the WHS.

An evaluation carried out between March and June 2018 found evidence for Late Neolithic activity represented by flint scatters. Five trial trenches excavated within Site 35 contained few remains (Highways England, 2019g [REP1-044]).

A relatively large quantity of burnt flint (approximately 5kg) and a single worked flint flake were recovered from the lower fill (110704) of tree throw hole 110703 (minimum dimensions 1.6m x 1.1m, and 0.32m deep).

A pair of vehicle wheel ruts were uncovered in Trench 1106, which corresponded to parallel linear geophysical trends. Wheel rut 110605 was excavated and found to be 0.21 m wide and 0.07 m deep, with evidence of bioturbation to the side. No finds were recovered from its single fill. The wheel ruts may relate to military activity across the north of the site (proximity of Rolleston Camp), although this has not been proven. A linear anomaly that had been detected by geophysics crossing the south end of the trench (part of a possible field system) was not identified during the excavation of Trench 1106 and may have been ploughed-out.
