M42 Junction 6 Development Consent Order

Scheme Number TR010027

8.10 Statement of Common Ground with Natural England

**STATEMENT OF COMMON GROUND
NATURAL ENGLAND**

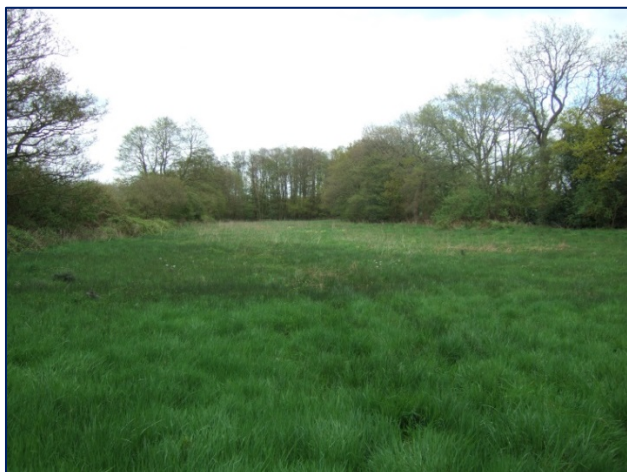
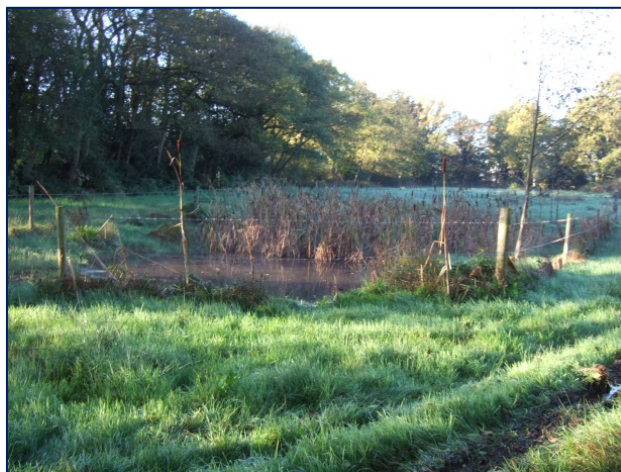
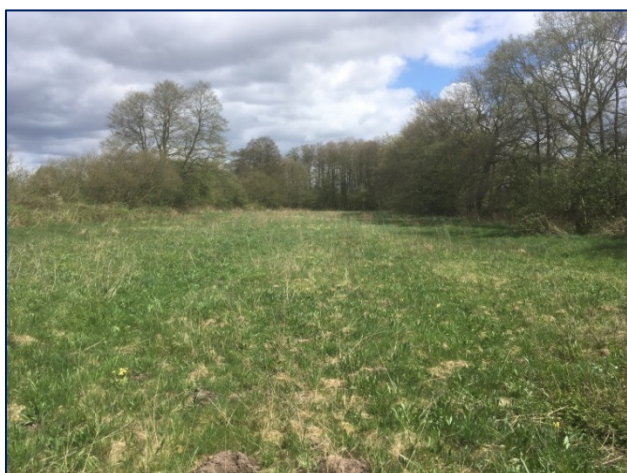
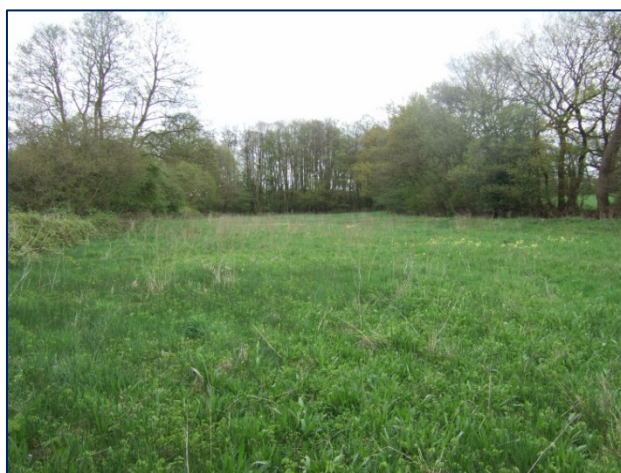
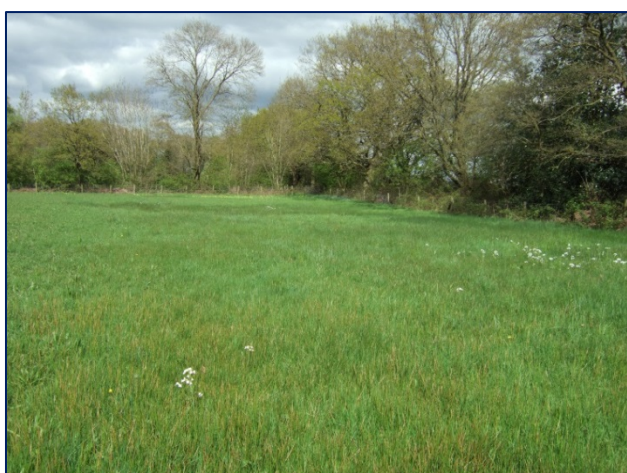
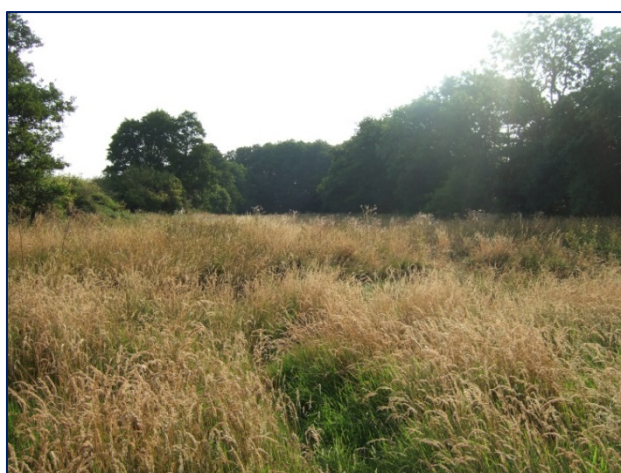
Photo 1 (top left) and Photo 2 (top right) Wet meadow fields at Bickenhill Meadows SSSI SE Unit in cold/wet conditions; Photo 3 (middle left) Wet meadow fields at Bickenhill Meadows SSSI SE Unit in warm/dry conditions; Photo 4 (middle right) and Photo 5 (bottom left) Bickenhill Meadows SSSI SE Unit in warm/dry conditions; Photo 6 (bottom right) Bickenhill Meadows SSSI unit southern field after a prolonged period of hot weather.

The southeastern unit consists of four fields and wet woodland at the far north of the site, and (along with the LNR) covers 4.4 hectares. The stream that flows through the centre of the site (from southwest to northeast) is a tributary of Shadow Brook. It meets Shadow Brook to the east of the M42 approximately 2 km downstream at NGR SP 20625 82231. The dry meadows are to the east of the site, and wet meadows are to the west. General views of the wet meadows are shown in Photos 1 to 6 under different conditions.

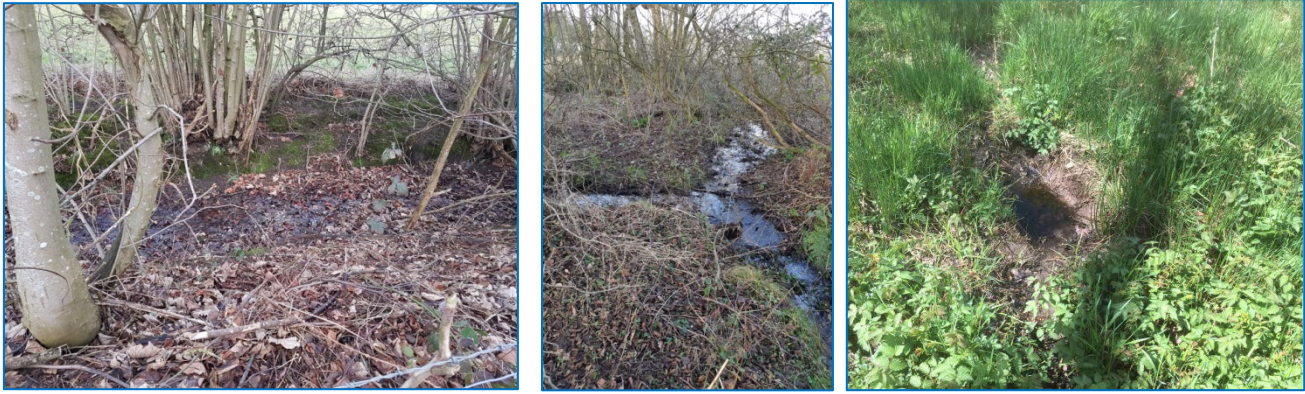
Photo 7 (left) Ponded water in agricultural drainage ditch at NW border of SE SSSI Unit; Photo 8 (right) confluence of the tributary of Shadow Brook and the drainage ditch within the alder woodland; Photo 9. Furrows and depressions saturated with water following rainfall in meadow field of SE SSSI Unit.

There is also an ephemeral drainage ditch bordering the northwest of the site (Photo 7), which varies between 1 and 1.5 m wide. This was largely dry on the majority of site visits, with some ponded water in places of 1-2 cm depth adjacent to the upper wet meadow. However, when observed after heavy rain there was obvious flow in the ditch, which presumably was sourced from runoff from the adjacent arable field which slopes significantly down to the SSSI. As the ditch enters the alder woodland at the northern extent of the SSSI there was a small amount of flow even during the drier site visits, which drains into the tributary of Shadow Brook (approximate NGR SP 18950 81743), see Photo 8.

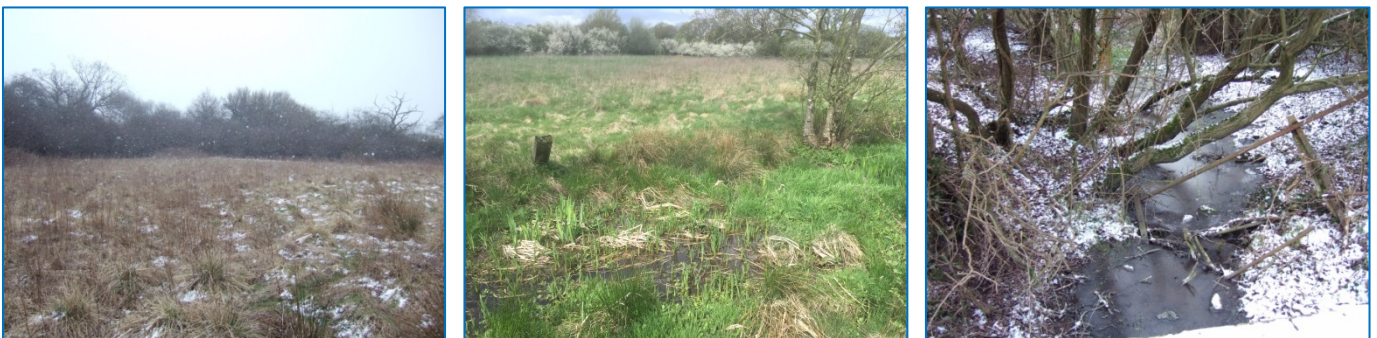
Photo 13 (left), Photo 14 (centre) and Photo 15 (right). Bickenhill Meadows SSSI NW Unit.

The watercourse appears to emanate from numerous ephemeral drainage ditches which flow around the elevated historic landfill area and coalesce at the south of the site to then flow north through the SSSI. A further drainage ditch flows north along the western boundary of the site. As the watercourse flows north through the SSSI unit it widens out into a very silted marshland area, with little discernable surface water flow (Photo 14), before reverting to a well-defined stream of up to 2.5m width (Photo 15) which has generally good floodplain connectivity within the SSSI, and emergent macrophytic vegetation in places. The watercourse is not considered of sufficient size to cause significant flooding of the adjacent fields.

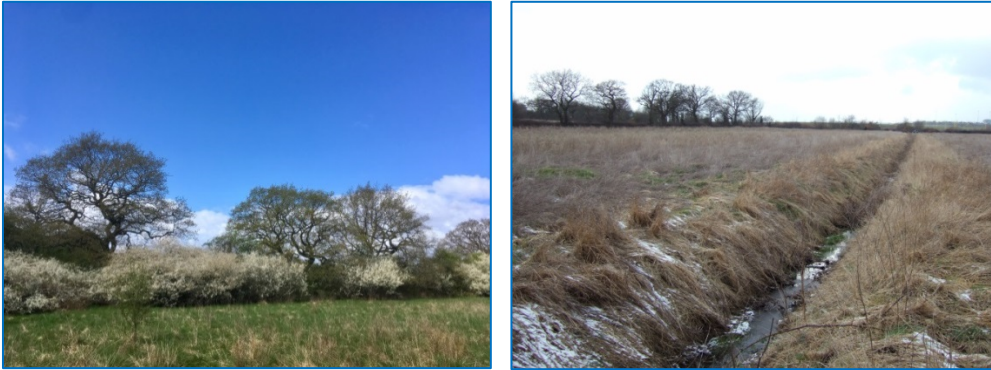
Photo 16 (left) – eastern field within the NW SSSI Unit showing the fringing blackthorn trees. Photo 17 (right) tributary of Low Brook immediately north of the SE SSSI Unit boundary looking towards Birmingham International Airport.

The western field has a generally drier and more uniform character than the eastern field (Photo 16), and is at a slightly greater elevation than the eastern field. The spatial distribution of the MG4 and MG5 grasslands across both fields is a likely consequence of local variability in moisture content in the upper 30-40 cm of soil, with tussocks and ridges across the site providing slightly drier conditions than localised depressions and troughs.

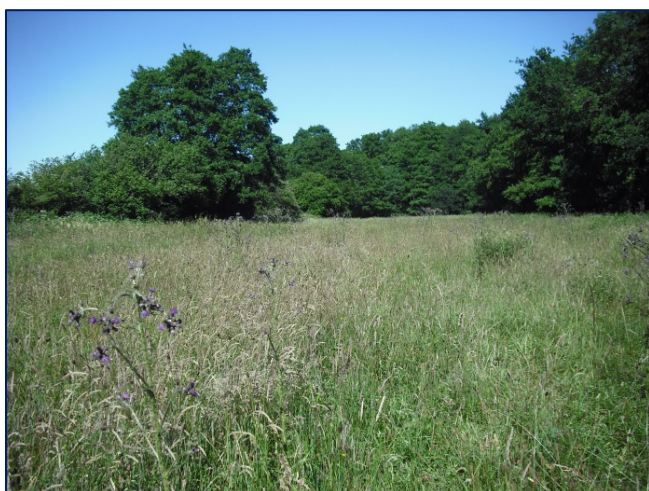
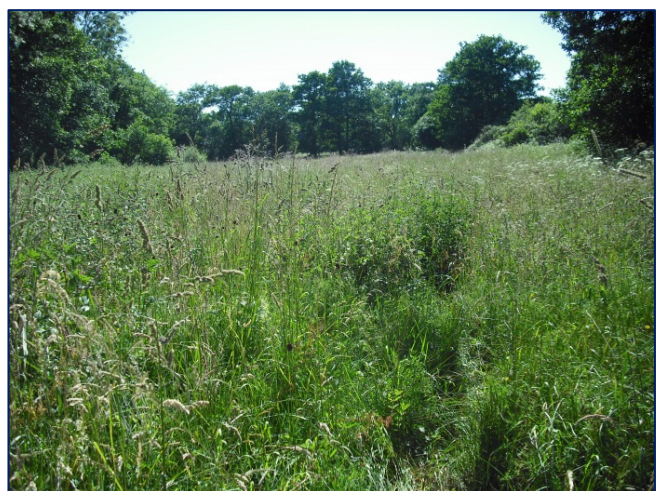
Photo 20 (left) and Photo 21 (right), typical vegetation in the SE SSSI unit wet meadow field.

The field within the SE SSSI unit on the west side of the watercourse was generally flat but with an apparent rise towards the northern boundary; the grasses did not dominate to the degree they did in the dry fields and there were patches of meadowsweet (*Filipendula ulmaria*) and great burnet (*Sanguisorba officinalis*) (Photo 20 and 21). Meadowsweet and other wetland species such as wild angelica (*Angelica sylvestris*) seemed to be more frequent towards the watercourse where the vegetation was taller and coarser. Interesting species recorded here were betony (*Stachys officinalis*) and tormentil (*Potentilla erecta*). It has been reported that meadow thistle (*Cirsium dissectum*) is also present but this was not found during the current survey.

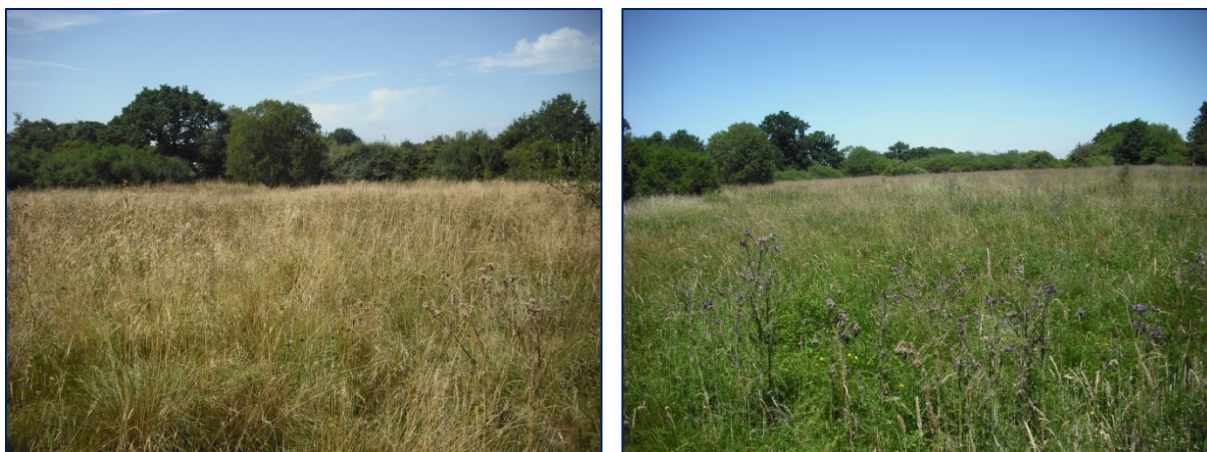
Photo 22 (left) and Photo 23 (right), typical vegetation in the NW SSSI unit western field.

The NW SSSI unit comprises two fields separated by a small, ephemeral watercourse, which was dry on the day of the survey. The western field appeared to be uniform in structure and was generally a mix of patches of larger forbs such as great burnet (*Sanguisorba officinalis*) and meadowsweet (*Filipendula ulmaria*), and grasses with a range of smaller forbs including several legumes scrambling through the vegetation. This field appeared to be more diverse than the corresponding field in the SE SSSI unit and here saw-wort (*Serratula tinctoria*), quaking grass (*Briza media*) and devil's bit scabious (*Succisa pratensis*) were recorded in addition to the more typical and commoner forb species. When visited in August 2018, tufted hair grass (*Deschampsia cespitosa*) was the dominant species in this field.

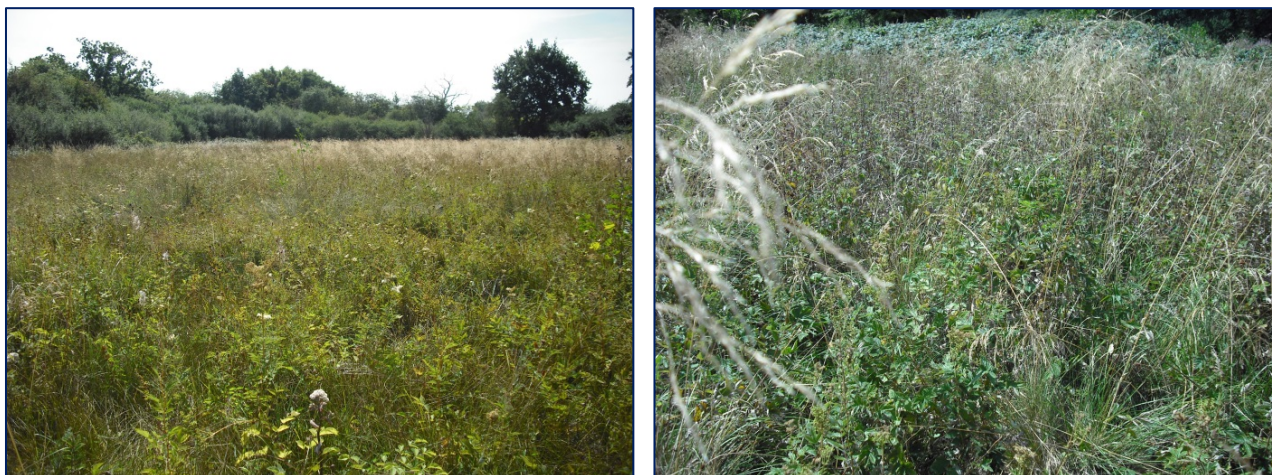
Photo 24 (left) and Photo 25 (right), typical vegetation in the NW SSSI unit eastern field.

The eastern field of the NW SSSI unit was only visited in August and had much coarser vegetation and the dominant grass across larger areas was tufted hair grass (*Deschampsia cespitosa*) but with meadowsweet and great burnet also frequent throughout the field. Sedges appeared to be more common in this field and included hairy sedge (*Carex hirta*), false fox sedge (*Carex otrubae*), common sedge (*Carex nigra*) and tufted sedge (*Carex acuta*). Otherwise it was very similar to the western field (Photos 24 and 25).

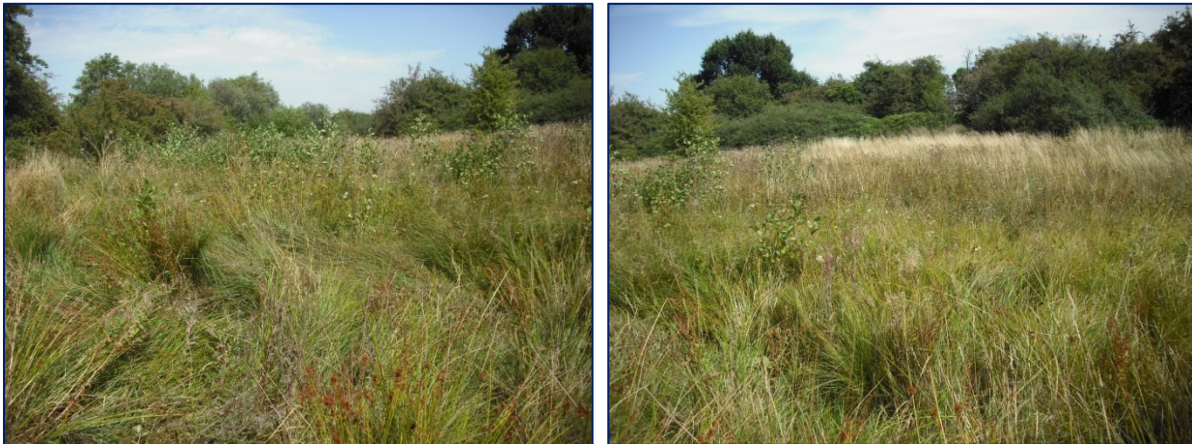
Photo 26 (left) and Photo 27 (right), typical vegetation in the distinct wetter area within the NW SSSI unit eastern field.

Part way along the western boundary of the field, there was a distinctive change in vegetation and whilst this will have to be shown by survey, it appeared to be delineated by a low spot, possibly linked to the ditch and was demarked by young alders (*Alnus glutinosa*). The vegetation here was dominated by tall rushes including soft rush (*Juncus effusus*), hard rush (*Juncus inflexus*) and sharp flowered rush (*Juncus acutiflorus*), along with sedges with abundant great hairy willowherb (*Epilobium hirsutum*) and in the wettest areas patches of fool's watercress (*Apium nodiflorum*). This is the area considered to be a potential spring in the preceding discussion (Photo 26 and Photo 27).

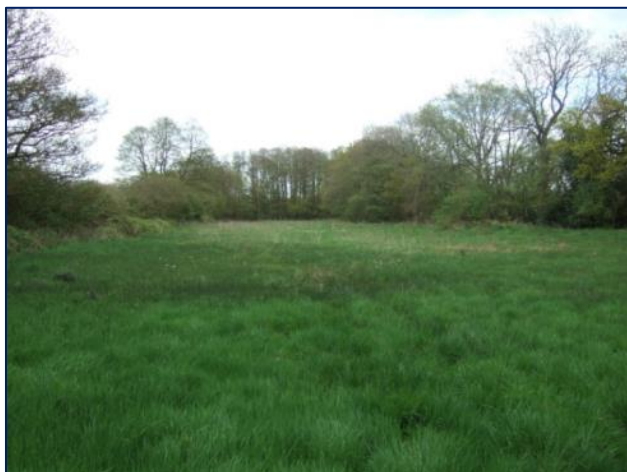
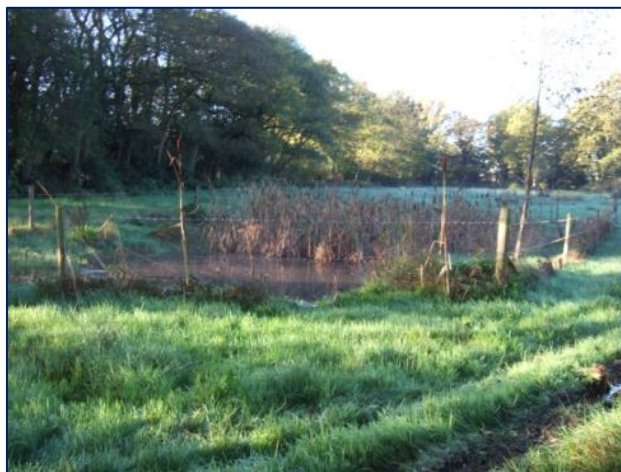
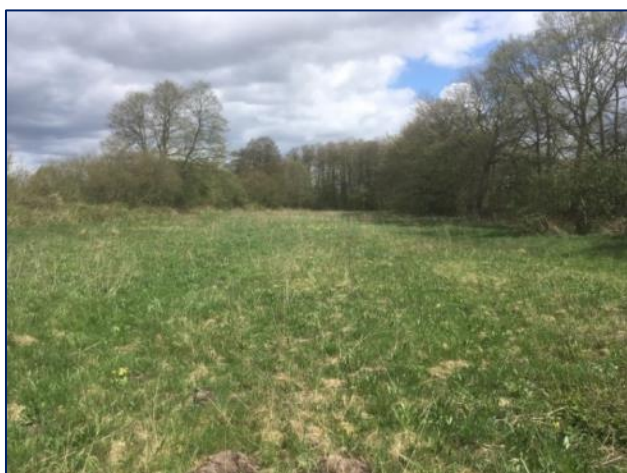
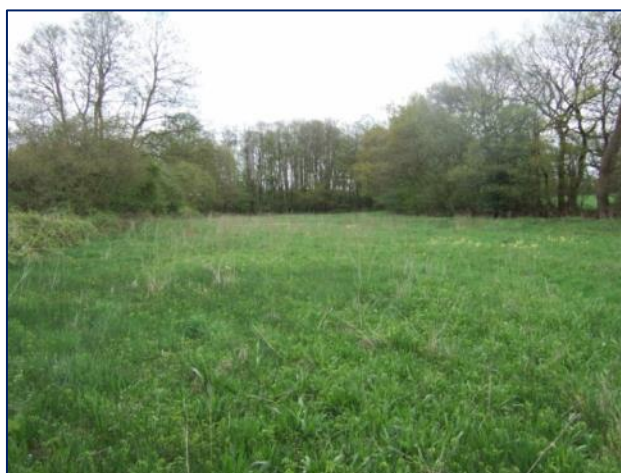
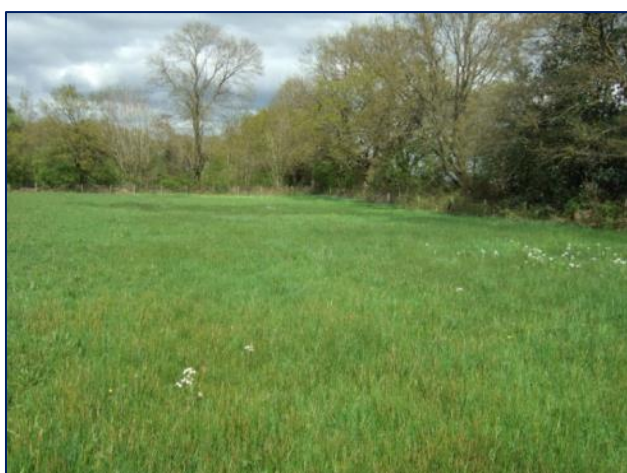
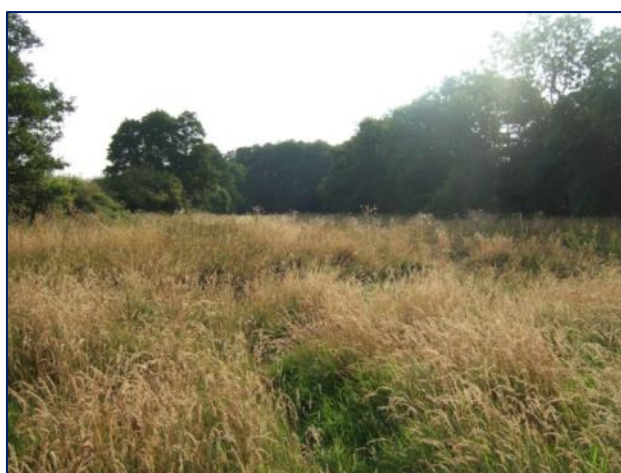
Photo 1 (top left) and Photo 2 (top right) Wet meadow fields at Bickenhill Meadows SSSI SE Unit in cold/wet conditions; Photo 3 (middle left) Wet meadow fields at Bickenhill Meadows SSSI SE Unit in warm/dry conditions; Photo 4 (middle right) and Photo 5 (bottom left) Bickenhill Meadows SSSI SE Unit in warm/dry conditions; Photo 6 (bottom right) Bickenhill Meadows SSSI unit southern field after a prolonged period of hot weather.

The southeastern unit consists of four fields and wet woodland at the far north of the site, and (along with the LNR) covers 4.4 hectares. The stream that flows through the centre of the site (from southwest to northeast) is a tributary of Shadow Brook. It meets Shadow Brook to the east of the M42 approximately 2 km downstream at NGR SP 20625 82231. The dry meadows are to the east of the site, and wet meadows are to the west. General views of the wet meadows are shown in Photos 1 to 6 under different conditions.

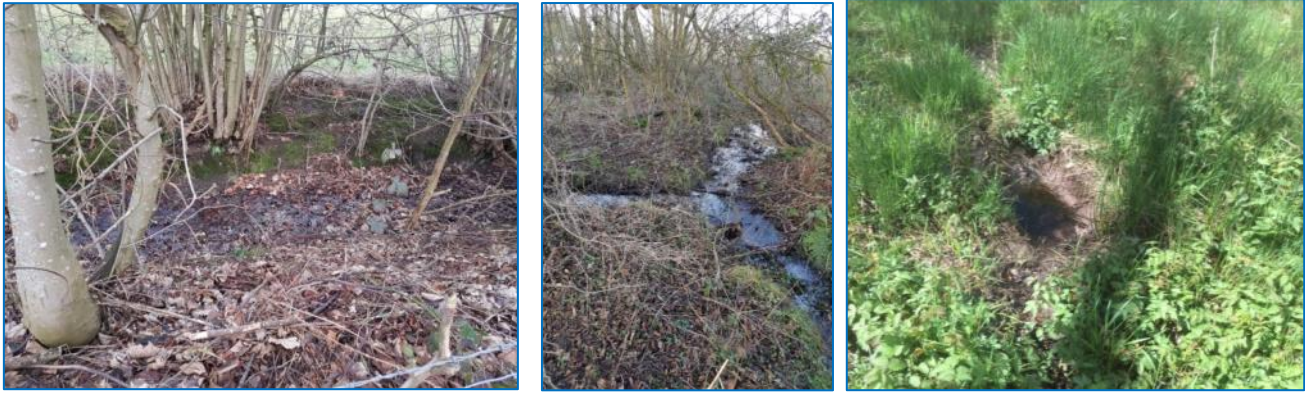
Photo 7 (left) Ponded water in agricultural drainage ditch at NW border of SE SSSI Unit; Photo 8 (right) confluence of the tributary of Shadow Brook and the drainage ditch within the alder woodland; Photo 9. Furrows and depressions saturated with water following rainfall in meadow field of SE SSSI Unit.

There is also an ephemeral drainage ditch bordering the northwest of the site (Photo 7), which varies between 1 and 1.5 m wide. This was largely dry on the majority of site visits, with some ponded water in places of 1-2 cm depth adjacent to the upper wet meadow. However, when observed after heavy rain there was obvious flow in the ditch, which presumably was sourced from runoff from the adjacent arable field which slopes significantly down to the SSSI. As the ditch enters the alder woodland at the northern extent of the SSSI there was a small amount of flow even during the drier site visits, which drains into the tributary of Shadow Brook (approximate NGR SP 18950 81743), see Photo 8.

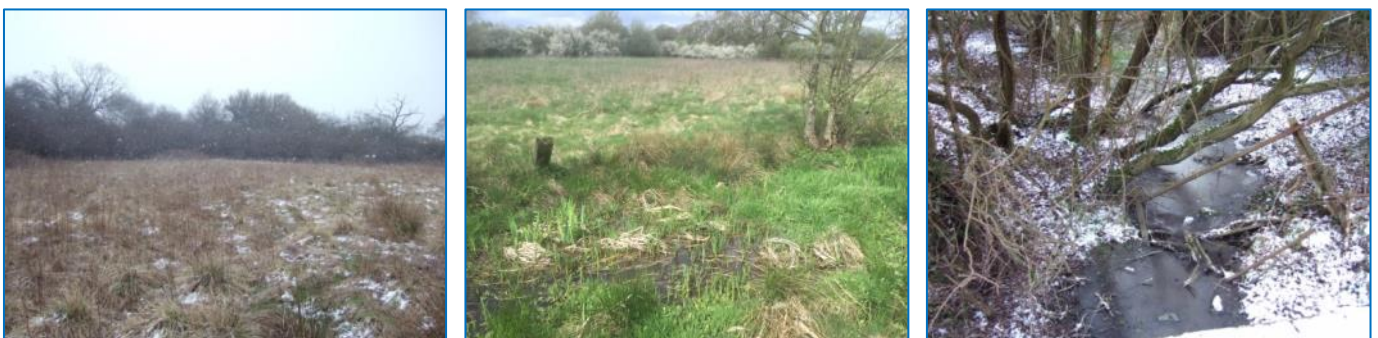
Photo 13 (left), Photo 14 (centre) and Photo 15 (right). Bickenhill Meadows SSSI NW Unit.

The watercourse appears to emanate from numerous ephemeral drainage ditches which flow around the elevated historic landfill area and coalesce at the south of the site to then flow north through the SSSI. A further drainage ditch flows north along the western boundary of the site. As the watercourse flows north through the SSSI unit it widens out into a very silted marshland area, with little discernable surface water flow (Photo 14), before reverting to a well-defined stream of up to 2.5m width (Photo 15) which has generally good floodplain connectivity within the SSSI, and emergent macrophytic vegetation in places. The watercourse is not considered of sufficient size to cause significant flooding of the adjacent fields.

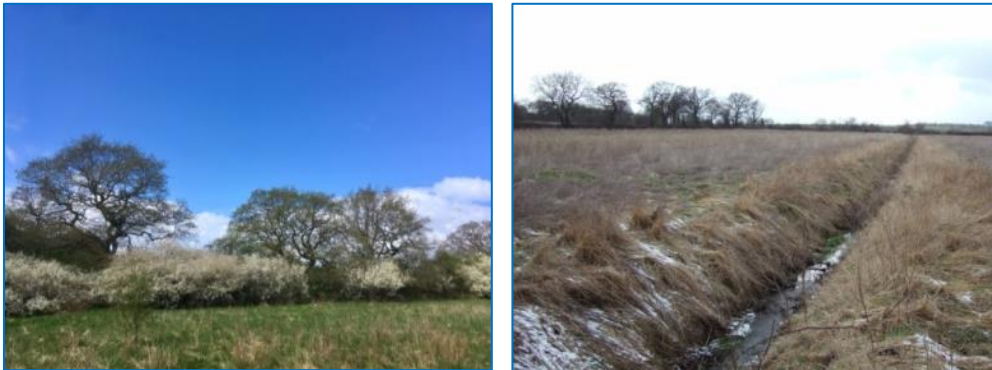
Photo 16 (left) – eastern field within the NW SSSI Unit showing the fringing blackthorn trees. Photo 17 (right) tributary of Low Brook immediately north of the SE SSSI Unit boundary looking towards Birmingham International Airport.

The western field has a generally drier and more uniform character than the eastern field (Photo 16), and is at a slightly greater elevation than the eastern field. The spatial distribution of the MG4 and MG5 grasslands across both fields is a likely consequence of local variability in moisture content in the upper 30-40 cm of soil, with tussocks and ridges across the site providing slightly drier conditions than localised depressions and troughs.

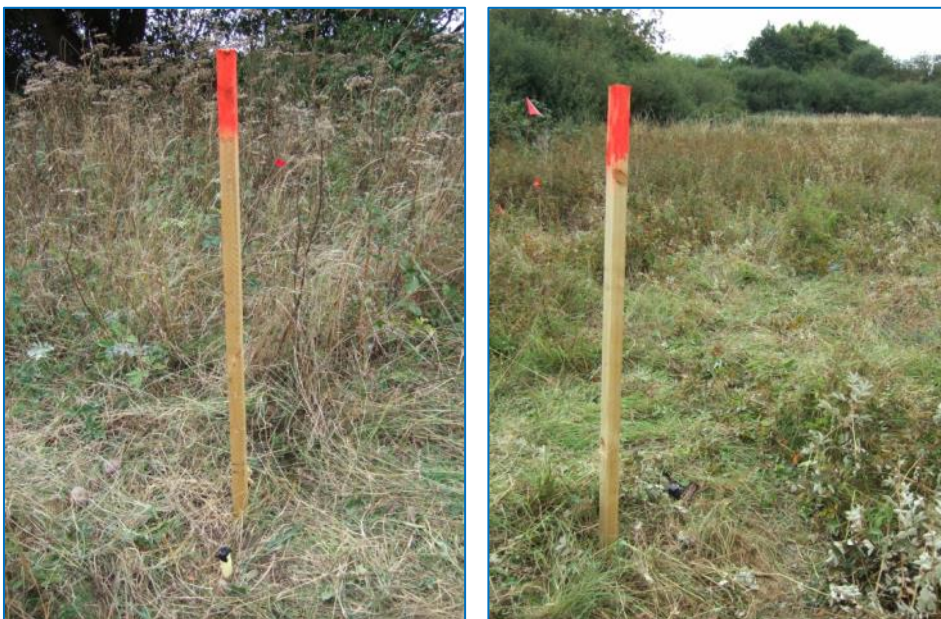
Photo 18 (left) Dipwell T2-D at the SE SSSI unit; and Photo 19 (right) Dipwell N2-B on the NW SSSI unit.

Dipwells were installed in the SE SSSI unit on 13-14th August 2018 (see Figure 12a for locations and Photo 18 for an example). A total of 10 dipwells were installed, covering MG4 grassland, MG5 grassland and transitional grassland areas. The dipwells were prefabricated from a perforated plastic pipe of 32 mm diameter. They are sealed above ground to prevent rainwater from filling the pipe. The plastic pipe is perforated at regular intervals along its length on all sides, to allow throughflow of soil water, and to allow equilibration to be achieved with the surrounding water table.

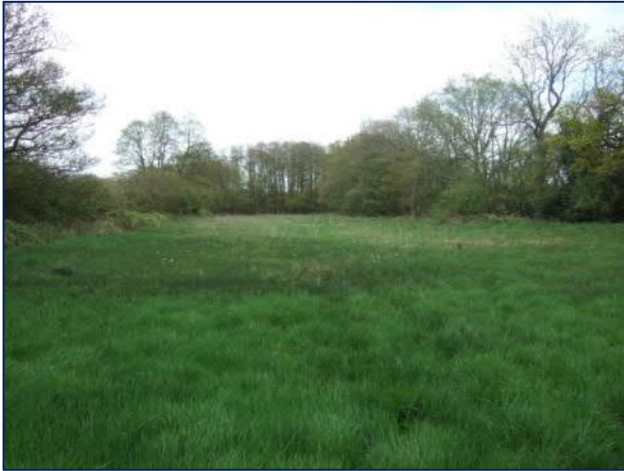
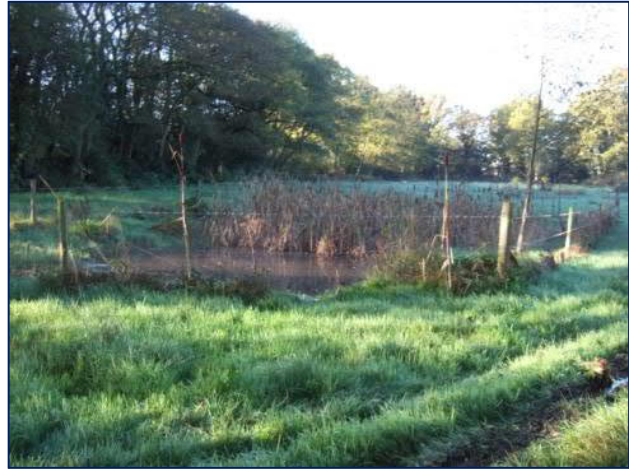
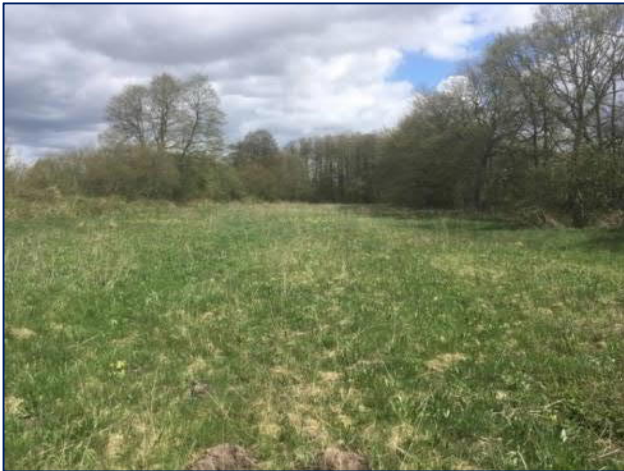
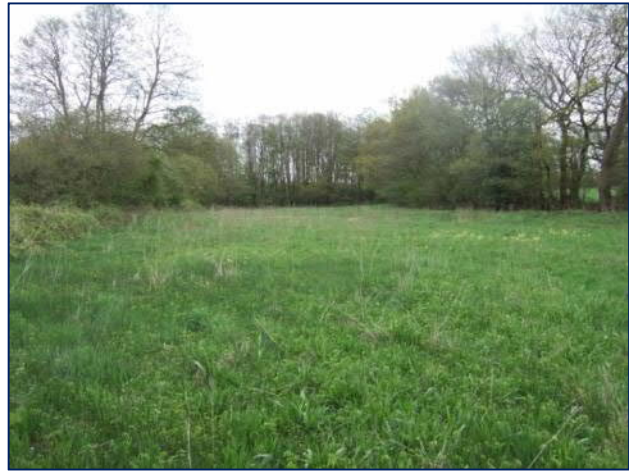
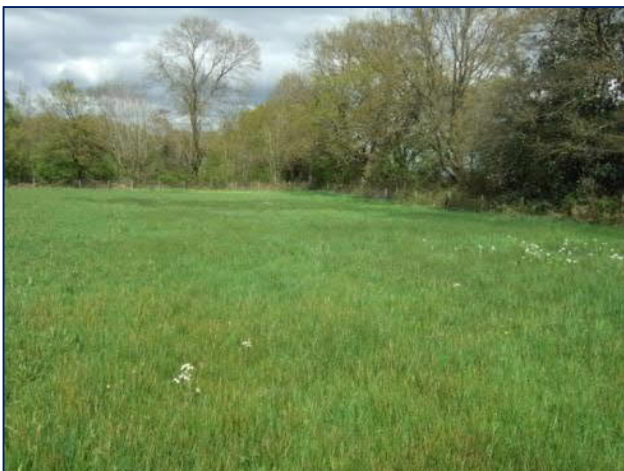
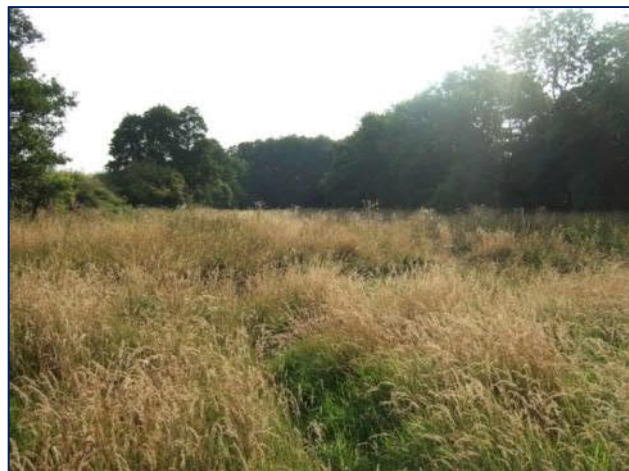
Photo 1 (top left) and Photo 2 (top right) Wet meadow fields at Bickenhill Meadows SSSI SE Unit / Shadowbrook Meadows LNR in cold/wet conditions; Photo 3 (middle left) Wet meadow fields at

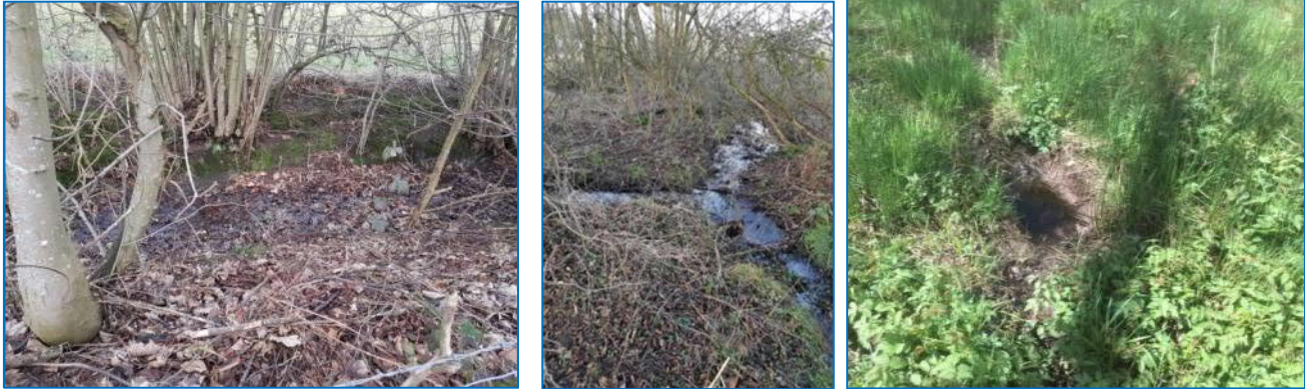
Photo 7 (left) Pondered water in agricultural drainage ditch at NW border of SE SSSI Unit; Photo 8 (right) confluence of the tributary of Shadow Brook and the drainage ditch within the alder woodland; Photo 9. Furrows and depressions saturated with water following rainfall in meadow field of SE SSSI Unit.

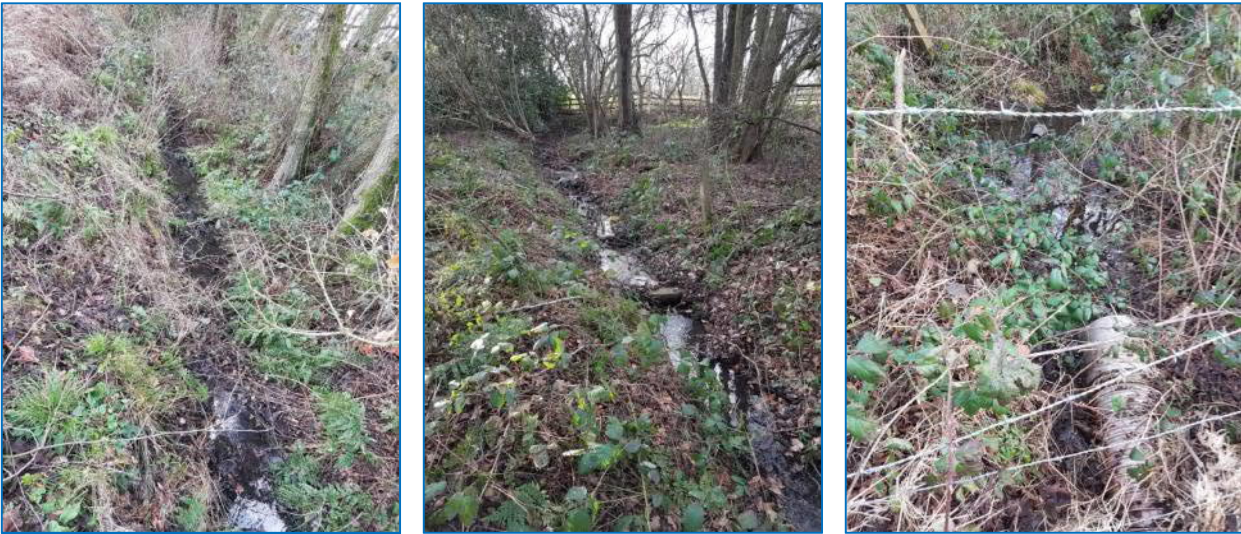
Photo 10 (left) and Photo 11 (centre): Tributary of Shadow Brook within the wet woodland. Photo 12: (right) Culvert exit downstream of the grassed land bridge.

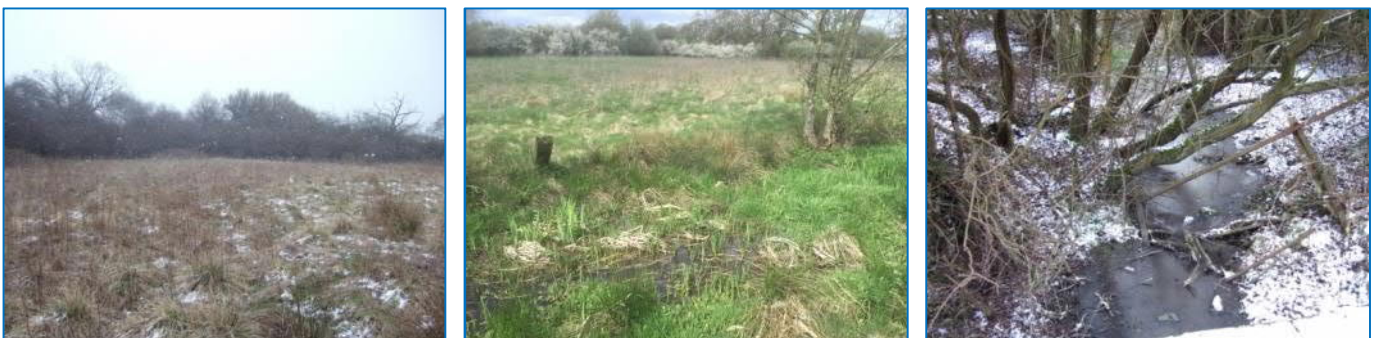
Photo 13 (left), Photo 14 (centre) and Photo 15 (right). Bickenhill Meadows SSSI NW Unit.

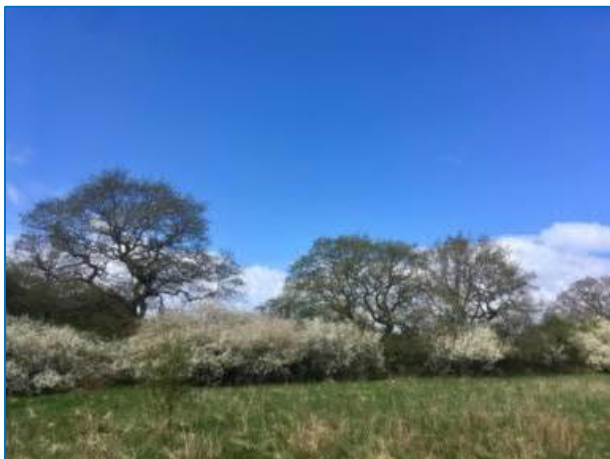
Photo 16 (left) – eastern field within the NW SSSI Unit showing the fringing blackthorn trees.

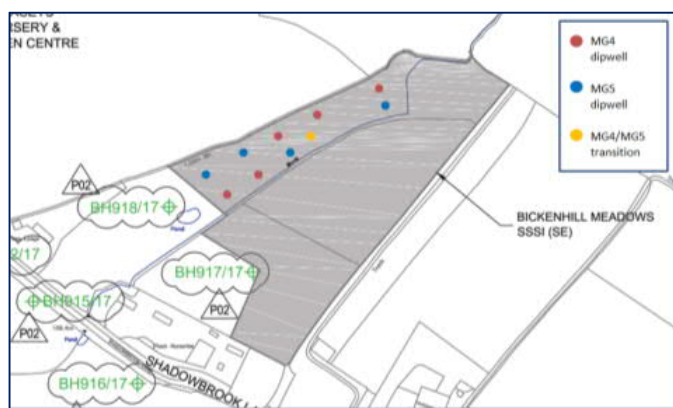
Figure 12a. Locations of dipwells installed in the wet meadow field at the SE SSSI unit

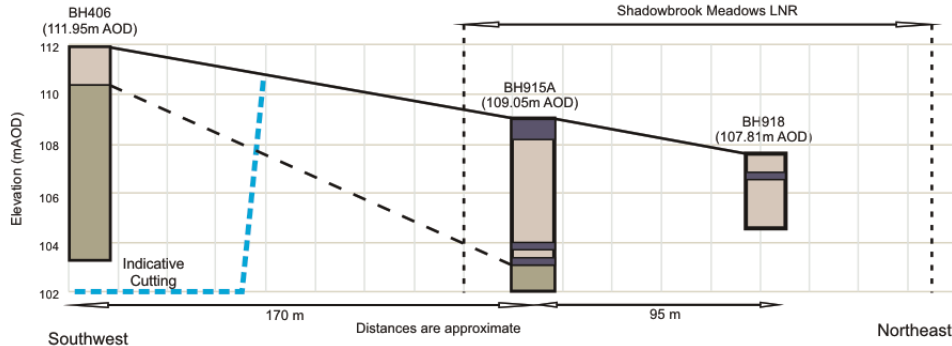
The superficial deposits in the vicinity of the cutting do not include sand layers, and so infiltration is not expected to be significant. Sand layers are only located closer to the SSSI in the area that is not 'cut-off' by the Scheme.
