M42 Junction 6 Development Consent Order

Scheme Number TR010027

8.10 (a) Statement of Common Ground with Natural England

**STATEMENT OF COMMON GROUND
NATURAL ENGLAND**

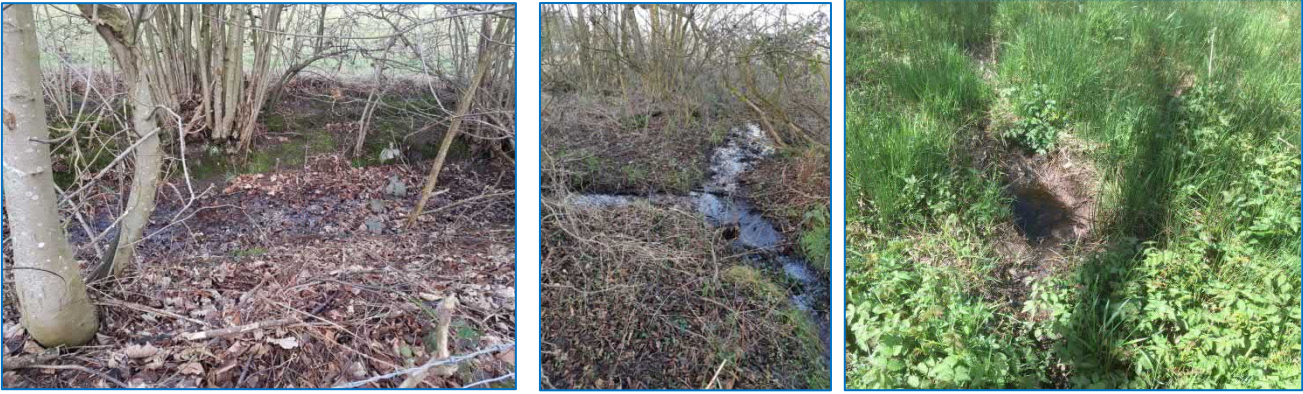
Photo 7 (left) Ponded water in agricultural drainage ditch at NW border of SE SSSI Unit; Photo 8 (right) confluence of the tributary of Shadow Brook and the drainage ditch within the alder woodland; Photo 9. Furrows and depressions saturated with water following rainfall in meadow field of SE SSSI Unit.

There is also an ephemeral drainage ditch bordering the northwest of the site (Photo 7), which varies between 1 and 1.5 m wide. This was largely dry on the majority of site visits, with some ponded water in places of 1-2 cm depth adjacent to the upper wet meadow. However, when observed after heavy rain there was obvious flow in the ditch, which presumably was sourced from runoff from the adjacent arable field which slopes significantly down to the SSSI. As the ditch enters the alder woodland at the northern extent of the SSSI there was a small amount of flow even during the drier site visits, which drains into the tributary of Shadow Brook (approximate NGR SP 18950 81743), see Photo 8.

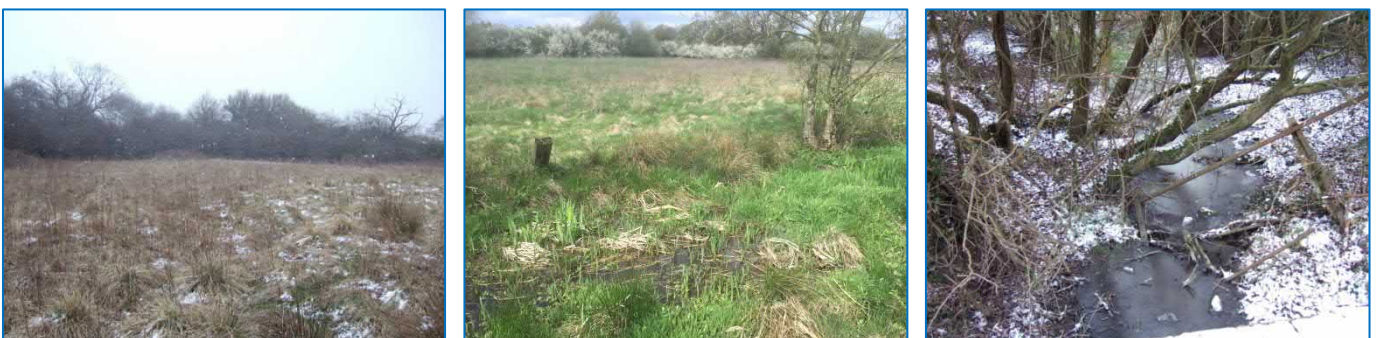
Photo 13 (left), Photo 14 (centre) and Photo 15 (right). Bickenhill Meadows SSSI NW Unit.

The watercourse appears to emanate from numerous ephemeral drainage ditches which flow around the elevated historic landfill area and coalesce at the south of the site to then flow north through the SSSI. A further drainage ditch flows north along the western boundary of the site. As the watercourse flows north through the SSSI unit it widens out into a very silted marshland area, with little discernable surface water flow (Photo 14), before reverting to a well-defined stream of up to 2.5m width (Photo 15) which has generally good floodplain connectivity within the SSSI, and emergent macrophytic vegetation in places. The watercourse is not considered of sufficient size to cause significant flooding of the adjacent fields.

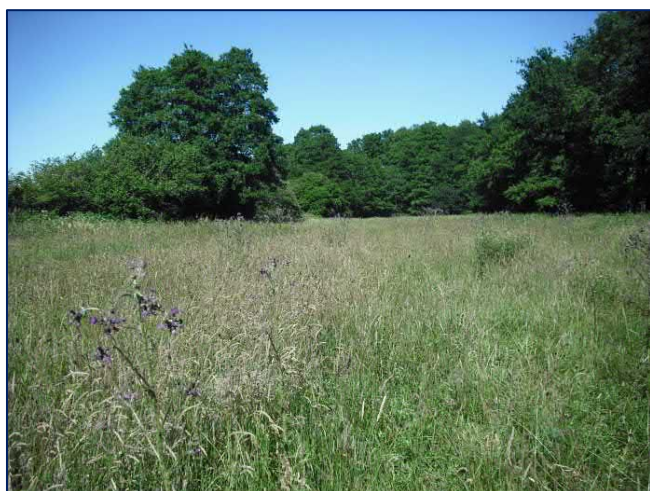
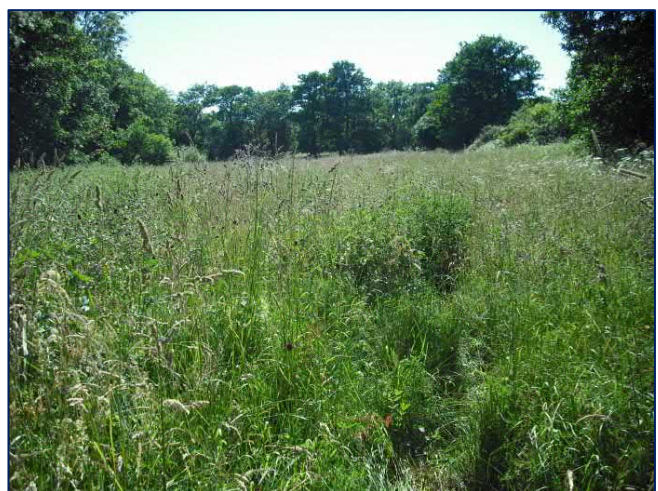
Photo 20 (left) and Photo 21 (right), typical vegetation in the SE SSSI unit wet meadow field.

The field within the SE SSSI unit on the west side of the watercourse was generally flat but with an apparent rise towards the northern boundary; the grasses did not dominate to the degree they did in the dry fields and there were patches of meadowsweet (*Filipendula ulmaria*) and great burnet (*Sanguisorba officinalis*) (Photo 20 and 21). Meadowsweet and other wetland species such as wild angelica (*Angelica sylvestris*) seemed to be more frequent towards the watercourse where the vegetation was taller and coarser. Interesting species recorded here were betony (*Stachys officinalis*) and tormentil (*Potentilla erecta*). It has been reported that meadow thistle (*Cirsium dissectum*) is also present but this was not found during the current survey.

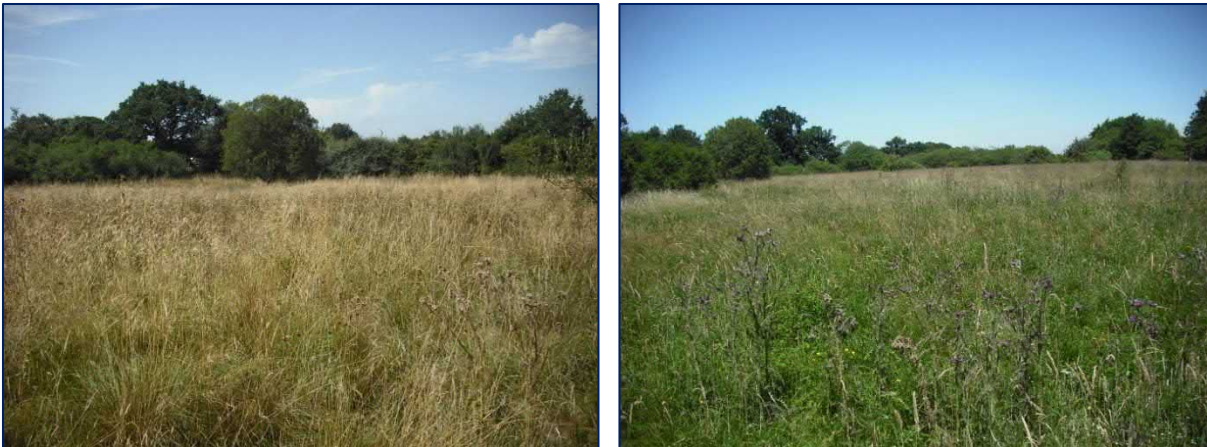
Photo 22 (left) and Photo 23 (right), typical vegetation in the NW SSSI unit western field.

The NW SSSI unit comprises two fields separated by a small, ephemeral watercourse, which was dry on the day of the survey. The western field appeared to be uniform in structure and was generally a mix of patches of larger forbs such as great burnet (*Sanguisorba officinalis*) and meadowsweet (*Filipendula ulmaria*), and grasses with a range of smaller forbs including several legumes scrambling through the vegetation. This field appeared to be more diverse than the corresponding field in the SE SSSI unit and here saw-wort (*Serratula tinctoria*), quaking grass (*Briza media*) and devil's bit scabious (*Succisa pratensis*) were recorded in addition to the more typical and commoner forb species. When visited in August 2018, tufted hair grass (*Deschampsia cespitosa*) was the dominant species in this field.

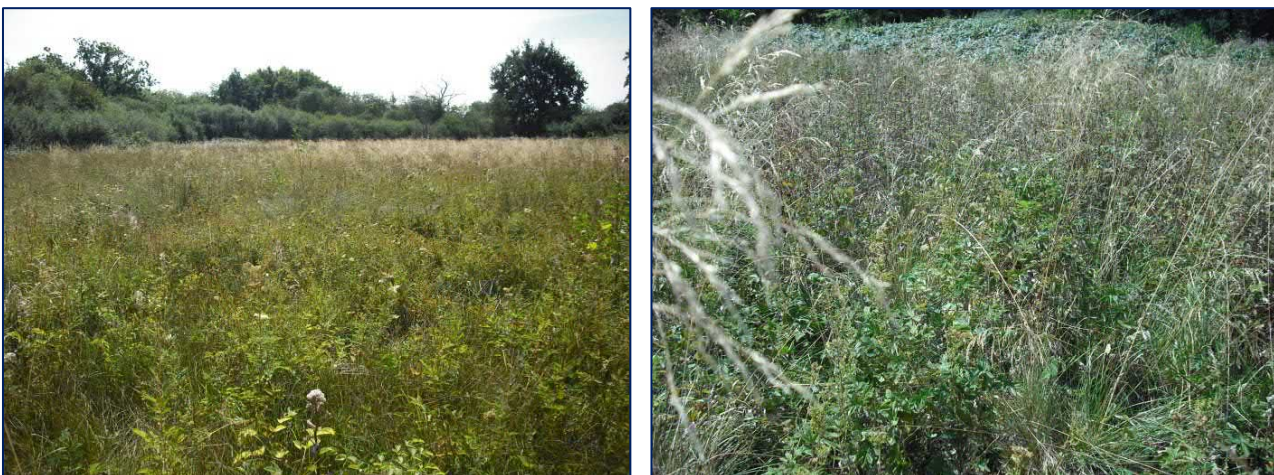
Photo 24 (left) and Photo 25 (right), typical vegetation in the NW SSSI unit eastern field.

The eastern field of the NW SSSI unit was only visited in August and had much coarser vegetation and the dominant grass across larger areas was tufted hair grass (*Deschampsia cespitosa*) but with meadowsweet and great burnet also frequent throughout the field. Sedges appeared to be more common in this field and included hairy sedge (*Carex hirta*), false fox sedge (*Carex otrubae*), common sedge (*Carex nigra*) and tufted sedge (*Carex acuta*). Otherwise it was very similar to the western field (Photos 24 and 25).

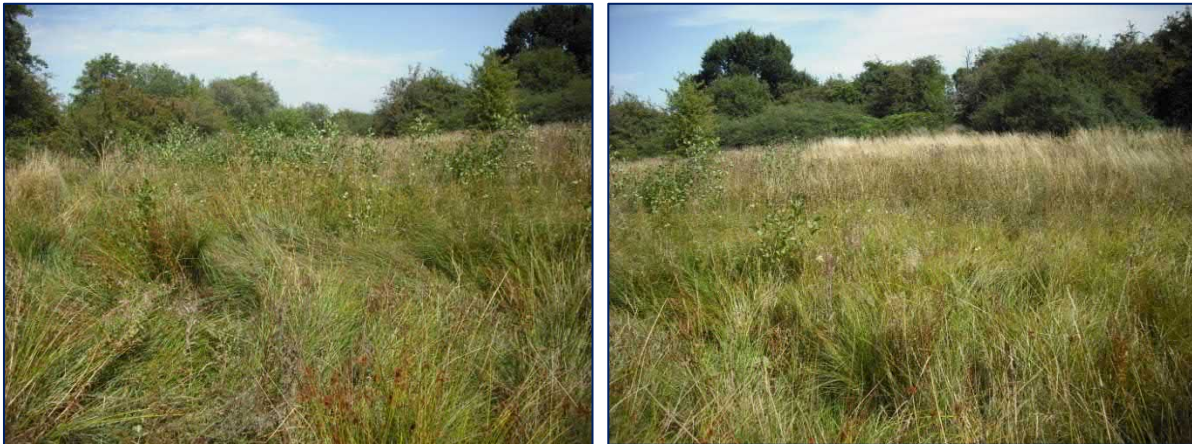
Photo 26 (left) and Photo 27 (right), typical vegetation in the distinct wetter area within the NW SSSI unit eastern field.

Part way along the western boundary of the field, there was a distinctive change in vegetation and whilst this will have to be shown by survey, it appeared to be delineated by a low spot, possibly linked to the ditch and was demarked by young alders (*Alnus glutinosa*). The vegetation here was dominated by tall rushes including soft rush (*Juncus effusus*), hard rush (*Juncus inflexus*) and sharp flowered rush (*Juncus acutiflorus*), along with sedges with abundant great hairy willowherb (*Epilobium hirsutum*) and in the wettest areas patches of fool's watercress (*Apium nodiflorum*). This is the area considered to be a potential spring in the preceding discussion (Photo 26 and Photo 27).

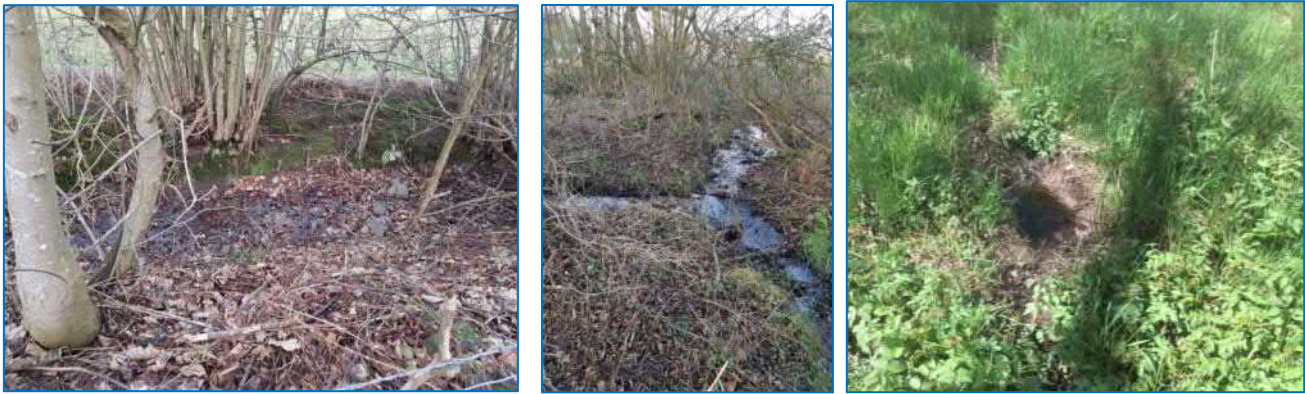
Photo 7 (left) Ponded water in agricultural drainage ditch at NW border of SE SSSI Unit; Photo 8 (right) confluence of the tributary of Shadow Brook and the drainage ditch within the alder woodland; Photo 9. Furrows and depressions saturated with water following rainfall in meadow field of SE SSSI Unit.

There is also an ephemeral drainage ditch bordering the northwest of the site (Photo 7), which varies between 1 and 1.5 m wide. This was largely dry on the majority of site visits, with some ponded water in places of 1-2 cm depth adjacent to the upper wet meadow. However, when observed after heavy rain there was obvious flow in the ditch, which presumably was sourced from runoff from the adjacent arable field which slopes significantly down to the SSSI. As the ditch enters the alder woodland at the northern extent of the SSSI there was a small amount of flow even during the drier site visits, which drains into the tributary of Shadow Brook (approximate NGR SP 18950 81743), see Photo 8.

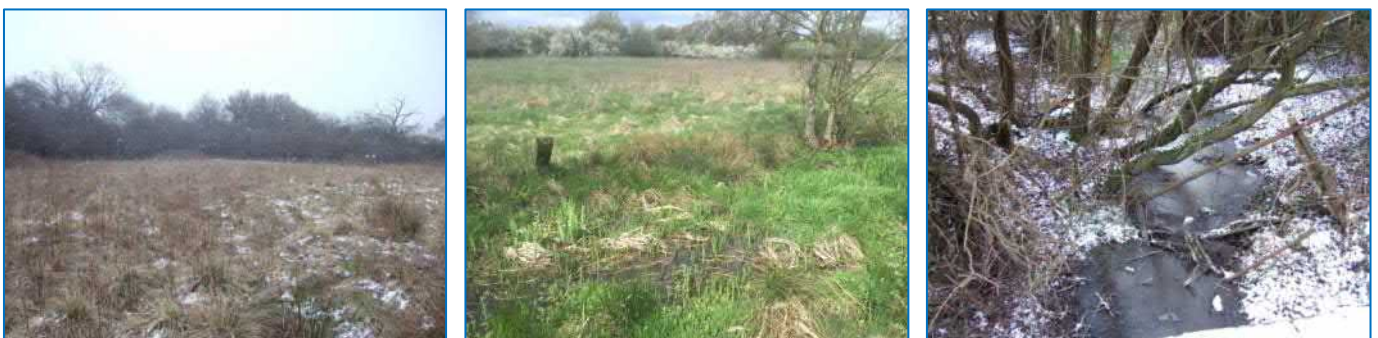
Photo 13 (left), Photo 14 (centre) and Photo 15 (right). Bickenhill Meadows SSSI NW Unit.

The watercourse appears to emanate from numerous ephemeral drainage ditches which flow around the elevated historic landfill area and coalesce at the south of the site to then flow north through the SSSI. A further drainage ditch flows north along the western boundary of the site. As the watercourse flows north through the SSSI unit it widens out into a very silted marshland area, with little discernable surface water flow (Photo 14), before reverting to a well-defined stream of up to 2.5m width (Photo 15) which has generally good floodplain connectivity within the SSSI, and emergent macrophytic vegetation in places. The watercourse is not considered of sufficient size to cause significant flooding of the adjacent fields.

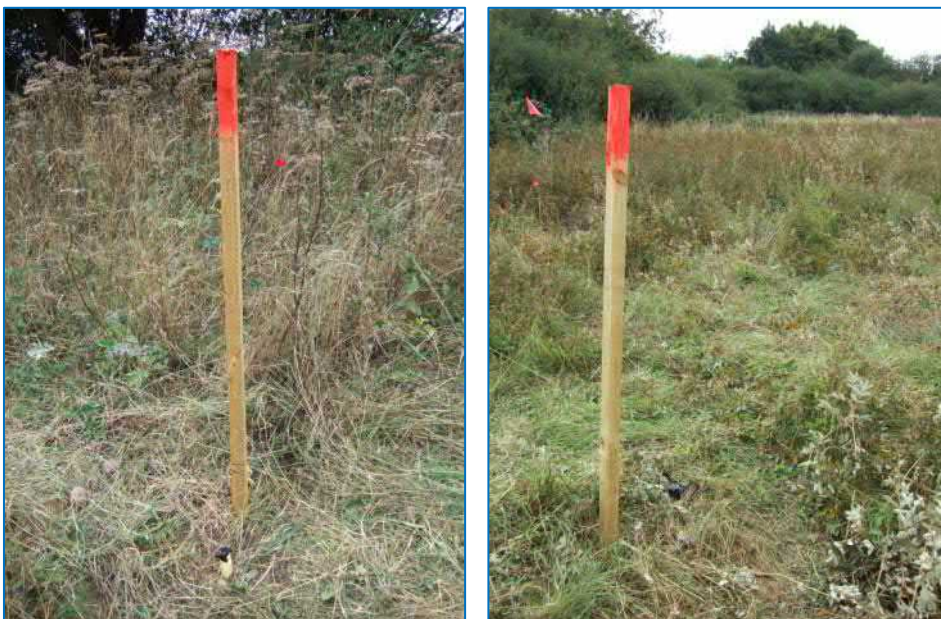
Photo 18 (left) Dipwell T2-D at the SE SSSI unit; and Photo 19 (right) Dipwell N2-B on the NW SSSI unit.

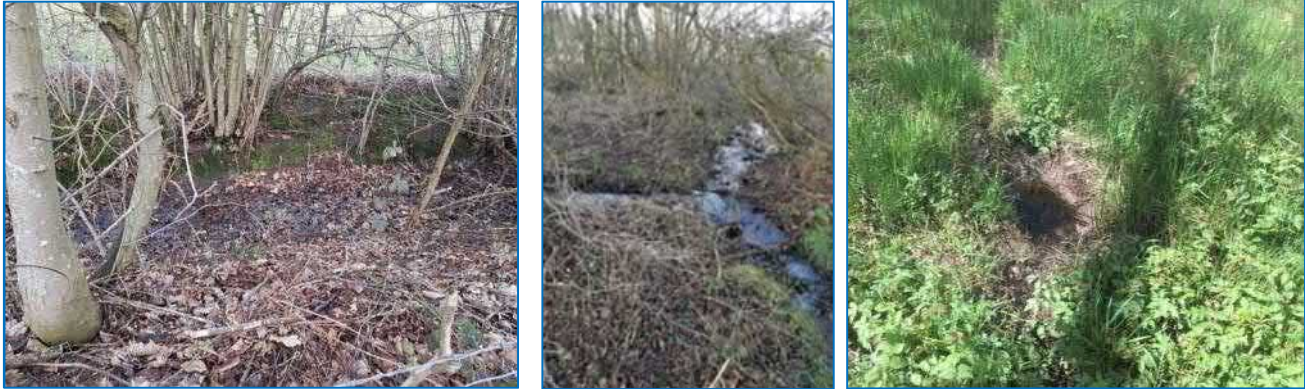
Photo 7 (left) Ponded water in agricultural drainage ditch at NW border of SE SSSI Unit; Photo 8 (right) confluence of the tributary of Shadow Brook and the drainage ditch within the alder woodland; Photo 9. Furrows and depressions saturated with water following rainfall in meadow field of SE SSSI Unit.

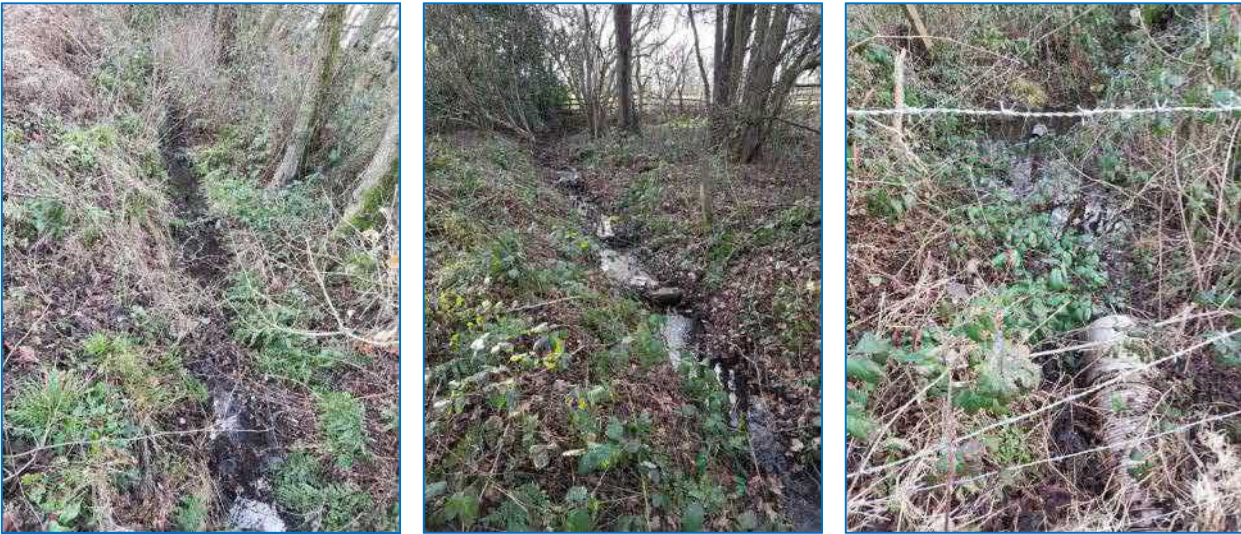
Photo 10 (left) and Photo 11 (centre): Tributary of Shadow Brook within the wet woodland. Photo 12: (right) Culvert exit downstream of the grassed land bridge.

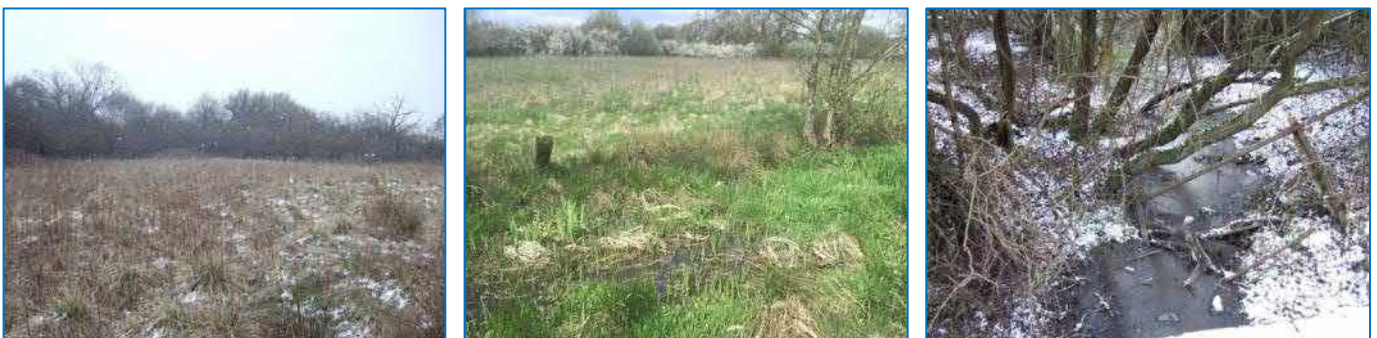
Photo 13 (left), Photo 14 (centre) and Photo 15 (right). Bickenhill Meadows SSSI NW Unit.

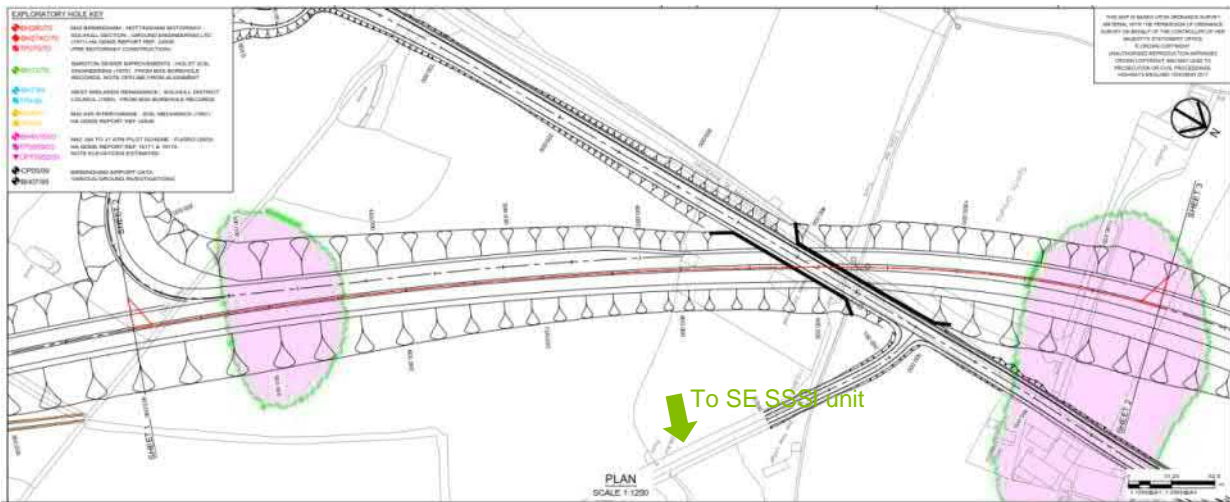
Figure 9. Location of Glacial Sands and Gravels along the proposed link road (shown by Pink shading), in the vicinity of the southeastern SSSI unit.

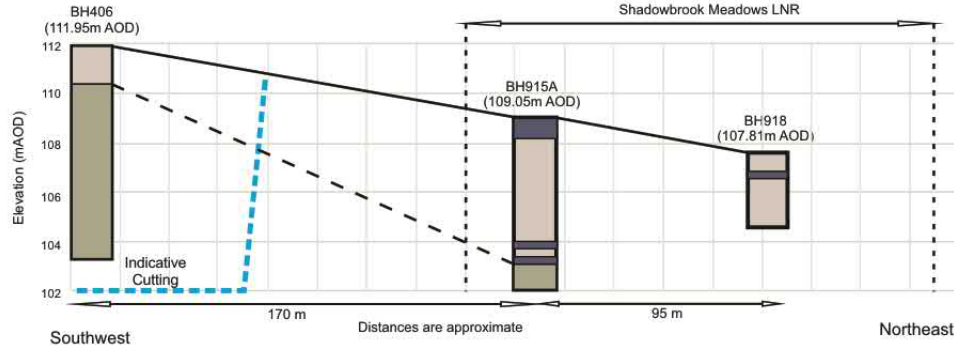
The superficial deposits in the vicinity of the cutting do not include sand layers, and so infiltration is not expected to be significant. Sand layers are only located closer to the SSSI in the area that is not 'cut-off' by the Scheme.

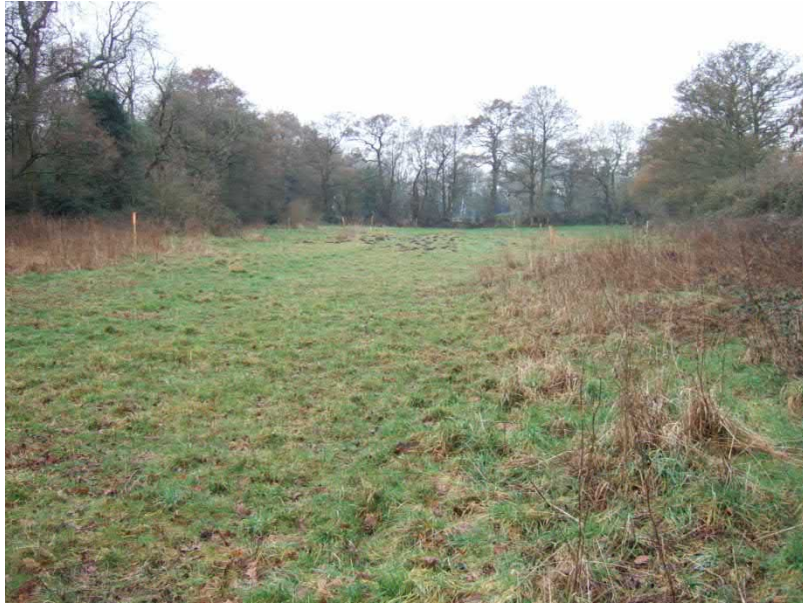
1. 21% total catchment loss. However, this includes only ~2% of the 'direct' catchment to SE Unit.
2. Groundwater recharge appears driven by rainfall events and likely completed prior to central stream flowing continuously.
3. Of the total catchment area lost, this is unlikely to be a significant source of groundwater due to thin superficial deposits and lack of sand layers important for infiltration.
4. Low risk of draw down into cutting due to lack of sand layers.

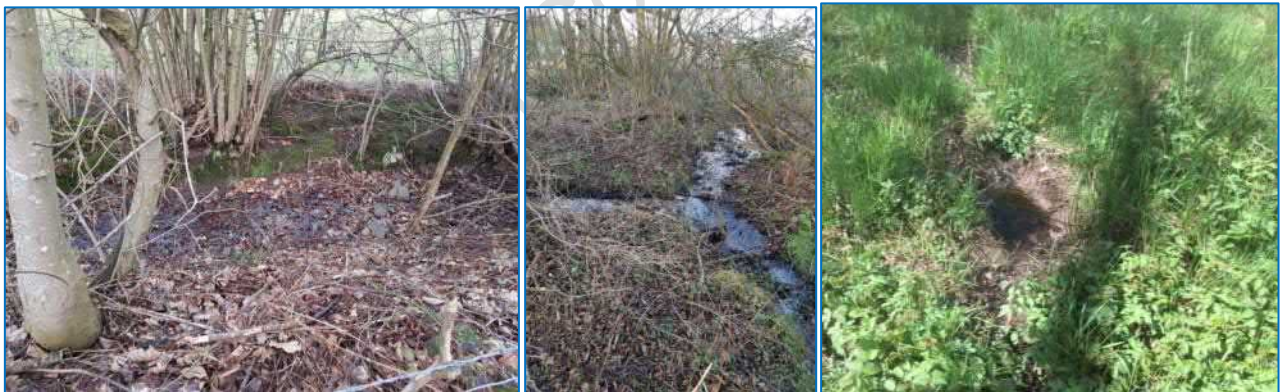
Photo 7 (left) Ponded water in agricultural drainage ditch at NW border of SE Unit; Photo 8 (right) confluence of the tributary of Shadow Brook and the drainage ditch within the alder woodland; Photo 9. Furrows and depressions saturated with water following rainfall in meadow field of SE Unit.

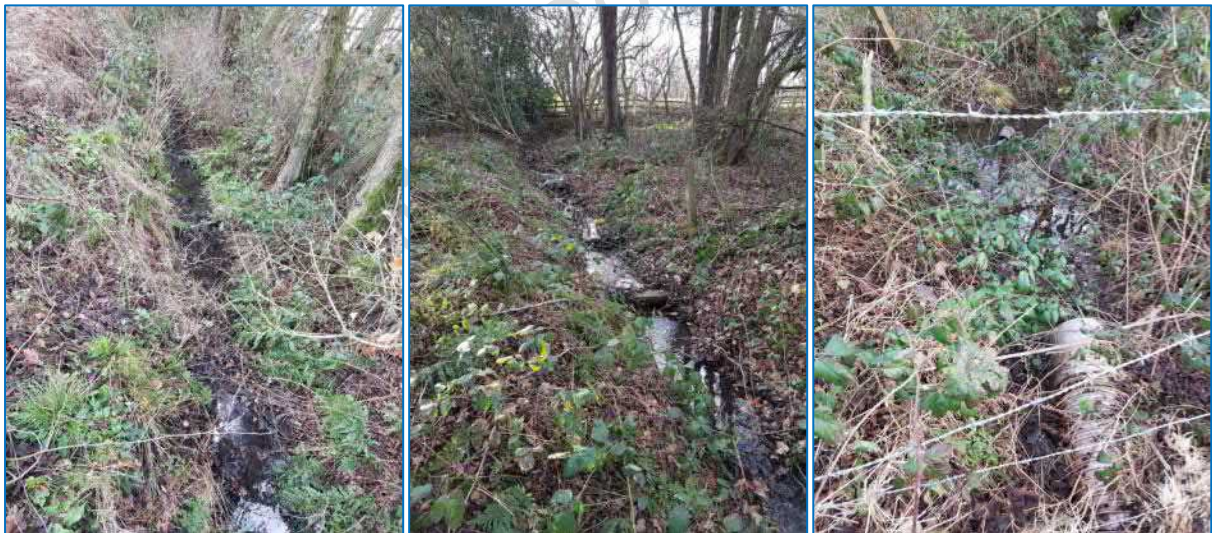
Photo 10 (left) and Photo 11 (centre): Tributary of Shadow Brook within the wet woodland. Photo 12: (right) Culvert exit downstream of the grassed land bridge.

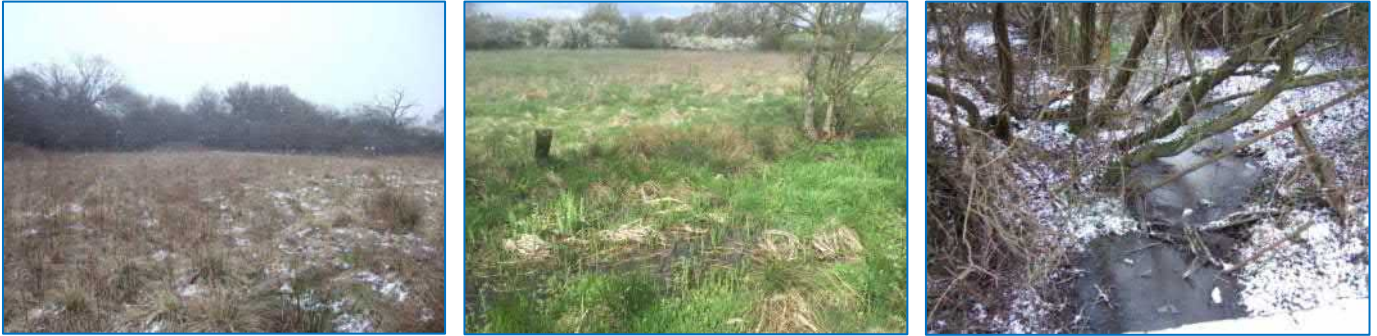
Photo 13 (left), Photo 14 (centre) and Photo 15 (right). Bickenhill Meadows SSSI NW Unit.

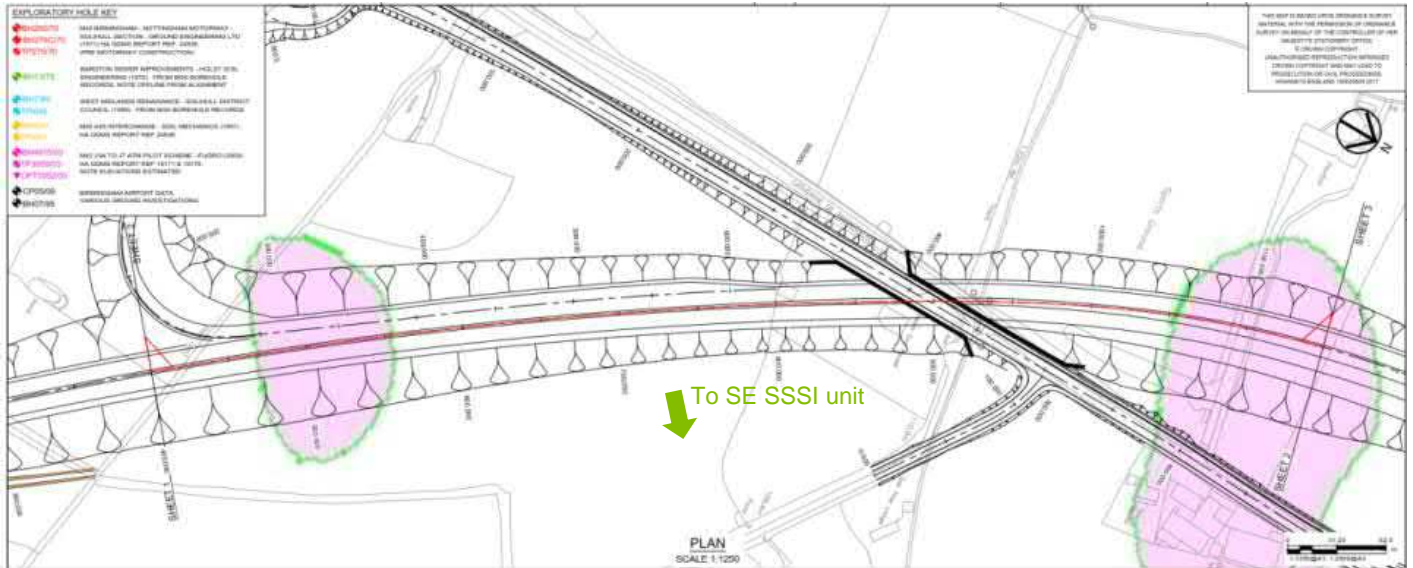
Figure 9. Location of Glacial Sands and Gravels along the new mainline link road (shown by Pink shading), in the vicinity of the southeastern SSSI unit.

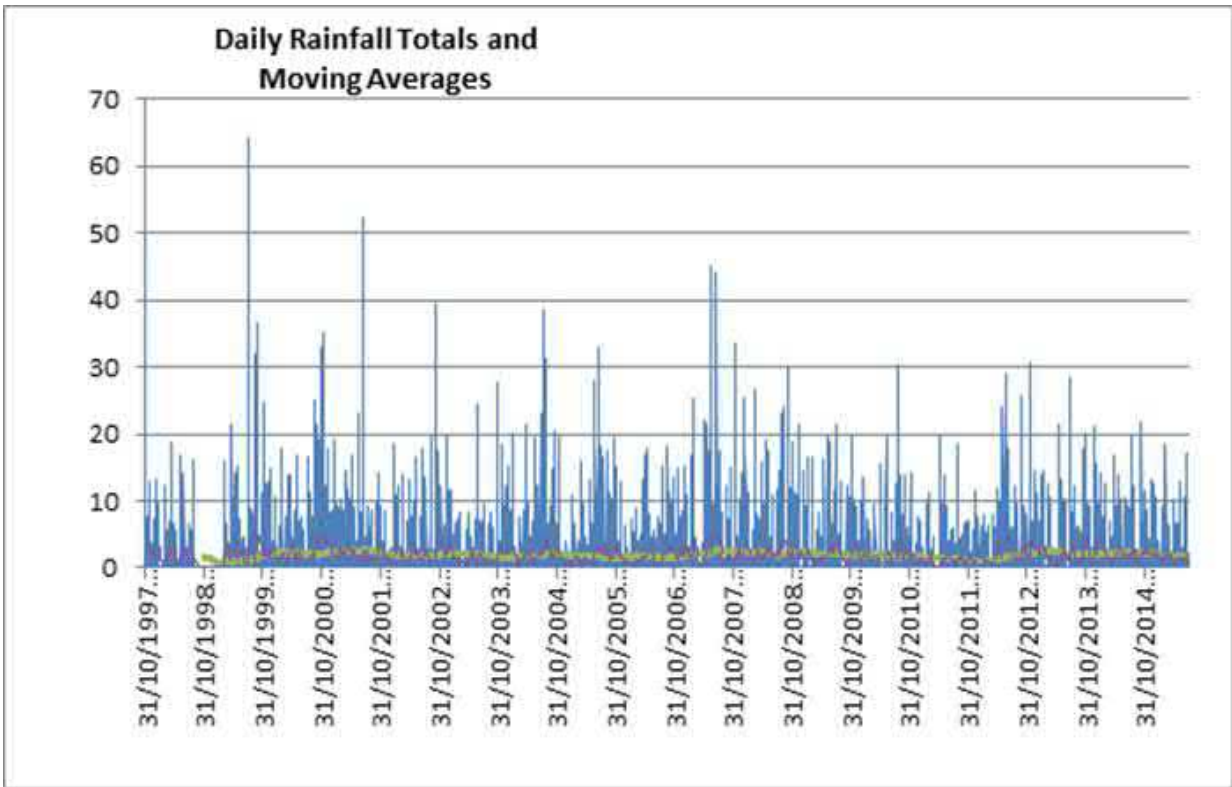
Figure 3: Daily total and moving averages of rainfall data from the Coleshill rain gauge

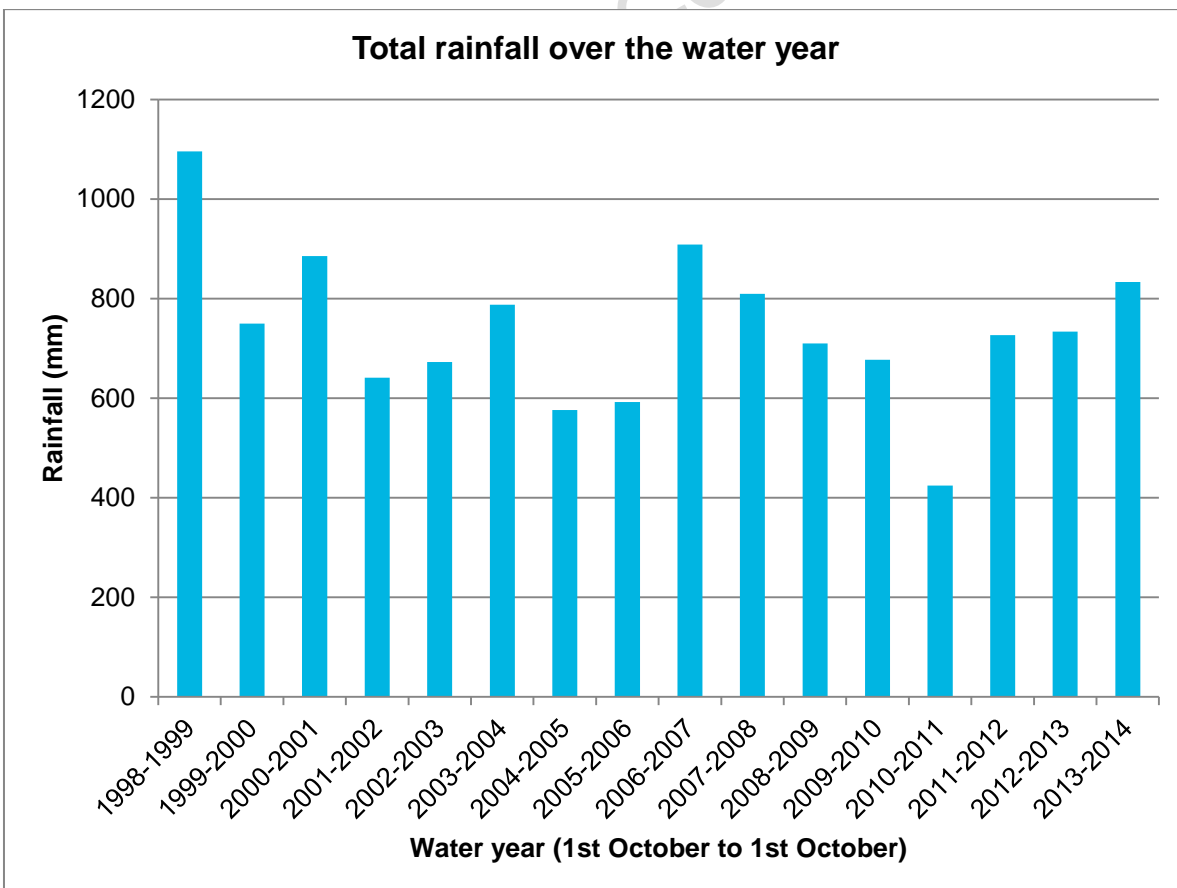
Figure 4: Rainfall total over water years (1st October to 1st October) from the Coleshill rain gauge
