M42 Junction 6 Development Consent Order

Scheme Number TR010027

8.10(b) Statement of Common Ground with Natural England

October 2019

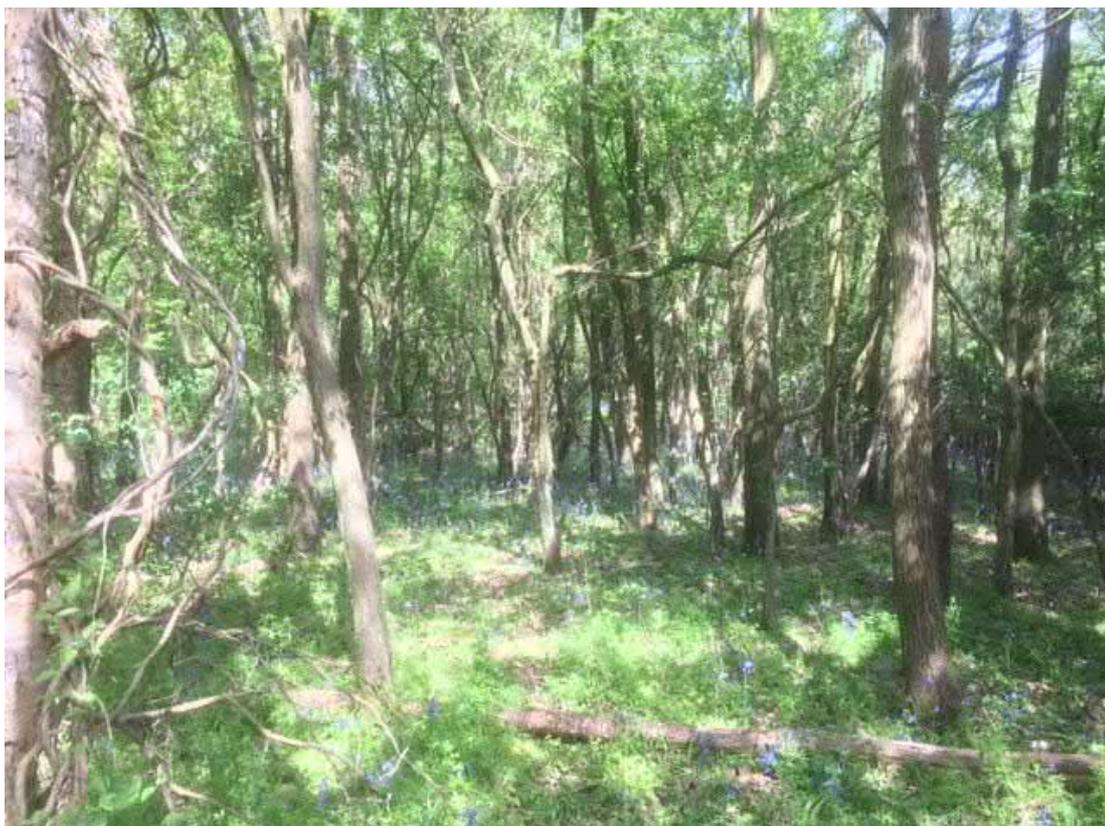
Photograph 1 - Typical canopy and field layer community within Area 1

The woodland within Area 1 therefore most closely conforms to communities W8 or W10 – oak or ash woods that are generally found in lowland Britain on calcareous (W8) to acidic soils (W10). Both W8 and W10 woodlands are relatively variable in the composition of the canopy, with the species composition within the field layer defining the two communities and their respective sub-communities. Where soils are intermediate between calcareous and acidic, the separation between W8 and W10 can be problematic.

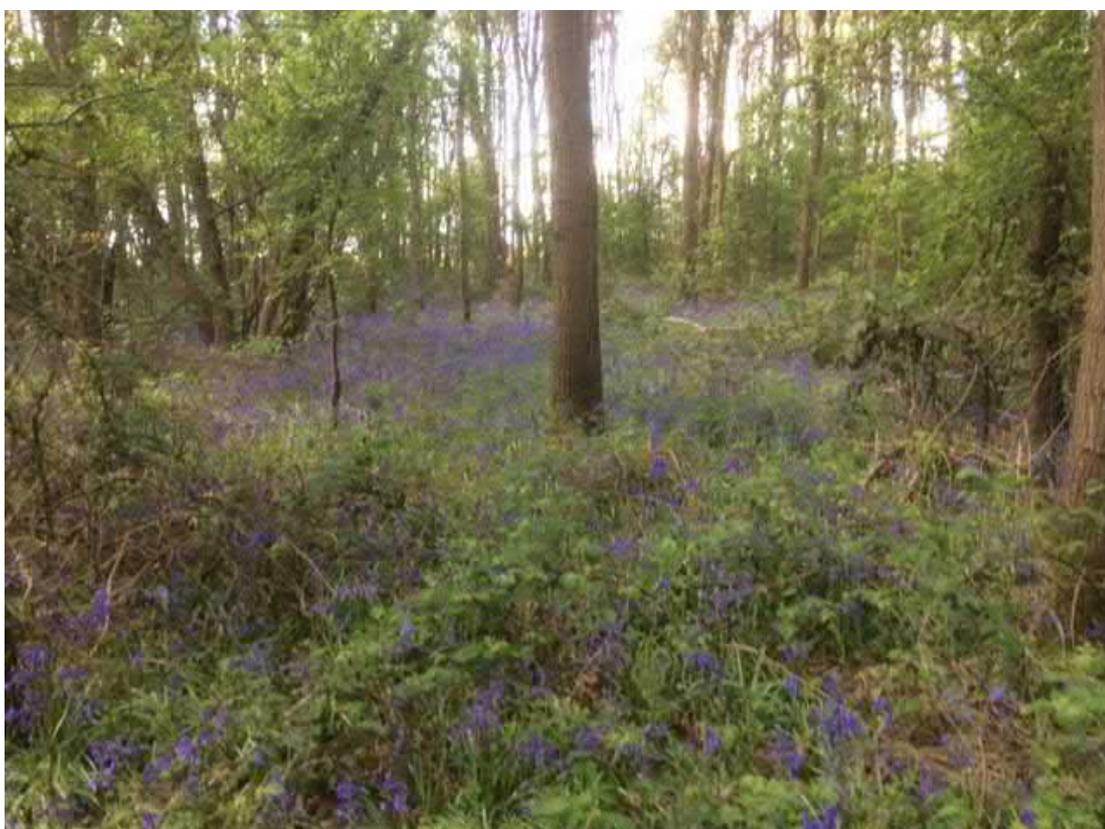
Photograph 2 - Woodland canopy and field layer within Area 2

The woodland within Area 2 is generally of a similar character to Area 1, in that it supports similar species within the canopy, understorey, and field layers. Analysis with MAVIS has shown that Area 2 most closely fits with woodland community W8b *Fraxinus excelsior-Acer campestre-Mercurialis perennis* woodland - *Anemone nemorosa* sub-community. A notable difference between Area 1 and 2, is the relative abundance of dog's mercury within Area 2, which is indicative of more basic soil conditions. This woodland community is, as with Area 1, an intermediary between W8 and W10 woodland, although it is likely to be a closer fit to W8b - *Fraxinus excelsior-Acer campestre-Mercurialis perennis* woodland - *Anemone nemorosa* sub-community, given the abundance of dog's mercury.

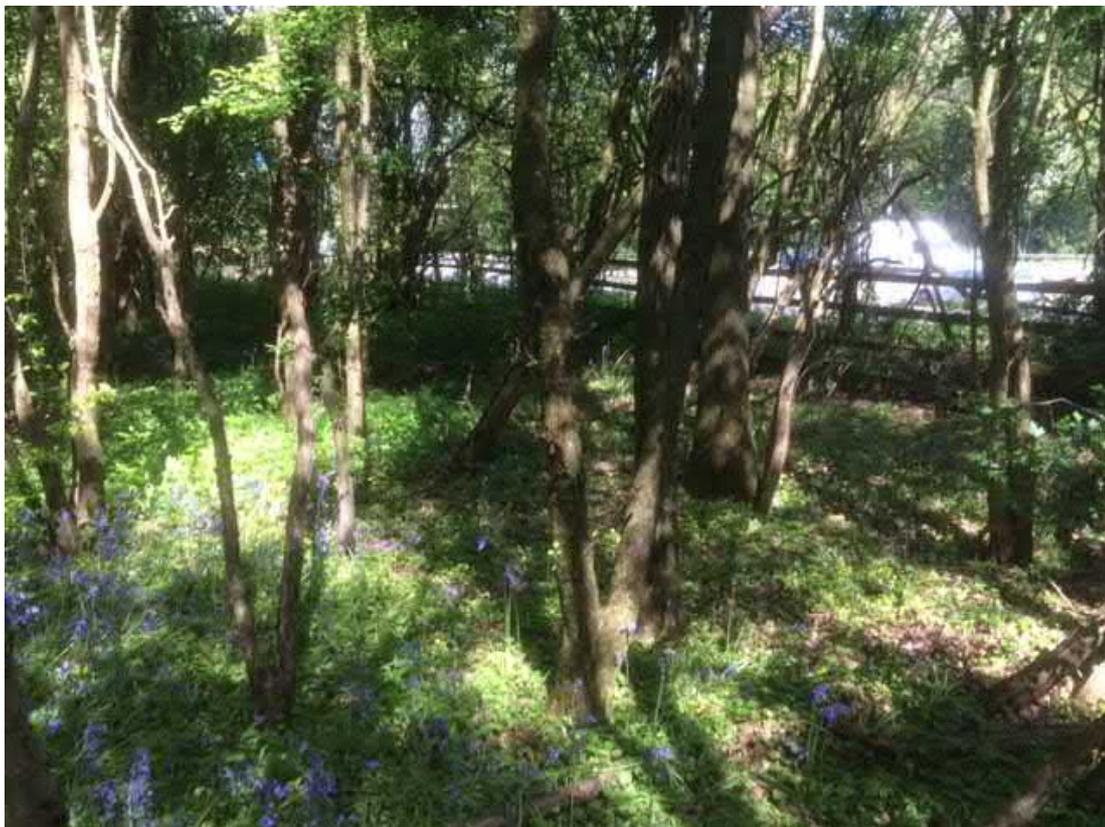
Photograph 3 - Typical woodland habitat within near vicinity of M42 verge in Area 1

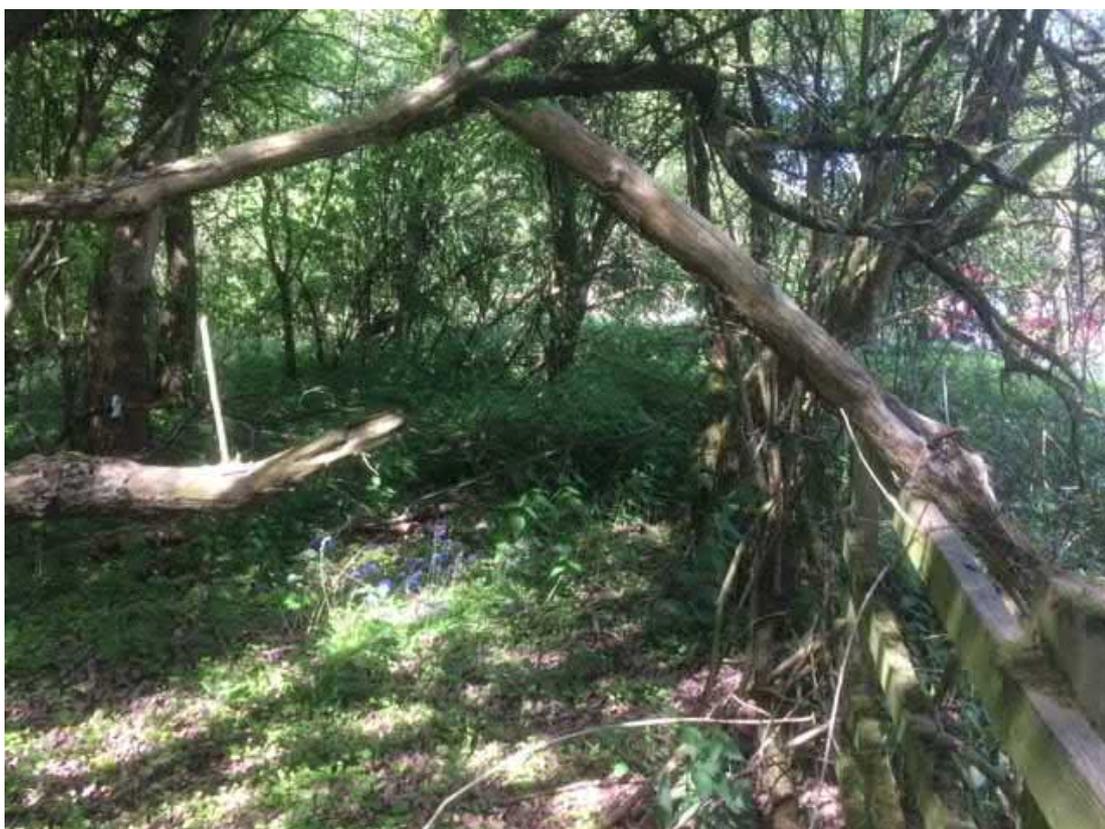
Photograph 4 - Woodland habitat adjacent to M42 verge within Area 2

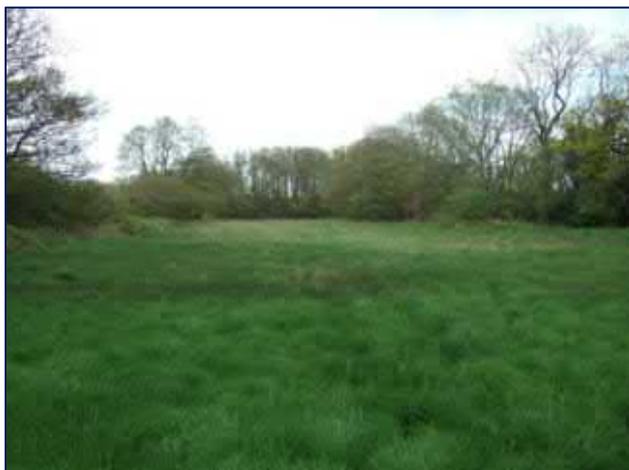
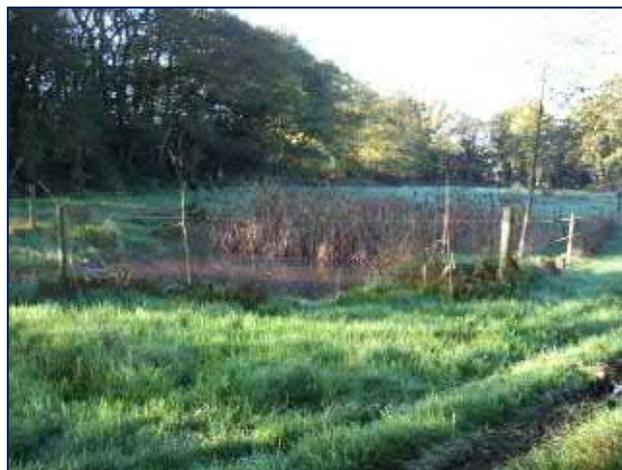
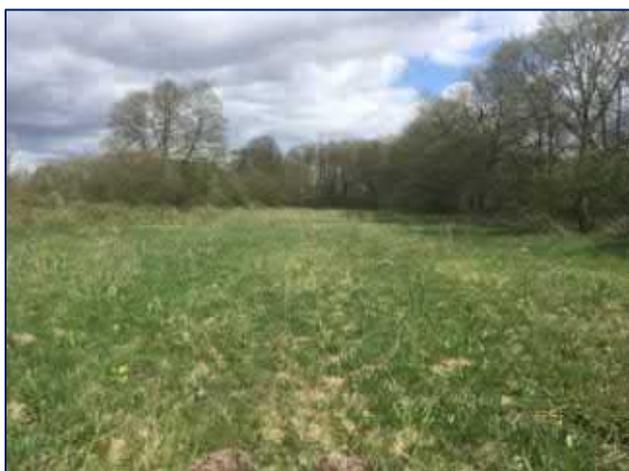
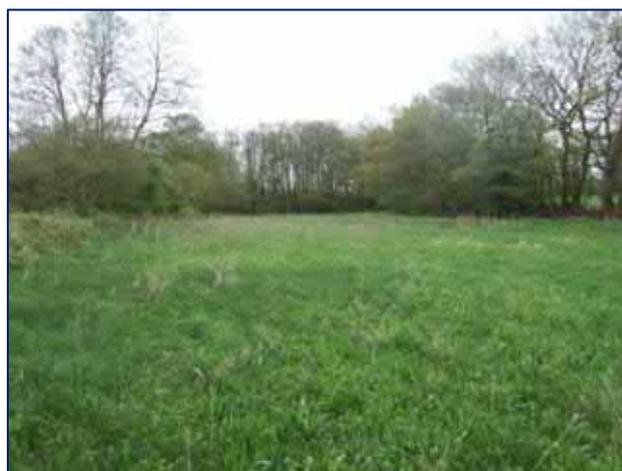
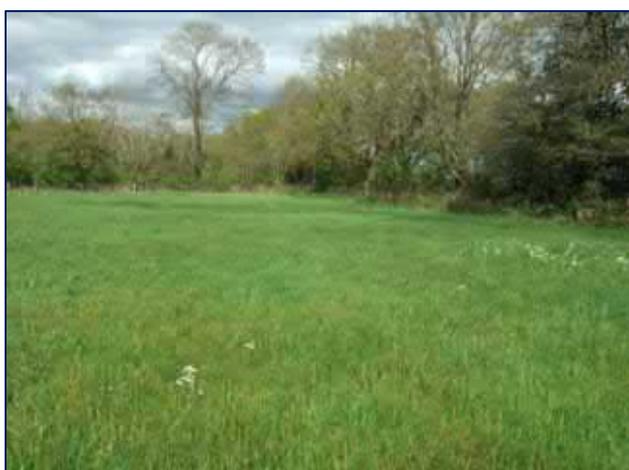
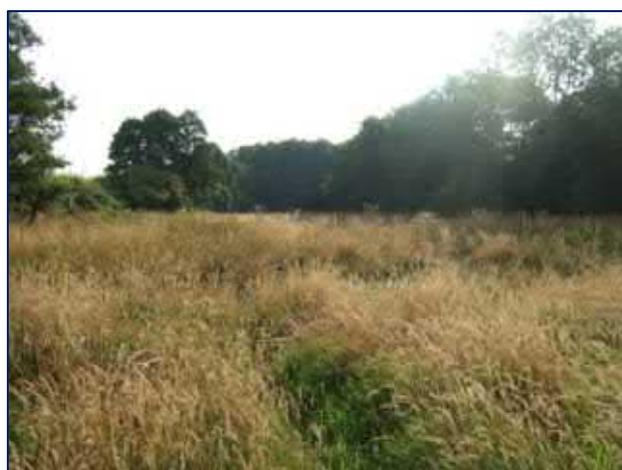
The southeastern unit consists of four fields and wet woodland at the far north of the site, and (along with the LNR) covers 4.4 hectares. The stream that flows through the centre of the site (from southwest to northeast) is a tributary of Shadow Brook. It meets Shadow Brook to the east of the M42 approximately 2 km downstream at NGR SP 20625 82231. The dry meadows are to the east of the site, and wet meadows are to the west. General views of the wet meadows are shown in Photos 1 to 6 under different conditions.

Photo 1 (top left) and Photo 2 (top right) Wet meadow fields at Bickenhill Meadows SSSI SE Unit in cold/wet conditions; Photo 3 (middle left) Wet meadow fields at Bickenhill Meadows SSSI SE Unit in warm/dry conditions; Photo 4 (middle right) and Photo 5 (bottom left) Bickenhill Meadows SSSI SE Unit in warm/dry conditions; Photo 6 (bottom right) Bickenhill Meadows SSSI unit southern field after a prolonged period of hot weather.

The topography of the site is generally level, with a gentle rise in elevation away from the tributary of Shadow Brook, which flows through the approximate centre of the site. The wet meadow to the north of the brook is relatively flat and may have been the route of the former watercourse prior to digging of the new brook course to the south and the ephemeral ditch to the north (which collects runoff from the steeper hillside slopes but is essentially a soakaway).

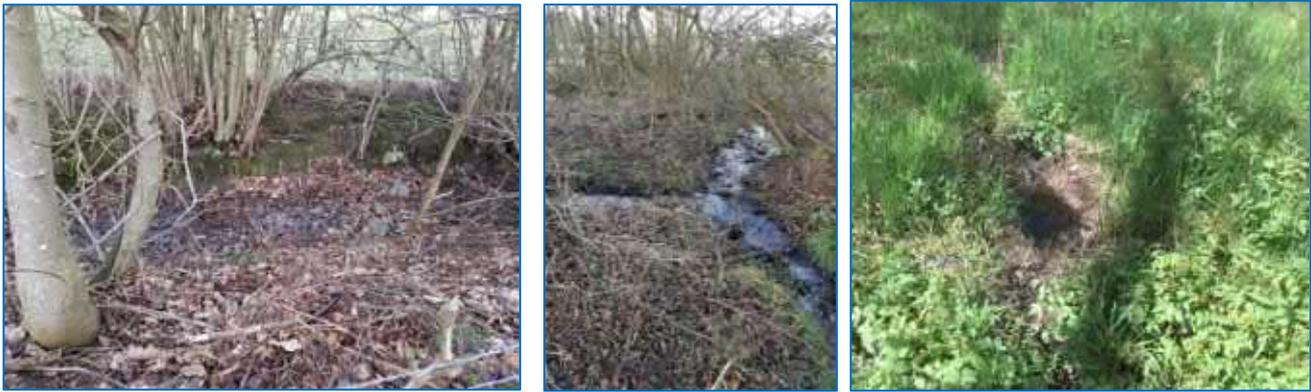
Photo 7 (left) Ponded water in agricultural drainage ditch at NW border of SE SSSI Unit; Photo 8 (right) confluence of the tributary of Shadow Brook and the drainage ditch within the alder woodland; Photo 9. Furrows and depressions saturated with water following rainfall in meadow field of SE SSSI Unit.

There is also an ephemeral drainage ditch bordering the northwest of the site (Photo 7), which varies between 1 and 1.5 m wide. This was largely dry on the majority of site visits, with some ponded water in places of 1-2 cm depth adjacent to the upper wet meadow. However, when observed after heavy rain there was obvious flow in the ditch, which presumably was sourced from runoff from the adjacent arable field which slopes significantly down to the SSSI. As the ditch enters the alder woodland at the northern extent of the SSSI there was a small amount of flow even during the drier site visits, which drains into the tributary of Shadow Brook (approximate NGR SP 18950 81743), see Photo 8.

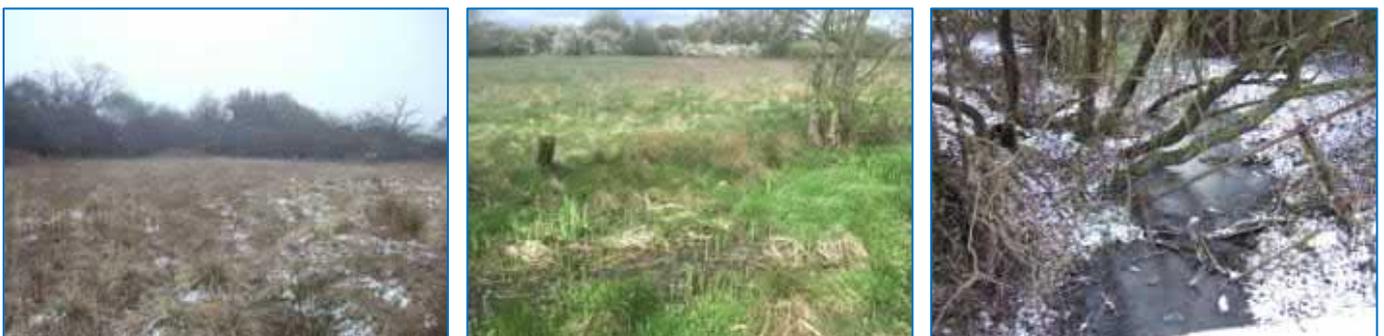
The NW SSSI unit is a small, roughly square grassland area of 2.7 ha, bordered on all sides by a scrub and woodland margin (Photo 13). A tributary of Low Brook flows from south to north and divides the field approximately in half, with the topography rising away from the tributary gently on both sides initially, becoming steeper further field. The brook itself is surrounded by intermittent hedgerow vegetation. Immediately south of the site is a historic landfill site of raised elevation, from which groundwater (of unknown quality) may flow out towards the SSSI, as indicated by iron staining seeping from the embankment.

Photo 13 (left), Photo 14 (centre) and Photo 15 (right). Bickenhill Meadows SSSI NW Unit.

The watercourse appears to emanate from numerous ephemeral drainage ditches which flow around the elevated historic landfill area and coalesce at the south of the site to then flow north through the SSSI. A further drainage ditch flows north along the western boundary of the site. As the watercourse flows north through the SSSI unit it widens out into a very silted marshland area, with little discernable surface water flow (Photo 14), before reverting to a well-defined stream of up to 2.5m width (Photo 15) which has generally good floodplain connectivity within the SSSI, and emergent macrophytic vegetation in places. The watercourse is not considered of sufficient size to cause significant flooding of the adjacent fields.

Vegetation patterns on the eastern side of the SSSI indicate that there may be a spring just upslope of the tributary of Low Brook towards the centre of the site. This is indicated by a slightly raised area with a distinct and ‘spongy’ vegetation assemblage, which is different in character from the surrounding communities of MG4 grasslands (including great burnet (*Sanguisorba officinalis*) and meadowsweet (*Filipendula ulmaria*) and MG5 grasslands (including knapweed (*Centaurea nigra*)) that are found across the eastern field of the site. The wetter ground conditions may also be influenced by dredged material

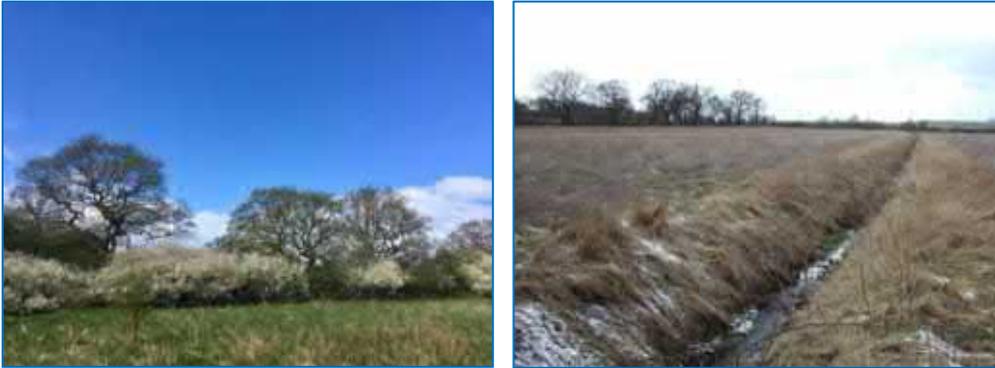
Photo 16 (left) – eastern field within the NW SSSI Unit showing the fringing blackthorn trees. Photo 17 (right) tributary of Low Brook immediately north of the SE SSSI Unit boundary looking towards Birmingham International Airport.

The western field has a generally drier and more uniform character than the eastern field (Photo 16), and is at a slightly greater elevation than the eastern field. The spatial distribution of the MG4 and MG5 grasslands across both fields is a likely consequence of local variability in moisture content in the upper 30-40 cm of soil, with tussocks and ridges across the site providing slightly drier conditions than localised depressions and troughs.

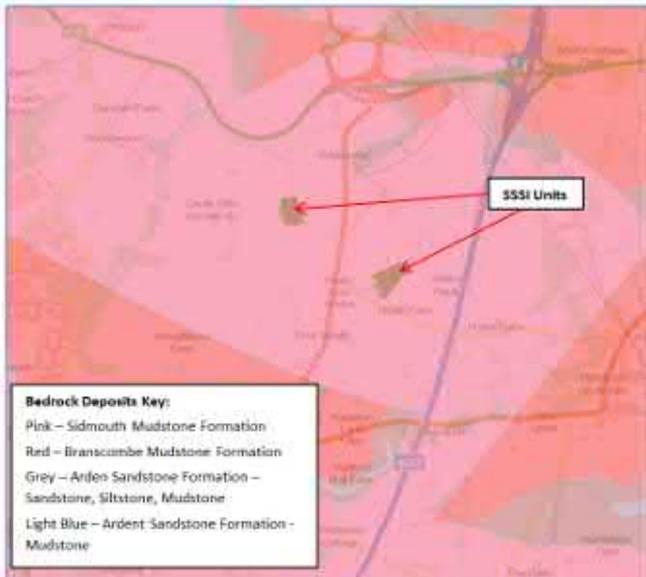
Figure 4. Bedrock deposits in the area around Bickenhill Meadows SSSI (source: British Geological Survey Geindex website, <http://www.bgs.ac.uk/geindex>).

located approximately 250m north of the SSSI unit, adjacent to the tributary of Low Brook (i.e. towards the valley bottom). This borehole (reference CP26) indicated slightly gravelly sandy clay with gravelly sand lenses to 2.2m, underlain by Mercia mudstone, with groundwater struck at 4.2m depth (in October 2011). A borehole approximately 380m north of the SSSI (reference CPRC31) recorded slightly sandy clay to 1.65m underlain by Mercia Mudstone group. No groundwater was encountered (in October 2011).

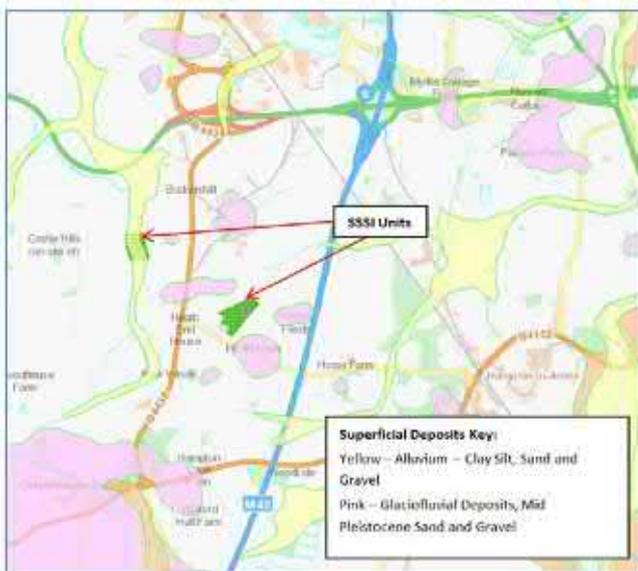
Figure 5. Superficial deposits in the area around Bickenhill Meadows SSSI (source: British Geological Survey Geindex website, <http://www.bgs.ac.uk/geindex>).

There are no historic borehole records in the immediate vicinity of the SE SSSI unit. The nearest is 340m to the east of the site (SP18SE/26B) and was drilled as part of the ground investigation for the M42 in 1970. This borehole had a depth to water of 11.05m. The borehole log indicates that the upper layers consisted of silty clay (weathered mudstone), with lumps of hard mudstone apparent from 4.45m depth, and weathered mudstone extending to the borehole base at 13.55m.

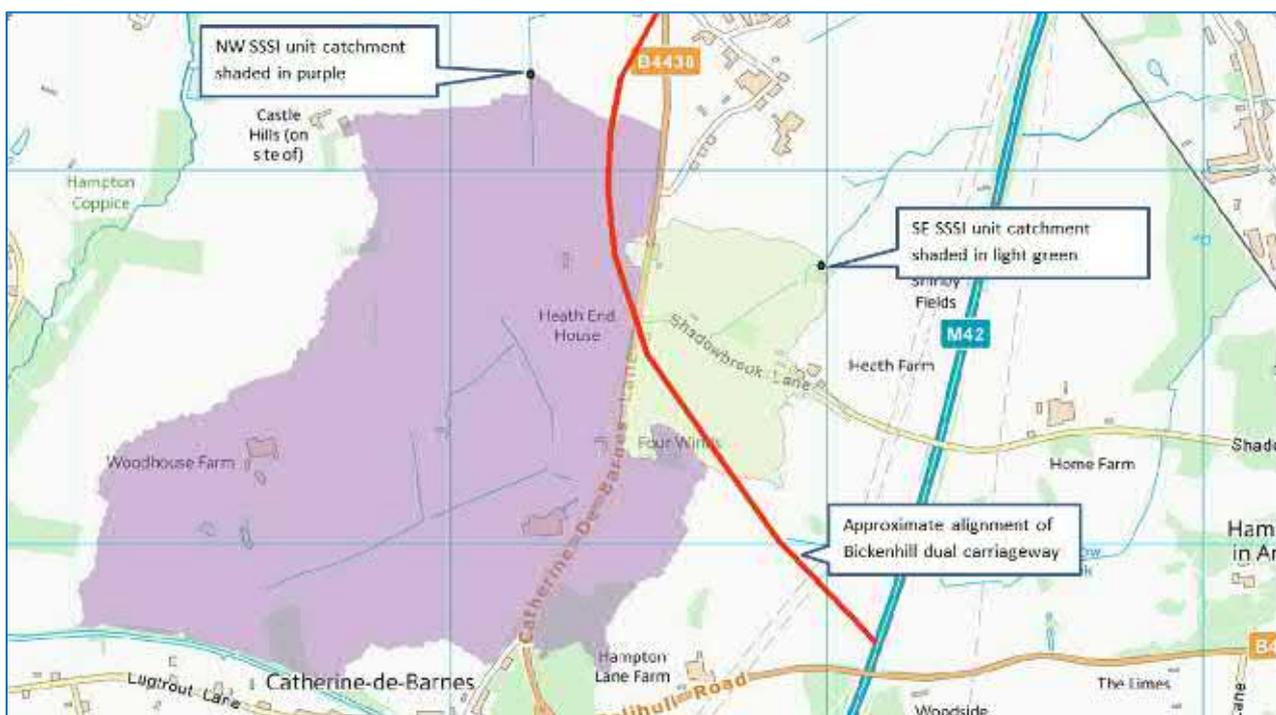
In Figure 8, the catchments for each SSSI unit have been derived from the LiDAR data. The NW SSSI unit has a noticeably larger catchment than the SE SSSI unit, and extends a considerable distance to the southwest where it is interrupted by the Grand Union Canal near Catherine de Barnes. On the basis of the approximate road alignment shown in Figure 8, the proportion of the catchment lost for each SSSI unit would be in the region of 3% for the NW unit and 14% for the SE unit. This is an approximation, and can be updated following release of a shapefile for the general arrangement of the proposed scheme from the design team.

Figure 8. Catchment boundaries as determined from GIS analysis, with approximate road alignment overlain in red.

The site observations and topographic investigation of LiDAR data suggest that surface water flows are important contributors to the habitats in the two SSSI units, particularly in the close vicinity of the channels. However, significant flooding of the units is very unlikely and it is more likely that rainfall combined with the ridge and furrow topography and localised hillslope runoff is the most significant source of water controlling the hydrology of the wet meadows. The role of groundwater flow is unclear, but features such as the apparent spring in the NW SSSI suggest that it is a contributor, at least in certain locations.

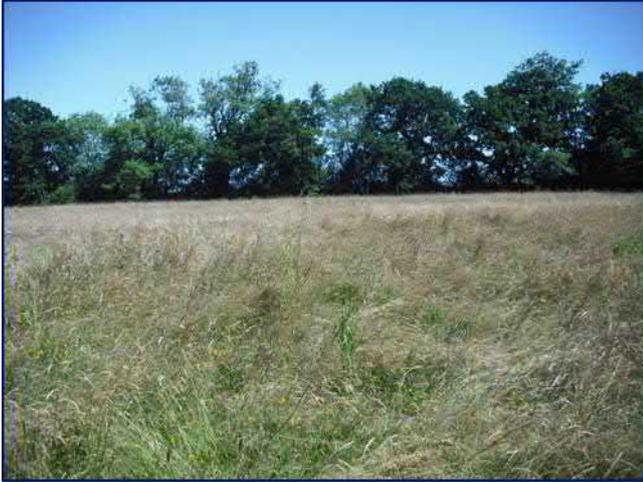
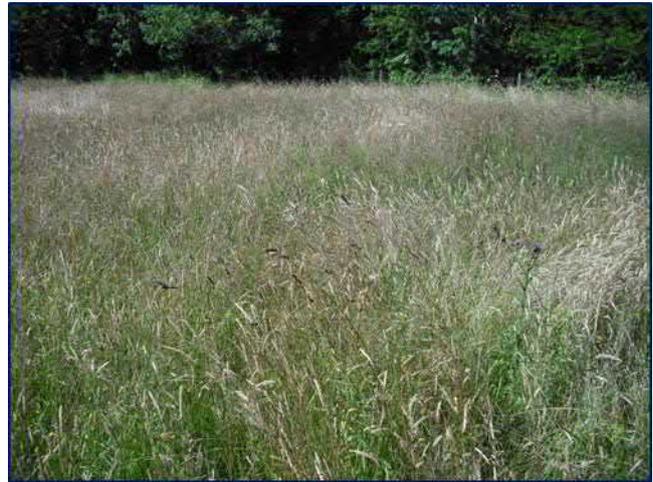
The two fields on the eastern side slope down to the watercourse and the vegetation on the day of the survey was grass dominated (tall and lodging in places) and dry (Photo 18 and 19). Yorkshire fog (*Holcus lanatus*) was abundant with other grasses such as cock’s foot (*Dactylis glomerata*), common bent (*Agrostis capillaris*), red fescue (*Festuca rubra*), crested dog’s tail (*Cynosurus cristatus*) and meadow fescue (*Schedonorus pratensis*). A range of generally common forbs were recorded and included ribwort

Photo 18 (left) and Photo 19 (right), typical vegetation in the SE SSSI unit eastern fields.

Seven quadrats were recorded in the two fields, as they were uniform in appearance and structure. The data obtained was run through TABLEFIT and the goodness of fit to the NVC community type MG5; *Cynosurus cristatus* - *Centaurea nigra* was at around 83% and classed as very good fit. The second best fit was to the MG5a *Lathyrus pratensis* sub-community type.

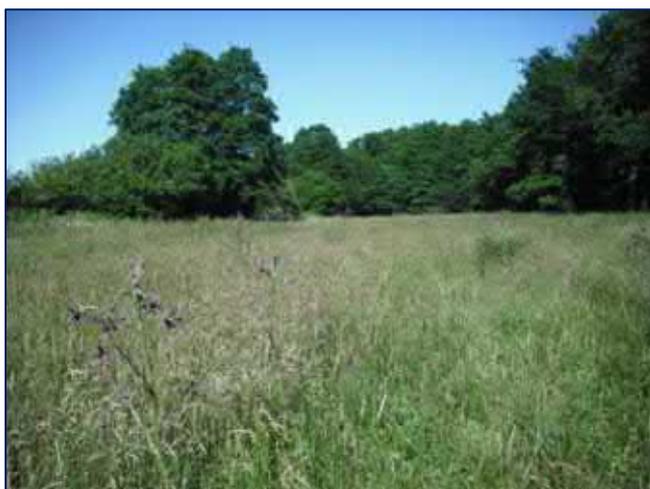
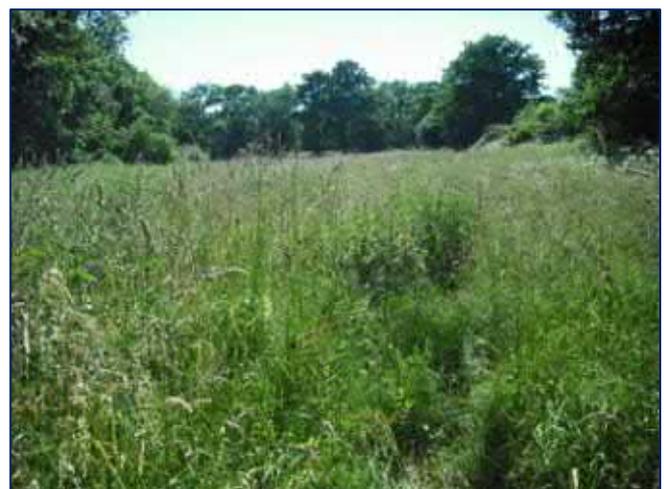
The field within the SE SSSI unit on the west side of the watercourse was generally flat but with an apparent rise towards the northern boundary; the grasses did not dominate to the degree they did in the dry fields and there were patches of meadowsweet (*Filipendula ulmaria*) and great burnet (*Sanguisorba officinalis*) (Photo 20 and 21). Meadowsweet and other wetland species such as wild angelica (*Angelica sylvestris*) seemed to be more frequent towards the watercourse where the vegetation was taller and coarser. Interesting species recorded here were betony (*Stachys officinalis*) and tormentil (*Potentilla erecta*). It has been reported that meadow thistle (*Cirsium dissectum*) is also present but this was not found during the current survey.

Photo 20 (left) and Photo 21 (right), typical vegetation in the SE SSSI unit wet meadow field.

Five quadrats were recorded in this western field and along with the data collected from similar vegetation recorded in the NW section of the SSSI (describe below) were run through TABLEFIT. The goodness-of-fit to the NVC community type MG4; *Alopecurus pratensis* – *Sanguisorba officinalis* was around 63% and classed as a fair fit. Any variation in the vegetation from topographical variation was masked by the tall growth and a better understanding of this would be obtained once the field has been cut. This will provide

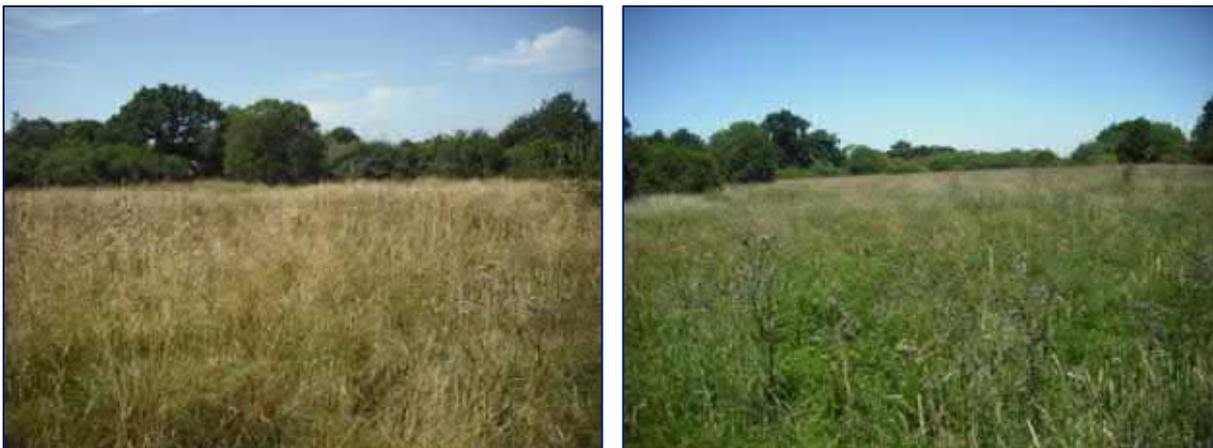
The NW SSSI unit comprises two fields separated by a small, ephemeral watercourse, which was dry on the day of the survey. The western field appeared to be uniform in structure and was generally a mix of patches of larger forbs such as great burnet (*Sanguisorba officinalis*) and meadowsweet (*Filipendula ulmaria*), and grasses with a range of smaller forbs including several legumes scrambling through the vegetation. This field appeared to be more diverse than the corresponding field in the SE SSSI unit and here saw-wort (*Serratula tinctoria*), quaking grass (*Briza media*) and devil's bit scabious (*Succisa pratensis*) were recorded in addition to the more typical and commoner forb species. When visited in August 2018, tufted hair grass (*Deschampsia cespitosa*) was the dominant species in this field.

Photo 22 (left) and Photo 23 (right), typical vegetation in the NW SSSI unit western field.

Five quadrats were recorded in the field and along with the data collected from similar vegetation recorded in the SE SSSI unit were run through TABLEFIT. The goodness-of-fit to the NVC community type MG4; *Alopecurus pratensis* – *Sanguisorba officinalis* was around 63% and classed as a fair fit.

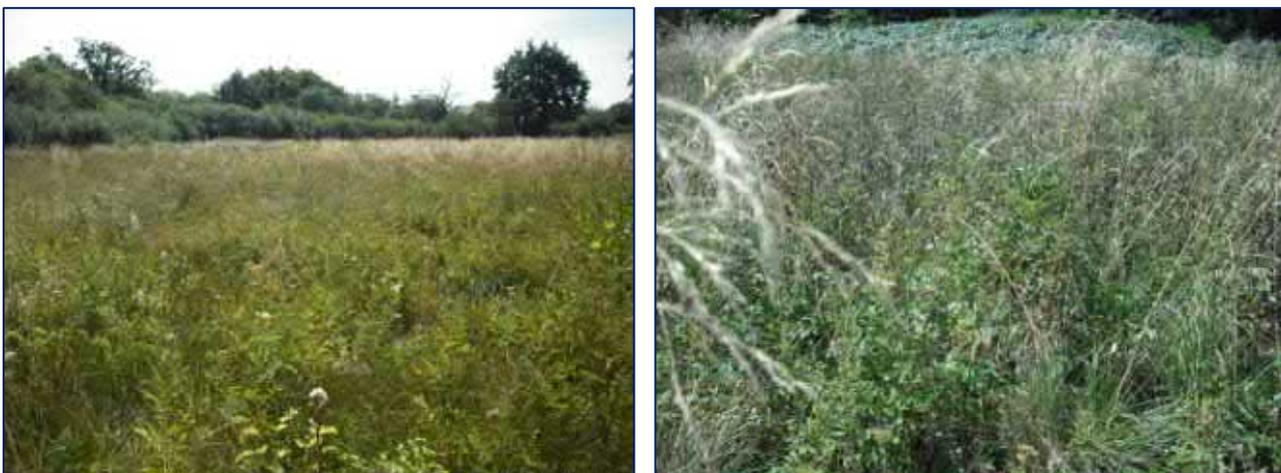
The eastern field of the NW SSSI unit was only visited in August and had much coarser vegetation and the dominant grass across larger areas was tufted hair grass (*Deschampsia cespitosa*) but with meadowsweet and great burnet also frequent throughout the field. Sedges appeared to be more common in this field and included hairy sedge (*Carex hirta*), false fox sedge (*Carex otrubae*), common sedge (*Carex nigra*) and tufted sedge (*Carex acuta*). Otherwise it was very similar to the western field (Photos 24 and 25).

Photo 24 (left) and Photo 25 (right), typical vegetation in the NW SSSI unit eastern field.

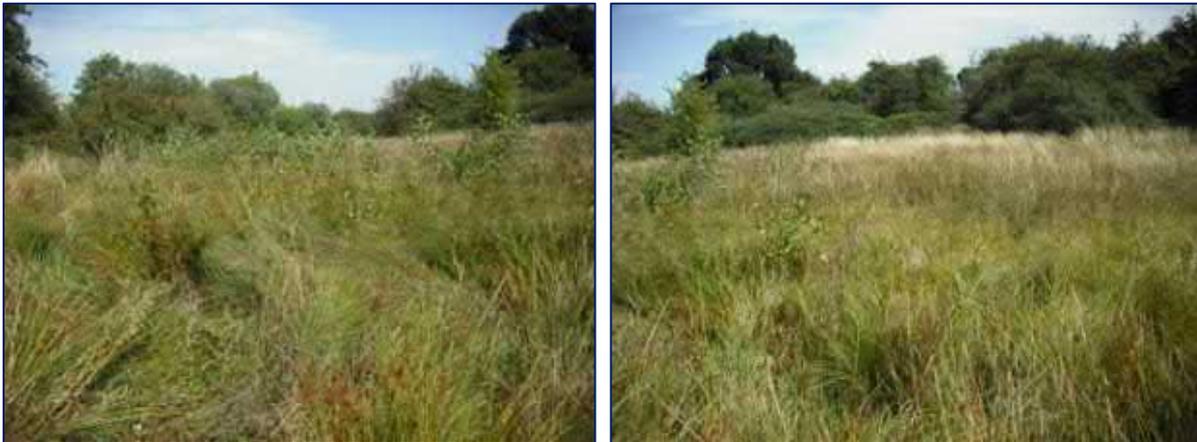
Part way along the western boundary of the field, there was a distinctive change in vegetation and whilst this will have to be shown by survey, it appeared to be delineated by a low spot, possibly linked to the ditch and was demarked by young alders (*Alnus glutinosa*). The vegetation here was dominated by tall rushes including soft rush (*Juncus effusus*), hard rush (*Juncus inflexus*) and sharp flowered rush (*Juncus acutiflorus*), along with sedges with abundant great hairy willowherb (*Epilobium hirsutum*) and in the wettest areas patches of fool's watercress (*Apium nodiflorum*). This is the area considered to be a potential spring in the preceding discussion (Photo 26 and Photo 27).

Photo 26 (left) and Photo 27 (right), typical vegetation in the distinct wetter area within the NW SSSI unit eastern field.

Five quadrats were recorded in this area and the data was run through TABLEFIT. The goodness-of-fit to the NVC community type OV26; *Epilobium hirsutum* community was around 58% and classed as a fair fit. A similar fit was obtained from the MG9 community; *Holcus lanatus-Deschampsia cespitosa* grassland. This community is found in area where the ground is seasonally waterlogged and can be found in association with MG4 grassland but is not usually as species diverse and is tolerant of less free draining soils.

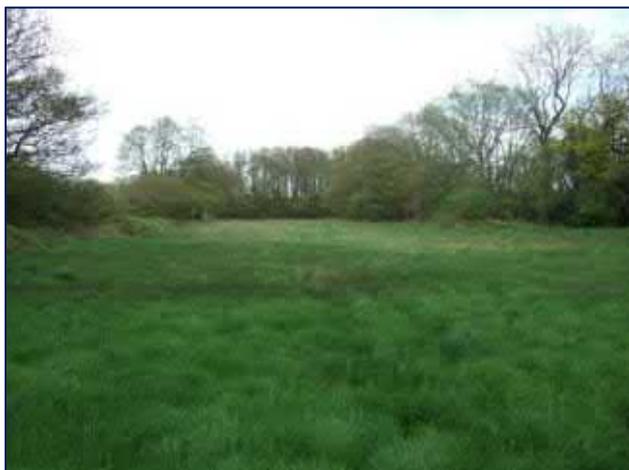
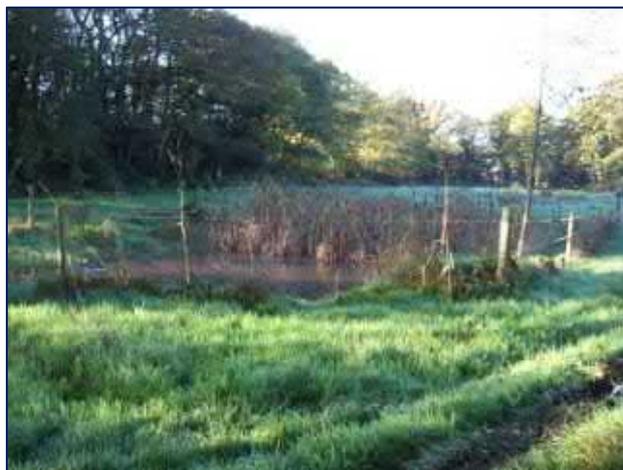
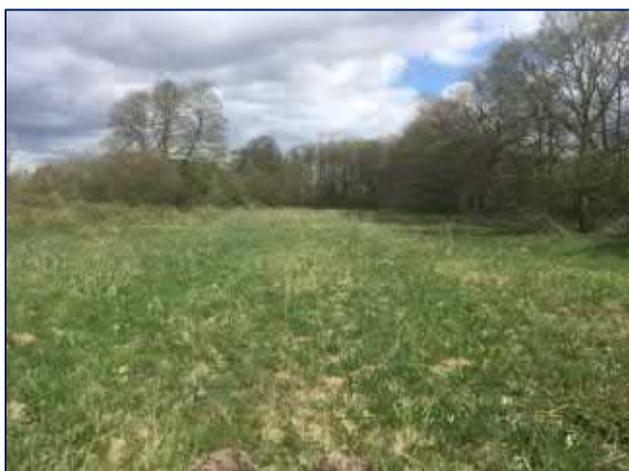
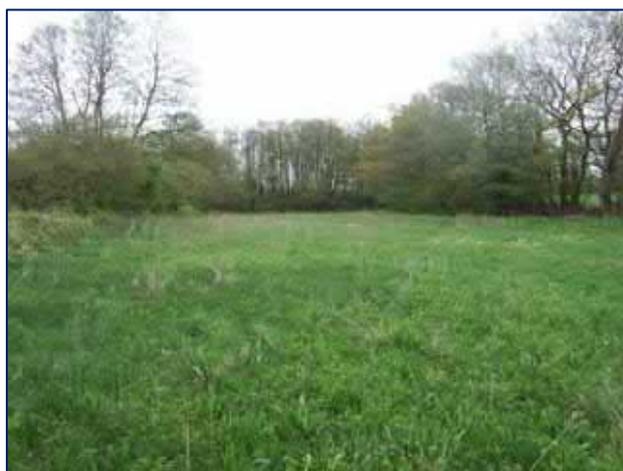
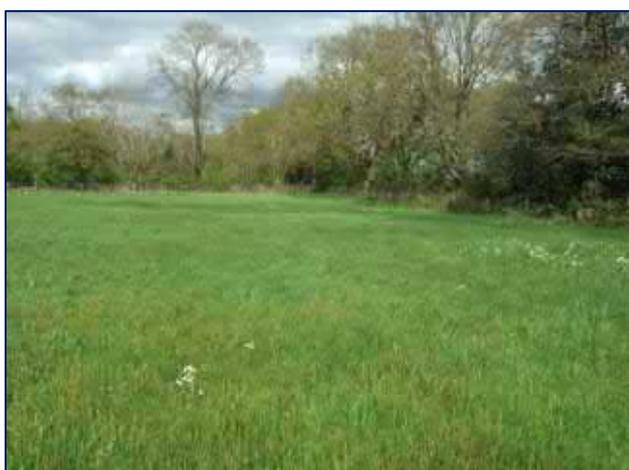
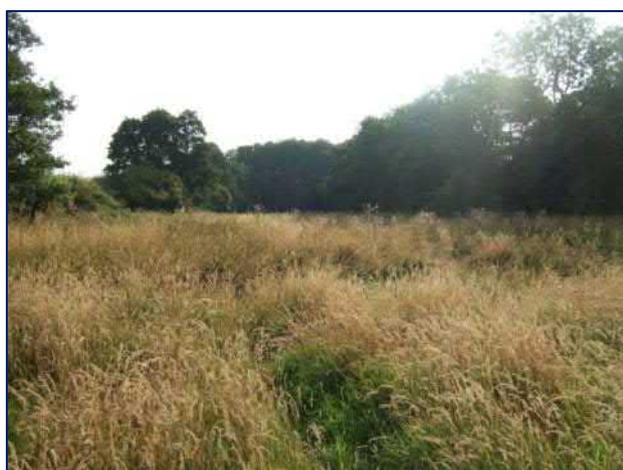
The southeastern unit consists of four fields and wet woodland at the far north of the site, and (along with the LNR) covers 4.4 hectares. The stream that flows through the centre of the site (from southwest to northeast) is a tributary of Shadow Brook. It meets Shadow Brook to the east of the M42 approximately 2 km downstream at NGR SP 20625 82231. The dry meadows are to the east of the site, and wet meadows are to the west. General views of the wet meadows are shown in Photos 1 to 6 under different conditions.

Photo 1 (top left) and Photo 2 (top right) Wet meadow fields at Bickenhill Meadows SSSI SE Unit in cold/wet conditions; Photo 3 (middle left) Wet meadow fields at Bickenhill Meadows SSSI SE Unit in warm/dry conditions; Photo 4 (middle right) and Photo 5 (bottom left) Bickenhill Meadows SSSI SE Unit in warm/dry conditions; Photo 6 (bottom right) Bickenhill Meadows SSSI unit southern field after a prolonged period of hot weather.

The topography of the site is generally level, with a gentle rise in elevation away from the tributary of Shadow Brook, which flows through the approximate centre of the site. The wet meadow to the north of the brook is relatively flat and may have been the route of the former watercourse prior to digging of the new brook course to the south and the ephemeral ditch to the north (which collects runoff from the steeper hillside slopes but is essentially a soakaway).

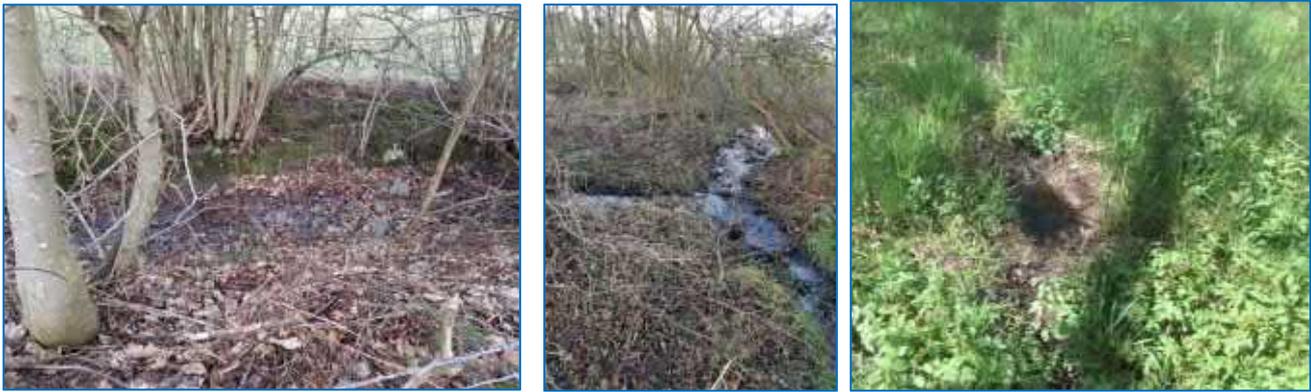
Photo 7 (left) Ponded water in agricultural drainage ditch at NW border of SE SSSI Unit; Photo 8 (right) confluence of the tributary of Shadow Brook and the drainage ditch within the alder woodland; Photo 9. Furrows and depressions saturated with water following rainfall in meadow field of SE SSSI Unit.

There is also an ephemeral drainage ditch bordering the northwest of the site (Photo 7), which varies between 1 and 1.5 m wide. This was largely dry on the majority of site visits, with some ponded water in places of 1-2 cm depth adjacent to the upper wet meadow. However, when observed after heavy rain there was obvious flow in the ditch, which presumably was sourced from runoff from the adjacent arable field which slopes significantly down to the SSSI. As the ditch enters the alder woodland at the northern extent of the SSSI there was a small amount of flow even during the drier site visits, which drains into the tributary of Shadow Brook (approximate NGR SP 18950 81743), see Photo 8.

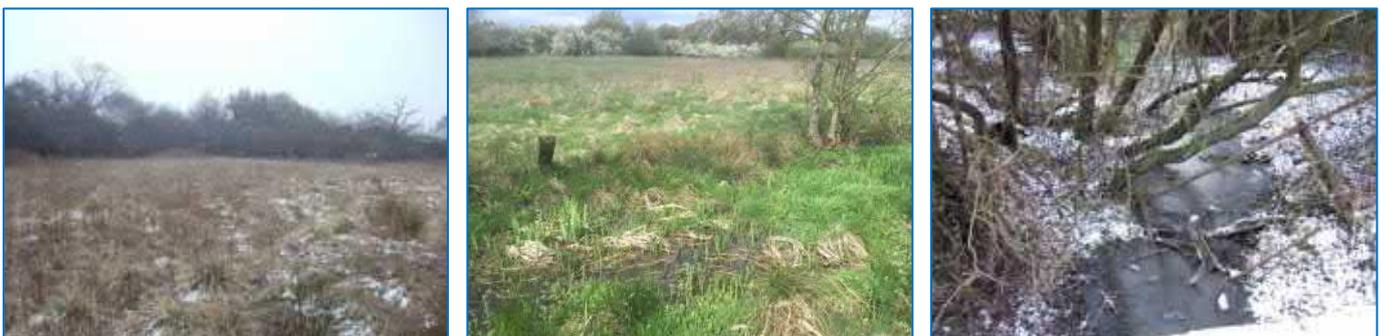
The NW SSSI unit is a small, roughly square grassland area of 2.7 ha, bordered on all sides by a scrub and woodland margin (Photo 13). A tributary of Low Brook flows from south to north and divides the field approximately in half, with the topography rising away from the tributary gently on both sides initially, becoming steeper further field. The brook itself is surrounded by intermittent hedgerow vegetation. Immediately south of the site is a historic landfill site of raised elevation, from which groundwater (of unknown quality) may flow out towards the SSSI, as indicated by iron staining seeping from the embankment.

Photo 13 (left), Photo 14 (centre) and Photo 15 (right). Bickenhill Meadows SSSI NW Unit.

The watercourse appears to emanate from numerous ephemeral drainage ditches which flow around the elevated historic landfill area and coalesce at the south of the site to then flow north through the SSSI. A further drainage ditch flows north along the western boundary of the site. As the watercourse flows north through the SSSI unit it widens out into a very silted marshland area, with little discernable surface water flow (Photo 14), before reverting to a well-defined stream of up to 2.5m width (Photo 15) which has generally good floodplain connectivity within the SSSI, and emergent macrophytic vegetation in places. The watercourse is not considered of sufficient size to cause significant flooding of the adjacent fields.

Vegetation patterns on the eastern side of the SSSI indicate that there may be a spring just upslope of the tributary of Low Brook towards the centre of the site. This is indicated by a slightly raised area with a distinct and ‘spongy’ vegetation assemblage, which is different in character from the surrounding communities of MG4 grasslands (including great burnet (*Sanguisorba officinalis*) and meadowsweet (*Filipendula ulmaria*) and MG5 grasslands (including knapweed (*Centaurea nigra*)) that are found across the eastern field of the site. The wetter ground conditions may also be influenced by dredged material

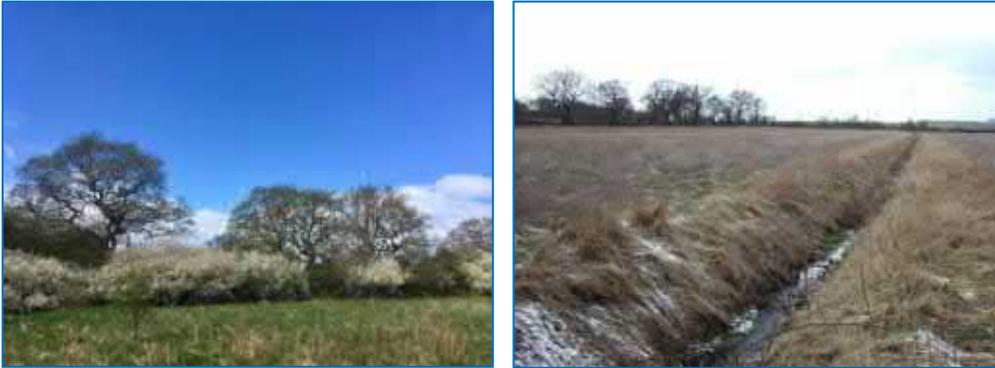
Photo 16 (left) – eastern field within the NW SSSI Unit showing the fringing blackthorn trees. Photo 17 (right) tributary of Low Brook immediately north of the SE SSSI Unit boundary looking towards Birmingham International Airport.

The western field has a generally drier and more uniform character than the eastern field (Photo 16), and is at a slightly greater elevation than the eastern field. The spatial distribution of the MG4 and MG5 grasslands across both fields is a likely consequence of local variability in moisture content in the upper 30-40 cm of soil, with tussocks and ridges across the site providing slightly drier conditions than localised depressions and troughs.

As the tributary of Low Brook flows out of the SSSI to the north of the site, the watercourse becomes a perfectly straight (artificially straightened), deeply incised drainage channel with a width of around 1 m (see Photo 17). This flows north to Low Brook, which is then culverted beneath the Birmingham International Airport runway.

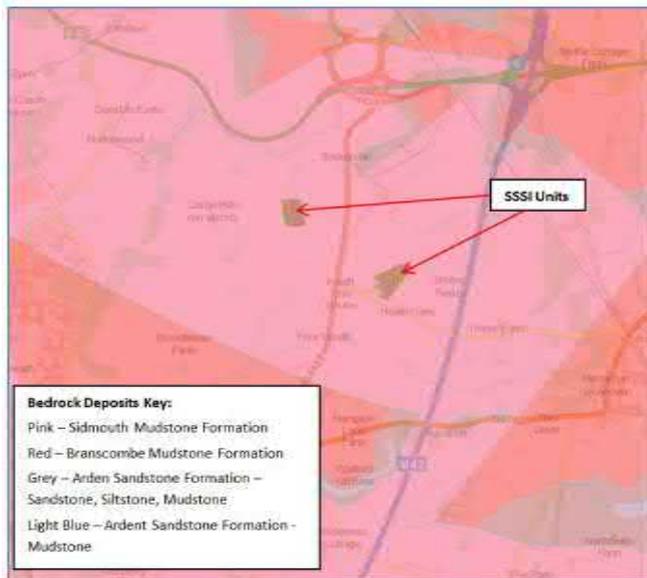
Figure 4. Bedrock deposits in the area around Bickenhill Meadows SSSI (source: British Geological Survey Geindex website, <http://www.bgs.ac.uk/geindex>).

According to the British Geological Survey's Geology of Britain website (<http://mapapps.bgs.ac.uk/geologyofbritain3d/>) the bedrock geology beneath both SSSI units is Sidmouth Mudstone Formation (Figure 4). No superficial deposits are recorded below the SE SSSI unit, while alluvium (clay, silt, sand and gravel) is found around the stream through the NW SSSI unit (Figure 5).

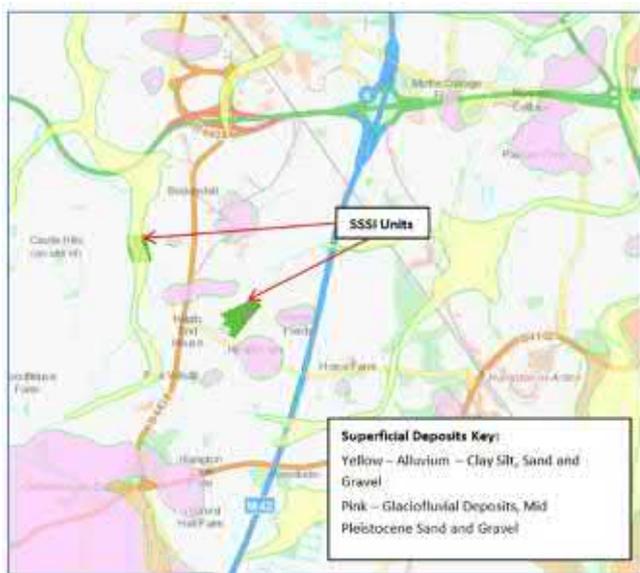
Figure 5. Superficial deposits in the area around Bickenhill Meadows SSSI (source: British Geological Survey Geindex website, <http://www.bgs.ac.uk/geindex>).

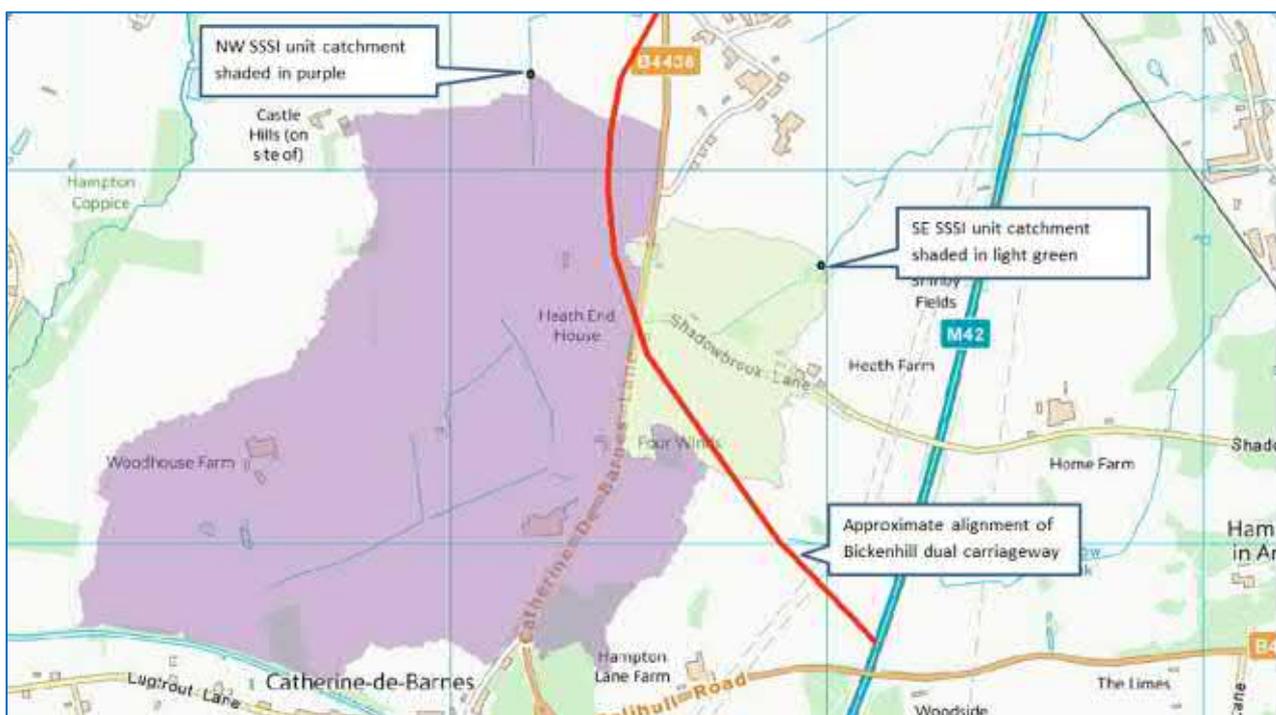
Figure 8. Catchment boundaries as determined from GIS analysis, with approximate road alignment overlain in red.

In Figure 8, the catchments for each SSSI unit have been derived from the LiDAR data. The NW SSSI unit has a noticeably larger catchment than the SE SSSI unit, and extends a considerable distance to the southwest where it is interrupted by the Grand Union Canal near Catherine de Barnes. On the basis of the approximate road alignment shown in Figure 8, the proportion of the catchment lost for each SSSI unit would be in the region of 3% for the NW unit and 14% for the SE unit. This is an approximation, and can be updated following release of a shapefile for the general arrangement of the proposed scheme from the design team.
